**ROCKFALL HAZARD ASSESSMENT AT BOOTH FALLS
CONDOMINIUMS
AND PROPOSED MITIGATION**

prepared for
The Town of Vail, Colorado

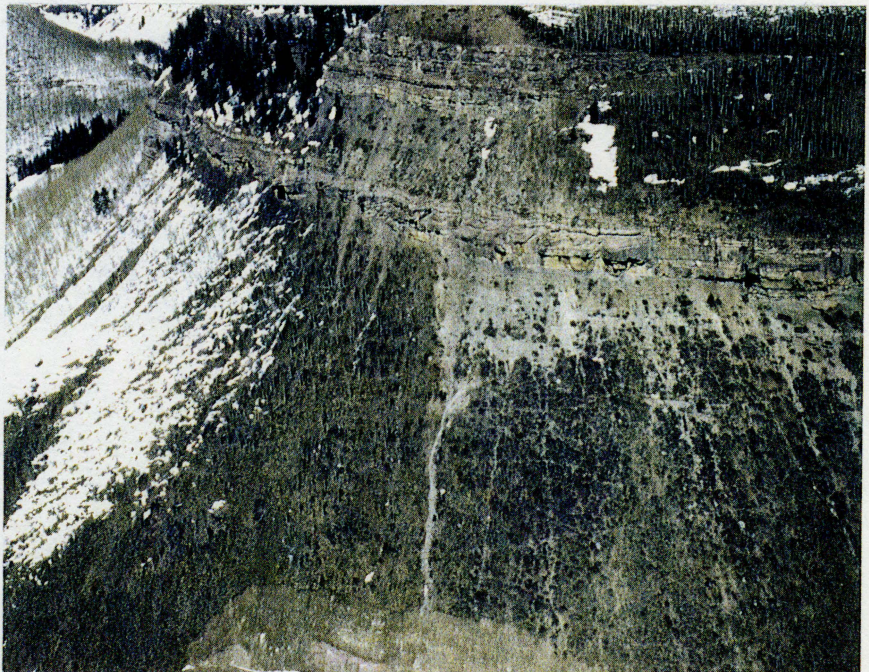
Photo #1. Booth Creek rockfall source area. Note enlargement of upper cliff exposure and corresponding rockfall source area, northwest of the ditch and berm terminus.

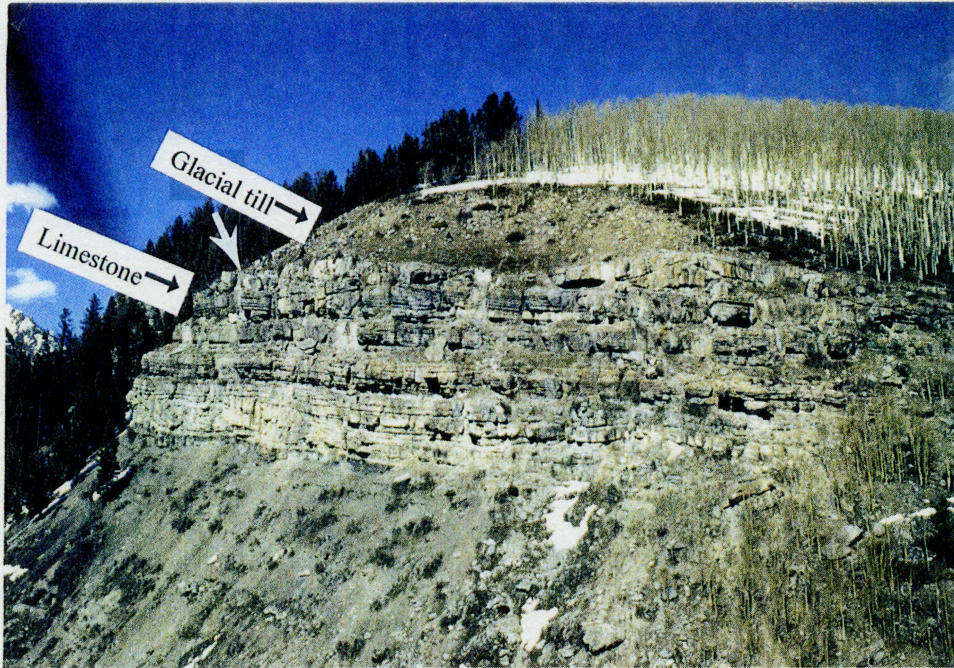
Photo #2. Top cliff rockfall source area. White arrow marks location of March 26, 1997 rockfall.

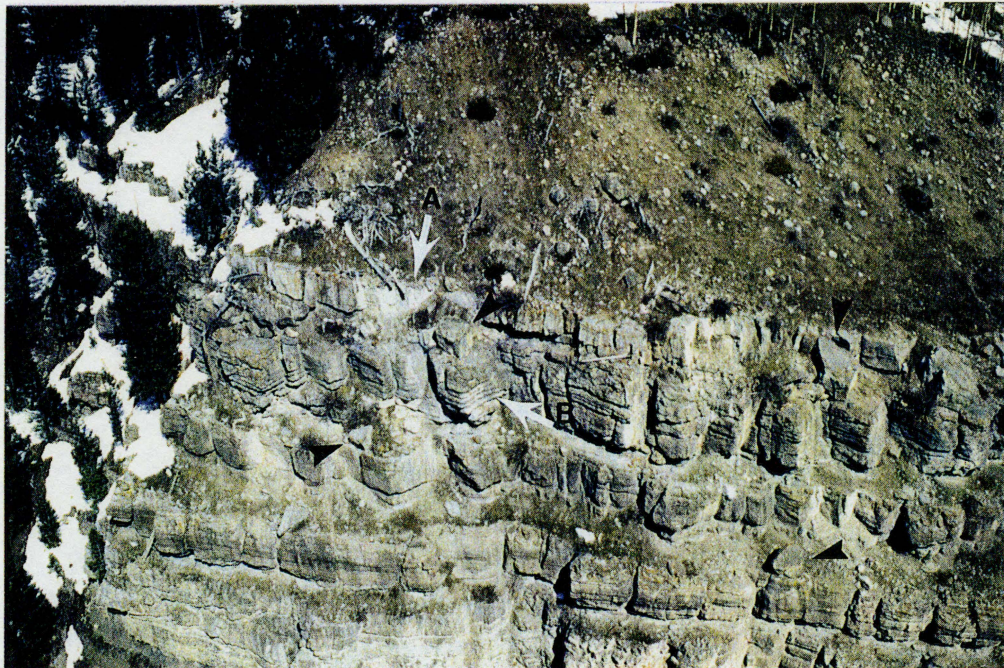
Photo #3. Close-up aerial view of source area. Note ledgy appearance with joint defined blocks undermined by eroding shale partings. White arrow A marks scar from March 26, 1997 rockfall. White arrow B marks rock pedestal that was hit by rockfall and may be destabilized. Note loose blocks, marked by black arrows.

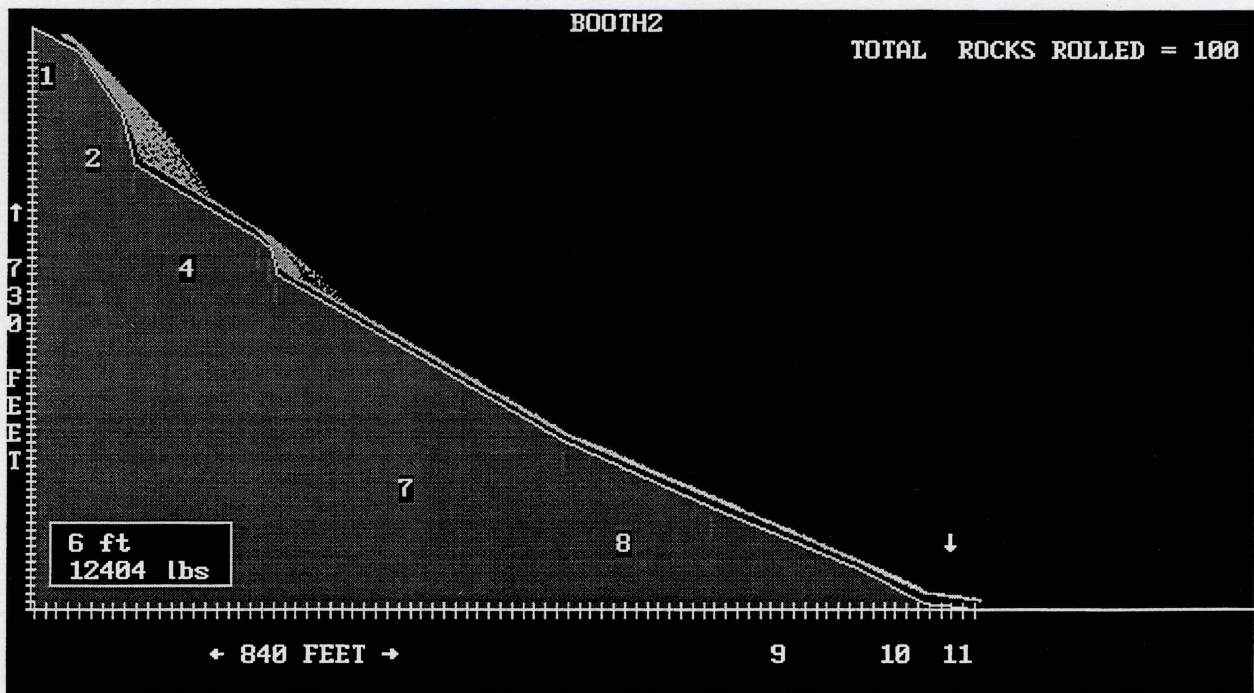
Figure 2. Screen dump of CRSP program of Booth Creek-west side. Analysis point arrow is 30 feet above condominiums. Horizontal and vertical are not at the same scale.

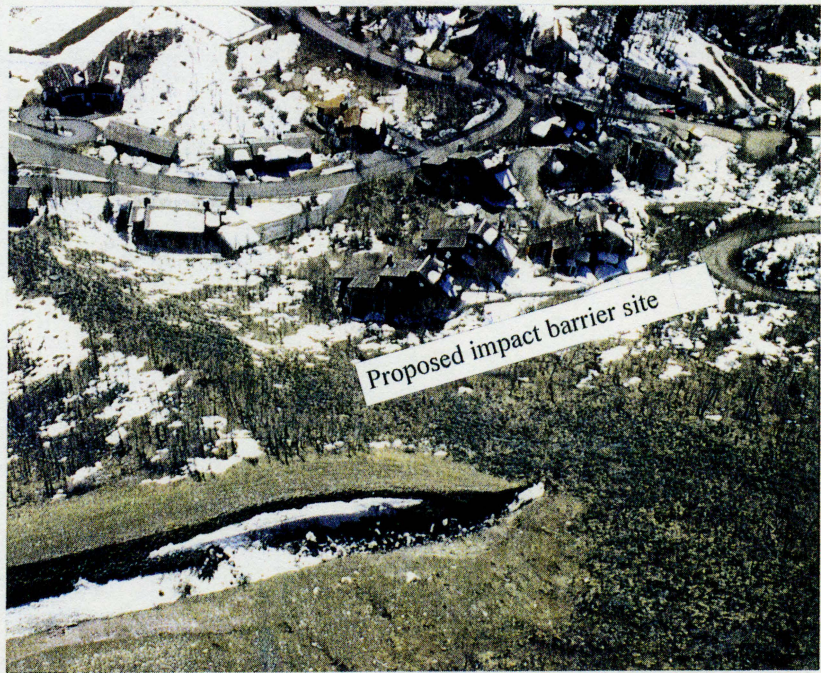
Photo #4. Location of proposed impact barrier or berm site. Note accumulation of rocks in existing ditch. The largest are 5 feet in diameter.

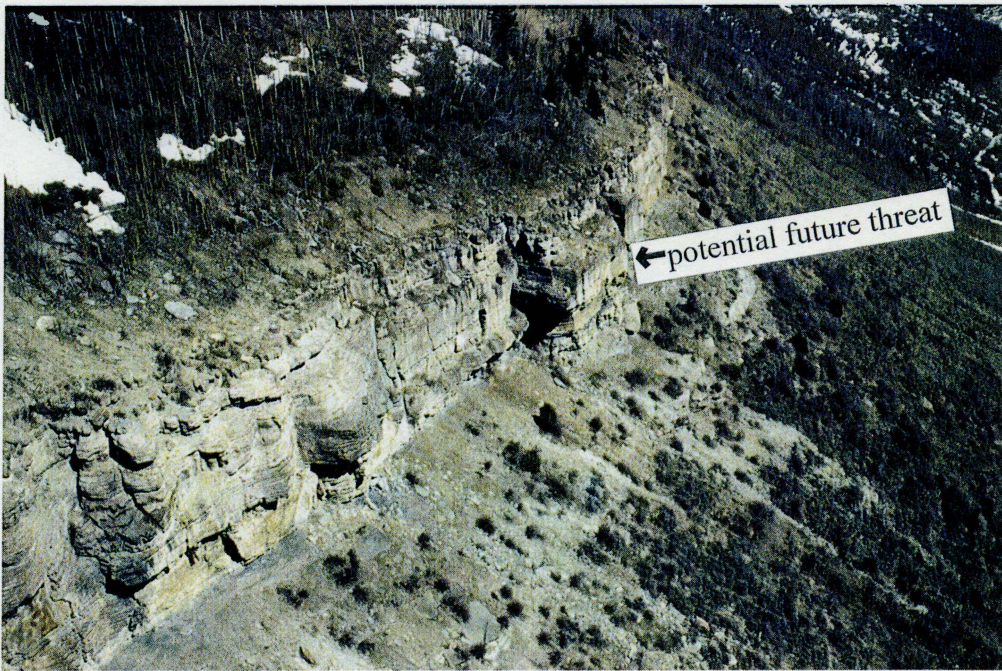
Photo #5. Lower sandstone cliff above district ditch and berm. The CGS will visit this feature this spring and install movement gauges for future monitoring.

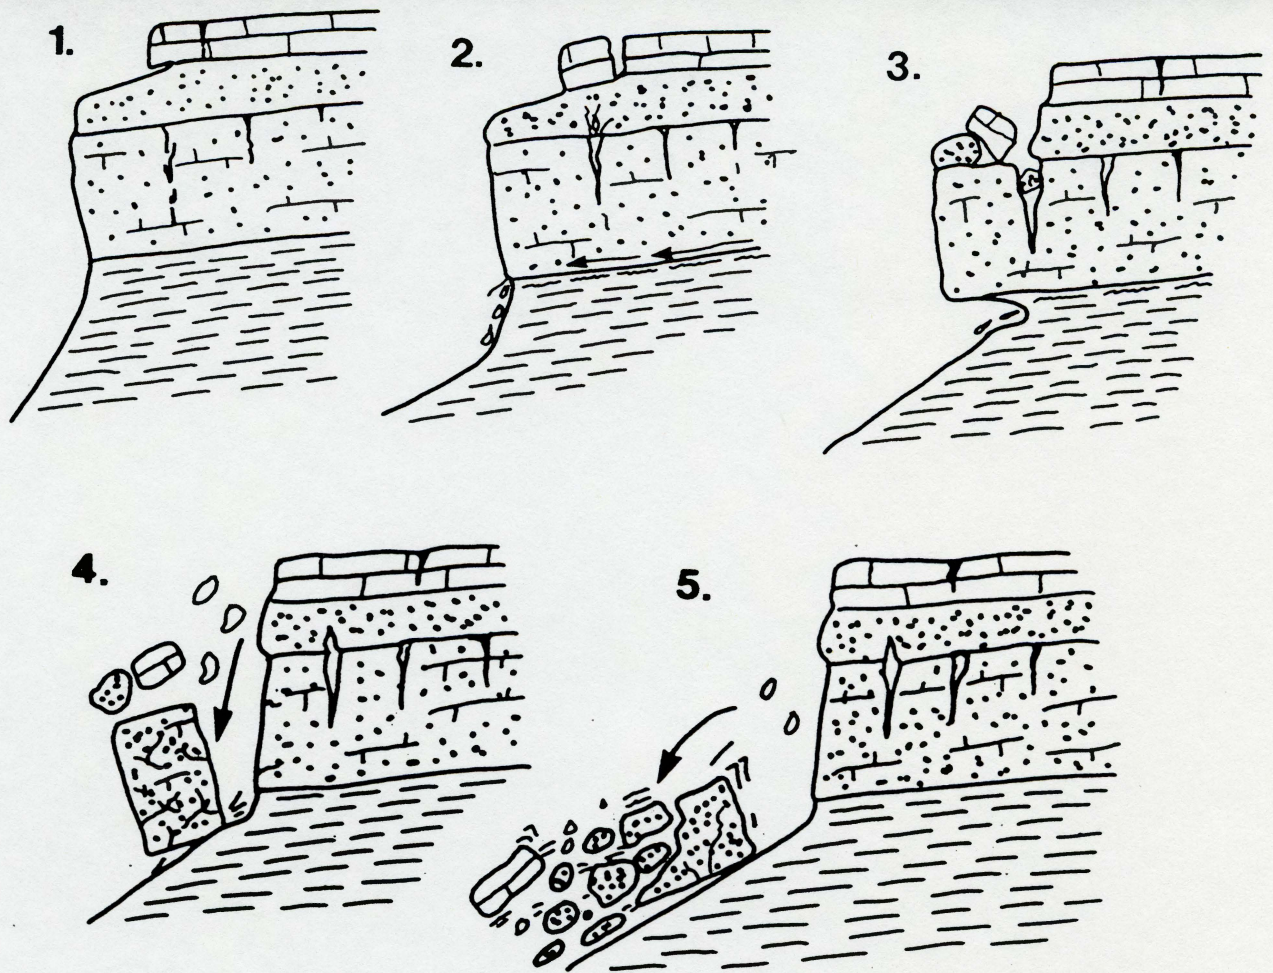
Figure 3. Toppling Slab-failure Sequence. 1. Initial cliff configuration. 2. Differential weathering of soft shale begins to undercut massive cliff forming slabs. Joints open and widen due to slope creep and frost wedging. Springs issue from contact beneath cliff. 3. Undercutting continues. Joints widen and are wedged open by smaller rocks, causing slab to tilt outwards. 4. Slab falls from cliff face onto acceleration slopes, bringing down overlying rocks. 5. Slab topples and shatters, showering runout zone below with boulders, and exposing new cliff face to erosion.

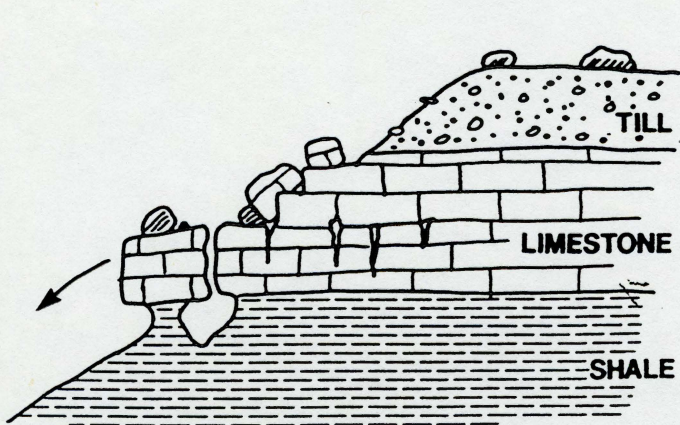
Figure 4. Limestone slabs resting on weak shale pedestals, upper cliff source area.

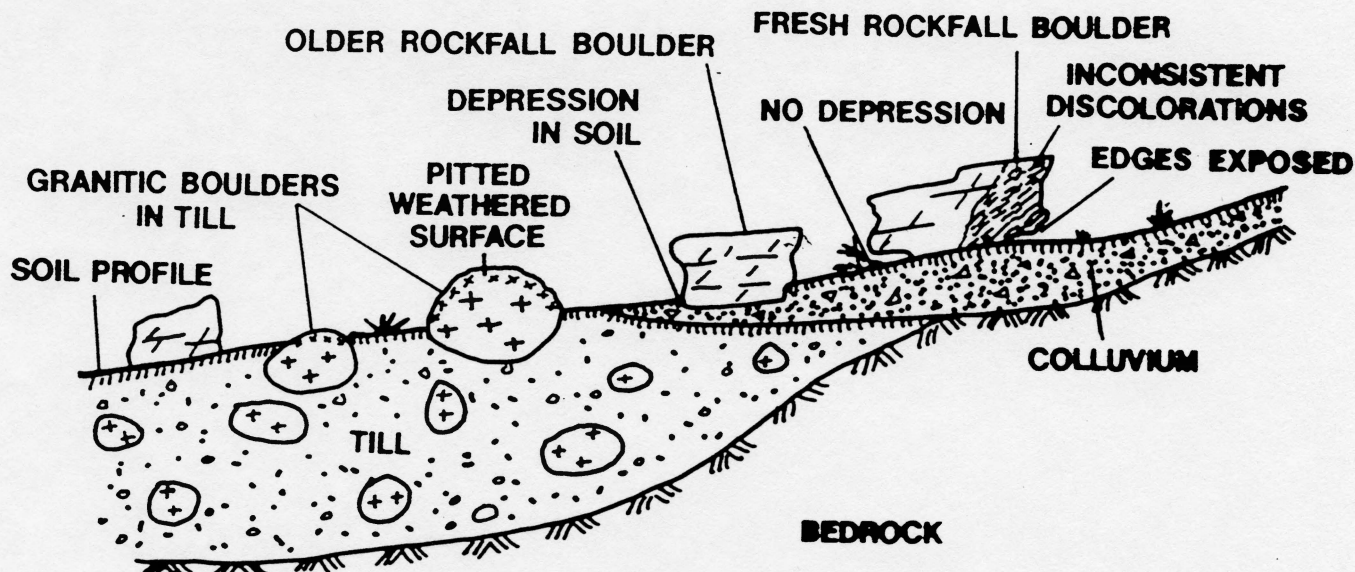
Figure 6. Physical differences between rockfall and glacially deposited boulders in runout zone. Rockfall boulders are all limestone or sandstone, while glacial boulders are mostly rounded granite or metamorphic lithologies. Note that soil exists below rockfall boulders, while it is absent beneath glacial boulders.

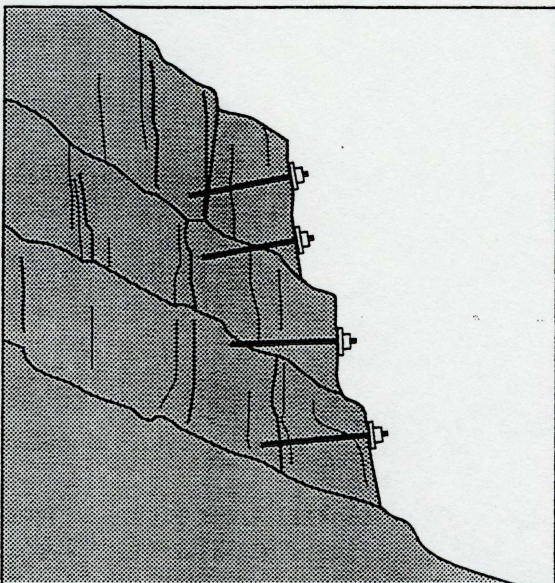
Figure 1. Rockbolts and dowels.

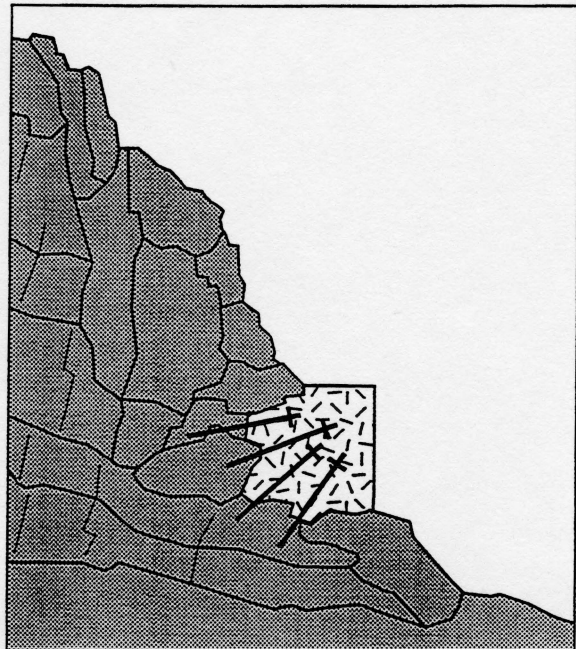
Figure 4. Anchored concrete buttress.

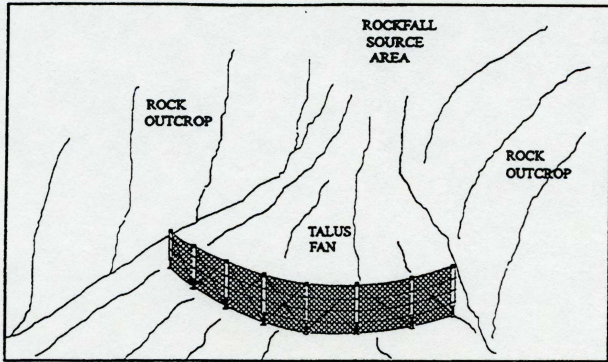
Figure 6. Rockfall fence.

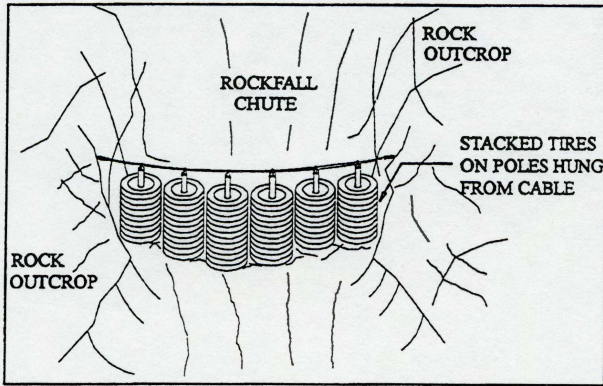
Figure 9. Tire impact attenuator.

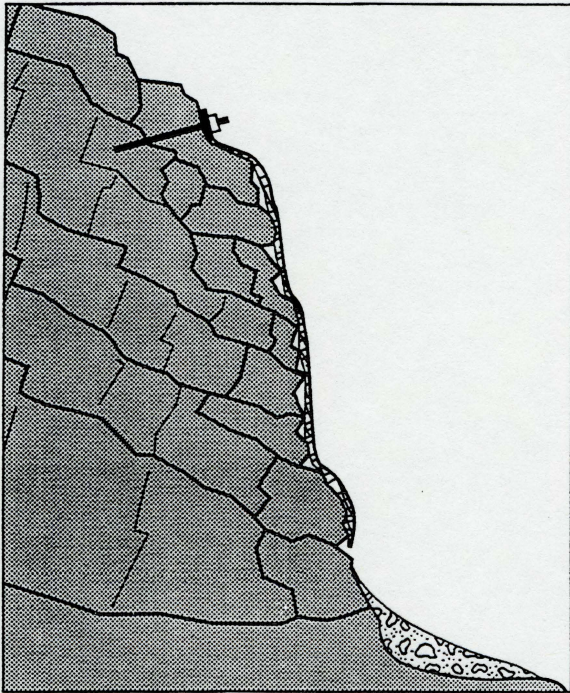
Figure 10. Draped mesh.
