**USFS-ABANDONED MINE LAND INVENTORY PROJECT
FINAL SUMMARY REPORT**

BOULDER RANGER DISTRICT

December 30, 1993

Colorado Geological Survey

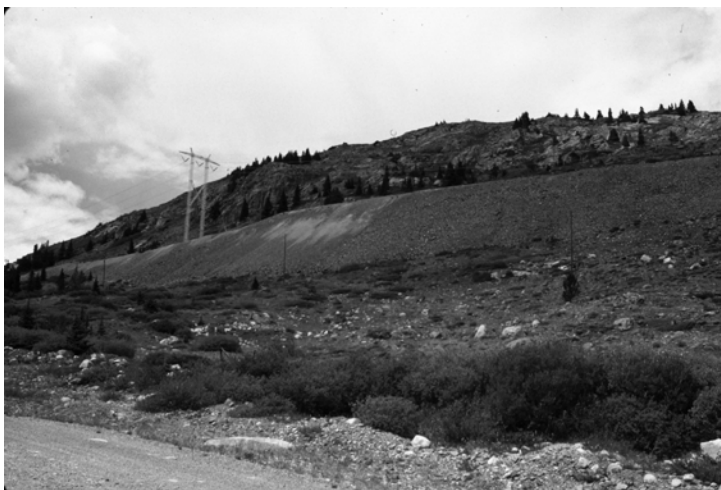
Aluminum	6000	ug/g
	Arsenic	44	ug/g
	Barium	61	ug/g
	Cadmium	15	ug/g
	Chromium	U 10	ug/g
	Copper	2800	ug/g
	Iron	130000	ug/g
	Lead	1500	ug/g
	Manganese		
400	ug/g		
	Mercury		
0.88	ug/g		
	Nickel		
35	ug/g		
	pH		
6.6			
	Silver		
U 10	ug/g		
	Zinc		
2600	ug/g

The high levels of copper, iron, lead, and zinc impact aquatic life, specifically native and sport fish. This site was given a rating of 2 (significant environmental degradation) because it is likely that surges of waters with high metal concentrations occur every spring from this drainage into Mosquito Creek when it is flushed by run-off. The dump supplies new fines annually, recharging metal concentrations into the drainage.

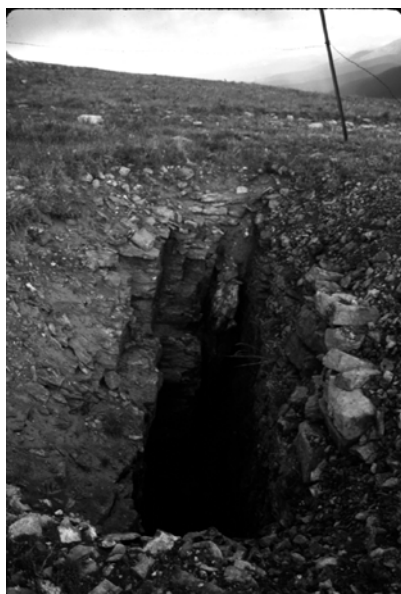
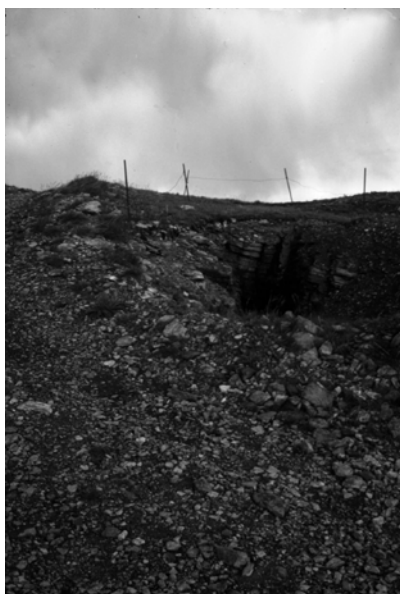
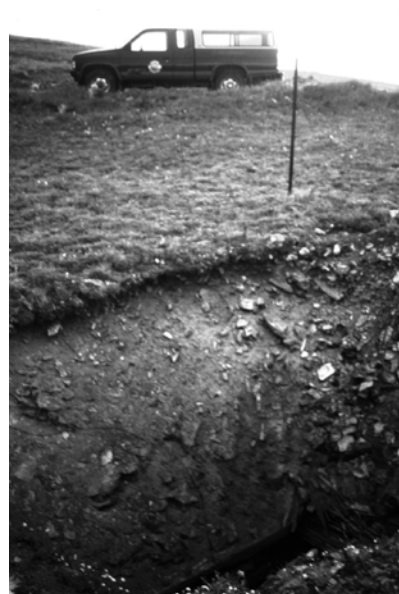
Sites 107, 108, 109 are also open shafts and daylighted stopes(?) and, while on private property, are immediately next to FR 189. Site #108 cratering is beginning to encroach into the edge of the road. These three sites have single strand barb wire fencing around them but they are deteriorating and the

deterrent effect is minimal. These features were given hazard ratings of 1 (extremely dangerous) because of their immediate proximity to the public 4WD road. These sites are narrow enough at the surface that winter snow pack could conceivably bridge across at times creating lethal traps.

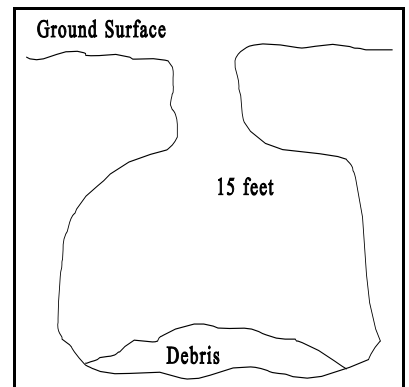
Feature #: 100

Description and pertinent facts: The A & C Claims are a group of shafts and prospect trenches,

pits, and adits. The area is centered 0.9 miles east of Tarryall. Access is provided by FR 212 at a turn-off 4200 feet south of Tarryall on CR 77. An unnamed road forks off of FR 212 at inventory area 12-10-460/4329-1 to the mine location. This road has been closed by the USFS but, judging by tire tracks, the road is in continued use with 4WD vehicles bypassing the closure sign and bulldozed trench. While several mine features were given potentially dangerous ratings two features were assigned a rating of 2 (dangerous).
