HAZ-1983-01

PRELIMINARY EVALUATION OF ROCKFALL HAZARD
IN THE BOOTH CREEK AREA

PREPARED BY THE COLORADO GEOLOGICAL SURVEY
FOR THE TOWN OF VAIL, COLORADO
1983

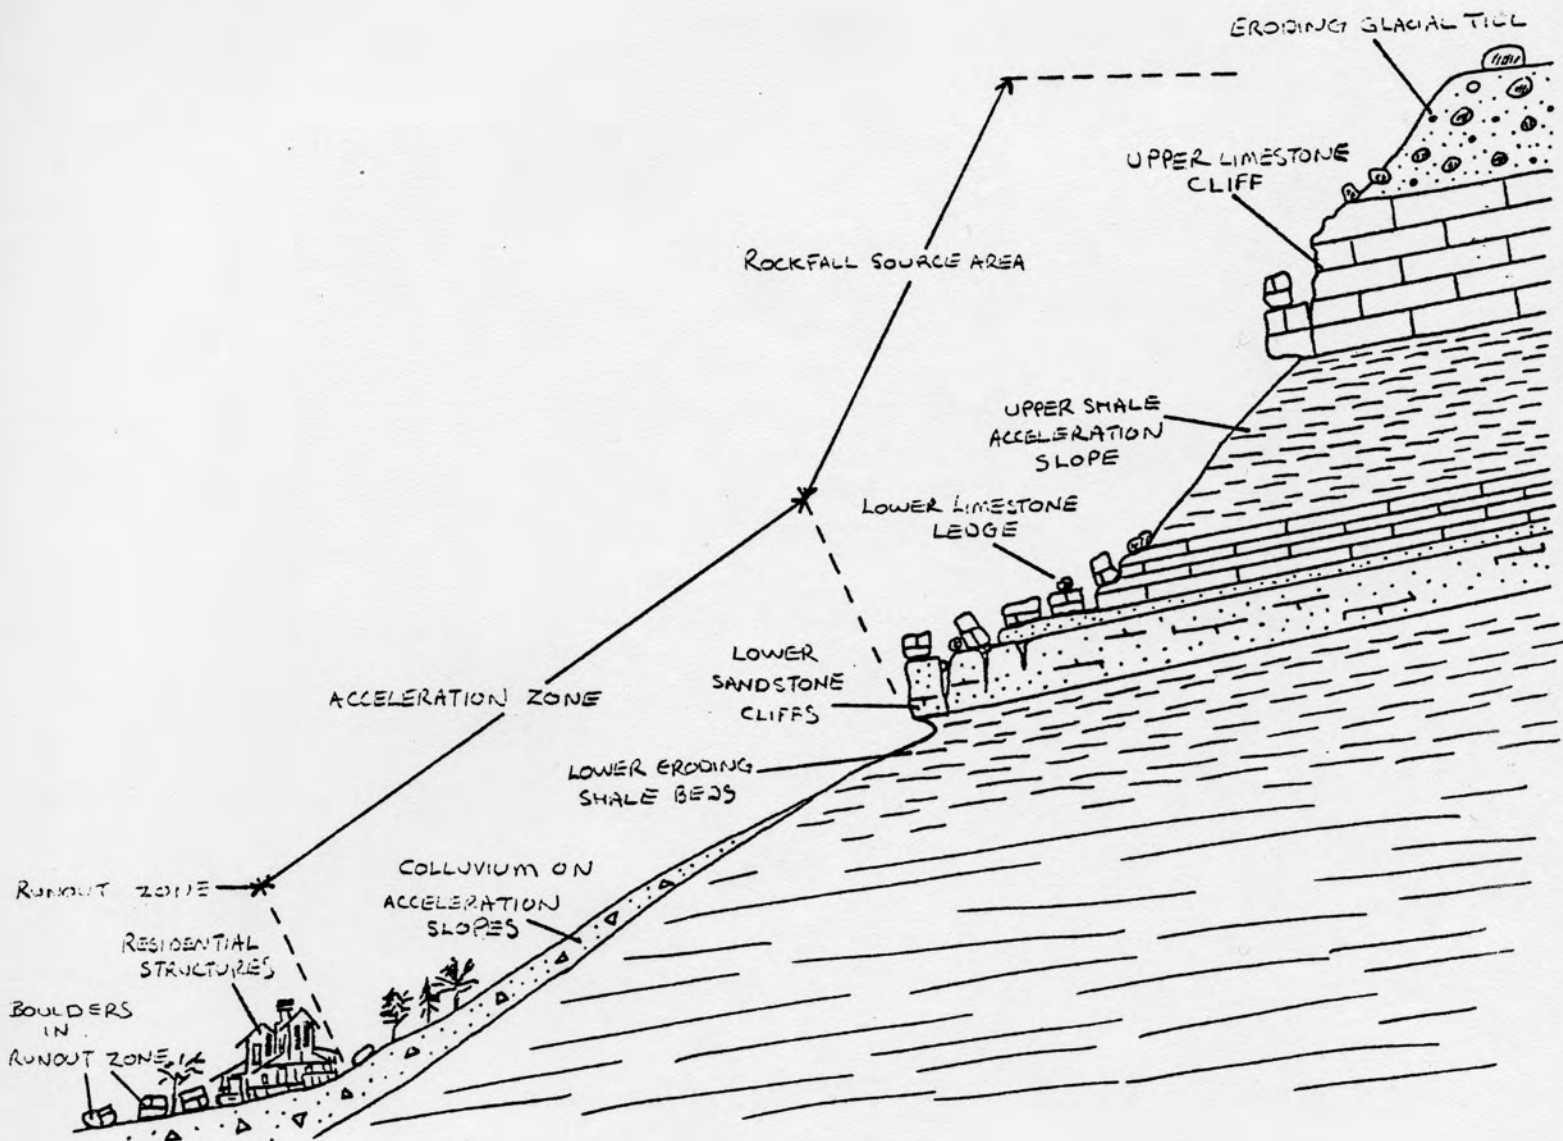
The steep southwest-facing slopes and rocky cliffs investigated in this report tower 1,000 ft (305 m) above Vail Village Filing 12 on its northern boundary. These heights are attained within a horizontal distance of 1,700 ft (520 m) resulting in an average slope of 58 percent. The slope can be divided into several zones which combine to produce the rockfall known to occur along this portion of the Gore Creek Valley as follows: (Refer to Fig. 2)

The geologic make-up of the cliffs above Vail Village Filing 12 is shown diagrammatically in Figure 2. Sedimentary strata exposed in the cliffs are part of the Minturn Formation of Middle Pennsylvanian Age, and include beds of sandstone, shale, grit, conglomerate, and limestone. The beds strike N85°W and dip 15° to 18° into the valley axis. The lower cliff consists of shaley sandstone beds about 40 ft thick resting on a weak, fissile, rapidly eroding

Fig. 2 Geologic diagram of compound rock-fall slopes in study area. Drawn to scale with no vertical exaggeration. Note dip of strata toward valley.

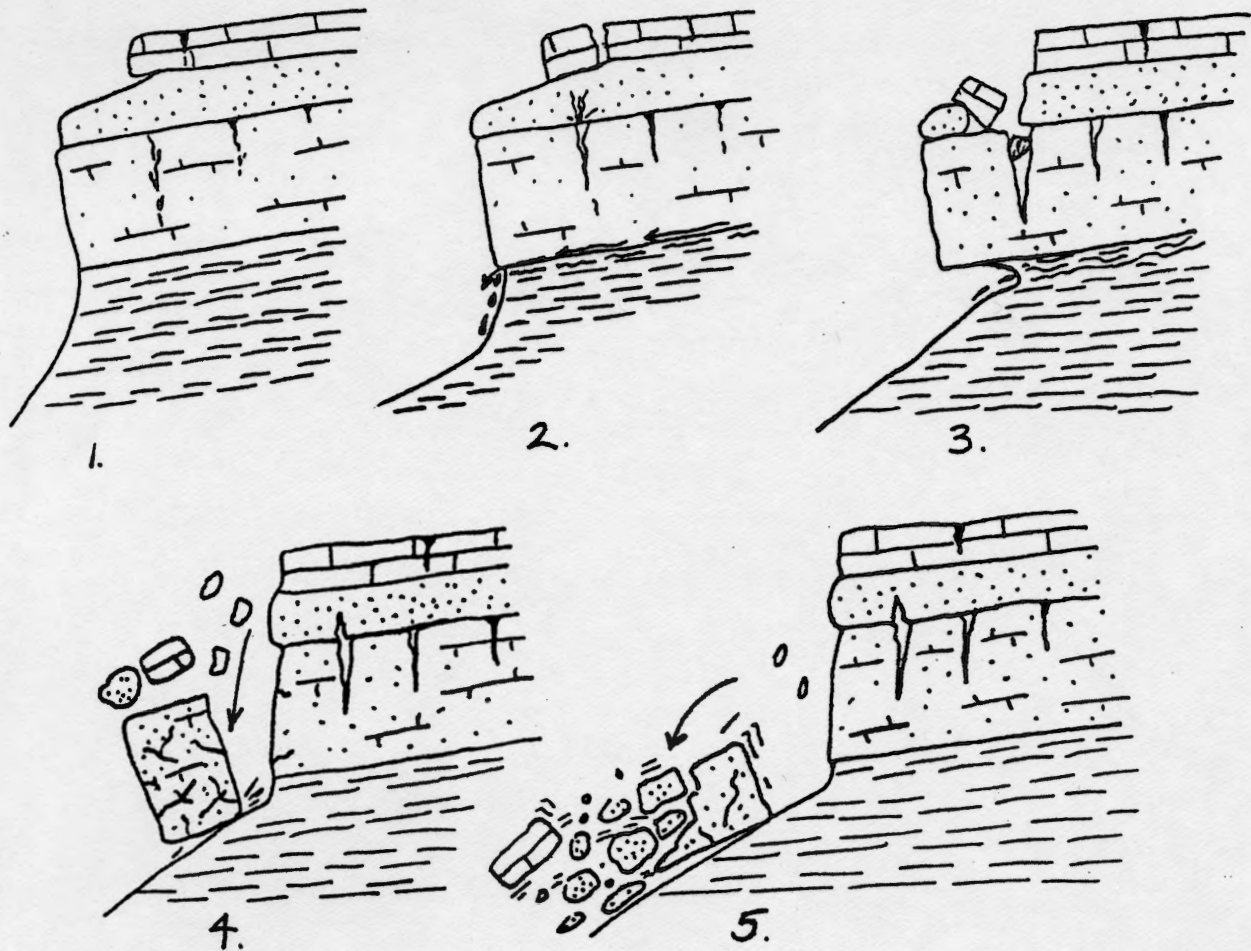
Fig. 3 Toppling Slab-failure Sequence

C) Lower vertical cliff source area - A 50 ft high (16 m) cliff of jointed sandstone and limestone outcrops 560 vertical ft (10m) above the runout zone. Large slabs 15 to 20 ft (4.5 to 6 m) in diameter periodically detach from the cliff face and tilt outwards until they topple over and shatter, showering boulders onto the acceleration slopes below. (Fig. 3)

1. Initial cliff configuration
2. Differential weathering of soft shale begins to undercut massive cliff forming slabs. Joints open and widen due to slope creep and frost wedging. Springs issue from contact beneath cliff.
3. Undercutting continues. Joints widen and are wedged open by smaller rocks, causing slab to tilt outwards.
4. Slab falls from cliff face onto acceleration slopes, bringing down overlying rocks.
5. Slab topples and shatters, showering runout zone below with boulders, and exposing new cliff face to erosion.

Joint patterns in the cliff forming rocks are caused by stress relief and physical properties of the rock. The joints so formed define the planar vertical cliff faces and act to separate large sections of the cliff into slabs along joints subparallel to the cliff face. Once a slab has detached from the sedimentary bed, it begins to creep outwards due to gravity and frost wedging in the joints. The joints widen with time, and are often wedged farther apart by tree roots or smaller rocks that fall into the cracks formed by the joints (Fig. 3).

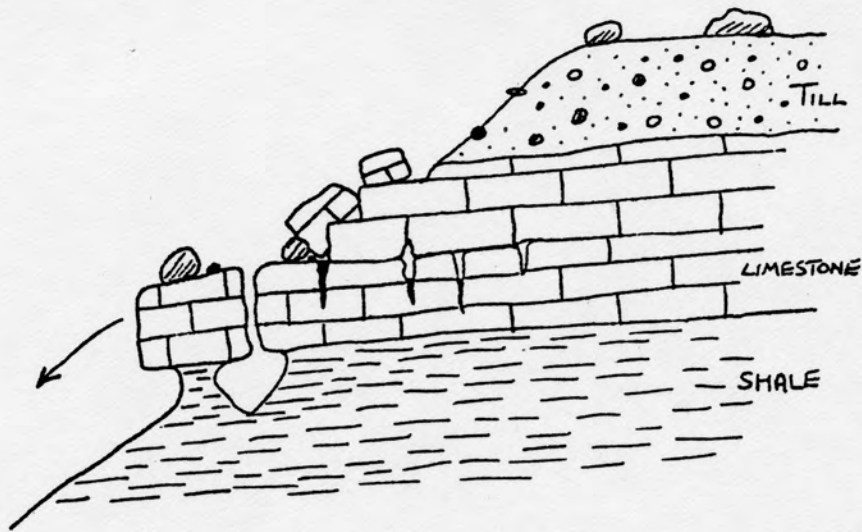
E) Upper vertical cliff source area - jointed slabs and boulders 1,000 vertical ft (305 m) above the runout zone periodically detach from the cliff and free fall and bound downslope and off the lower cliff. Most rocks do not shatter, but remain as intact approximately 8x5 ft (2.5x1.5m) limestone boulders which are capable of reaching the farthest limits of the runout zone. (Fig. 4)

Fig. 4 Limestone slabs resting on weak shale pedestals, upper cliff source area.

The shale zone upon which the upper limestone cliffs rest is weak and by erosion undercuts the massive limestone ledges, creating pedestal-like blocks which eventually topple off their perches. The limestone is jointed such that blocks approximately 9ftx5ft are separated from the cliff and tilt outward toward the cliff edge. Thinner beds within the limestone cliff produce more slabby rocks that if not turned onto their edges by chance during the initial fall, remain flat-side down on the steep slopes.

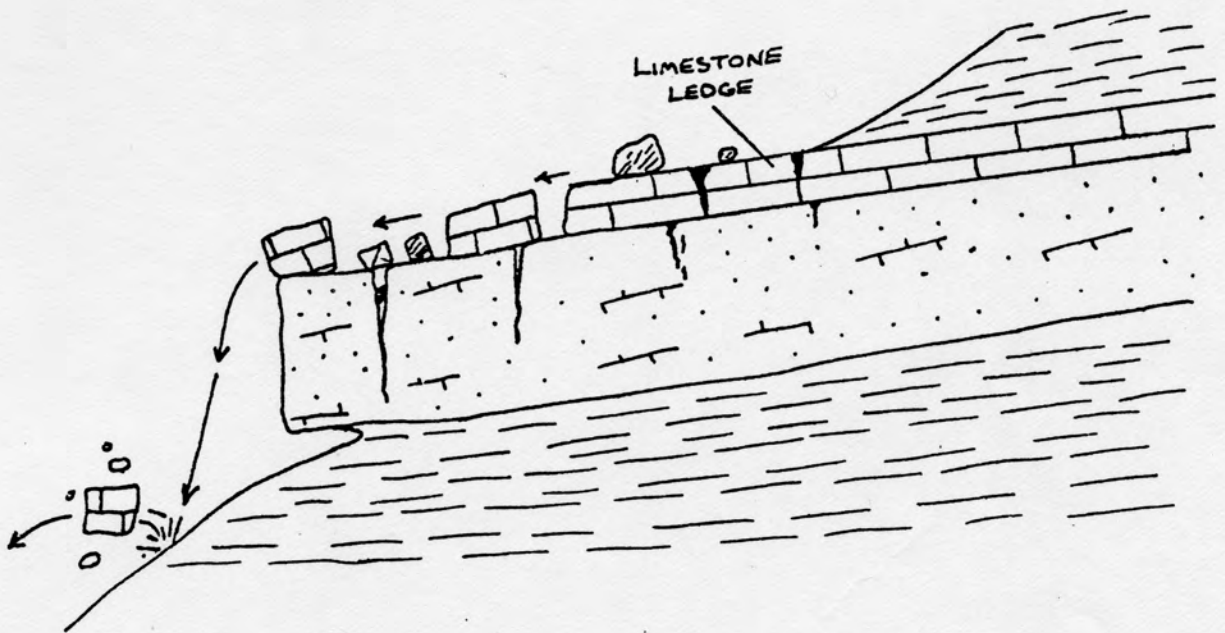
Fig. 5 Slope creep causing limestone blocks to move down bedding planes and off lower cliff edge. Blocks are generally 2 ft X 3 ft. This mechanism is responsible for frequent rock falls in the study area.

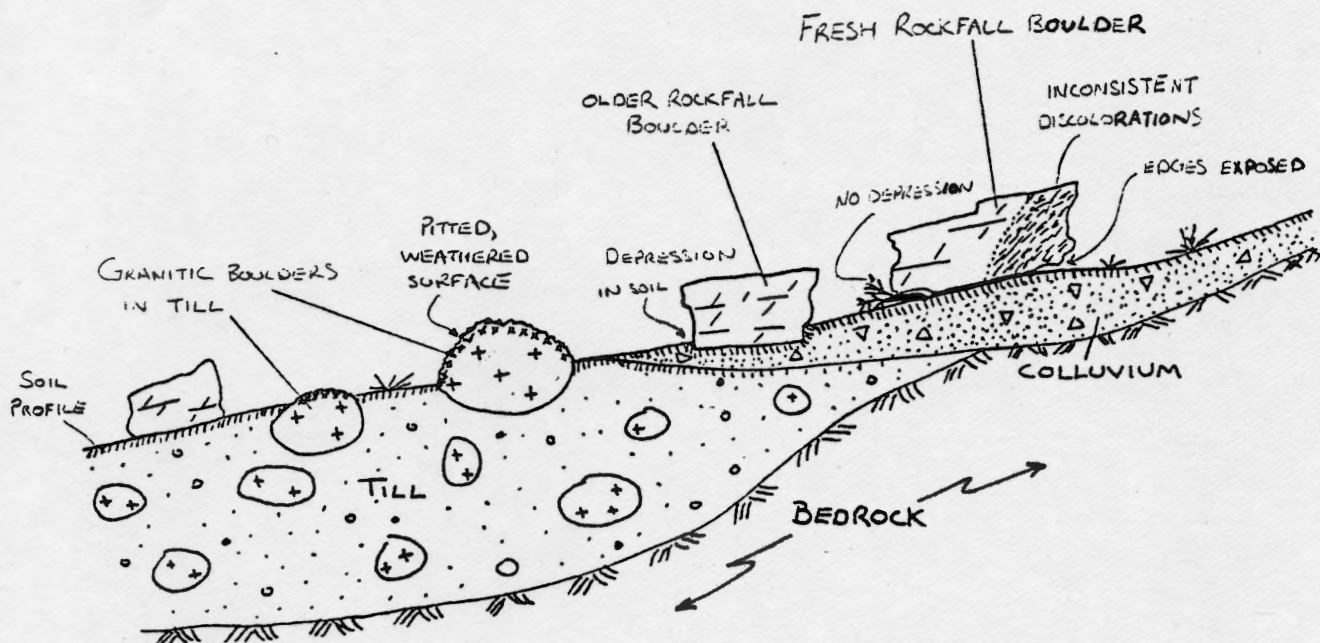
Fig. 6 Physical differences between rockfall and glacially deposited boulders in runout zone. Rockfall boulders are all limestone or sandstone, while glacial boulders are mostly rounded granite or metamorphic lithologies. Note that soil exists below rockfall boulders, while it is absent beneath glacial boulders.

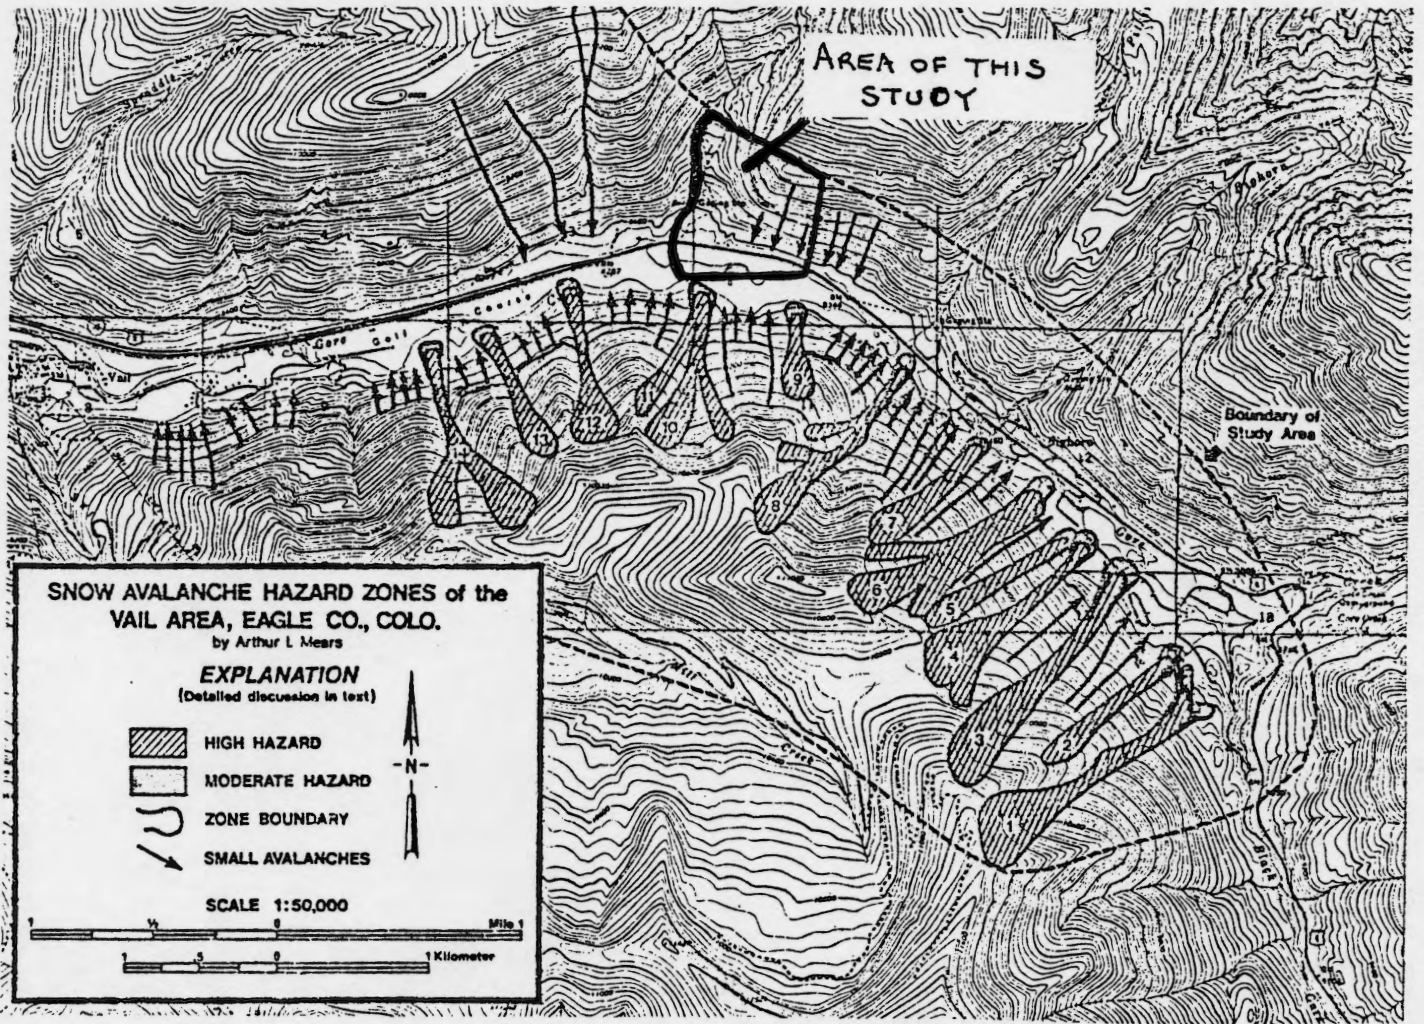
Several relatively small snow avalanche tracks exist on the slopes above the subdivision, as shown in (Fig 7). They are narrow gulleys which generally start below the lower cliff and conduct mostly dry powder avalanches during or shortly after heavy snows. The overly steep south facing aspect of the cliffs and limited starting zones is not conducive to large destructive avalanches. Structures are generally not in the paths of these minor avalanche gulleys. The danger of rockfall far exceeds the concerns for avalanches.

Fig. 7 Snow avalanche hazard zones in study area, from Mears, 1979. Three small avalanche tracks are present in the area of this investigation.
