OPEN-FILE REPORT 00-10

# History, Geology, and Environmental Setting of the Lower Fair Day Mine, Arapaho/Roosevelt National Forest, Boulder County, Colorado

By John Neubert and Robert H. Wood II

Colorado Geological Survey  
Division of Minerals and Geology  
Department of Natural Resources  
Denver, Colorado  
2000

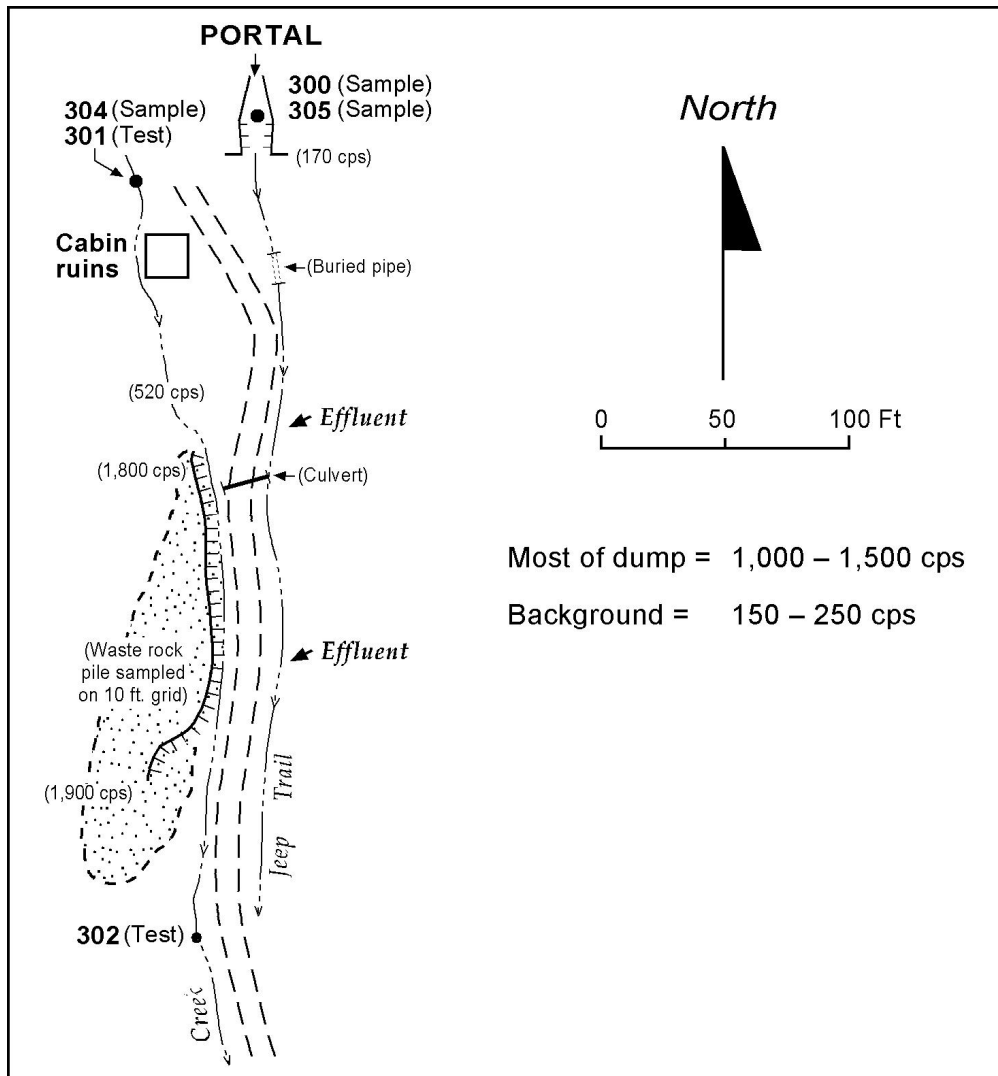
The lower adit has “Devils Den” spray painted in blue on a timber above the portal. The portal is about 7 feet high and 6 feet wide, and the adit is open for at least 20 feet. As of 1967, this lower adit was caved at an unspecified depth (Baker, 1967). Wire mesh on the ceiling just inside the portal helps prevent the roof from caving. Slow-moving water flows from the working.

**Figure 2. Sketch map of the lower adit and waste-rock pile at the Fair Day Mine.**

The most important environmental characteristic of the lower adit is the water flowing at about 4 to 8 gpm from the portal. After leaving the portal, effluent flows a short distance south, through a pipe, and down the road ditch, splitting at a mostly collapsed culvert near the north end of the waste-rock pile. Part of the mine discharge flows through the culvert into the unnamed tributary of James Creek. Most of the mine drainage remains in the road ditch on the east side of the road. In the large meadow about 500 feet south of the mine, the effluent merges with an eastern branch of the unnamed tributary, flows into a mudhole, and eventually reaches the main stem of the unnamed tributary.

The effluent channel is lined with moderate amounts of red precipitate at the portal. The precipitate volume diminishes downstream of the portal, and the effluent channel has no precipitate in the meadow south of the mine.

Immediately below the waste-rock pile, and downstream of the confluence with the small amount of effluent from the culvert (Figure 2, test #302), water in the unnamed tributary showed pH of 7.66 and conductivity of 135  $\mu\text{S}$  in a June test. No samples were collected.

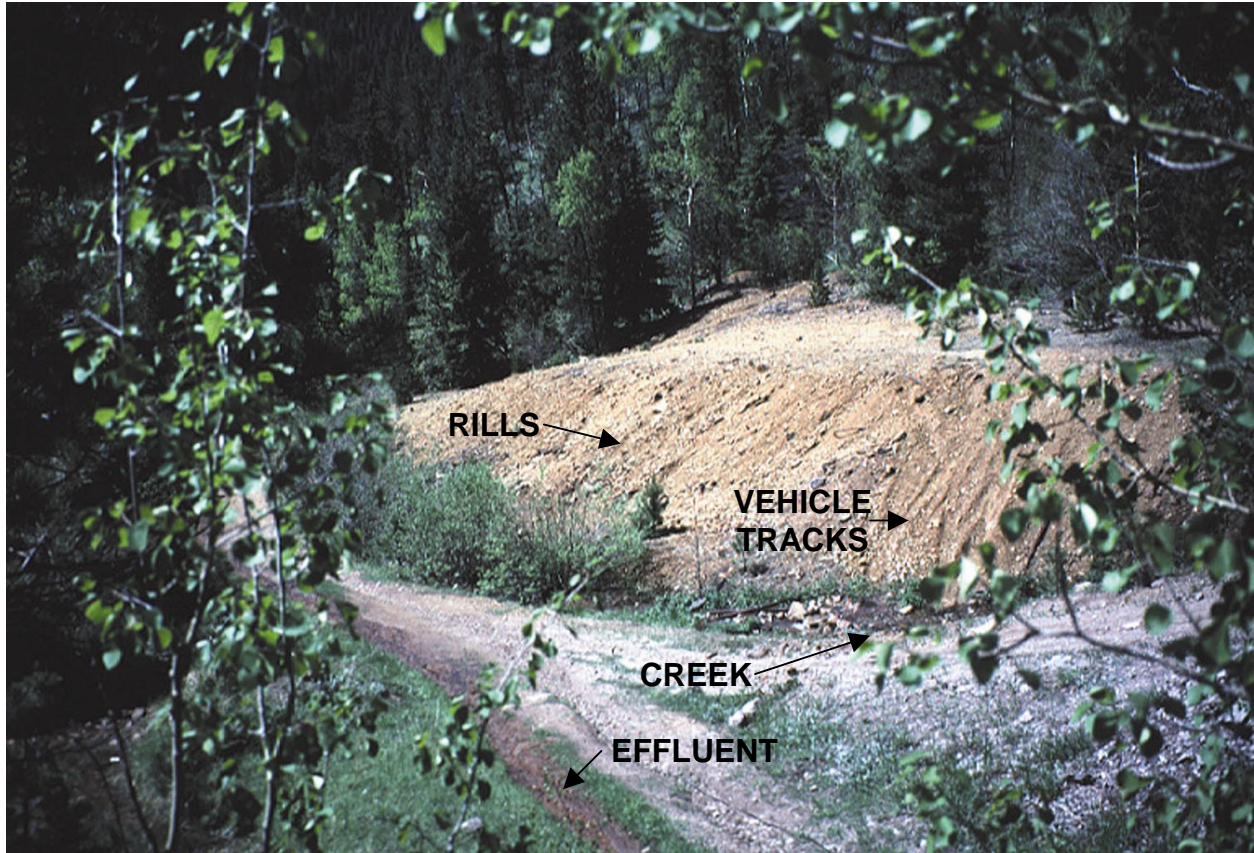
The 800-cubic-yard waste-rock pile toes into the west side of the unnamed tributary for about 30 feet and lies very close to the creek for another 70 feet. The pile is thickest to the north, gradually thinning to the south. Rills cut the face of the sparsely vegetated dump, and minor sheet wash erosion is evident. ATV and motorcycle tracks are on the bench and face. (See Figure 3.)

**Figure 3. Photograph showing waste-rock pile for the lower Fair Day adit, looking downstream.**
