OPEN-FILE REPORT 01-12

History, Geology, and Environmental Setting of the Lienhart Mine, Pike/San Isabel National Forest, Chaffee County, Colorado

Colorado Geological Survey
Department of Natural Resources
Division of Minerals and Geology
Denver, Colorado
2001

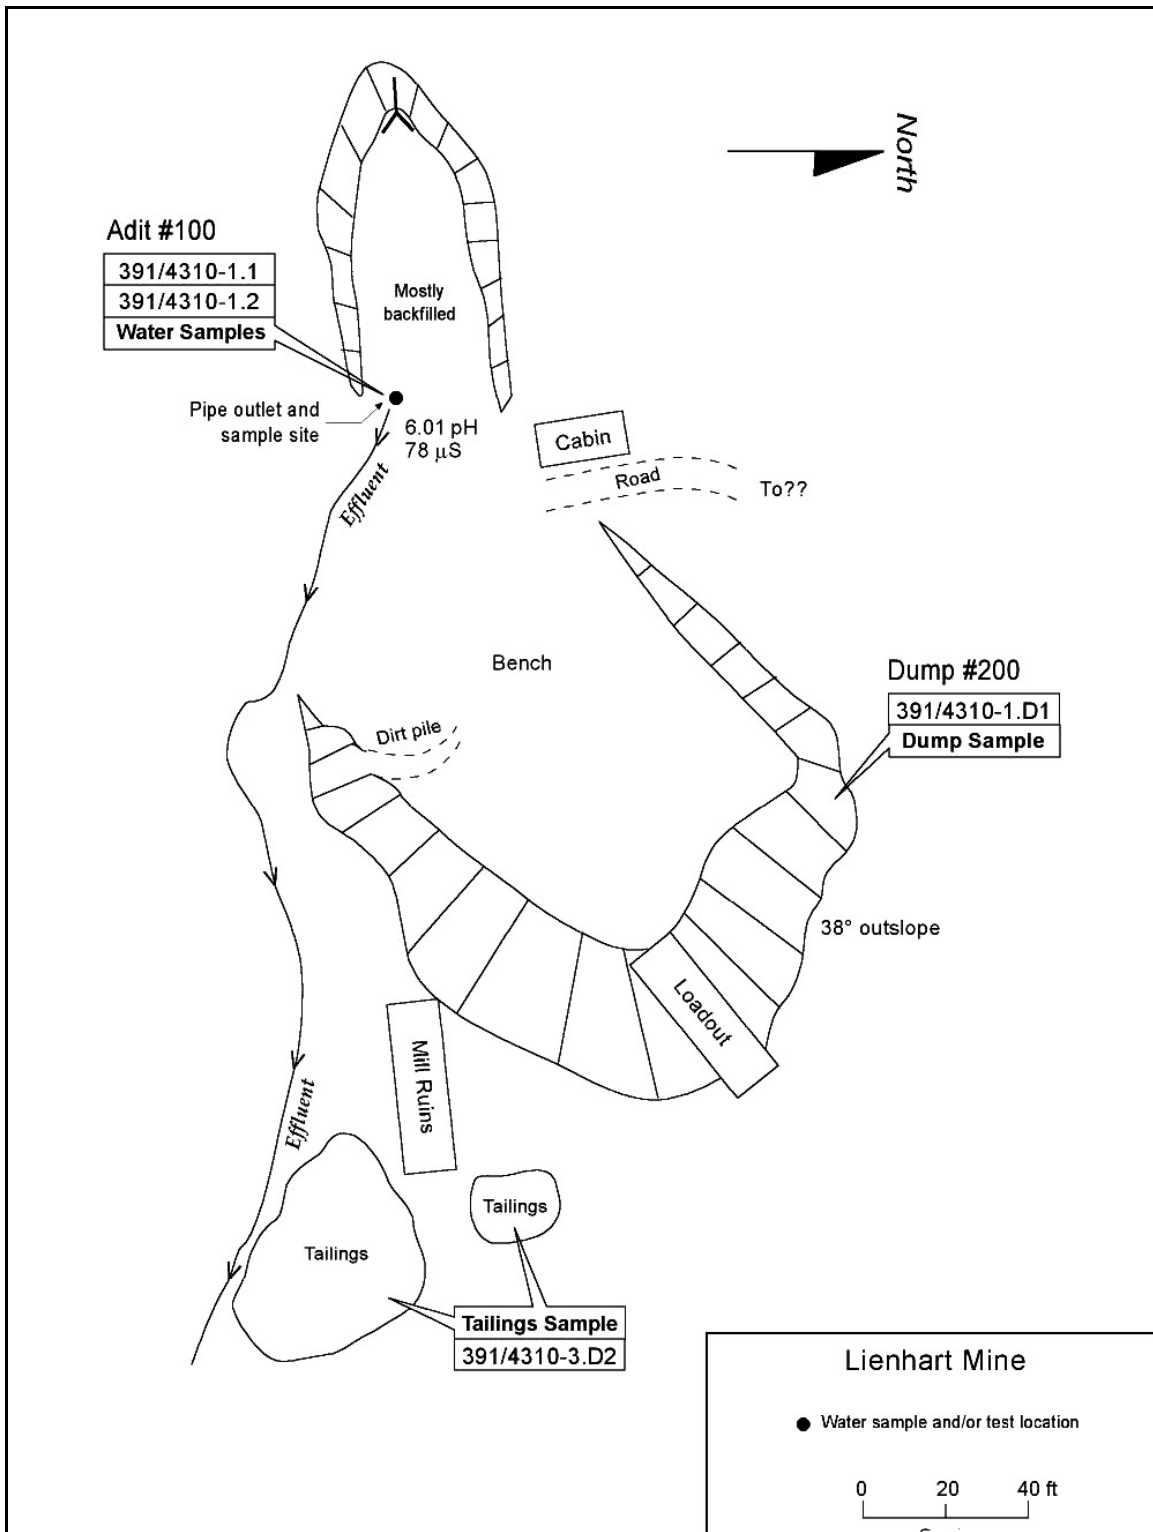
Figure 2. Map showing adit, dump, tailings, and effluent path at the Lienhart Mine.

By July 1999 the portal had been backfilled, and a buried plastic pipe transported mine water to a ditch at the top of the dump (Figures 2, 8). The remediation cells below dump #202 had been removed, and mine effluent was flowing past the break-in-slope at a rate of 30 gpm. Both in 1996 and in 1999 surface flow in this gulch originated at the portal of the Lienhart Mine.

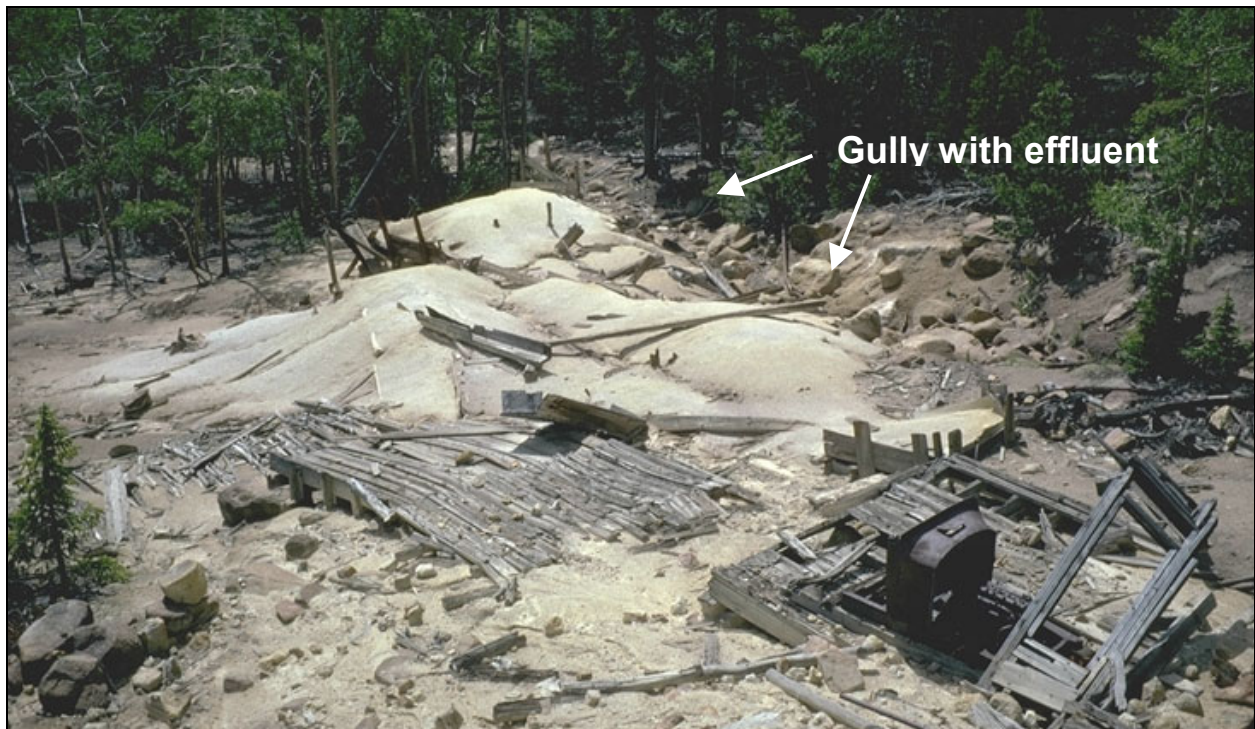
Figure 3. Mill ruins and tailings at the Lienhart Mine.

Remains of a collapsed mill (old equipment and foundations) were at the base of the south side of dump #202, just above the tailings piles (Figure 3). This was probably the Doris Ruby Mining Company's mill constructed in 1937.

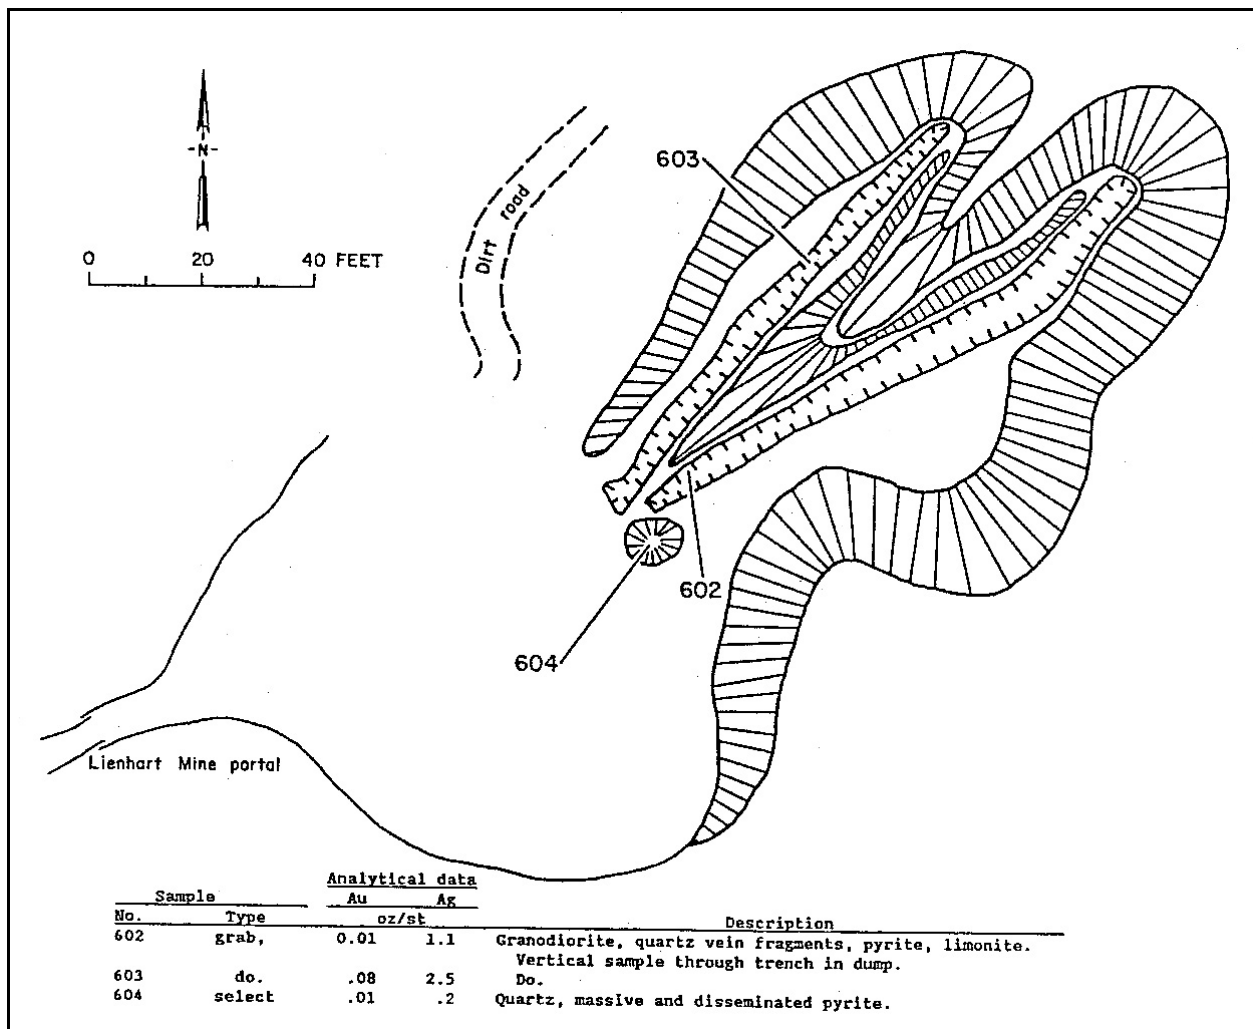
Figure 5. 1983 map and sample results for the Lienhart Mine dump. (From Baskin, 1987, Figure 23.)

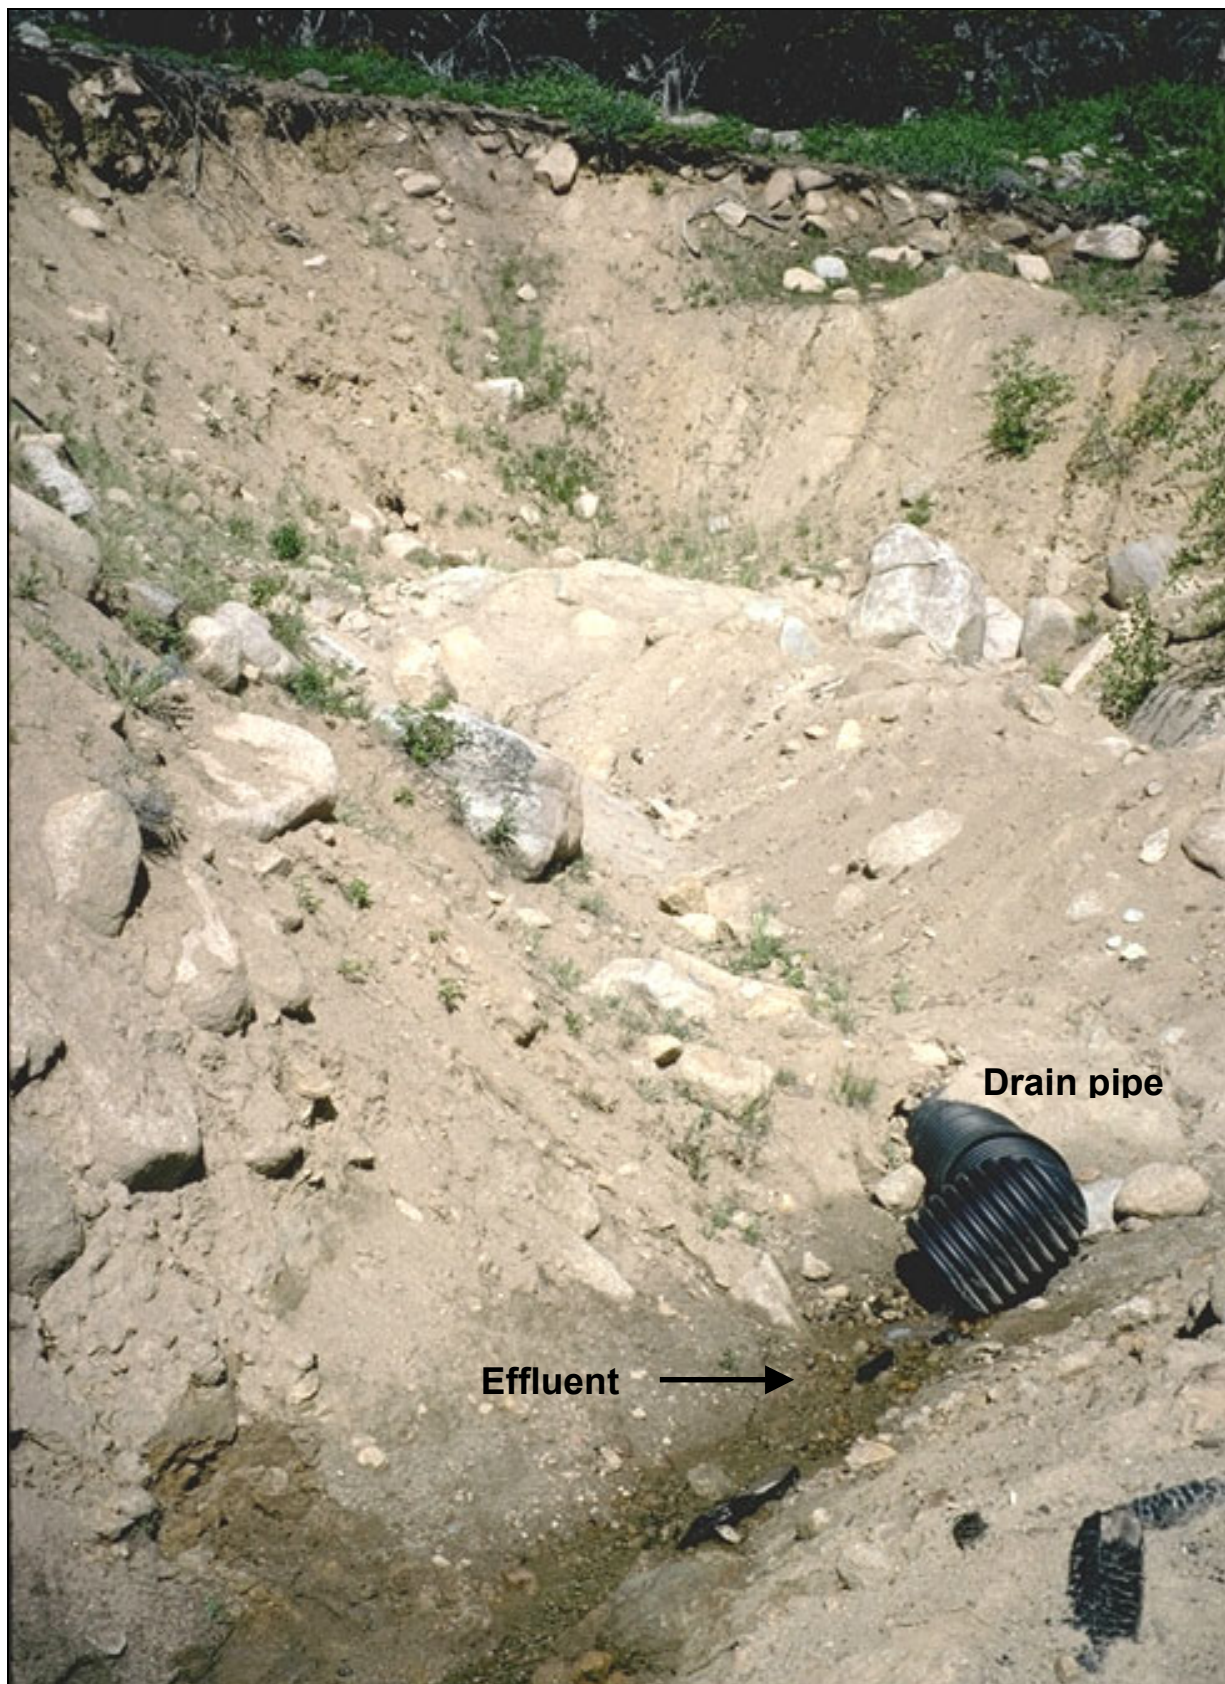
Figure 8. Backfilled portal and effluent at the Lienhart Mine.

In July 1999 about 21 gpm of effluent with 6.01 pH and 78 $\mu\text{S}/\text{cm}$ conductivity was flowing through a plastic pipe from the backfilled portal (sample 391/4310-1.1, Table 3). State standards were exceeded in aluminum, cadmium, copper, lead, manganese, and zinc. At the break-in-slope about 750 feet downstream of the portal, flow had increased to about 30 gpm, and the water had 6.76 pH and 68 $\mu\text{S}/\text{cm}$ conductivity (sample 391/4310-1.3, Table 3). Standards were exceeded in cadmium, copper, lead, and zinc, although the concentrations of these metals were reduced.

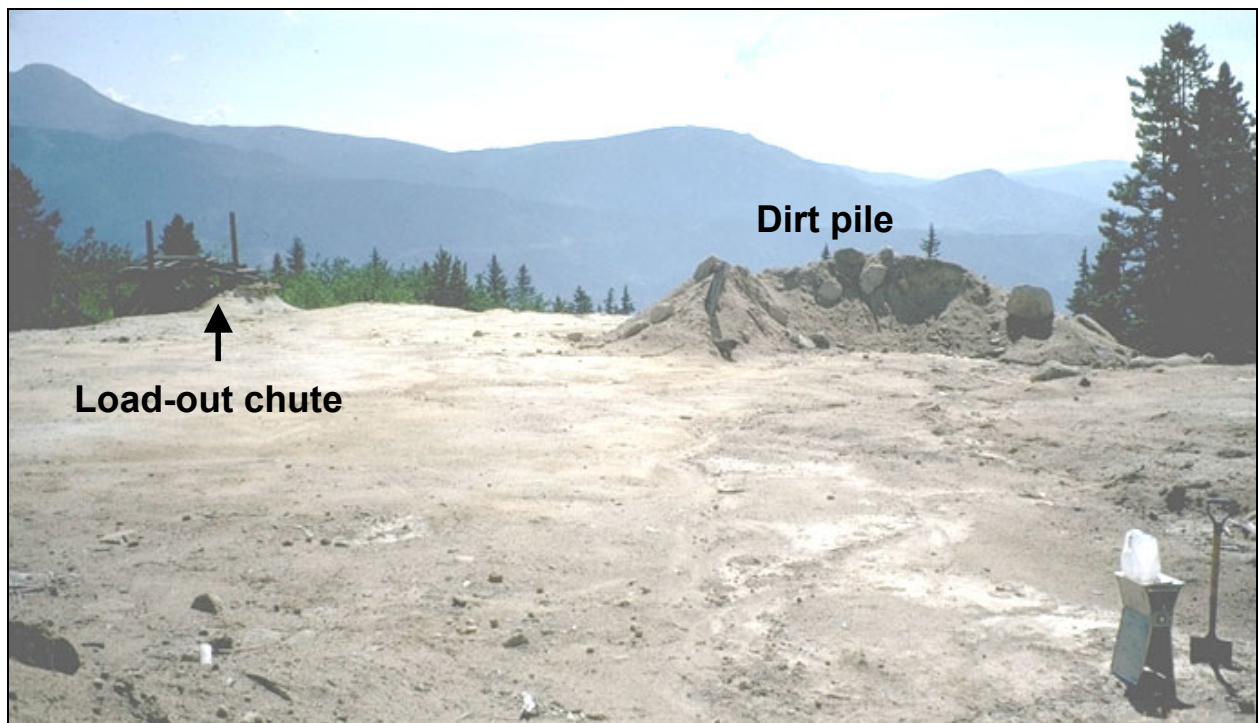
Dump #202 contained about 2,000 cubic yards and had two lobes. A small, unmineralized dirt pile on the bench composed less than 5 percent of the dump (Figures 2, 9). Gullies, rills, and sheet wash indicate moderate rates of erosion. A well-preserved log cabin was at the top of dump #202 near the portal, and a wooden loading chute was on the north side of the dump (Figures 9-11).

Figure 9. Bench of dump and unmineralized dirt pile at the Lienhart Mine.

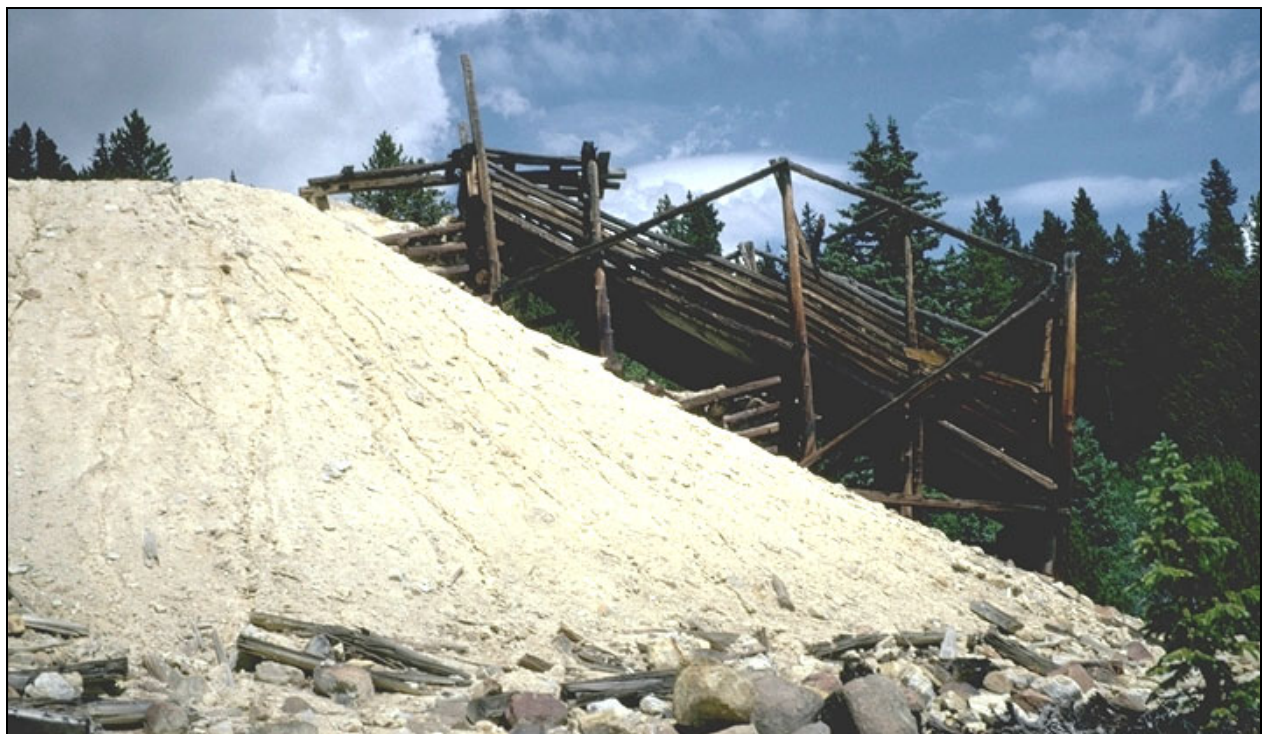
Figure 10. Rills and load-out chute on the Lienhart Mine dump.

Waste-rock pile #202 contains about 2,000 cubic yards of crushed rock that is mostly light yellow with some red-stained areas. Gullies, rills, and sheetwash erosion have affected the dump. Abundant fine-grained pyrite and a moderate amount of muscovite were observed. Pyrite, sphalerite, galena, chalcopyrite, and bornite occurred in the vein (Baskin, 1987, p. 35) and are probably on the dump. Composite sample 391/4310-1.D1 from dump #202, excluding material from the apparently unmineralized pile on the southwest side of the dump (Figures 2, 9), indicates that the dump is moderately to highly mineralized with lead, silver, arsenic, iron, gold, copper, zinc, and manganese. The sample produced a paste pH of 4.00 and a high acid-generating potential of -29.5 tons CaCO_3 /1,000 tons (Table 4).
