OPEN-FILE REPORT OF-87-02

THE APRIL 30, 1987 TELLURIDE AIRPORT  
LANDSLIDES AND RESULTANT DEBRIS FLOWS

Bruce K. Stover, Susan H. Cannon, and W. Rahe Junge

Colorado Geological Survey  
Department of Natural Resources  
Denver, Colorado

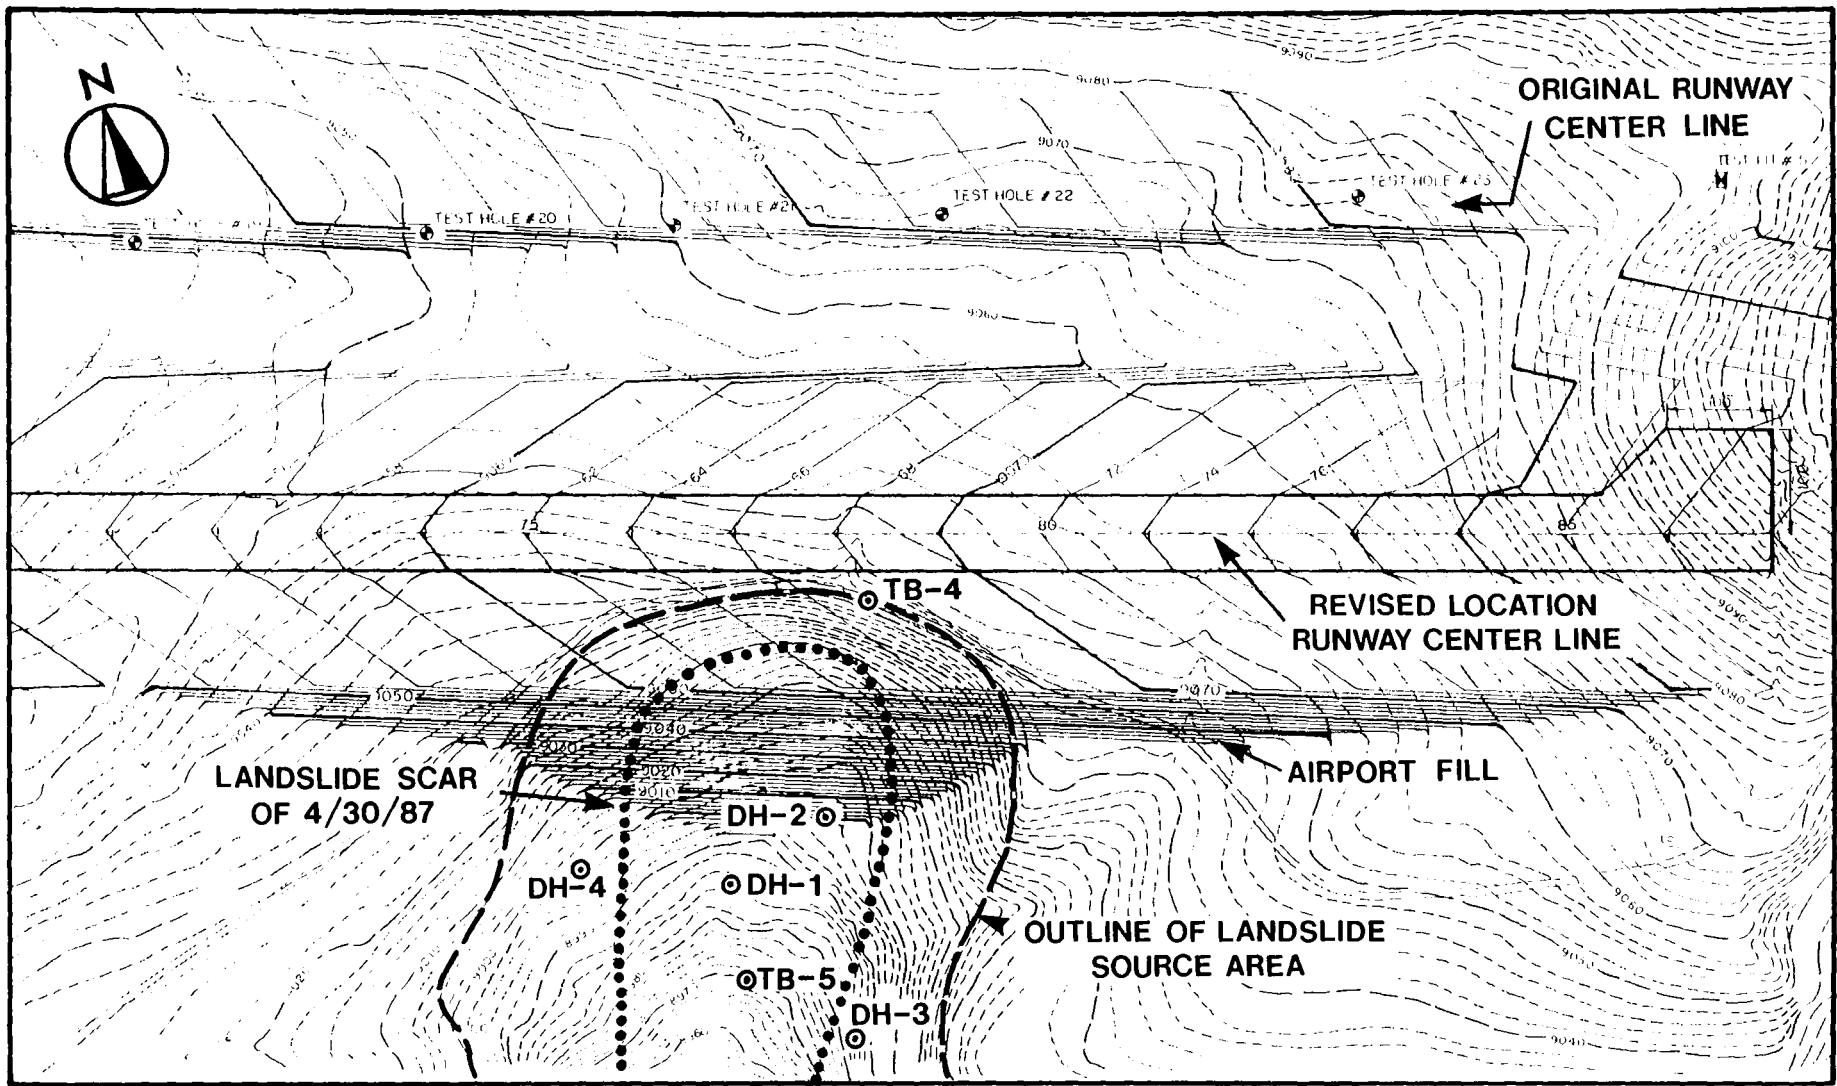
Figure 2. Map of landslide source area showing locations of test borings, fill configuration, and runway location.

Test borings by Lincoln DeVore, a geotechnical engineering firm, along the original proposed runway centerline (Figure 2) indicate that what had been previously mapped as Mancos shale outcrop was actually 5 to 15 ft of weathered colluvial clay overlying glacial clayey sands and gravels that extend to a depth of at least 20 ft. Water was present at the contact between the glacial deposits and the underlying Mancos shale.

Inspection of large-scale aerial photographs taken prior to airport construction (provided by Lincoln DeVore) indicates that the present landslide scar occupies a pre-existing landslide source area (Figure 2). The area consists of a bowl-shaped depression that outlets downslope over the edge of Deep Creek mesa. The slope of the head of the bowl is approximately 60%, and the base is approximately 17% and steepens to 30% in a narrow throat near the edge of the mesa. Test holes drilled by Lincoln DeVore during airport-siting studies, and on May 6 and 7 of this year, indicate that at least 20 ft, and at most, 32 ft, of colluvial silty clay, sand, and gravel derived from nearby Mancos Shale and glacial deposits have been deposited in the source area (Figure 4). The drill log for TB-5 describes saturated, silty clay to a depth of 13 ft, then gravel to refusal at 20 ft. Drill-hole 1 encountered water-bearing gravels and cobbles to 32 ft. A map of the airport site by Lincoln DeVore also shows five springs and a wet, marshy area on the floor of

In order to build the Telluride Airport runway a fill prism of Mancos Shale derived from nearby "Windy Knoll" was placed across the upper part of the landslide source area (Figure 2). The fill was up to 70 ft thick with a 2:1 slope and extended 270 ft southward into the source area.

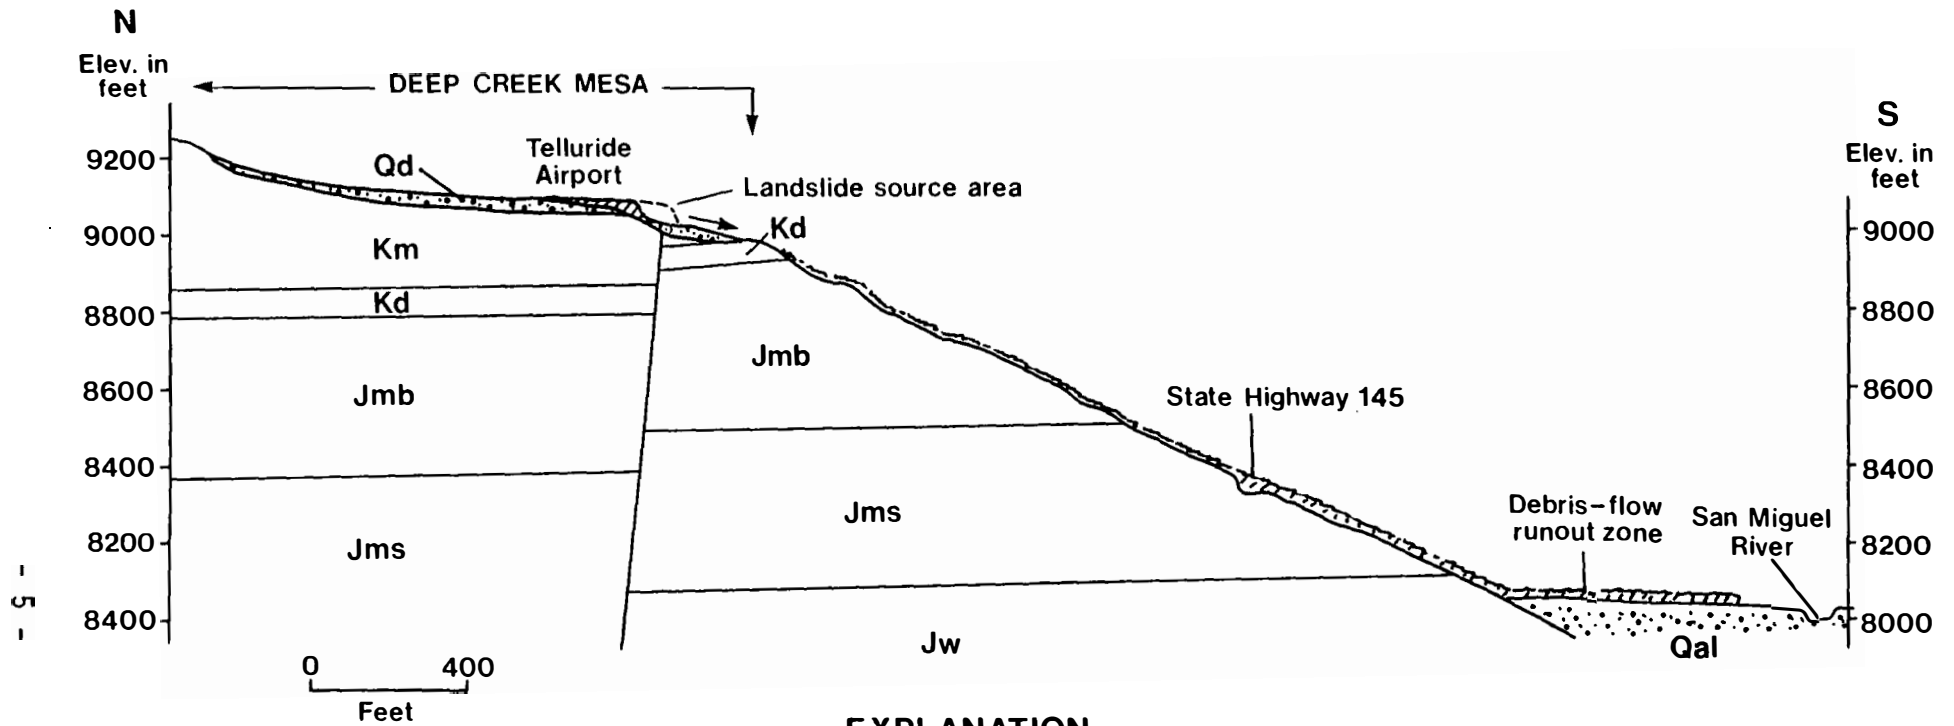
Figure 3. Schematic-geologic cross section of Telluride Airport landslide and debris flow.

Deep Creek Mesa is underlain by interbedded sandstones and shales of the Cretaceous-age Dakota Group and the Mancos Shale (Figure 3). The Dakota Sandstone forms the resistant rim of the mesa, the remainder of which is underlain by Mancos Shale. These units dip approximately 3° towards the northeast. Scattered patches of glacial drift overlie the Mancos and Dakota in swales and form small isolated hills on top of the mesa. The glacial deposits consist of brownish to brownish-orange silty clays, clayey sands, granitic and volcanic gravels, cobbles, and boulders.

In the area of concern, the east-west trending Vanadium fault (Bush, et al., 1961) displaces the Dakota Sandstone up against the Mancos Shale approximately 350 ft from the edge of the mesa (Figures 1 and 3).

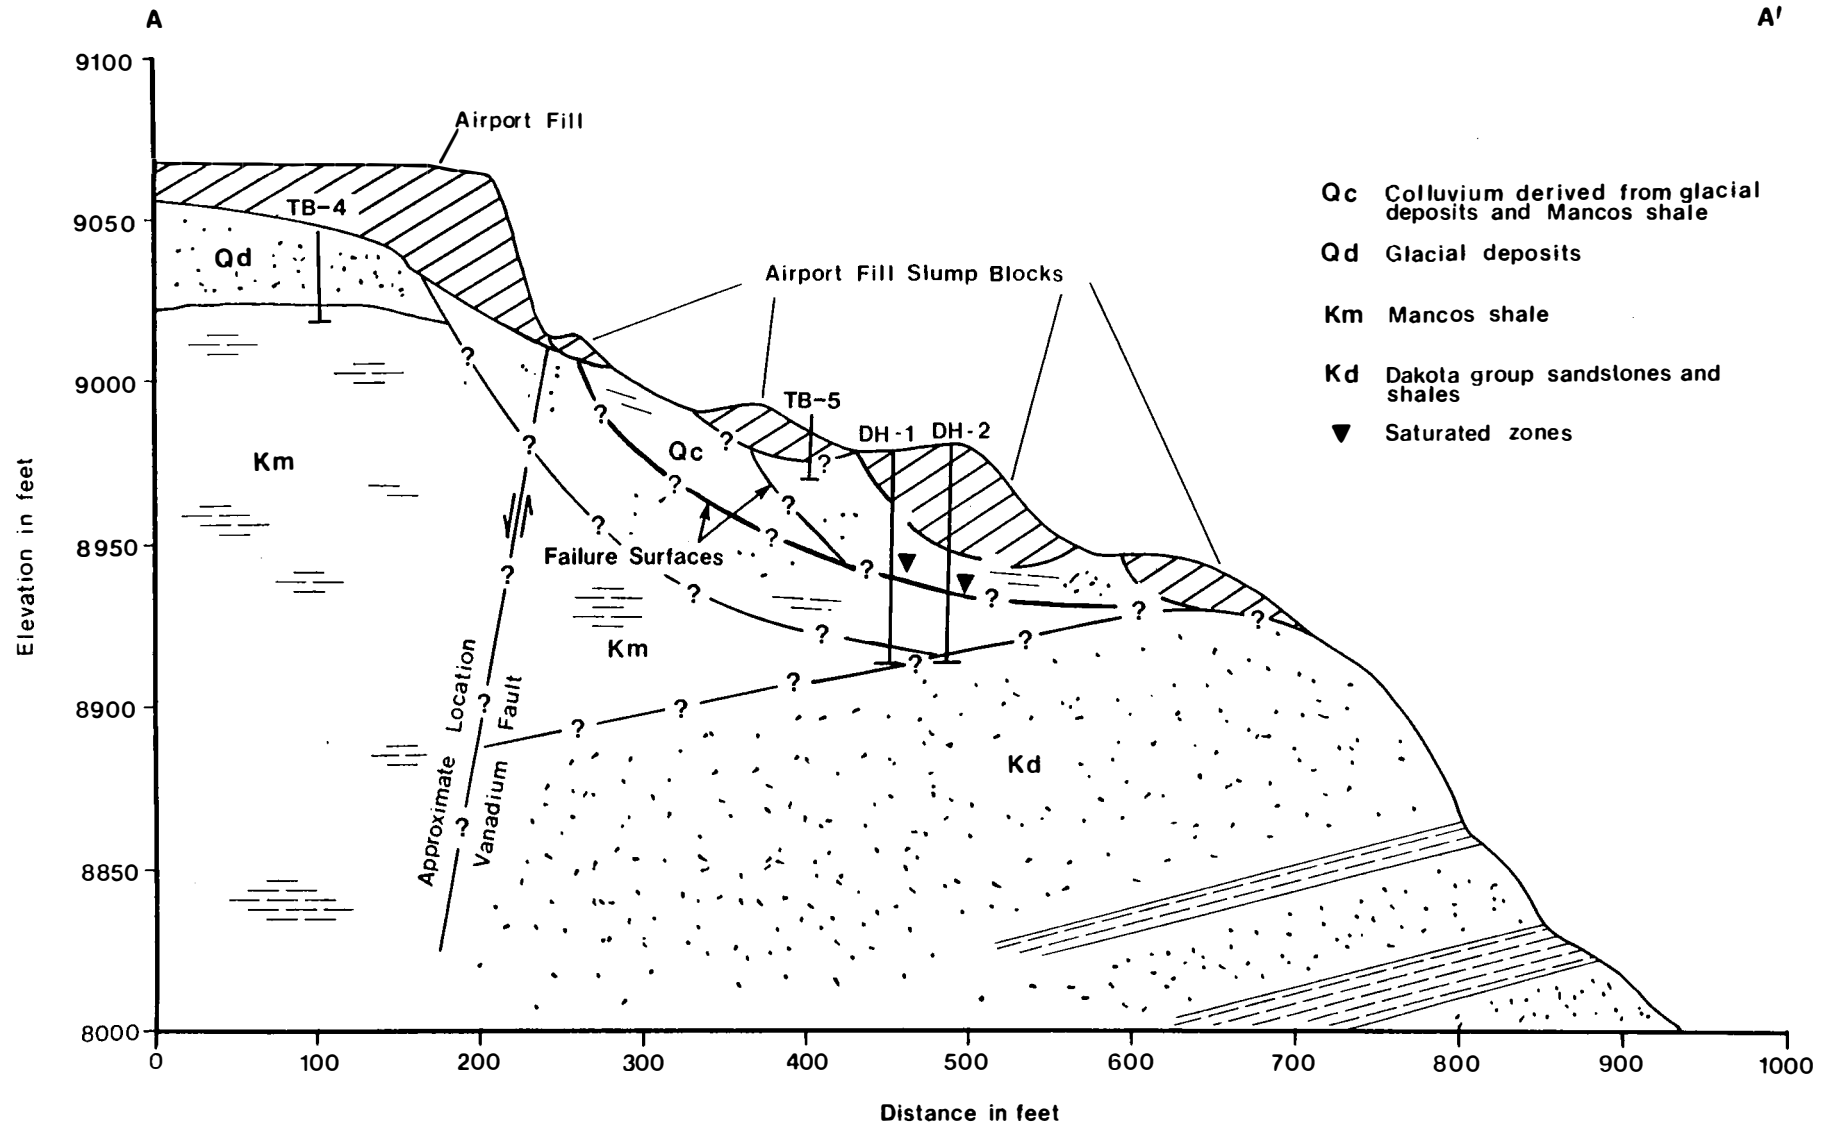
Figure 4B. Geologic cross section through landslide source area following movement.

The landslide scar is located in a pre-existing landslide source area that had been partially filled by engineered materials (Figures 2 and 4, Plate 1). Portions of the runway and safety zone of the Telluride Airport are constructed on the fill, and the headscarp of the failure is in the fill (Figure 4B). The day following the event, the fill exposed in the headscarp was essentially dry.

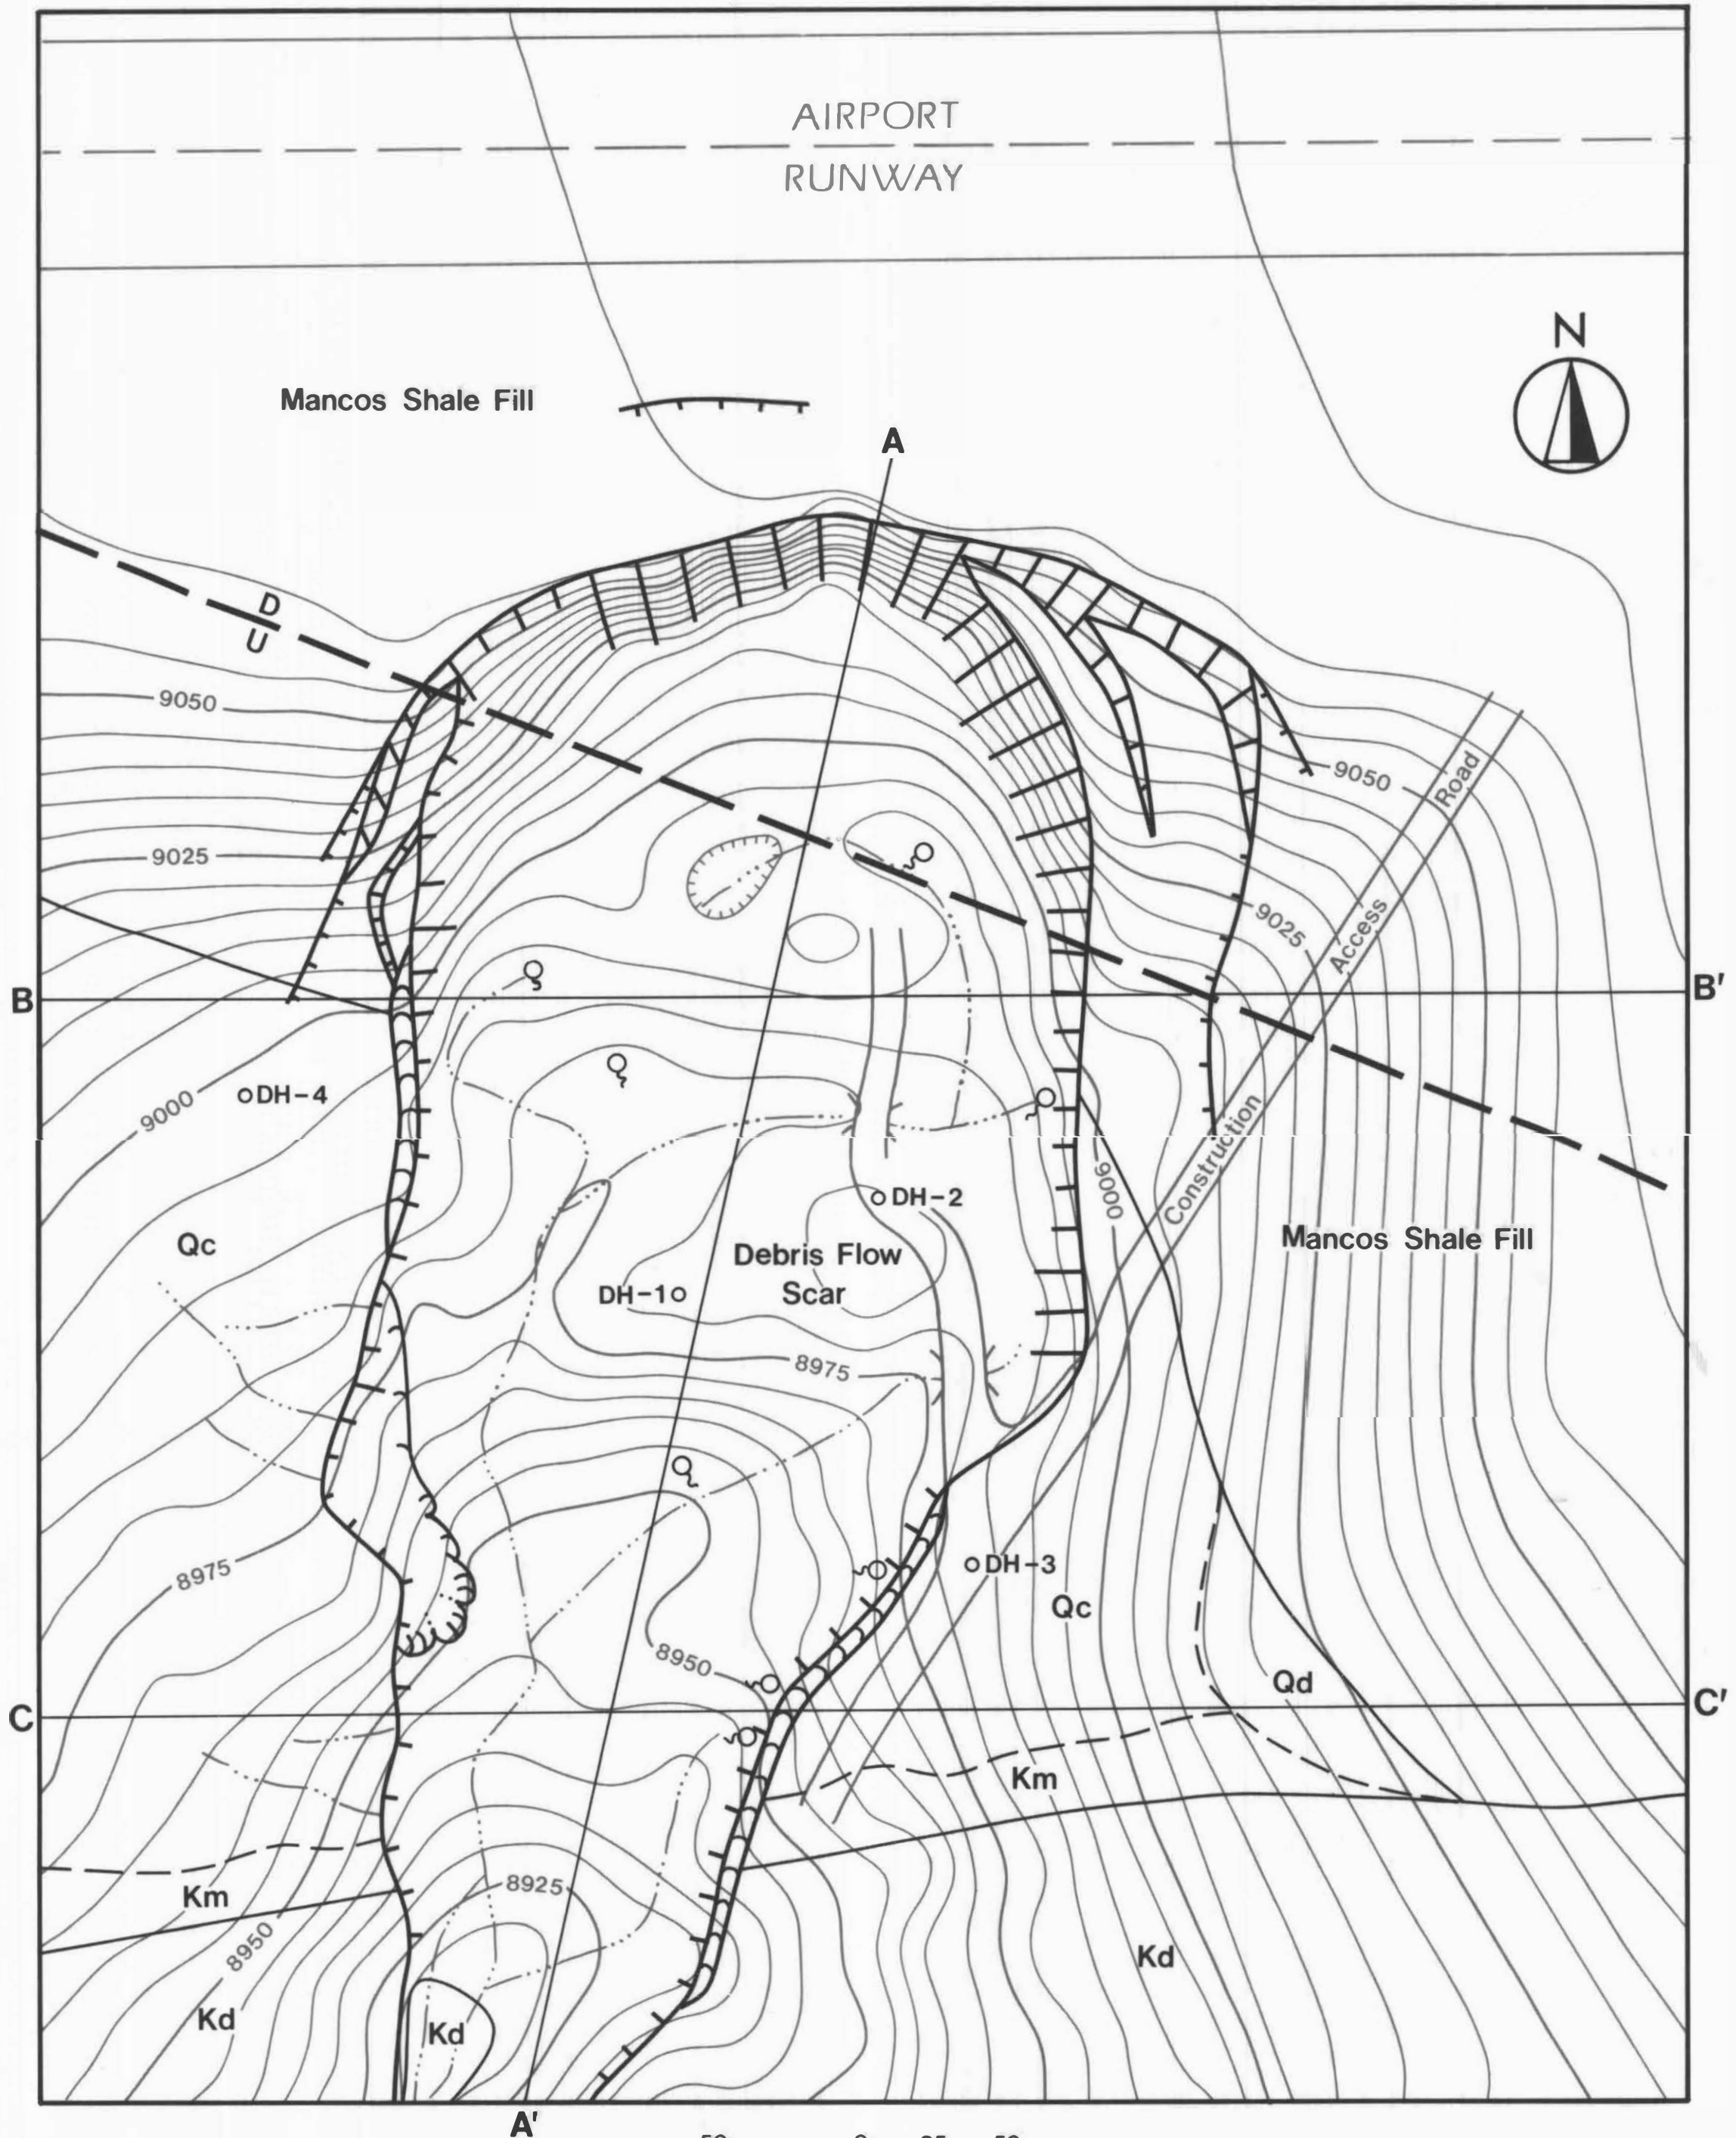
### Topographic and Geologic Map of the Telluride Airport Landslide

An additional fill prism (not shown on the available grading plan [Figure 2]) was constructed parallel to, and on the eastern edge of, the source area (Plate 1). This fill covered a small surface drainage channel.

The sides of the landslide scar extend from the toe of the fill 380 ft to the edge of the mesa. The u-shaped scar is 300 ft wide and 52 ft deep at its head, and narrows and thins to 130 ft wide and 2 to 3 ft deep at its lip (Plate 1).
