OPEN-FILE REPORT 89-01

Field Studies and Modeling Analysis of the Roan Creek Landslide, Garfield County, Colorado

By
David Umstot*

Colorado Geological Survey
Department of Natural Resources
Denver, Colorado
1989

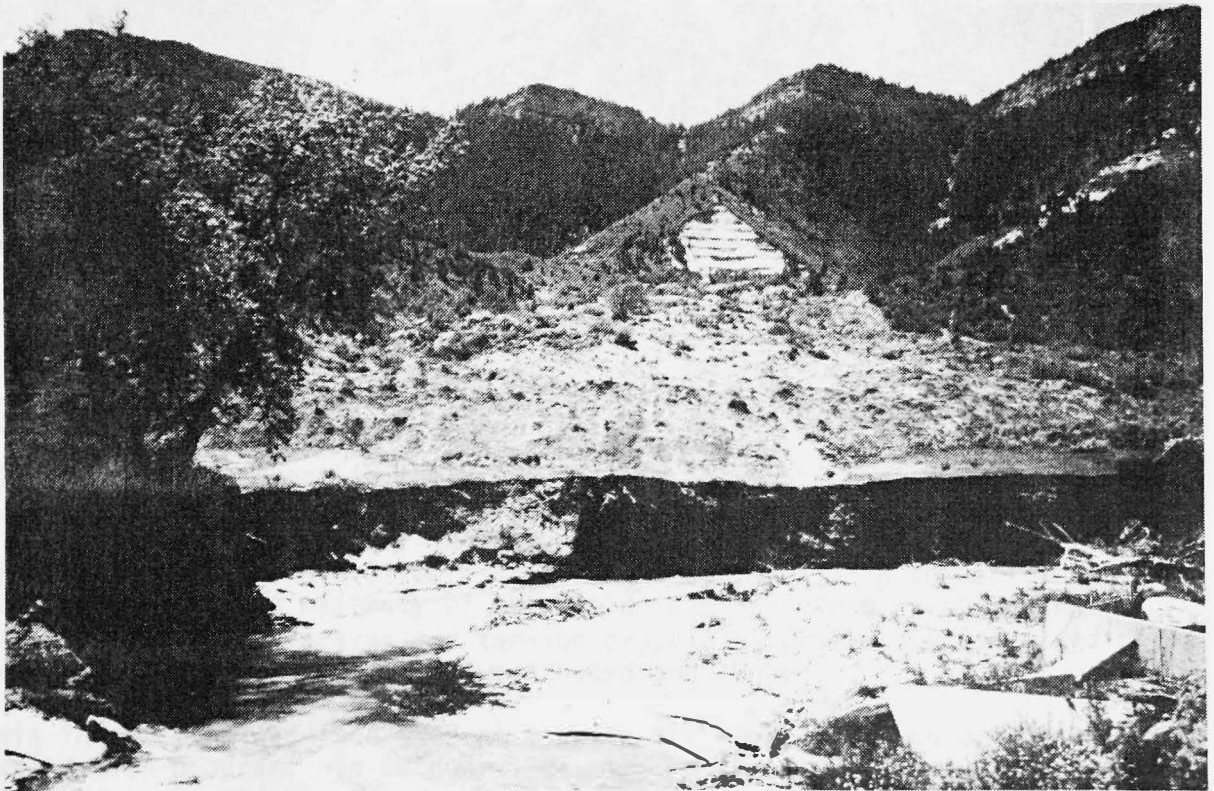
Figure 3. The Roan Creek landslide halted 50 feet from Roan Creek. The height of the cliff bank in foreground is approximately 15 feet.

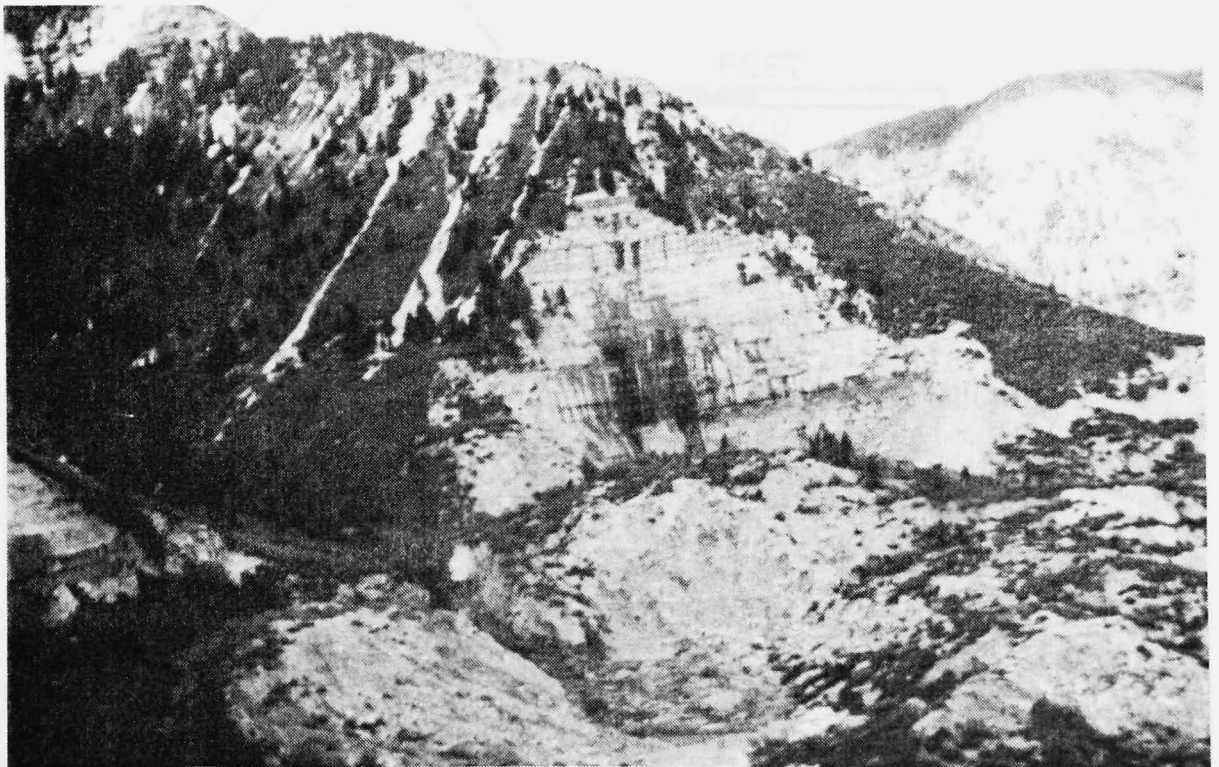
5.1.2.1 Head scarps The head scarps are present continuously around the perimeter of the slide mass in the upper third of the slide. To the west and east of the drainage are large cliff scarps (Figures 14 and 15) which are not visible on USGS topographic maps printed in 1968. Seepage in the center of the scarp face should be noted in Figure 15. Groundwater flow appears to be along horizontal bedding planes near the contact of the Garden Gulch and Douglas Creek Members of the Green River Formation as evidenced by seeps in the western cliff scarp. Olson (1974) mapped both cliff scarps in his field work, but at a lesser magnitude with less extensive associated landslide deposits. This would indicate initial failure of the slopes occurred sometime between the aerial missions flown to collect data for the topographic maps and 1974, or that the scarps were small enough to be masked when preparing a small-scale topographic base map without adequate field checking.

Figure 15. The western head scarp is approximately 200 feet high. Refer to Figure 16 for location.

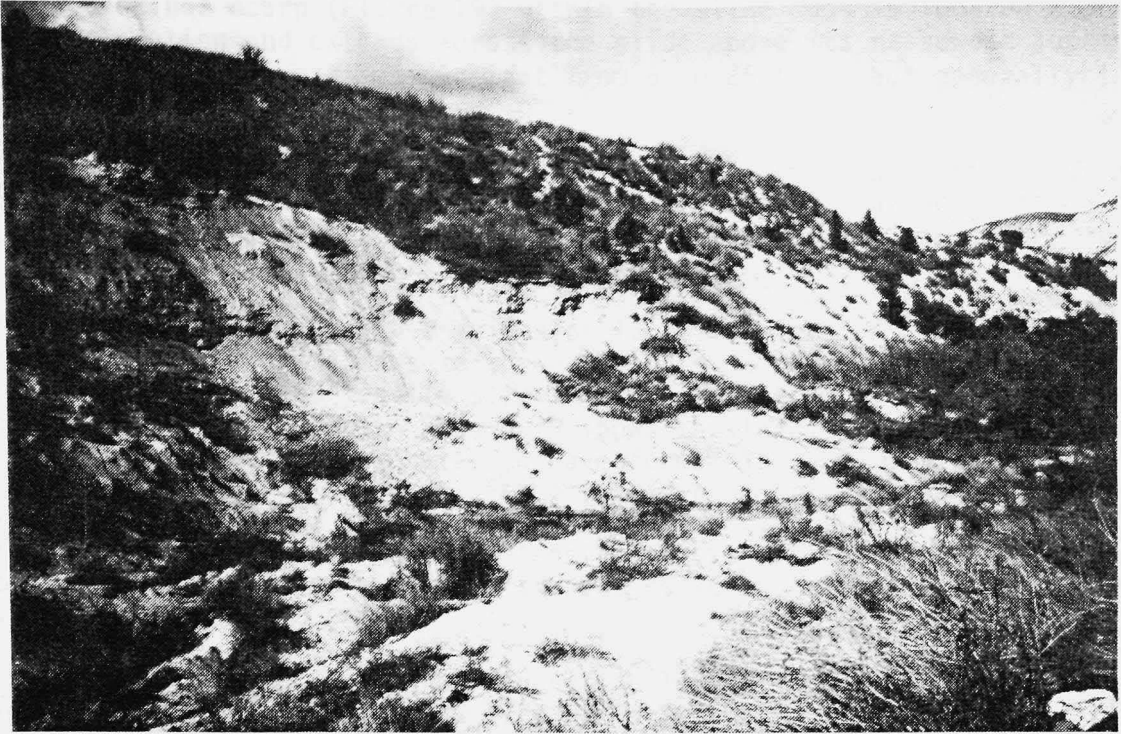
Figure 17. Scarp along western margin of Roan Creek landslide. Refer to Figure 18 for location.

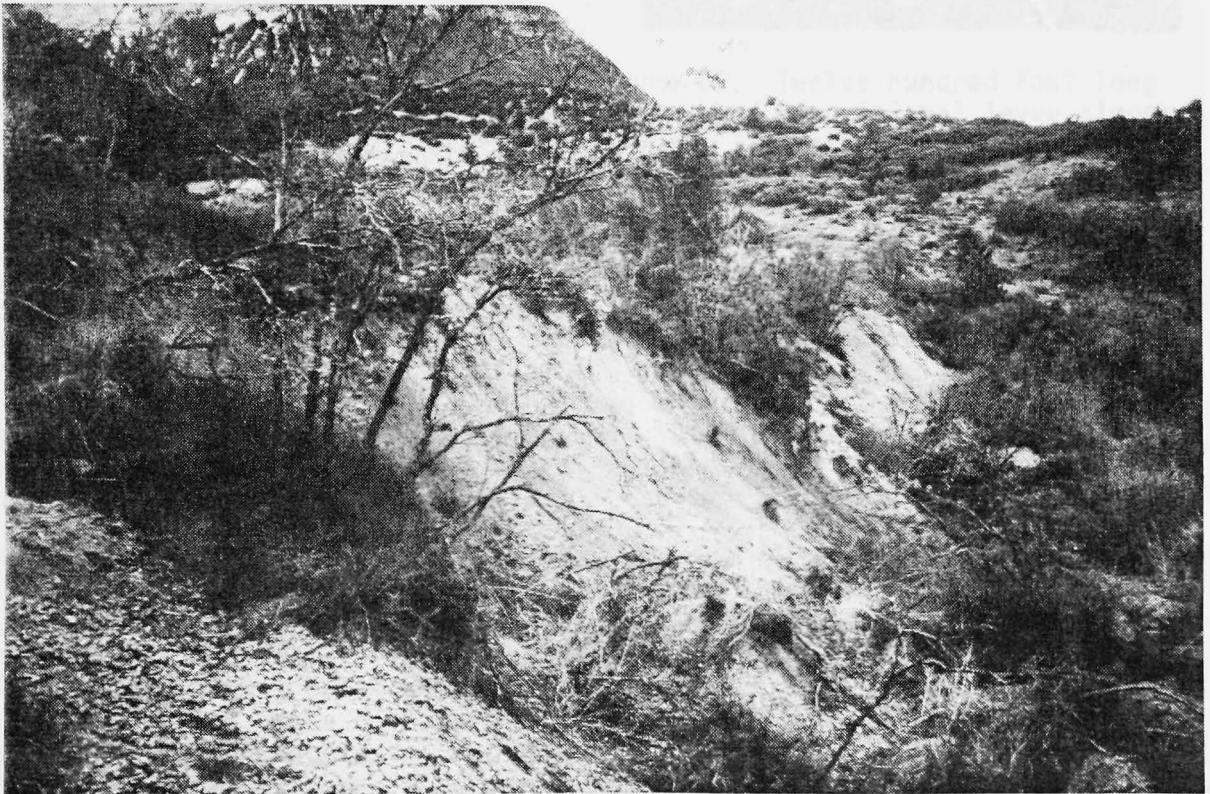
Another distinct scarp (Figure 19) within the slide mass is located at 6175 feet in elevation and extends across the slide above its narrowest juncture (see Figure 18). It varies in height from 6 to 25 feet, but generally is 20 feet high.

Figure 19. Scarp exhibiting about 20 feet of vertical displacement crosscuts the slide mass approximately one third of the distance up the slide from the toe. Refer to Figure 18 for location.

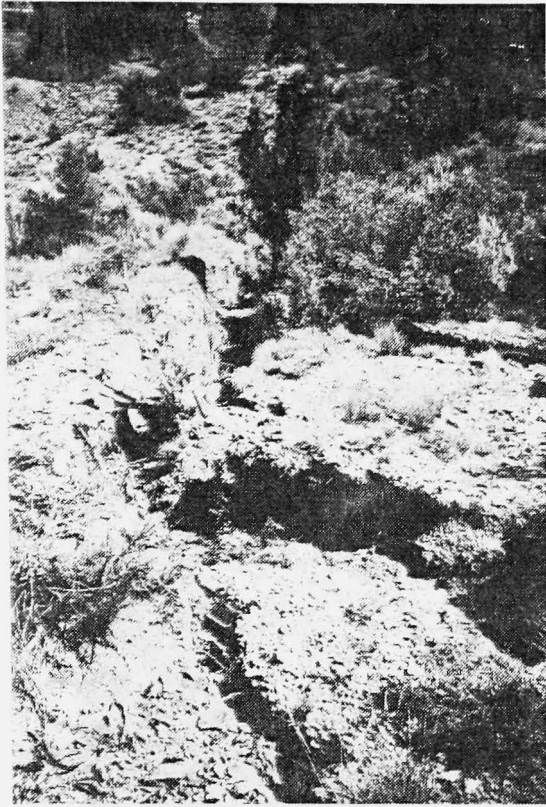
Figure 20. Tension cracks east of the slide mass. Refer to Figure 18 for location.

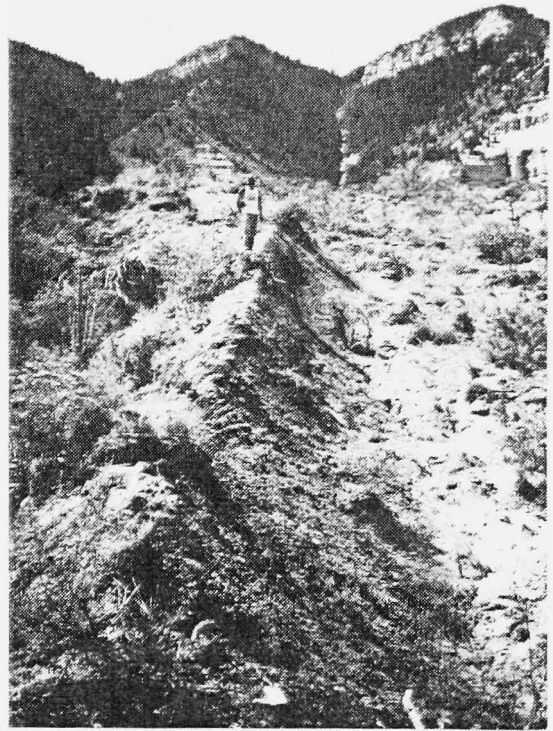
5.1.2.4 Lateral levee A lateral deposition levee is present on the eastern flank of the slide with a length of 1200 feet (Figure 21). The height of the levee varies from 4 feet in its lower reaches to 15 feet in its upper reaches. Width also is variable decreasing from 15 feet to 6 feet towards the

Figure 21. Twelve hundred foot long depositional levee along the eastern margin of the landslide. Refer to Figure 18 for location.

toe of the slide. Depositional levees are common landforms in earthflow deposits as the velocity of the flow is slower at its edges than in its center due to increased shearing stresses along the margins. Therefore, as the flow material on the sides stops, it is at the same height as the remainder of the flow material. However, flow continues in the center and the center areal mass is depleted as the soil flows onward. The difference in elevation between the center and lateral areas of the flow deposit results in what appears to be a levee.

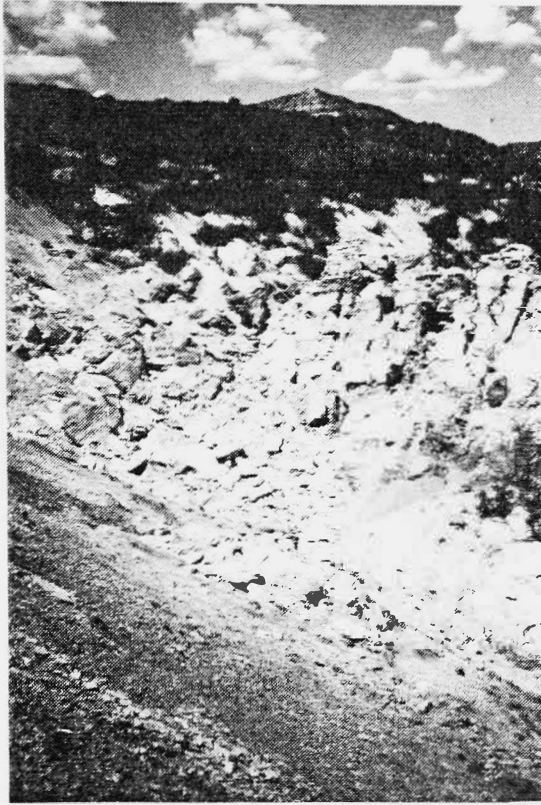
5.1.2.5 Depressions Several topographic depressions were mapped on the slide deposits, some of which form ponds. In the upper reaches of the slide are large depressions dominated by blocks of bedrock. The largest of these has dimensions of 200 feet in length, 100 feet in width and 40 feet in depth (Figure 22). It was noted that after a torrential rain, no standing water was present in any of these depressions. Numerous open cracks and holes allow infiltration of surface water into the slide mass. These depressions are interpreted to have formed when a large slab of rock present in the rock flows emanating from the western cliff scarp region broke apart due to tensile stresses.

Figure 22. Forty foot deep depression in upper reaches of slide. Person for scale in right center of photo. See Figure 23 for location.

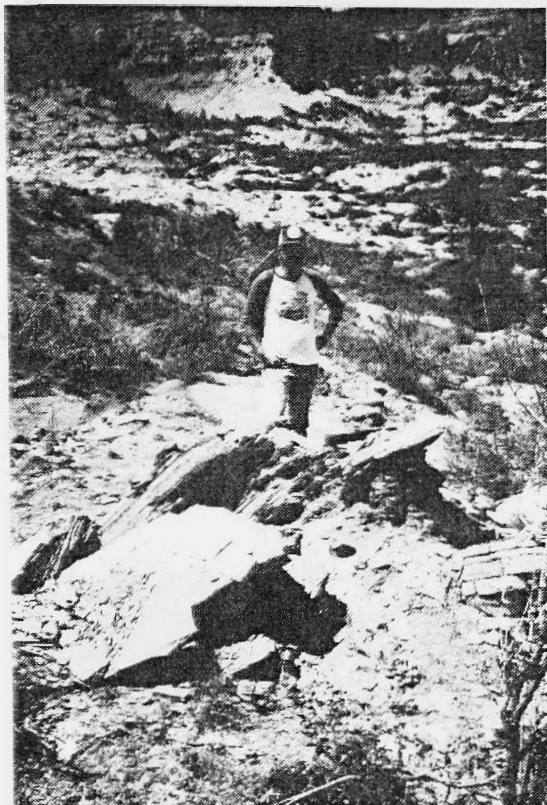
Figure 24. Highly fissile blocks of rock comprise the upper reaches of the landslide. Refer to Figure 23 for location.

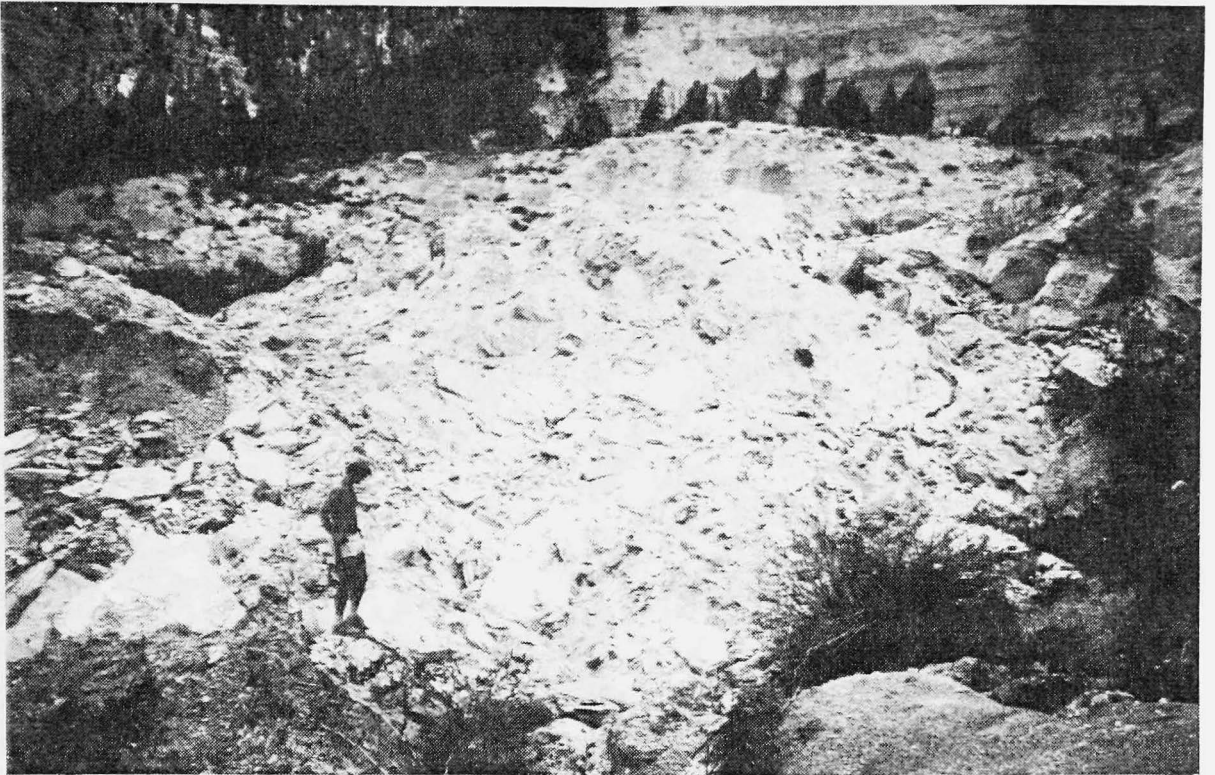
Figure 25. Texture of the upper reaches of the landslide where rock rubble dominates lithology. Refer to Figure 23 for location.

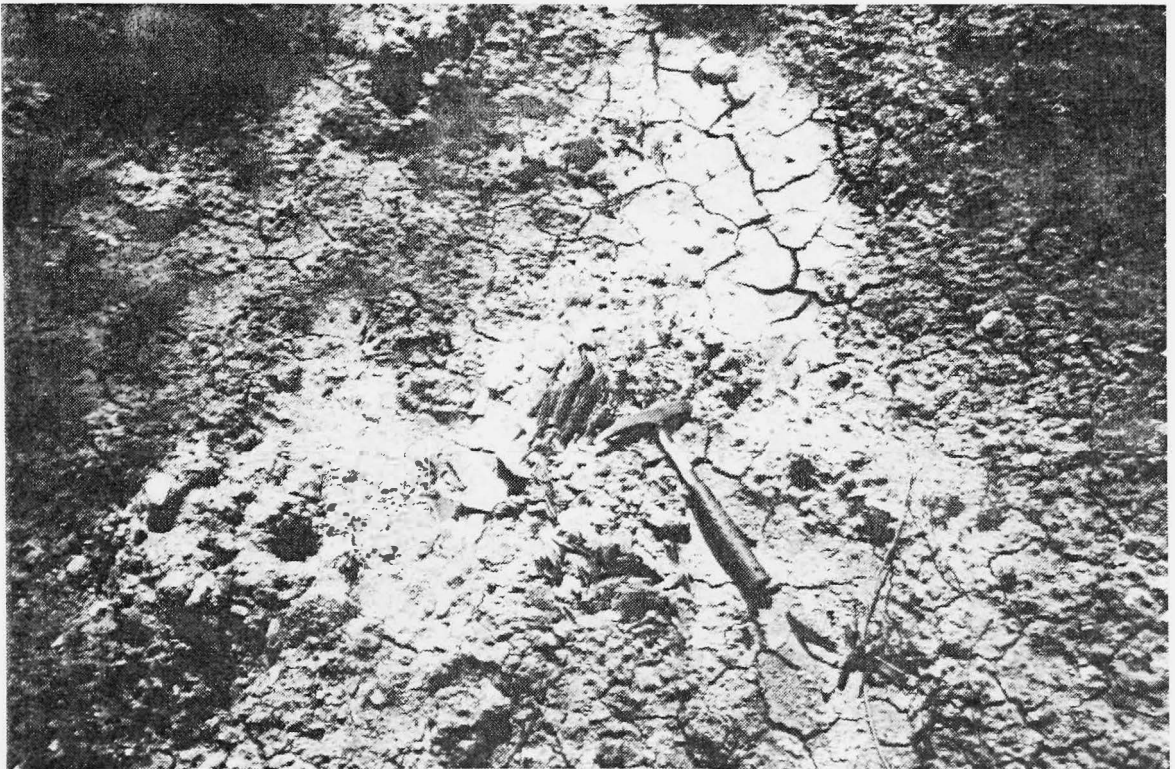
The lower two thirds of the slide is predominantly fine-grained with an abundance of smaller rock fragments suspended within the clay-size matrix (Figure 26). In this zone, abundant blocks of vegetation and "A" soil horizon appear to have rafted on top of the slide mass as it moved downhill (Figure 27). The root structures of the vegetation have kept the blocks intact. On the flanks of the toe of the slide, another zone of predominantly fine-grained material is present, denoted as fine-grained zone 2 on Figure 23. It has a different texture and color from the primary fine-grained zone 1 and correlates to the hillslopes adjacent to the slide. The material was most probably incorporated into the slide mass as the slide moved into the drainage bottleneck before spreading onto an alluvial fan. A small debris flow deposit (see Figure 23) is present at the head of the slide below the juncture where the head scarp intersects the drainage from the upper elevations of Kimball Mountain.

Figure 26. Fine-grained materials dominate the lower reaches of the landslide.

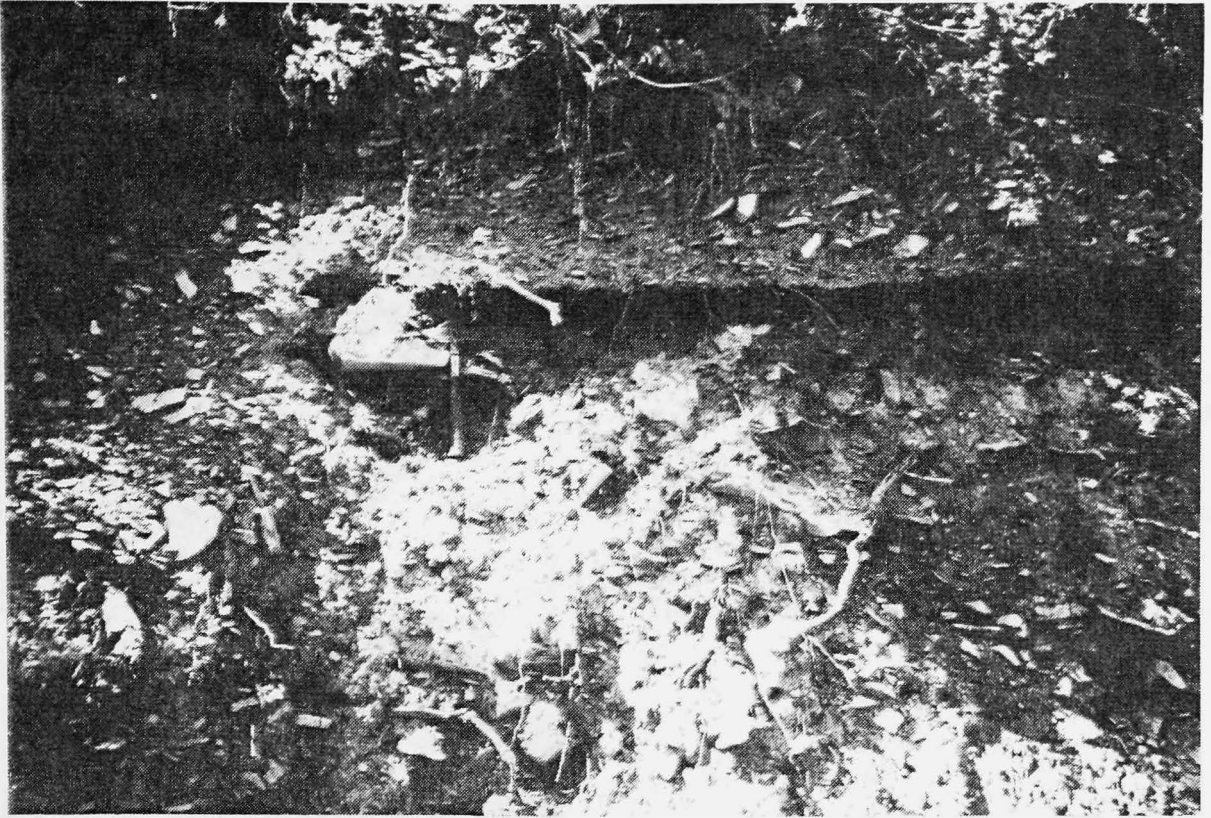
Figure 27. Vegetation and A-horizon "rafts" found in the central portion of the landslide. Refer to Figure 23 for location.

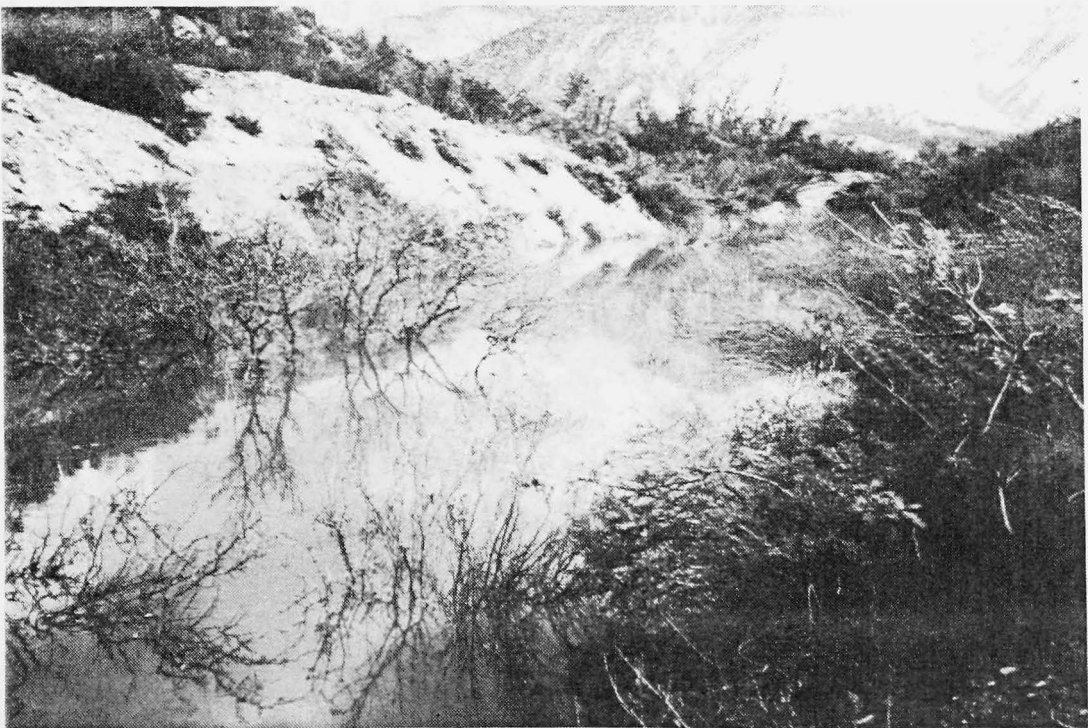
Figure 28. Standing water in the west central part of the landslide. Refer to Figure 23 for location.

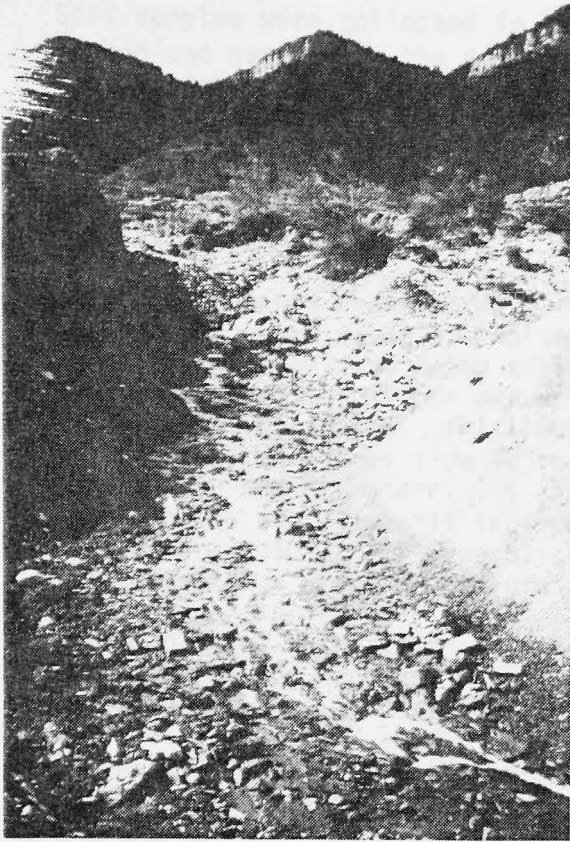
Figure 29. Stream flowing on toe of slide (Figure 23 for location).

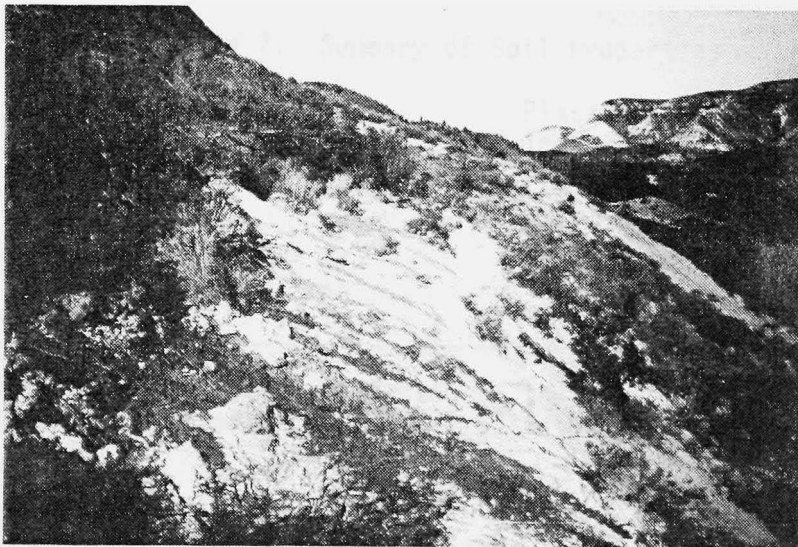
Groundwater recharge to the slide material most probably is the source of the water flowing off the slide. Several seeps were noted and mapped (Plate 1). Seeps are highly concentrated along the western flank in the lower one half of the slide (Figure 30), but also occur in other locations on the slide. The whiter areas on the photo are areas of calcite and gypsum mineralization. Study of the 1978 and 1985 aerial photographs indicates a well-defined drainage was overridden and infilled by the Roan Creek landslide along the western margin in the lower one half of the slide in 1985. This infilled, pre-existing drainage may act as a conduit for groundwater flow due to a differential permeability with the surrounding subsurface material and explain the high concentration of seeps along the western flank of the landslide. Abundant crystals of calcite, aragonite and gypsum are present on the surface throughout the lower one half of the slide suggesting groundwater was present at or very near the surface at some time, quite possibly at the time of failure and immediately after subsequent movement of the slide. The surface water and groundwater observations are important as water played an important role in the failure of the Roan Creek landslide.

Figure 30. Seeps and associated calcite and gypsum mineralization along the central western margin of the landslide (Figure 23 for location).

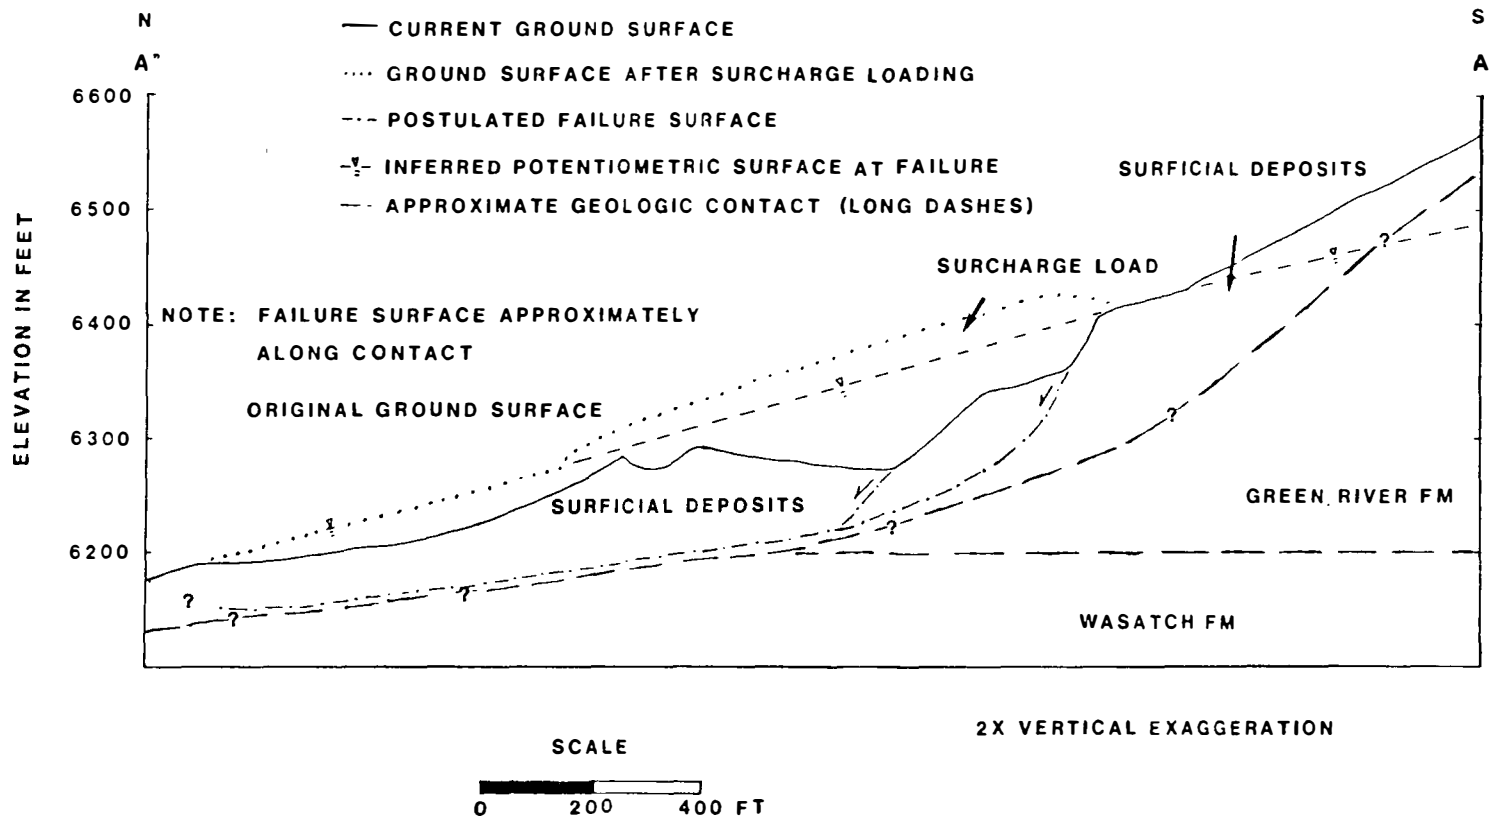
Figure 38. Cross-section along A-A' after surcharge loading.

Concentric topographic contours on Plate 1 suggest the failure shown in cross-section along A-A' (Figure 38). One major scarp is present at the failure head with an additional scarp present downhill due to progressive, or downhill, failure. Failure most probably occurred due to surcharge loading by the rock debris from the eastern cliff scarp on soil previously saturated by high precipitation and accelerated snowmelt. The sudden loading also most probably generated excess pore water pressures within the soil mass. A zone

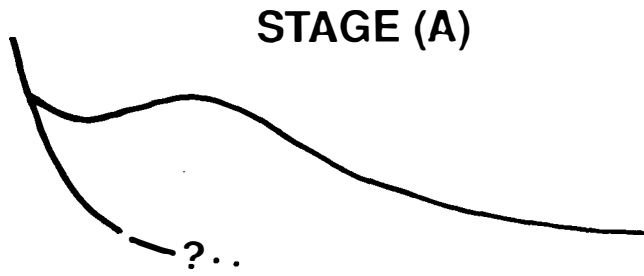
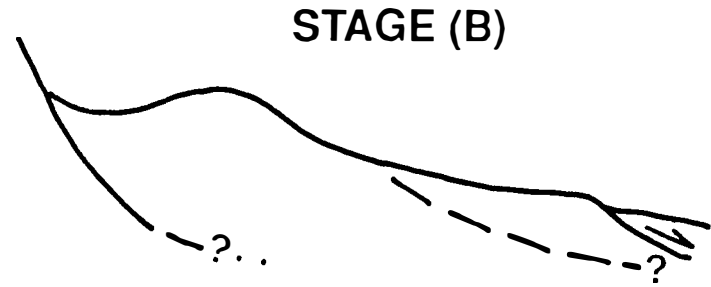
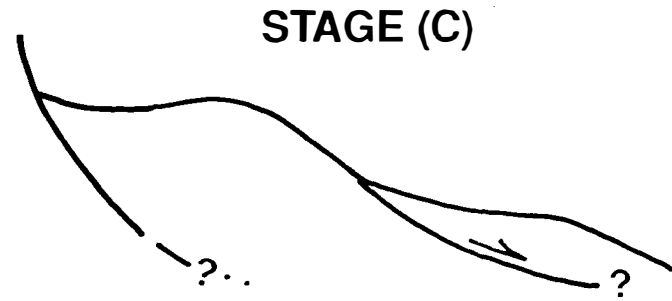
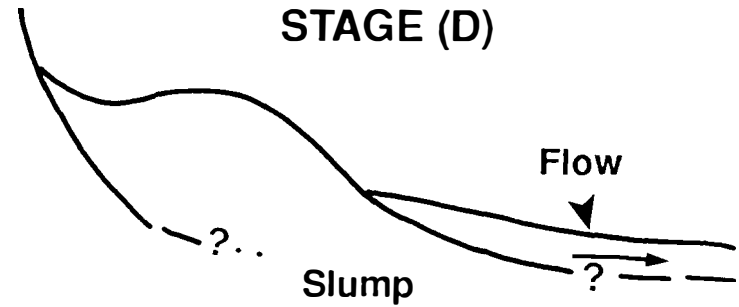
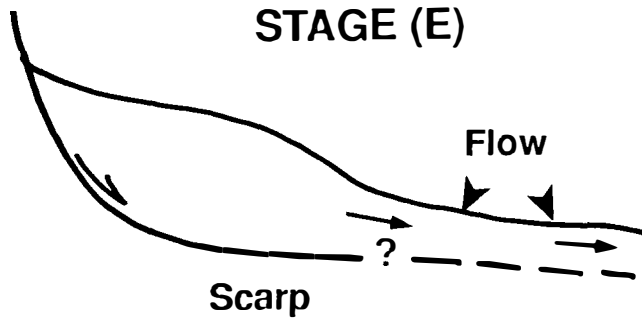
Figure 43. Diagrammatic representation of proposed failure sequence along cross-section C-C'.

Figure 42 is a cross-section along C-C' through the western cliff scarp and rotation block area. The failure model postulates that removal of material along A-A' reduced the lateral confining pressures acting on the slopes below the western cliff scarp, subsequently causing retrogressive failure of these slopes. A five-stage, diagrammatic representation of failure along C-C' is shown in Figure 43. Stage (a) shows the pre-existing topography and failure

plane daylighting at the cliff scarp. The failure along A-A' and subsequent removal of lateral support is represented in stage (b). Failure due to removal of lateral support by failure along A-A' is shown in stage (c). The head scarp of this failure surface is coincident with that representing the upper boundary of unit 5 in Figure 32. Stage (d) shows the vertical displacement at the head scarp in (c) immediately after failure which resulted in reduced lateral support of the failure plane daylighting at the cliff scarp. Failure along the pre-existing failure plane is shown in stage (e).
