Open File Report 91-01

**Identification and Remediation
of a Mine Flooding Problem in Rico,
Dolores County, Colorado
with a Discussion on the Use of Tracer Dyes**

By Mark W. Davis

Colorado Geological Survey
Division of Minerals and Geology
Department of Natural Resources
Denver, Colorado
1994

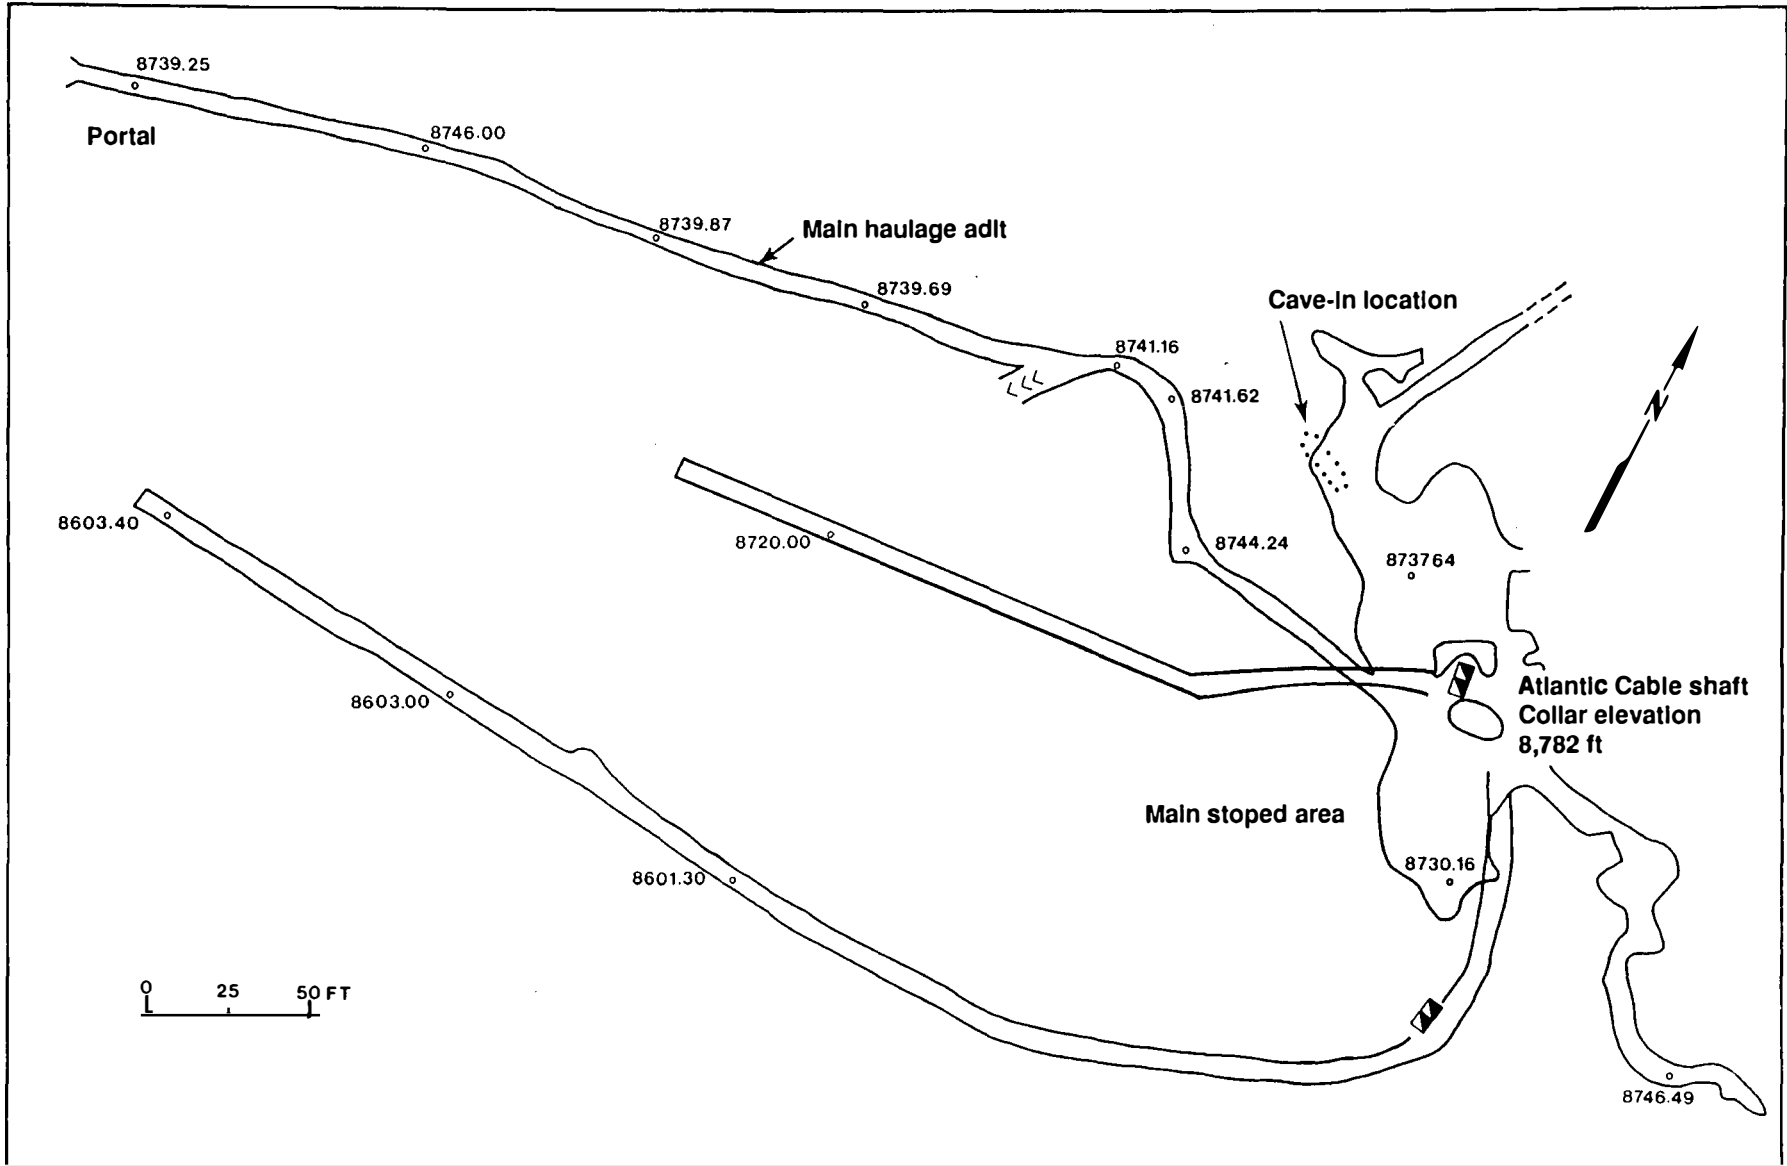
Figure 3. Atlantic Cable Mine, main haulage adit and exploration drifts.

Another map in the Dolores County Courthouse files, titled "The Van Winkle and Atlantic Cable Mines, Rico Argentine Mining Company Map 7-104" includes the west adit and shows no mining near this west adit but does show additional development headings driven from the 8600-ft level to the west and from an intermediate level assumed to be at the 8720-ft elevation. The longer of these two exploration drifts is shown on company maps to extend approximately 400 ft west of the Atlantic Cable shaft (Figure 3).

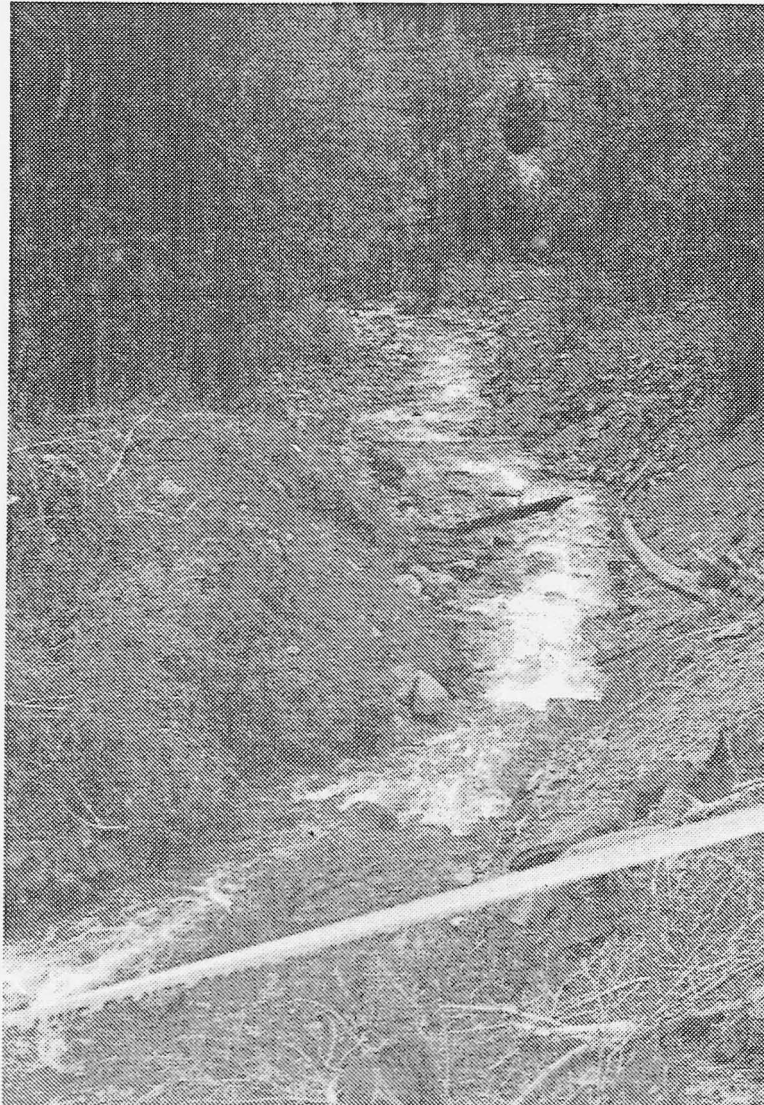
Late in May, residents noticed flooding around certain residences and also noticed a whirlpool west of the Atlantic Cable shaft in Silver Creek (Figure 4). This whirlpool was located approximately N. 60 W., 60 to 75 ft from the shaft and on the south bank. The observers could detect no reduction in stream volume. One observer mentioned that an open hole could be seen in the bedrock and that mine timbers were

encountered while he was operating a backhoe in the stream. Rico maintenance people reported that four truck loads (16 yds) of rock and soil were dumped into the whirlpool and much of this material sank into a hole. This whirlpool area overlies the first level stope suggesting that a cave-in could have occurred from the back (roof) of the stope up to the stream bed.

Figure 4. Location of whirlpool and cribbing encountered during re-alignment of Silver Creek channel. The loose fill material on the left side of the Creek in the center of the picture was dumped into the whirlpool.

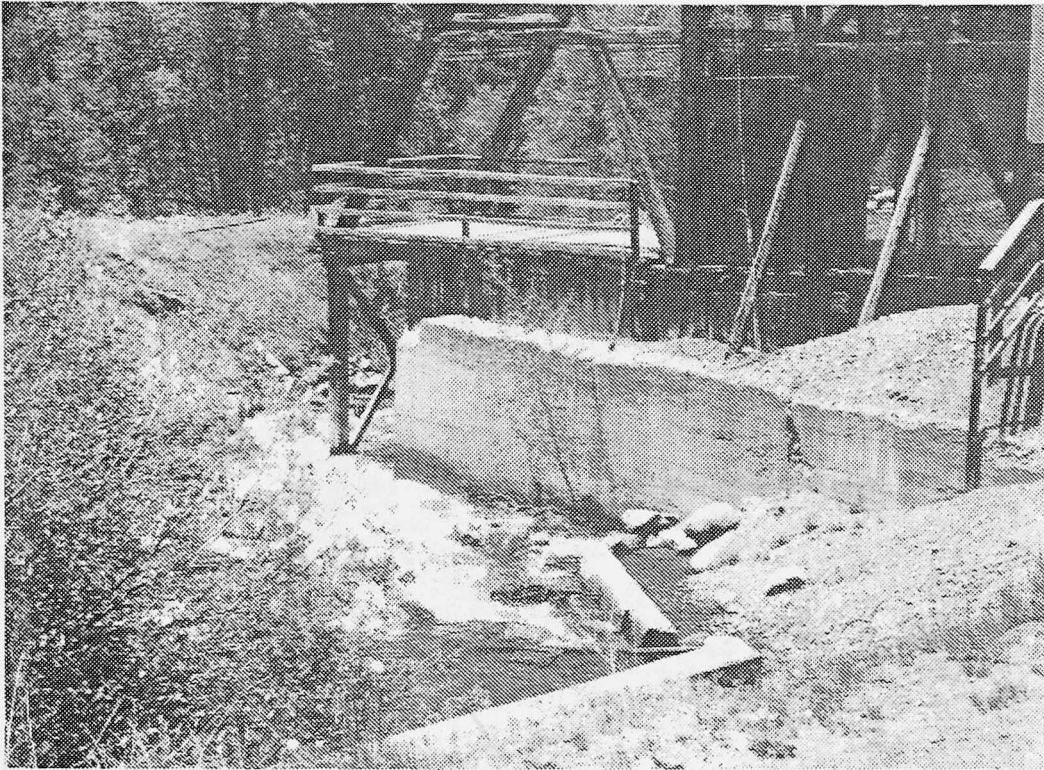
Figure 5. Looking westward at the Atlantic Cable shaft with concrete flood protection wall.

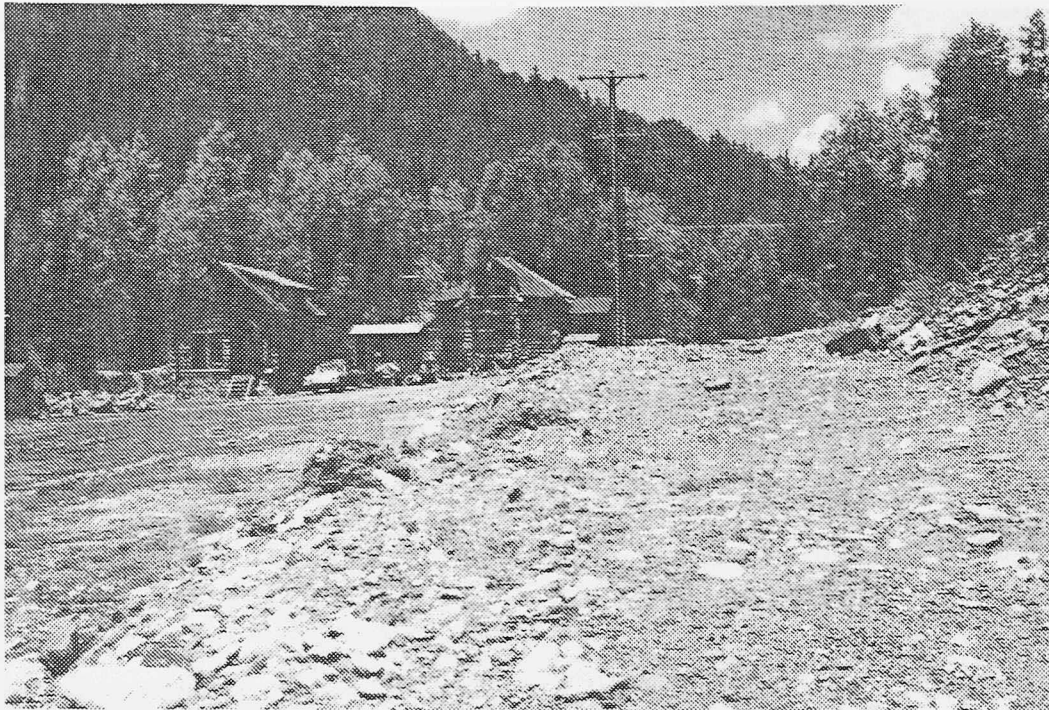
Seeping and minor piping has occurred immediately west of the west adit and could still be seen in the road, the adjacent front yard and along the bench that extends further to the south (Figures 6 and 7).

Figure 6. Looking north toward the most seriously affected properties. The main haulage adit is in the trees on the right of the picture.

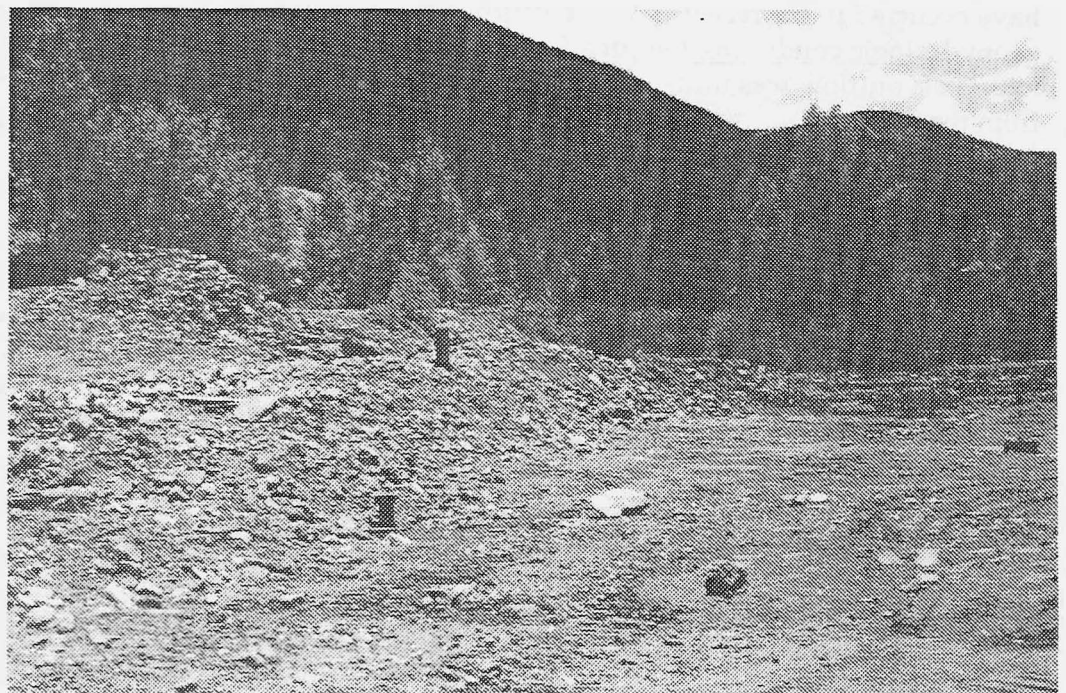
Figure 7. Water line on flooded bench. The riser pipe in the lower foreground and the hydrant are connected to the water line.

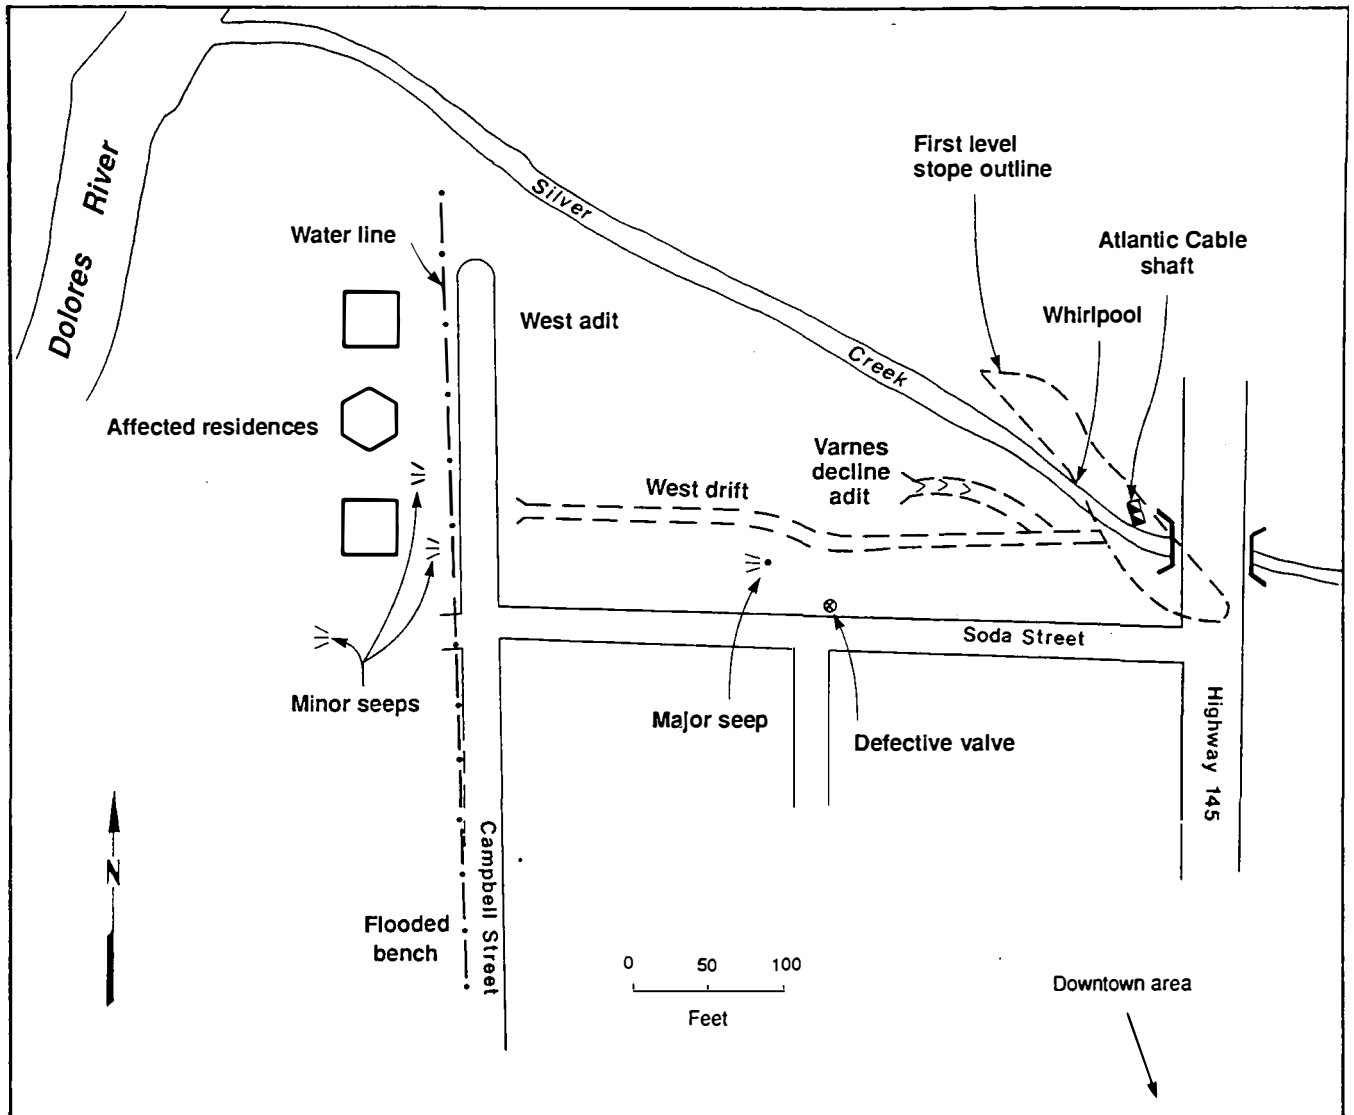
Figure 8. Affected residences and their relationship to Silver Creek and the west adit.

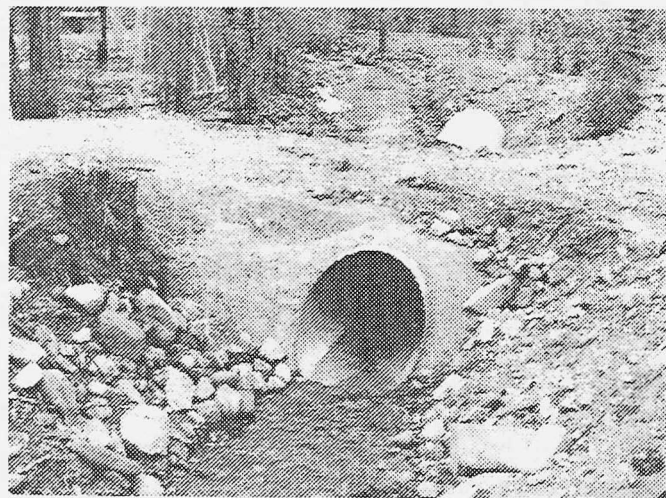
Figure 9. Silver Creek culvert over caved-in area of Atlantic Cable Mine.

Following the chemical and dye testing, Silver Creek flow had dropped off to not much more than a trickle, measured by WCD to be between 1 and 2 cfs. During this low water period, the bed of the stream was investigated and the cave-in area surveyed to the Atlantic Cable shaft. The center of the cave-in lay 63-ft west of the concrete retaining wall on the west side of the shaft. Although cobbles and boulders made identification difficult, the hole in the stream bed was approximately 3-ft wide measured perpendicular to the stream direction by 7-ft long. Timbers were observed running on either side of the hole with eight inch lagging supported on the timbers. At the time of these observations the entire above-bed flow of Silver Creek was flowing into the caved mine workings. It was decided that the most cost effective short-term solution to the flooding problem was the installation of a culvert over the cave-in beneath the creek (Figure 9).

Rico maintenance personnel and members of his own staff. The creek was contoured to accept a 6-ft-diameter by 60-ft-long culvert.

Concrete was used to pave the hole and to form a cover over the backfill and bedding material to minimize erosion at the upstream end of the culvert.
