Special Publication 30

# Debris-Flow Hazard in the Immediate Vicinity of Ouray, Colorado

Colorado Geological Survey  
Department of Natural Resources  
Denver, Colorado / 1986

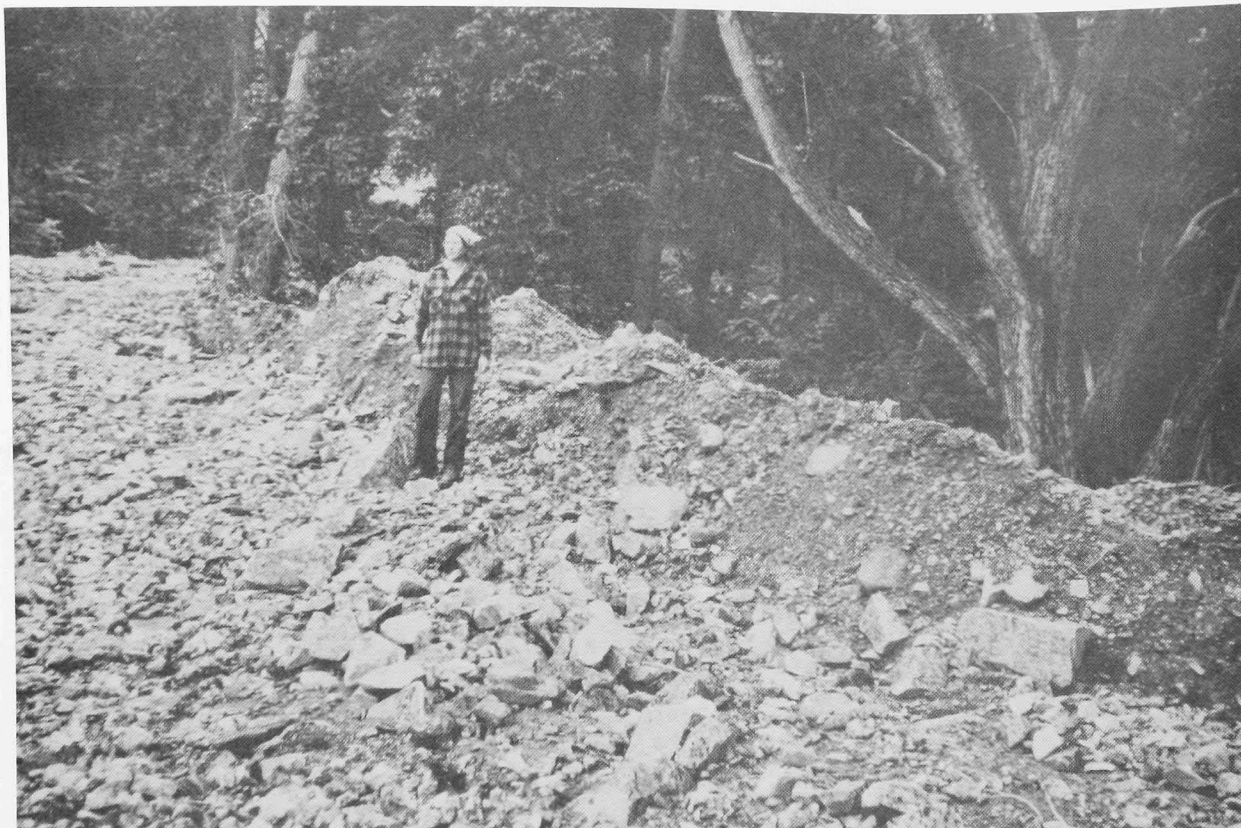
Figure 6. Debris on Skyrocket Creek fan, 1982.

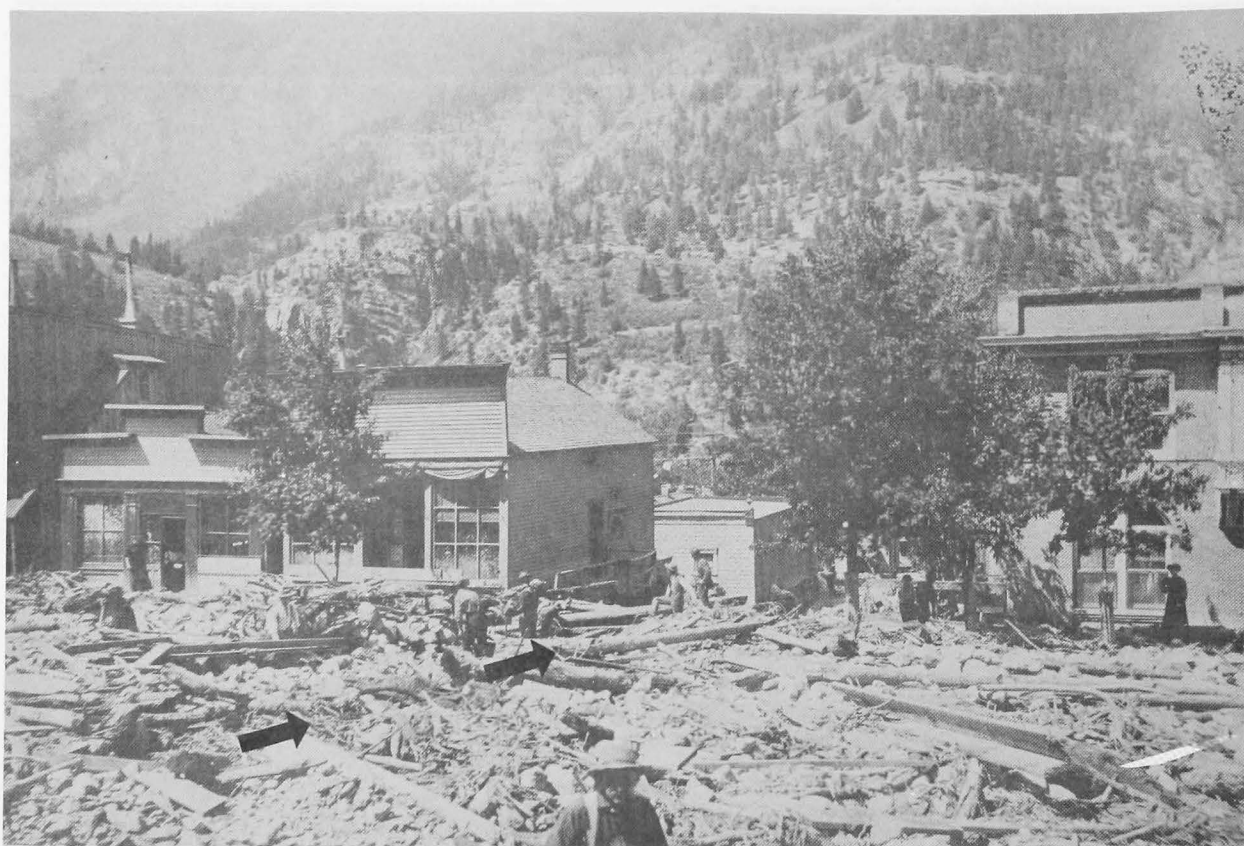
Figure 11. Debris flow on Portland Creek, 1909. Looking west across Main Street. Flume passes between buildings on left and tree (see arrows). (Photo courtesy Denver Public Library Western History Collection)

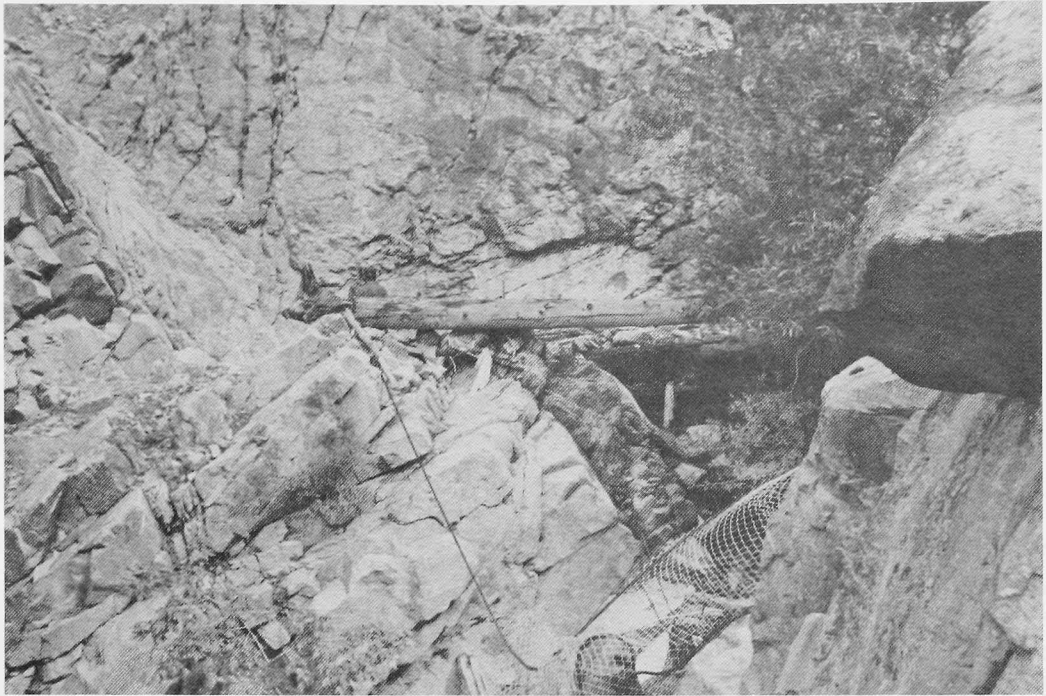
Figure 13. Remains of wooden diversion dam constructed on Skyrocket Creek in 1929. (Photo courtesy William P. Stanton, CWCB)

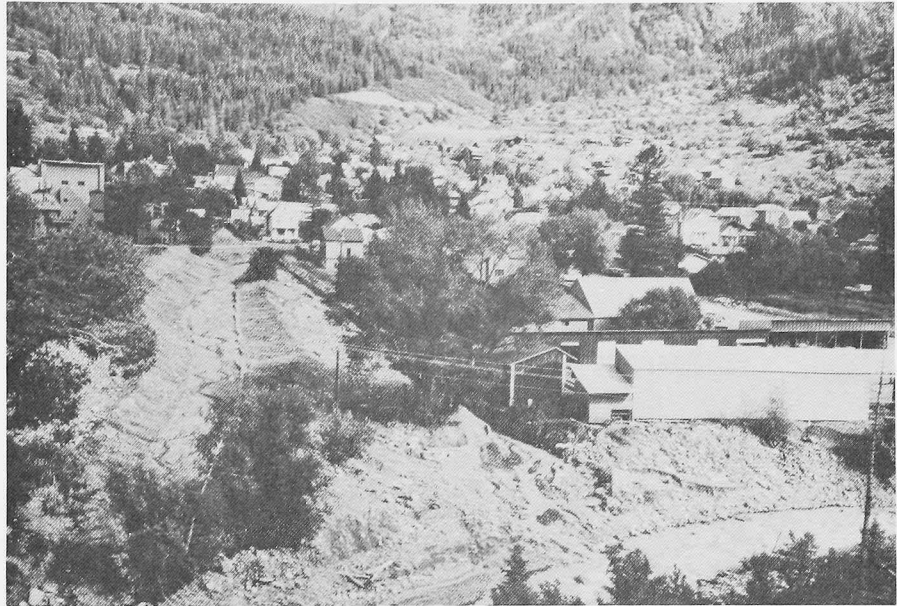
In July of 1981 Portland, Cascade, and Skyrocket Creeks flooded on two successive days. On the first day, four pedestrian bridges were destroyed on Portland Creek, and several others heavily damaged. The Portland Creek flume

plugged at the mouth and backed-up, depositing a huge pile of debris. This caused flooding of the lumber yard and the Baptist Church adjacent to the river. A side of the flume was deliberately knocked out to allow the flood waters to take another course to the river (Fig. 14). When Cascade's flume plugged on the second day (from the river to Fourth Street), the city diverted the water and debris down Main Street, contributing to the flooding at the Radium Springs Park, where the goldfish pond, swimming pool, and park were already being inundated by mud and water from Skyrocket Creek. Both flumes sustained heavy damage during this storm.

Figure 14. Portland Creek flume after 1982 event. Looking east from Oak Street. Debris is spread out where flume was broken in 1981.

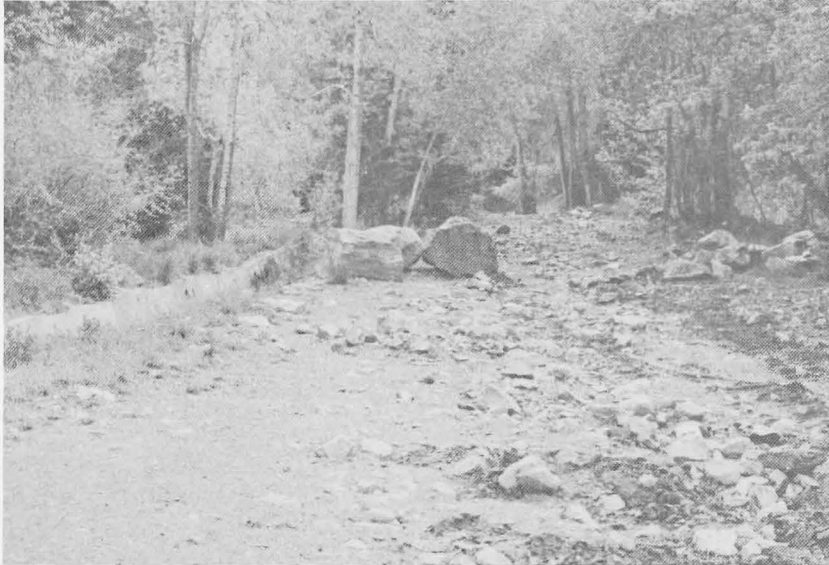
In 1982 flooding occurred on four successive days in August. On the first day, Cascade Creek jumped its flume and ran down Eighth Avenue, depositing rocks and logs and causing minor water damage (Fig. 15). Once again, Cascade's flume plugged at the box culvert under Highway 550 (also called Third Street or Main Street) and filled with debris on both sides from Fourth Street down to Second Street (Fig. 16). Portland Creek's flume plugged below Second Street and backed-up to the east. During this storm, at least thirty-five homes and businesses received damage. Also, many foot and auto bridges were destroyed.

Figure 15. Debris deposited on Eighth Avenue when Cascade Creek jumped flume in 1982.

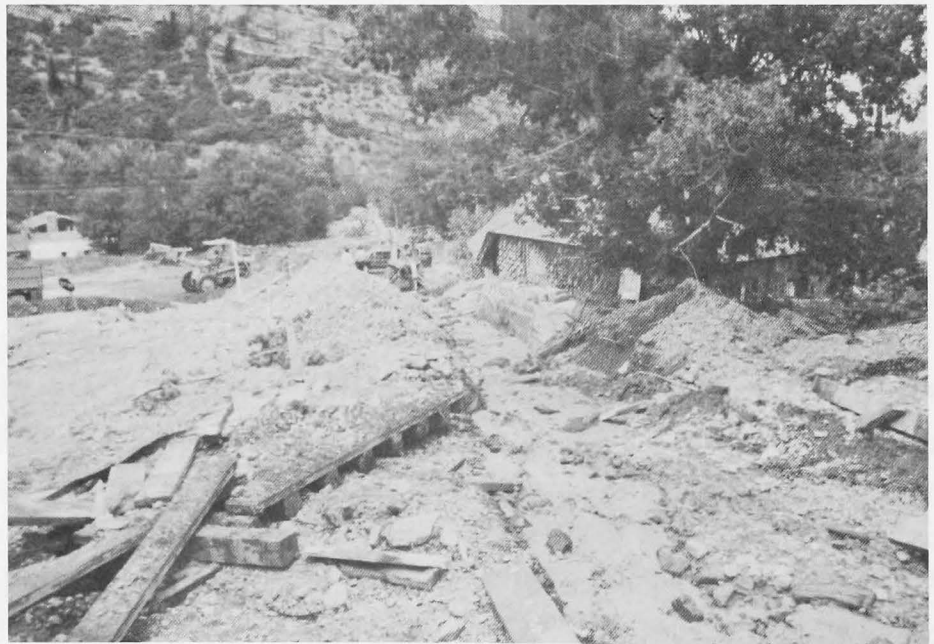
Figure 16. Debris back-up caused by plugged culvert on Cascade Creek at intersection with Highway 550, 1982 Looking west. (Photo courtesy William P. Stanton, CWCB)

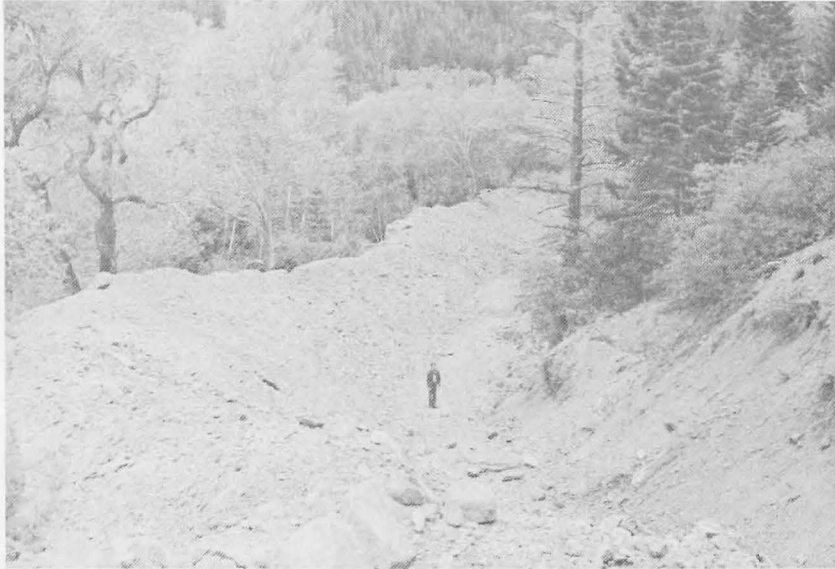
Figure 23. Manmade berms on Skyrocket Creek fan.

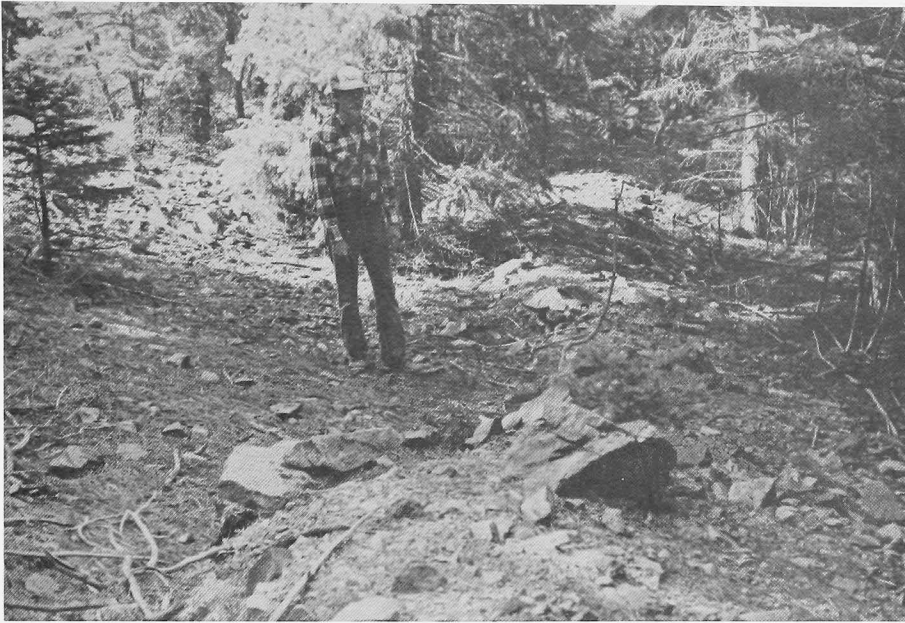
Figure 24. Debris-flow levee on Bridalveil Creek fan.

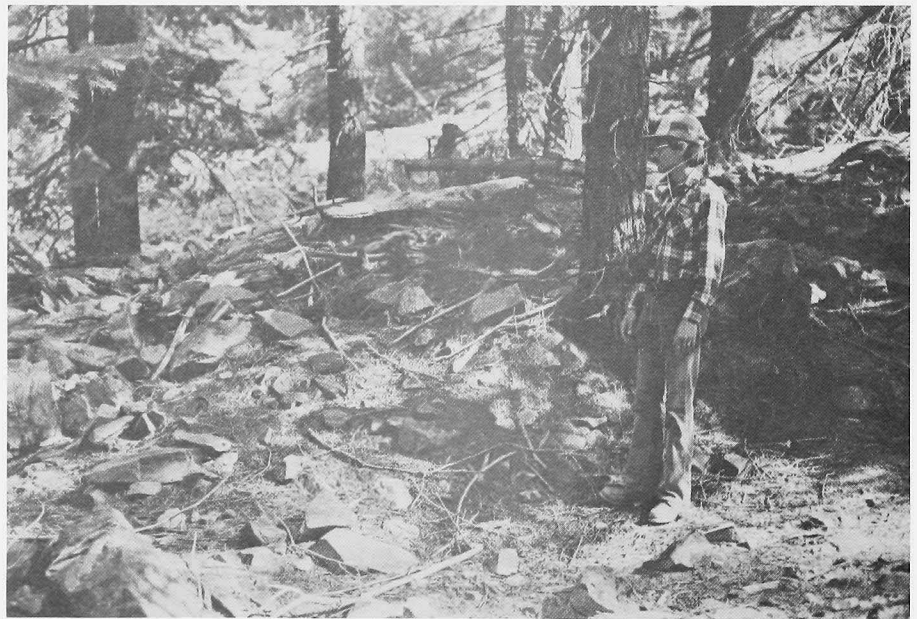
Figure 25. Debris-flow levee on Bridalveil Creek fan.

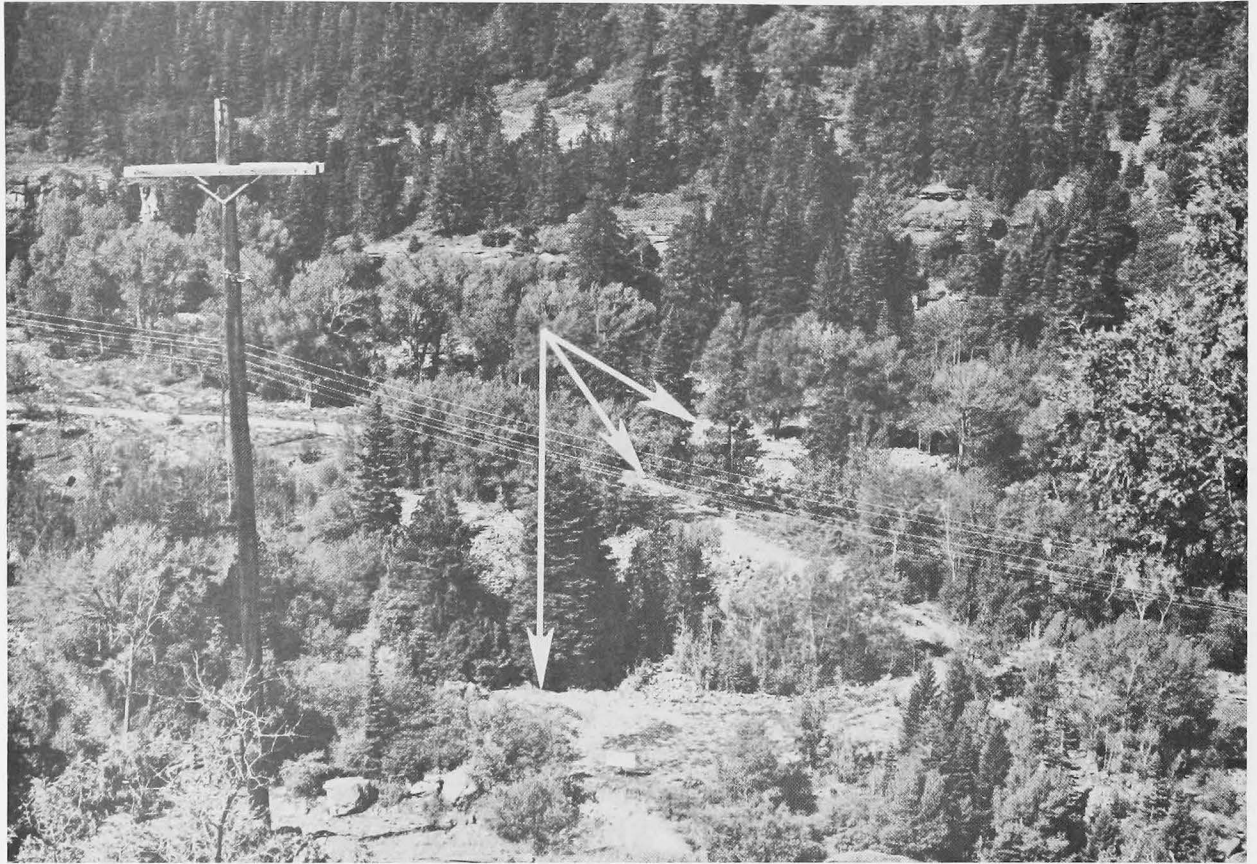
Figure 26. Debris-flow levees on Corbett Creek fan.

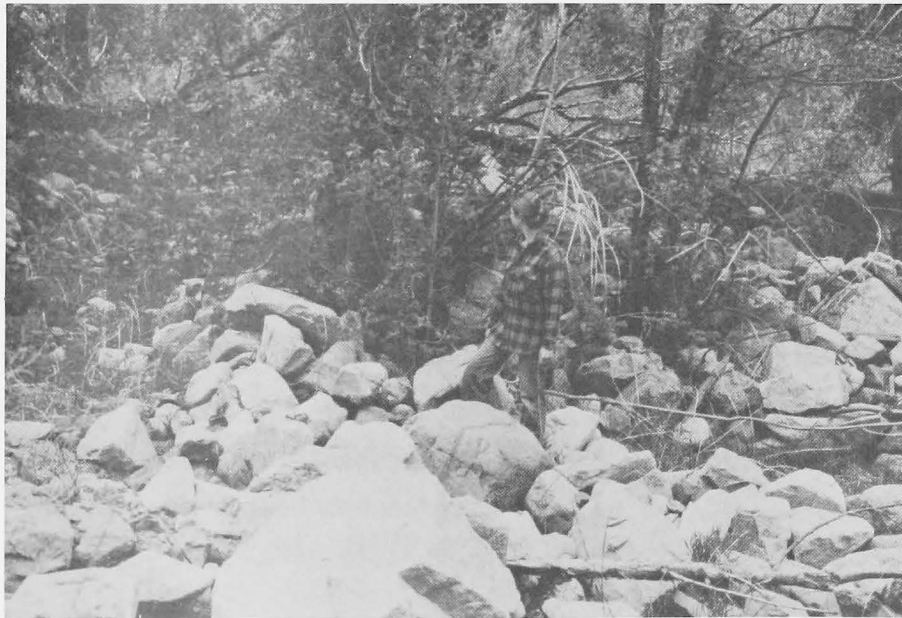
Figure 27. Debris-flow levee on Corbett Creek fan.

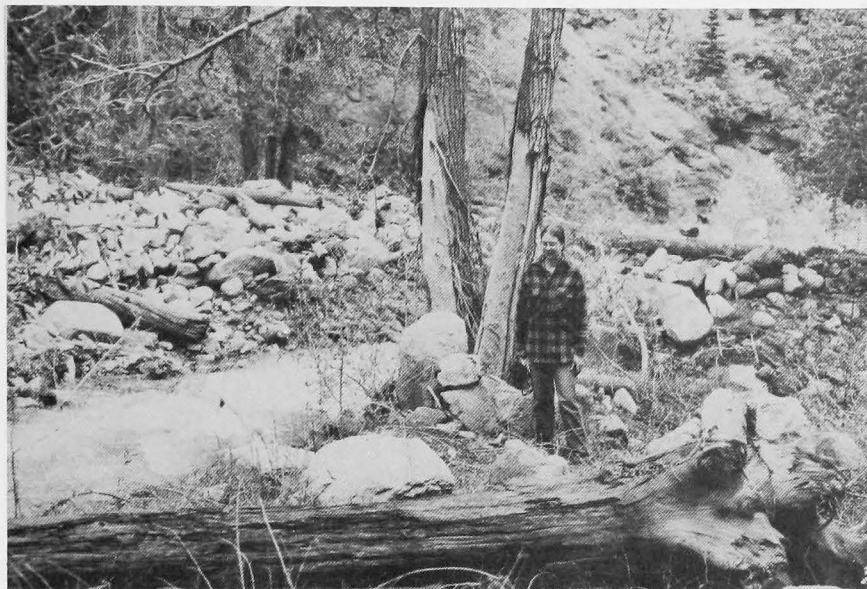
Figure 28. Tree scarring on and boulder wedged between tree trunks adjacent to Corbett Creek, 1982.

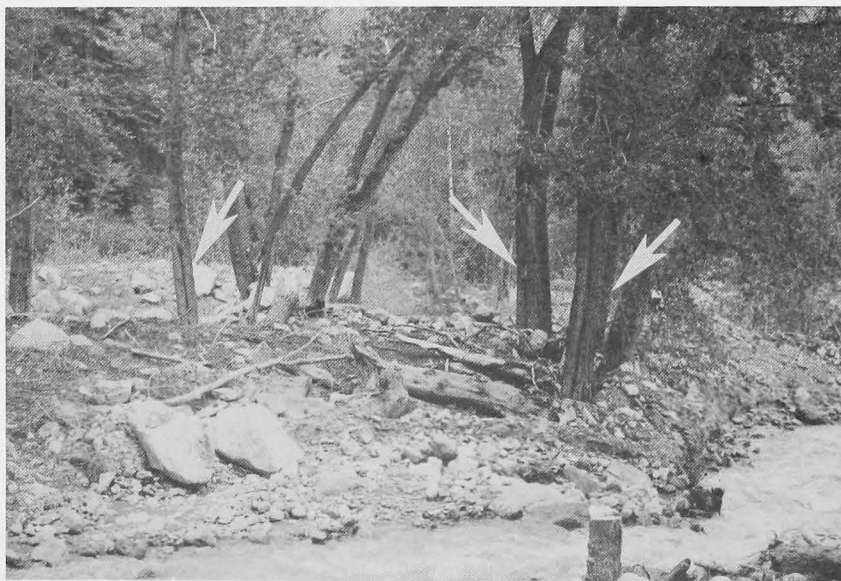
Figure 29. Healed scars on trees bordering Corbett Creek.

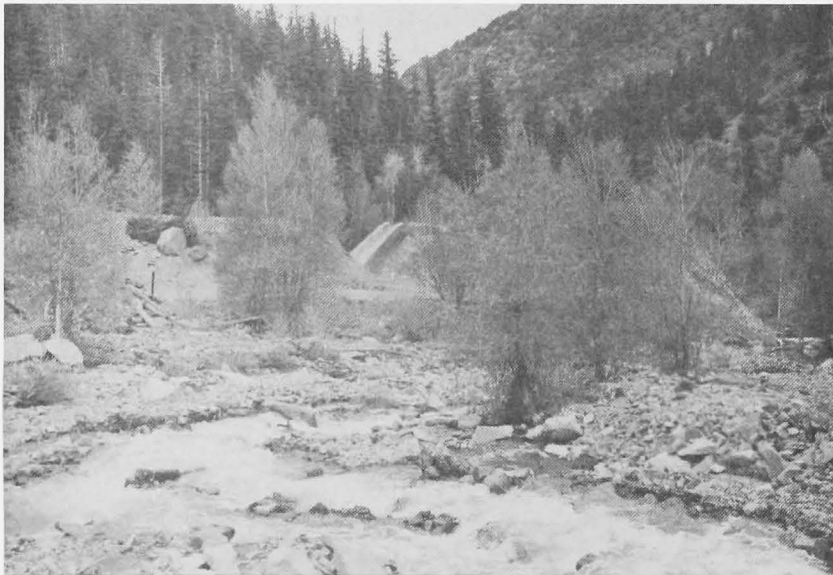
Examination of the basin showed that there is an abundance of loose debris available for mobilization. The source of the debris is mass wasting in the volcanics, landslide material, and mine tailings (Figs. 30, 31).

Figure 30. Mine tailings near the Bachelor Mine in Dexter Creek basin.

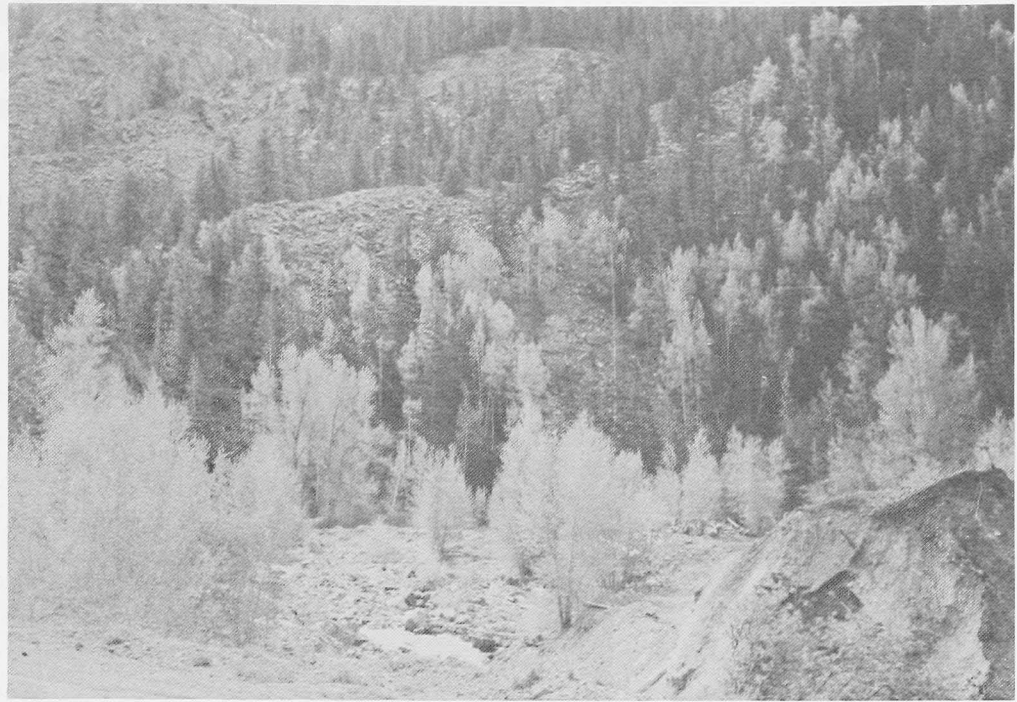
Figure 31. Debris available for mobilization in the Dexter Creek basin.

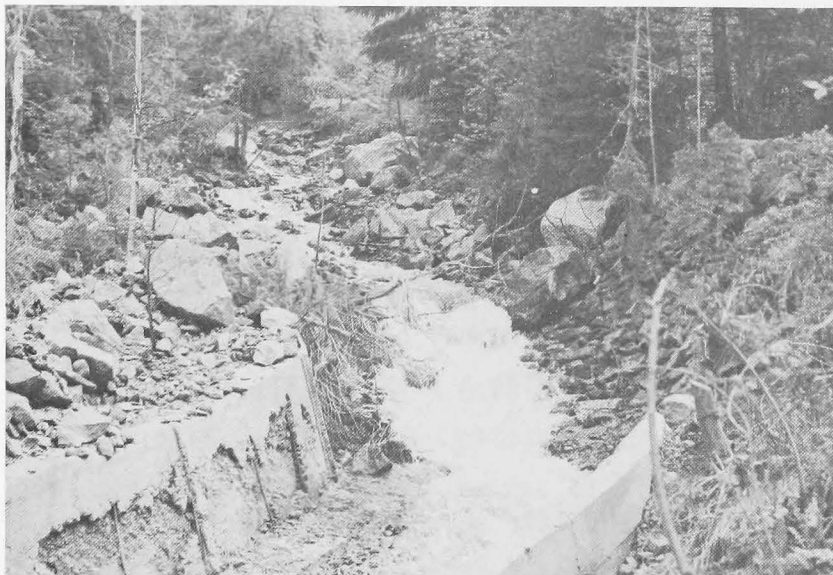
Figure 33. Cascade Creek flume entrance, 1982, before modification.

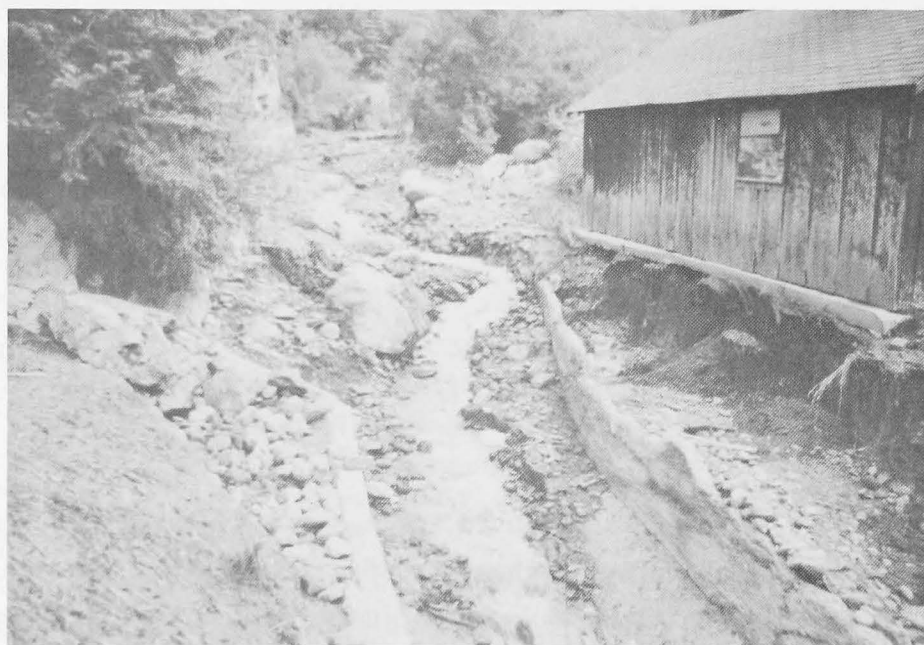
Figure 34. Portland Creek flume entrance, 1982. The flume shows damage from past events. The building on the right is spattered with mud from the 1982 event.

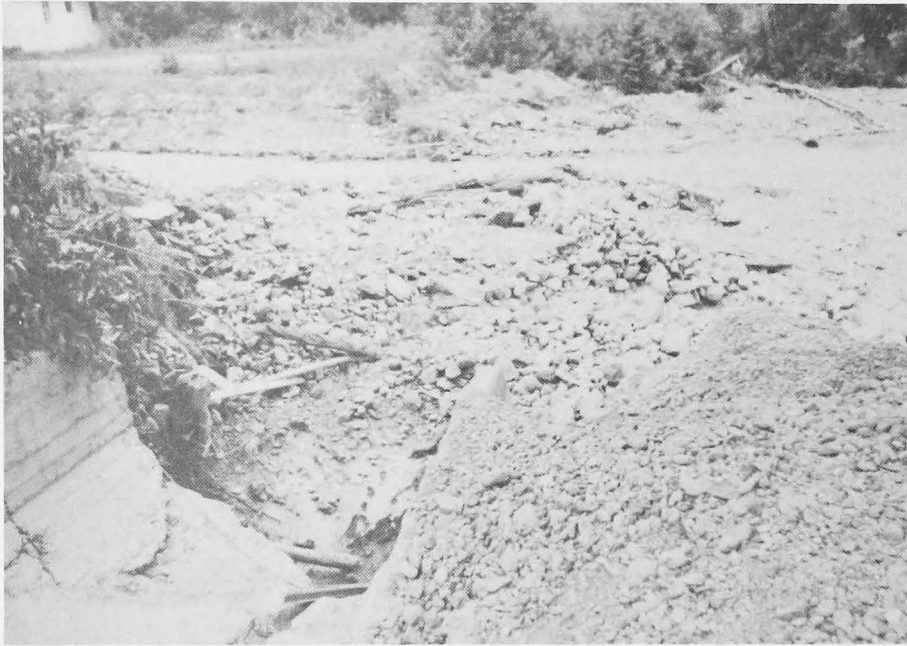
Figure 36. Debris accumulated at mouth of Portland Creek flume after 1982 event. (Photo courtesy William P. Stanton, CWCB)

Upon recommendation by Simons, Li & Associates, the city agreed that the Uncompahgre River should be periodically dredged below the mouth of the Portland Creek flume. This is to allow more room for the deposition of debris and help prevent the flume from backing-up at the mouth (Fig. 36). The catchment basins on Cascade Creek should eliminate the need for dredging at the mouth of that flume.
