OPEN-FILE REPORT 78-10

GEOLOGIC HAZARDS OF THE  
GLENWOOD SPRINGS METROPOLITAN  
AREA - GARFIELD COUNTY, COLORADO

PREPARED BY  
LINCOLN - DEVORE  
ENGINEERS AND GEOLOGISTS

1978

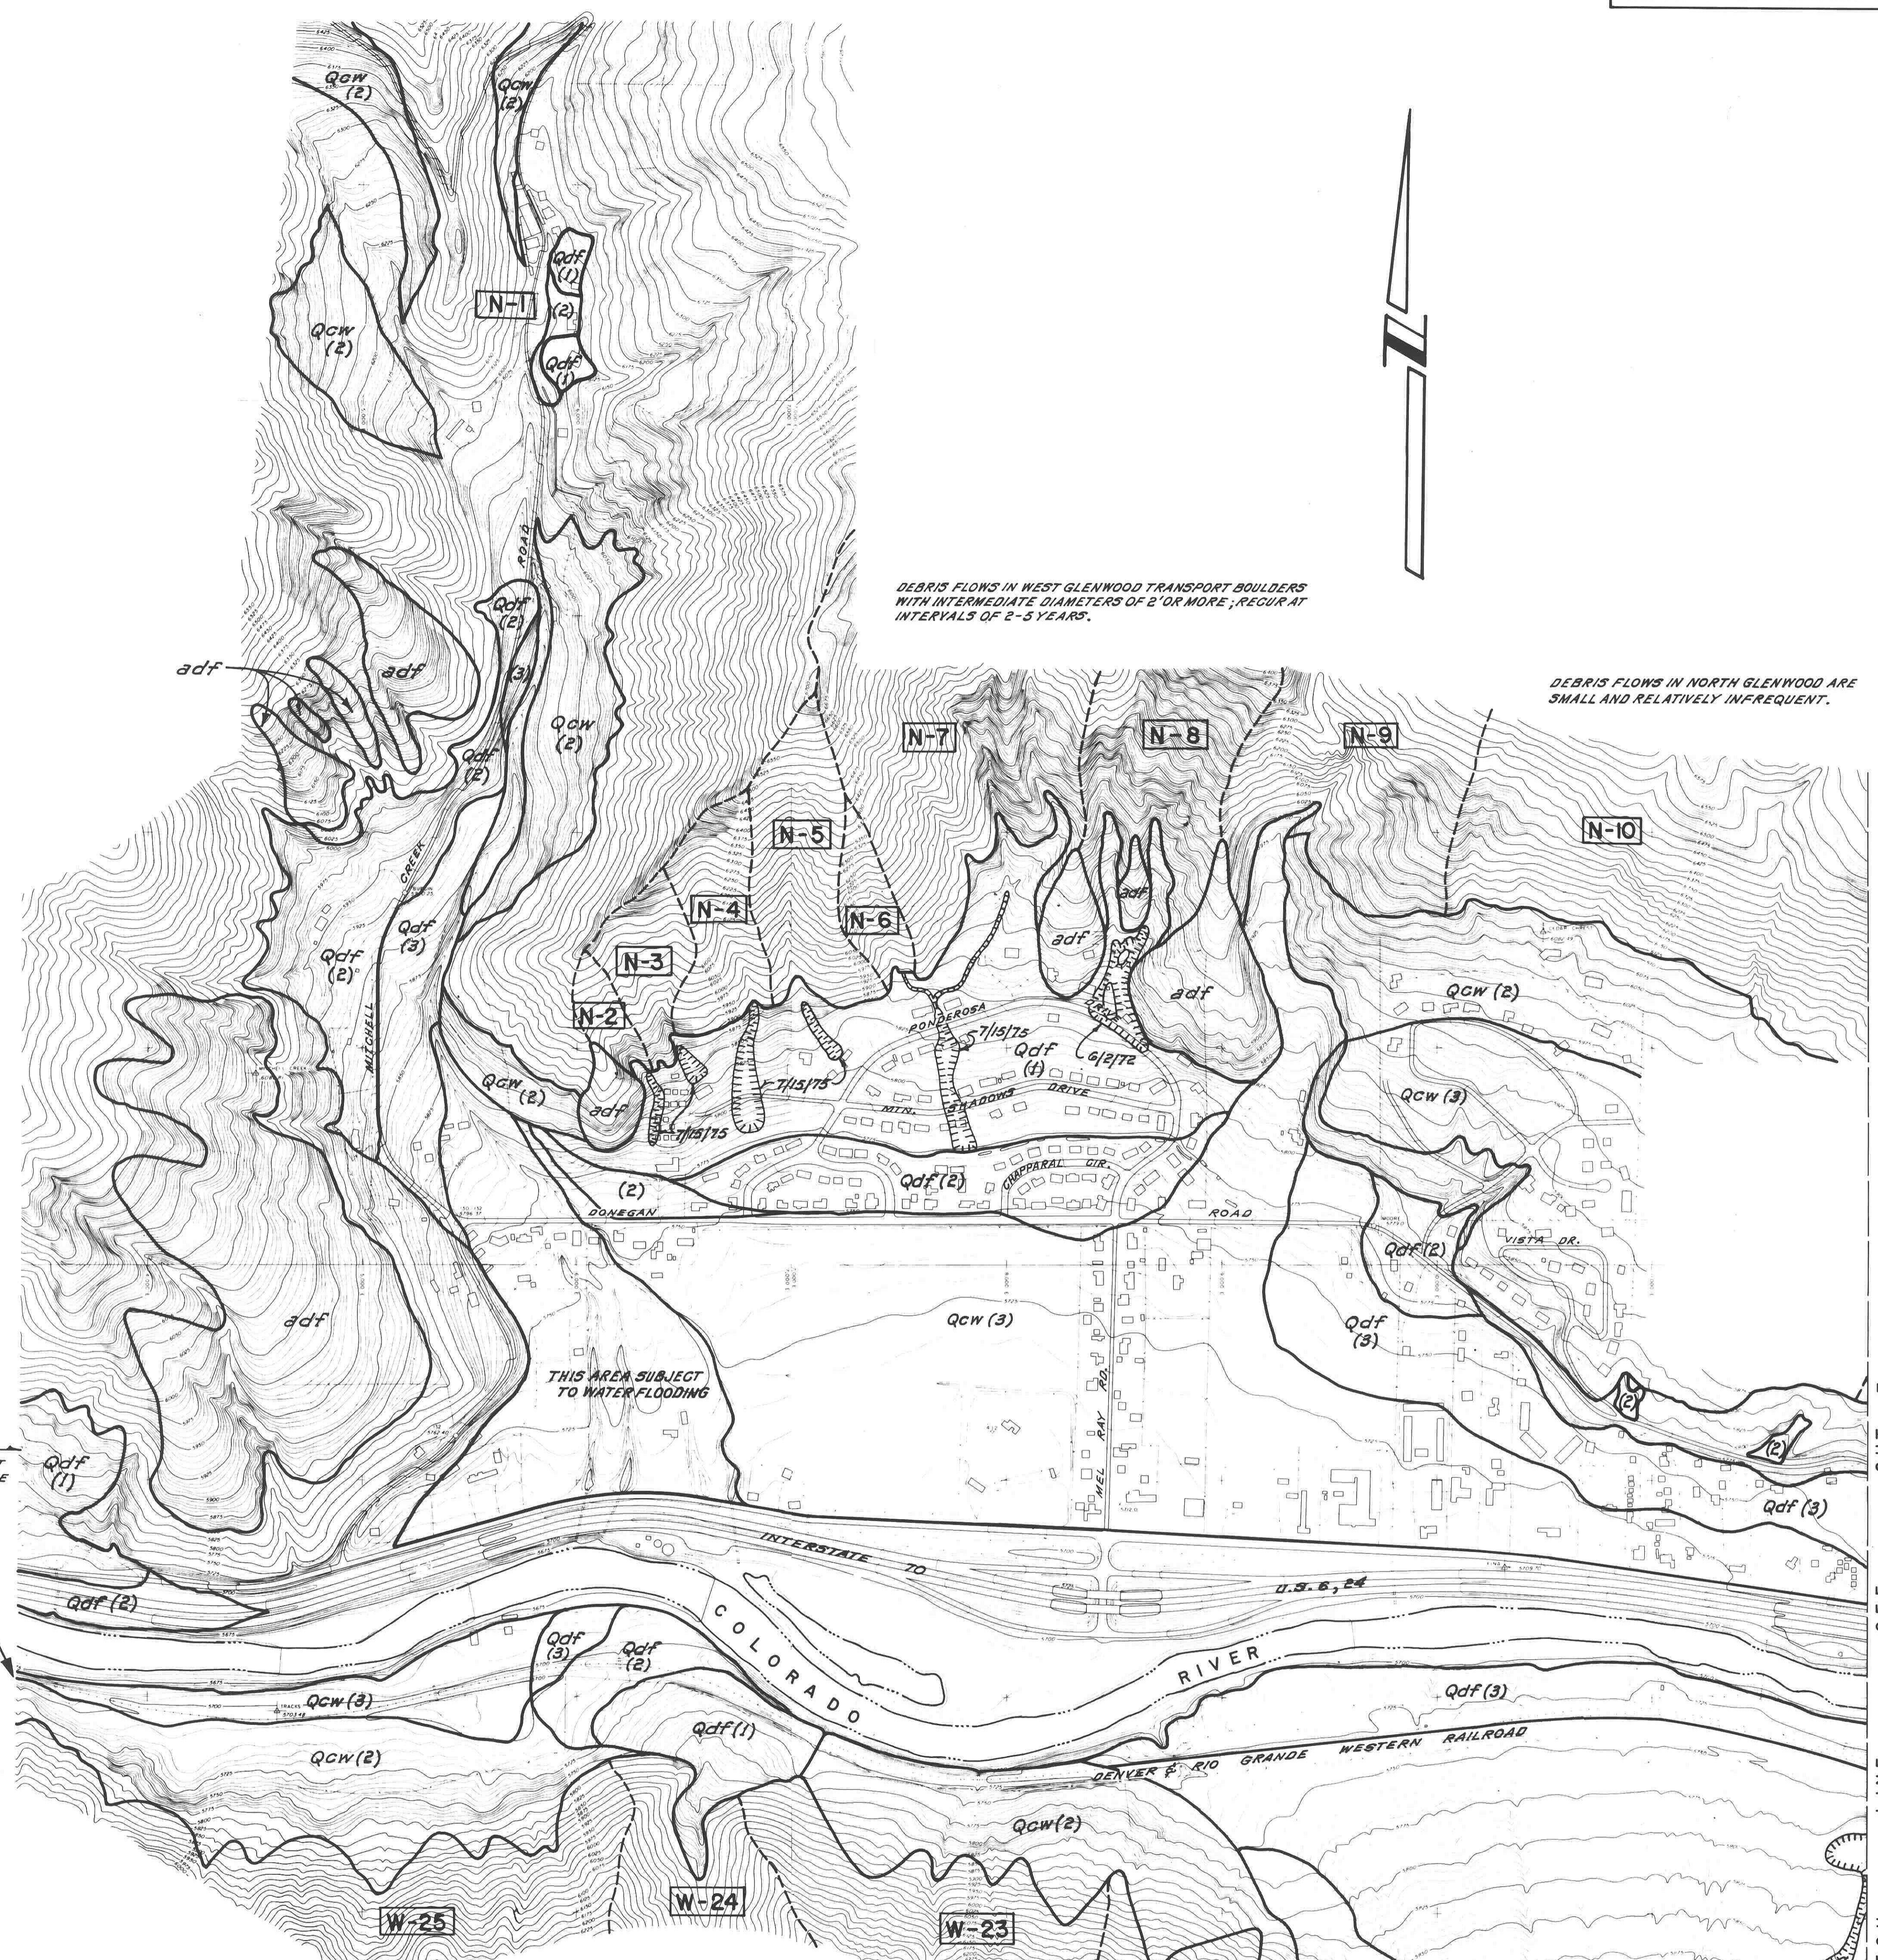
**MAP OF DEBRIS FAN DEPOSITS AND HAZARDS**

DEBRIS FLOWS IN WEST GLENWOOD TRANSPORT BOULDERS WITH INTERMEDIATE DIAMETERS OF 2' OR MORE; RECUR AT INTERVALS OF 2-5 YEARS.

DEBRIS FLOWS IN NORTH GLENWOOD ARE SMALL AND RELATIVELY INFREQUENT.

Avoidance should be practiced at the apices of fans, where the high velocities of flows exiting from the gulches result in impact pressures which cannot reasonably be resisted by conventional residential and commercial structures. Elsewhere in the city, the only useful mitigation technique on the fans involves the design of flow-resistant buildings; such buildings require heavily-reinforced lower walls and should not have low windows or other openings on the uphill side. In some cases, it may be possible to grade a site so as to create an island which will split slowly-moving flows. This measure will, however, increase damage to surrounding property. Damage to structures and their contents by debris flows is covered under the flood insurance program of the Federal Insurance Administration. However, coverage does not extend to damage to landscaping and open ground. As most of the reported damage in the 1977 event involved landscaping and cleanup of open areas, it does not appear that fan-level mitigation techniques are sufficient to alleviate the problems posed by debris flows.

The place for truly effective mitigation is above the fan, in the lower reaches of the source basins. One possible technique requires the construction of detention dams to completely retain the flowing mass. A dam of this type is in successful operation in basin W-21, and others have been proposed in the small basins of West Glenwood. Detention dams must be cleaned

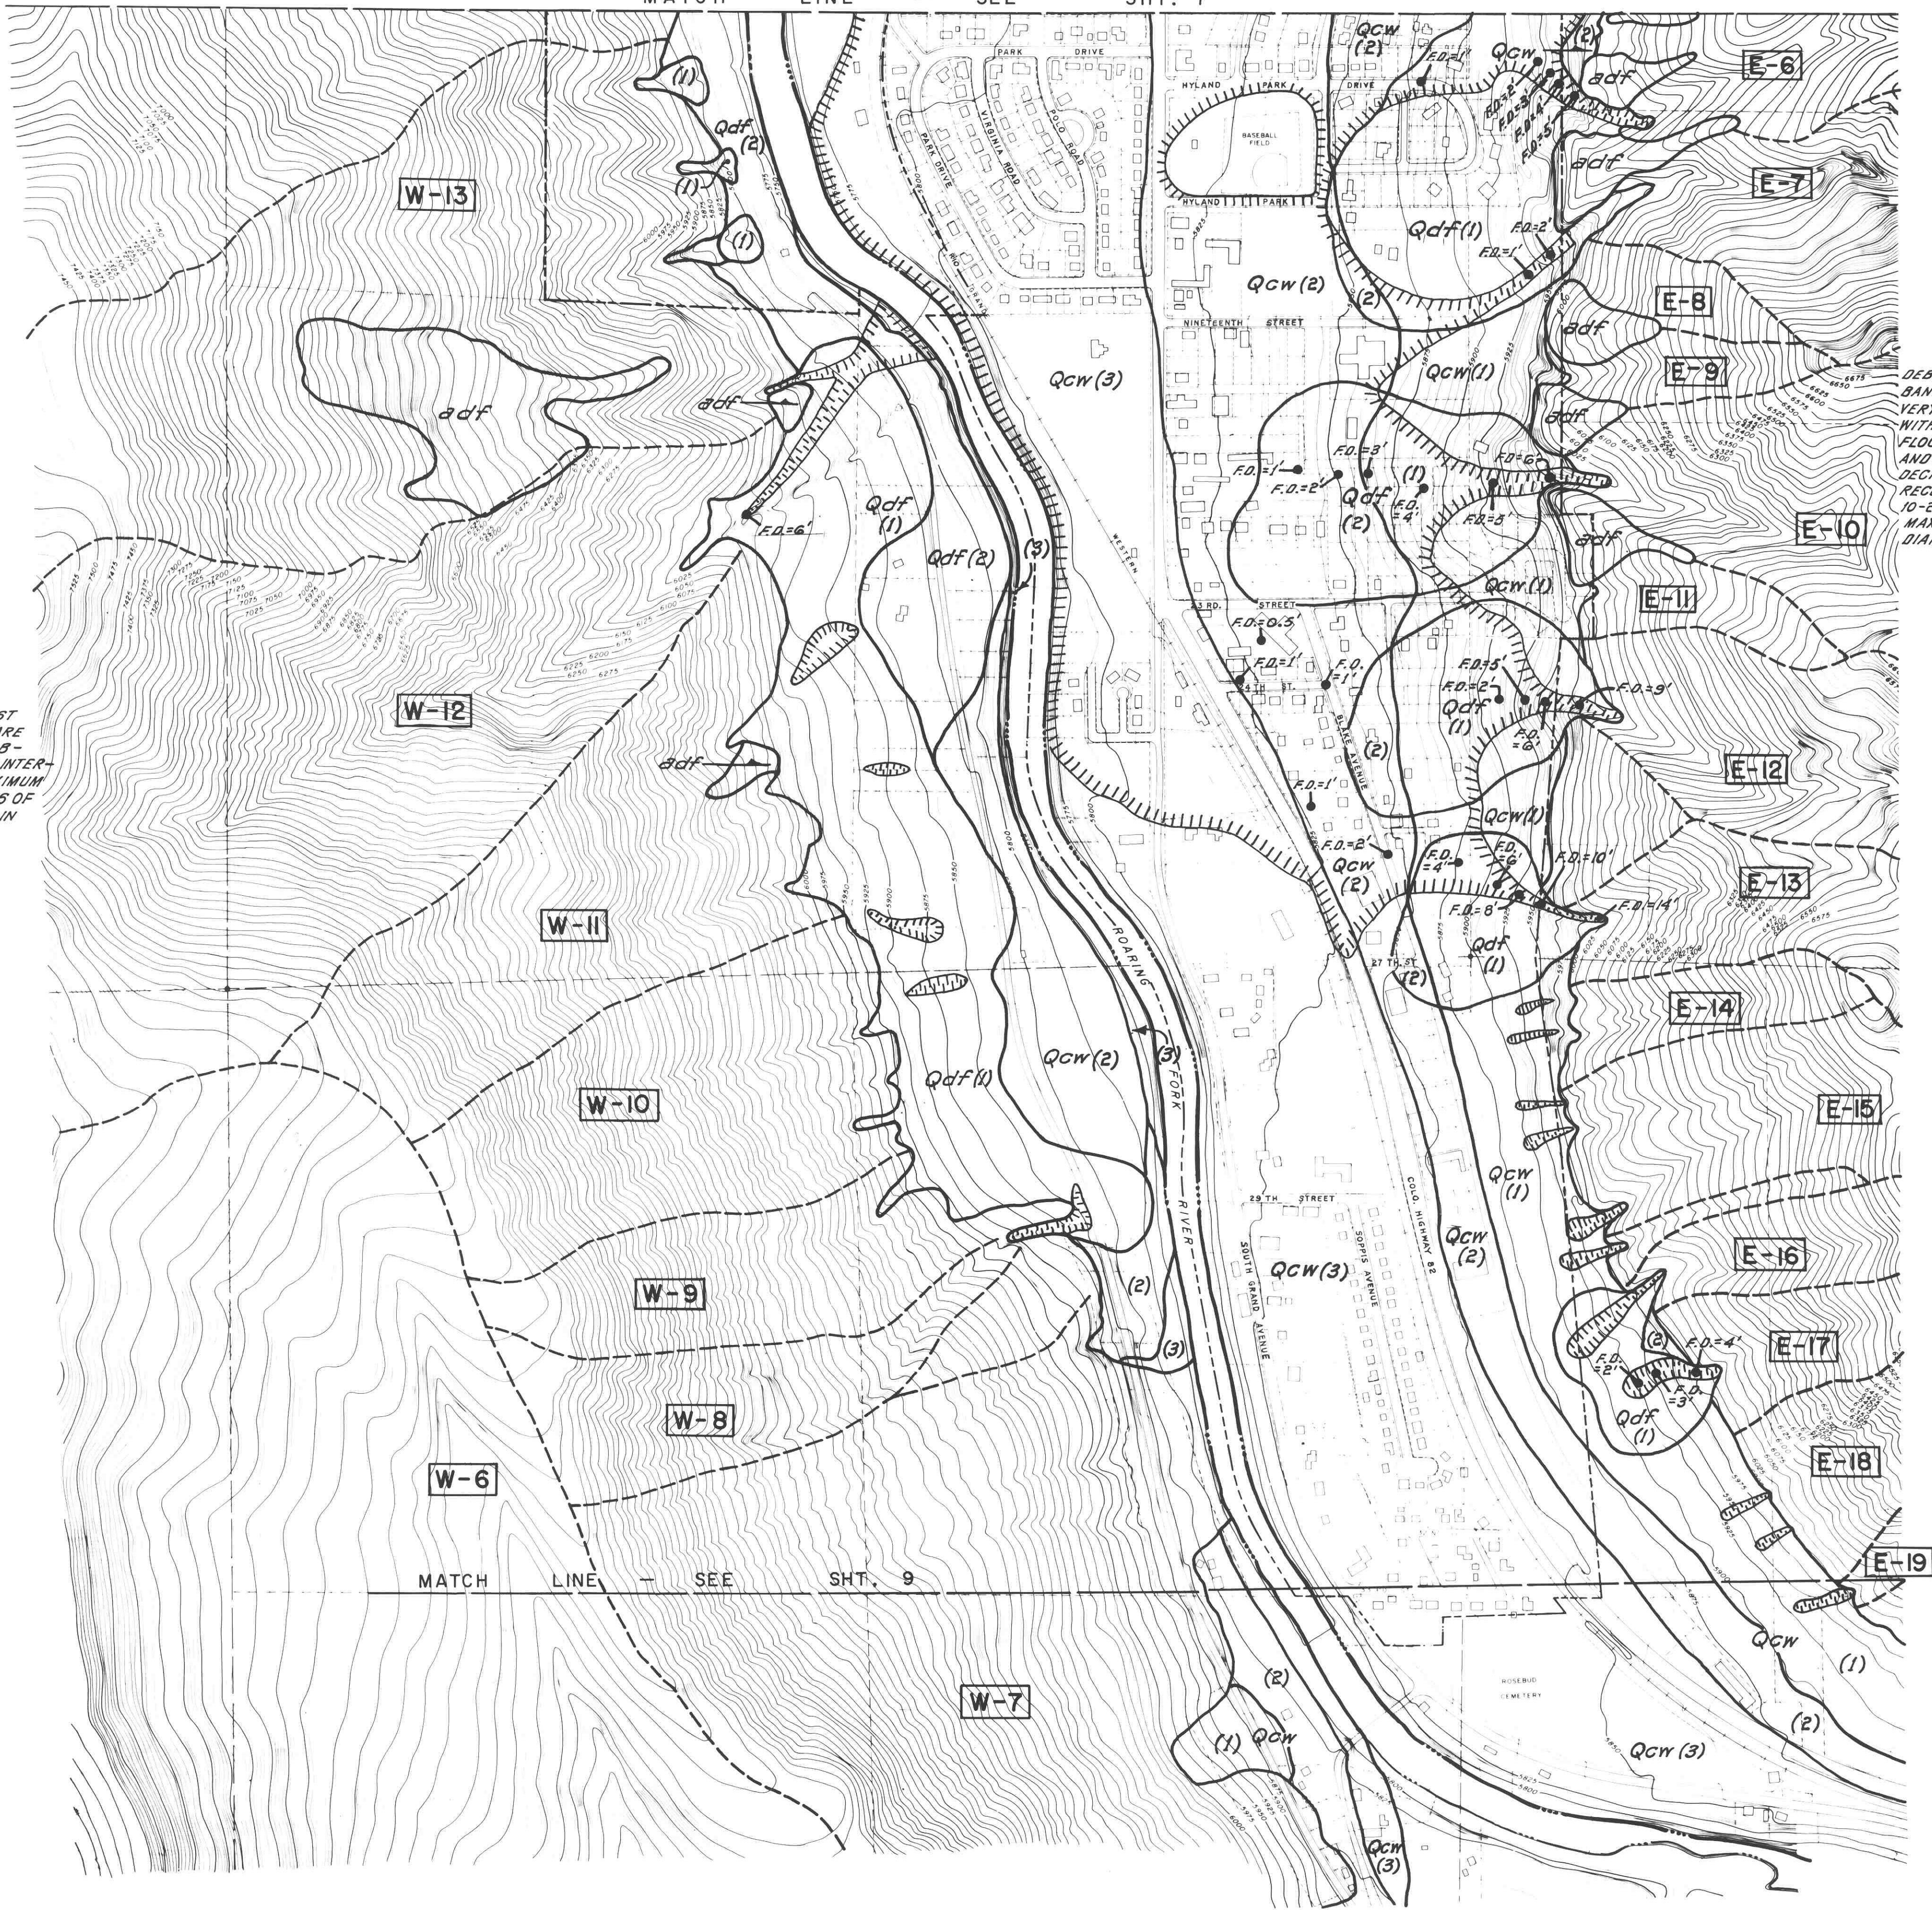
### MAP OF DEBRIS FAN DEPOSITS AND HAZARDS

DEBRIS FLOWS ALONG WEST BANK OF ROARING FORK ARE RELATIVELY SMALL; PROBABLY HAVE RECURRENCE INTERVALS OF 10-20 YEARS. MAXIMUM INTERMEDIATE DIAMETERS OF BOULDERS TRANSPORTED IN RECENT FLOWS IS 5'-7'.

DEBRIS FLOWS ALONG EAST BANK OF ROARING FORK ARE VERY LARGE AND ASSOCIATED WITH EXTENSIVE DEBRIS FLOODING. BOTH FLOW SIZE AND MAGNITUDE OF FLOODING DECREASE TO THE SOUTH. RECURRENCE INTERVAL OF 10-20 YEARS. BOULDERS HAVE MAXIMUM INTERMEDIATE DIAMETERS OF 3'-5'.
