Miscellaneous Publication 8

# Engineering Geologic Factors of the Marble Area, Gunnison County, Colorado

By  
William P. Rogers,  
Engineering Geologist  
and  
John W. Rold,  
Director and State Geologist

Colorado Geological Survey  
Department of Natural Resources  
Denver, Colorado  
1972

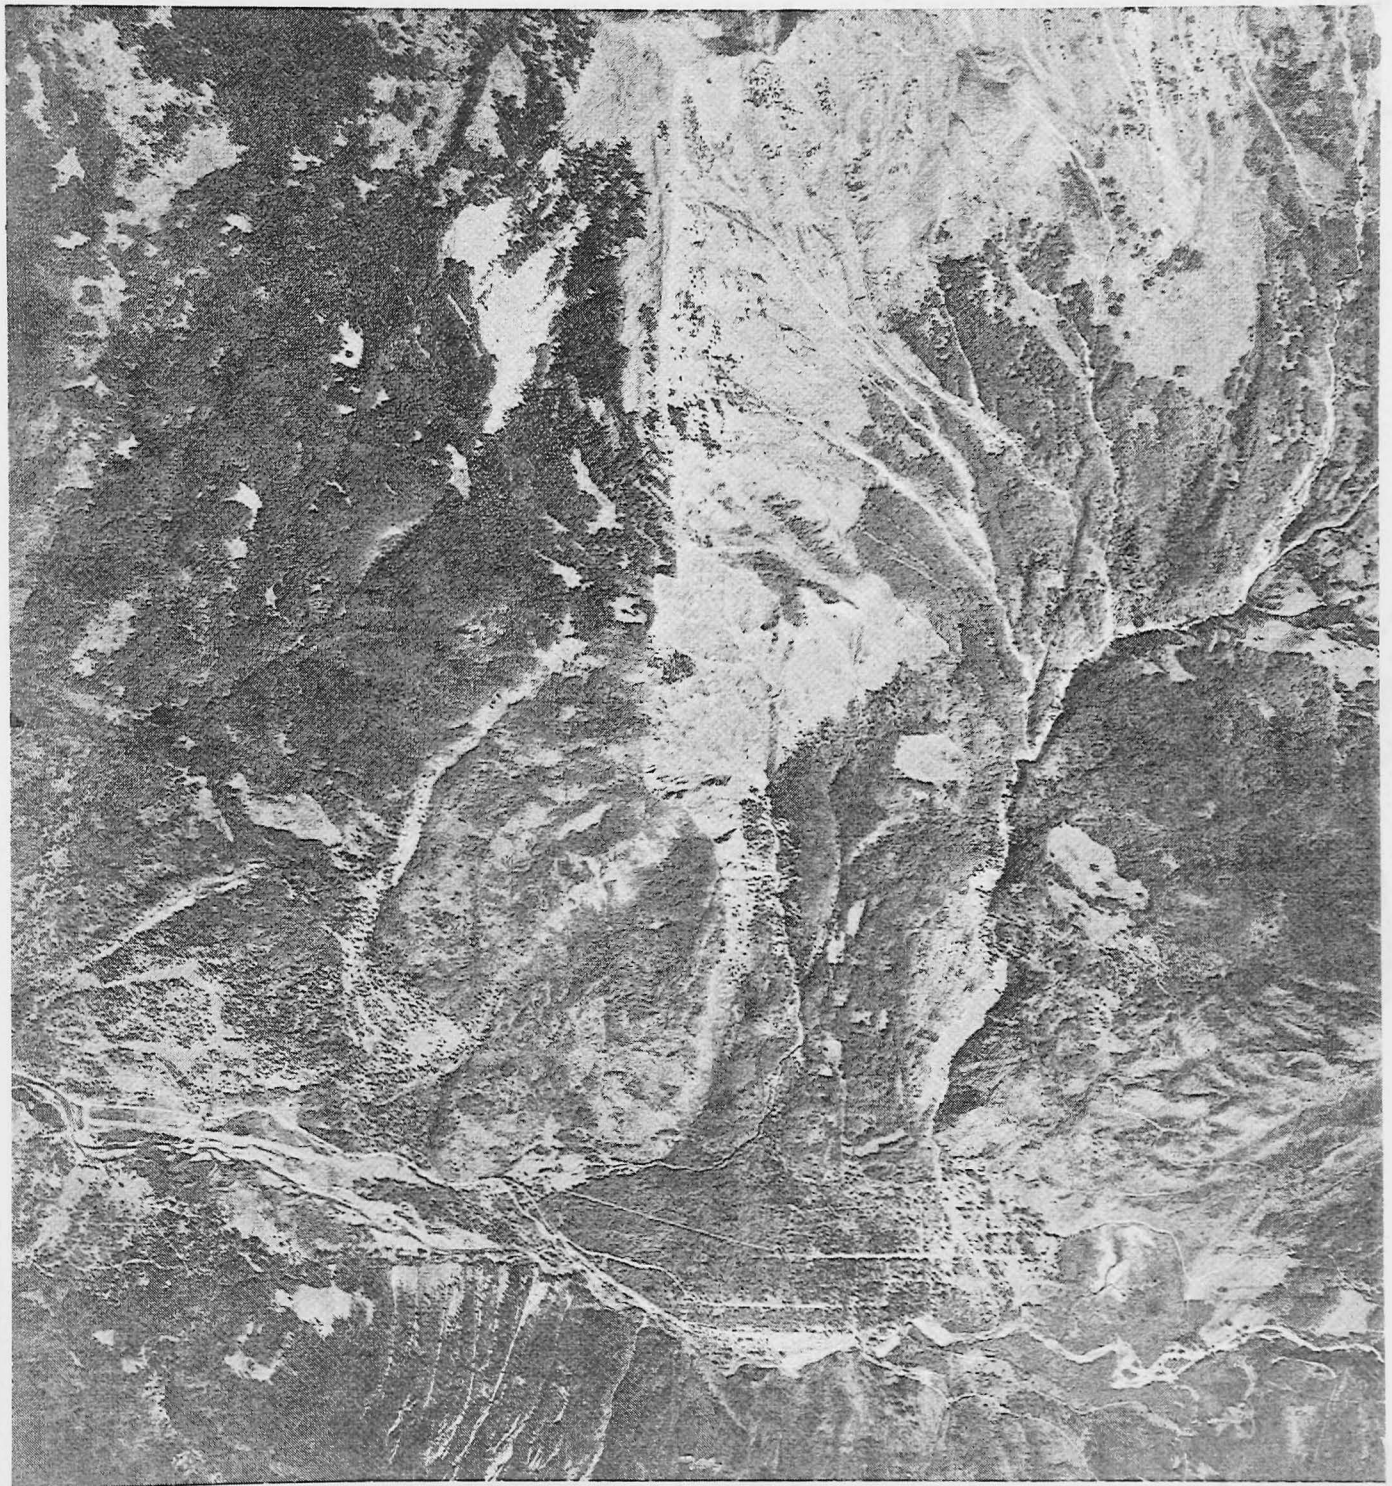
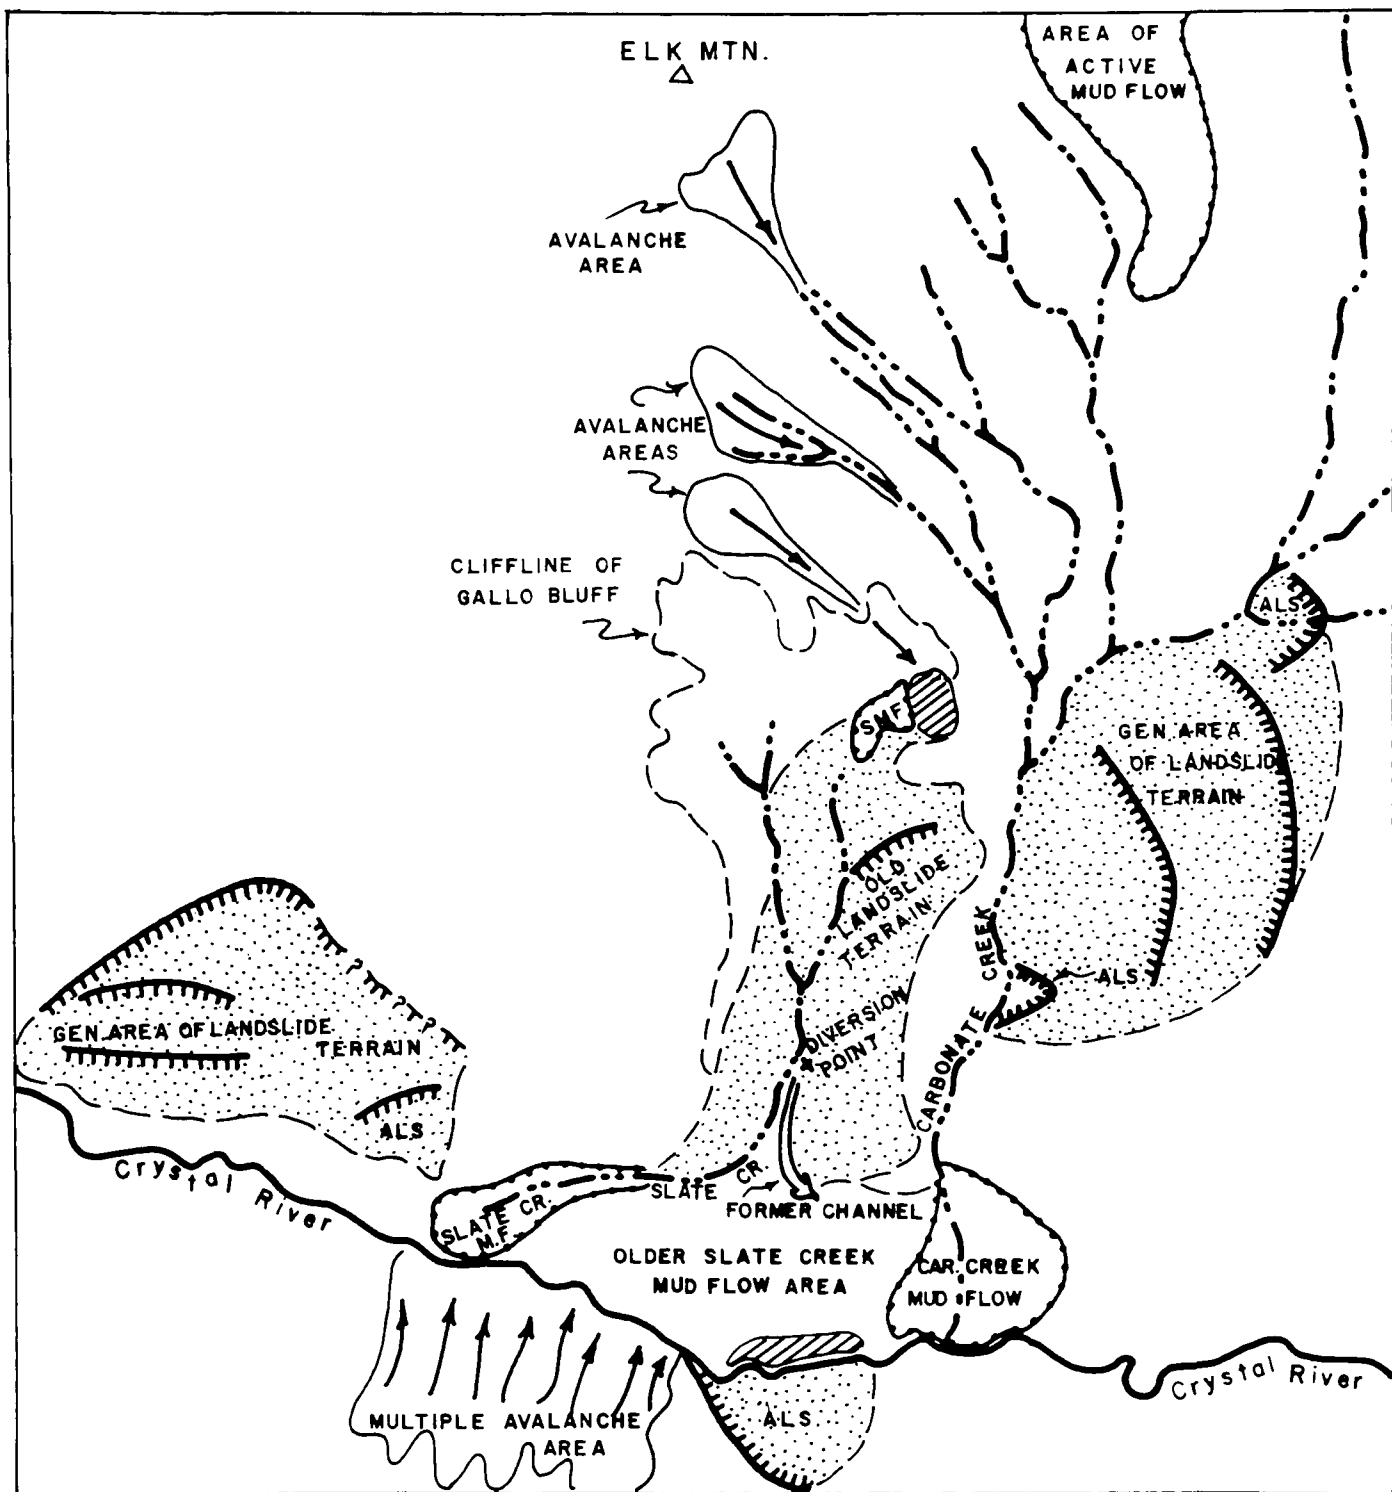
FIGURE 1. PHOTOGEOLOGIC INTERPRETATION OF MAJOR FEATURES

Easily identifiable features recognizable from photograph on facing page are shown in line drawing below. Symbols not self-explanatory are listed below.

ALS indicates areas believed to be active landslides.

Heavy Arrows indicate snow avalanche chutes, and Diagonal Pattern shows identifiable landing areas.

SMF indicates area of small mudflows at base of Gallo Bluff.

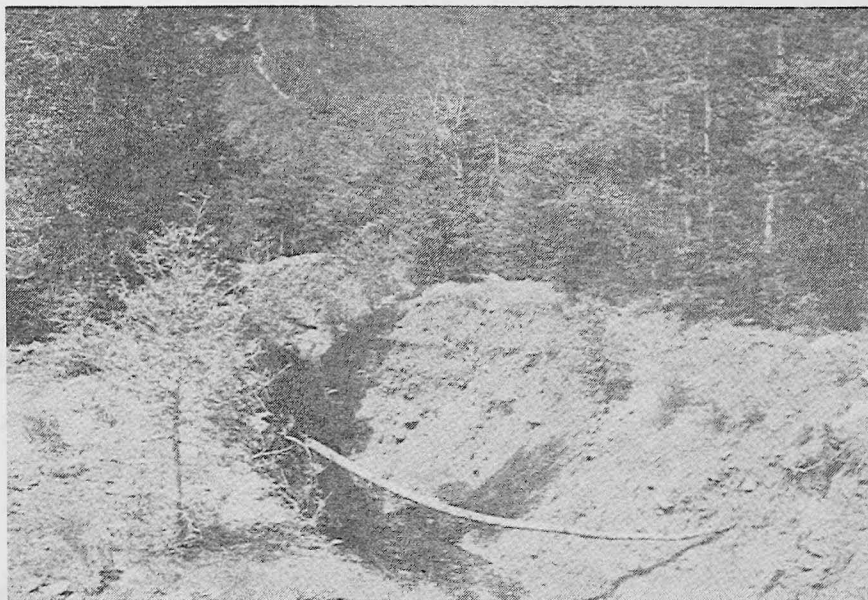
Figure 2. Entrenched portion of Slate Creek channel, showing steepness of banks and mudflow material in channel sides.

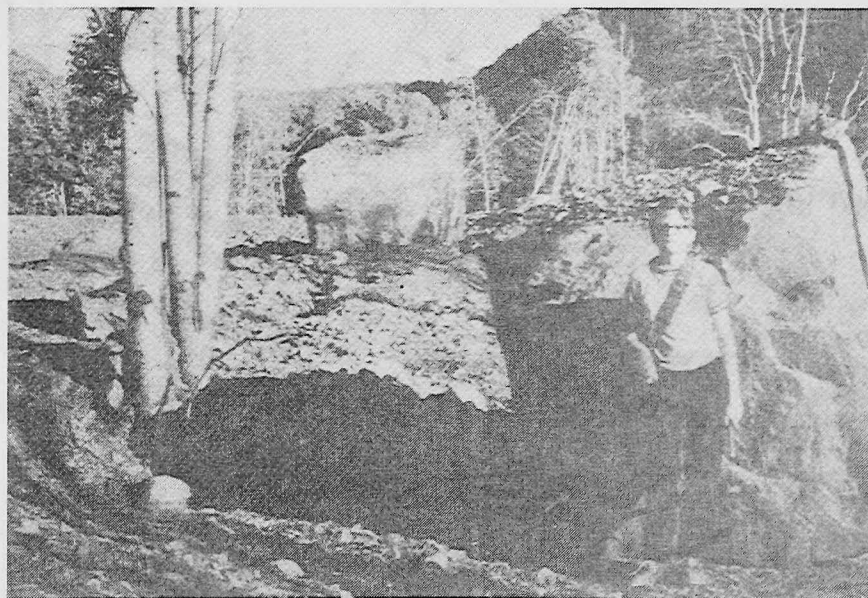
Figure 3. Large blocks of Mesa Verde Sandstone in recent mudflow debris of Slate Creek, twelve year old boy in foreground. Recency of deposit indicated by fine debris on top of blocks.

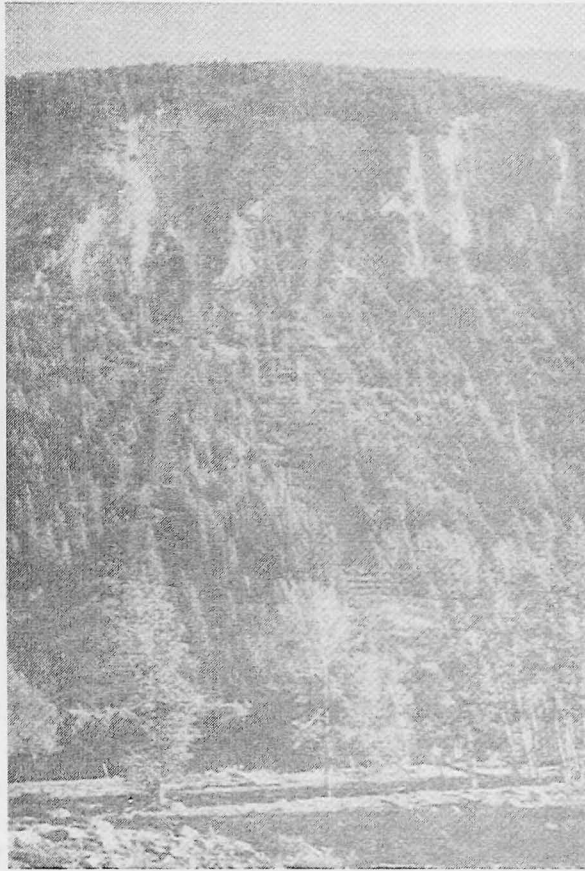
Figure 4. Lower part of Slate Creek mudflow area in foreground, avalanche and rockfall area south of the Crystal River in background.

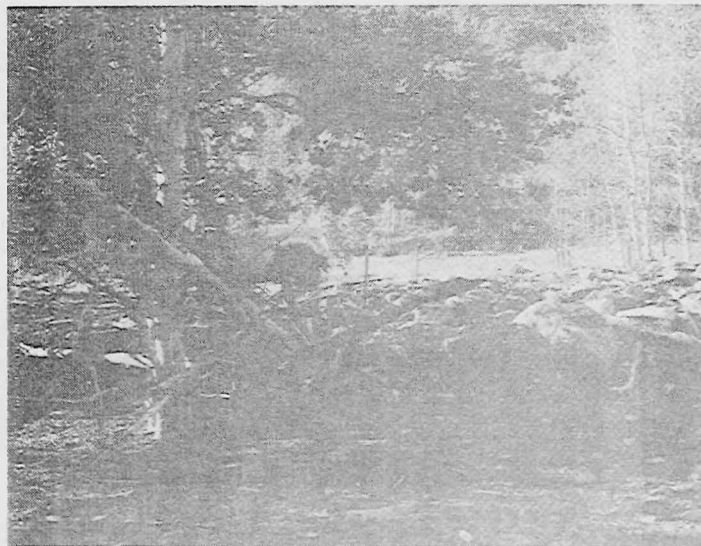
Figure 5. Edge of very recent mudflow debris sheet in Slate Creek area.

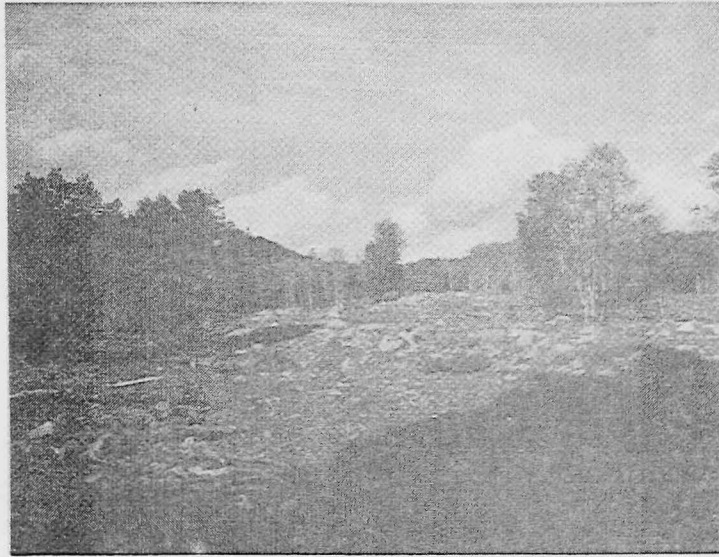
Figure 6. Looking up (northeast) along recent mudflow plain of Slate Creek.

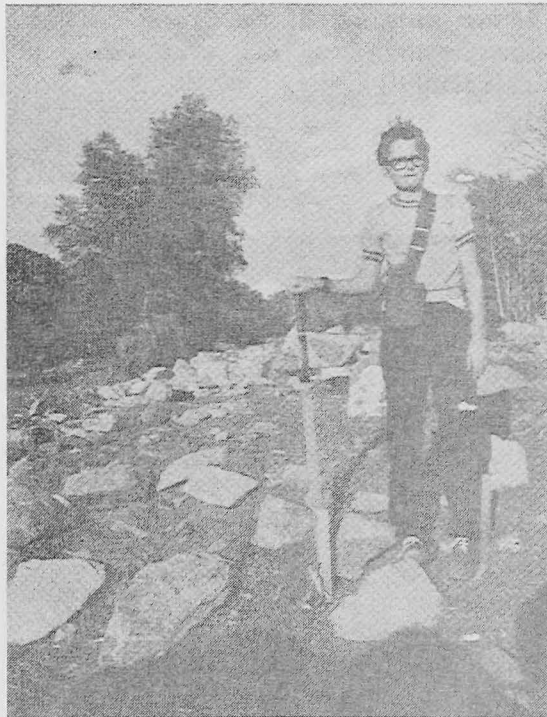
Figure 7. Rock-strewn surface of upper part of Slate Creek mudflow plain in subdivided area. Stake indicates a lot corner.

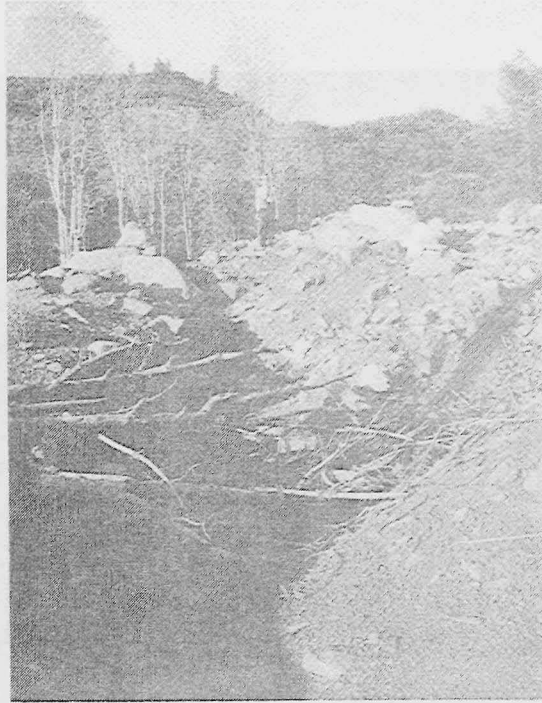
Figure 8. Abandoned channel and mudflow debris in subdivided land of recent Slate Creek mudflows. Boy is standing by the same lot corner shown in figure 7.

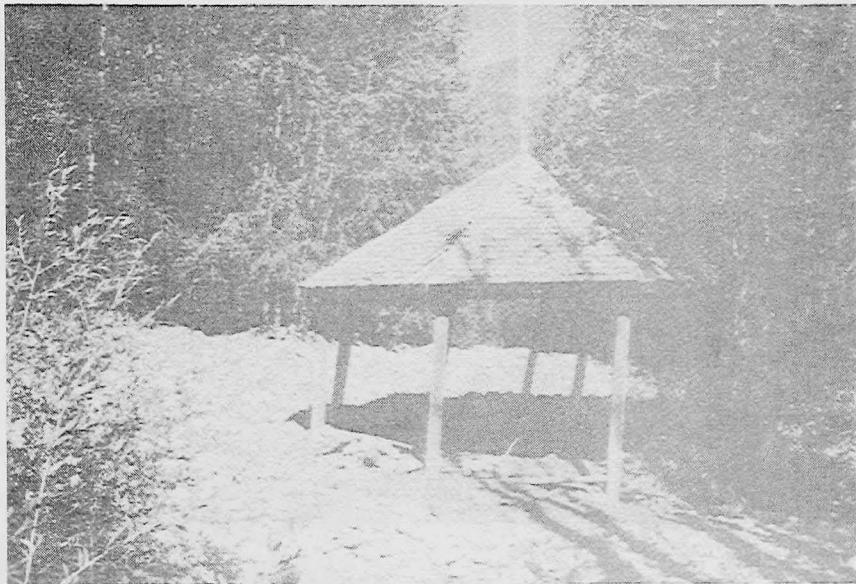
canyon and the Crystal River has a history of similar but much larger mud floods than those described on Slate Creek (figure 9, and plate 1). The area affected by periodic recent mud floods from Carbonate Creek covers approximately twice the area of the Slate Creek flows (2b, plate 1). The most recent catastrophic mud floods on Carbonate Creek occurred in 1936, 1941 and 1945, and smaller floods are reported nearly every year. This area of active mudflow hazard is within the townsite of Marble; however, we believe that construction activities related to recreational, residential, or other development anywhere within the watershed of Carbonate Creek could profoundly increase the threat of mud and water flooding in the lower reaches of Carbonate Creek. In addition, it is possible that a major landslide from the slopes of Mt. Daly or the steep shale bluffs west of Carbonate Creek could divert the creek to another course over the older mudflow fan. Photogeologic studies and limited field inspection of the steep basin rim between the north end of Gallo Bluff and Mt. Daly indicate active as well as old mudflows and potential debris avalanches which are additional reasons for carefully evaluating the water and mud flood potential of the entire drainage basin as a part of any proposed construction or development.

Figure 9. Top of park bandstand in town of Marble, lower part was buried by coarse mudflow debris of 1945 mudflood on Carbonate Creek.

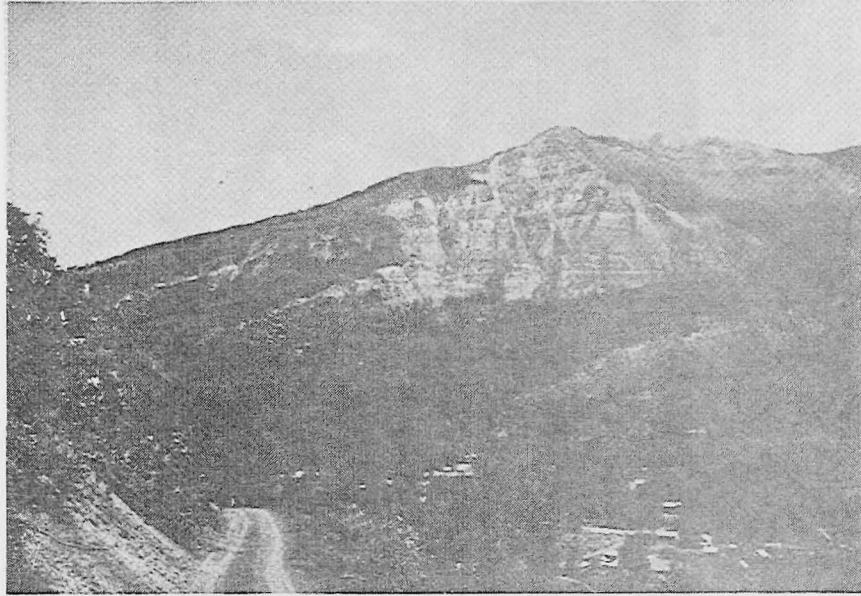
Figure 10. Large unvegetated scar in background is Gallo Bluff. Bare scarp in right center is Mancos Shale on the west bank of Carbonate Creek. Town of Marble in right foreground.

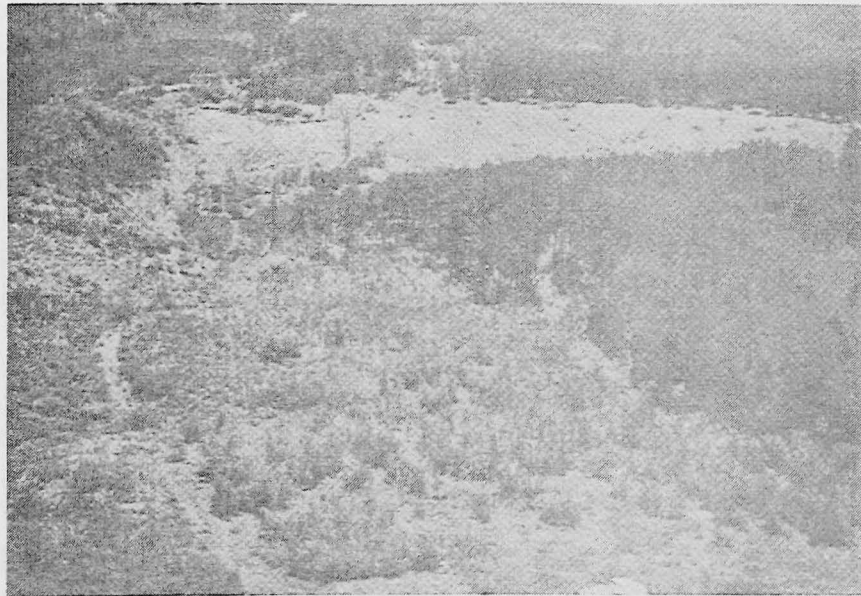
Figure 11. Area below north end of Gallo Bluff. Stunted and pushed timber on left side is result of airborne snow avalanches from Elk Mtn. Small mudflows have moved through larger timber on the right to the edge of the clearing in background.

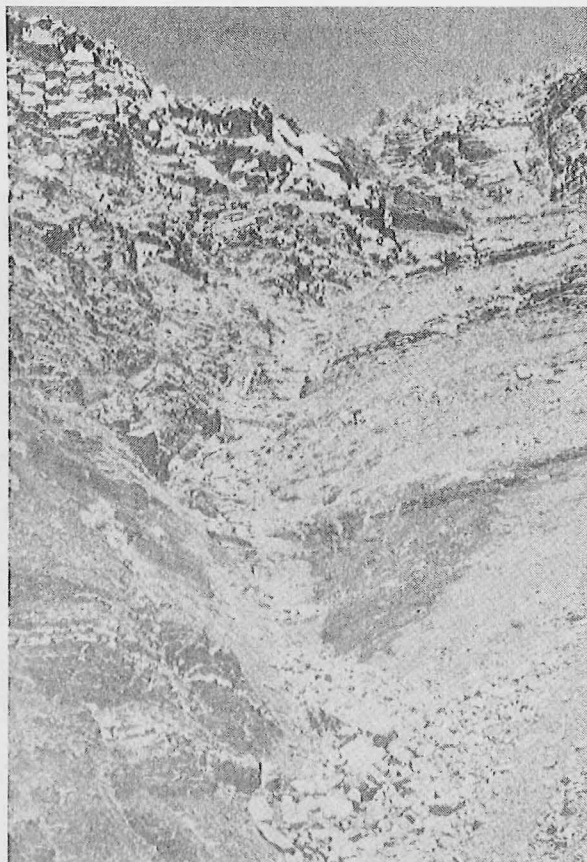
sist of stacks of loose, joint-bounded blocks which are precariously unstable when undercut by erosion (figures 12, 14, 15, 16). This situation gives rise to the constant minor rockfalls which can be precipitated by a gust of wind or another falling rock. Evidence of larger scale instability in the cliffs can be seen in the weathered and open joints which, in many cases, form fissures several tens of feet back of the cliff face (figures 13, 17). These are especially prominent in projecting points in the cliff which form between adjacent gullies. Such gullies or re-entrants in the cliffline tend to follow minor faults which are oriented at approximate right angles to the cliffline. The precipitous gullies on Gallo Bluff, and also those in the Carbonate Creek watershed that lie between the north end of the bluff and Elk Mountain, are locally choked with coarse rock rubble at a precarious angle of repose. The currency and active nature of cliff retreat is shown by still-green trees that can be seen along with rubble in the steep gullies (figure 12).

Figure 12. Typical gully on face of Gallo Bluff. In background, loose overhanging sandstone blocks can be seen. Dark color just below center is from water seepage. In lower center, note loose rock rubble and recently fallen tree.

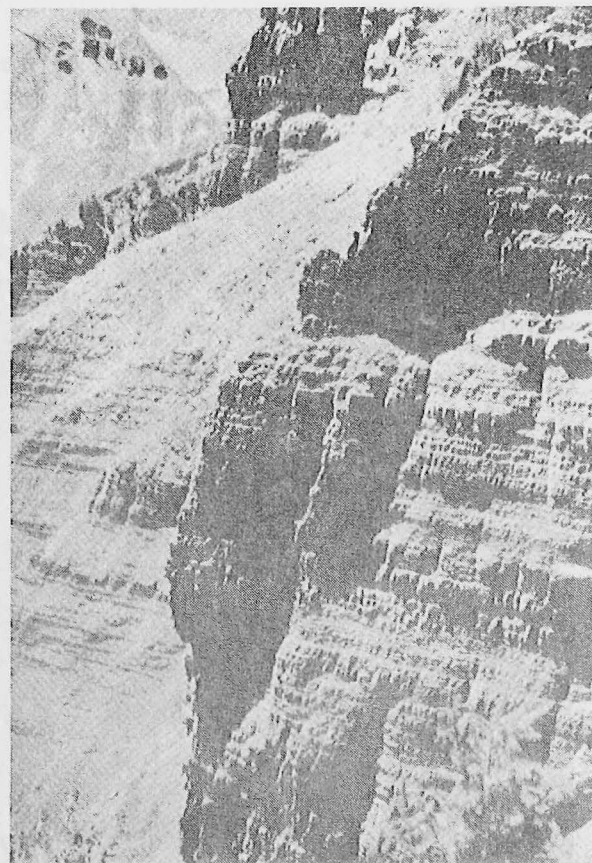
The above described processes produces a general "Grand Canyon" type of topography with waste slopes of shaley debris alternating with nearly vertical ledges of broken sandy shale or sandstone (figure 13). The average slope of the highest part of the cliff is approximately 36 degrees, or 75%. At this location, the bluff has 1,400 ft. of vertical rise in 1,900 ft. horizontal distance.

Figure 13. Typical appearance of middle part of Gallo Bluff. More resistant sandy beds stand near-vertical with numerous open and weathered joints back of cliff face.

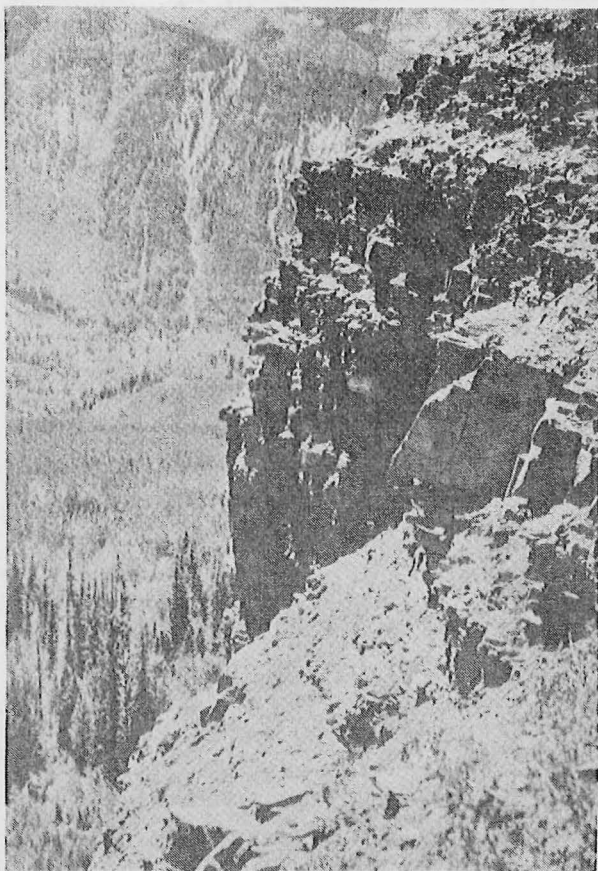
Figure 14. Interbedded shale and sandstone in middle part of Gallo Bluff. Avalanche scars south of Crystal River in background.

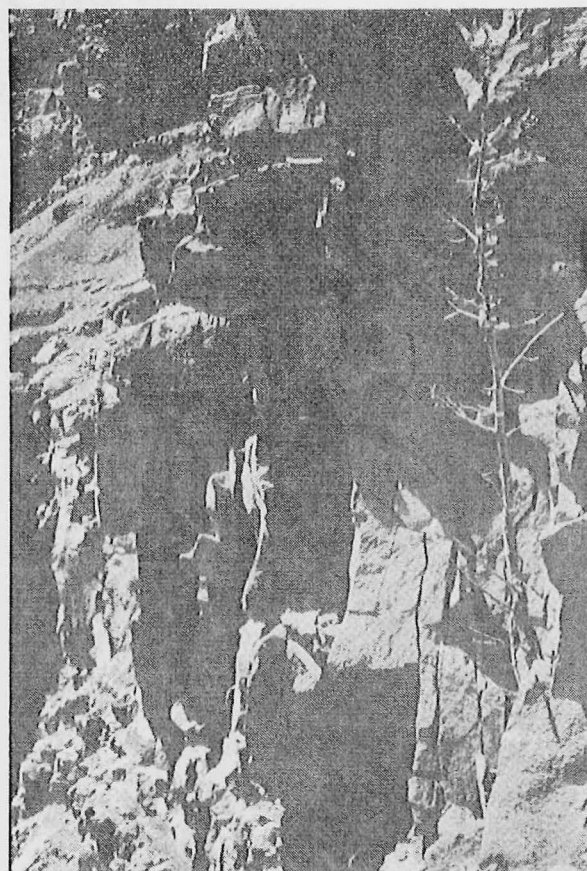
Figure 15. Fractured and loose blocks of Mesa Verde Sandstone in upper part of cliff of Gallo Bluff.

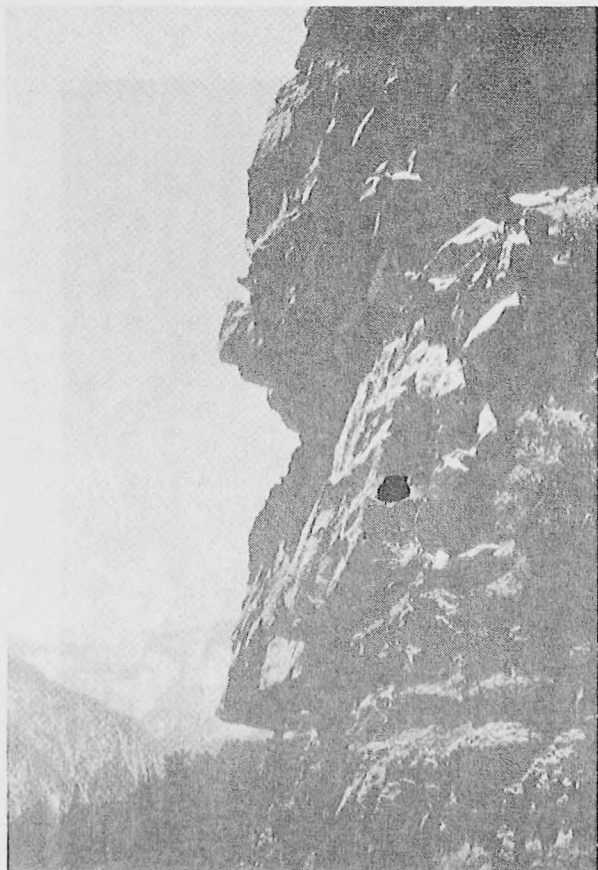
Figure 16. Overhanging ledges of broken and fractured Mesa Verde Sandstone in upper part of Gallo Bluff.

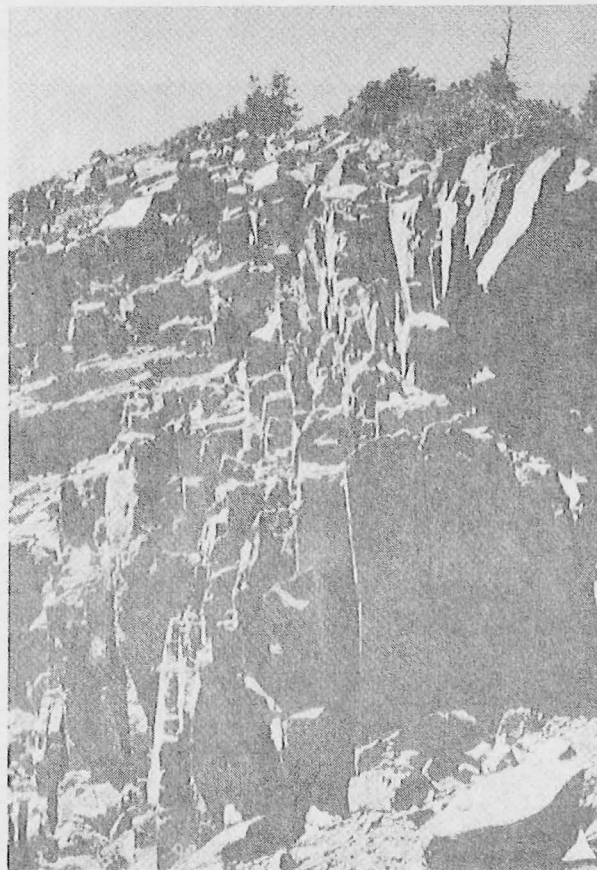
Figure 17. Strongly jointed Mesa Verde Sandstone on ridge just above Gallo Bluff.

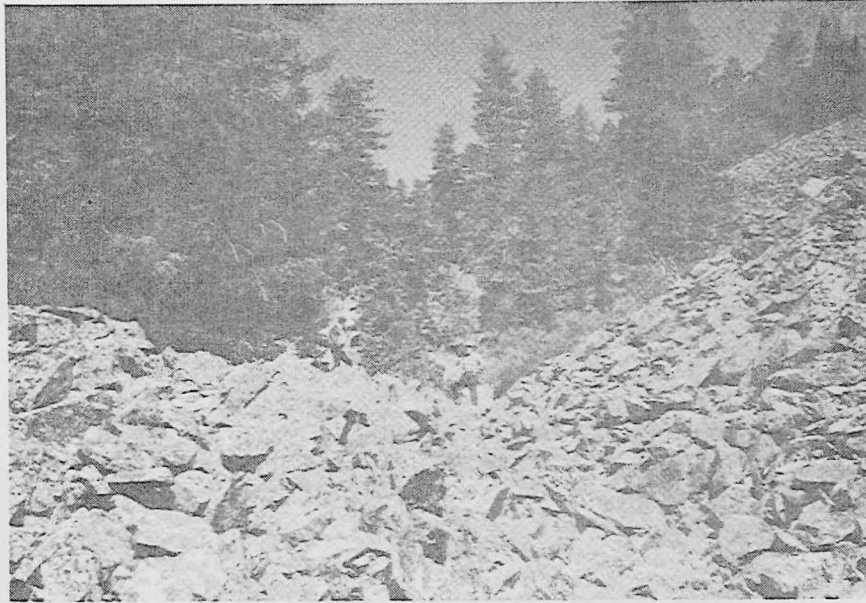
Figure 18. Corrugated surface of coarse talus produced by landslide movements within the talus (area 5 of text).

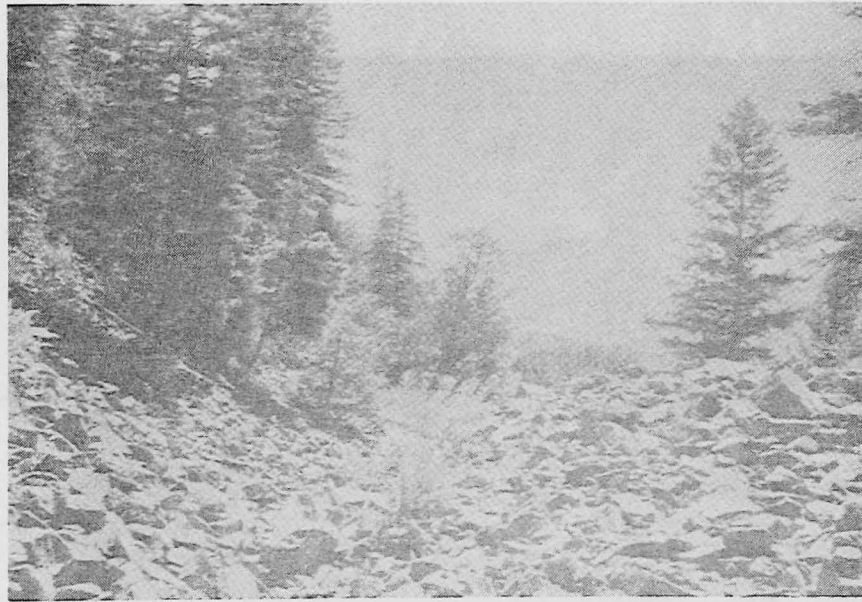
Figure 19. Same general area as above but showing tilting of trees indicating recent movements.
