GEOLOGIC HAZARDS MAP OF THE HIGHLANDS RANCH QUADRANGLE

BY
JAMES M. SOULE
1978

CGS-OF-78-5
PLATE 2 of 16

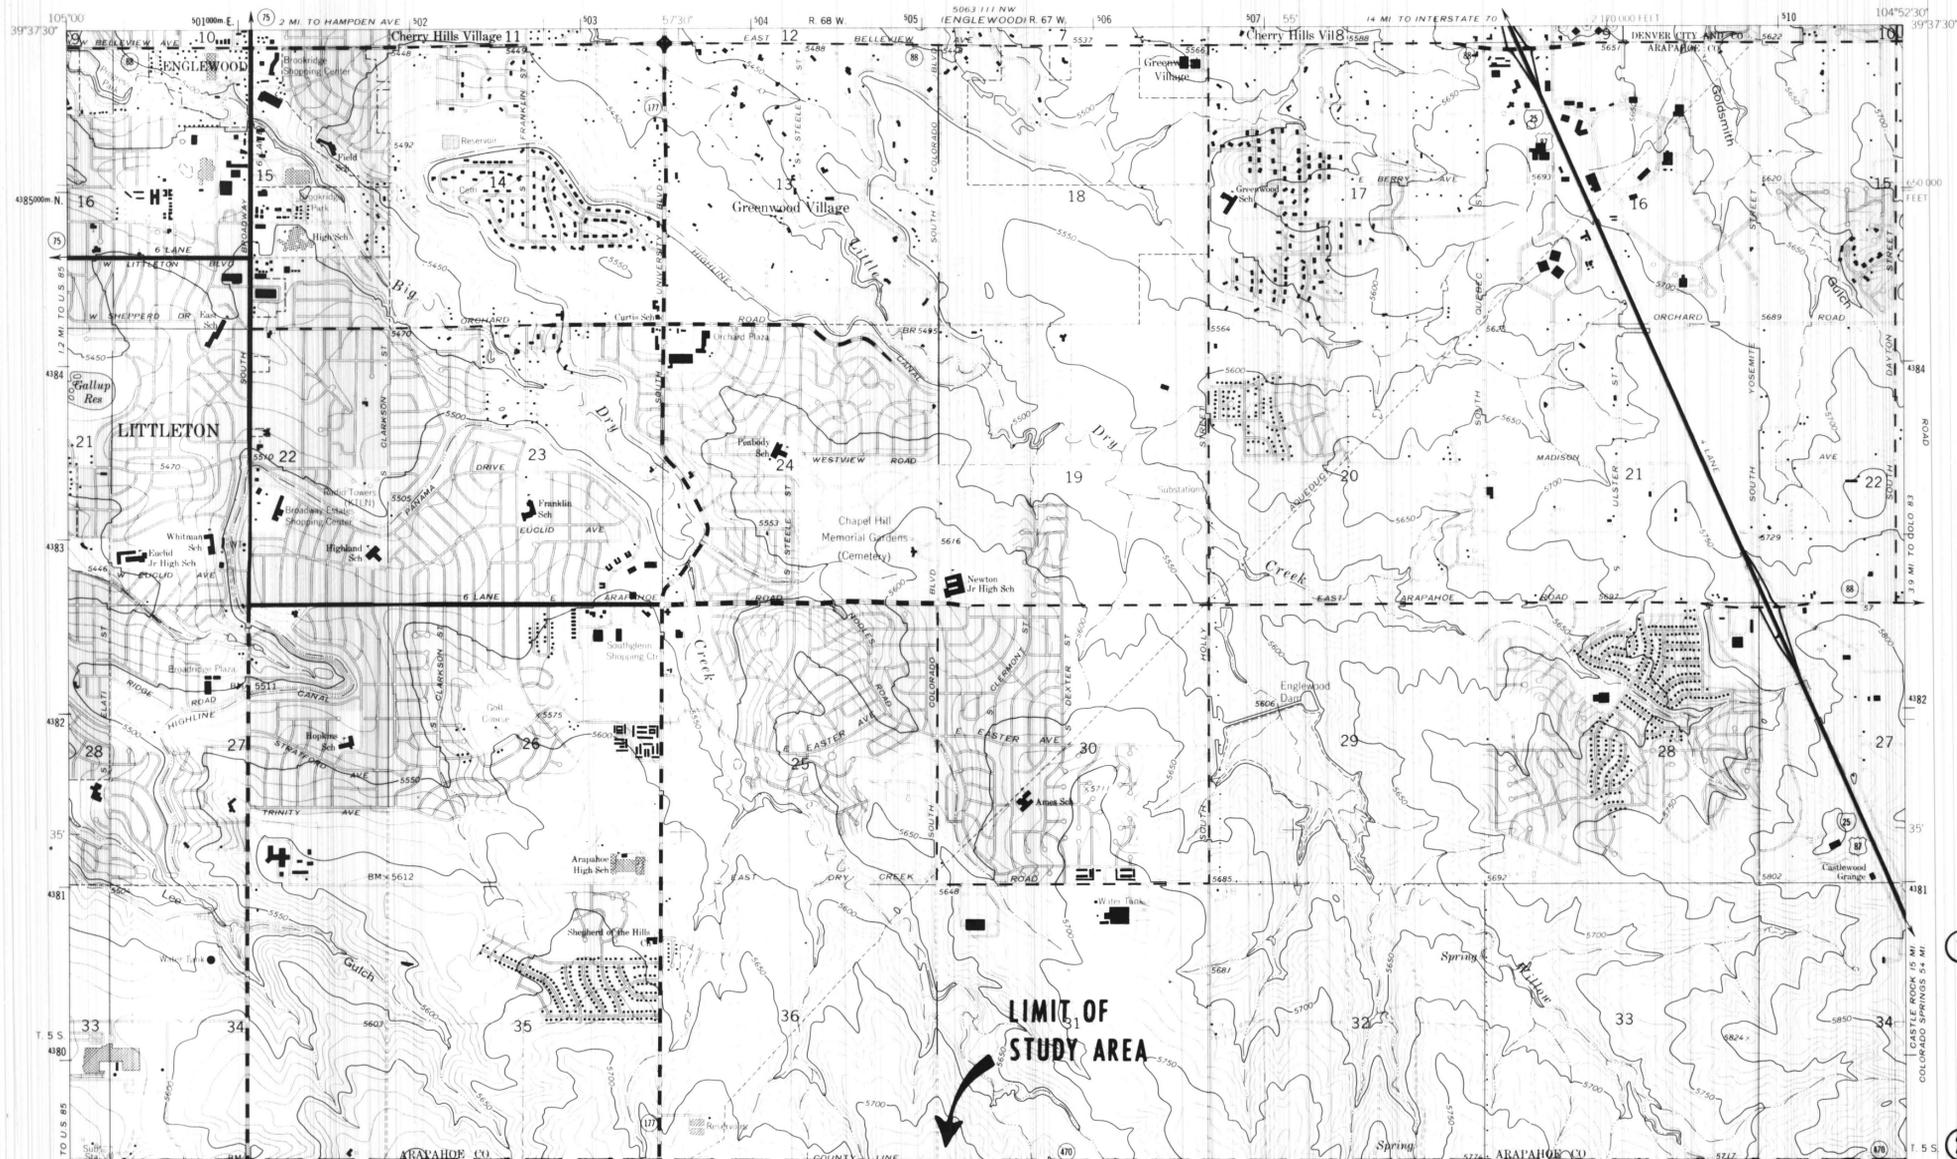
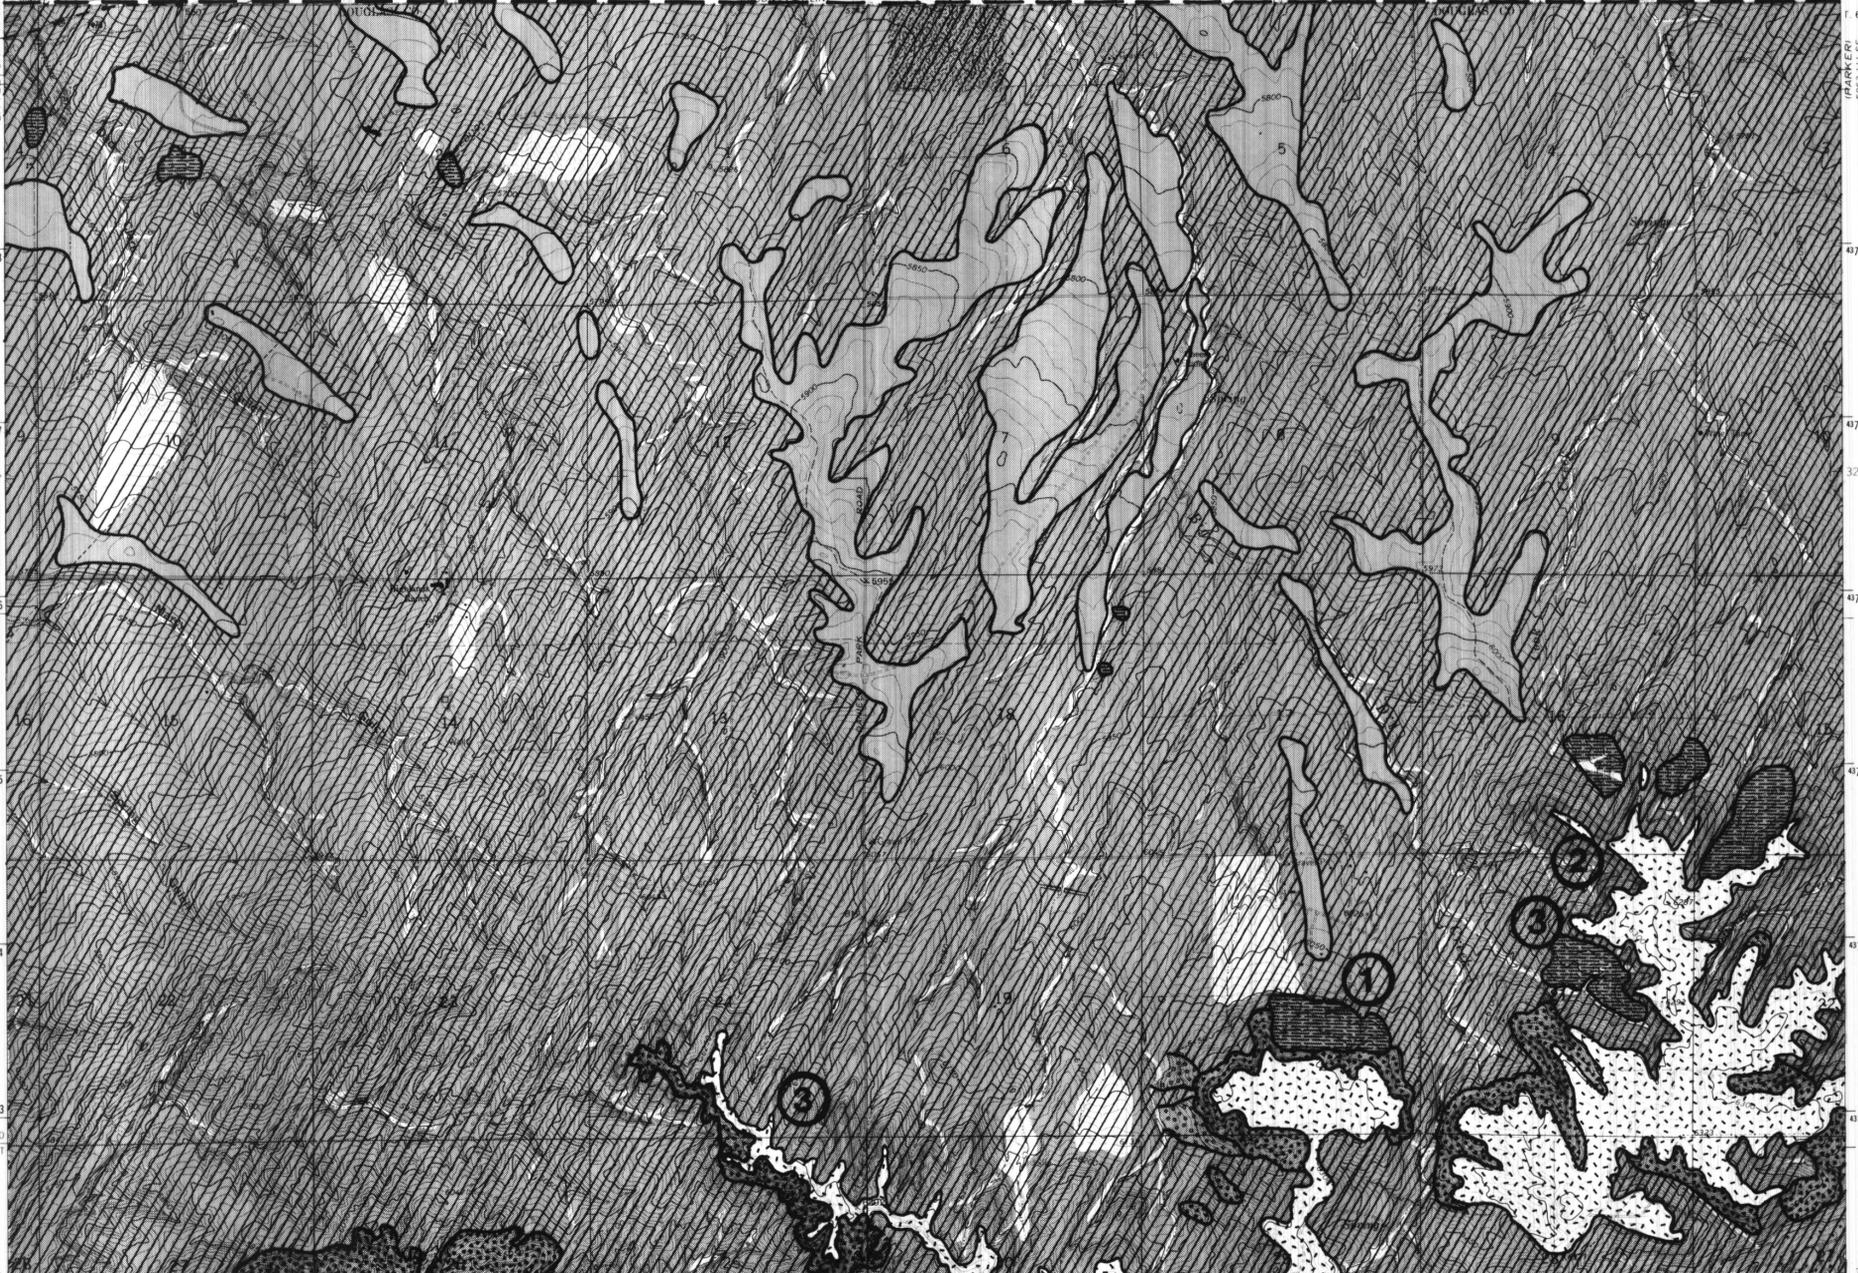
- ① This large landslide appears to be inactive. Intensive residential development of this feature could reactivate its movements.
- ② There are many small areas of accelerated creep and small-scale landsliding on steeper mesa sideslopes in this area.
- ③ Most small drainage-ways adjacent to mesa sideslopes are localized small debris-flow areas.
