**Bulletin 55**

# **The West Salt Creek Landslide: A Catastrophic Rockslide and Rock/Debris Avalanche in Mesa County, Colorado**

By Jonathan L. White, Matthew L. Morgan, and Karen A. Berry

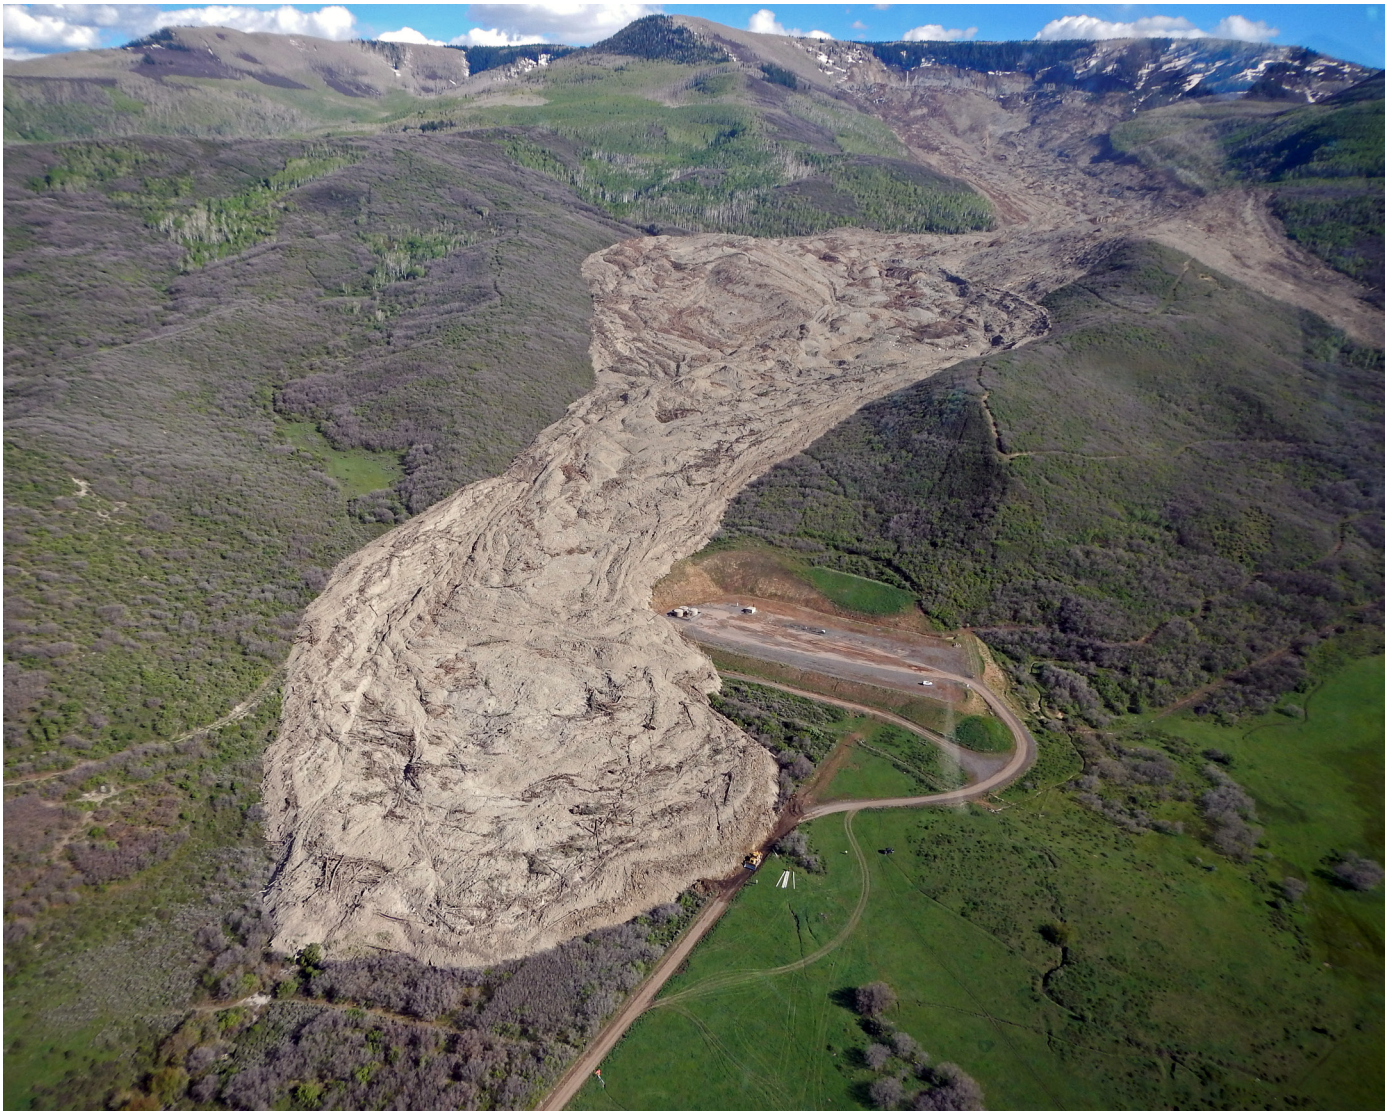
**Cover Photo:** Oblique aerial image of the May 25th, 2014 West Salt Creek landslide near Collbran, Colorado. The landslide complex, which includes rock slide, rock avalanche, and debris-flow components, traveled approximately 3 miles down the West Salt Creek valley. The landslide covers almost one square mile. Aerial view is looking south toward the Grand Mesa. Image was taken on May 26th, 2014.

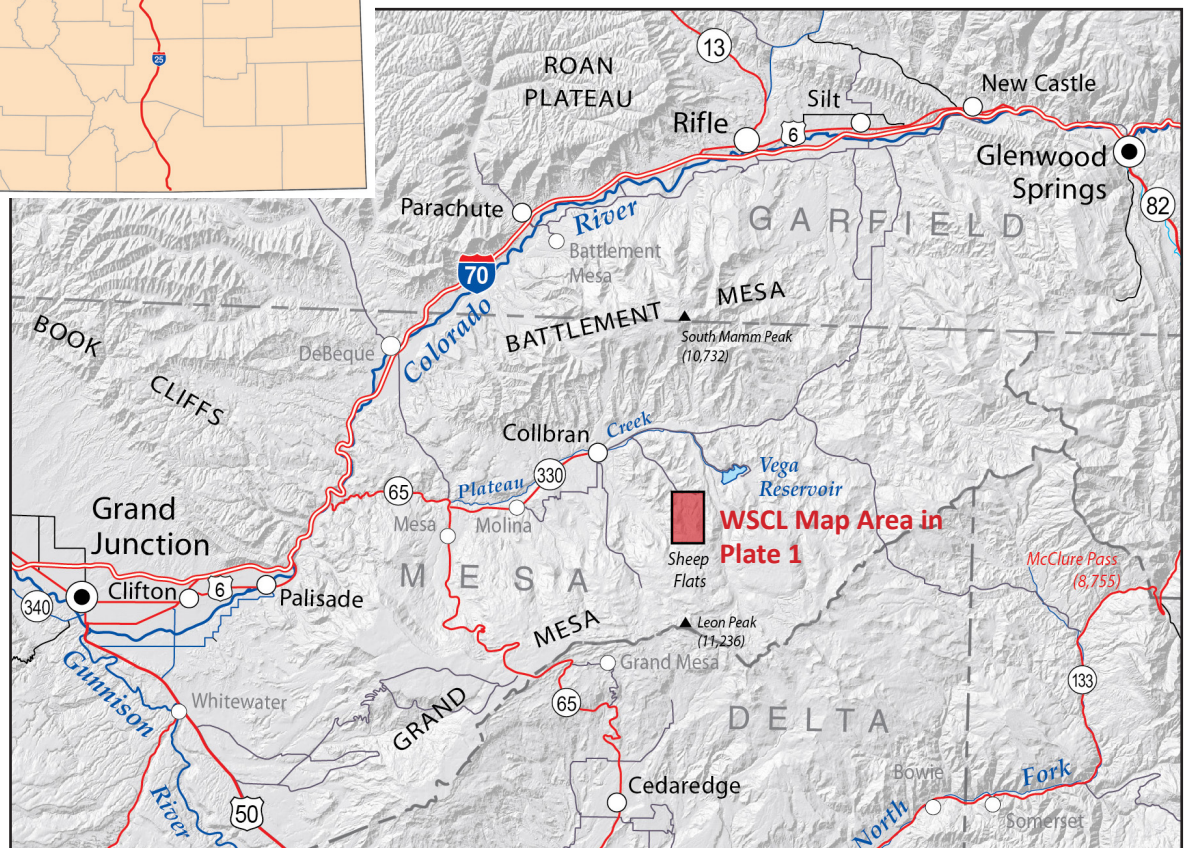
Figure 1. West Salt Creek Landslide (WSCL) map area shown in eastern Mesa County.

The landslide lies in west-central Colorado within the west-fork valley of Salt Creek, which is a tributary stream within the greater Plateau Creek basin between Battlement Mesa to the north and the northern flank of Grand Mesa to the south. The closest town, Collbran (pop. 708, 2010 census) is 6 mi (10 km) downstream on Plateau Creek. County Road 330 and State Highway 65 follow Plateau Creek to its confluence with the Colorado River in DeBeque Canyon where State Highway 65 links with Interstate 70 (see Figure 1).

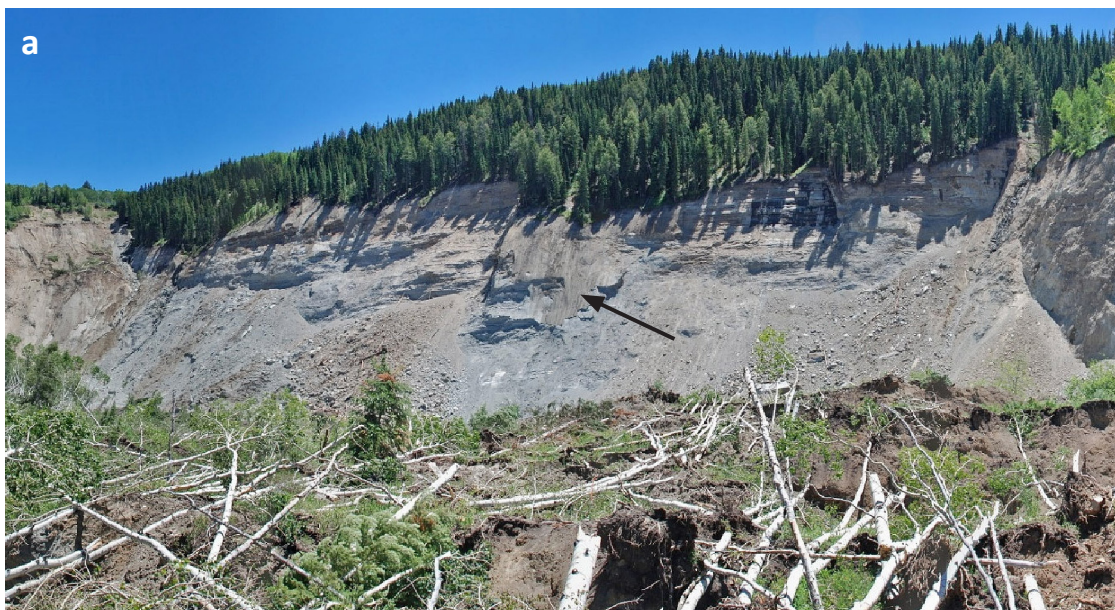
**Figure 6(a).** View of the east flank of the WSCL headscarp from the Upper Block. Black arrow shows location of slickenside remnants of the landslide failure surface. This slip surface remnant has subsequently fallen into the sag pond. Note downed tree orientations toward the scarp on ruptured surface of the back tilted Upper Block.

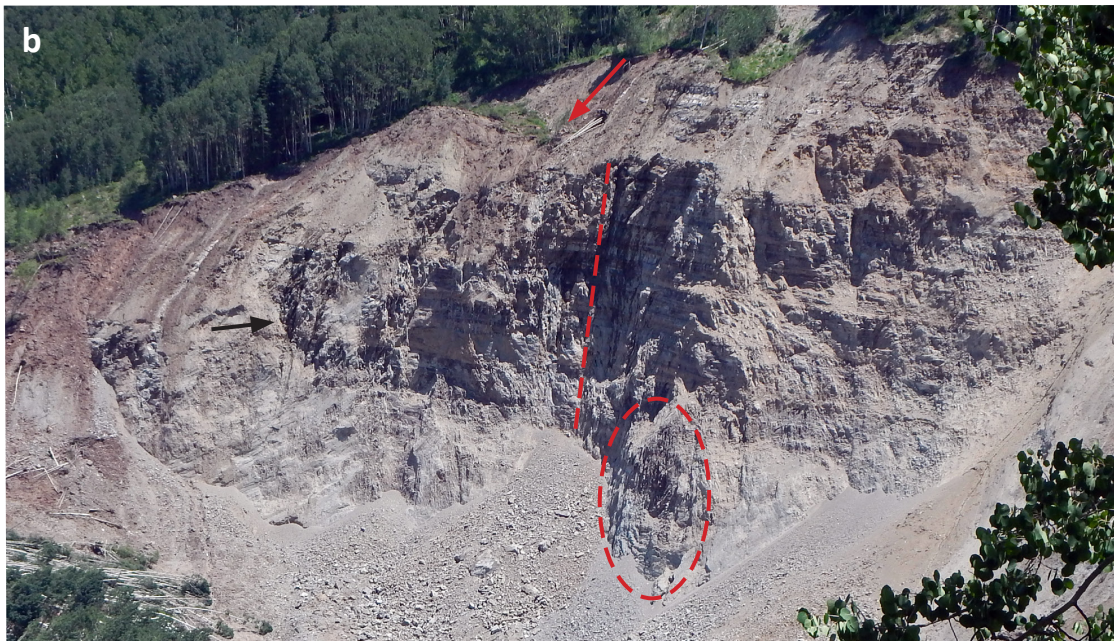
Figure 6(b). Photo of the east side scarp. Disturbed rockmass is the Green River Formation. Note sheared rock fabric and landslide displacement at side scarp shown by red arrow. Colluvial red soil is also seen in the scarp along left edge of photo. Red dashed line approximates major near-vertical shear zone. Dashed oval marks tightly spaced, near vertical shearing in rockmass.

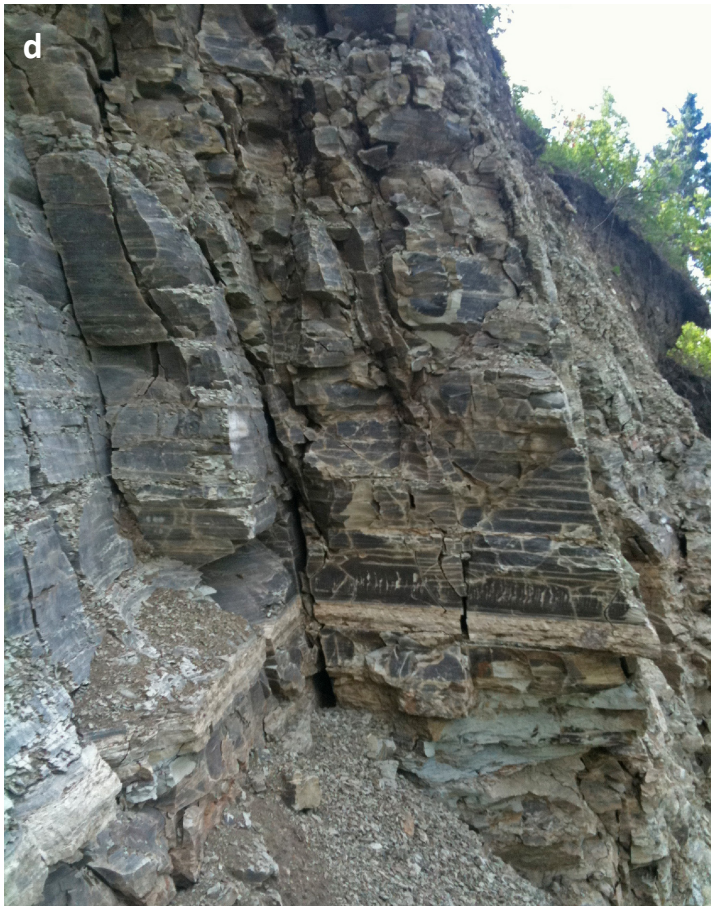
**Figure 6(d).** Exposed Green River Formation on west flank of scarp. Note blue-gray staining and degree of fracturing in the rockmass. Photos taken summer of 2014.

and highly fractured with prominent blue-gray stained surfaces (Figure 6d). Active seeps in the rock faces of the head scarp and flank scarps continued for several days after the landslide.

in outcrop near the headscarp (Figure 6d); while speculative, this range in clast size may be indicative of the fracture network and preferential gradation in the disaggregation of the rock mass. Accessory clast types include rare sandstone and limestone, chert, and basalt boulders derived from alluvium, colluvium, and glacial till deposits that were originally deposited on the plateau above.

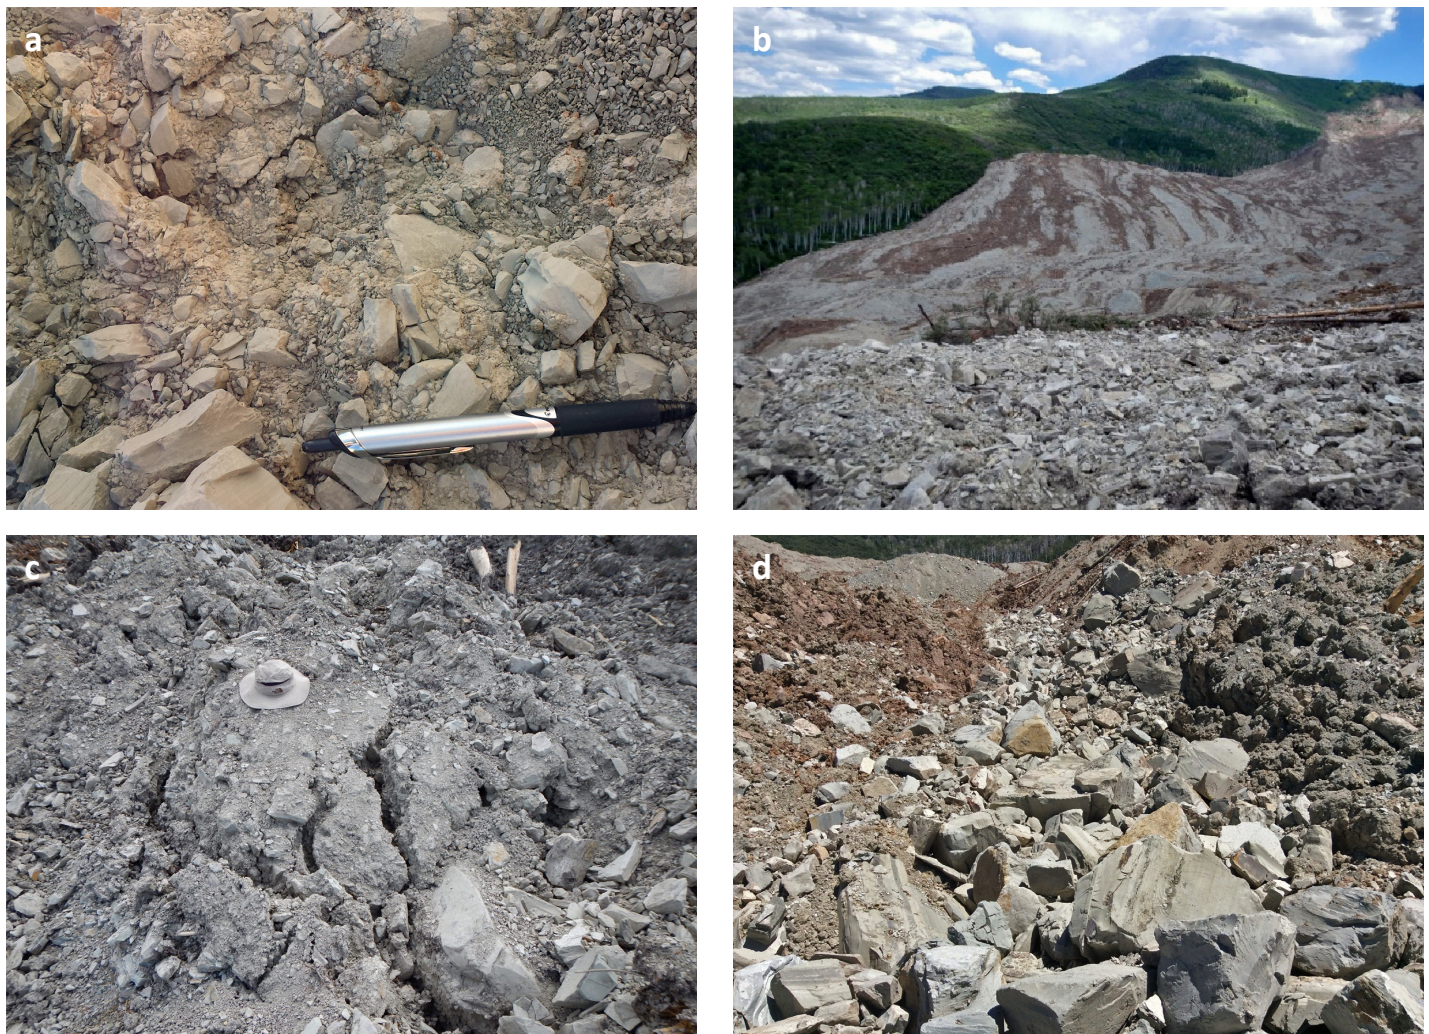
**Figure 10.** Rock avalanche debris locations: (a) typical matrix of avalanche deposit. Note pen for scale; (b) typical rocky debris field on west ridgeline. Note red-soil zebra-stripes related to spread of surficial soils on east flank; (c) subsidence fissures in deposit; (d) bouldery segregation within late-surge hummocky rock-debris flow; (e) debris on rise of west ridge spill over, red circle encloses person for scale; (f) east edge of debris field near toe. Photos taken summer of 2014. Photo locations are shown on Figure 9 map.

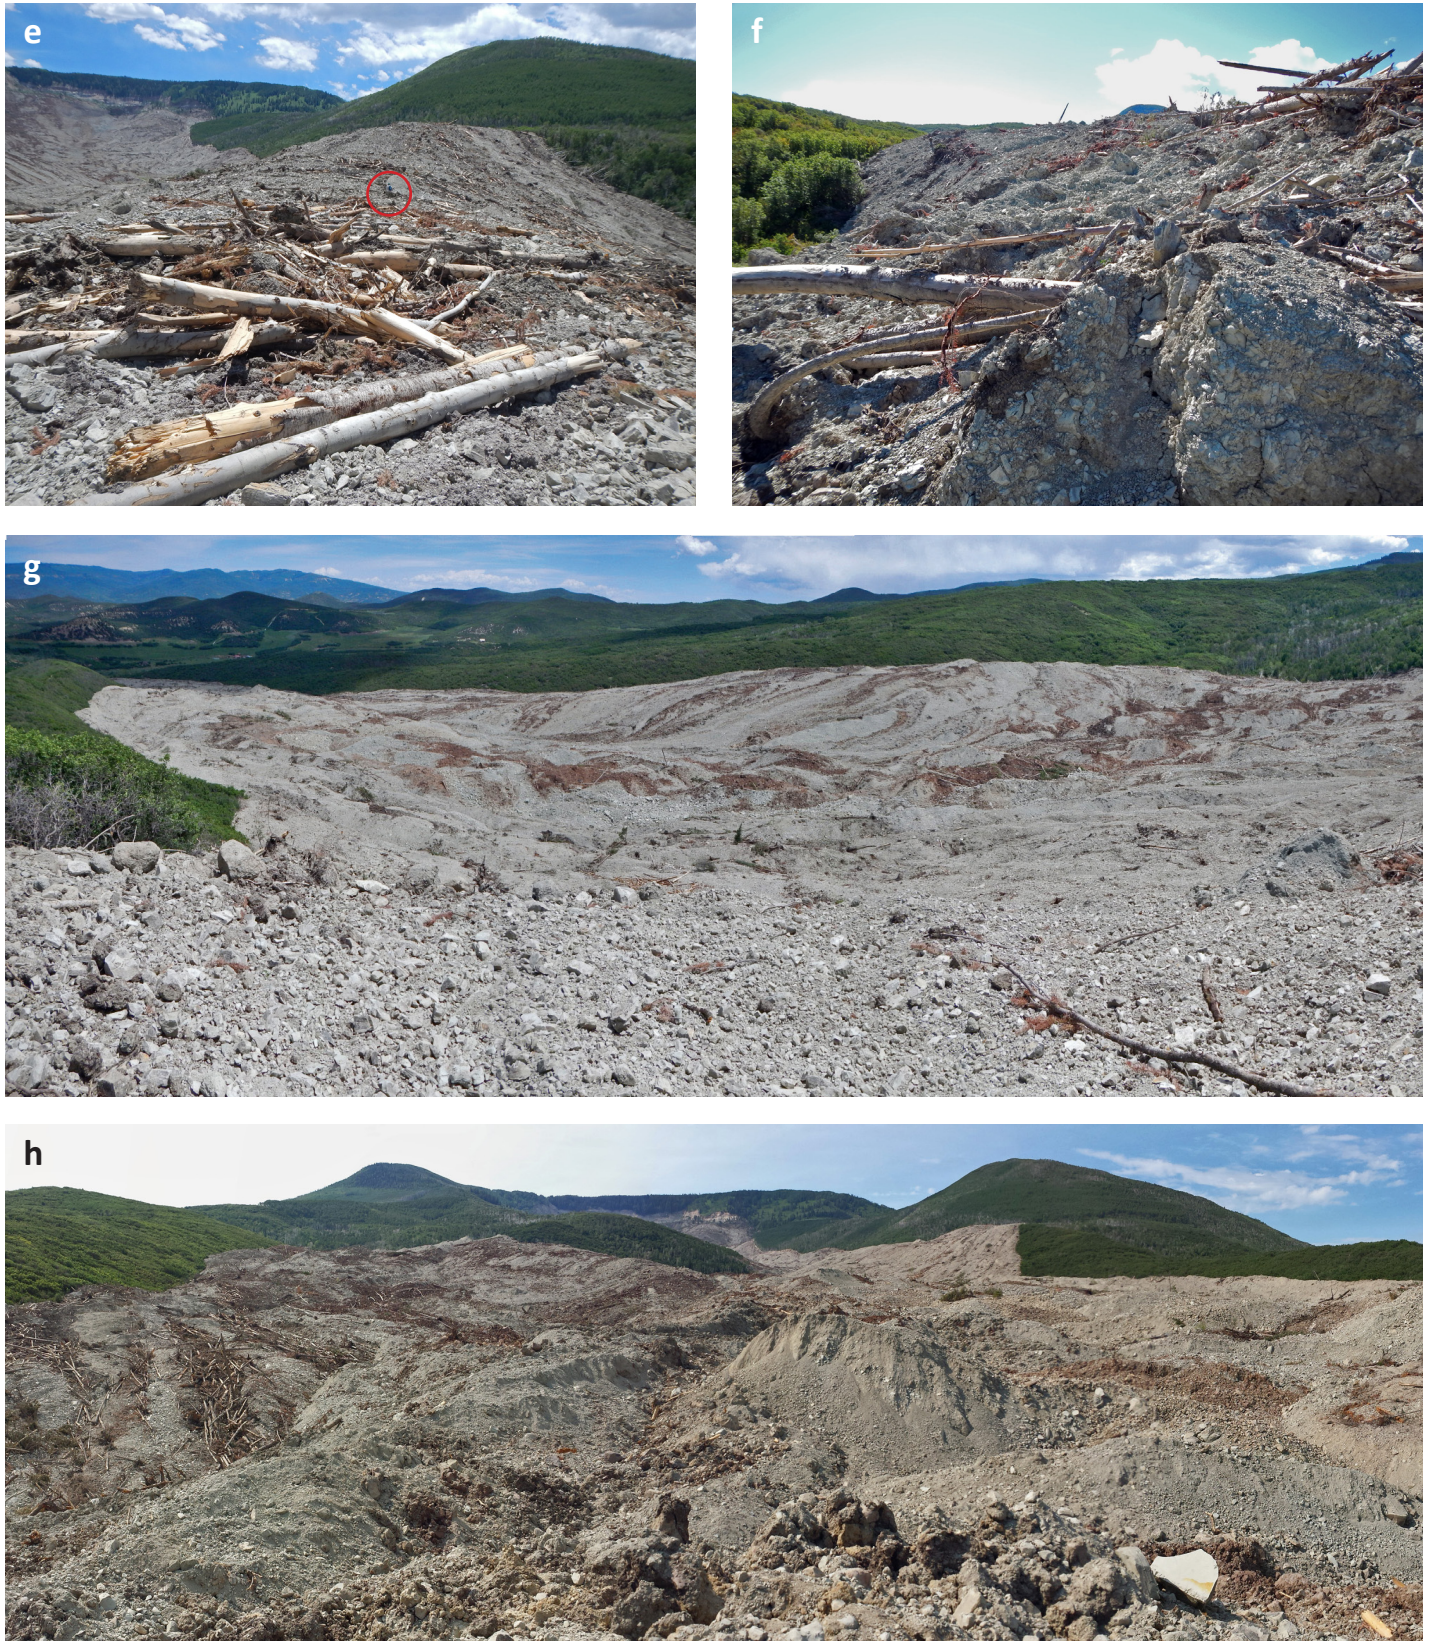
Figure 10 (con't). Rock avalanche debris locations: (g) debris field, photo taken from West Ridge towards East Ridge. Late surge hummocky rock-debris flow can be seen in center; (h) view up slope from flank of East Ridge, note spill over at West Ridge, dog-leg in East Elk Creek thalweg, and late surge hummocky rock-debris flow on floor; (i) con't on page 16.

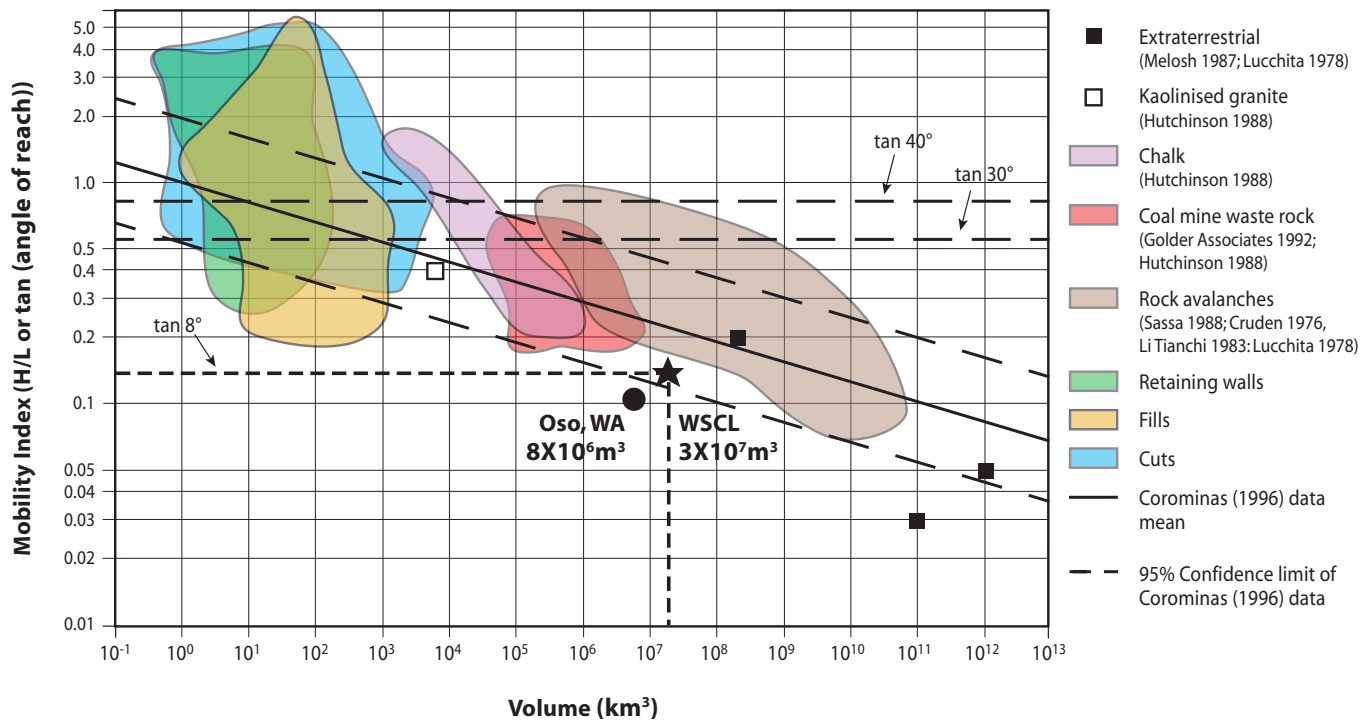
**Figure 14.** Graphic representation of volume, angle of reach, and runout lengths of large catastrophic landslides and rock/debris avalanches. Top graph is a Log mobility index vs. Volume (V) graph modified from Finlay and other's (1999) compilation. Lower graph is a runout length versus volume chart from the GEER Association report (Keaton and others, 2014) of the Oso landslide that shows rock avalanches and debris flows compiled by Legros (2002). WSCL point is the star. For comparison, the Oso landslide point (Iverson, 2014) is shown as black circle.

and other's (1999) compilation. The second lower graph of Figure 14 contains a compilation of data from Legros (2002) that shows the relationship between volume and runout length. This graph does not take into account landslide height and the WSCL plots within the general trend of rock avalanches. Also included in Figure 14 is a comparison point from the March 22, 2014 Oso landslide that caused 43 fatalities. This smaller but extremely rapid, high mobility, catastrophic mud and debris flow occurred in Washington State (Iverson and George, 2014; Keaton and others, 2014).

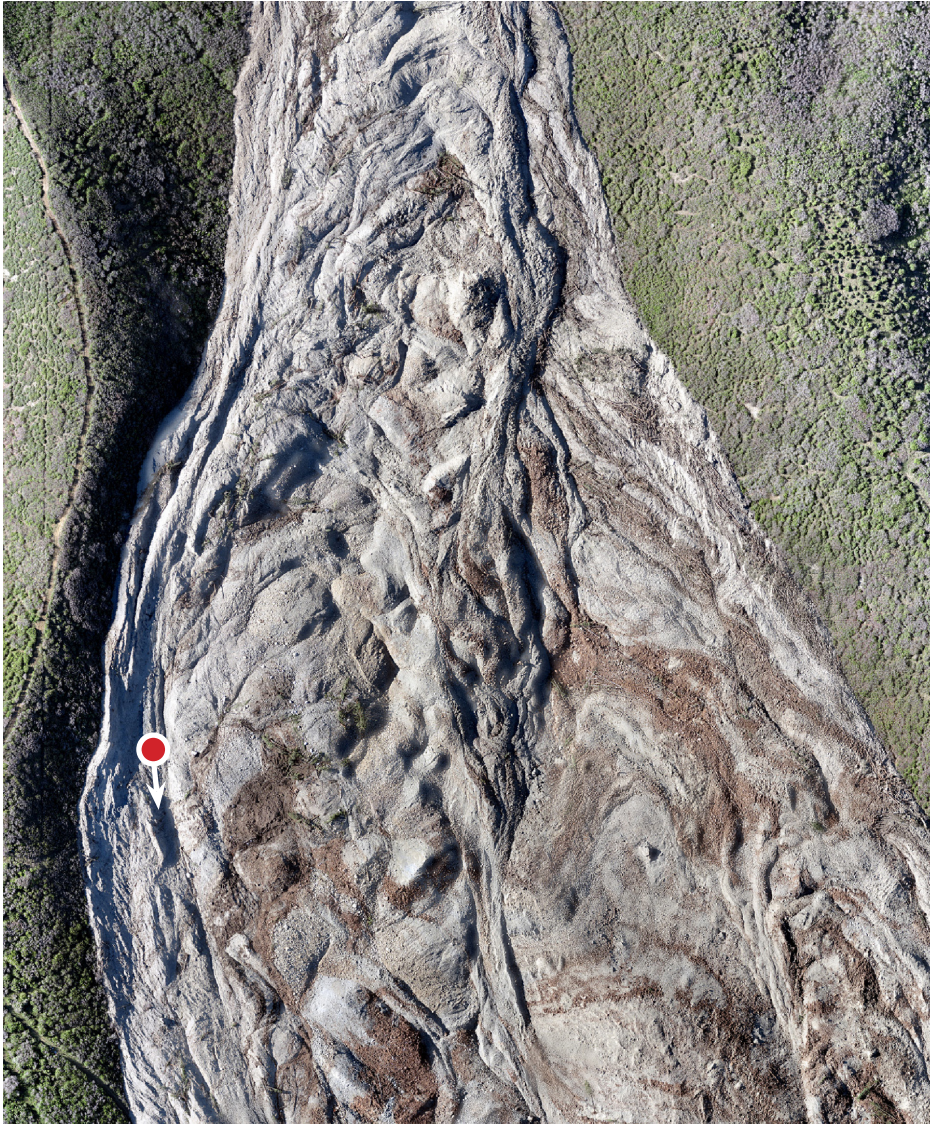
**Figure 15.** Aerial photograph at low sun angle showing complex crosscutting relationship of discrete surges in the avalanche debris field. Note parallel to-flow linear shears and ridgelines at the boundary of the late hummocky surge. Photo was stitched from UAV images courtesy of Ben Miller, Mesa County Sheriff's Office taken 24 hours after the landslide occurred. Red dot shows approximate location of photo in Figure 18. Extent of photo is shown by boxed area in Figure 9.

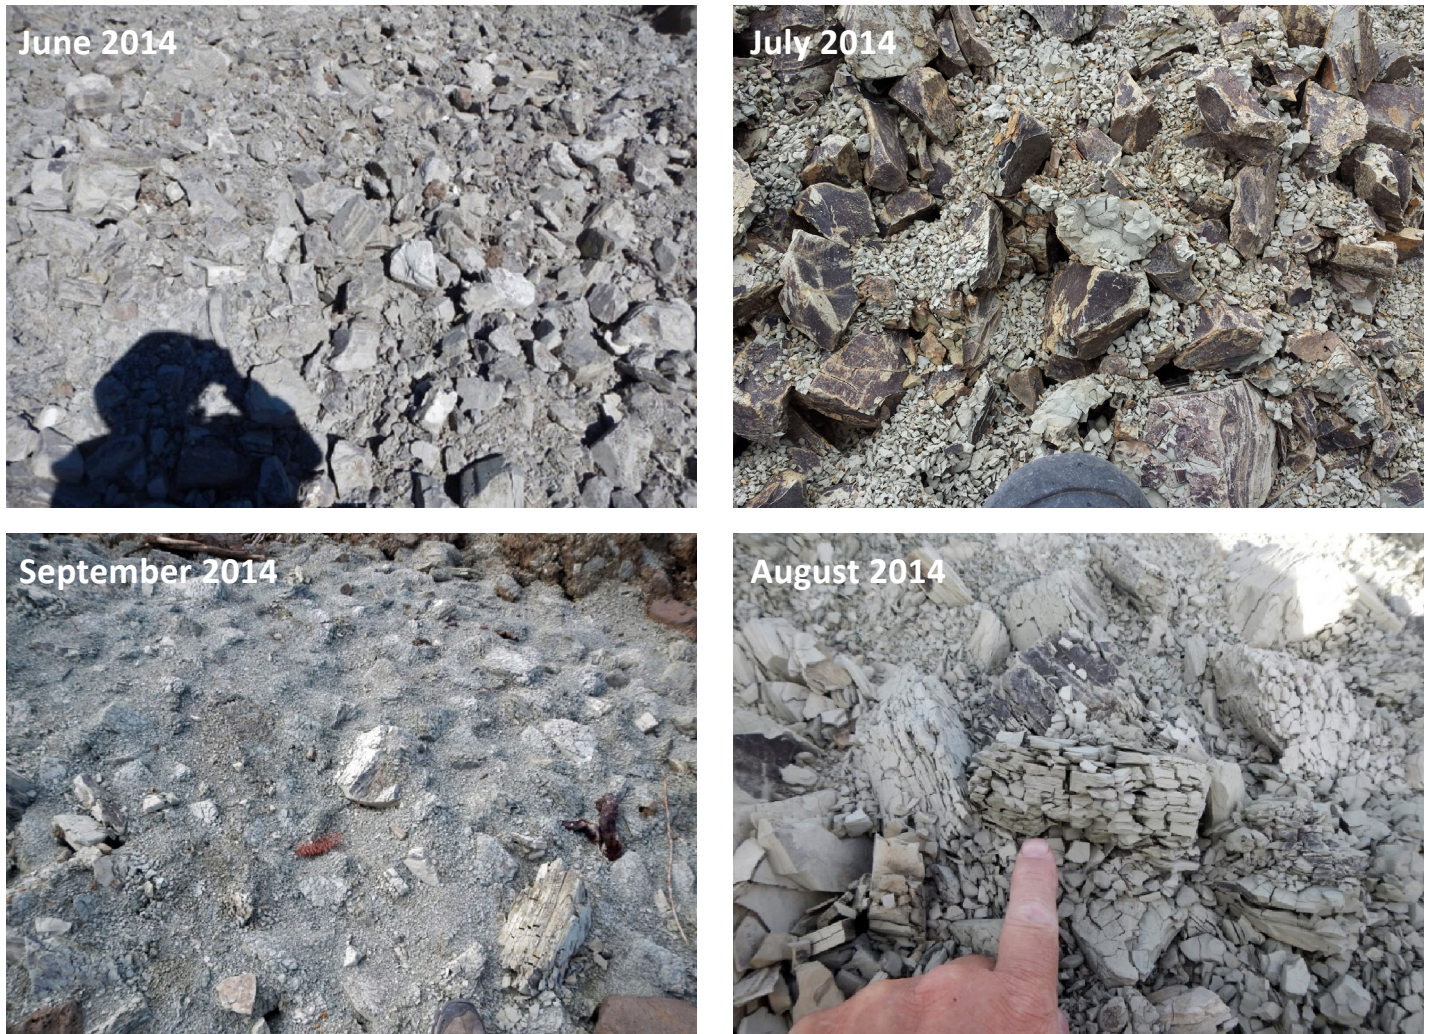
**Figure 16.** Rapid slaking of Green River Formation claystone and marlstone clasts in the WSCL debris field. Note surface staining of clasts and progression, clockwise from upper left, of rock disintegration in less than 4 months.

During the summer and fall of 2014, CGS observed that clasts of the Green River Formation, which comprise almost all of the landslide deposit, are highly susceptible to slaking when exposed to physical weathering. The clasts on the surface of the debris field rapidly disintegrated into finer and finer material (**Figure 16**) that will be easier for future debris flows to entrain and may increase their bulking factor.

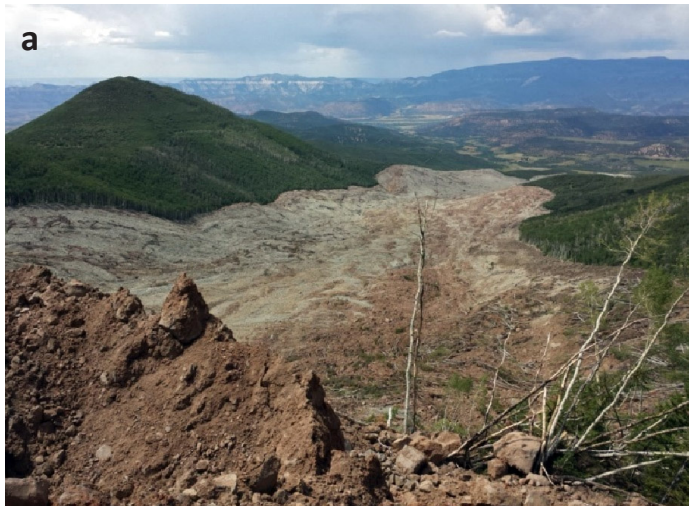
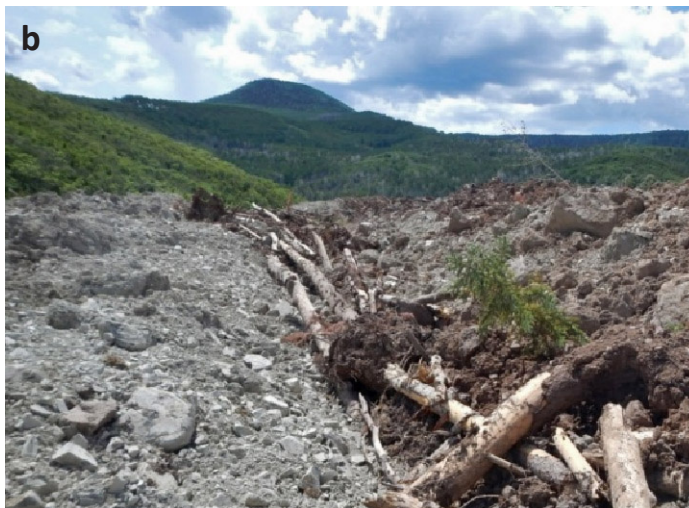
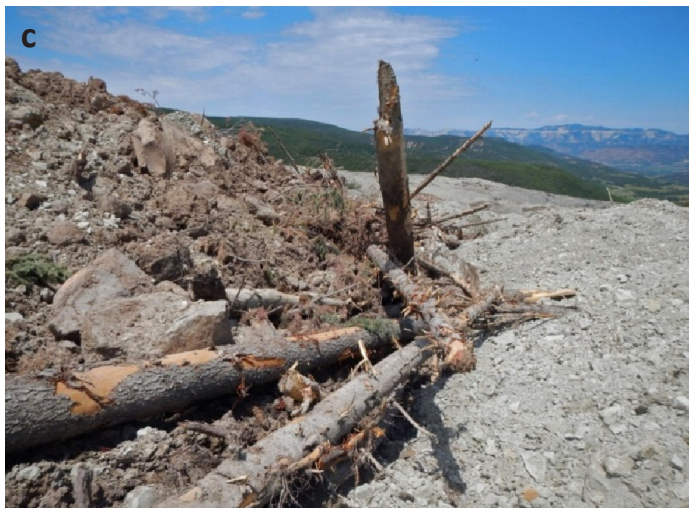
The rock blocks vary in size, approximating the size of cars to small houses. The blocks are in various stages of fragmentation, from nearly intact with only minor disruption of bedding planes to highly disturbed, almost disintegrated, where the original bedding is only slightly apparent. The blocks commonly form hummocks in the center of the landslide mass and appear to have “bulldozed” the underlying deposits into low ridges at the front and sides of the blocks. Remains of the original forest floor, with living trees (predominantly coniferous pines) and plants in growth position, is preserved on some of the surfaces of the hummock-forming blocks. This degree of block preservation in conjunction with the great distances the blocks traveled from the evacuation zone source indicates that near the end of its rotational movements, the Upper Block was detaching blocks of Green River Formation from the evacuation-zone without sufficient momentum or speed to completely disaggregate the rock mass as what occurred in the earlier surges. It is clear this was the last significant movement of the landslide because the lateral boundaries of its entire length is marked by sharp furrows (**Figure 18**) that define shear zones as this material flowed through, over, or past the pre-existing early to middle surge deposit runouts. The late surge rock-debris flow ground to a halt as it bulldozed earlier surges at the toe near and below the oil and gas well pad. The late surge boundary was discerned near the toe by the formation of pressure-ridges and flow bands normal to the flow direction and the down-slope cessation of red-soil remnants.

**Figure 17. Red bouldery deposits:** a) photo taken from the east side of the disturbed bench of the Upper Block at red soil deposit; b and c) photos on boundary, upslope and downslope, where middle surge material (with red soil remnants, basalt boulders, and tree fragments) has overrun light gray early surge deposit that is nearly completely composed of finer Green River Formation clasts. Photos taken summer of 2014. Photo locations are shown on Figure 9 map.

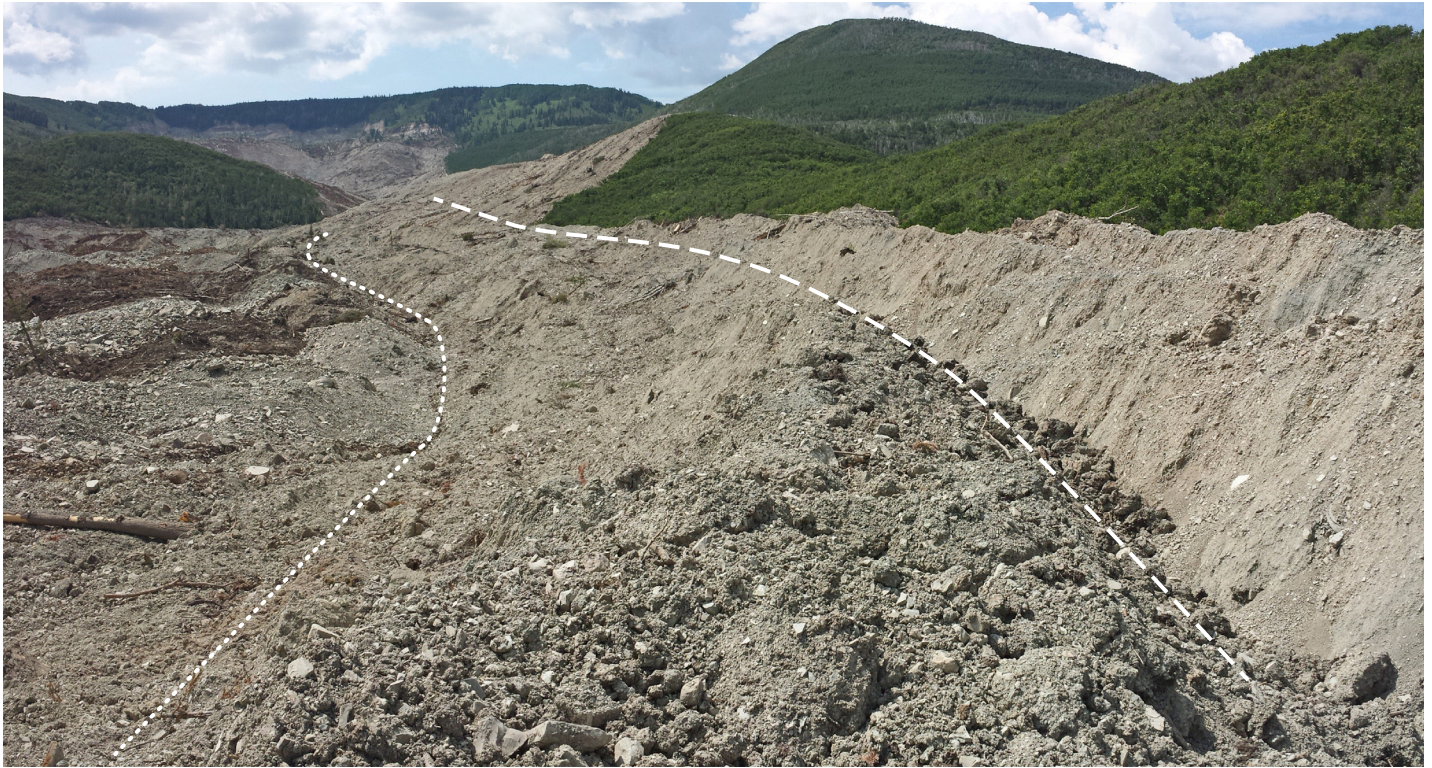
**Figure 18. Well-defined side furrow (dashed line) on west side of debris field marks a lateral shear of subsequent movements of a later, lower level, debris surge. West edge of late, hummocky surge along stream thalweg is shown by dotted white line. Photo taken summer of 2014. This photo location is also on the aerial photo in Figure 15 and is shown on Figure 9 map.**

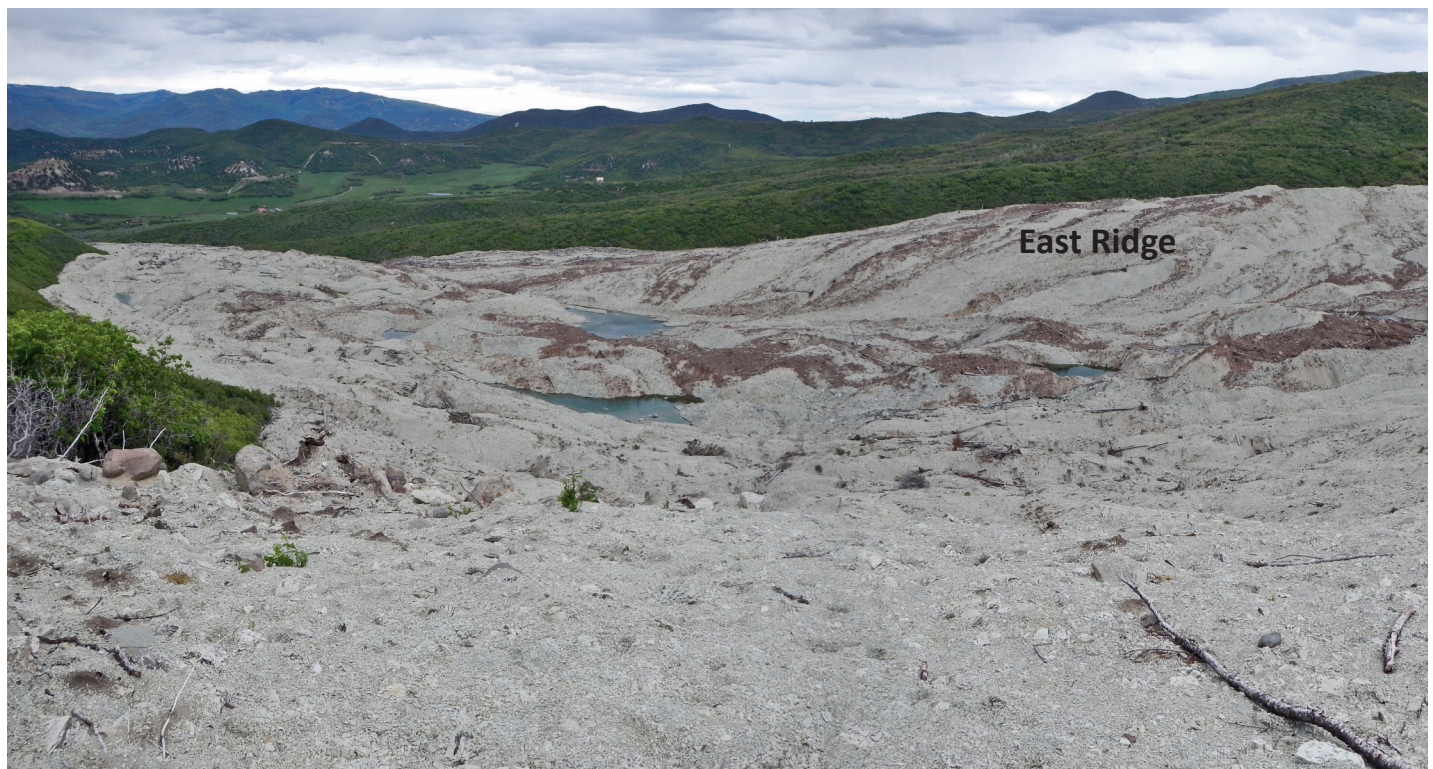
**Figure 21.** A year after the WSCL, large ponds formed on the hummocky late-surge rock/debris avalanche deposits. View is to the northeast from the West Ridge at the same location of Figure 11g. Note finer-grained debris field in foreground compared to Figure 11(g), as a result of year-long slaking of Green River Formation clasts. Photo date: June 5, 2015. Photo location is shown on Figure 9 map.

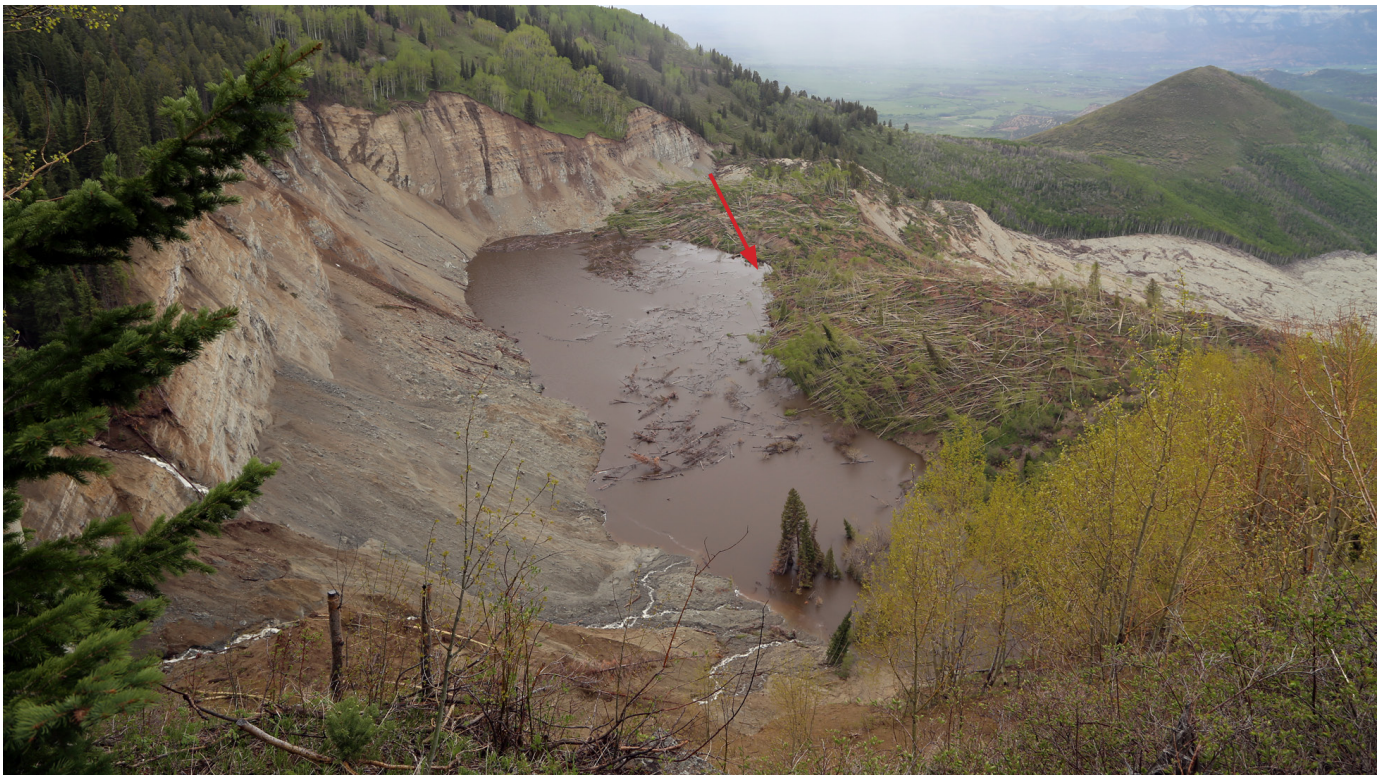
Figure 23. Image of the sag pond taken June 6th, 2015. The pond level is estimated to be 2–4 ft (0.6–1.2 m) below spill over (red arrow). Photo location is shown on Figure 9 map.

1. Embankment-failure type slump of a portion of the Upper Block and catastrophic release of the pond,

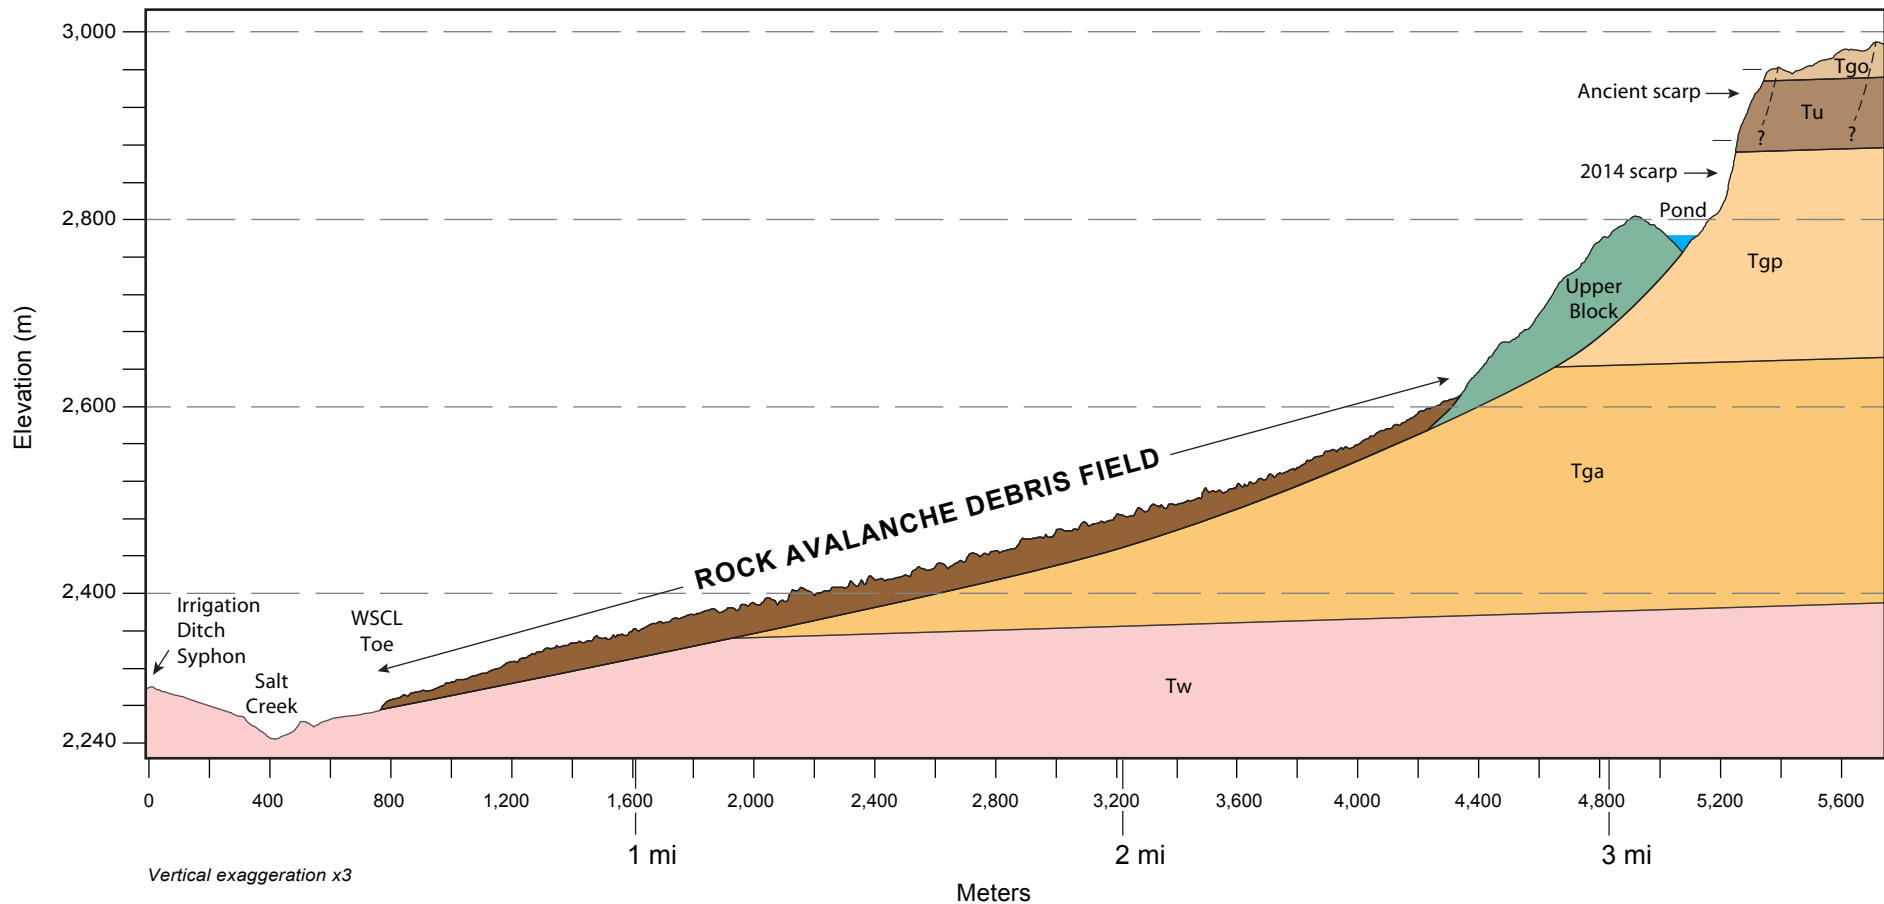
- Oil and gas wells
- ⊕ Horizontal bedding
- ↙ Strike and dip of bedding
- Ancient to recent (1984) scarps
- New scarps of May 2014 failure
- ⋯ Disturbed bedrock zone
- 🟦 Sag Pond Oct 2014
- 🟪 Late surge hummocky rock-debris flow
- 🟩 Middle surge avalanche with red soil
- 🟨 Middle surge avalanche
- 🟪 Early surge avalanche
- 🟩 Disturbed and rotated Upper Block
- 🟨 Qa - Alluvial deposits
- 🟩 Qls - Older landslide deposits
- 🟨 Qc/Tgo - Colluvium and Goodenough formation
- 🟪 Tu - Uinta Formation
- 🟩 Tg - Green River Formation
- 🟪 Tw - Wasatch Formation

Contours derived from LiDAR DEM (3 meter contour interval)
