COLORADO GEOLOGICAL SURVEY
Open-file Report OF-18-10
Debris Flow Susceptibility Map of Jefferson County, Colorado
Kevin M. McCoy, Matthew L. Morgan, and Karen A. Berry

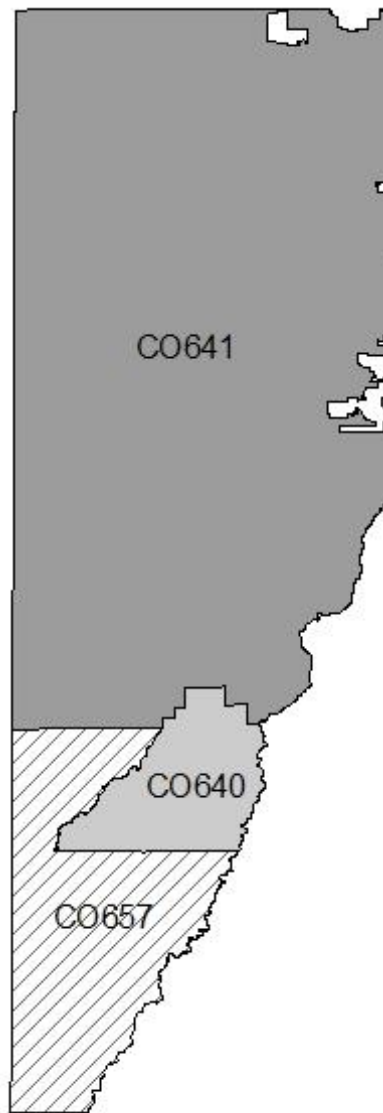
Figure 2. *Index of digital soil survey reports available for the study area.*

This map was prepared by combining GIS-based debris-flow source and runout models with visual interpretation of high-resolution lidar-based digital terrain data, digital geologic maps, and digital soil survey data. The lidar data used has a nominal horizontal accuracy of 1-m and is publicly available for the entire county on the USGS National Map viewer (<https://viewer.nationalmap.gov/basic/>). Burned area outlines for fires that have occurred since the year 2000 were delineated using the US Historic Fire Perimeters dataset downloaded from the Geospatial Multi-Agency Coordination (GEOMAC) website (<https://www.geomac.gov/>). The areal extent of the 1996 Buffalo Creek fire was roughly estimated based on vegetation changes still visible in recent aerial imagery. Figures 1 and 2 show the coverage of digital geologic maps and digital soil survey maps used for this study, respectively.
