COLORADO GEOLOGICAL SURVEY

HAZ-2011-01

Preliminary Damage Report of the August 22, 2011 Mw 5.3 Earthquake near Trinidad, Colorado

By Matthew L. Morgan and Karen S. Morgan

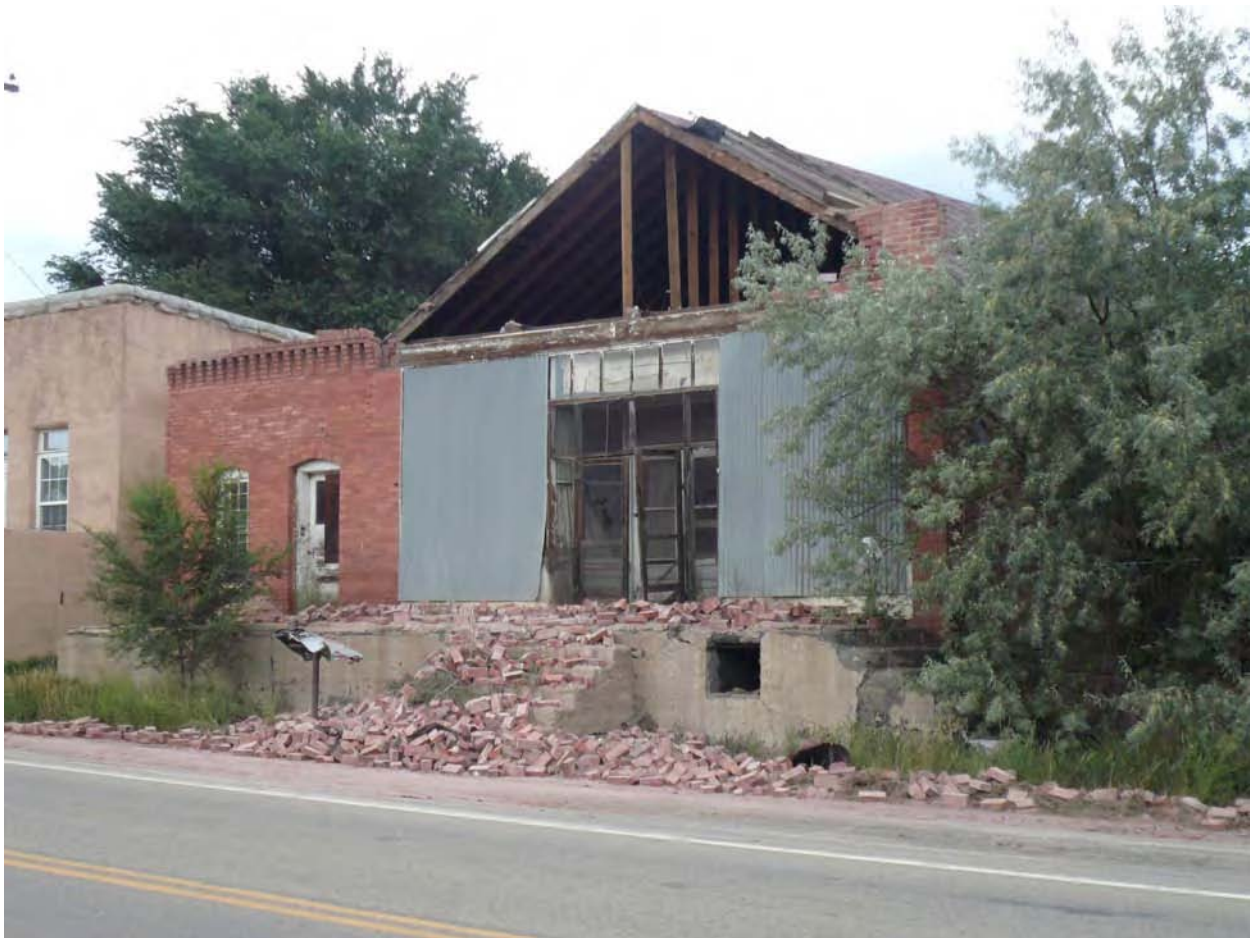
The front of this brick building collapsed, sending debris onto State Highway 12. Note the crushed mailbox. Segundo, CO.

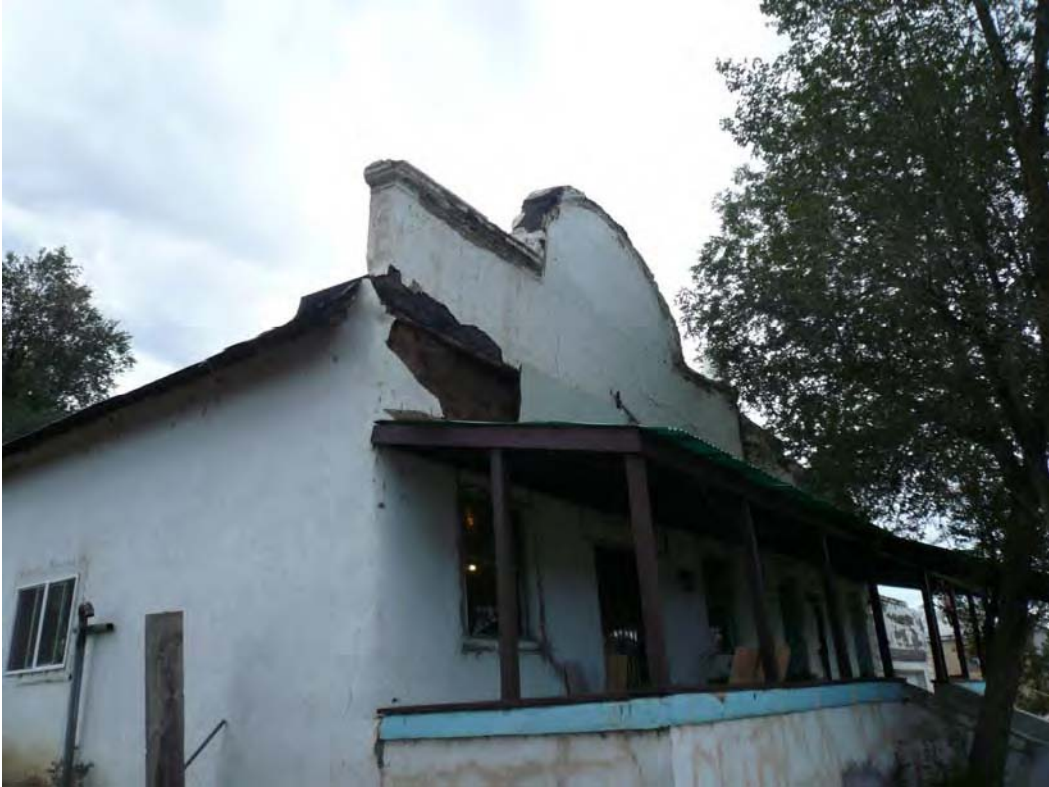
An adobe building from early 20th century had its front façade displaced horizontally. Part of the façade crumbled and adobe fragments were scattered on the front porch roof (Figure 1). Two-foot-long rock blocks from the façade fell 10 feet through the front porch roof (Figure 2). The front wall of the building moved 1" horizontally (north) (Figure 3). The floor within the house dropped 1-2" as measured from the base of the internal doors that closed before the event. The floor was visibly heaved and down-dropped in areas. 6-foot-high bookcases within the house were knocked over (Figure 4) and cupboards were left in shambles (Figure 5). The resident reported being thrown onto his wife while sleeping. Damage to the outside walls was clearly visible as cracks and missing plaster (Figure 6). In the backyard, the fence was displaced 2 feet horizontally (S-N). The outside chimney was displaced 2" (Figure 7). The local fire department recommended the residents evacuate the house until it could be reviewed for structural damage.

Figure 1. Highly damaged residence in Segundo where the façade has crumbled and pulled away from the main structure.

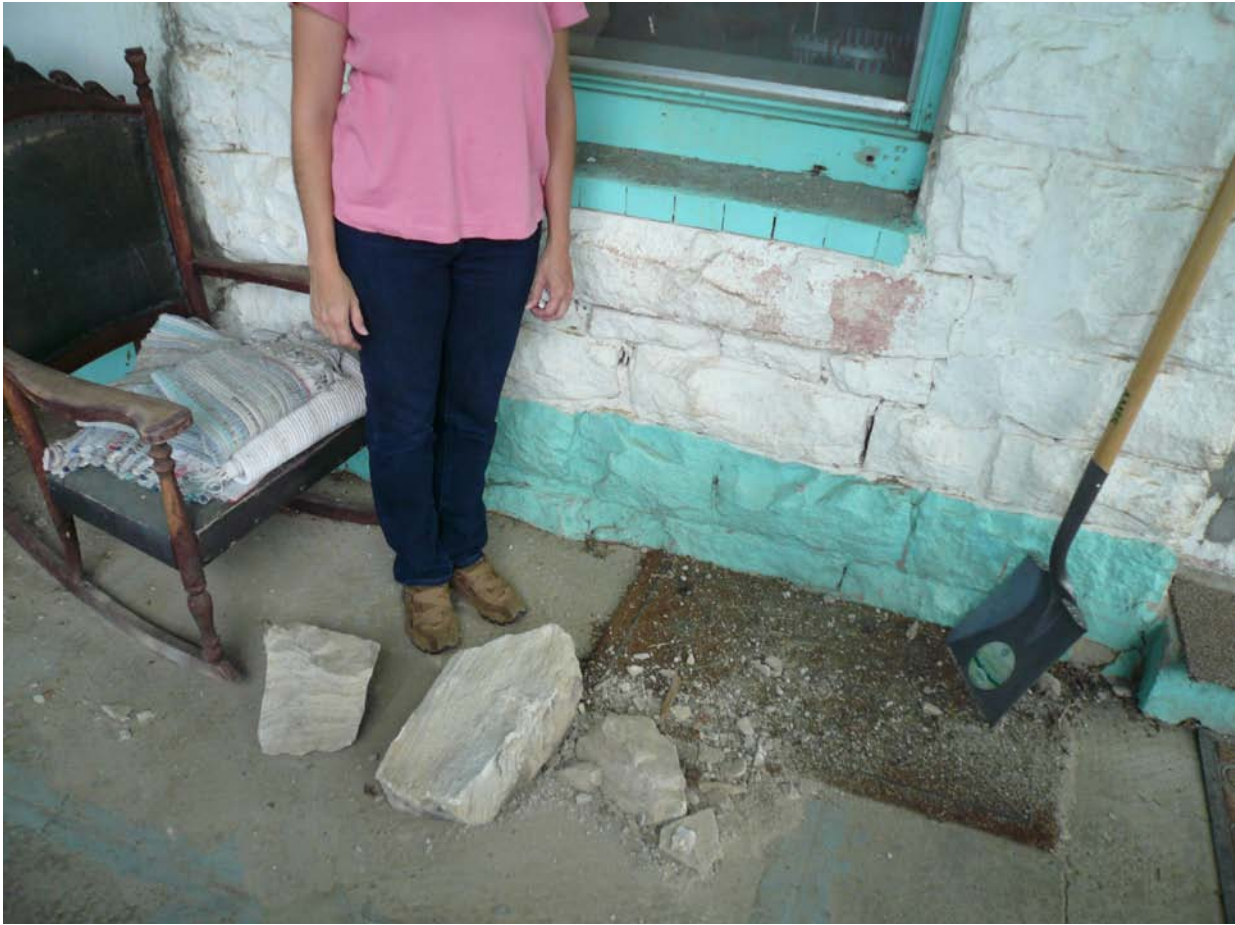
Figure 2. Two-foot-long rock blocks from the façade that fell 10 feet through the front porch roof. Segundo, CO.

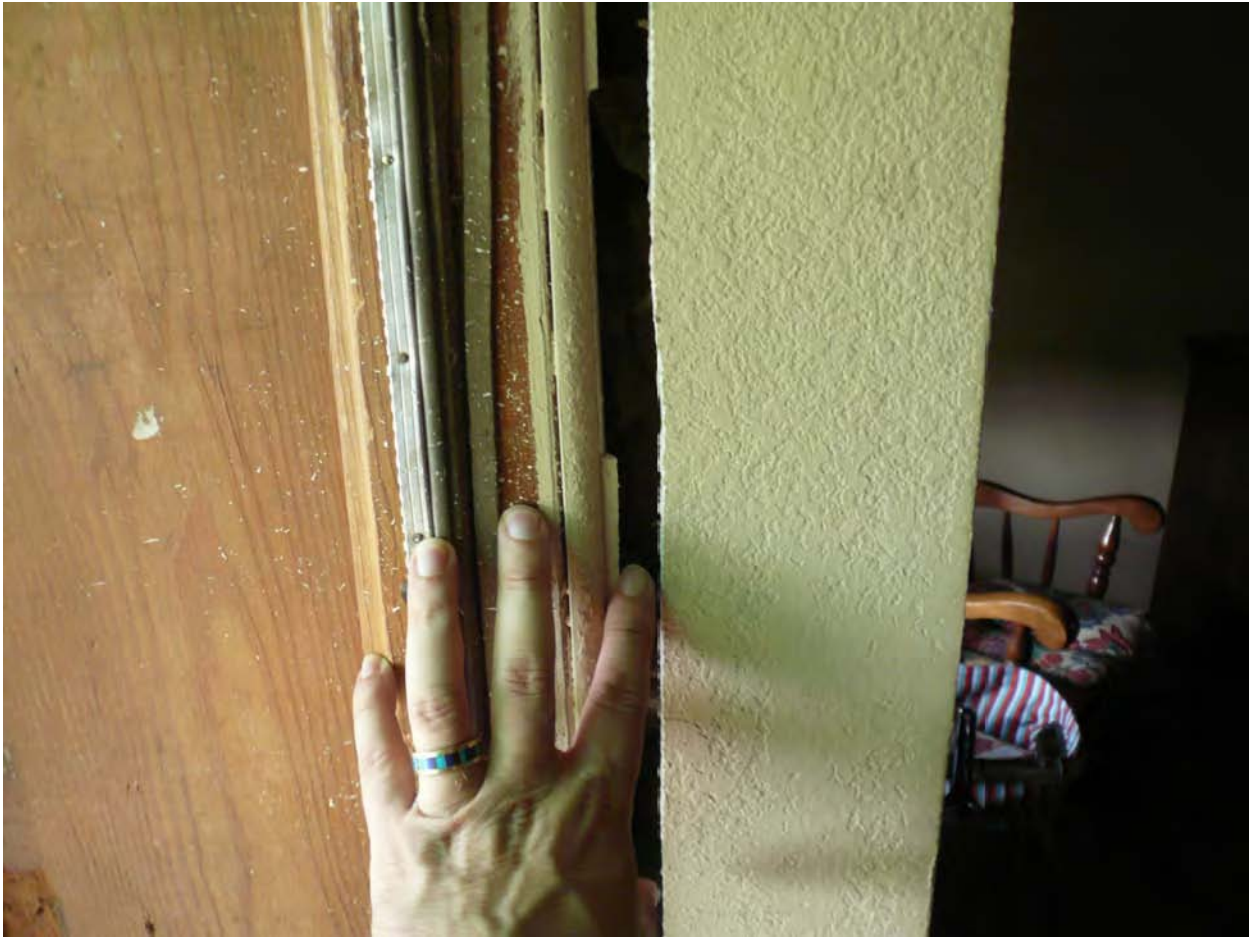
Figure 3. The exterior wall pulled away approximately 1" from the interior wall. Segundo, CO.

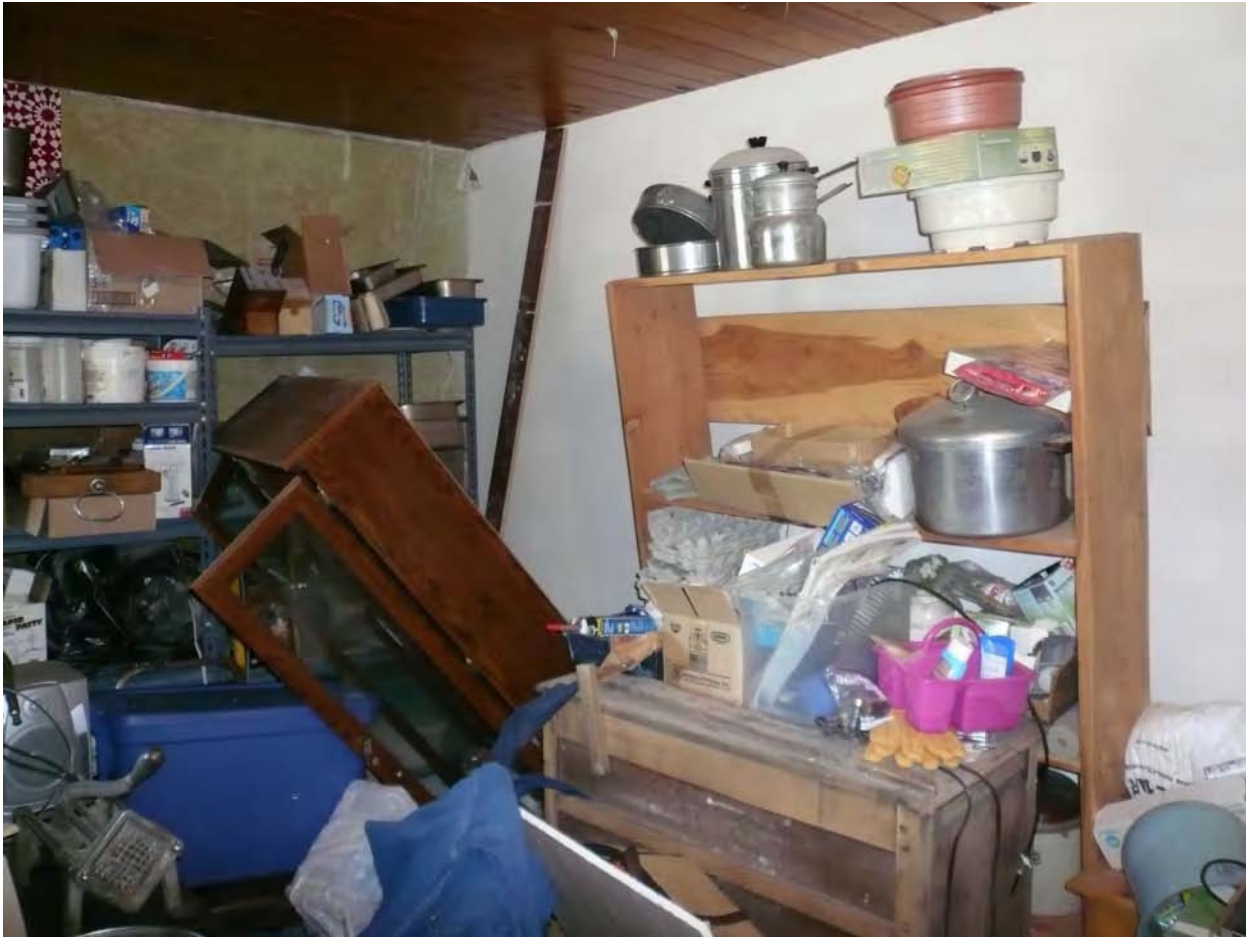
Figure 4. Large bookcases were toppled over from the shaking. The resident reported S-N movement. Segundo, CO.

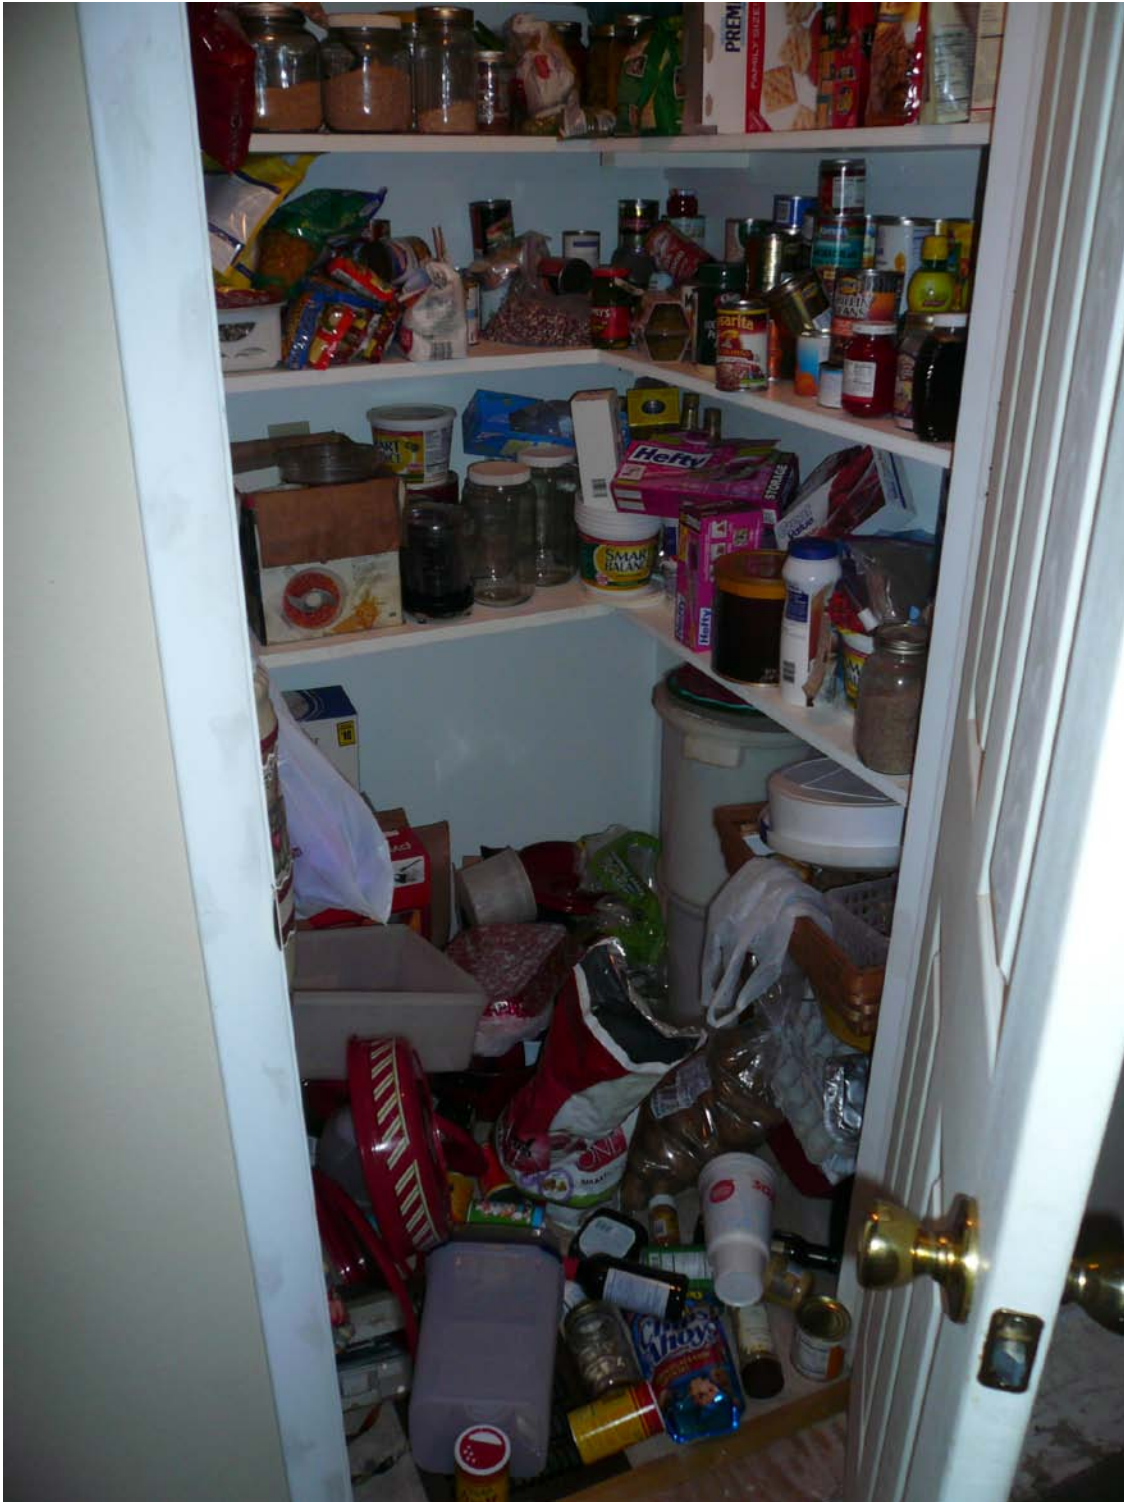
Figure 5. Cupboard contents thrown from the shelves. Segundo, CO.

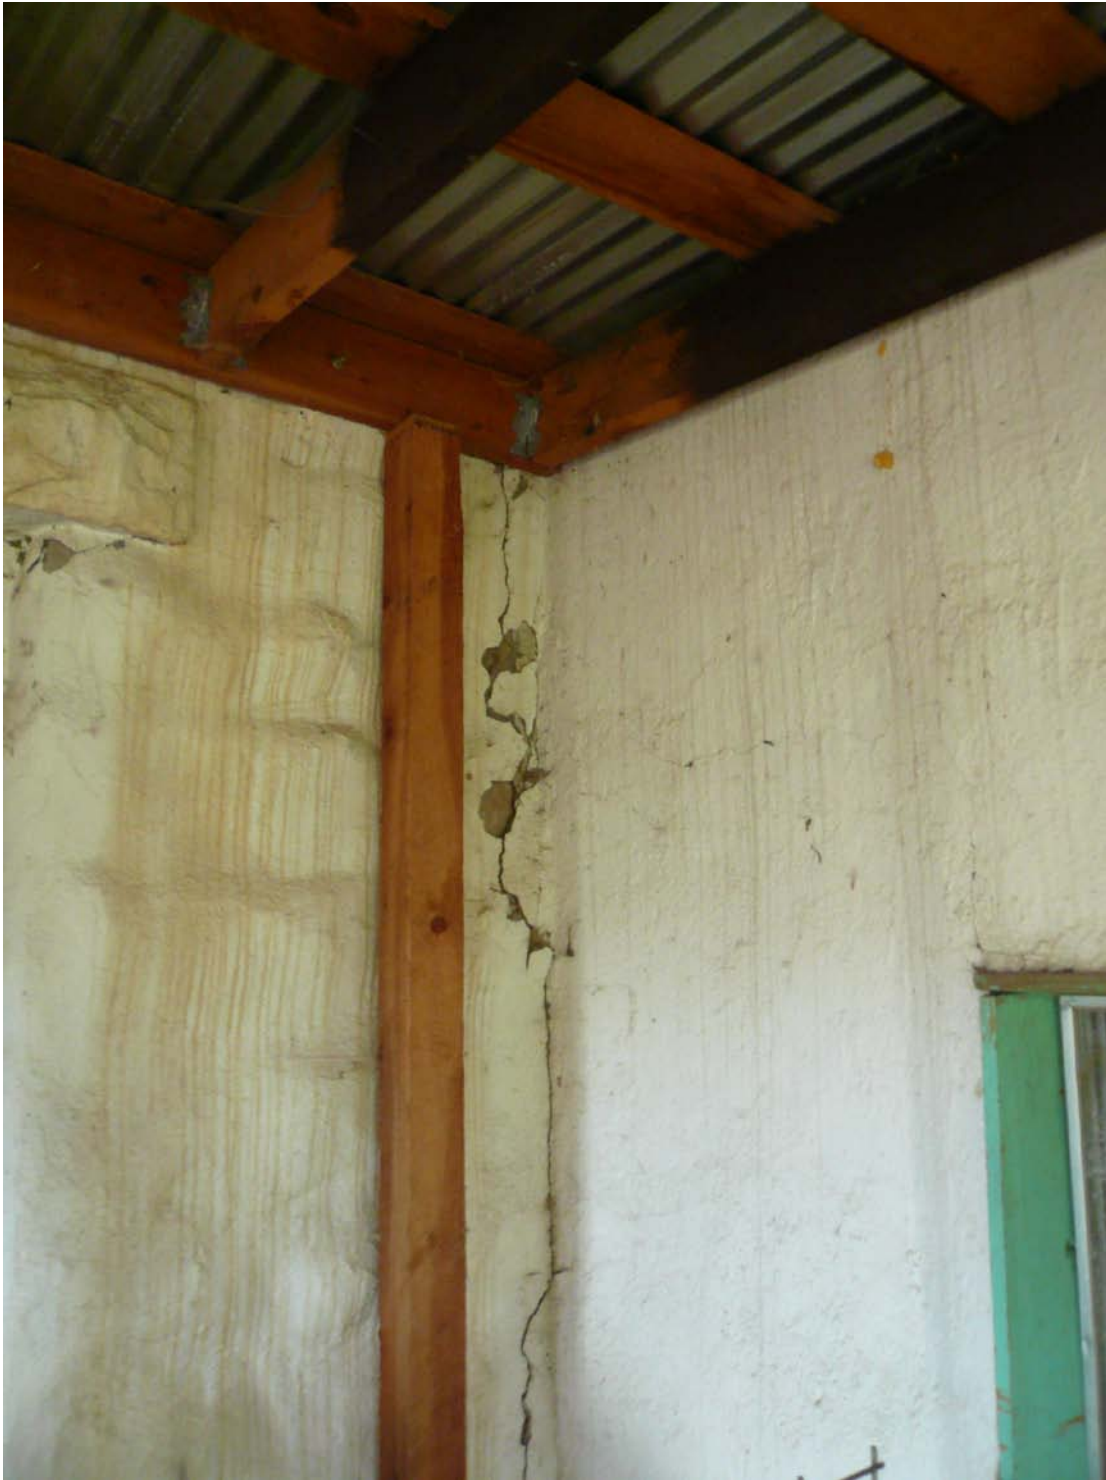
Figure 6. Cracked and missing plaster was pervasive. Segundo, CO.

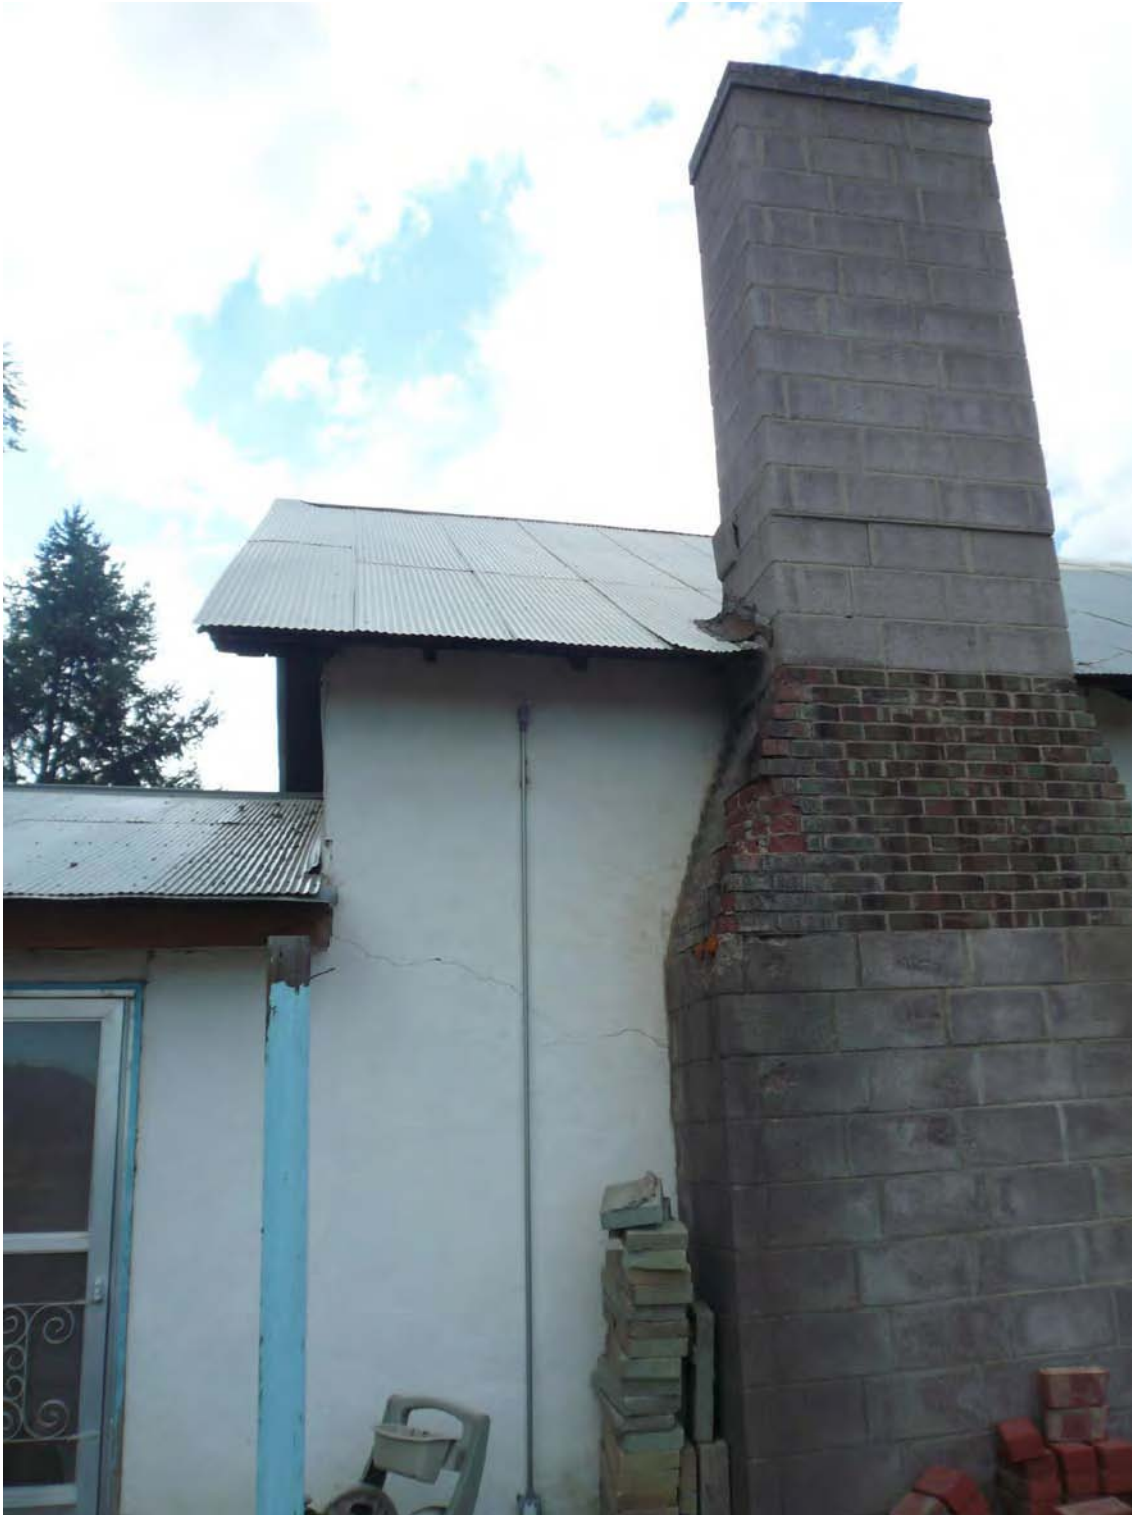
Figure 7. Chimney displaced approximately 2". Segundo, CO.

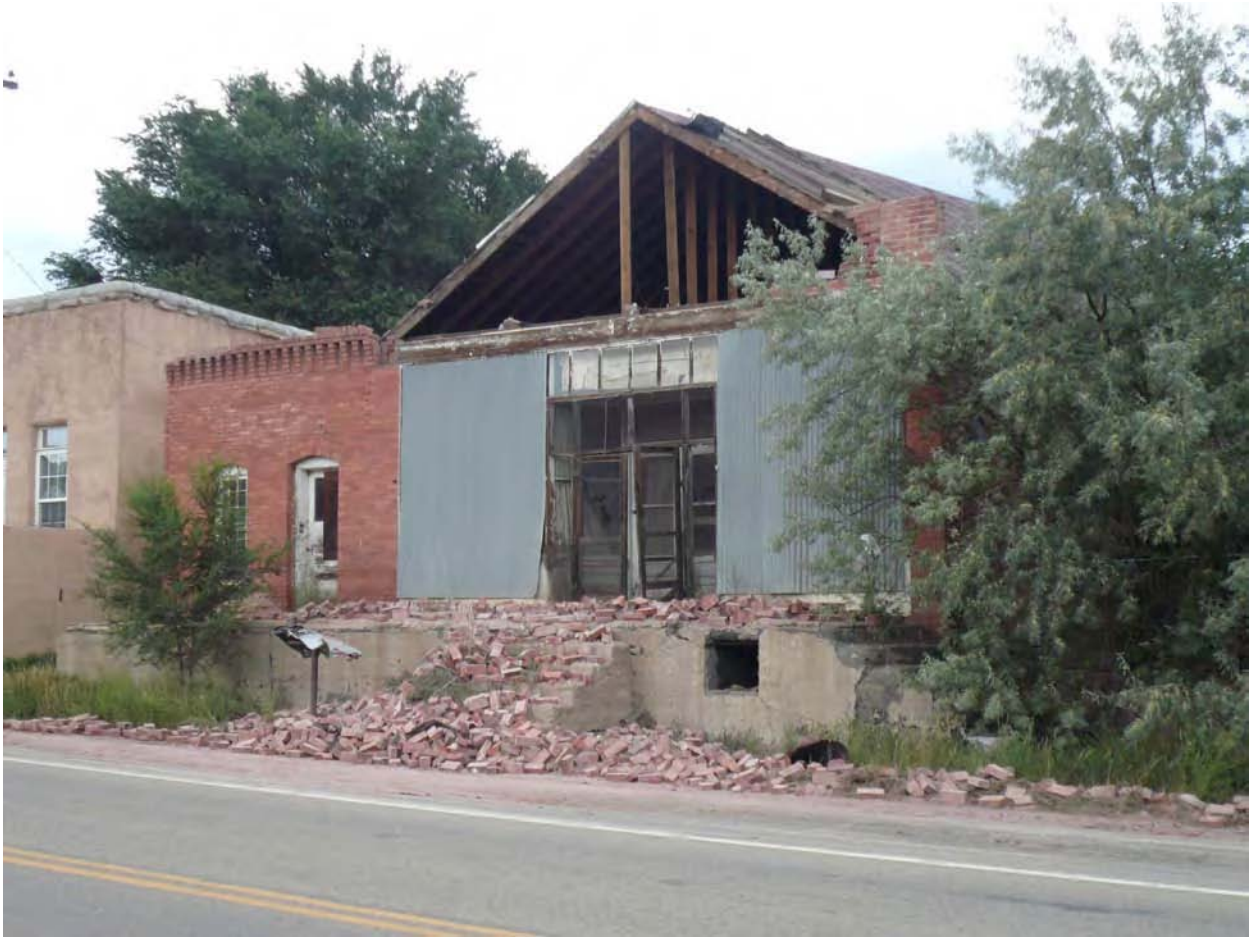
On State Highway 12, the front of an early 20th century brick building collapsed. Numerous bricks spilled onto the highway (Figure 8). The resident's mailbox was crushed by the falling debris. Nearby, a chimney was toppled and bricks were tossed onto the highway (Figure 9).

Figure 8. The front of this brick building collapsed, sending debris onto State Highway 12. Note the crushed mailbox. Segundo, CO.

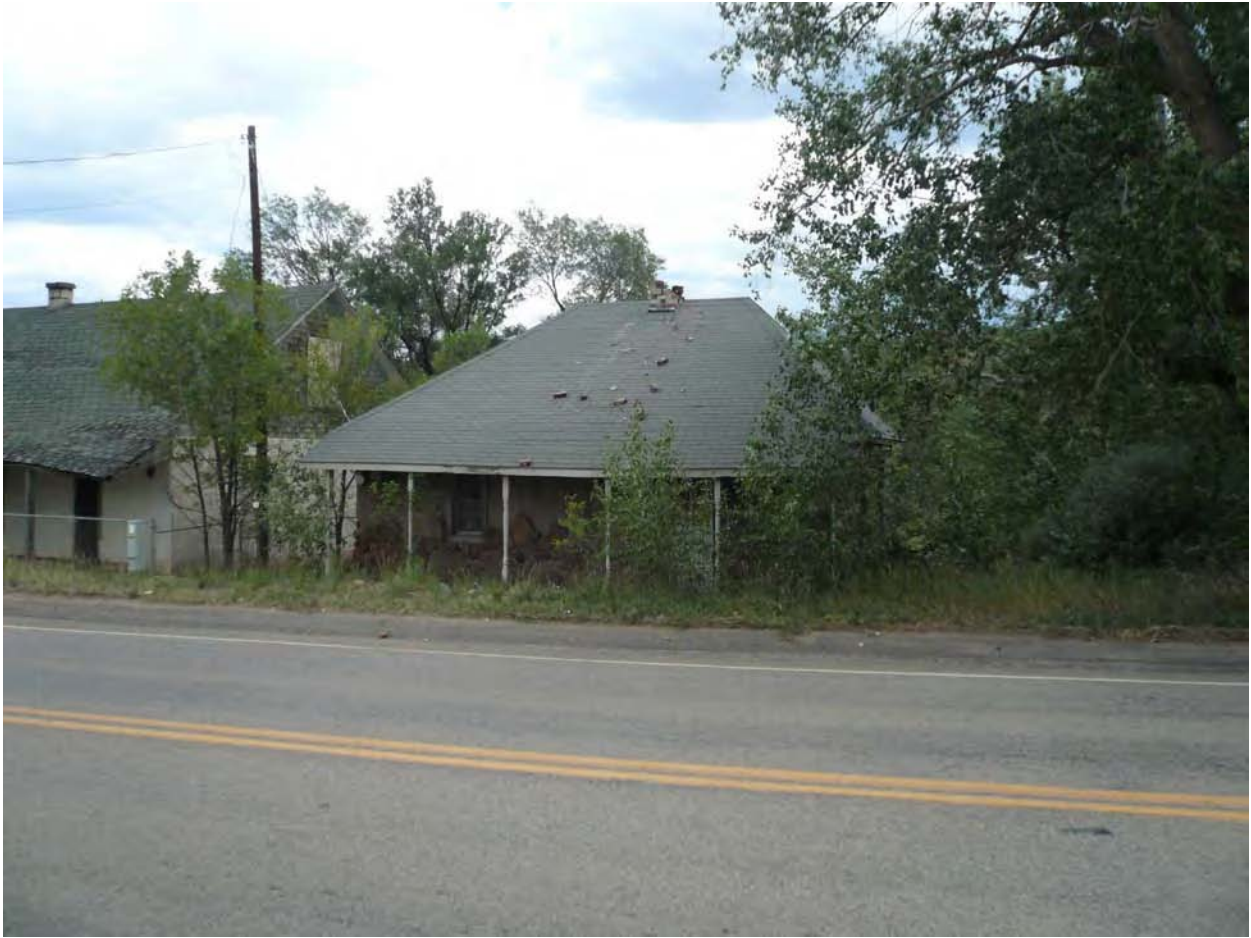
Figure 9. The earthquake toppled this chimney sending a few bricks onto State Highway 12. Segundo, CO.

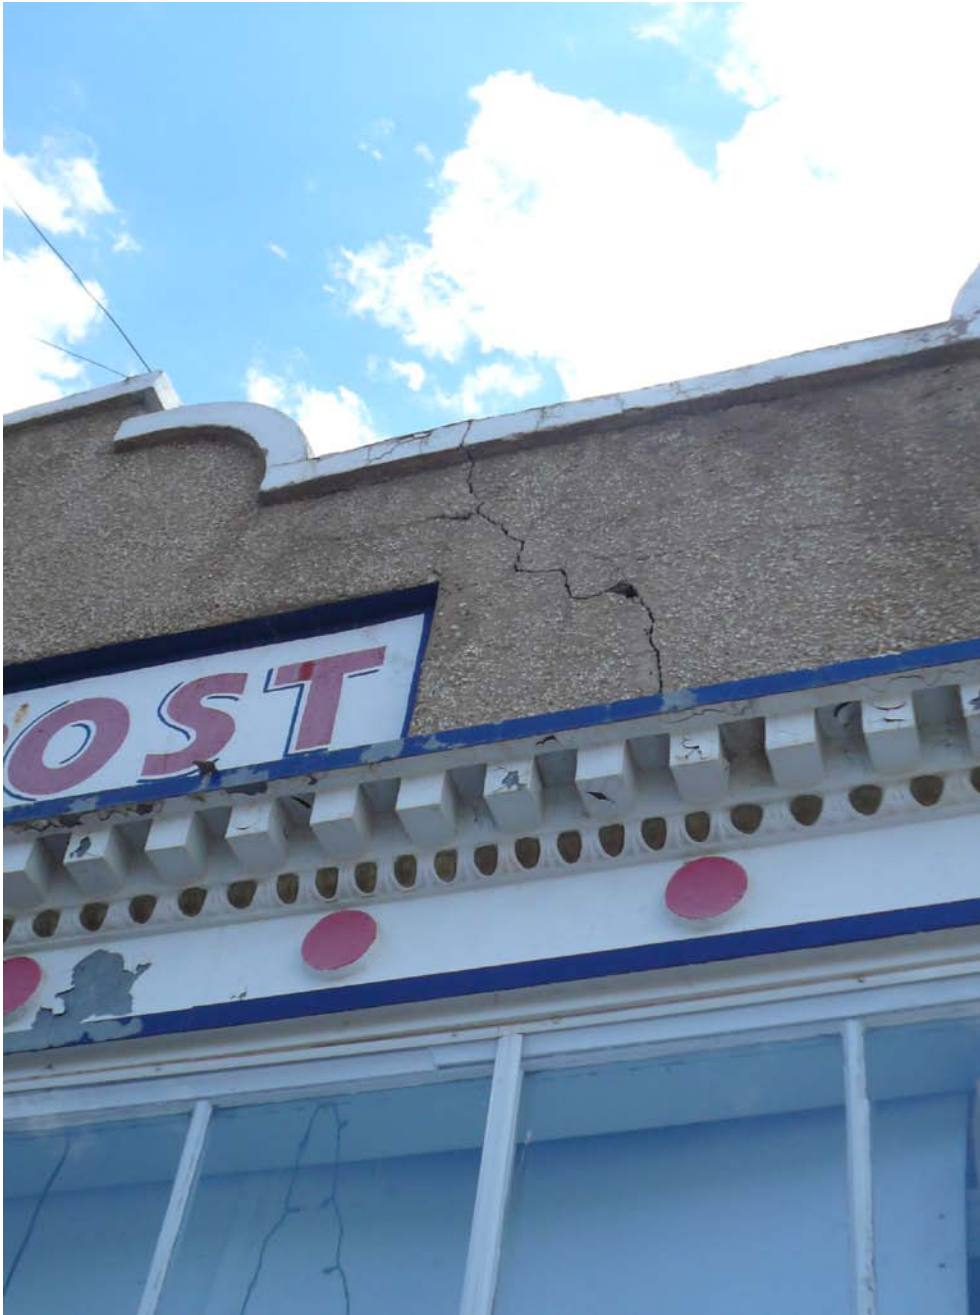
Liquor bottles in Ringo's Market were thrown from the shelves. Cracked plaster inside and outside of the building was evident (Figure 10). The clerk reported "collector-style" decanters were thrown from shelves and shattered.

Figure 10. Cracked plaster on Ringo's Market in Segundo, CO. All of the liquor bottles inside were thrown to the floor and walls were cracked.

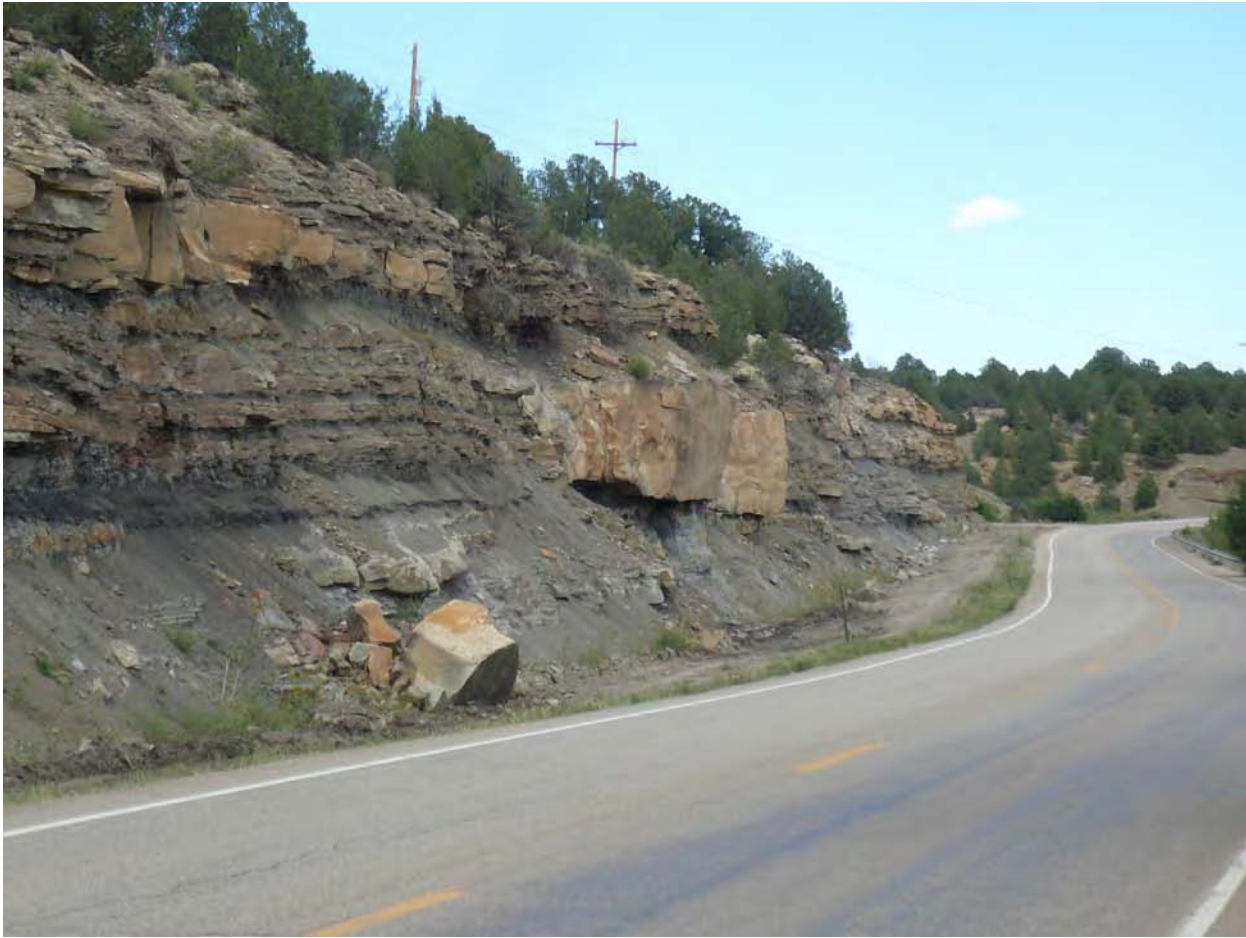
Rockfalls covered State Highway 12 approximately 1 mile east of Segundo-Valdez. These were quickly removed from the highway by CDOT. Large rock fragments were in excess of 6 feet (Figure 11).

Figure 11. Rockfall events along Highway 12, east of Valdez, temporarily closed the highway. Some boulders were in excess of 6 feet across. CDOT quickly cleaned up the roadway.

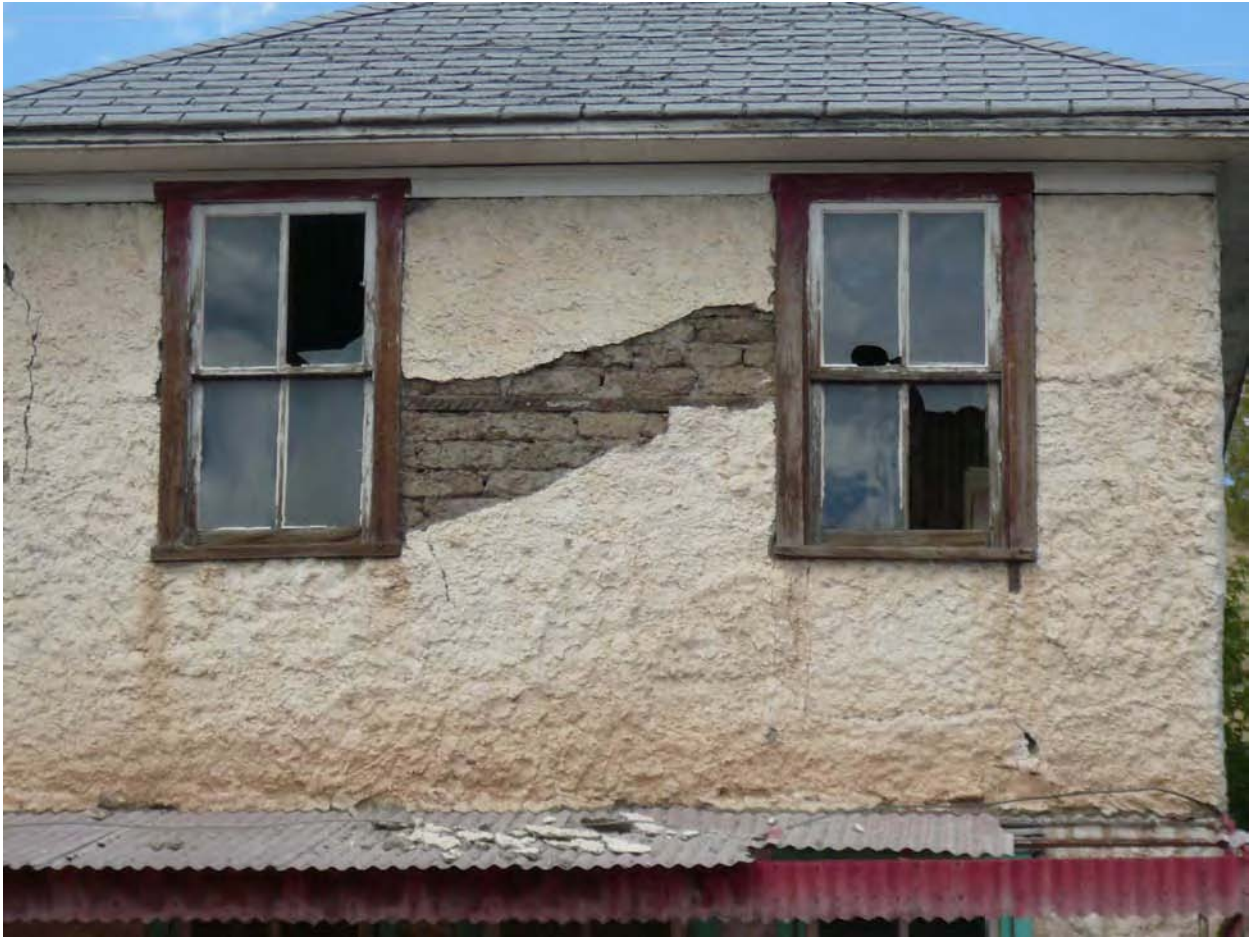
Several residents had plaster and brick damage; internal chimneys were pulled from the walls (Figures 12, 13, 14). Glassware, pictures, and other wall displays were thrown onto the floor. A paneled roof collapsed in one residence (Figure 15). Chimneys were displaced.

Figure 12. An old adobe building in Segundo with cracked and displaced plaster.

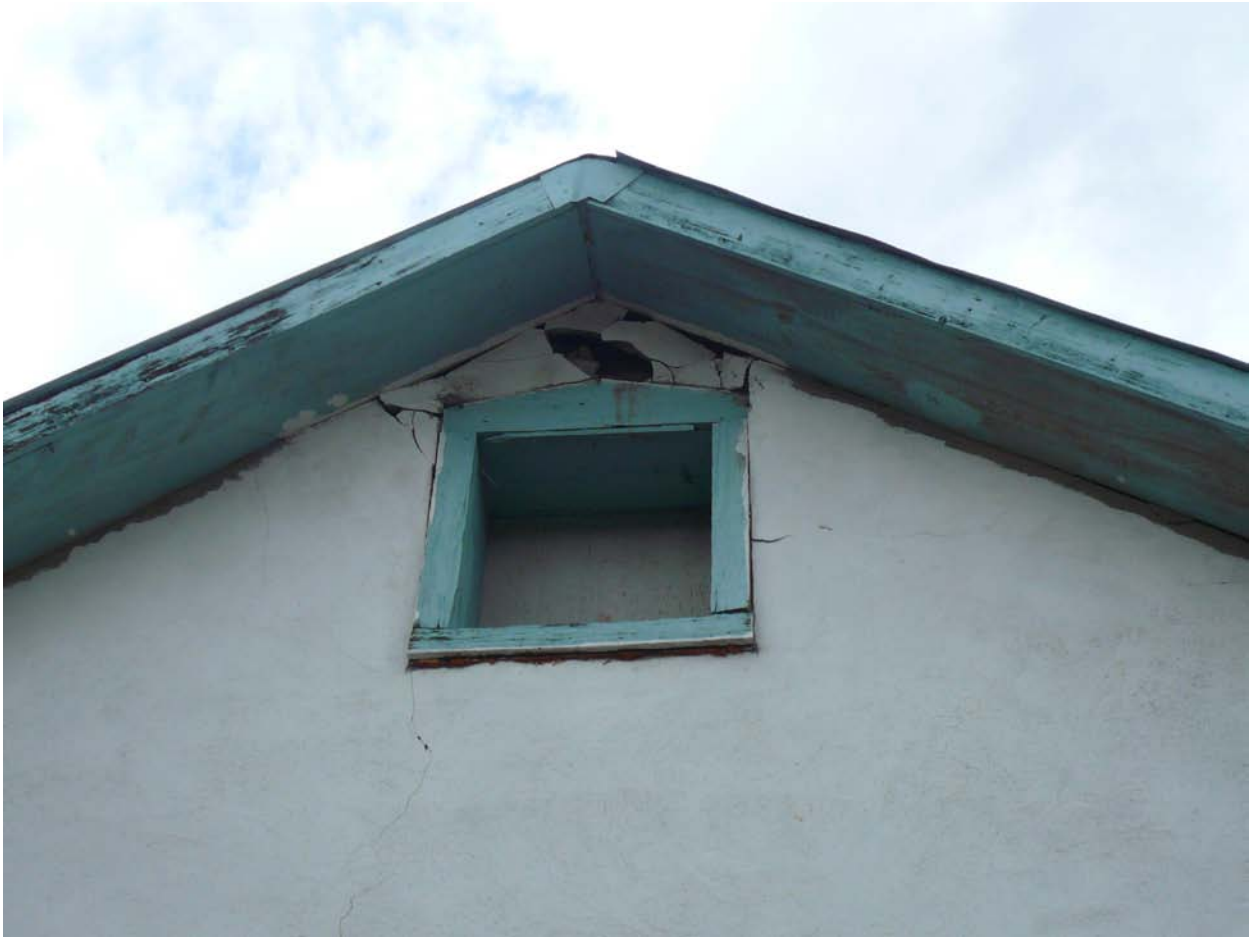
Figure 13. Major plaster and brick damage to a home in Segundo, CO.

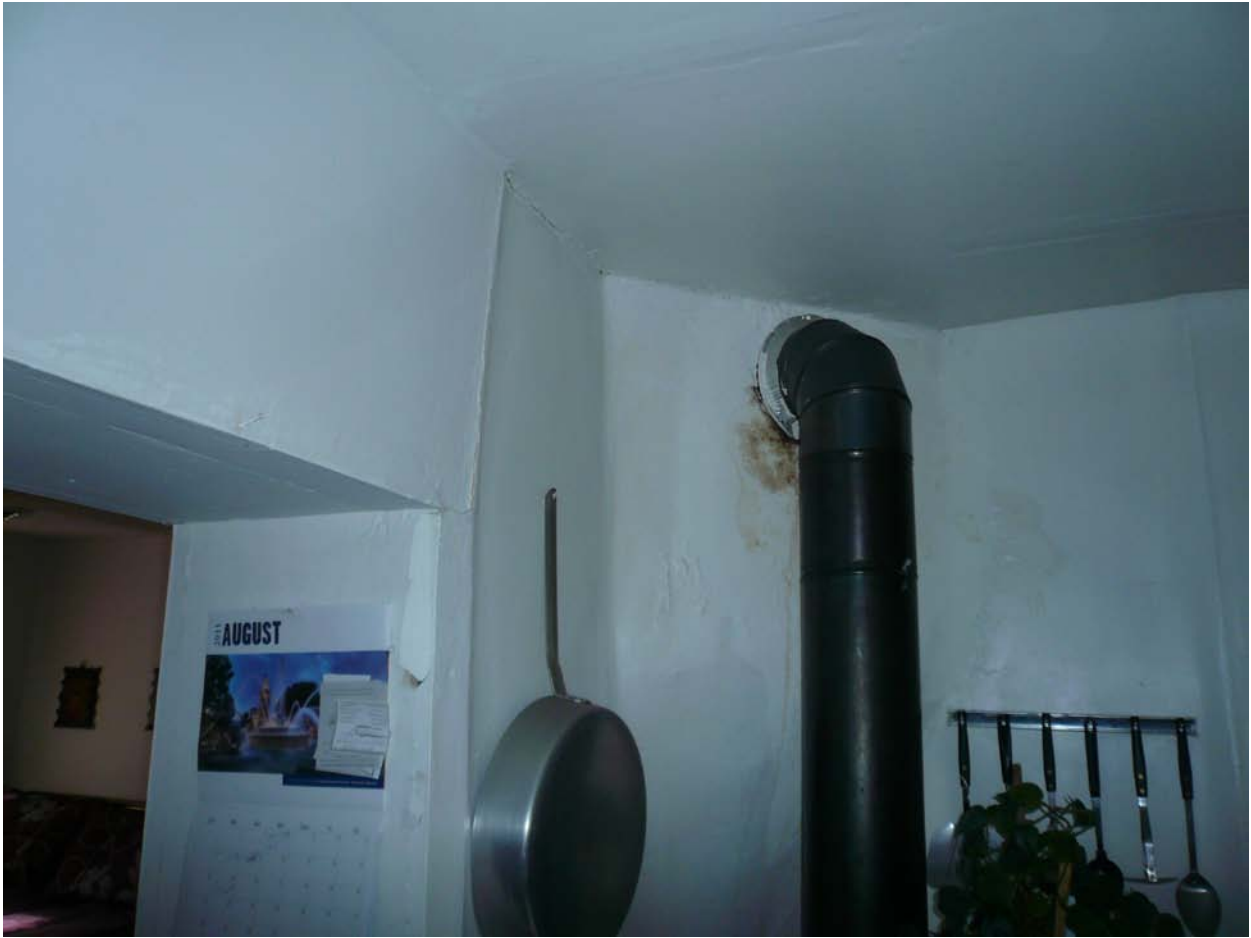
Figure 14. Chimney from a stove was pulled from the wall. Segundo, CO.

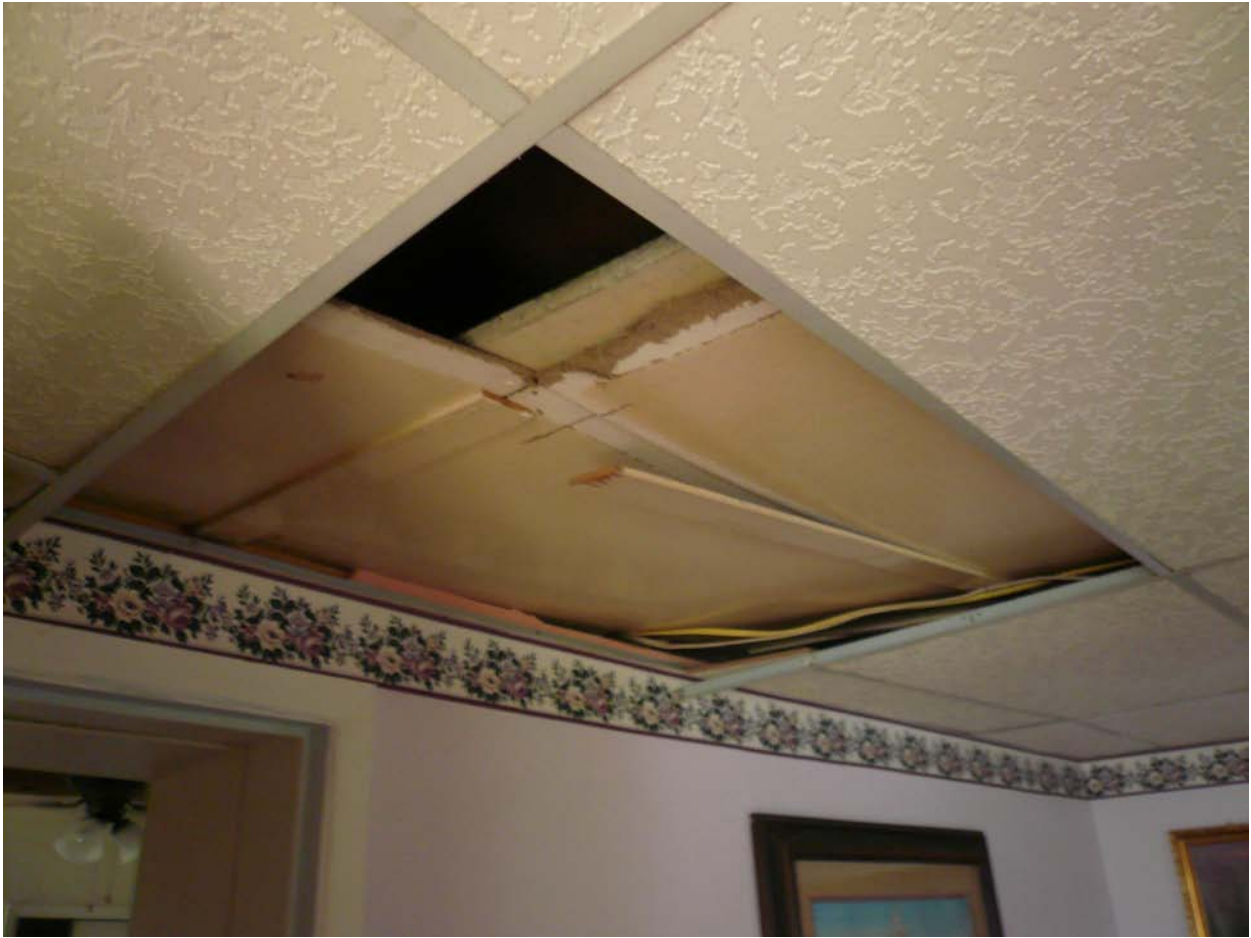
Figure 15. A ceiling panel collapsed sending debris on the resident's bed. Segundo, CO.

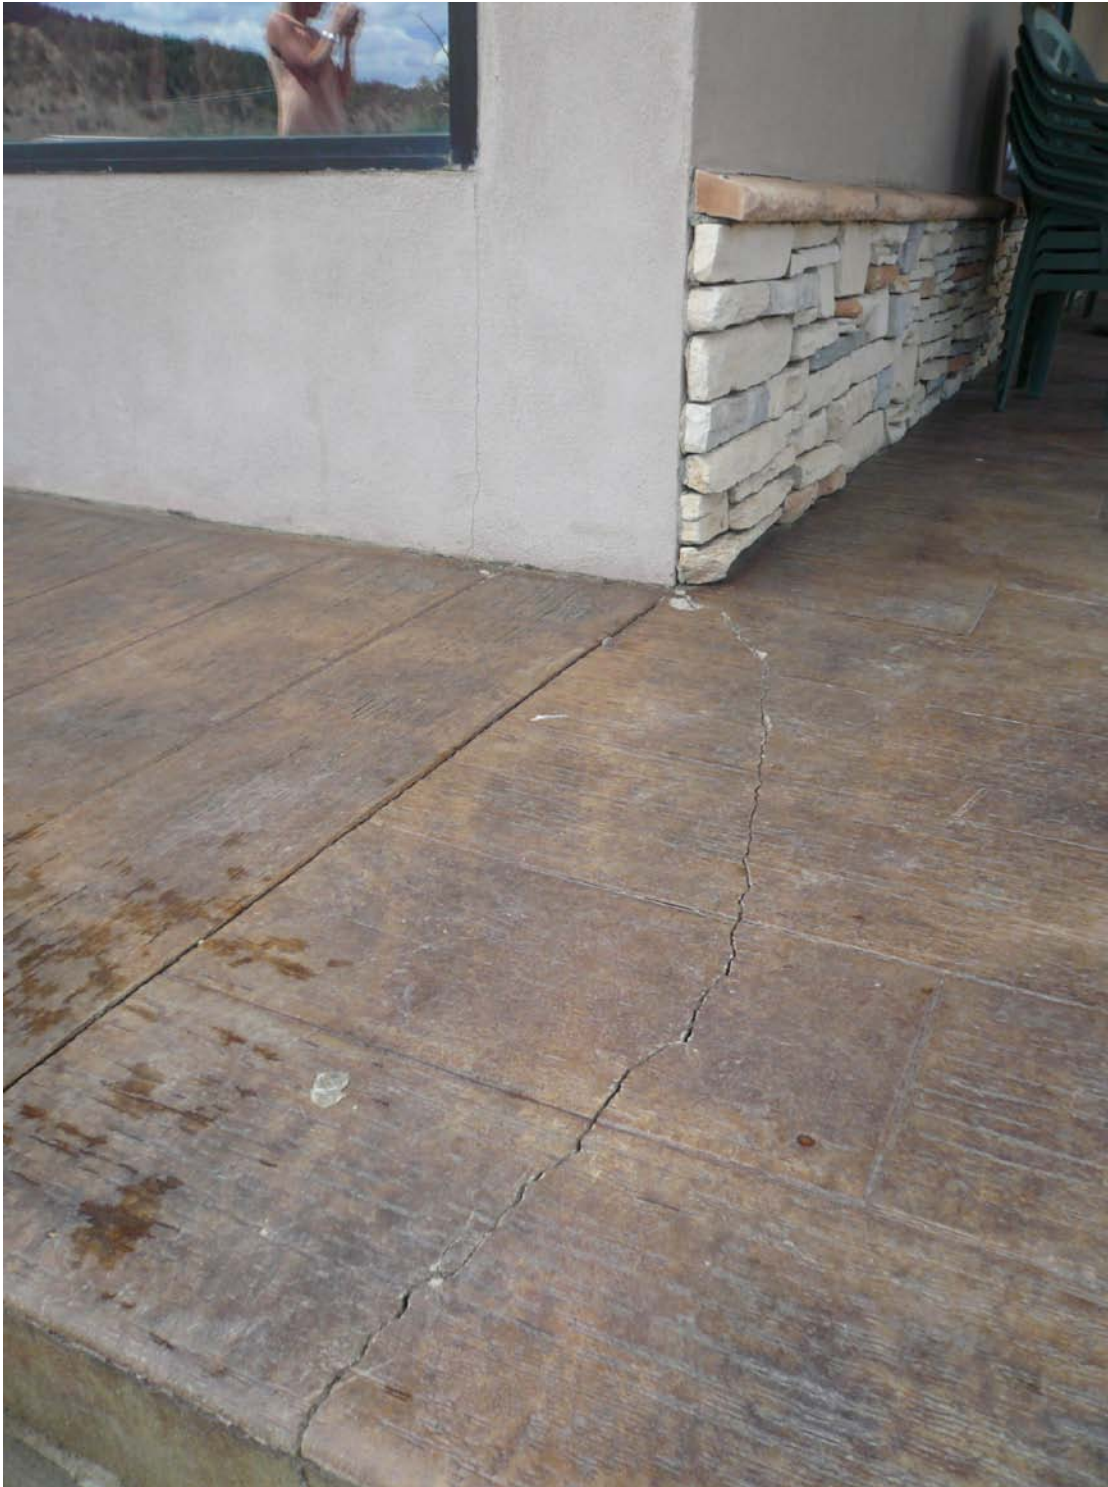
The Big 4 General Store, built in 2006, had a 5-foot-long crack in the porch pavement that had approximately 0.5" of offset (Figure 16). The east side of the building had a 7-foot-long horizontal crack in the plaster (Figure 17).

Figure 16. A five-foot-long crack in the concrete at the Big 4 Country Store in Valdez, CO.
