COLORADO GEOLOGICAL SURVEY

HAZ-2011-01

Preliminary Damage Report of the August 22, 2011 Mw 5.3 Earthquake near Trinidad, Colorado

By Matthew L. Morgan and Karen S. Morgan

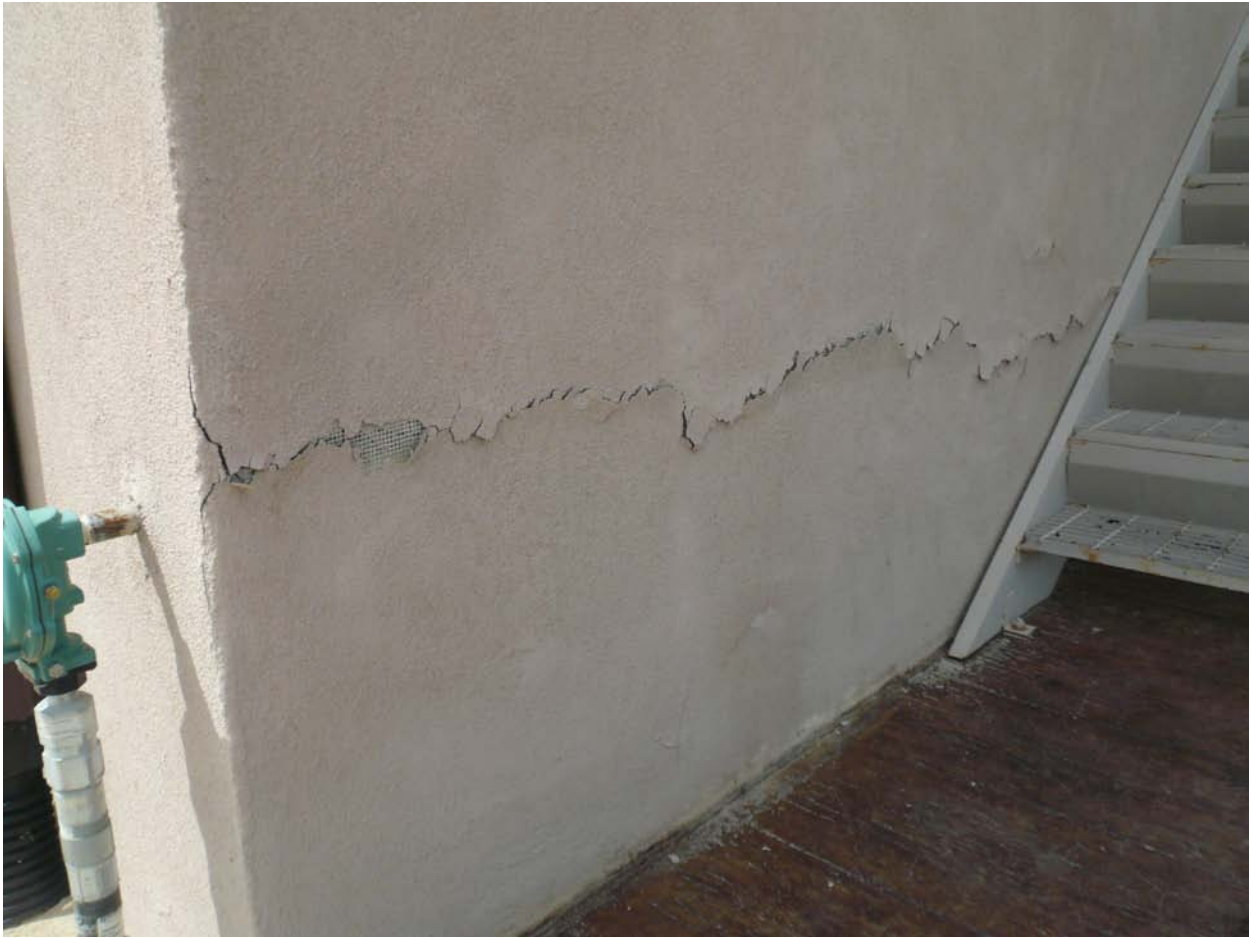
The Big 4 General Store, built in 2006, had a 5-foot-long crack in the porch pavement that had approximately 0.5" of offset (Figure 16). The east side of the building had a 7-foot-long horizontal crack in the plaster (Figure 17).

Figure 17. Cracked plaster at the Big 4 Country Store in Valdez, CO.

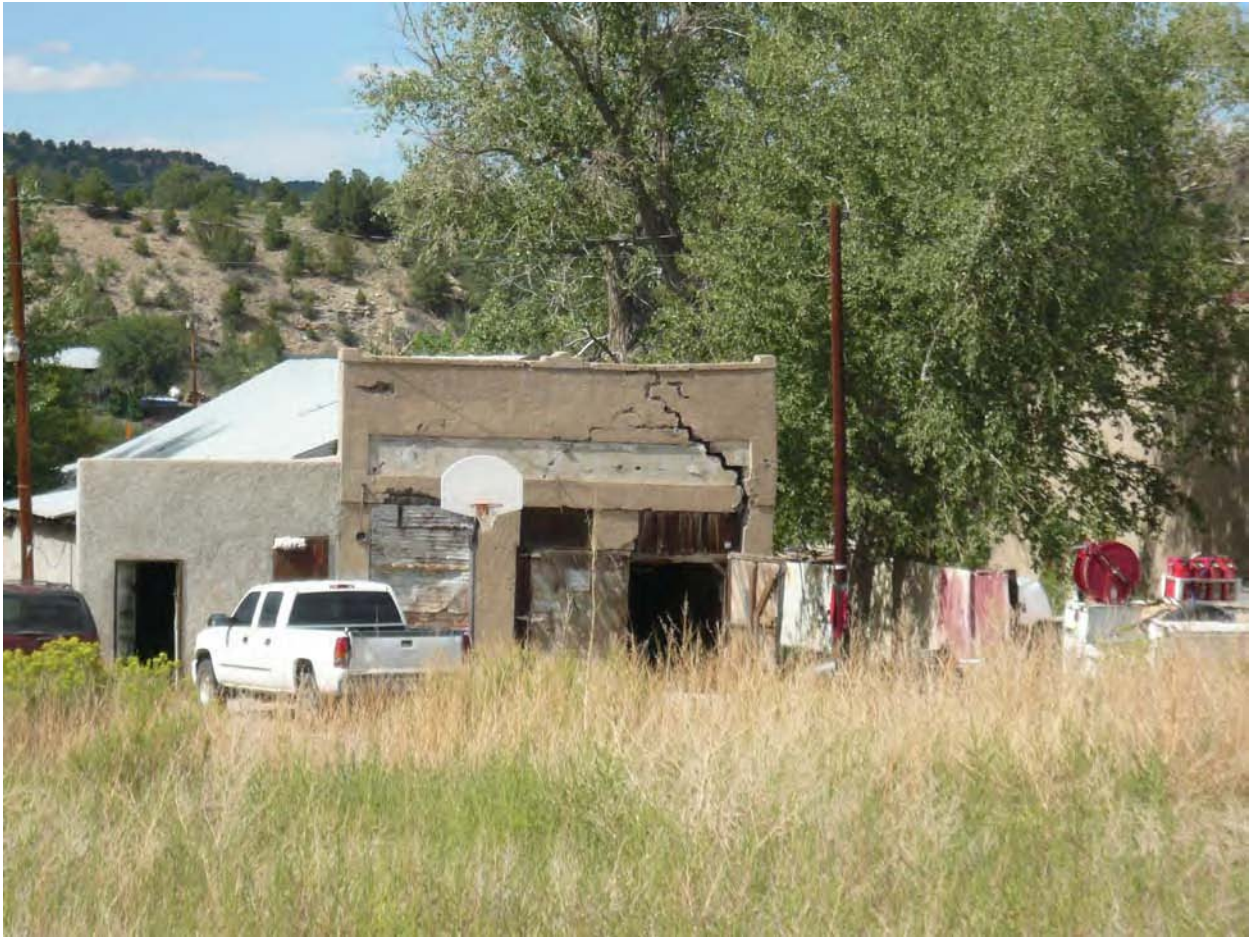
Several buildings had cracked plaster and damaged brickwork (Figure 18).

Figure 18. A severely damaged garage in Valdez, CO.

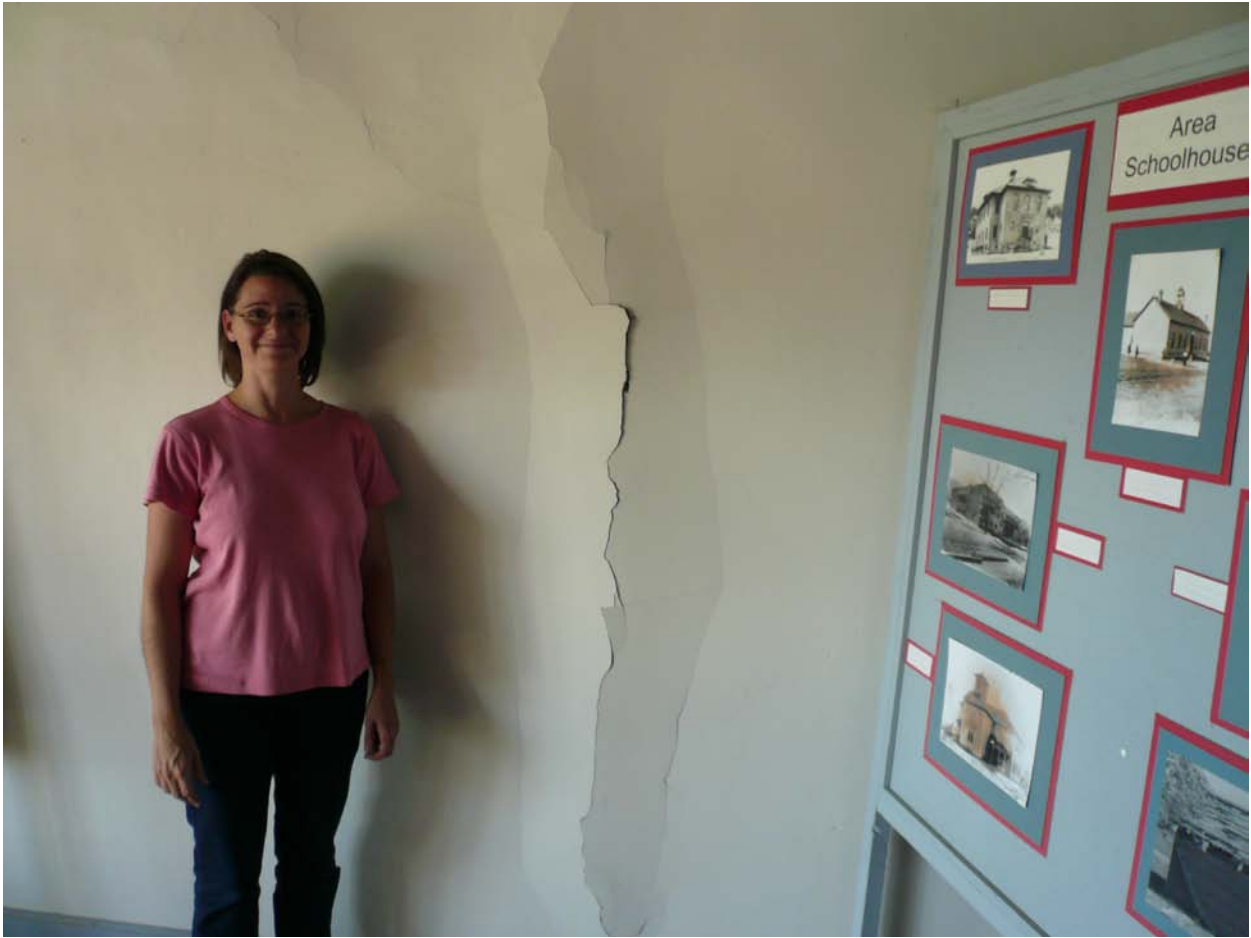
The town mayor reported "no significant damage to" the residences in the area. However, she reported a few pieces of glassware fell to the floor and cabinet doors rattled. The post office/town hall had a 10-foot-

long vertical crack that buckled 2" from the face of the wall (Figure 19, 20). The crack was visible internally and externally. A 10" fragment of plaster was missing from the crack on the outside of the building (Figure 21).

Figure 19. A 10 foot long vertical crack in the upstairs floor of the Cokedale post office/city hall.

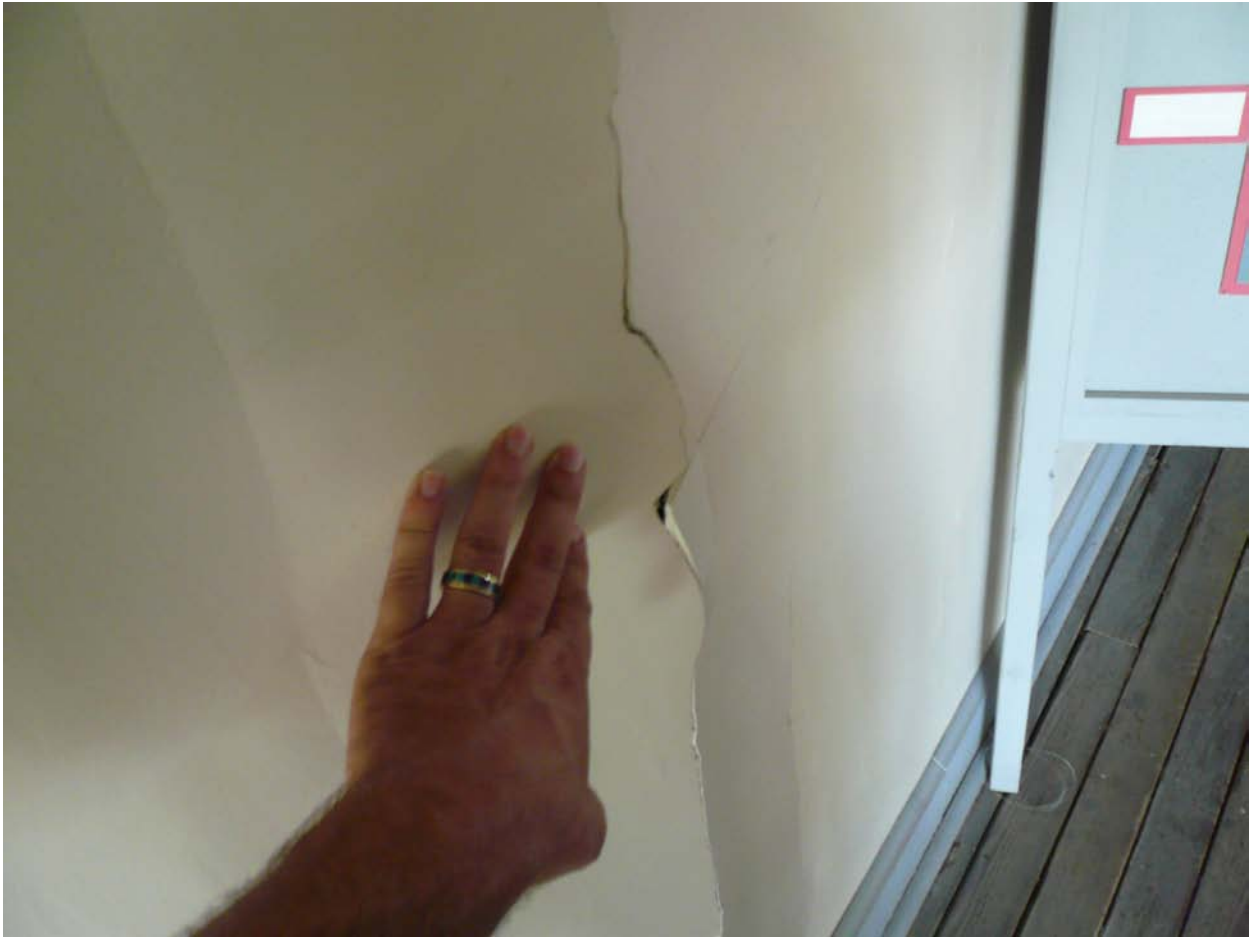
Figure 20. A few inches of buckling along the same crack in Figure 19. Cokedale, CO.

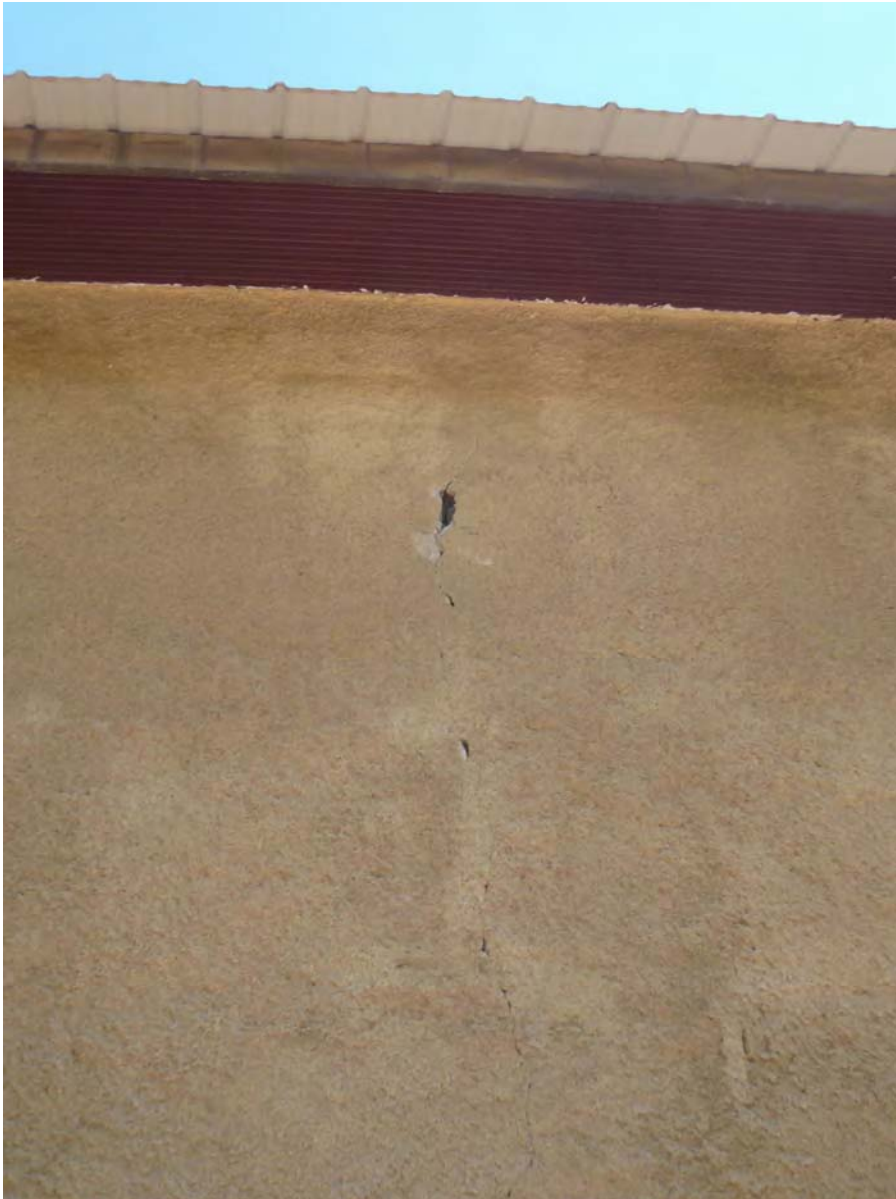
Figure 21. A large piece of plaster missing from an external crack on the Cokedale post office.

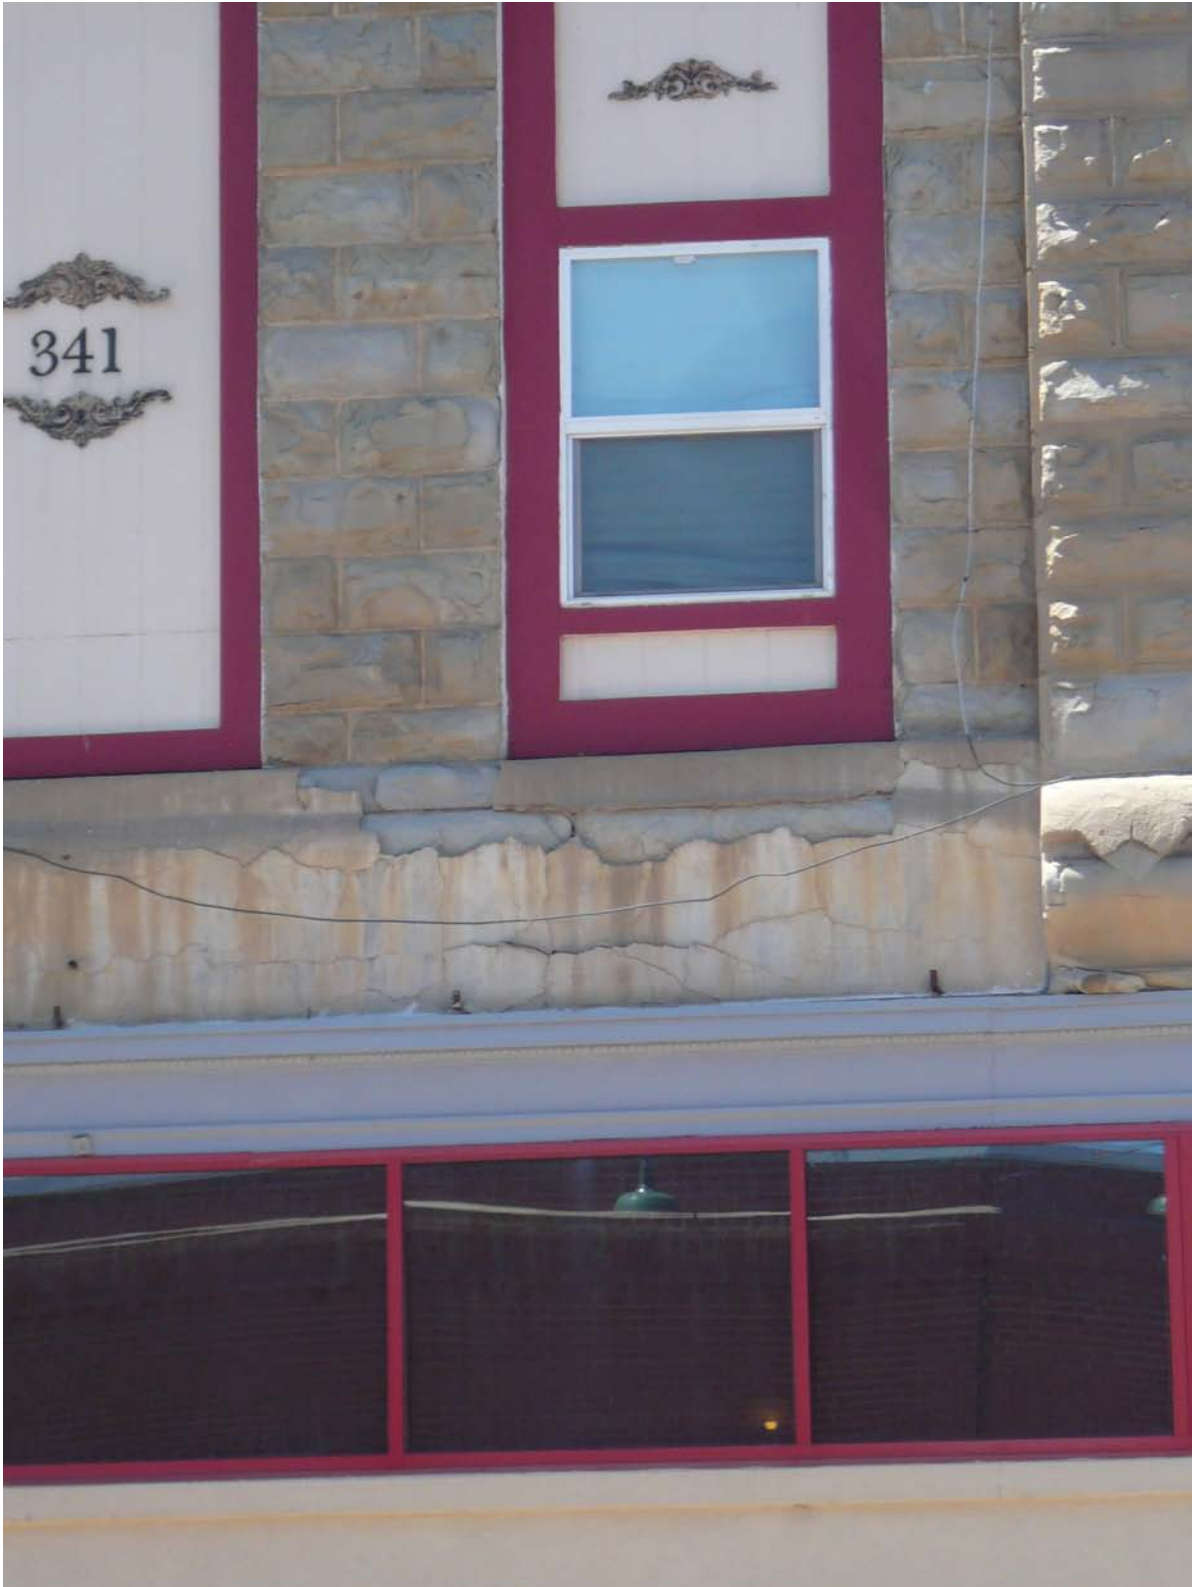
The "What a Grind" coffee shop had plaster and metal siding fall from the front of the building (Figure 22). A resident reported hearing a "freight train" coming "from the west". The resident also stated the event started slow, gained in strength, and fell off sharply and "my dogs howled".

Figure 22. Plaster and metal fell from the outside of the "What a Grind" coffee shop in Trinidad, CO.
