MAP SERIES 42

**COLORADO SPRINGS LANDSLIDE
SUSCEPTIBILITY MAP,
EL PASO COUNTY, COLORADO**

By Jonathan L. White and T.C. Wait

Colorado Geological Survey
Division of Minerals and Geology
Department of Natural Resources
Denver, Colorado
2003

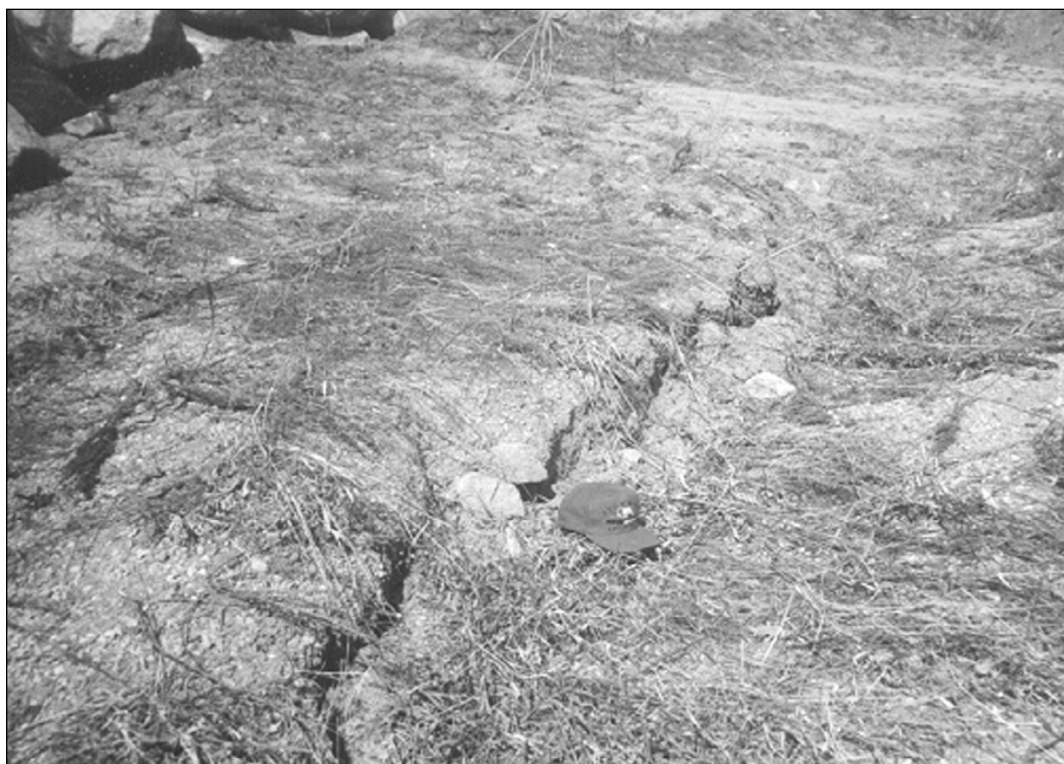
Figure 5. Ground crack and beginning of landslide scarp in the Broadmoor area in 1998. Note hat for scale. Photo by J. White.

cracks can sometimes be seen that show subsurface strain (e.g., extensional movements); such tension cracks are the visible precursor of a landslide (Figure 5). Cracks that show any vertical offset are considered scarps. In some cases, the slope may in fact be moving but the soil materials stretch or compress rather than break or tear, and slope movement can only be determined by detailed surface surveys and/or subsurface monitoring devices. This type of behavior in landslides generally occurs only briefly at onset of movement before displacement is evident and seen at surface. In cases where shallow soils and weak rock move and remold without defined slide planes, the movement is generally considered to be creep.

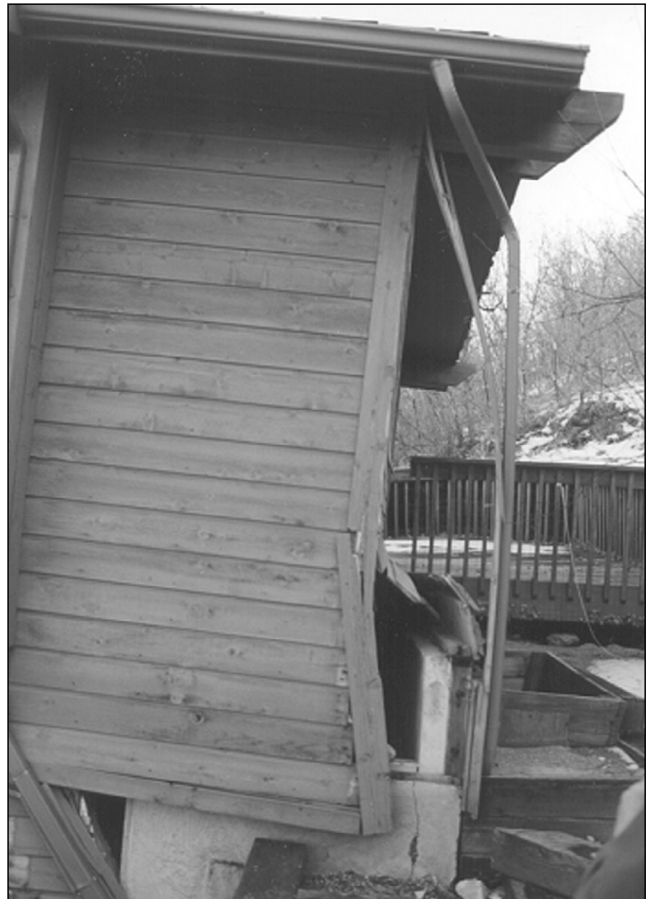
Figure 9. Catastrophic home damage near head scarp of Regency Landslide in 1995. This home was subsequently demolished. Photo by J. White.

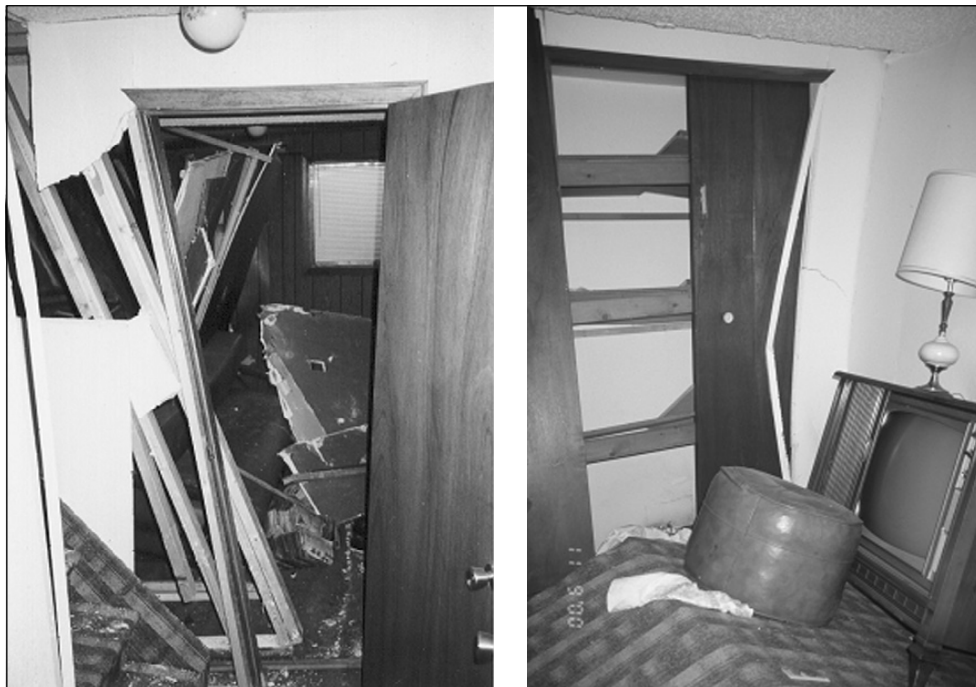
Figure 11. Ground movement caused this interior damage of a residence in the Hofstead Landslide in 1999. This home was condemned and later demolished. Photos courtesy of Hofstead Emergency Landslide Protection (HELP) Coalition and M. Squire.

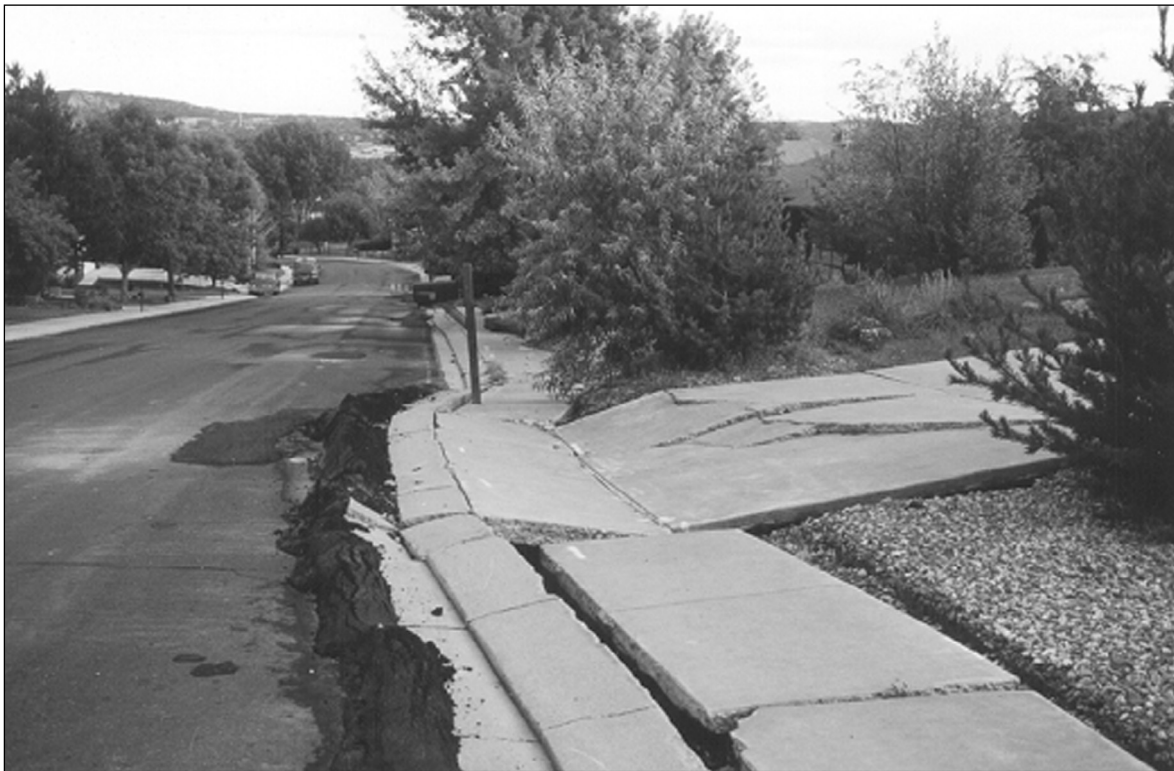
Figure 12. Damage to Hofstead Terrace roadway pavement, sidewalk, and driveway by lateral movement of landslide toe at Hofstead Landslide in 1999. Photo by J. White.
