OPEN-FILE REPORT 01-11

History, Geology, And Environmental Setting of the Tweed Mine, Pike/San Isabel National Forest, Chaffee County, Colorado

**By
Robert H. Wood II
and
John Neubert**

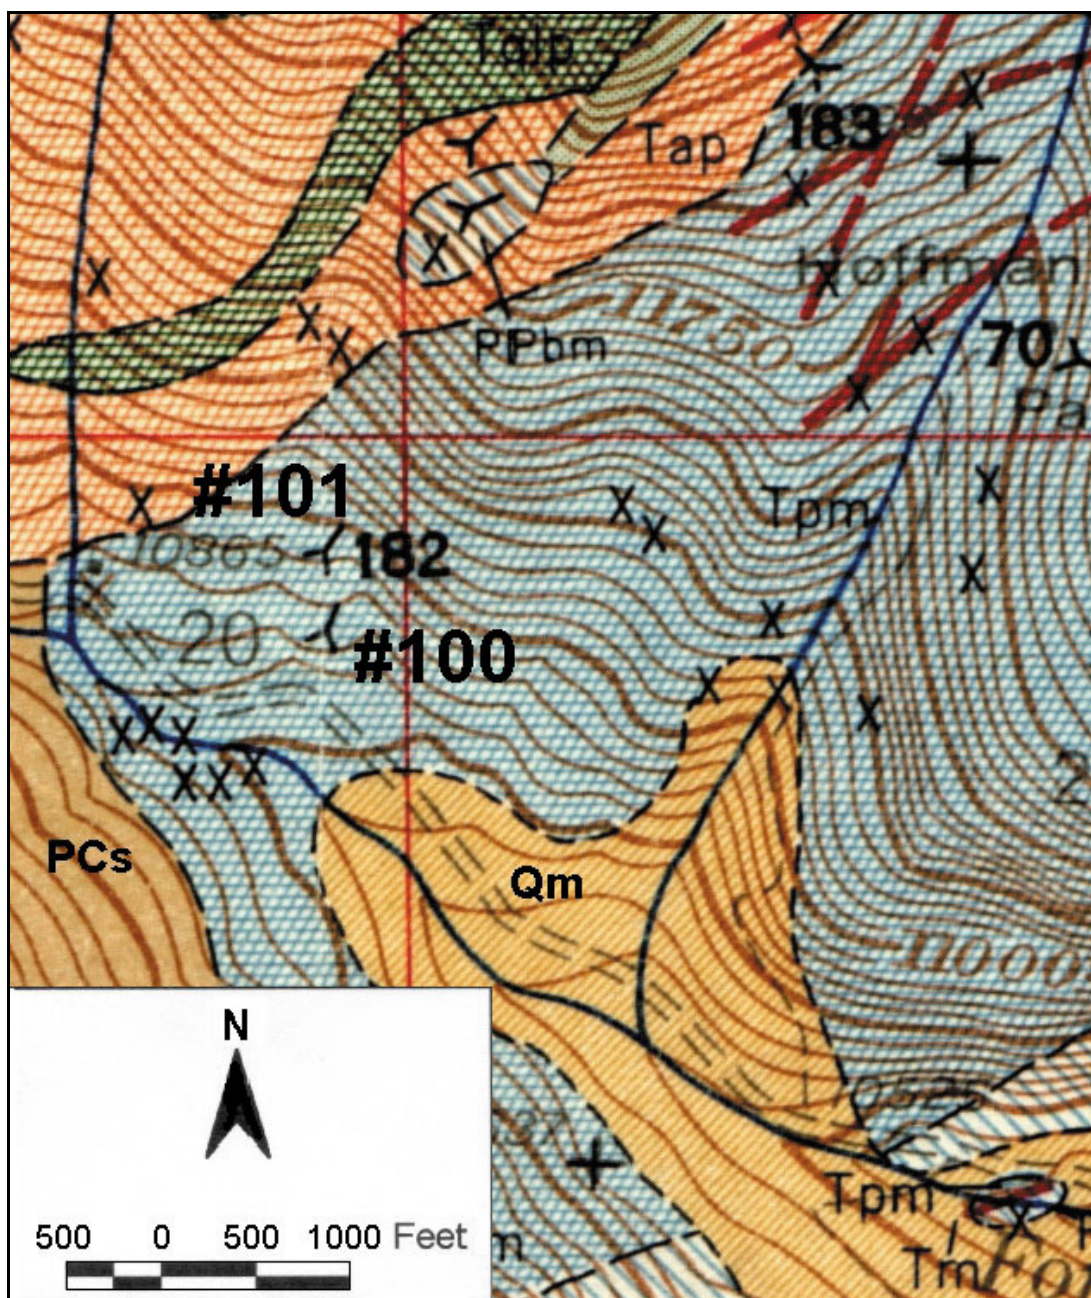
Figure 4. Geologic map of the Tweed Mine area. [Modified from Dings and Robinson (1957, plate 1); scale is approximate.]

The orientation and placement of underground workings shown on Mineral Survey No. 18695 suggest that the veins exposed underground at the Tweed Mine strike north to northeast, similar to those at the nearby Uncle Sam Mine to the northeast (Figure 4).

Qm-Quaternary moraine
 Tm (red lines)-monzonite or latite dikes
 Tap-Tertiary Mount Aetna quartz monzonite porphyry
 Tqlp-Tertiary quartz latite porphyry
 Tpm-Tertiary Mount Princeton quartz monzonite
 Tgm-Tertiary gneissic quartz monzonite
 PPbm-Pennsylvanian and Permian(?) Belden Shale and Minturn Formation
 PCs-Precambrian Silver Plume(?) granite
 Numbered mines: #70-Hercules; #182-Tweed; #183-Uncle Sam.

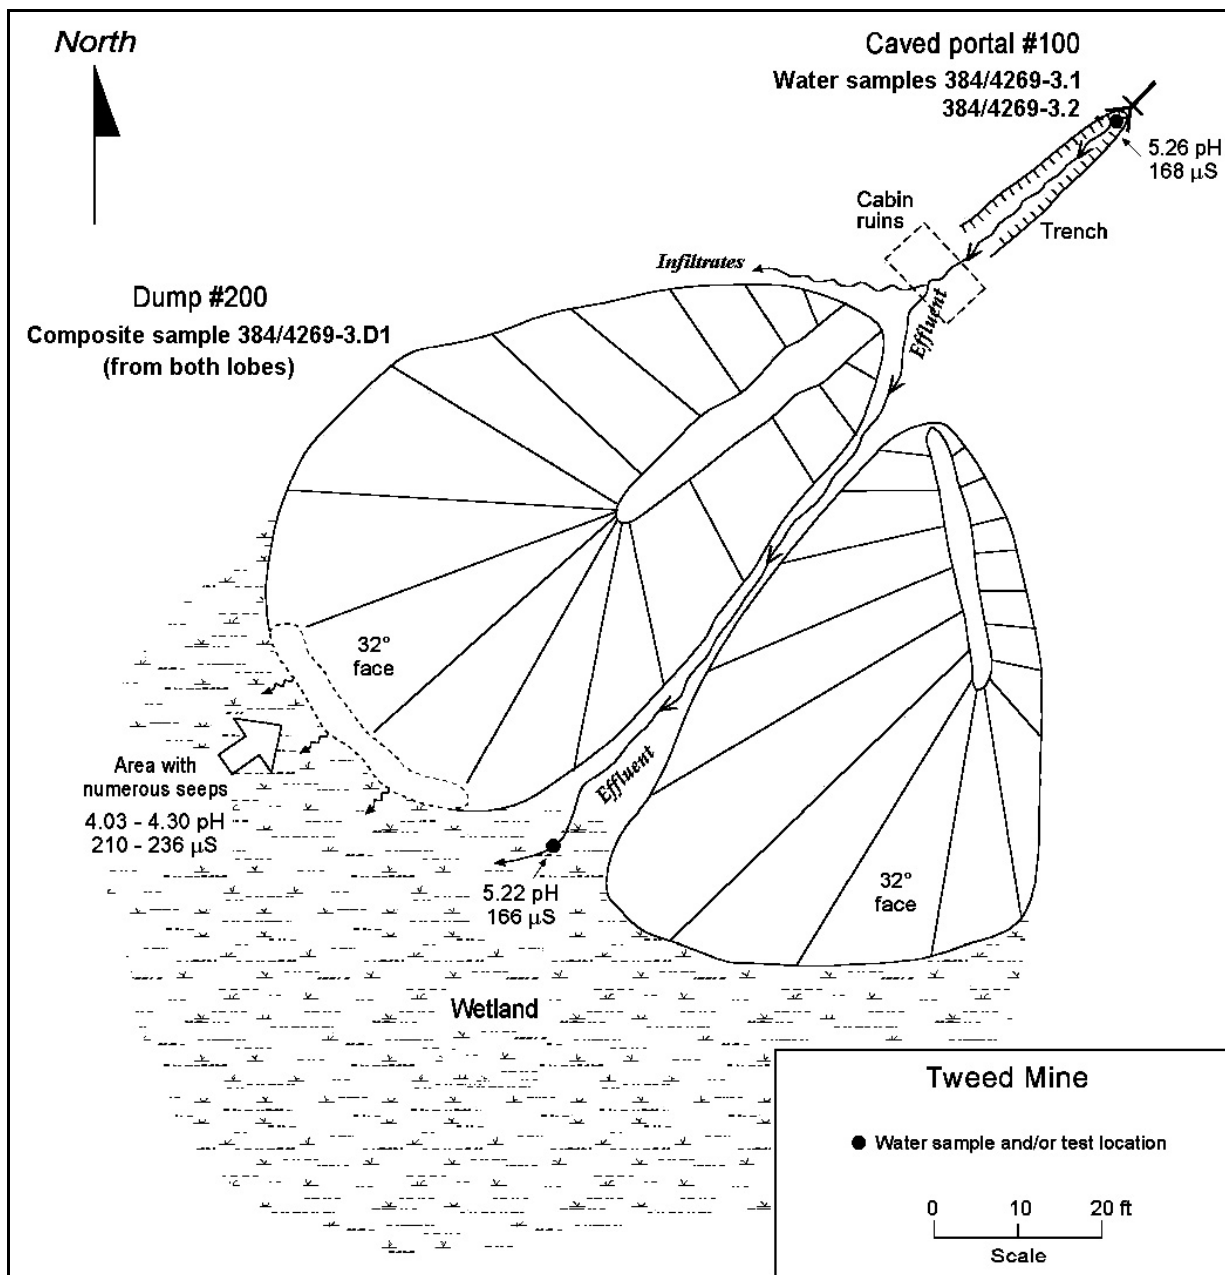
Figure 5. Surface map of the lower Tweed Mine area.

A moderate volume of water flows from collapsed adit #100, through a trench, and into the ruins of a log building, probably the blacksmith shop shown on the mineral survey (Figure 2). The effluent path splits in the building debris; most flows between the two lobes of dump #200, but some water flows west before soaking into the northwest lobe (Figures 5, 6). Some acidic water, which is probably a combination of mine effluent and groundwater that is percolating through the unconsolidated colluvium/soil on this slope, emerges at the toe of dump #200. The volume of these springs is less than 10% of the total water draining from the site. A large marsh below the toe of dump #200 (Figure 7) receives the mine effluent, dump seepage, and some surface runoff from higher on the hill. Water draining from this marsh crosses Forest Road 230 (Figure 8) and enters another marsh that joins the Middle Fork of the South Arkansas River. The portal of adit #100 is about 600 feet from the river.

No samples were collected from the small seeps at the base of dump #200 (Figure 5). Water from the seeps had lower pH (4.03 to 4.30) and higher conductivity (210 to 236 $\mu\text{S}/\text{cm}$) than effluent at the portal. Effluent seeping into the dump has increased residence time to react with and dissolve sulfide minerals in the waste rock, lowering the pH and increasing the conductivity.

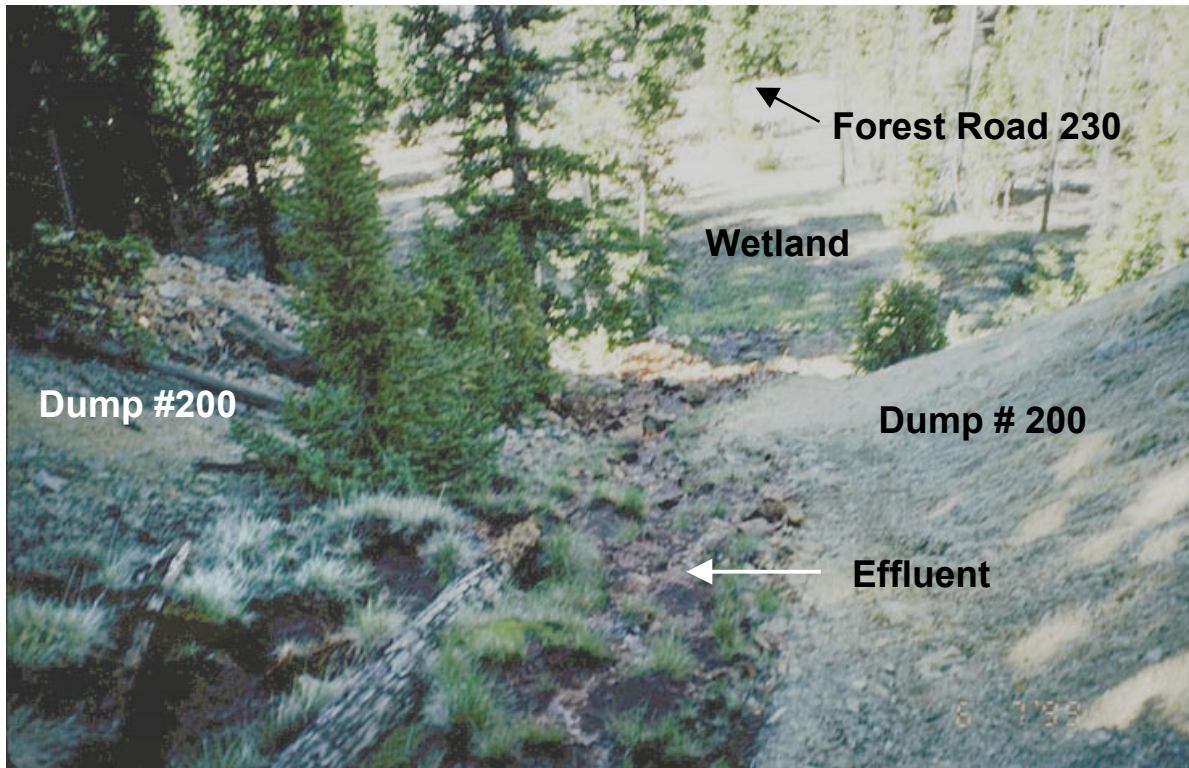
In June 1999 about 12 gpm of effluent with 5.26 pH and 168 $\mu\text{S}/\text{cm}$ conductivity flowed from caved adit #100. The effluent channel contained abundant, mostly uncemented red-brown precipitate, some of which was trapped in the plentiful algae. Two water samples were collected adjacent to the portal (384/4269-3.1 and 384/4269-3.2). Lab results showed that the effluent exceeded standards in aluminum, cadmium, fluoride, iron, lead, manganese, and zinc (Table 1). For many parameters, 1999 values were slightly lower than 1994 values, but the difference was generally insignificant.

Figure 6. Effluent and dump #200 at the Tweed Mine.

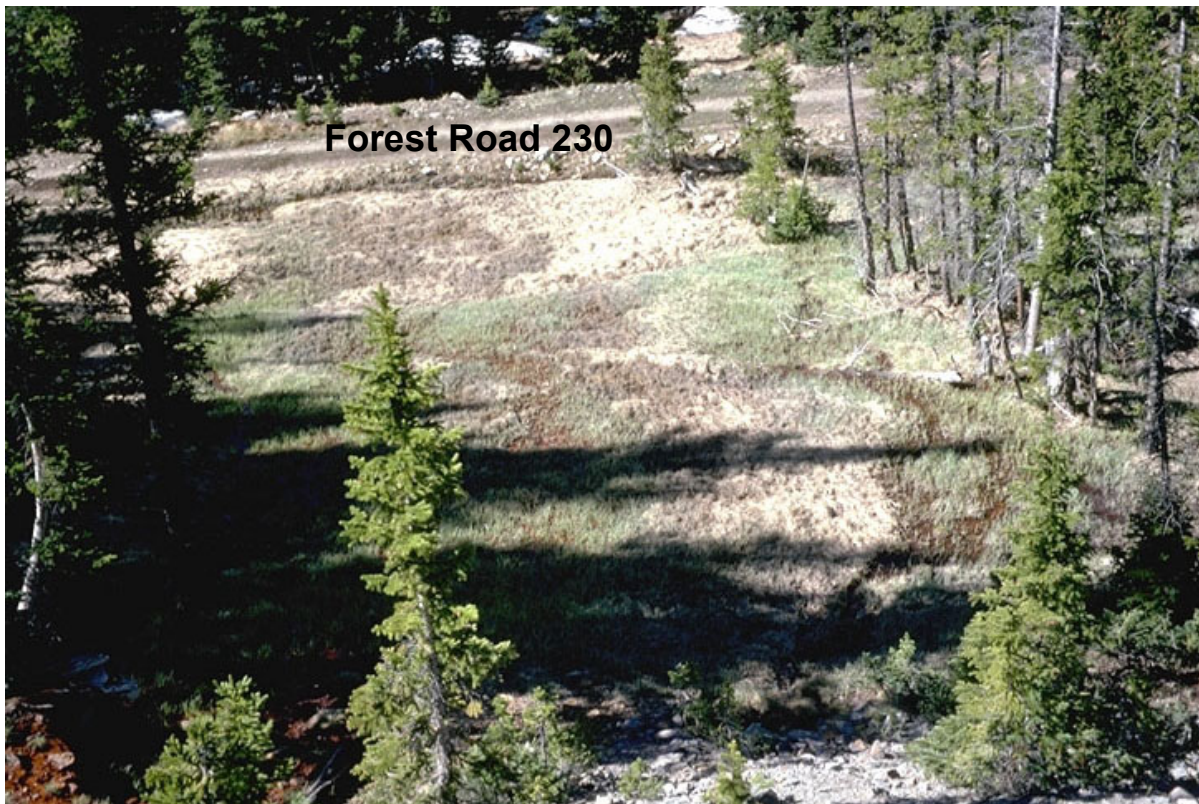
Water sample 384/4269-3.3 was collected adjacent to and above Forest Road 230, and below the marsh at the toe of dump #200. Flow was 8 gpm, pH had dropped to 4.24, and conductivity had increased to 212 $\mu\text{S}/\text{cm}$ compared to portal water. Aluminum, zinc, manganese, copper, cadmium, and lead concentrations also increased (Table 1). The lower pH and higher metal concentrations at this sample site may reflect the addition of the dump seepage described in the above paragraph. Although still exceeding standards, iron concentrations were significantly reduced at this site compared to the portal, probably because of the deposition of moderate to abundant amounts of red-brown precipitate along the effluent channel and in the marsh (Figures 6-8).

Figure 7. Wetland below dump #200 of the Tweed Mine.

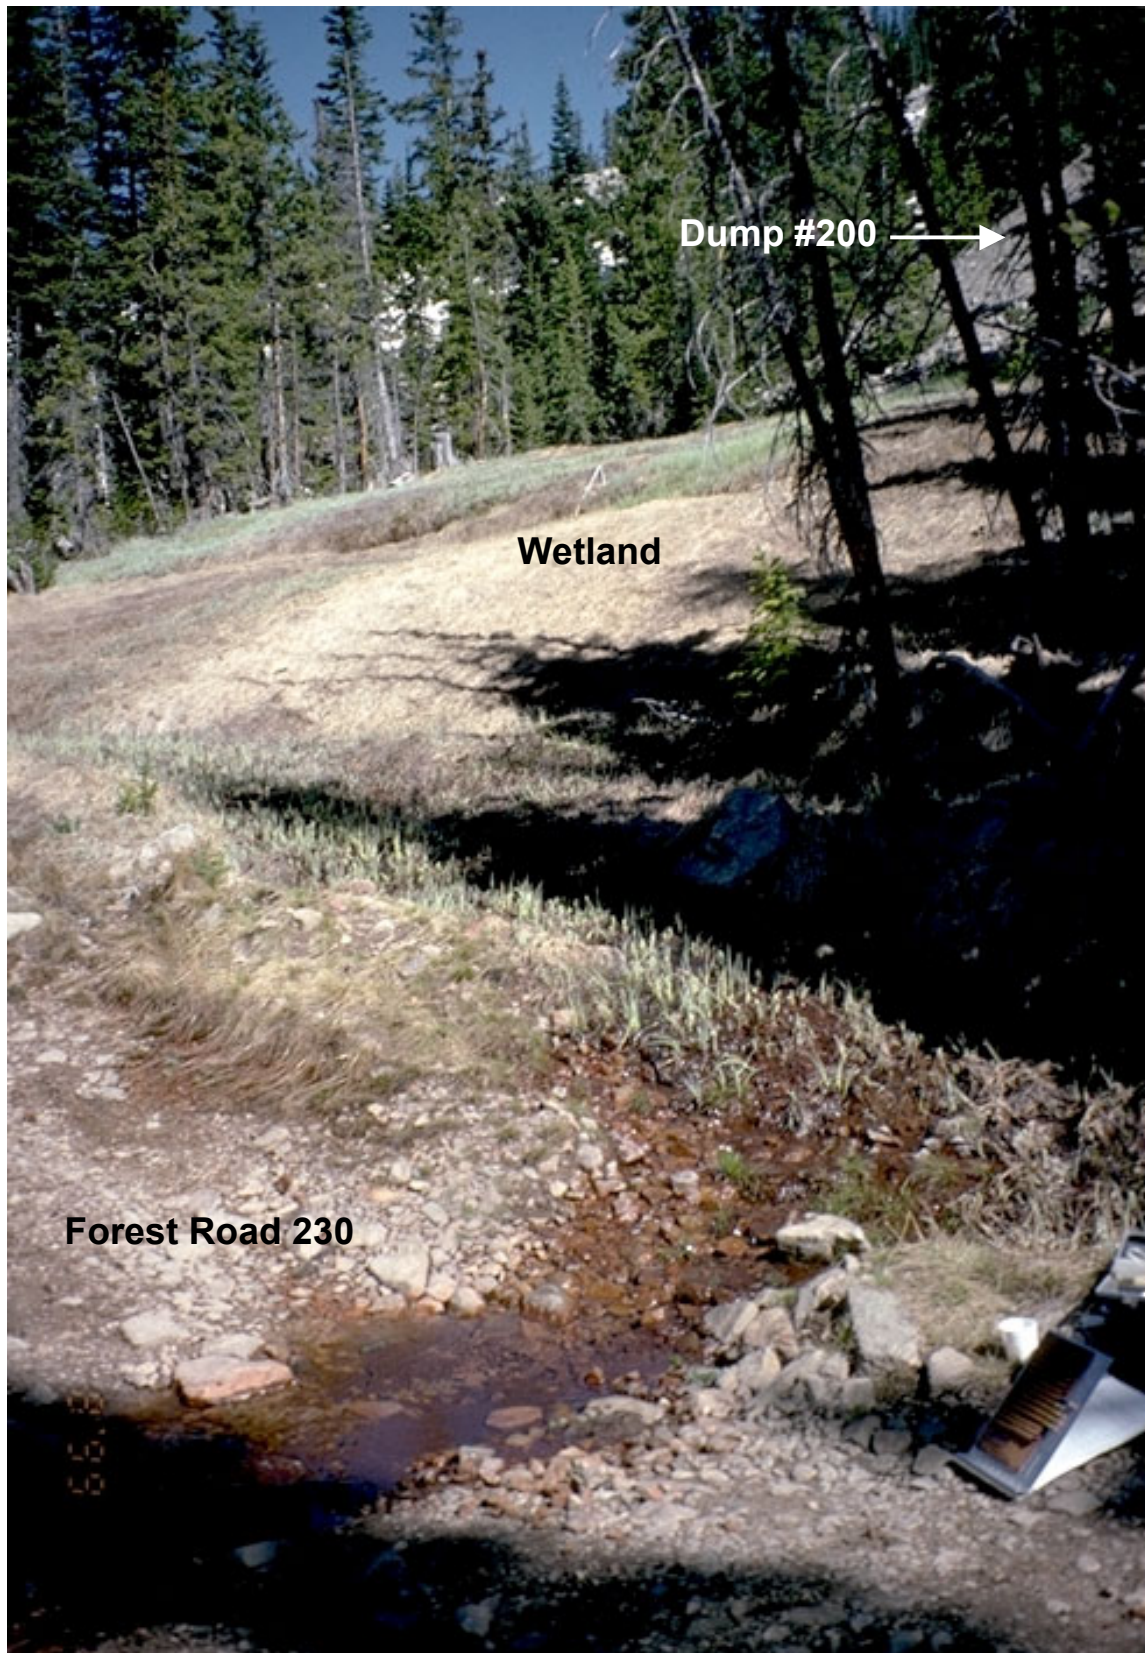
Figure 8. Effluent and wetland runoff crossing Forest Road 230.

After crossing Forest Road 230, the effluent spread into another marsh that extended to Middle Fork of the South Arkansas River. In June of 1999 mine water was dispersed and mixed with snowmelt and other water in the swamp and did not flow in a traceable channel. This wetland drained into the river over a width of at least 100 feet with no obvious “point of entry.” This lower wetland had no significant accumulations of precipitate. Water tested in the marsh had 5.16 pH and 131 $\mu\text{S}/\text{cm}$ conductivity.

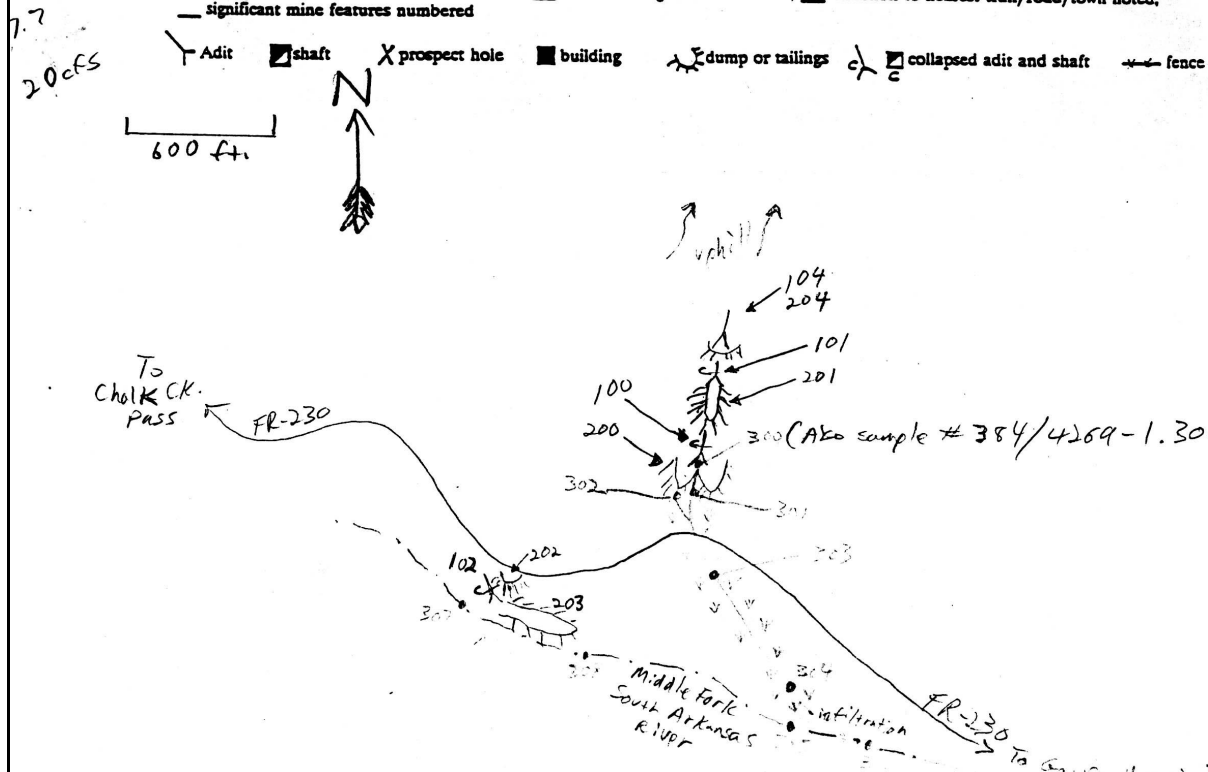
DIAGRAM OF PROBLEM AREA (Locate all adits, shafts, dumps, prospects, etc. on topo map.)

- 100 - fully collapsed, draining moderately poor quality water, and the flow is significant.
- 200 - water flow from adit drains over the middle of the dump for the full length and has eroded a large gully into the dump - abundant pyrite and Fe-staining in dump

A significant amount of water is being discharged from site 100/200. The water out of the portal of 100 is not extremely degraded, but abundant orange ferric oxy-hydroxide precipitate line the site drainage. Below the dump, dump seeps add significant acidity to the site drainage and creates a large marshy area with abundant plants which extends all the way to the Middle Fork South Arkansas River. This site drainage does have an effect on the river. Re-routing site drainage away from the dump and installing constructed wetlands is recommended for remediation of the site.

Cost	Time	Recommended reclamation activity
3	2	Re-route site drainage from adit 100 around dump 200 and install constructed wetlands to help remediate drainage
