OPEN-FILE REPORT 01-14

**History, Geology, and Environmental Setting  
of the Griffin and Wilkesbarre Mines,  
Pike/San Isabel National Forest,  
Lake County, Colorado**

**By John Neubert  
and  
Robert H. Wood II**

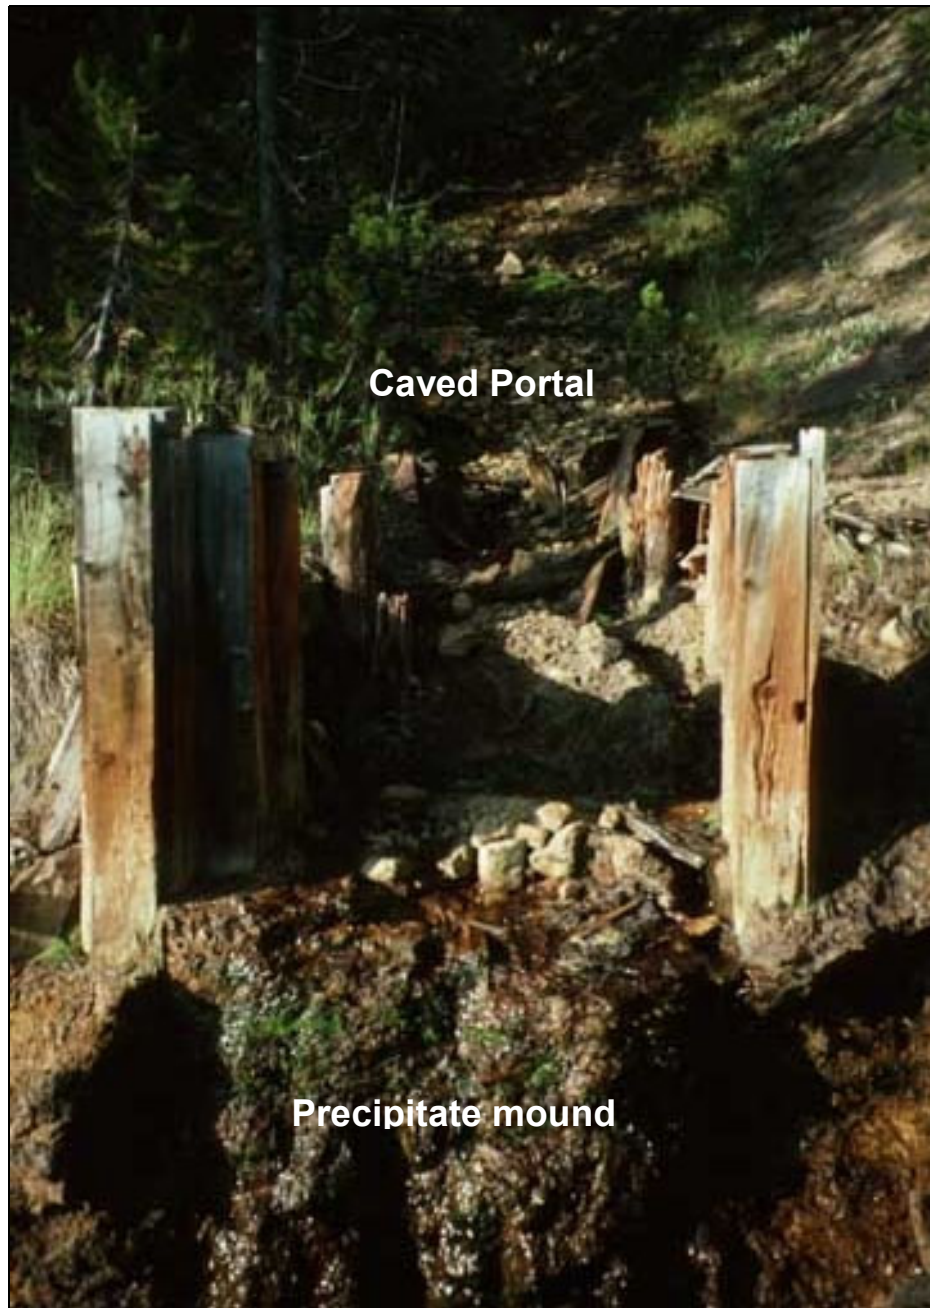
When inventoried in August 1996, water emerged from adit #100 where it was forming a mound of precipitate (Figure 8). The effluent infiltrated and flowed alongside bleached and yellow-stained dump #200 (Figure 9). A series of plastic pipes collected surface runoff and seepage from dump #200 and directed the flow into St. Kevin Gulch below its confluence with Shingle Mill Gulch. Abundant red precipitate lined the St. Kevin Gulch stream channel beginning where the effluent and dump seepage entered the gulch. (See Brown and others, 1996, p. 18-19.)

**Figure 8. Photograph of caved adit #100 and precipitate mound in 1996.**

Because of the large metal loading to St. Kevin Gulch from features #100/200, remediation efforts should be attempted. The source of the water that saturates dump #200 should be determined to engineer the most effective method to redirect that water away from the dump. Cutting off the source of the water should reduce or possibly eliminate the highly degraded seepage from the waste rock. Effluent from adit #100 should be diverted away from dump #200 and the Griffin Mill tailings. Surface runoff onto and through the tailings could be reduced by construction of diversion ditches. Removal of the waste rock and tailings and/or water treatment are also possible, but probably considerably more expensive solutions.

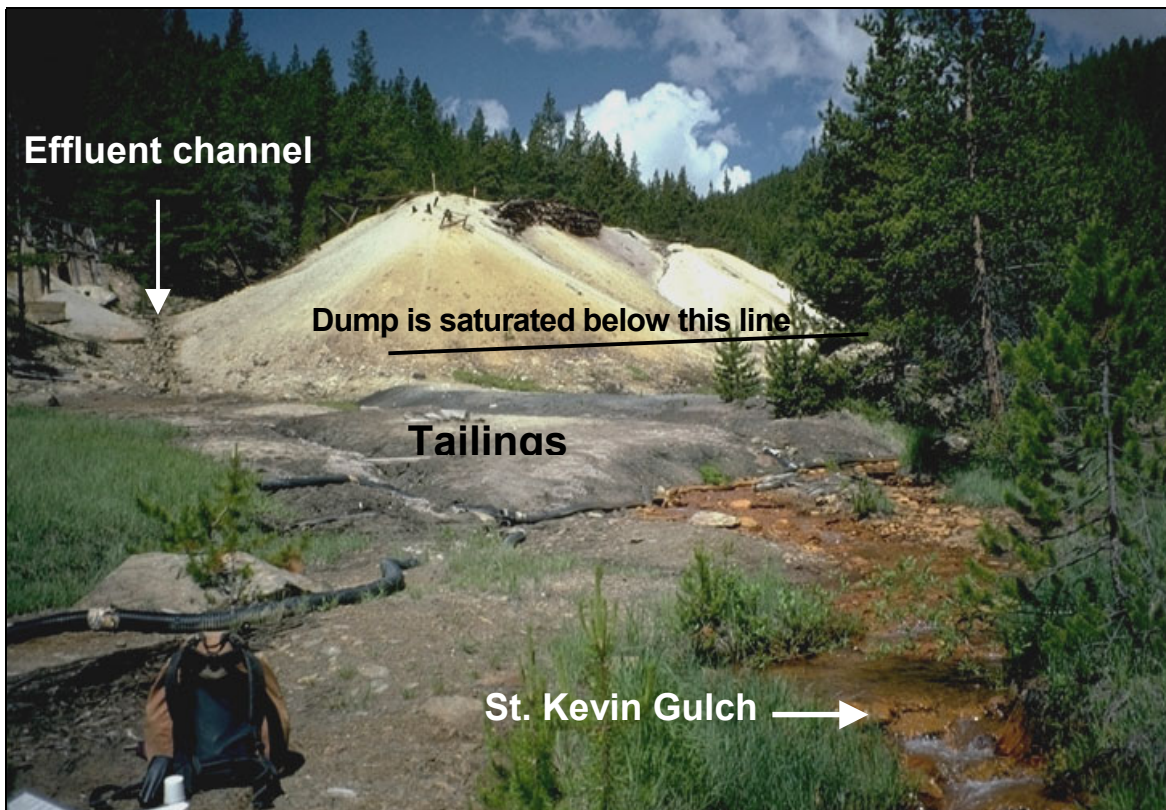
**Figure 9. Photograph of the Griffin Mine waste-rock pile (dump #200) and tailings below.**

Dump #200 contained about 1,100 cubic yards and had prominent sulfur staining and a strong smell of sulfur. Pyrite was abundant. Although not positively identified, the mineralogy of the vein suggests that sphalerite and galena probably occur. The plastic pipe collection system had been dismantled when the site was visited in July 1999, and degraded water emerged from several places close to the toe (Figure 10). One of the seeps was draining water with 2.39 pH and 1,950  $\mu\text{S}/\text{cm}$  conductivity. Some of the seepage from dump #200 entered directly into St. Kevin Gulch, and some flowed across tailings and merged with effluent from adit #100 before joining the St. Kevin Gulch stream (Figure 9). The mixture of effluent and dump seepage, after crossing the tails and just above the confluence with St. Kevin Gulch, had 2.27 pH and 1,913  $\mu\text{S}/\text{cm}$  conductivity, indicative of severely degraded water.

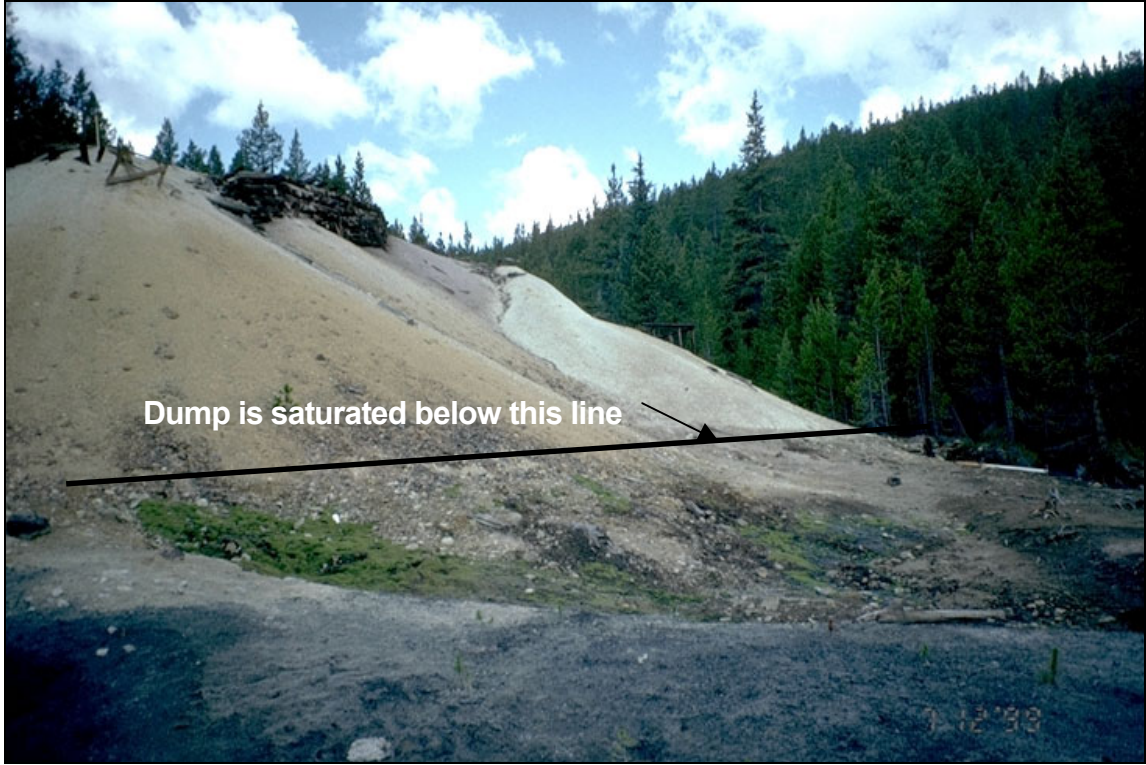
**Figure 10. Photograph of seeps with vegetation and water saturation level in dump #200.**

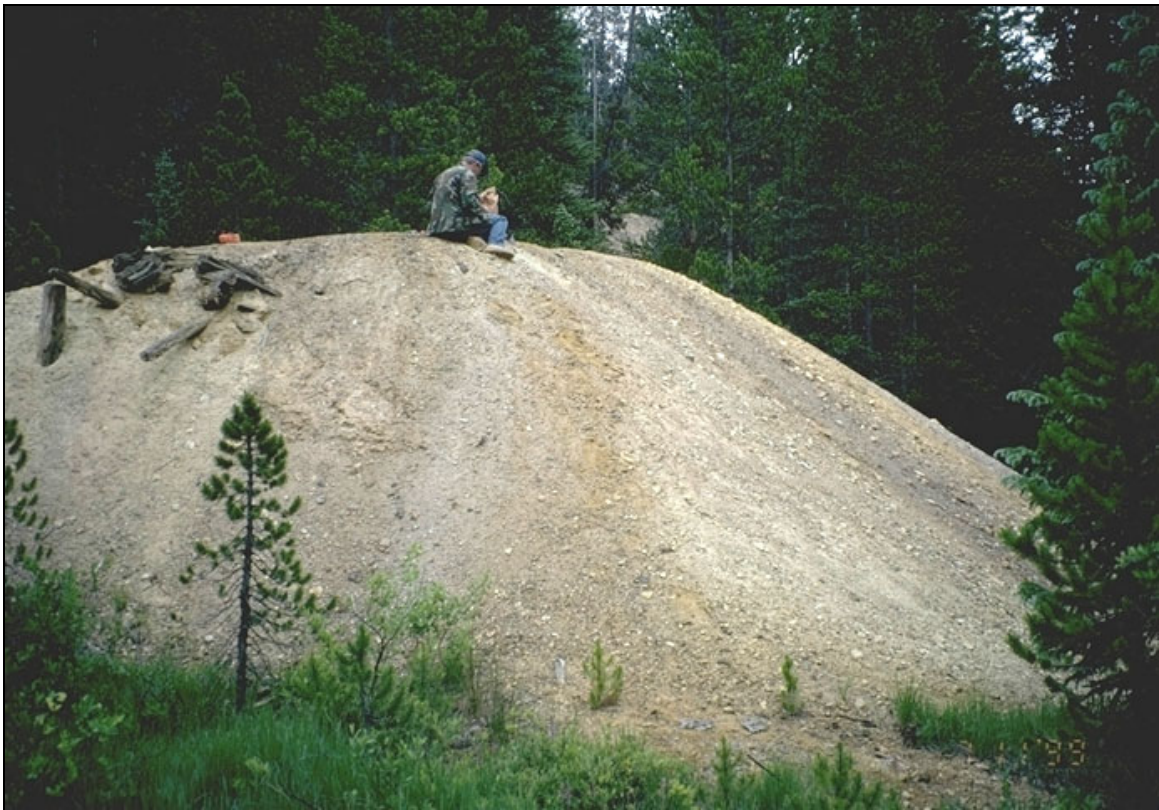
Adit #101 is on the west side of Shingle Mill Gulch (Figures 6, 7) and is probably associated with the unlabeled waste-rock pile shown by Singewald (1955, plate 26). This caved adit is most likely on private land, as is the upper lobe of associated dump #201 (Figure 4). In 1996 the adit was caved and discharged a small volume of water (Brown and others, 1996, p. 20). In 1999, recent survey stakes indicated that part of the lower lobe of dump #201 is probably on NFS land. This lower lobe lies in a wetland and is in contact with Shingle Mill Gulch for a short distance (Figure 11).

**Figure 11. Photograph of lower lobe of dump #201 in wetland.**

The small volume of apparently clean effluent from caved adit #101 is probably not a serious concern in this inventory area, especially when compared to the much larger flows of highly degraded water from features #100/200 and the moderate discharge from adit #102. The mineralized “island” lobe of dump #201 rests in a wetland and may contribute to minor degradation in Shingle Mill Gulch. This lobe could be removed relatively easily if a suitable repository is available. The detrimental effects of disturbing an undamaged portion of the wetland may outweigh the benefits of dump removal, at least in the short term. The alkaline nature of dump #201 might allow the material to be used in future remedial actions at features #100/200.

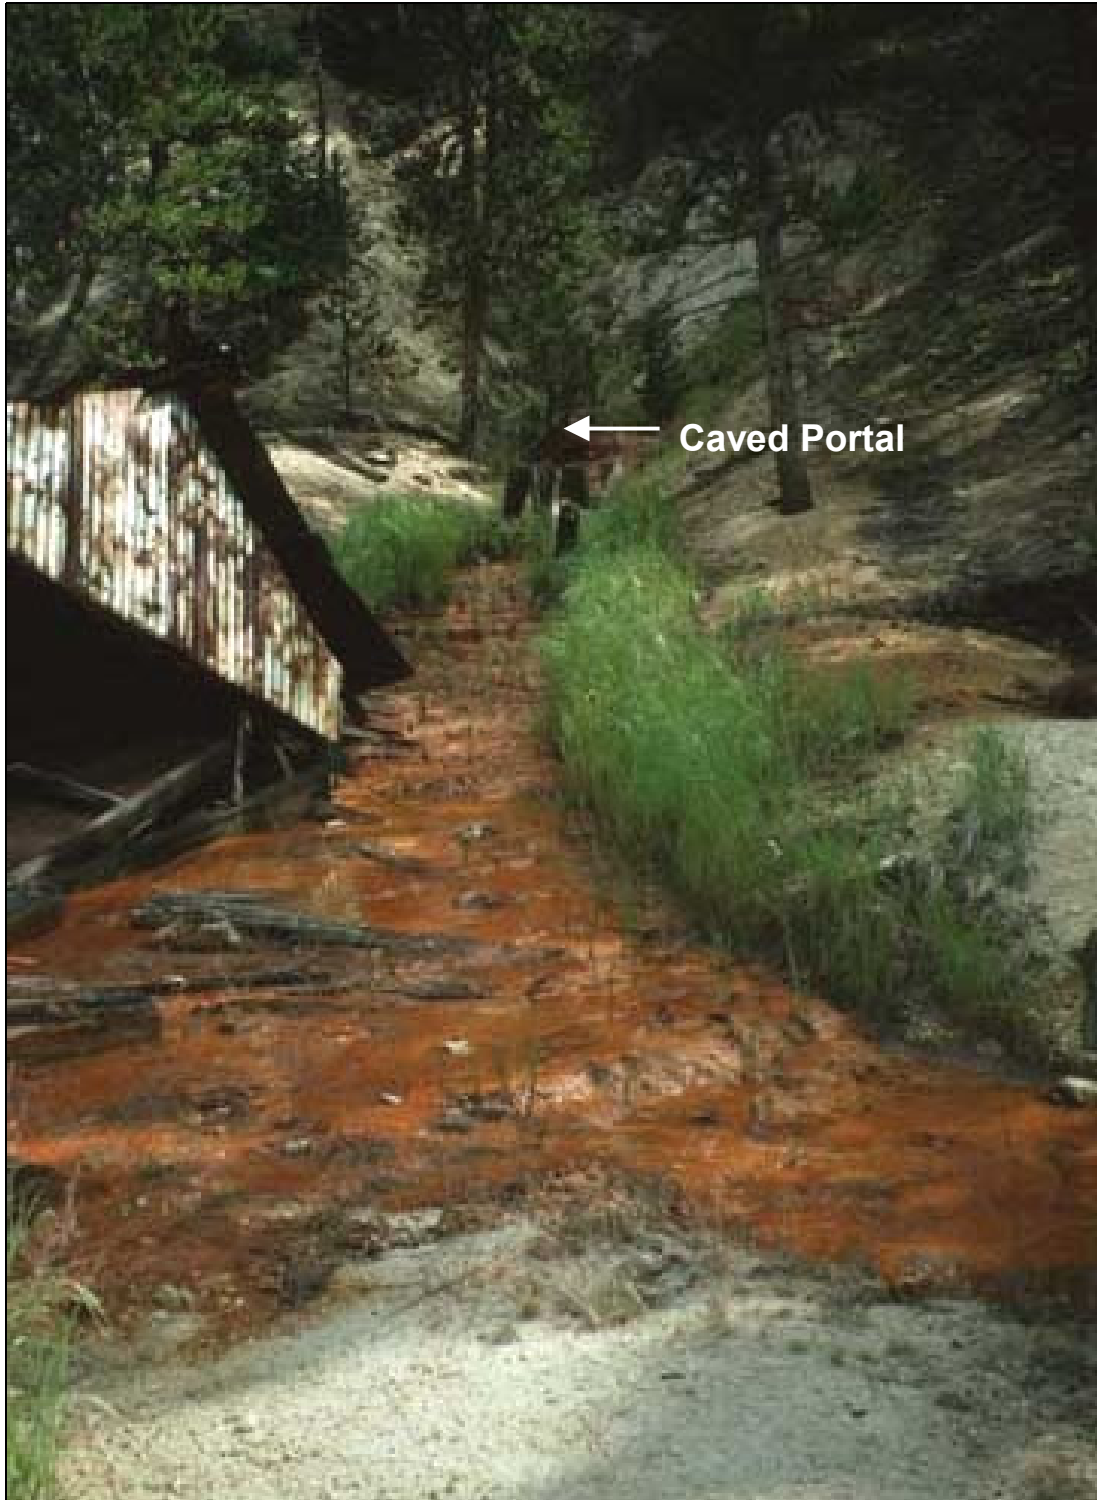
**Figure 12. Photograph of caved adit #102 and effluent in 1996.**

Adit #102 is apparently on private land, but the southernmost part of dump #202 may extend onto NFS land (Figure 4, Appendix). During the inventory in August 1996, about 4 gpm of water drained from adit #102 and infiltrated into the ground alongside dump #202. Effluent tested at the portal had 5.8 pH and 463  $\mu\text{S}/\text{cm}$  conductivity, suggesting moderate degradation. (See Brown and others, 1996, p. 20.) This effluent was not sampled in 1996 or 1999 because surface flow did not reach Shingle Mill Gulch or NFS land during the field visits. An iron-stained channel indicated that during high flow, the effluent probably reaches Shingle Mill Gulch at the surface (Appendix).

If permission is obtained from the landowner, water and waste-rock samples should be collected at features #102/202 to better determine the severity of any degradation caused by this site. Diverting mine effluent away from dump #202 may slightly improve water quality in Shingle Mill Gulch. Regrading and pulling back the toe of dump #202 would reduce erosion of the waste rock into the gulch.

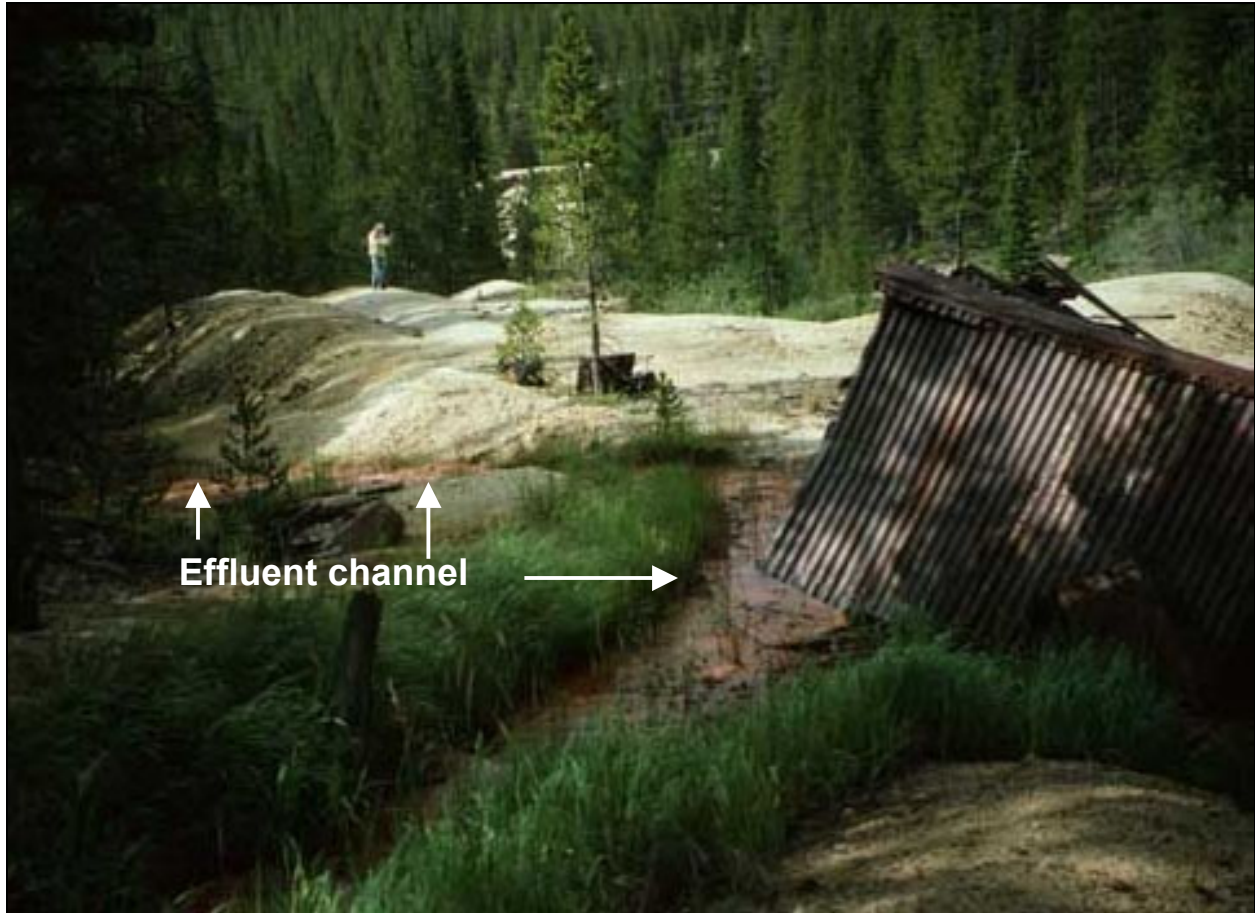
**Figure 13. Photograph of dump #202 and iron-stained effluent channel in 1996.**

Dump #202 had about 800 cubic yards of oxidized, altered granitic rock with abundant pyrite. The surface was stained yellow, and the base was in contact with the Shingle Mill Gulch stream. Gullies and rills indicated that dump material has been eroded into Shingle Mill Gulch (Appendix).

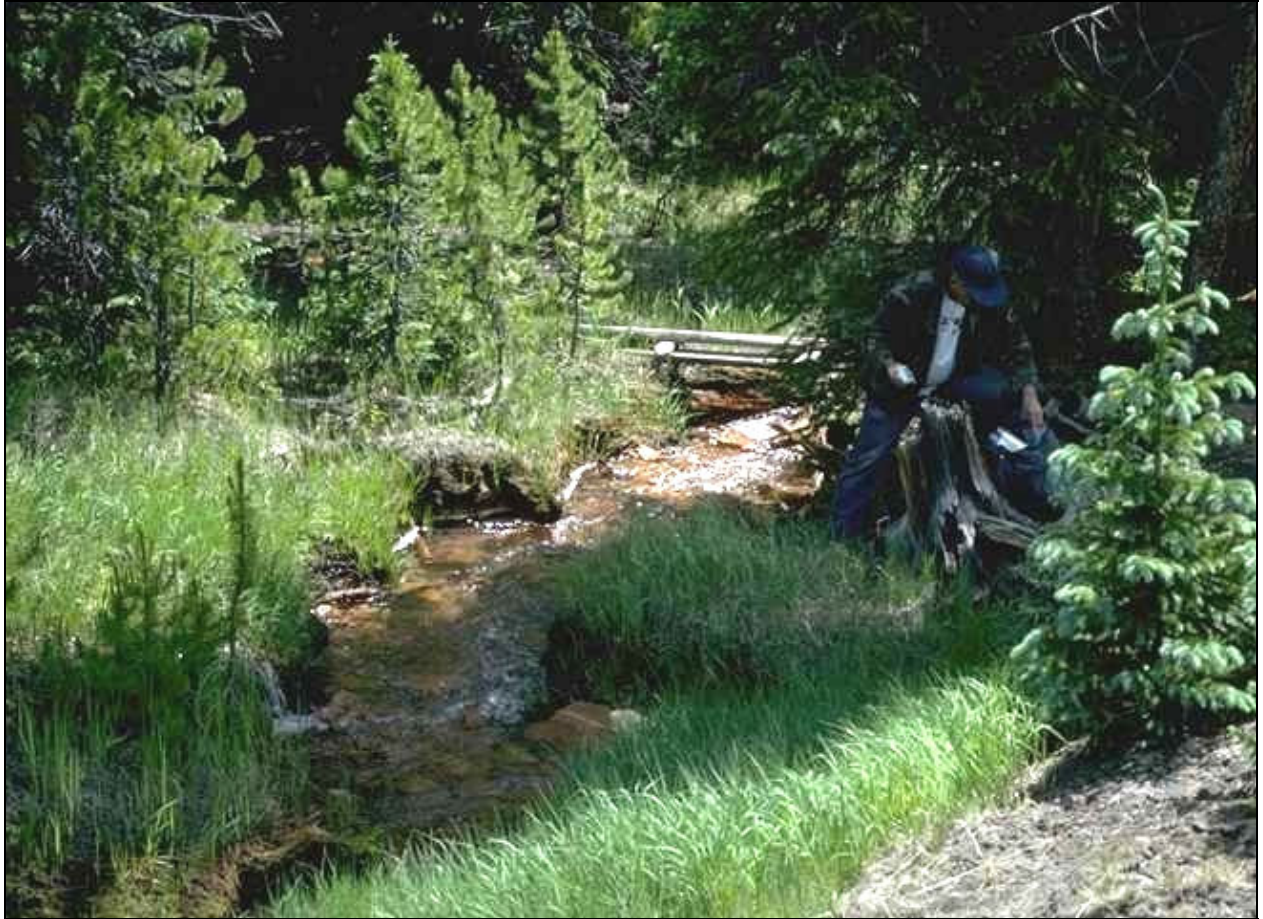
**Figure 14. Photograph of St. Kevin Gulch below the Griffin and Wilkesbarre Mines.**

Effluent from adit #100 (Griffin Tunnel No. 3) and seepage from associated dump #200 significantly impact St. Kevin Gulch above its confluence with Shingle Mill Gulch. Upstream of features #100/200, St. Kevin Gulch was lined with moderate quantities of red-brown precipitate. At sample site 12-01-381/4350-1.3 (Figure 7), flow was estimated at 180 gpm, pH was 4.75, and conductivity was 89  $\mu\text{S}/\text{cm}$ . This water was degraded and exceeded standards in aluminum, cadmium, copper, lead, manganese, and zinc. Abandoned mines higher in this drainage basin may be the source of high metal concentrations at this sample site.
