OPEN-FILE REPORT 03-13

**History, Geology, and Environmental Setting of
the Southern Cross and 7D Mines,
Hahns Peak Mining District,
Routt National Forest, Routt County, Colorado**

Open-File Report 03-13 describes the history, geology, and environmental setting of two mines in the Hahns Peak mining district. Both of the sites lie on U.S. Forest Service administered land and are within the Willow Creek drainage basin, a tributary of the Elk River. The U.S. Forest Service selected the sites based on the results of an abandoned mine inventory recently completed by the Colorado Geological Survey. This information is useful for State and Federal agencies and private owners for developing realistic and cost-effective reclamation plans for mines in the Willow Creek watershed.

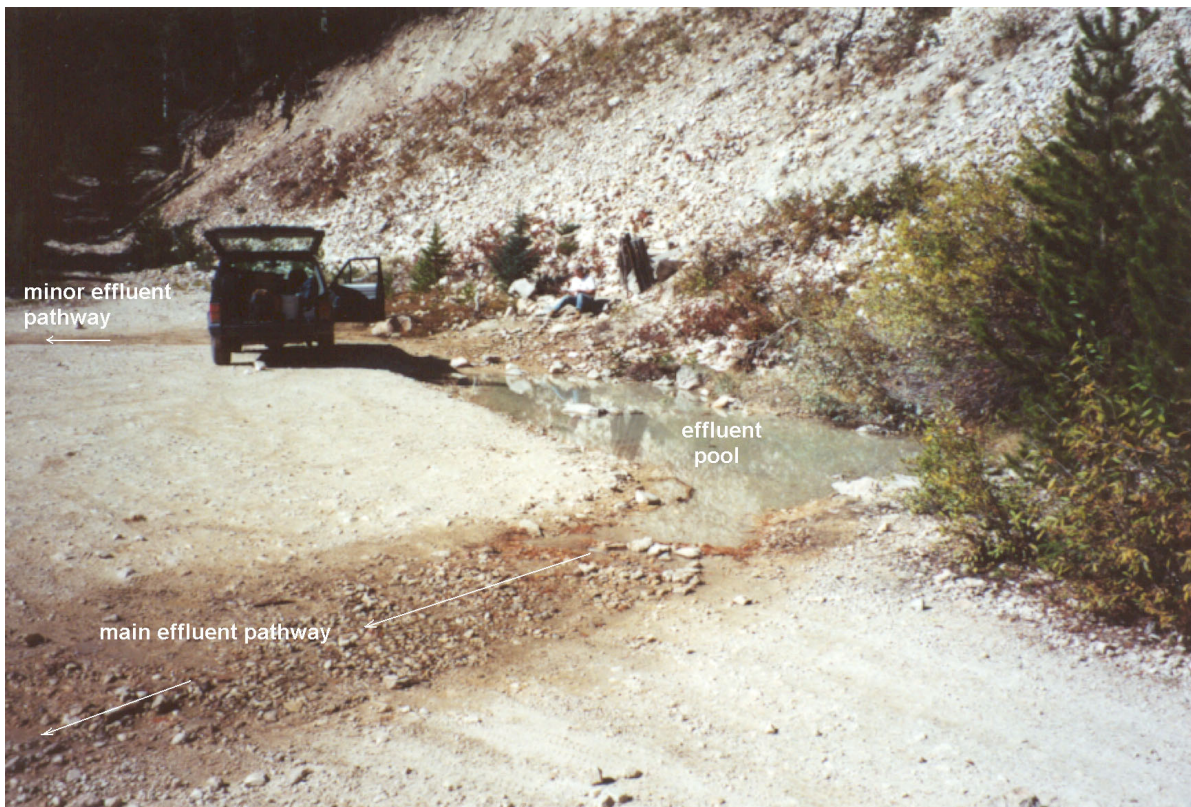
Figure 7. Effluent pool and drainage across the road at the Southern Cross Mine.

In September 2000, the portal of the Southern Cross Mine was completely caved. It apparently caved between 1984 and 1992 when evaluated by the U.S. Bureau of Mines. Most of the effluent flowed east from the collapsed portal and formed a 30-foot-long, 10-foot-wide, 9-foot-deep pool (Figures 7 and 8). Abundant fine white precipitate or sediment was deposited in the pool. From the pool, the effluent flowed across the road on the top of the dump and along the eastern side of the dump. This effluent creates a gully, actively eroding the dump (Figure 9). Surface flow infiltrated about 200 feet below the toe of the dump. The clear effluent supported a moderate amount of algae. A minor amount of effluent flowed west of the portal and infiltrated into the top of the dump.

White sediment lined the effluent pool near the portal. Flow discharge from the pool was measured at 3.4 gpm using a flume. Conductivity and pH were similar at the portal (451 $\mu\text{S}/\text{cm}$, 3.58 pH), discharge area from the pool (456 $\mu\text{S}/\text{cm}$, 3.59 pH), and 200 feet below the dump where the effluent infiltrated the subsurface (479 $\mu\text{S}/\text{cm}$, 3.59 pH). Effluent exceeded State standards in concentrations of aluminum (39,000 $\mu\text{g}/\text{L}$), cadmium (7.2 $\mu\text{g}/\text{L}$), copper (7.1 $\mu\text{g}/\text{L}$), iron (2,000 $\mu\text{g}/\text{L}$), manganese (460 $\mu\text{g}/\text{L}$), nickel (120 $\mu\text{g}/\text{L}$), lead (6.0 $\mu\text{g}/\text{L}$), and zinc (230 $\mu\text{g}/\text{L}$). The extreme concentration of aluminum in this sample indicates that the white sediment in the effluent pool is probably an amorphous aluminum precipitate. Compared to the 1997 sample, concentrations had increased in all of the elements that had exceeded State standards except for zinc, which decreased slightly. Decreased flow and greater residence time inside the mine workings probably accounted for the increased conductivity and metal concentrations.

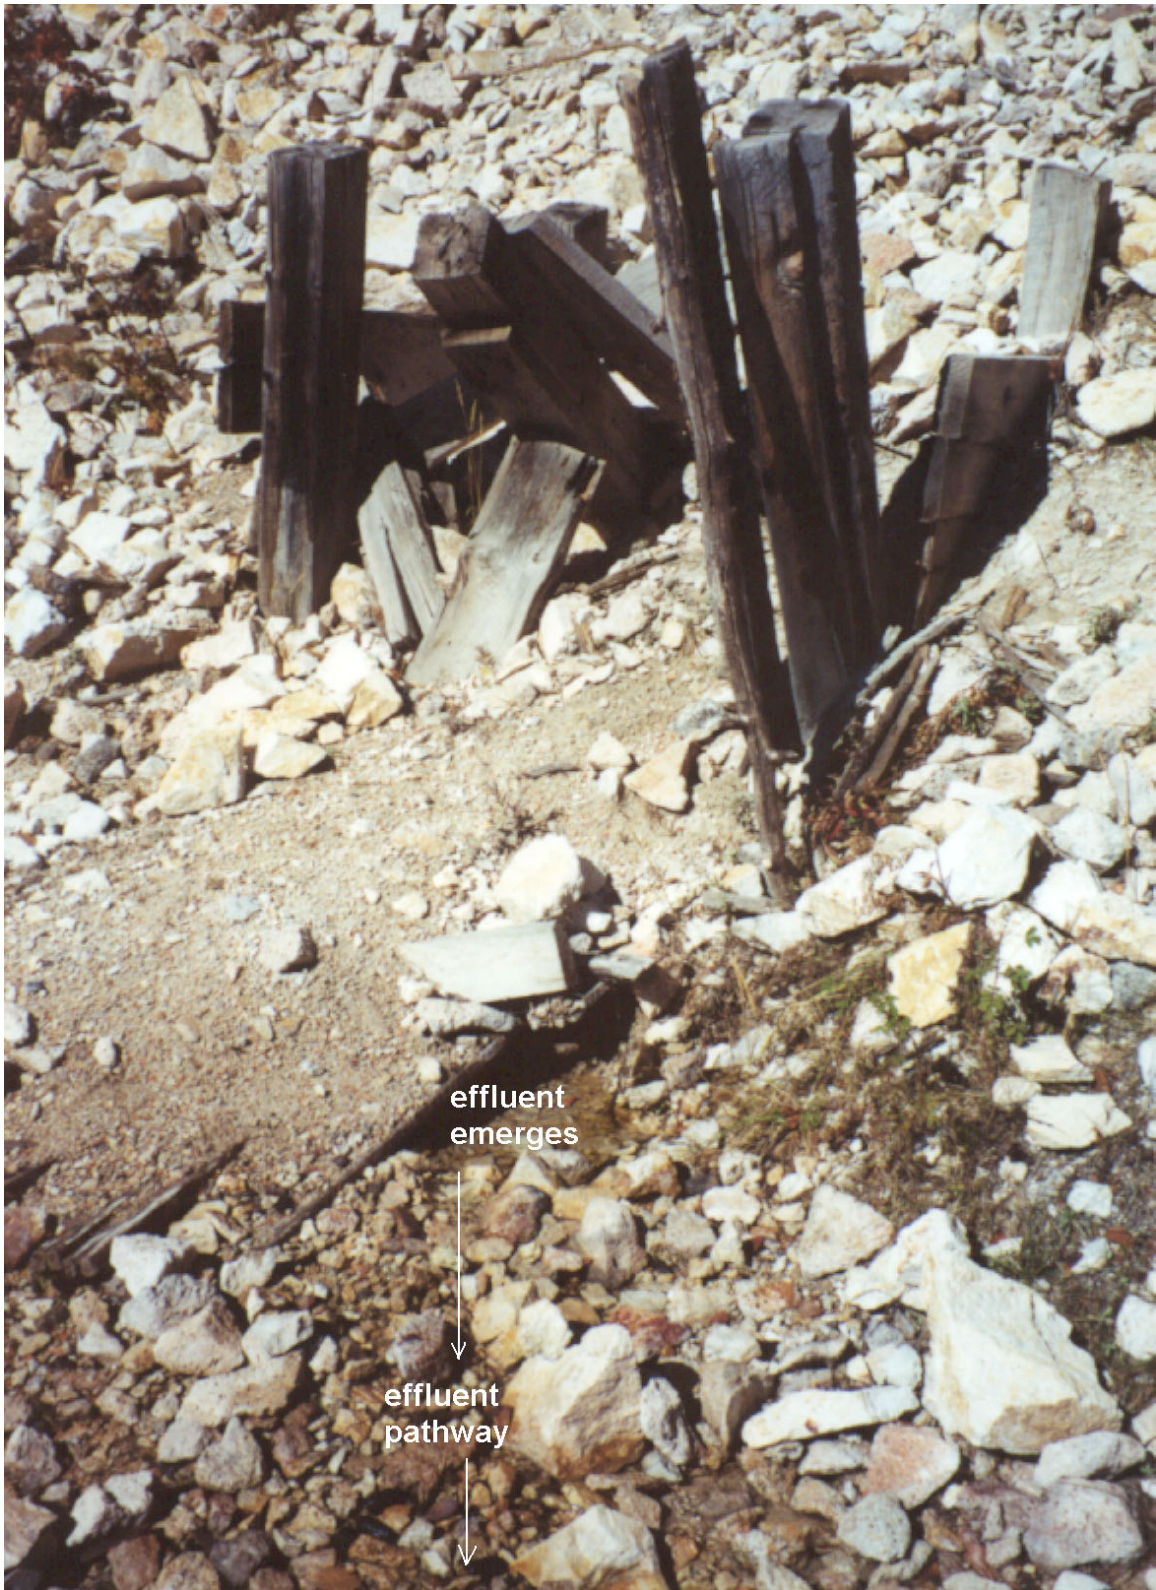
Figure 8. Effluent emerging from the caved Southern Cross portal.

Effluent was sampled near the portal during September 2000 for this investigation (Table 1, sample MH-2000-43). Effluent appeared clear and supported a moderate growth of algae.

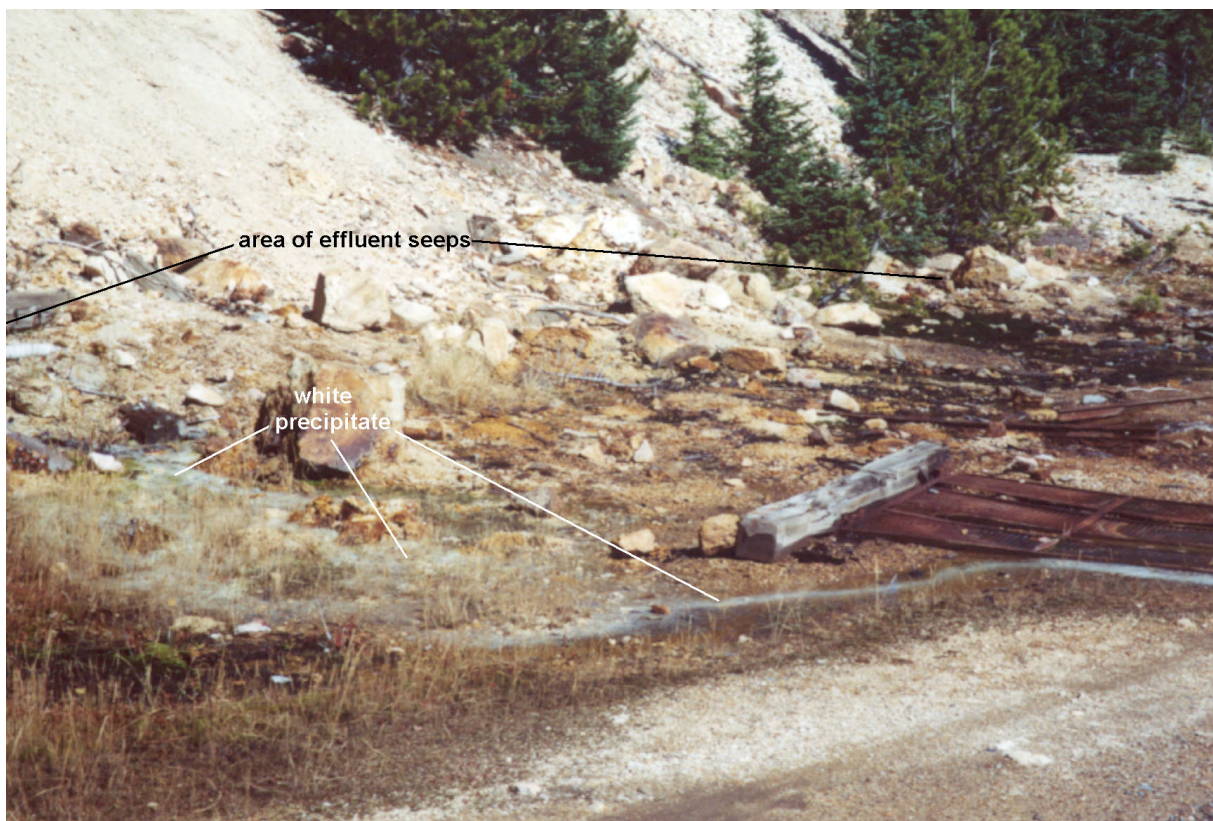
Figure 11. Effluent seeps from the caved 7D adit.

In June 1997 the portal of the 7D adit was caved. Apparently the portal caved between 1992 and 1997. Effluent emerges from several seeps over a 15-foot interval along the base of the slope (Figure 11). Some of the seeps had white precipitate. During higher flow the effluent flowed down the dump face in several places (Figure 12). In September 2000 the two largest seeps joined on the top of the dump east of the seeps. The effluent contained moderate amounts of filamentous algae. Minor red staining lined the channel. From the top of the dump, the effluent flowed down the dump face and carved a deep channel, up to 10-feet-deep (Figure 13). About 40 feet above the toe of the dump, the effluent channel begins to braid (Figure 14) and the effluent infiltrates and re-emerges. About 40 feet below the toe, the effluent completely infiltrates the subsurface. Abundant dump material is evident in the channel at least 200 feet below the last traces of effluent, indicating greater surface flow during snow melt and storm events.

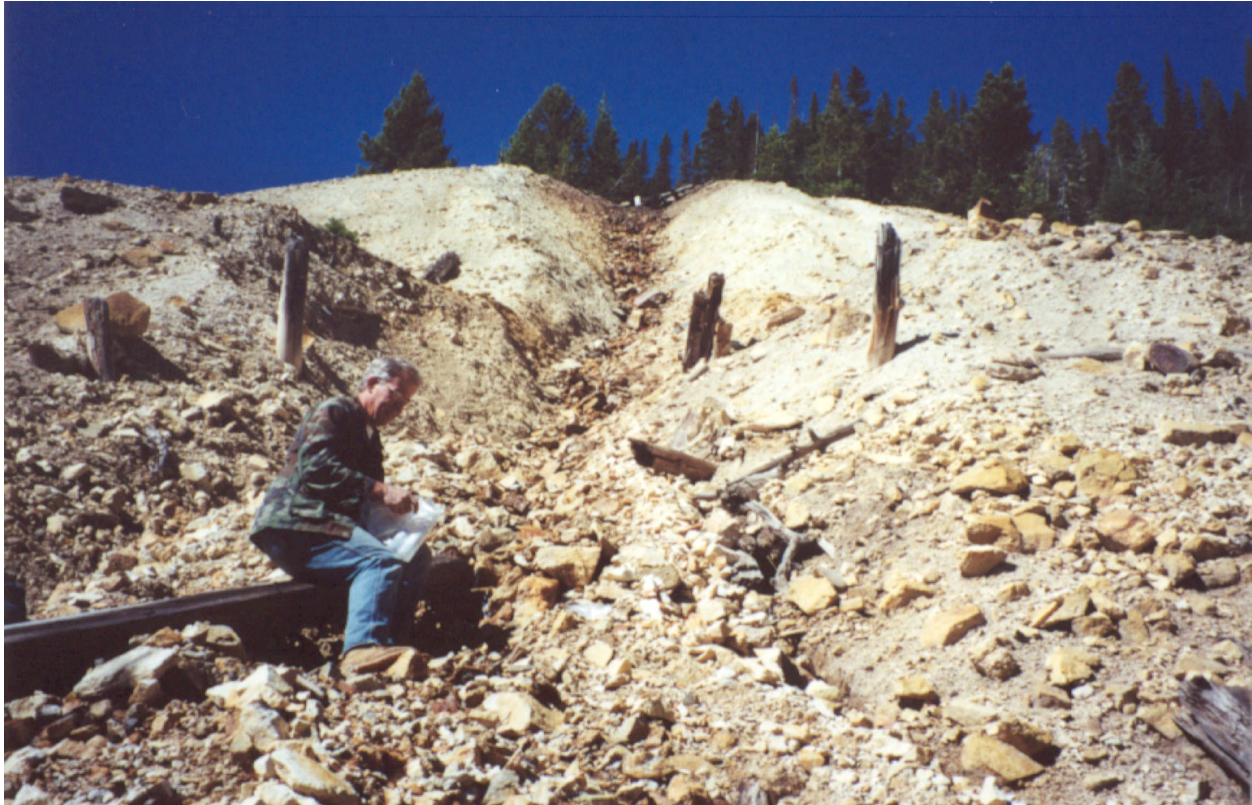
Figure 14. 7D dump from water sample location #41.

On September 27, 2000 the effluent was sampled near the caved portal (sample MH-2000-42) and about 40 feet above the toe of the dump (sample MH-2000-41). Flow near the portal was 6 gpm (flume) and the effluent had a pH of 3.52 and conductivity of 270 $\mu\text{S}/\text{cm}$. Effluent appeared clear and contained a moderate amount of filamentous algae. The effluent exceeded State standards in concentrations of iron (1,100 $\mu\text{g}/\text{L}$), aluminum (10,000 $\mu\text{g}/\text{L}$), cadmium (1.5 $\mu\text{g}/\text{L}$), copper (22 $\mu\text{g}/\text{L}$), lead (130 $\mu\text{g}/\text{L}$), manganese (83 $\mu\text{g}/\text{L}$), nickel (42 $\mu\text{g}/\text{L}$), silver (0.3 $\mu\text{g}/\text{L}$), and zinc (360 $\mu\text{g}/\text{L}$) (Table 2). Flow was measured at 8 gpm (catchment) above the dump's toe (sample MH-2000-41) and the effluent had a pH of 3.72 and conductivity of 239 $\mu\text{S}/\text{cm}$. Concentrations of parameters in the sample above the toe were slightly lower than at the portal

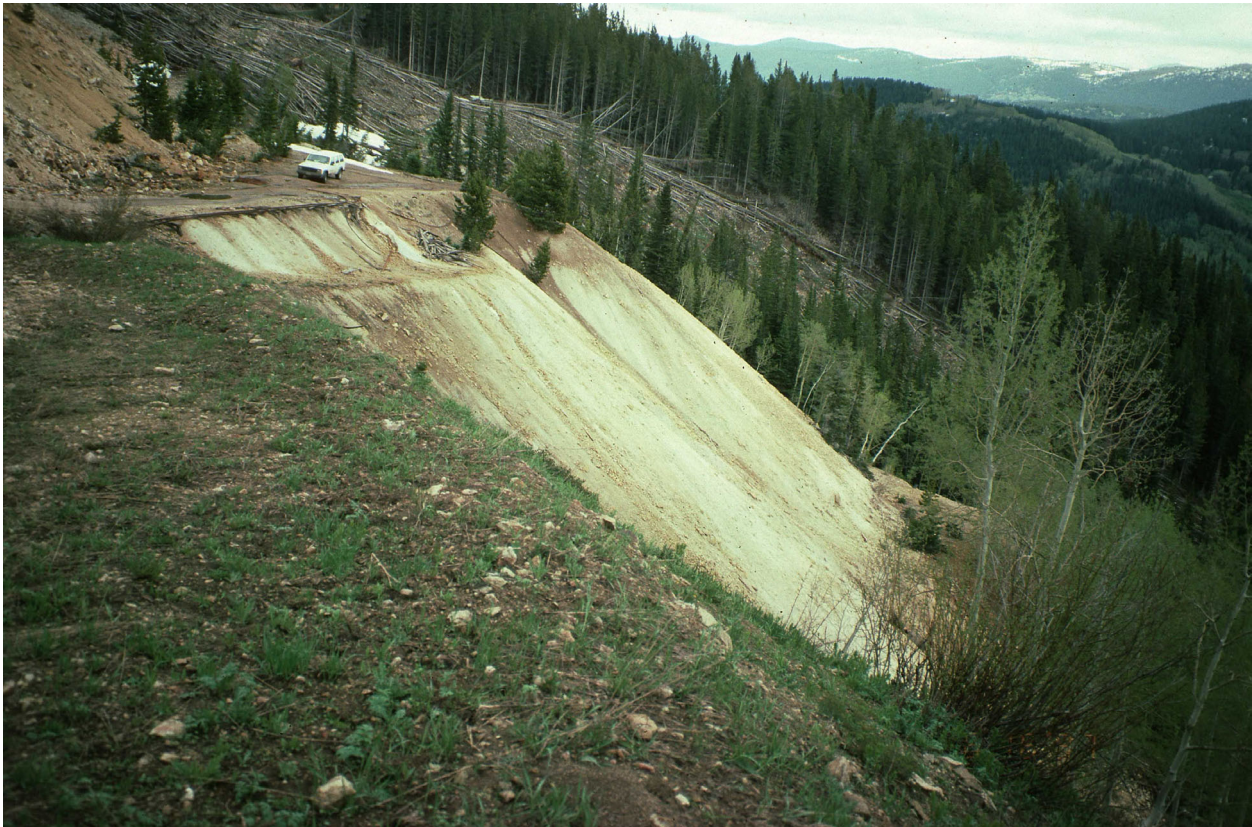
Figure 15. 7D dump.

Ellis and Wood (1998, p. 10) estimated waste-rock pile #200 (7D dump) to be about 25,000 cubic yards in volume. A calculation based on a map of the workings (Figure 10) suggests that the dump size should be between 15- and 20-thousand cubic yards. Effluent was in contact with the top of the dump and in a deep gully down the center of the dump. Vegetation (mostly pine, aspen, and weeds) is sparse, did not appear stressed, and occurs on or near the flatter areas of the dump. The moderately cemented white to light-yellow colored dump (Figure 15) is mostly composed of fine altered country rock. Coarser material is more prevalent in the channels and toward the base of this very steep dump. Fine disseminated pyrite was observed on fresh surfaces of some dump material. Galena was very rare; small pieces were found near the tracks just below the top of the dump. Waste rock material is weakly mineralized. A composite sample contained about 0.17% zinc, nearly 0.16% lead, and 0.4 oz/ton silver. Paste pH was 4.05, and net acid-base potential was -2.9 tons CaCO₃/1,000 tons (Table 3).

No evidence of windblown particulates or wind erosion was observed at either site. Although the surface of the 7D dump is mostly composed of finer material, the dump is moderately cemented. Waste-rock at the Southern Cross Mine was considered a slight environmental problem (EDR of 4). In addition, parts of the year the dumps are covered by snow. The air exposure pathway is considered insignificant because there is 1) no evidence of wind erosion, 2) the dump is moderately cemented, and 3) the lack of long-term exposure to the public.
