OPEN-FILE REPORT 03-14

**History, Geology, and Environmental Setting
of Selected Mines in the Upper Alamosa River
Basin, Rio Grande National Forest,
Conejos and Rio Grande Counties, Colorado**

**By
Robert H. Wood II
John T. Neubert
and
David A. Bird**

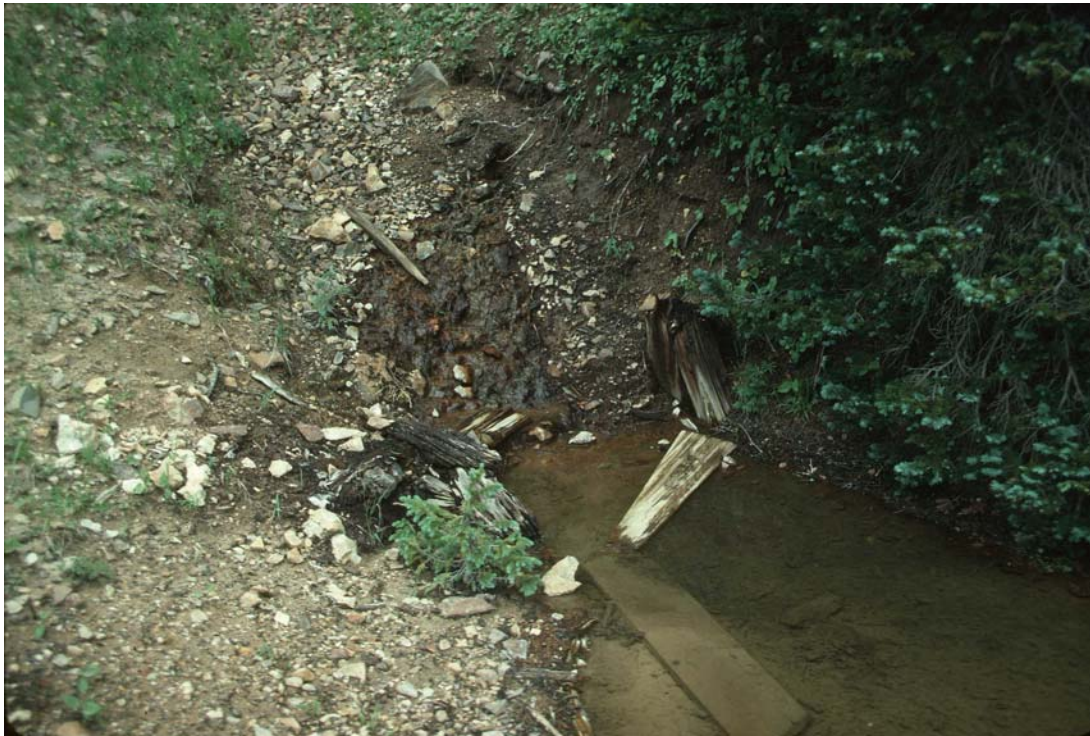
Figure 8. Seep from collapsed Pass-Me-By Mine portal (#100).

The Pass-Me-By mine is located on private land east of Iron Creek, on the western flank of Lookout Mountain. Included within the site is a draining adit (#100) and a dump (#200) with a seep at its base. The Pass-Me-By adit (#100) is regarded as the most serious environmental hazard in the inventory area. The adit portal has collapsed shut. On August 5, 1993 an estimated 1 gpm of water with a pH of 3.2 and conductivity of 1,410 $\mu\text{S}/\text{cm}$ was discharging from the collapse debris about 3 feet above the original portal floor. About 25 feet in front of the collapsed portal, water was surfacing out of dump material beneath the channel, at a measured rate of 27 gpm, including the drainage that issued from the collapse debris. The water surfacing from the dump material had essentially the same pH and conductivity as water issuing from the collapsed debris, and was assumed to be mine drainage that was following a drain tile or pipe along the haul track.

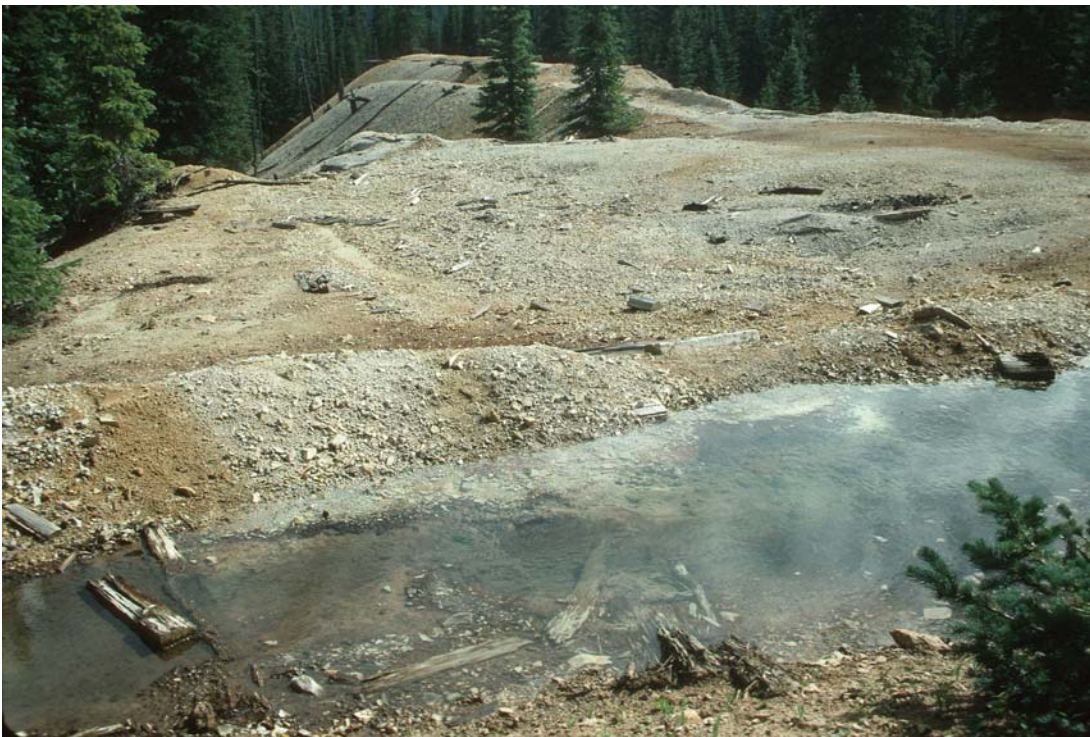
Figure 9. Effluent pond formed on the Pass-Me-By Mine dump (#200) bench.

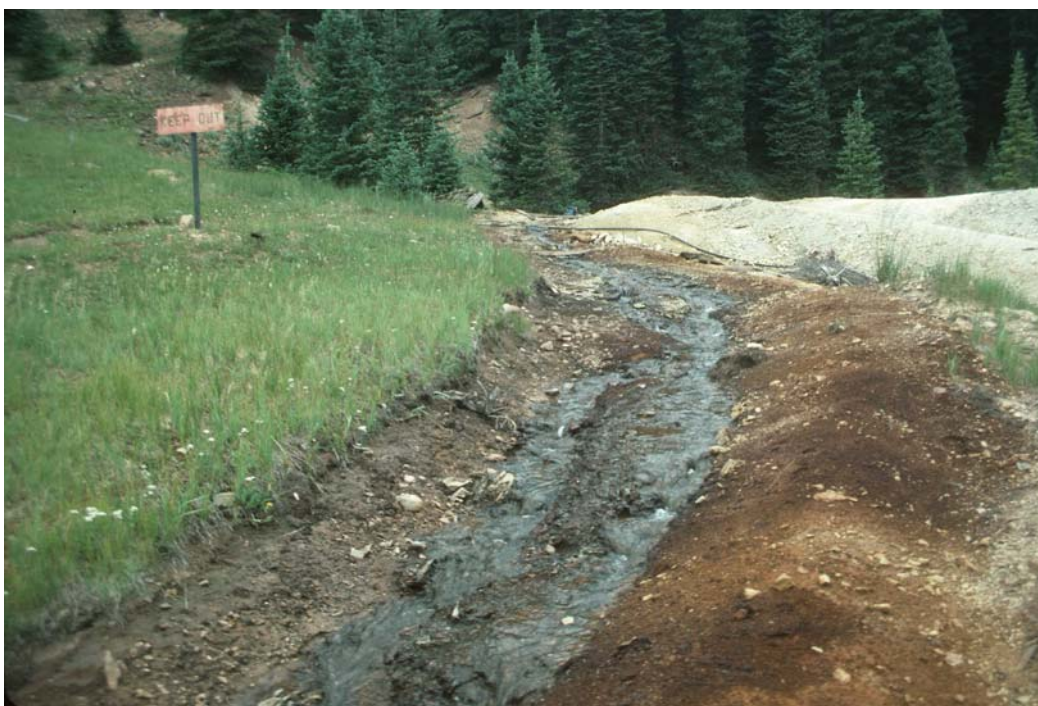
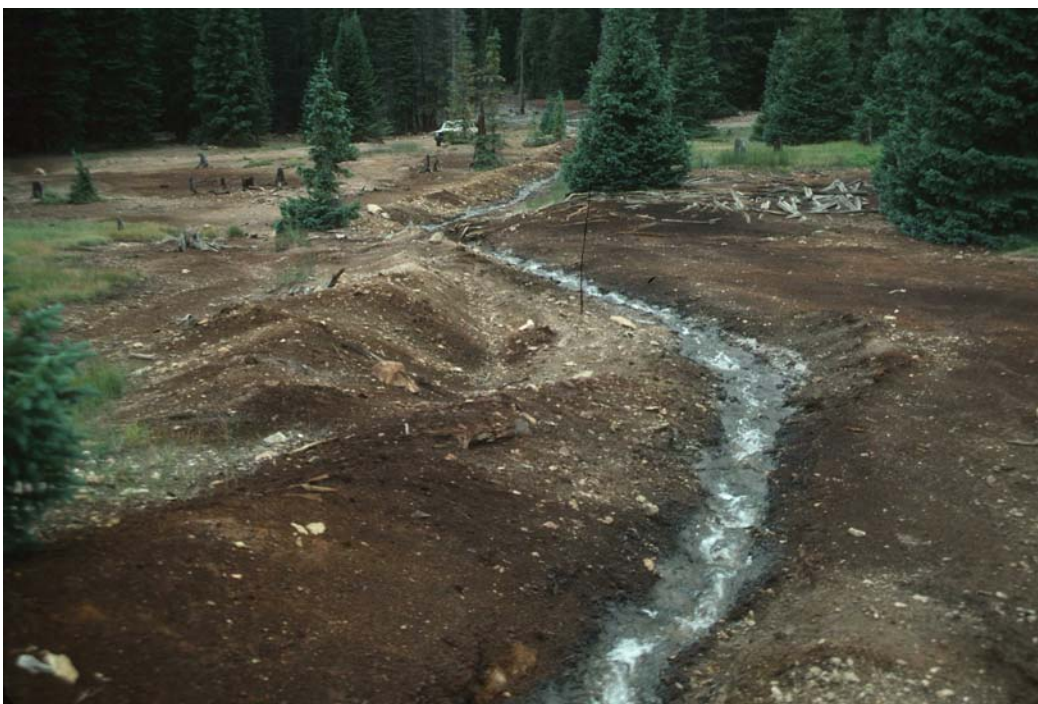
Figure 10. Channelized effluent from the Pass-Me-By Mine.

a) Effluent flows adjacent to waste-rock (flow from top to bottom of photo).

b) Channelized flowpath below waste-rock pile.

The total concentrations reported by Kirkham and Holm (1989) and by the USGS (1994) are similar for most constituents. Discharge from the Pass-Me-By mine flows down the hillslope across an impressive ferrosinter mound, along which most trees have died, before it enters Iron Creek. The investigator noted red or yellow precipitate in the channel (Appendix).

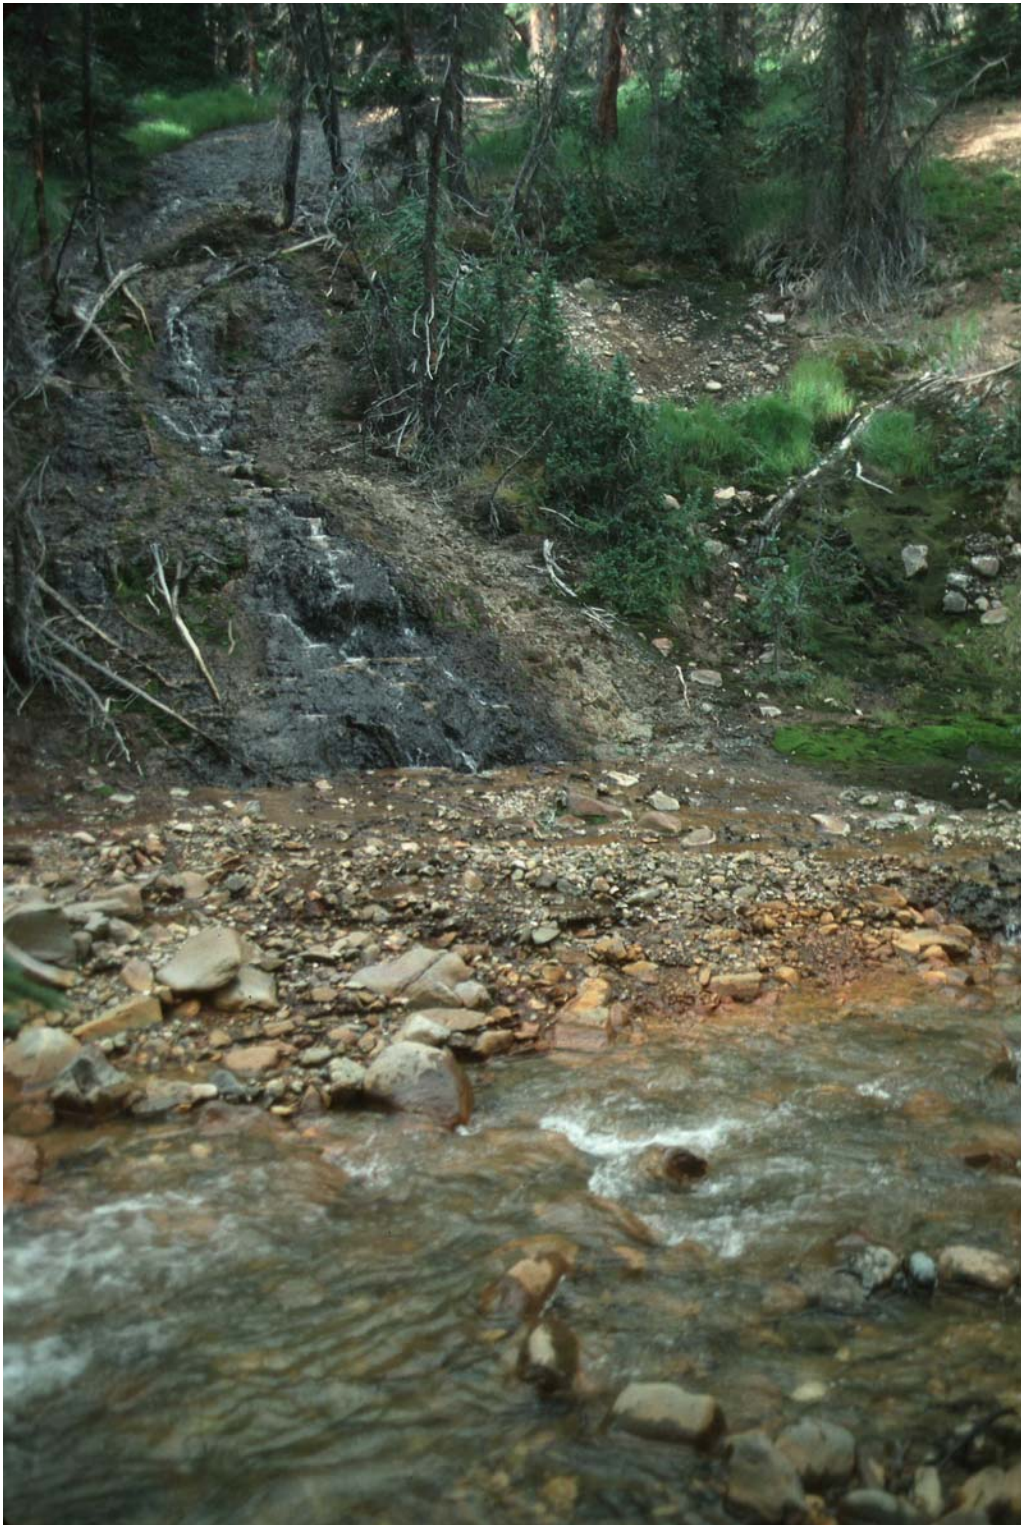
Figure 11. Pass-Me-By Mine effluent entering Iron Creek.

Iron Creek is degraded by naturally occurring pollution above the inflow from the Pass-Me-By mine. Major sources of degraded water include the tributary that drains the saddle between Cropsy and Lookout Mountain and the Upper Iron NOAMS (Naturally Occurring Acidic, Metal-Rich Spring). Significant sources of naturally degraded water entering Iron Creek below the inflow from the Pass-Me-By mine include the tributary draining the east flank of Sheepshead (pH 3.71; conductivity 348 $\mu\text{S}/\text{cm}$) and the Lower Iron NOAMS (Table 2). Numerous other smaller sources of naturally degraded water discharge into Iron Creek throughout the entire region west and southwest of Lookout Mountain.

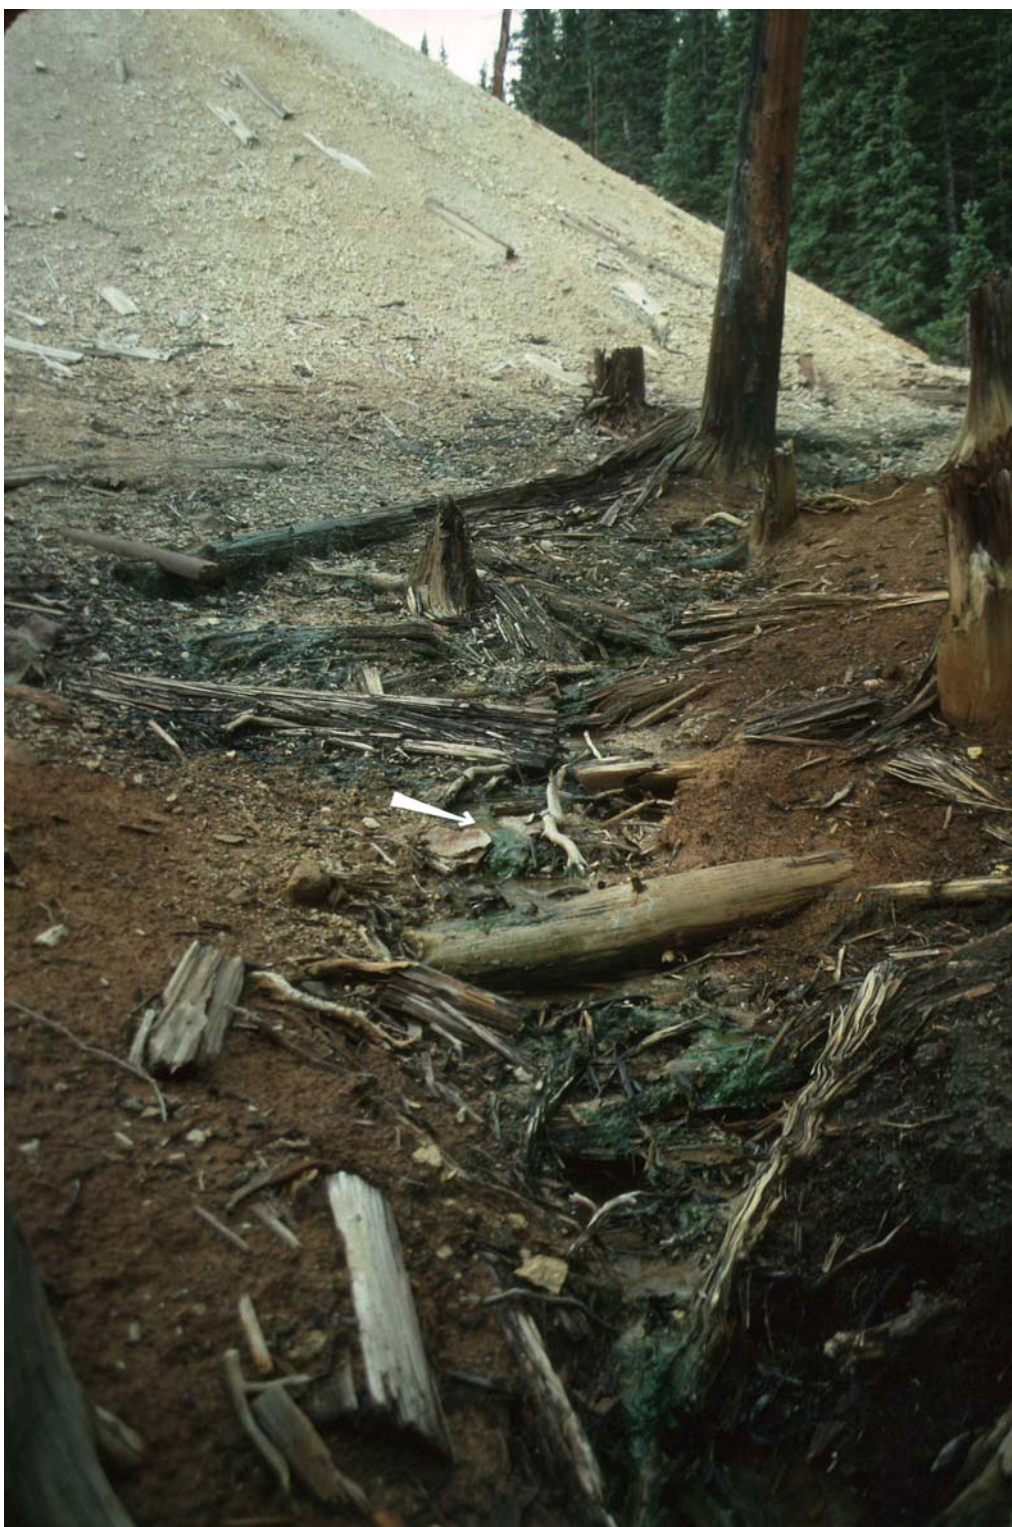
Figure 12. Seep emerging from base of Pass-Me-By Mine Dump (#200).

The waste-rock dump (#200) associated with the Pass-Me-By mine contains an estimated 12,000 yds of material with some pyrite, and has been assigned an EDR of 3. A small seep at the toe of the dump discharged an estimated 0.4 gpm with pH of 2.5 and conductivity of 2,430 $\mu\text{S}/\text{cm}$. The flow infiltrated into the ground a short distance below the dump. A prominent zone of dead trees and a deposit of ferricrete extend below the dump. Local landowners confirmed that the adit drainage was directed to this area in former years. In addition the dump seep may have discharged larger amounts of water during the past, contributing to the ferricrete deposit and soil toxicity. Downstream, just before flowing into Iron Creek, the seep flow increased to an estimated 2 gpm, with pH of 2.71 and conductivity of 1,190 $\mu\text{S}/\text{cm}$; no sample was collected.

Although the dump was only discharging an estimated 0.4 gpm from the seep at its base, the dump could possibly have a greater impact to ground water than is immediately apparent. The dimensions of the dump are recorded as 400 ft long by 125 ft wide, equaling a surface area of 50,000 sq. ft. The annual precipitation in the mine area is greater than 45 inches, thus it can be calculated that approximately 3 gpm of precipitation could be infiltrating to the dump, depending on evapotranspiration and runoff, and ultimately to groundwater. Depending on the extent of sulfide oxidation and other reactions that could release acidity and trace metals, this component could potentially be a greater contaminant source than the adit discharge. It is reasonable to assume that the dump discharge chemistry could be similar to the seep effluent that has pH of 2.5 and conductivity of 2,430 $\mu\text{S}/\text{cm}$. Further study would be required to quantify the contribution to ground water from dump infiltration.

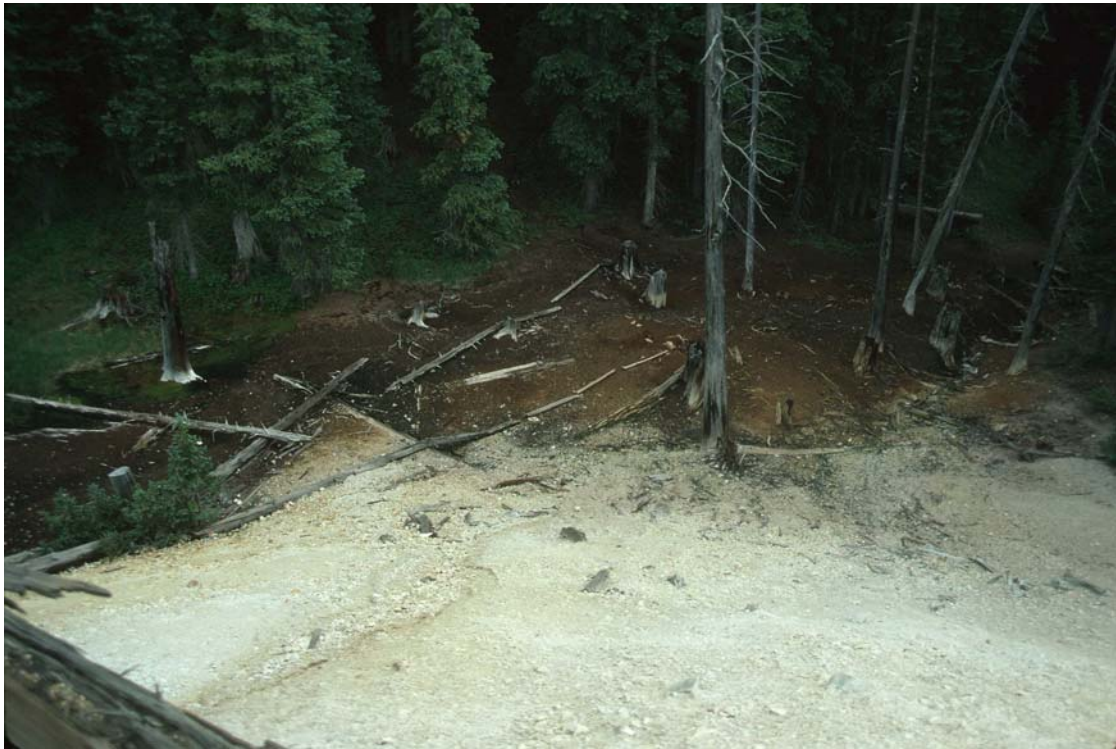
Figure 13. Seeps at the base of Pass-Me-By Mine Dump (#200).

From an outcrop adjacent to the aforementioned test site, several seeps emerged with an estimated combined flow of 2 gpm. The largest of the seeps had pH of 2.57 and conductivity of 1,630 $\mu\text{S}/\text{cm}$. The seeps were described as being 40 feet from Iron Creek, but the investigator did not specify if the seeps drained to Iron Creek. Red or yellow precipitate was noted (Appendix).

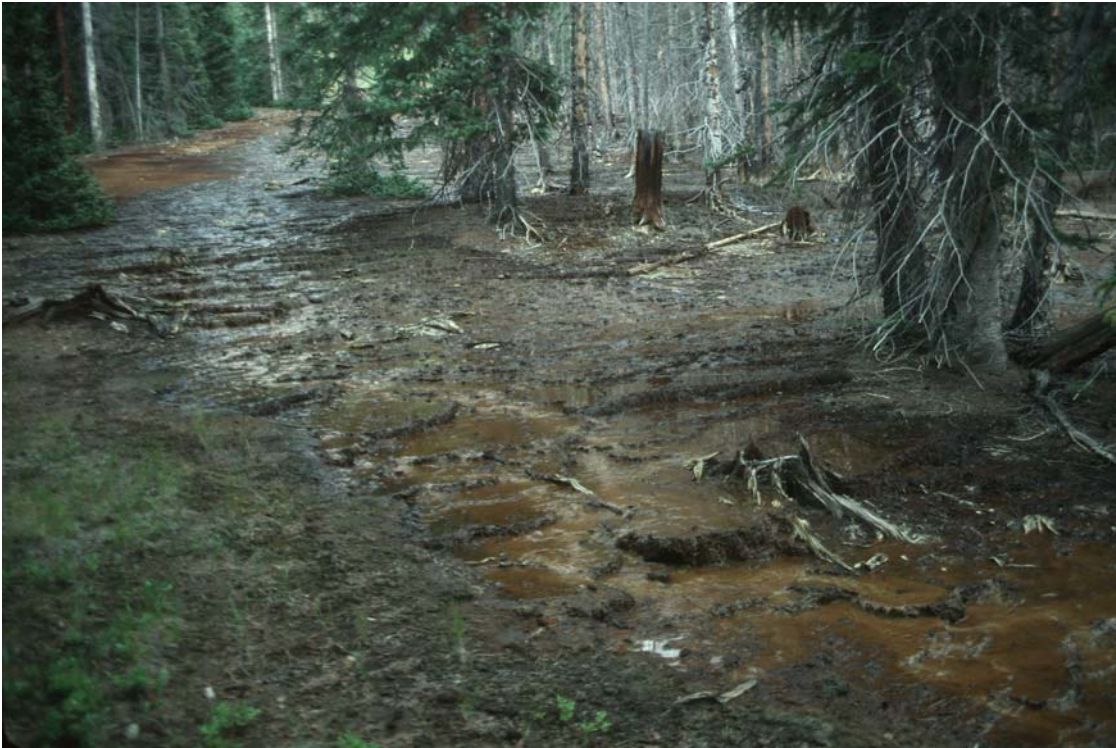
Figure 14. Effluent about 100 feet below Pass-Me-By Mine dump (#200).

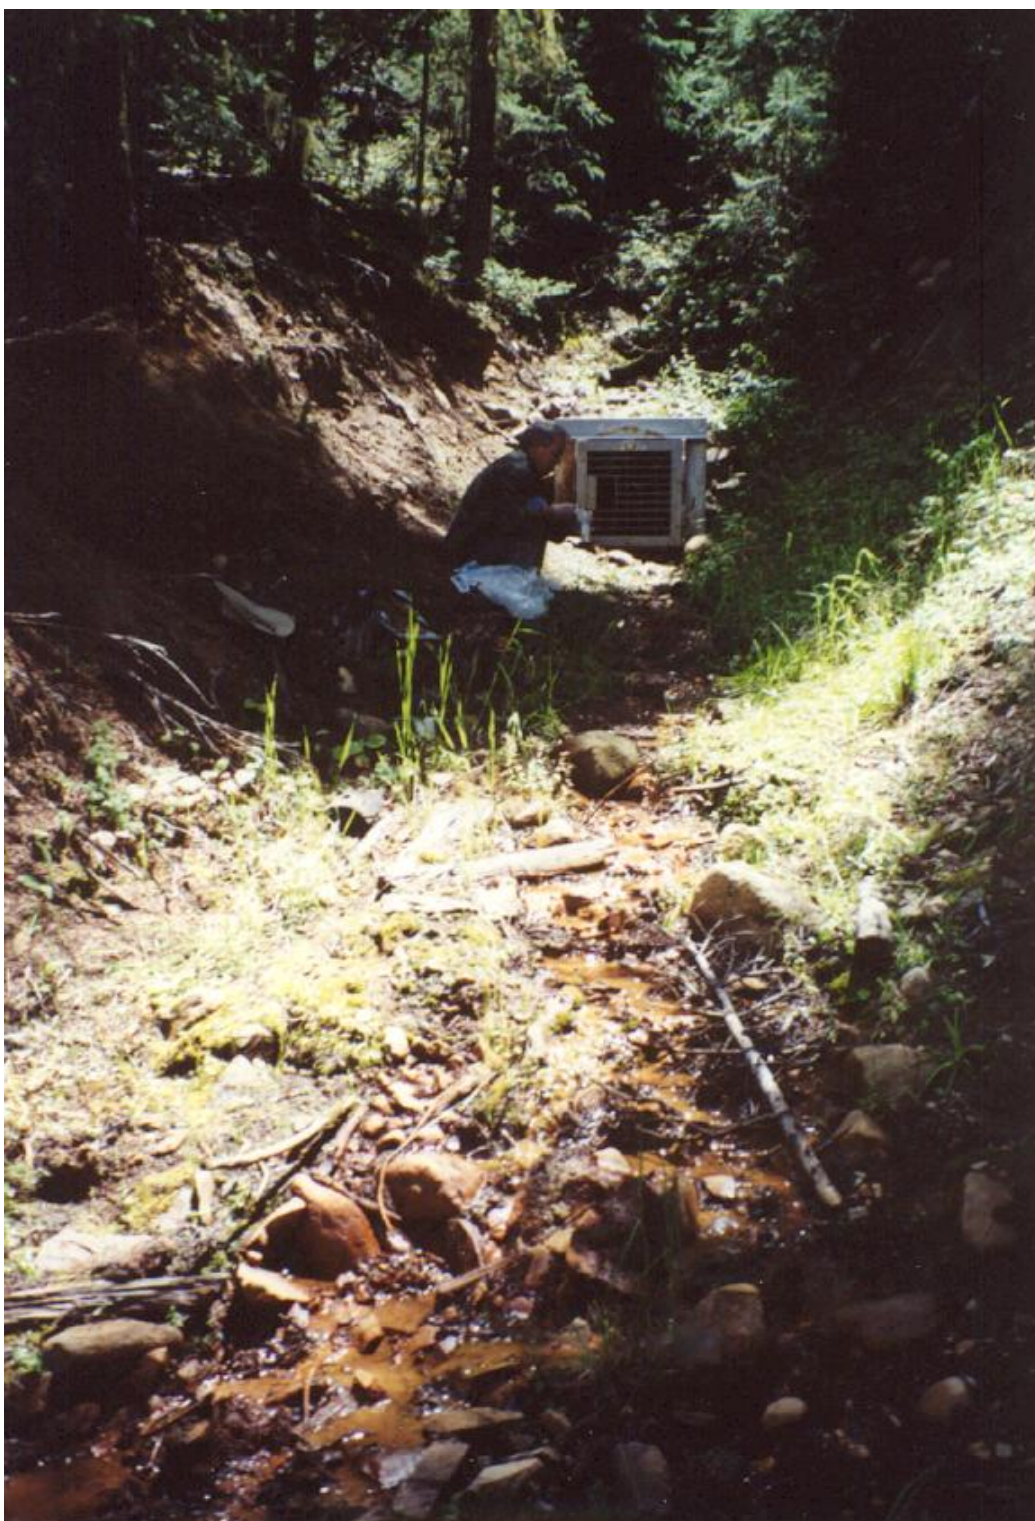
The Gilmore mine adit has been assigned an EDR of 3, and is the most significant environmental hazard known in the inventory area. In August of 2000, the portal effluent was flowing an estimated 0.5 gpm with pH of 6.66 and conductivity of 371 $\mu\text{S}/\text{cm}$, compared to 0.8 gpm with 5.29 pH and 276 $\mu\text{S}/\text{cm}$ in August of 1993. A water sample collected in 2000 (MH-2000-13) revealed that analytes exceeding State water quality standards included total recoverable iron and dissolved iron, and manganese (Table 3). The detection limits for dissolved chromium, silver, and total recoverable thallium were greater than the standards. Orange-red precipitate was observed in the effluent channel and on the filter during sampling (Appendix).

Figure 18. Adit #100 portal in Gilmore Meadow inventory area.

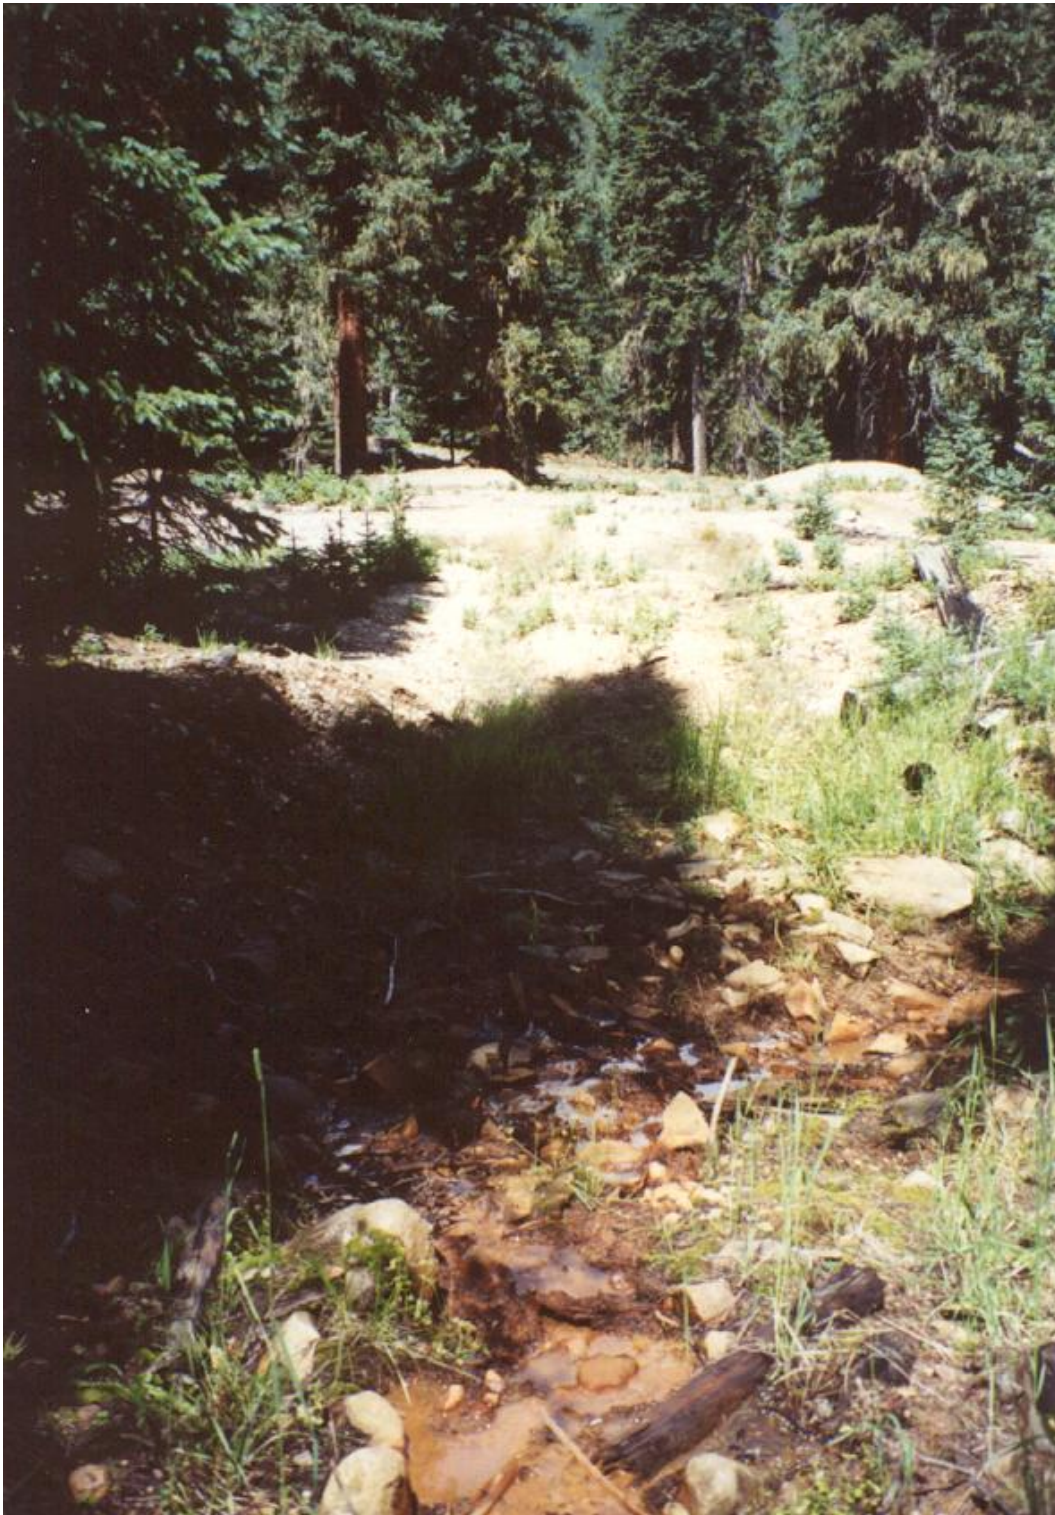
Figure 19. Effluent next to dump #200 in Gilmore Meadow inventory area.

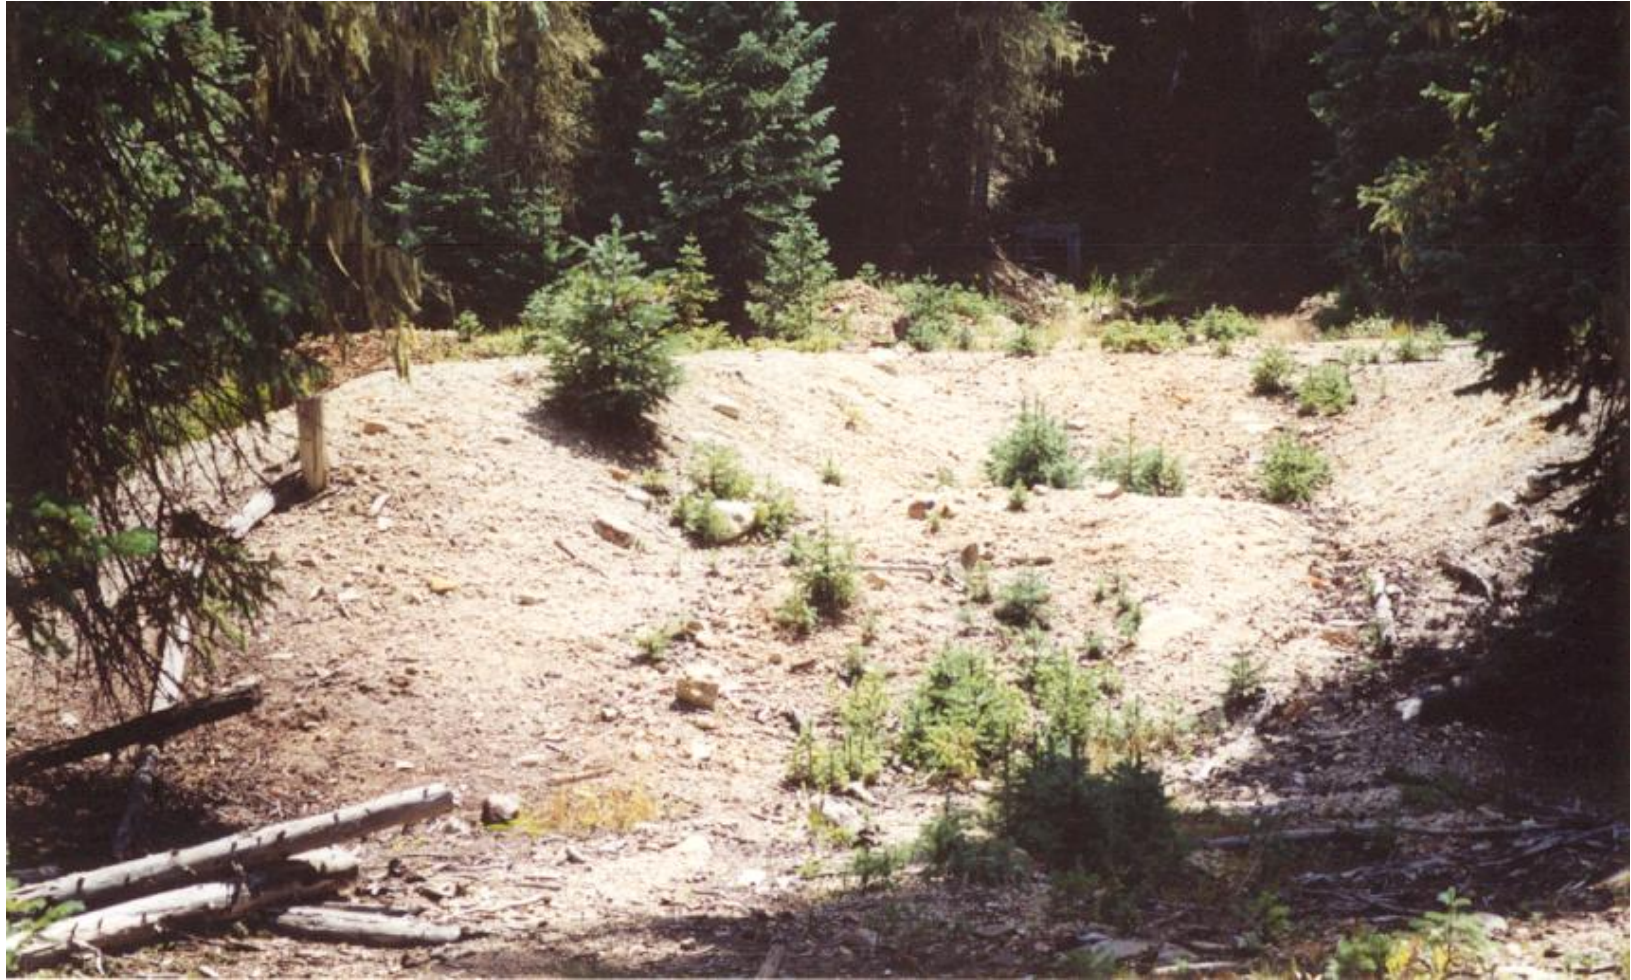
The Gilmore mine dump was assigned an EDR of 5, and is therefore not considered to be an environmental hazard. A composite sample (MWR-2000-4) collected from the dump (Table 4) revealed no significant anomalies. However, the sample is slightly acid generating as shown by the negative net acid base potential and the paste pH. In August of 2000, seeps were discharging from the toe of the dump in the wetlands, but samples could not be obtained. There is no record of the seeps having been sampled. The dump's aerial dimensions are reported as 100 ft by 50 ft, equaling a surface area of 5,000 sq. ft. Assuming annual precipitation of 45 inches (and neglecting evaporation and runoff), up to 0.3 gpm of precipitation could be infiltrating through the dump to ground water. If sulfide oxidation is occurring in the dump, then leaching of the dump could be contributing trace metals, and acidity could be released to ground water.

Figure 20. Dump #200 in Gilmore Meadow inventory area.

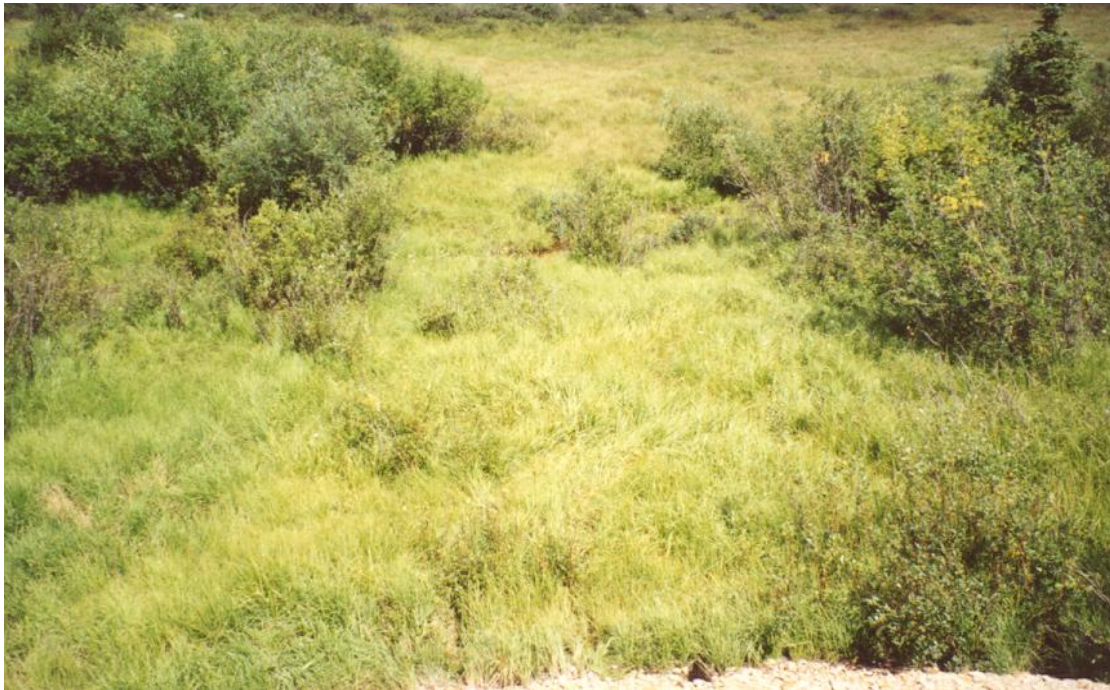
Figure 25. Globe Creek wetlands next to Globe Mine dump.

Globe Creek appears relatively clean above the Globe Mine, although some of the rocks in the channel are stained red. The upstream sample (MH-2000-10) had pH of 7.39 with conductivity of 161 $\mu\text{S}/\text{cm}$. No analytes exceeded State water quality standards, but the detection limits for dissolved chromium, silver, and total recoverable thallium were above the standard (Table 5). Downstream of the Globe Mine the red stain is more obvious and filamentous algae is common. The increase in visible degradation to the creek occurs gradually, beginning slightly upstream of the culvert. Test parameters at both locations were similar however.

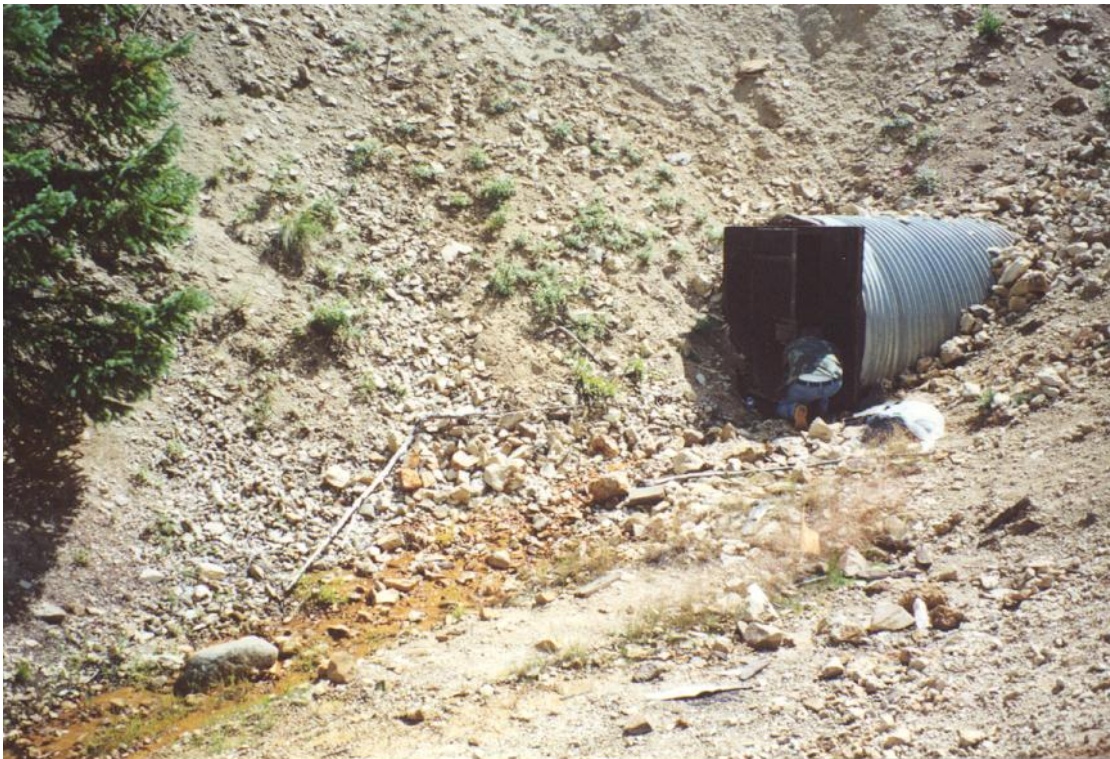
Figure 26. Globe Mine portal.

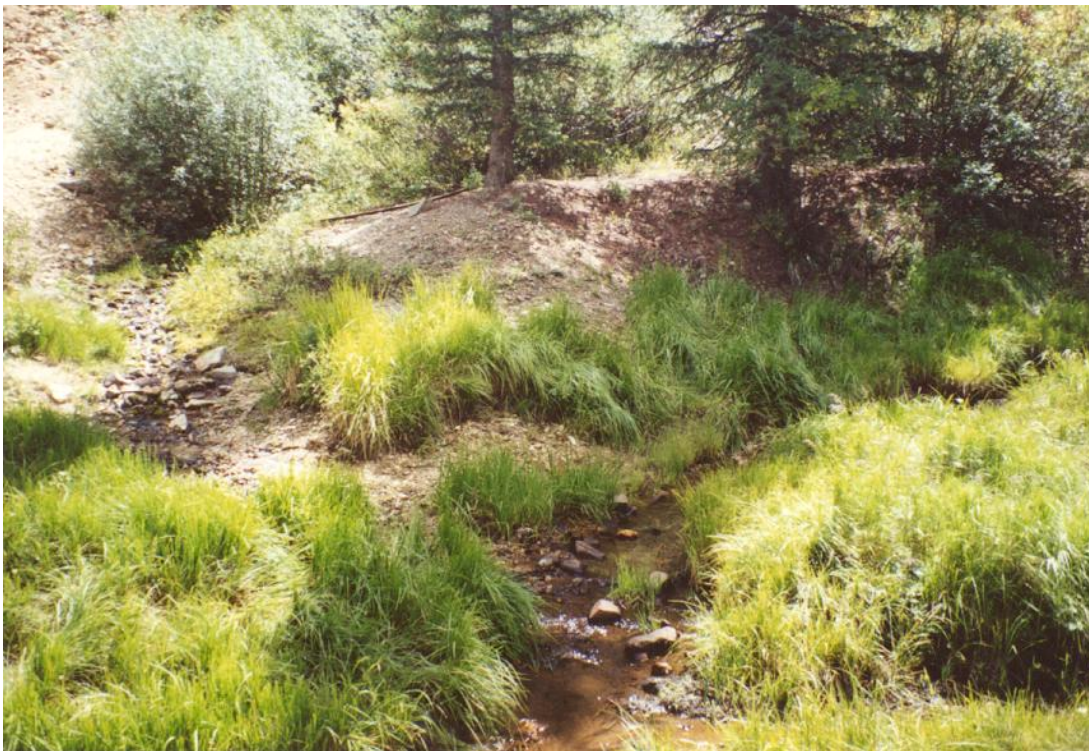
Figure 28. Effluent (left) entering Globe Creek (right) at toe of Globe Mine dump.

The dimensions of the dump are reported as 150 ft by 40 ft, equaling a surface area of 6,000 sq. ft. Assuming 45 inches of annual precipitation, it is possible that up to 0.3 gpm is infiltrating through the dump, potentially picking up metals and acidity, and discharging to Globe Creek or to ground water.

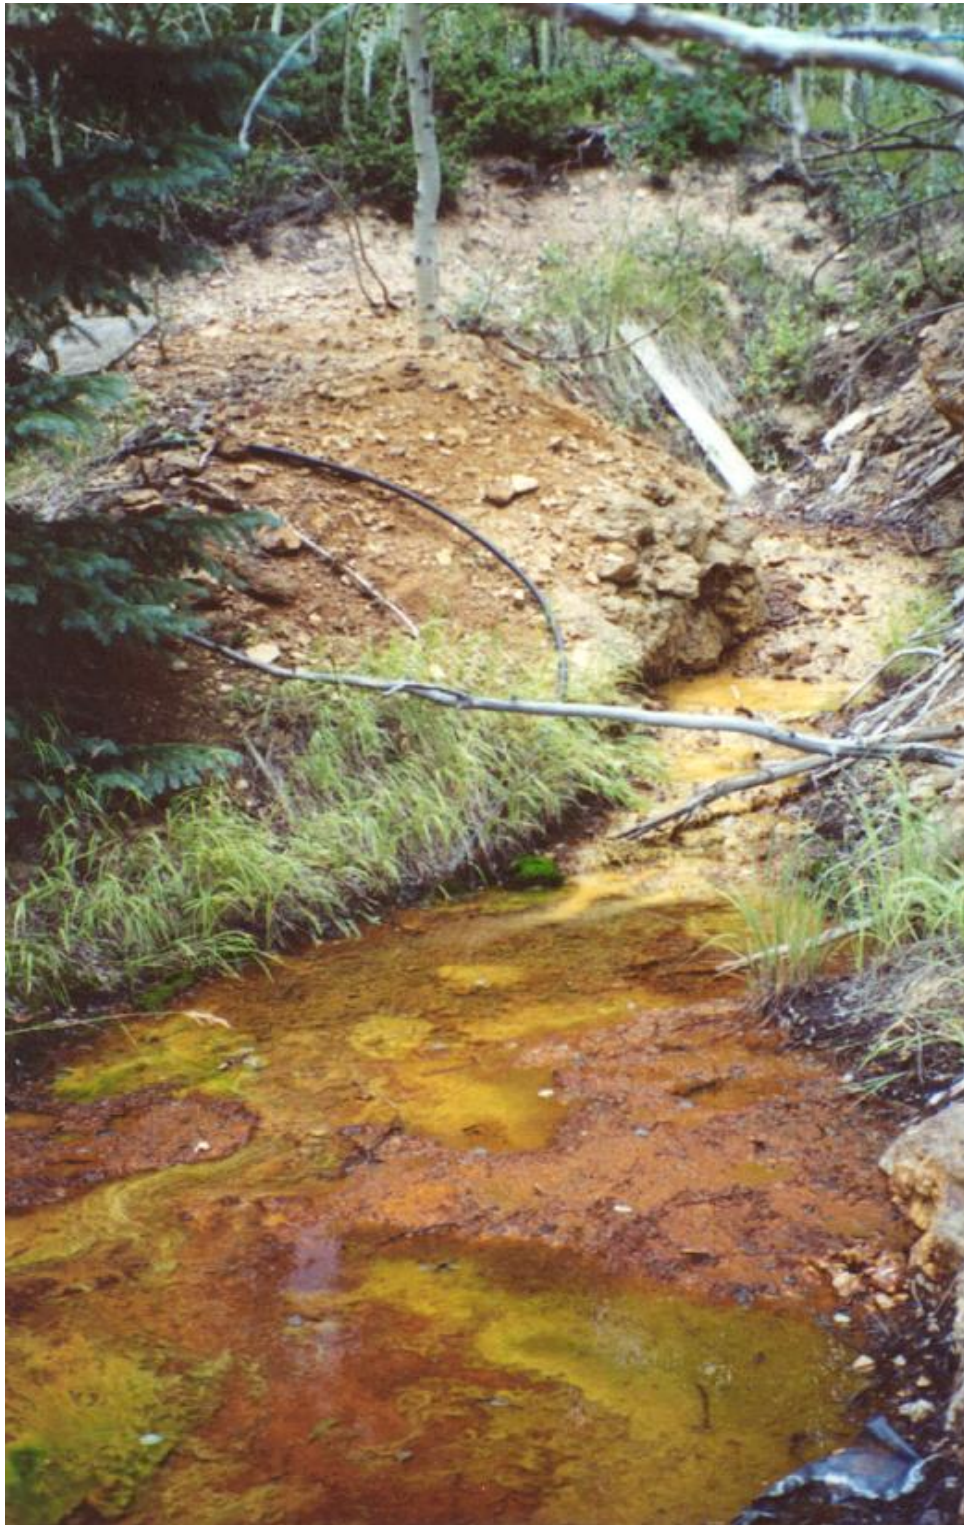
Adit #101 (Ferricrete Mine) was driven in Holocene colluvium overlying an unnamed Oligocene monzonite (Figure 3). The monzonite unit is a fine- to medium-grained, gray-colored intrusive rock that contains altered pyroxene and sparse biotite (Lipman, 1974). Ferricrete outcrops at the portal of adit #101 (Figure 32). Ferric-hydroxide precipitate from the mine effluent is forming a deposit of ferrosinter near the portal (Figure 33) and on the upper part of the dump (Figure 34).

Figure 32. Ferricrete outcrop at the portal of Ferricrete Mine adit #101.

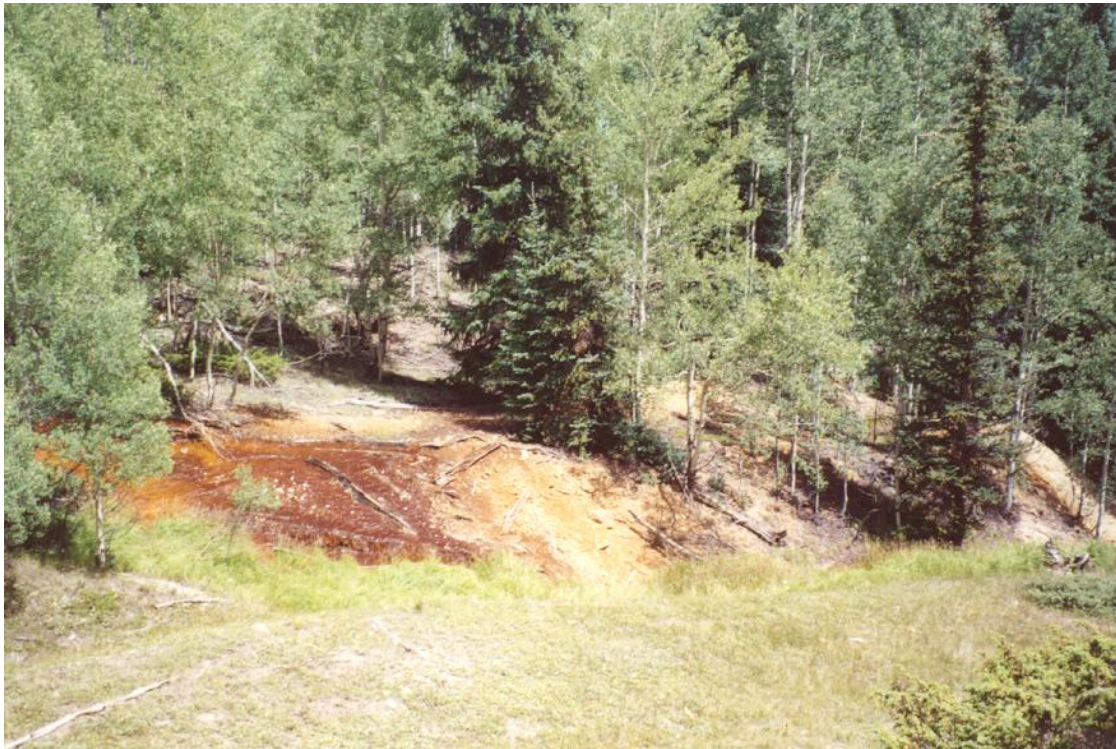
Figure 33. Iron-hydroxide precipitate and filamentous algal growth near portal of Ferricrete Mine adit.

Water was flowing from the partly collapsed portal at a rate of 0.8 gpm in August 1993 and 2.3 gpm in August 2000. On both occasions a flume was used to measure the flow rate. Above adit #101 the gulch was dry, suggesting that during part of the year the adit is the source of the water in the creek. Effluent spreads out over the dump bench and deposits abundant ferrosinter (Figure 35). Effluent drains into the creek on the southwestern side of the dump. The creek infiltrates into colluvium about 50 feet downstream from the top of the dump, then emerges 20 feet upstream from FR 250 and flows into the Alamosa River. Ferrosinter and ferricrete deposits are exposed in the stream channel above FR 250 and probably predate the mine.

The Ferricrete Mine adit is considered the most significant environmental hazard in the area, and has been assigned an EDR of 2. In August of 1993 the flow from the adit was measured at 0.8 gpm with pH of 3.98 and conductivity of 682 $\mu\text{S}/\text{cm}$. A water sample from the adit discharge had the chemical signature shown in Table 7.

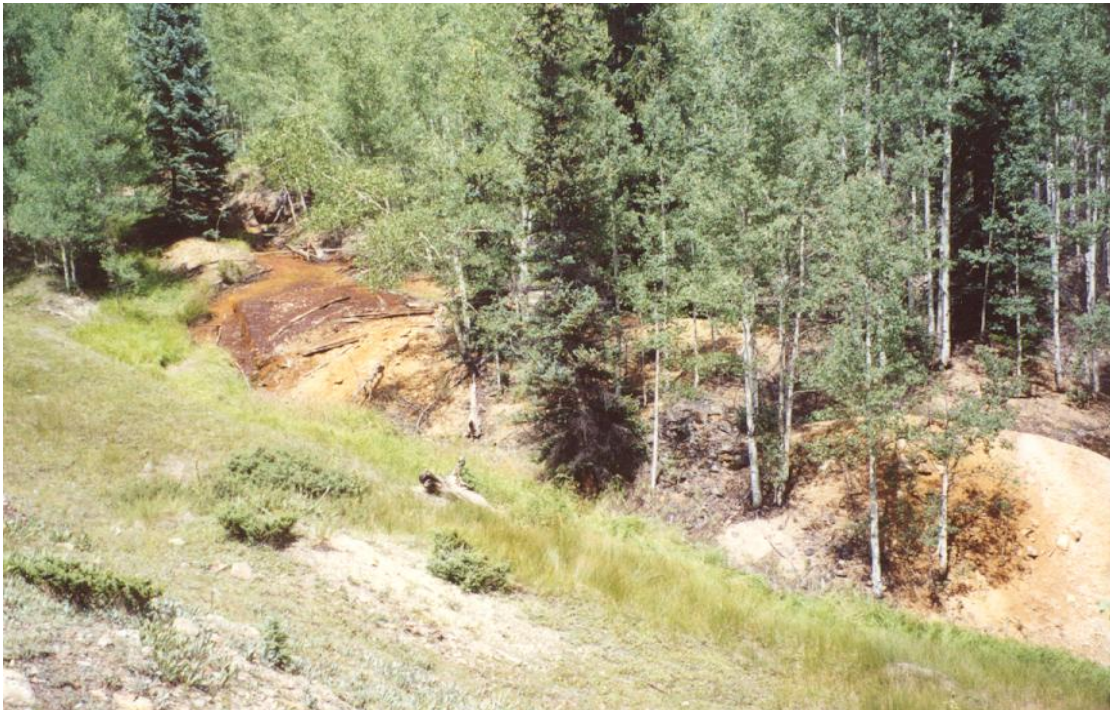
Figure 34. Ferricrete Mine dump #201. Upper photo is view to northeast, lower photo is view to southeast.

The Ferricrete Mine dump has been assigned an EDR of 4, indicating slight environmental degradation. The dump abuts the unnamed creek and has been partially eroded by it. The creek also flows over part of the dump, so it is reasonable to assume that the dump leaches metals and acidity to the stream. The combined surface area of the four dumps inventoried in the area is over 4,000 sq. ft. Assuming annual precipitation of 45 inches, up to 0.2 gpm of precipitation could be infiltrating into the dumps and mobilizing acidity and trace elements to ground water.

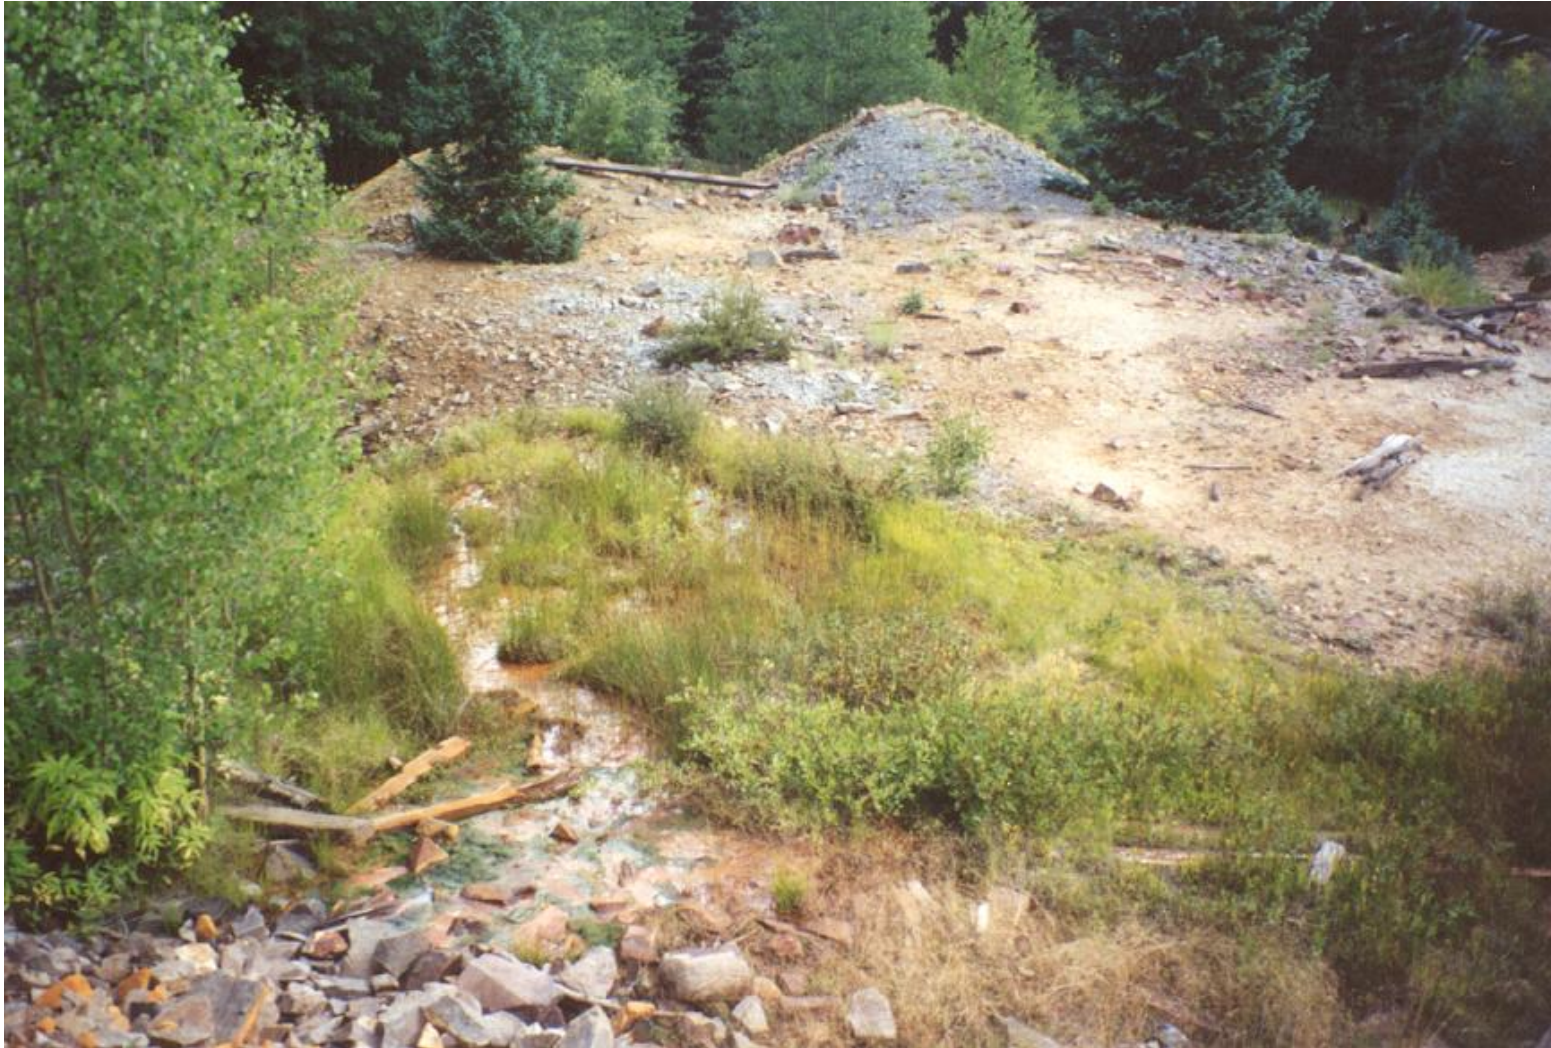
Figure 37. Water from Eastern Star adit #101 and wetland on dump #201 bench.
