OPEN-FILE REPORT 03-14

**History, Geology, and Environmental Setting
of Selected Mines in the Upper Alamosa River
Basin, Rio Grande National Forest,
Conejos and Rio Grande Counties, Colorado**

**By
Robert H. Wood II
John T. Neubert
and
David A. Bird**

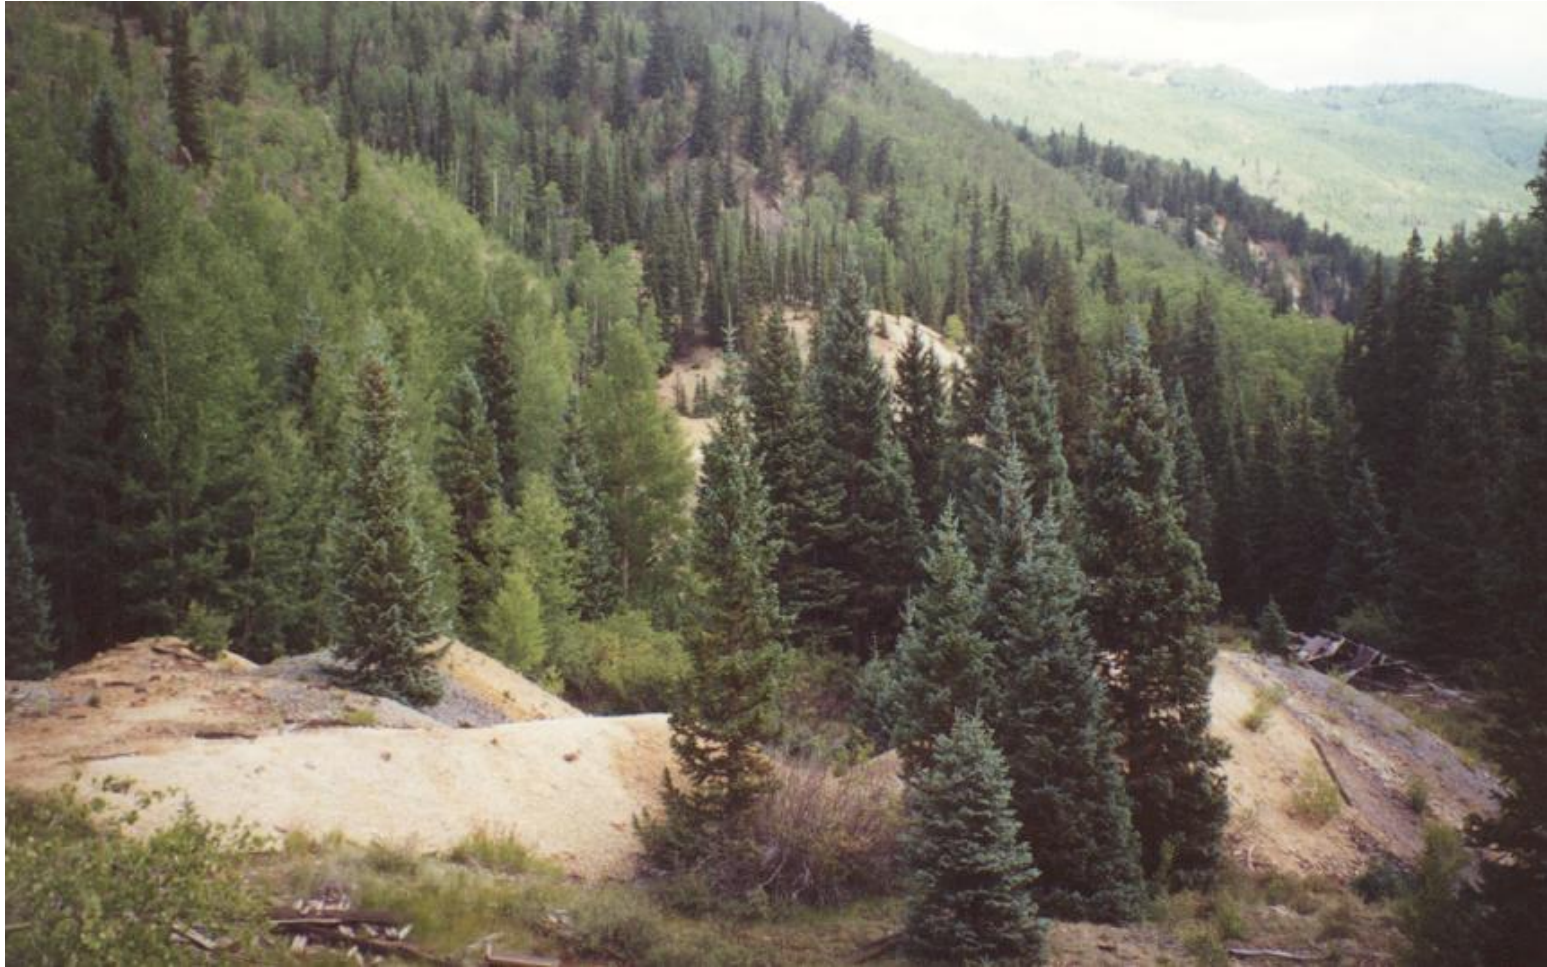
Dump #101 contains about 1,000 cubic yards of mostly light yellow waste rock with some gray and reddish areas. The yellow and reddish areas appear mineralized; gray material appears to be barren country rock. The dump has several lobes with a large pile on the east, close to the Alamosa River (Figures 39 and 40). Dump material is highly variable in size.

Figure 39. Side view of Eastern Star dump #201 looking north.

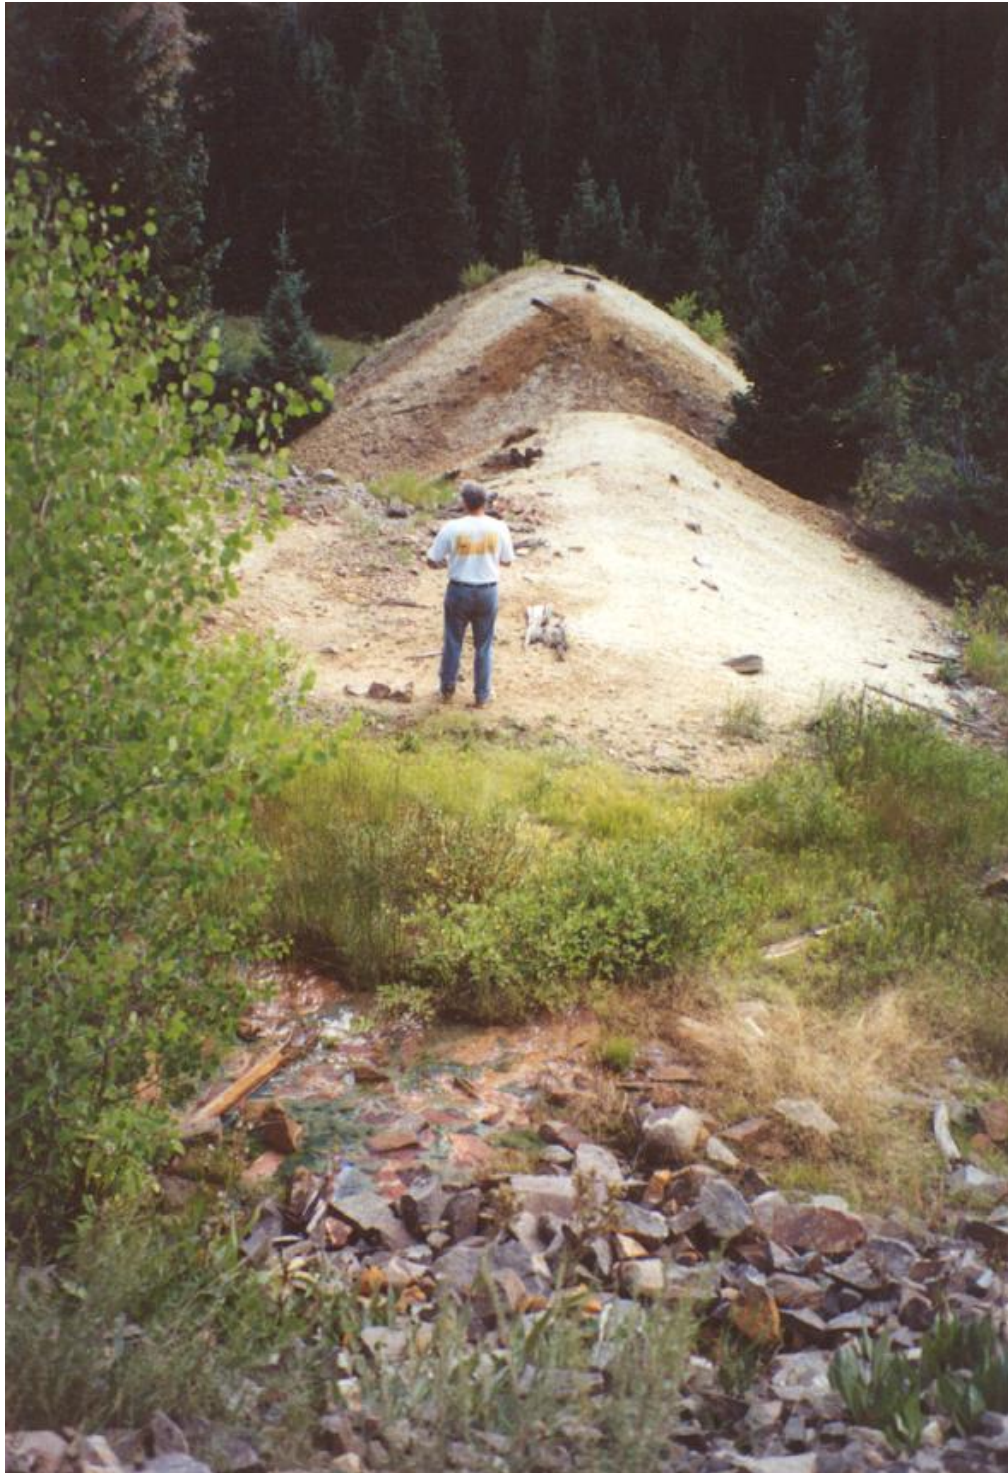
Figure 40. Eastern Star dump #201 bench.
