OPEN-FILE REPORT 05-01

**MINE SITE HISTORY AND WATERSHED
CHARACTERIZATION OF THE CINNAMON
GULCH AREA, DILLON RANGER DISTRICT,
WHITE RIVER NATIONAL FOREST,
SUMMIT COUNTY, COLORADO**

Colorado Geological Survey
Department of Natural Resources
Division of Minerals and Geology
Denver, Colorado
2005

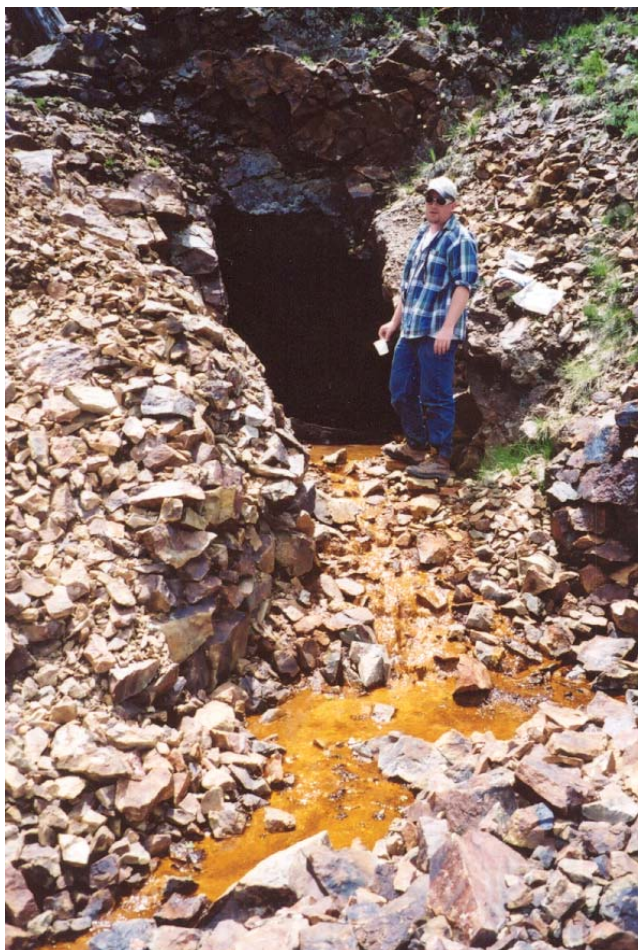
Water from a pool just inside the open adit (Figure 7) flows onto the bench and down the southern side of the upper lobe of the waste-rock pile (Figure 8). The effluent eventually disappears in the grass along the southern side of the dump. Reddish-orange precipitate was deposited in the channel from the slightly turbid effluent.

Figure 7. Adit #103 (Rich Ore Lode) showing effluent with orange precipitate.

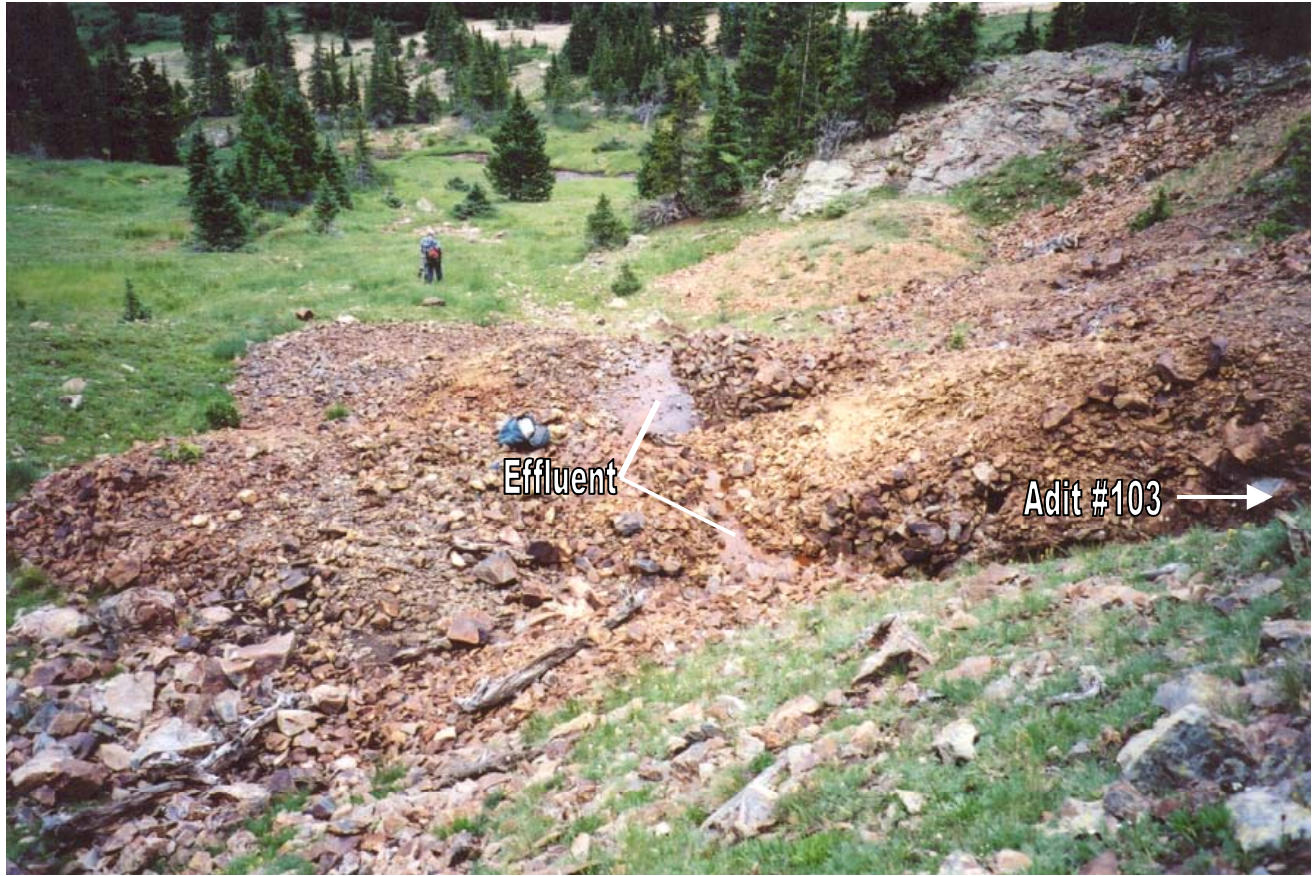
Four separate adits discharge water along the Rich Ore Lode, including adits #100, #101, #103, and an adit that was not inventoried in 1993. In July of 2001, the combined flow from the four adits was measured at about 4.5 gpm. The pH ranged from 3.16 to 3.58, and conductivity ranged from 287 to 611 $\mu\text{S}/\text{cm}$. In October of 2001, only one of the four adits was flowing (adit #100), at a rate of about 1 gpm. Standing water was present at the other three. The pH ranged from 2.91 to 3.21, and conductivity ranged from 464 to 593 $\mu\text{S}/\text{cm}$. Water samples were collected from all adits with flowing or standing water (high-flow samples CG-13 through CG-16, and their low-flow counterparts CG-22 through 25). Sample locations are shown on Figure 3, and water chemistry data are shown on Table 2.

Figure 9. Waste-rock pile and effluent from adit #103.

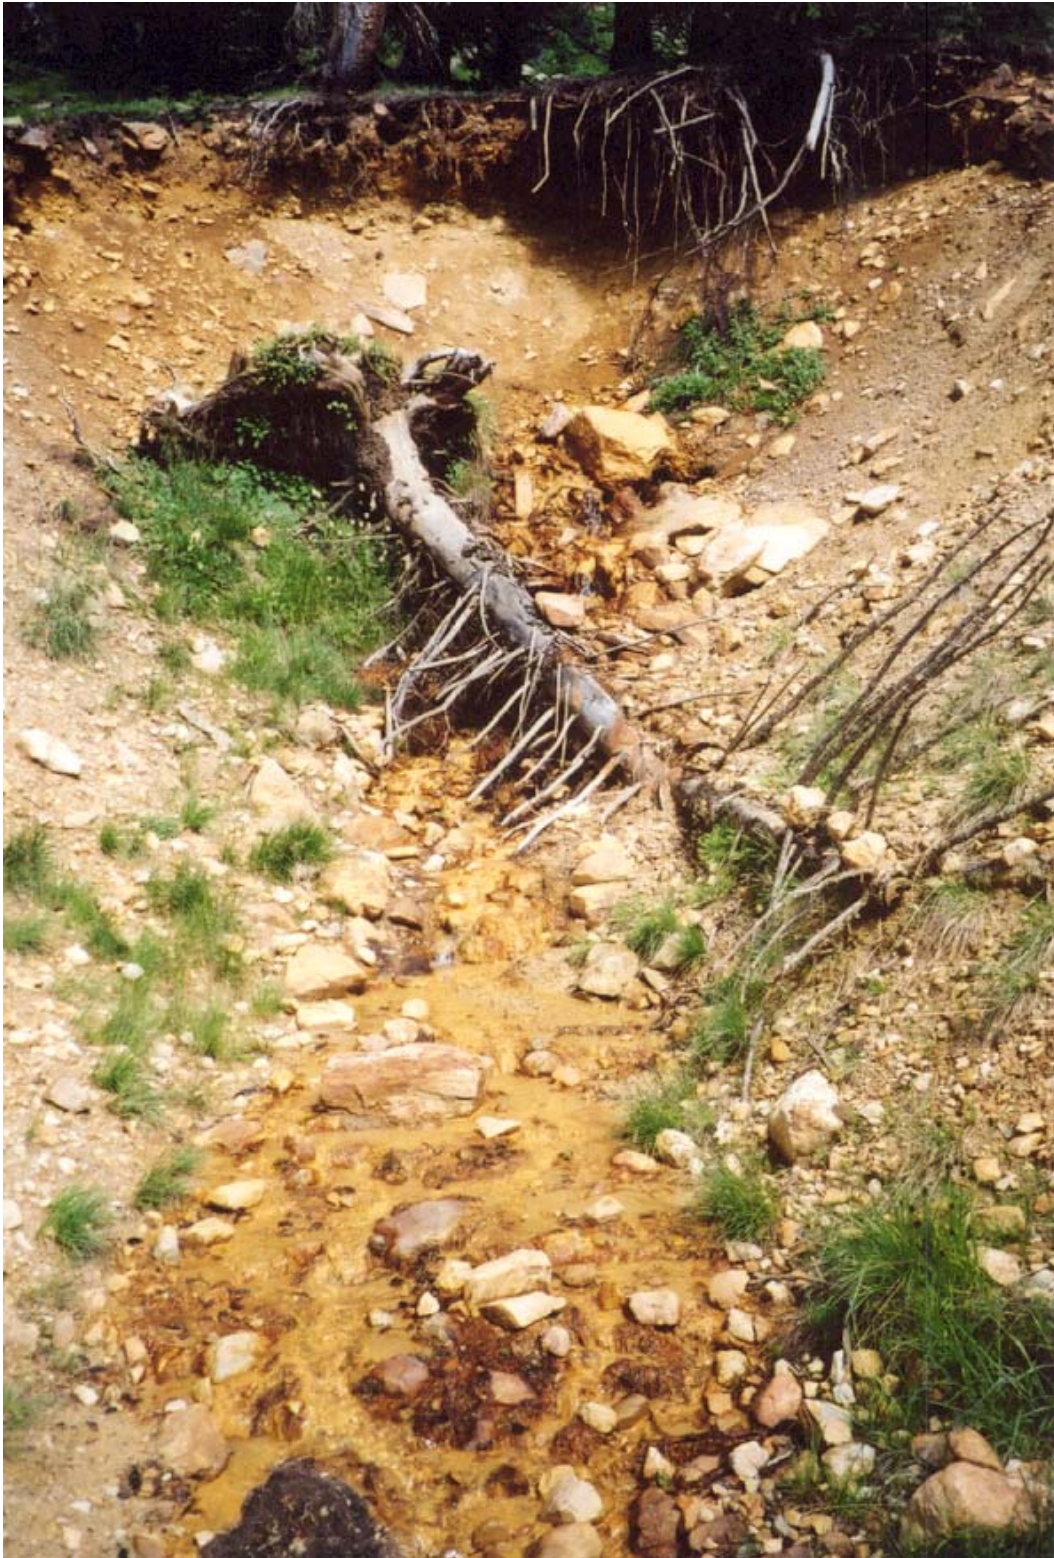
Adit #106 was assigned an EDR of 2, indicating “significant environmental degradation,” apparently due to the drainage effluent. Adit #105 was assigned an EDR of 4, indicating only “slight” environmental degradation. However, the notes on the inventory field data form report “significant” environmental degradation associated with adit #105. At the time of the inventory, adit #105 had a more neutral pH (6.0) and lower conductivity (200 $\mu\text{S}/\text{cm}$) than adit #106 (pH of 4.0; conductivity of 200 $\mu\text{S}/\text{cm}$). The inventory reports no physical hazards associated with either of the two adits.

Figure 15. Effluent emerging from caved Delaware Tunnel (adit #106).

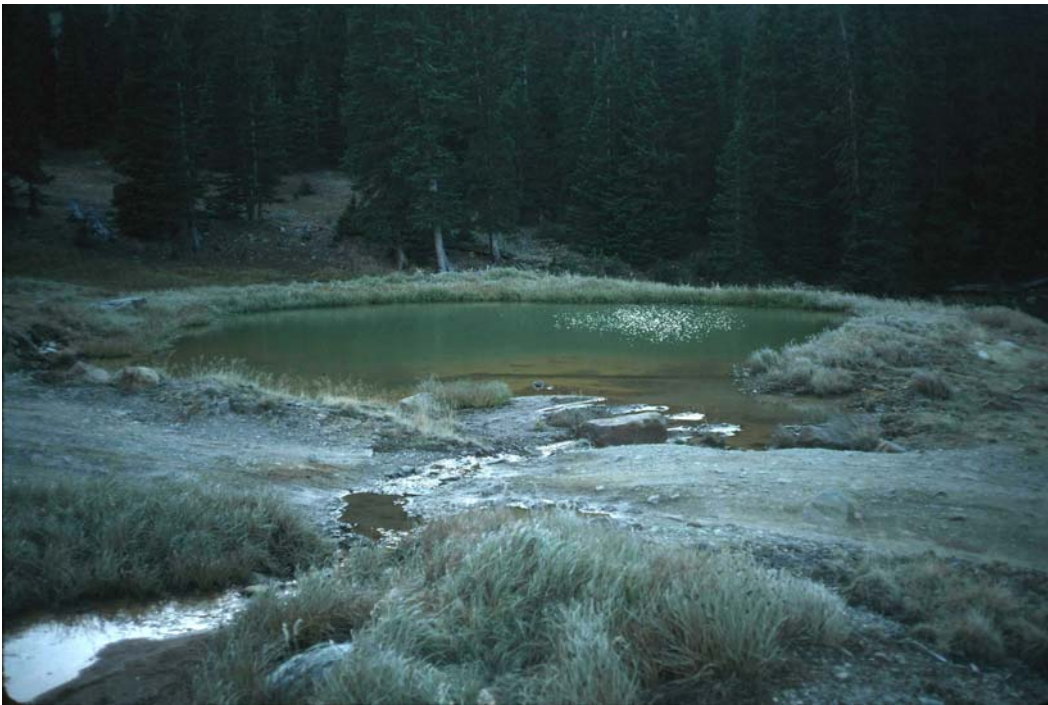
Figure 17. Effluent path from Delaware Tunnel crossing FR #262 to settling pond.
Photo from September 1993 inventory.

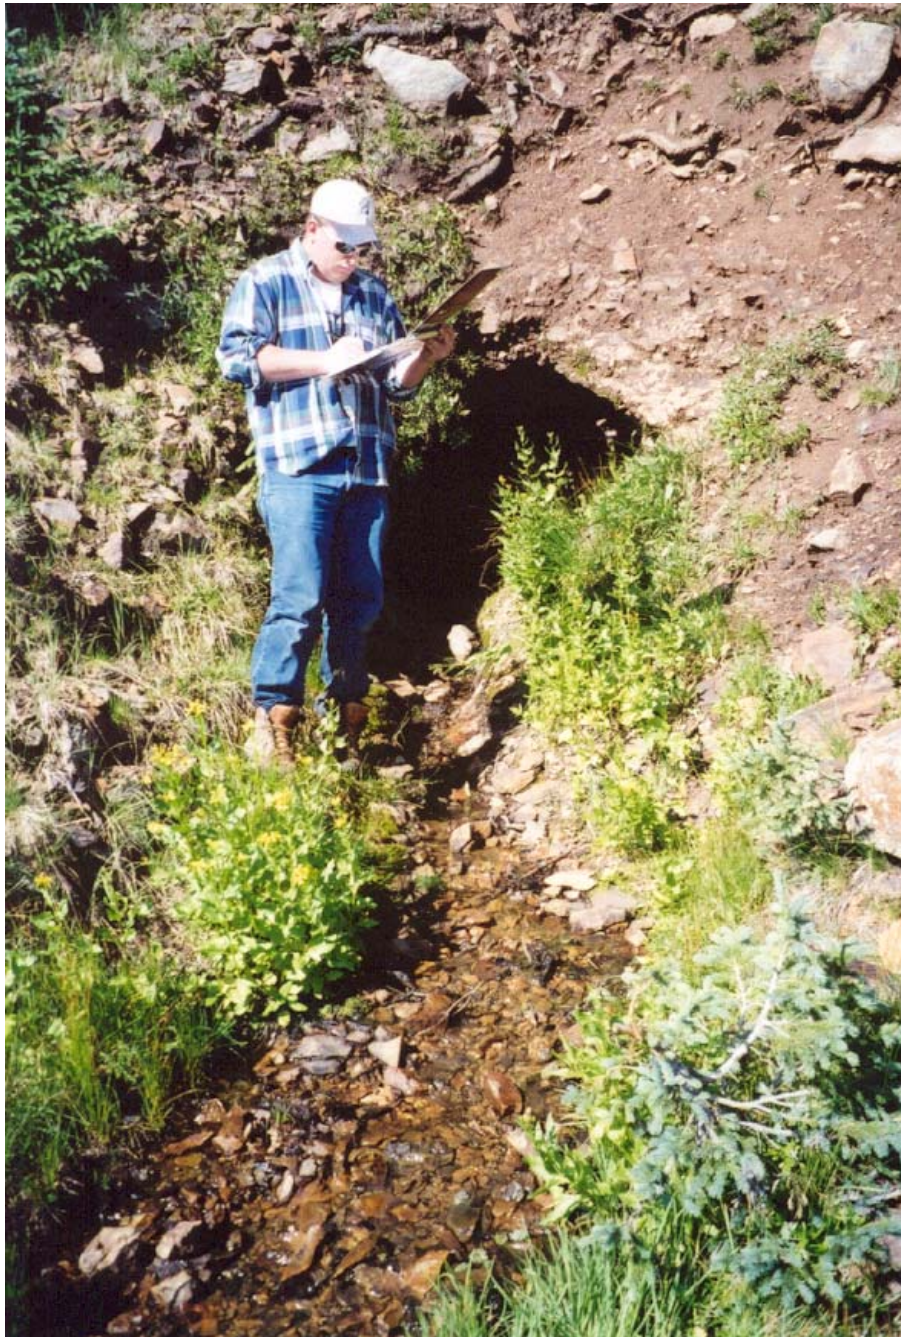
Effluent from Adit #105 (Figure 23) flows from a pool just inside the open adit forming a saturated area on the dump bench about 20 feet from the portal (Figure 24). From the saturated area the effluent flows down the south side of the dump and infiltrates into the coarse dump material. The effluent is clear, and supports the growth of grass and moss. Minor red precipitate was visible in the channel and was deposited on the filter during sampling. During episodes of higher flow, the effluent probably discharges to an intermittent creek on the south side of the

Figure 23. Effluent emerging from adit #105.

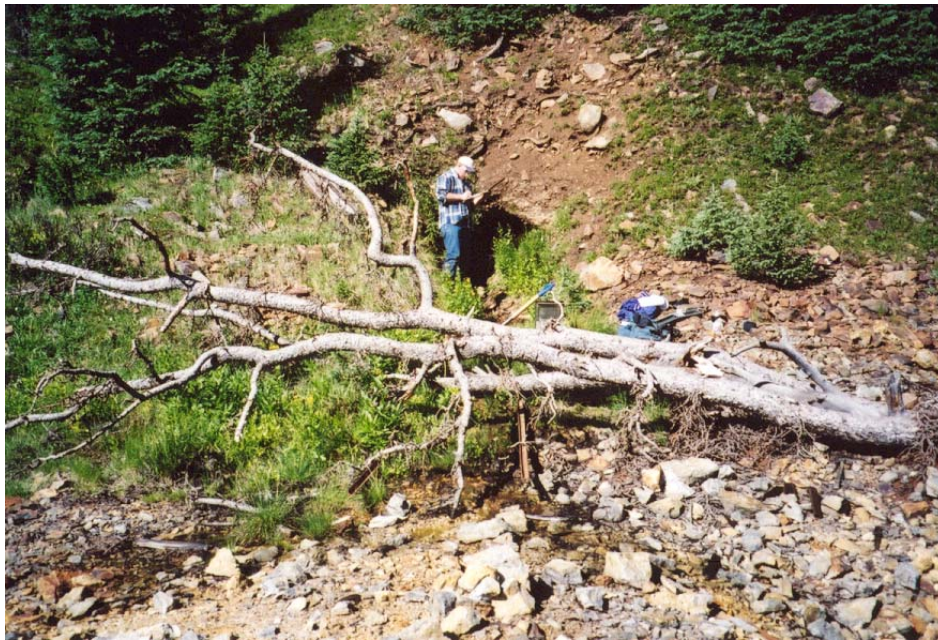
Figure 24. Adit #105 dump bench showing vegetation growth along effluent path.

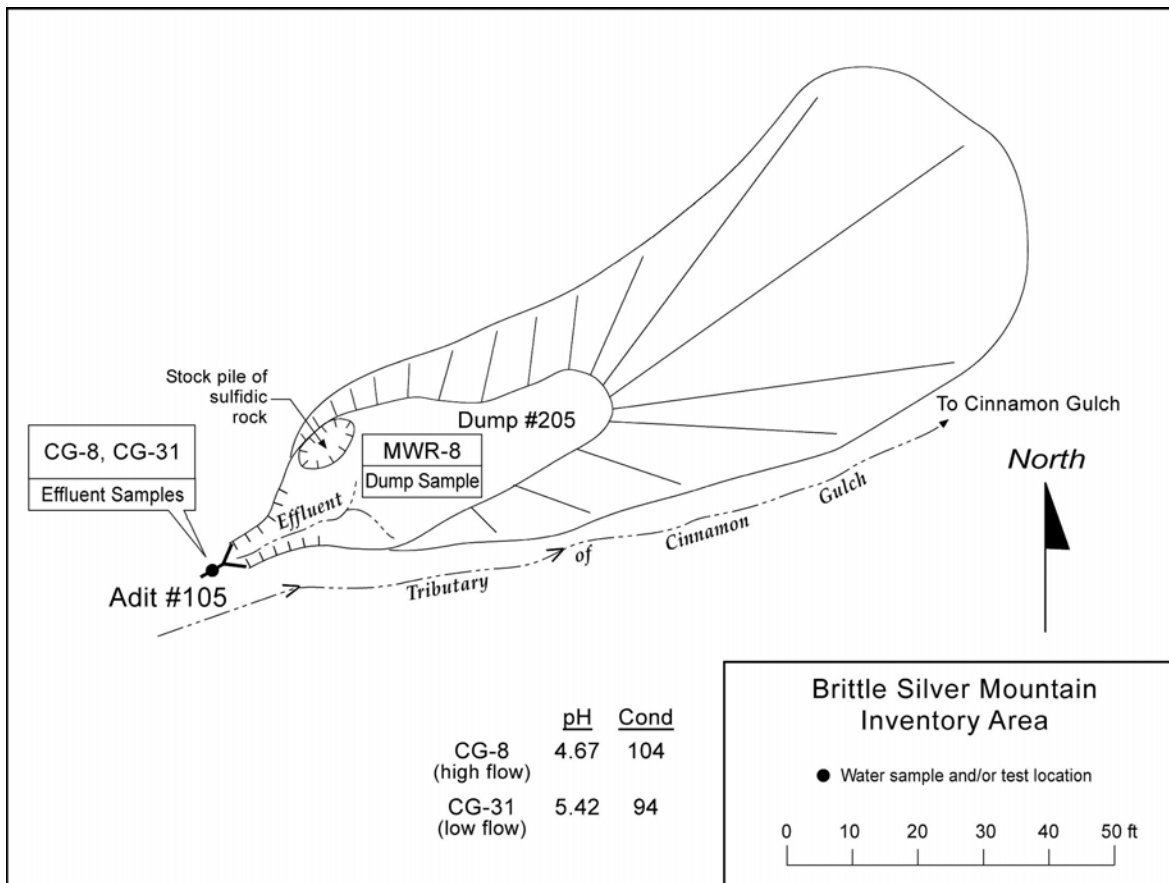
Figure 25. Schematic diagram of adit #105 and waste rock dump.

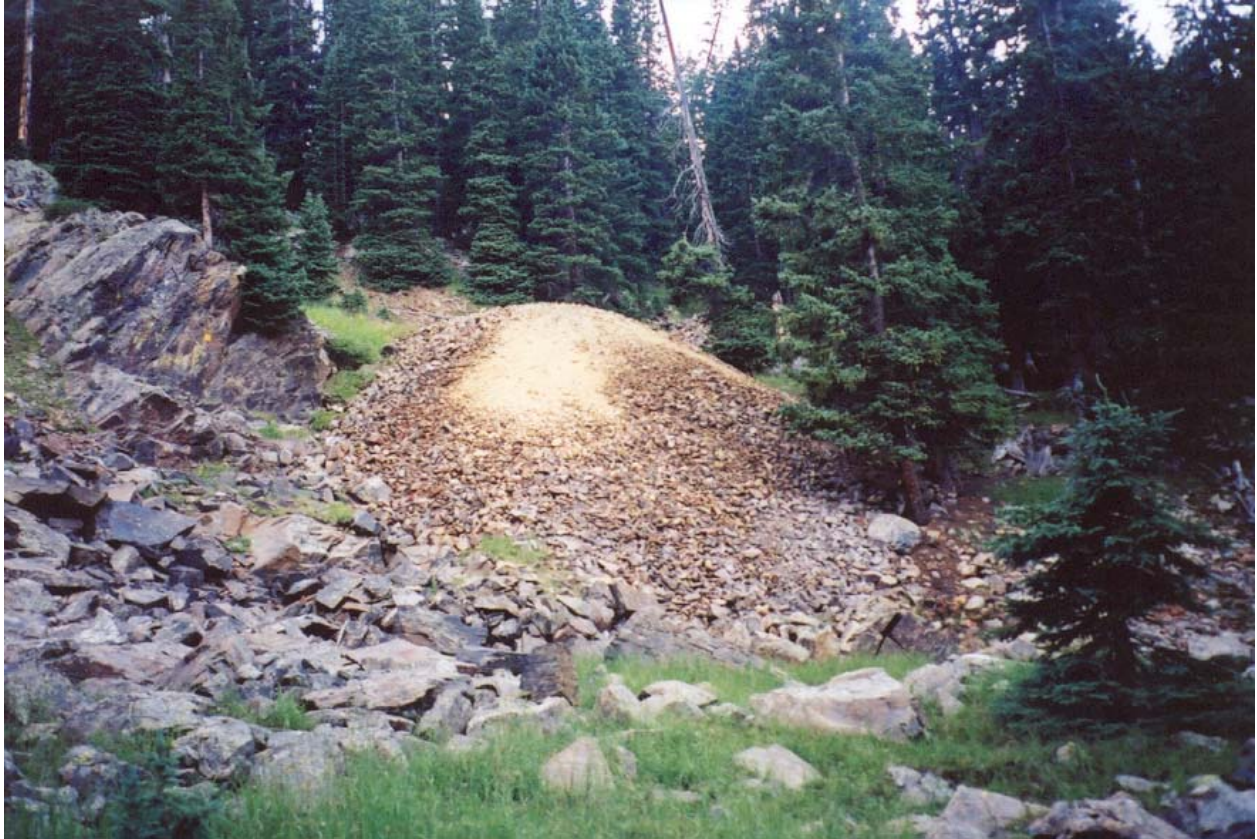
dump. Most of the water near the base of the dump probably is derived from the intermittent creek. However, some seepage could originate from the base of the dump. The intermittent creek does not appear to flow directly into Cinnamon Gulch Creek. The associated waste-rock dump (dump #205) contains nearly 1,000 cubic yards (inventoried at 2,500 cubic yards) of mostly coarse material (Figures 25 and 26). Quartz vein material on the dump contains abundant pyrite and moderate amounts of sphalerite.

Figure 26. Waste rock dump associated with adit #105.

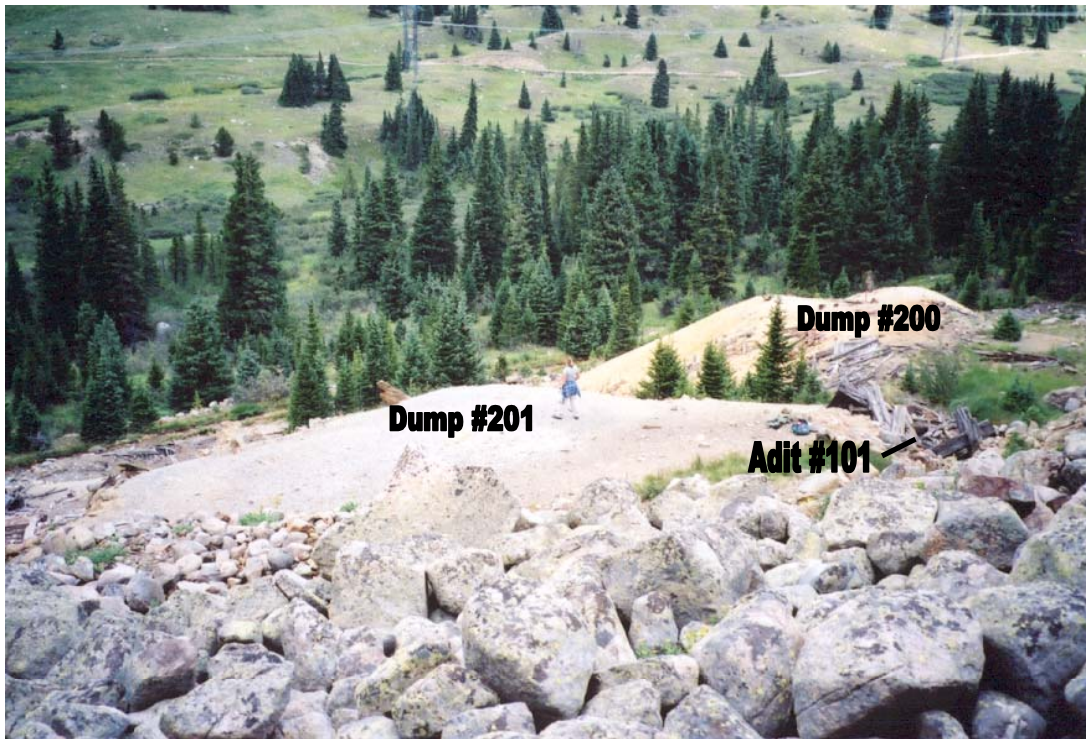
Effluent from the caved adit #101 emerges from a rocky area, possibly on NFS land above the Brittle Silver mill site. The effluent flows through the old timbered ruins of the collapsed portal covering and infiltrates between dumps #201 and #200 (Figure 27). The effluent is clear and supports grass and moss below the portal ruins. Minor amounts of reddish precipitate were observed on rocks in the channel, and were deposited on the filter during sampling. Mostly gravel to finer size material covered the surface of the 500-cubic-yard (inventoried at 2,500 cubic yards) dump #201 (Figure 27). Abundant pyrite, minor to moderate sphalerite, and rare galena are associated with the quartz vein material. Cobble size quartz vein material, stockpiled above the western side of the dump, could represent material hauled in from other mines for processing in the Brittle Silver Mill. A retaining wall keeps most of the dump material from the mill area below (Figure 28).

Figure 27. Adit #101 (collapsed portal timbers), dump #201, and dump #200.

Adit #101 was assigned an EDR of 4, indicating “slight environmental degradation,” apparently due to the drainage effluent. Adit #105 was also assigned an EDR of 4 due to drainage. Adit #101 was assigned a physical hazard rating of 5, indicating no danger. Adit # 105 was assigned a physical hazard rating of 3, due apparently to unobstructed access and its 50-ft depth.

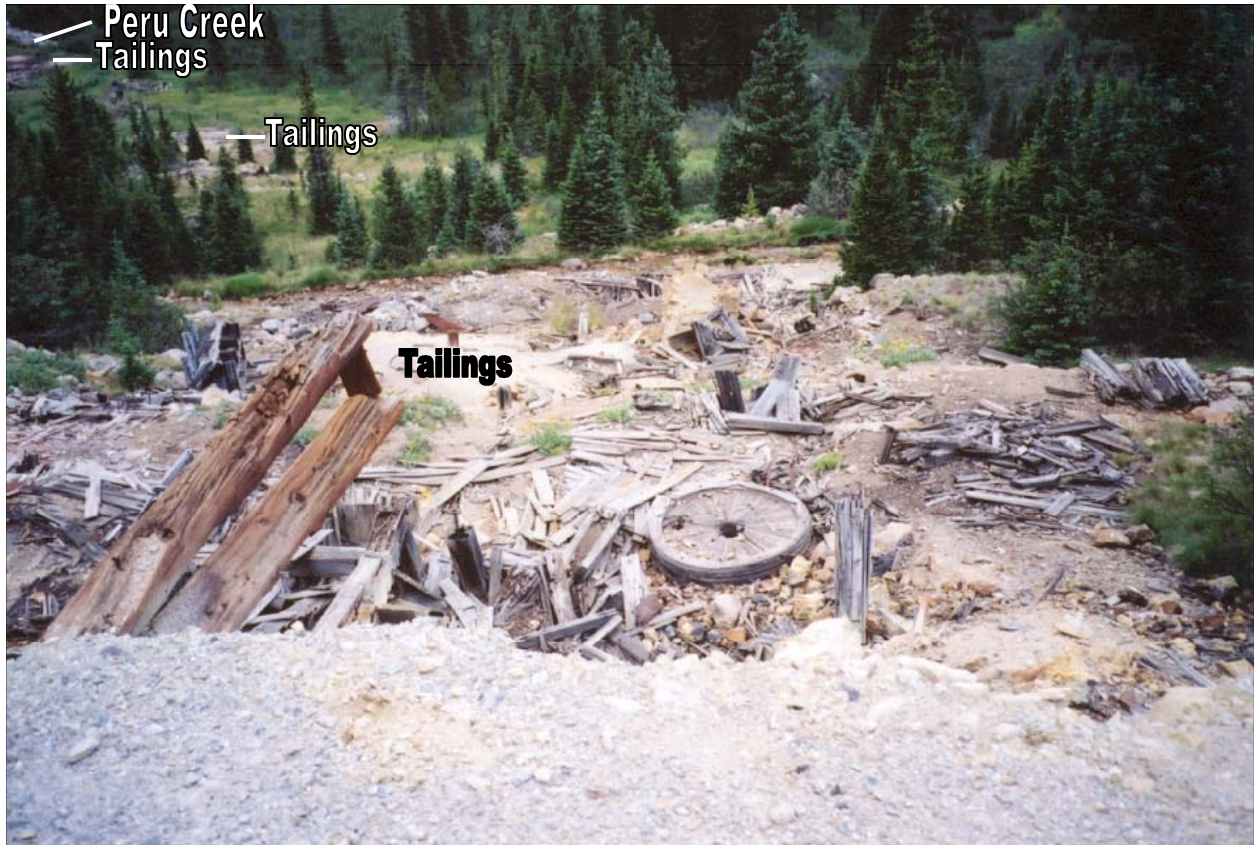
A series of retaining walls concentrate the sand and finer size tailings below the mill (Figures 28 and 29). No samples were collected from the 50-cubic-yard pile of tailings retained behind a rock wall near the base of the mill. A seep below the tailings at the base of the mill was too small to test or sample. No samples were collected from a small quantity of tailings mixed with a line of boulders, probably an old retaining wall, about 100 feet below the road. Numerous springs emerge between the road and the line of boulders. Grass, moss, and filamentous algae flourish in this area. Samples were collected from the tailings partly retained by a wooden wall about 200 feet below the road and from the lowest pile, about 75 feet above Peru Creek (Figures 30-32). The dense growth of grass between the lowest tailings pile and Peru Creek could be covering an earth dam. The main channel of Cinnamon Creek cuts back toward the east between the two lower tailing piles. At one time the creek probably flowed into a settling pond constructed west of the lower tailing pile. During the present investigation, no water was flowing directly into the settling pond from Cinnamon Creek and no water was flowing from the settling pond. During episodes of higher flow, some water could enter the pond and flow into Peru Creek from two low areas along the dam. Most of the area between the road and lowest tailings pile is wet and supports a dense growth of grass. Thicker accumulations of tailings are barren of vegetation. Water from Cinnamon Creek mixing with Peru Creek below the lowest tailings pile produces a reddish-orange precipitate coating on the streambed of Peru Creek (Figures 33 and 34). Upstream from this mixing zone the Peru Creek streambed has a white precipitate coating.

Figure 29. Brittle Silver Mill ruins. Dump #201 in foreground.

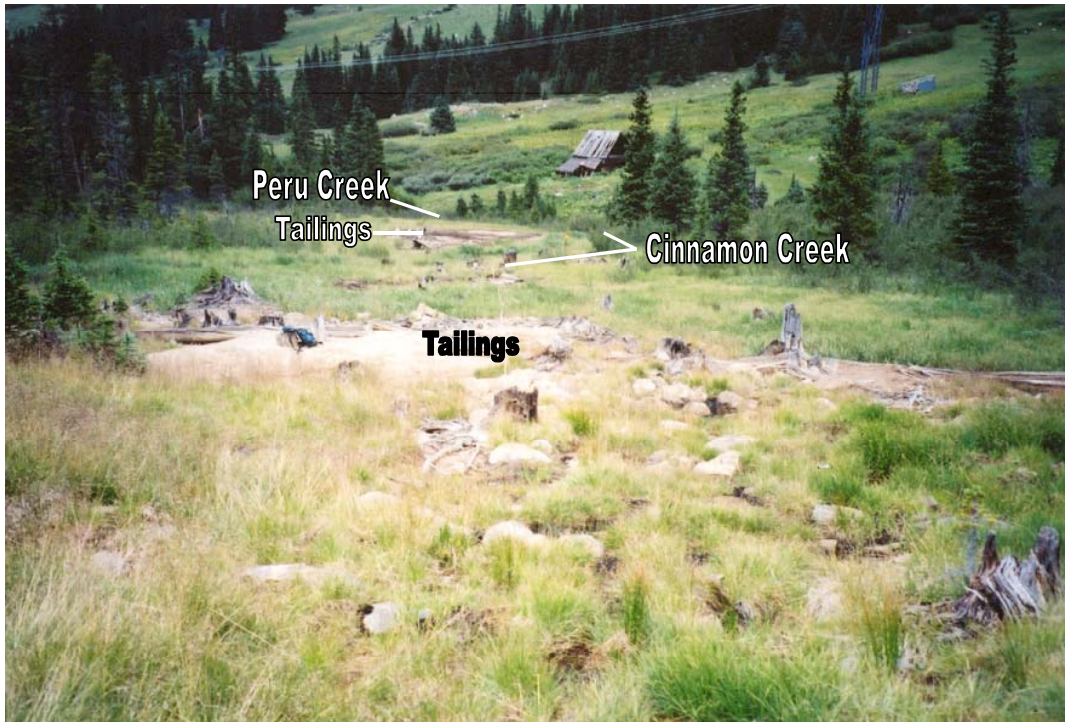
Figure 31. Two lower Brittle Silver Mill tailings piles (#205).

The Brittle Silver Mountain tailings (#205, inventory area #429/4383-1) was assigned an EDR of 4, apparently due to water flowing over and through the pile and into the Cinnamon Gulch watershed. Effluent from the tailings was flowing at an estimated 0.5 gpm during the 1993 inventory, with pH of 4.4 and conductivity of 100 µS/cm. The volume of tailings was estimated to be 2,900 yds, and was designated as stable in the 1993 inventory, but the upper pile was described as unstable in the CGS 2001 investigation. Gullies and evidence of sheet wash erosion were observed.

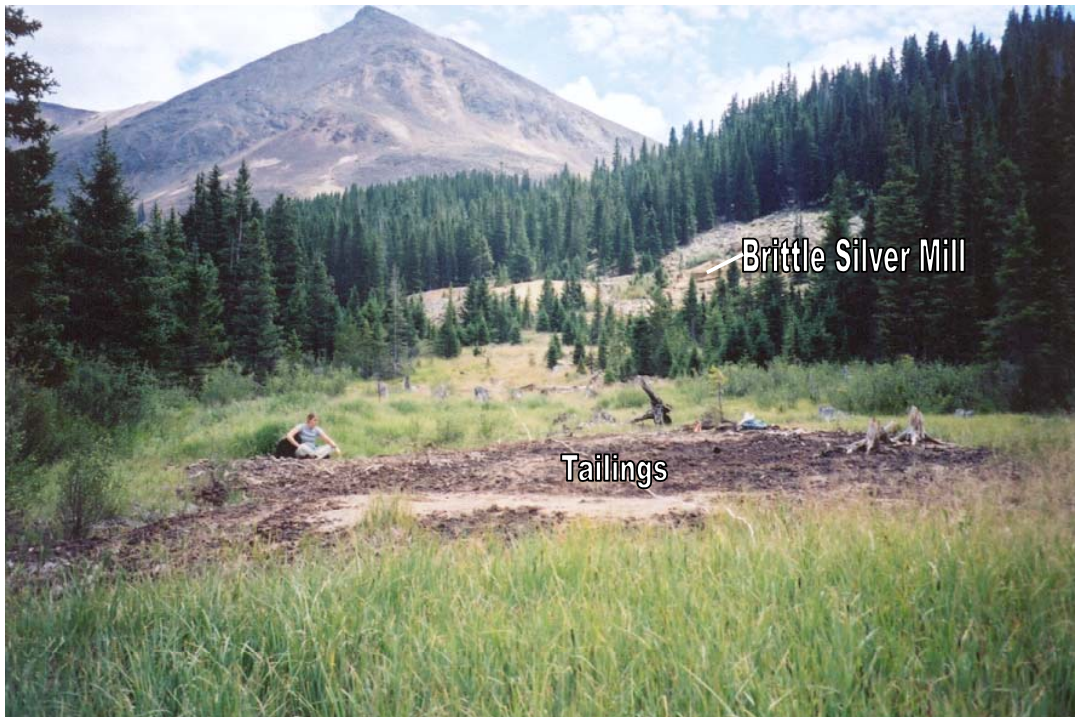
Figure 32. Lowest Brittle Silver Mill tailings pile (#205).

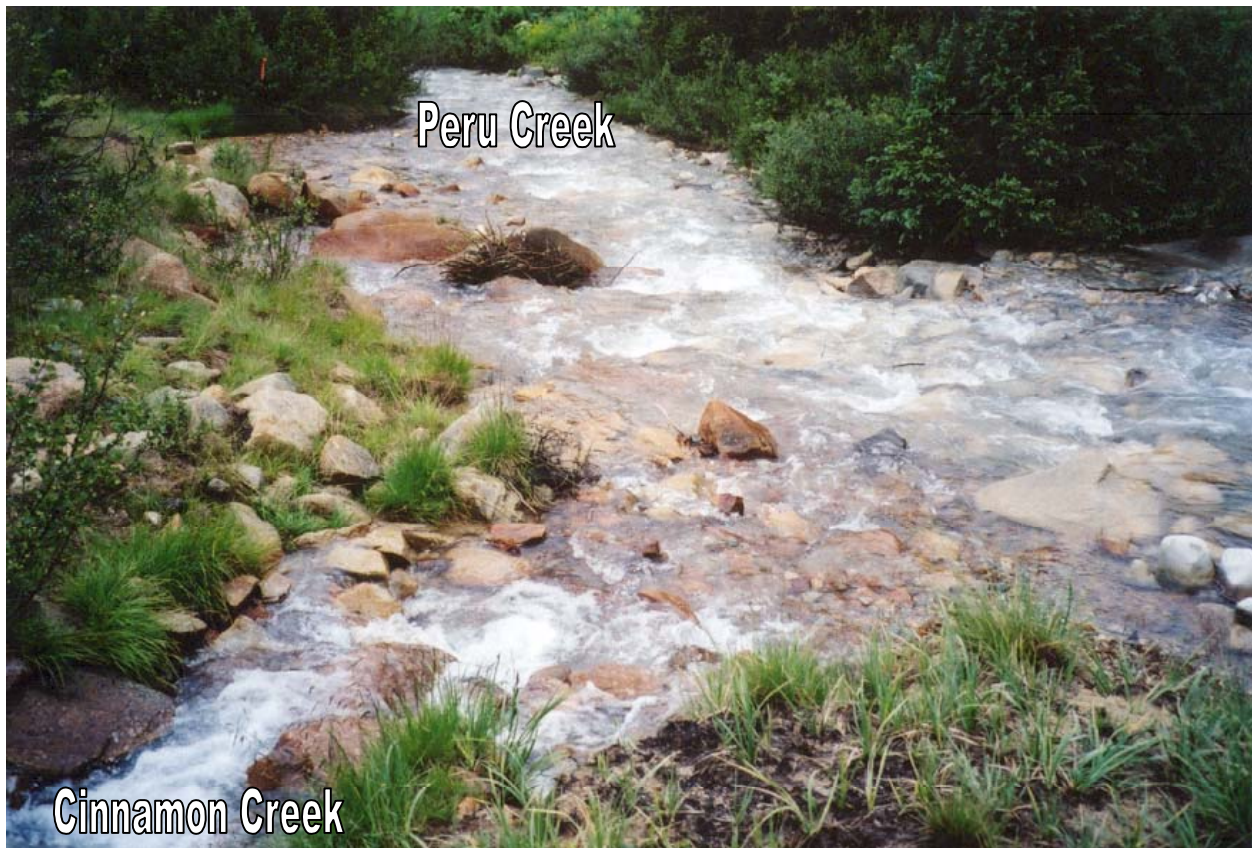
Figure 34. Lower Cinnamon Creek branch at confluence with Peru Creek.

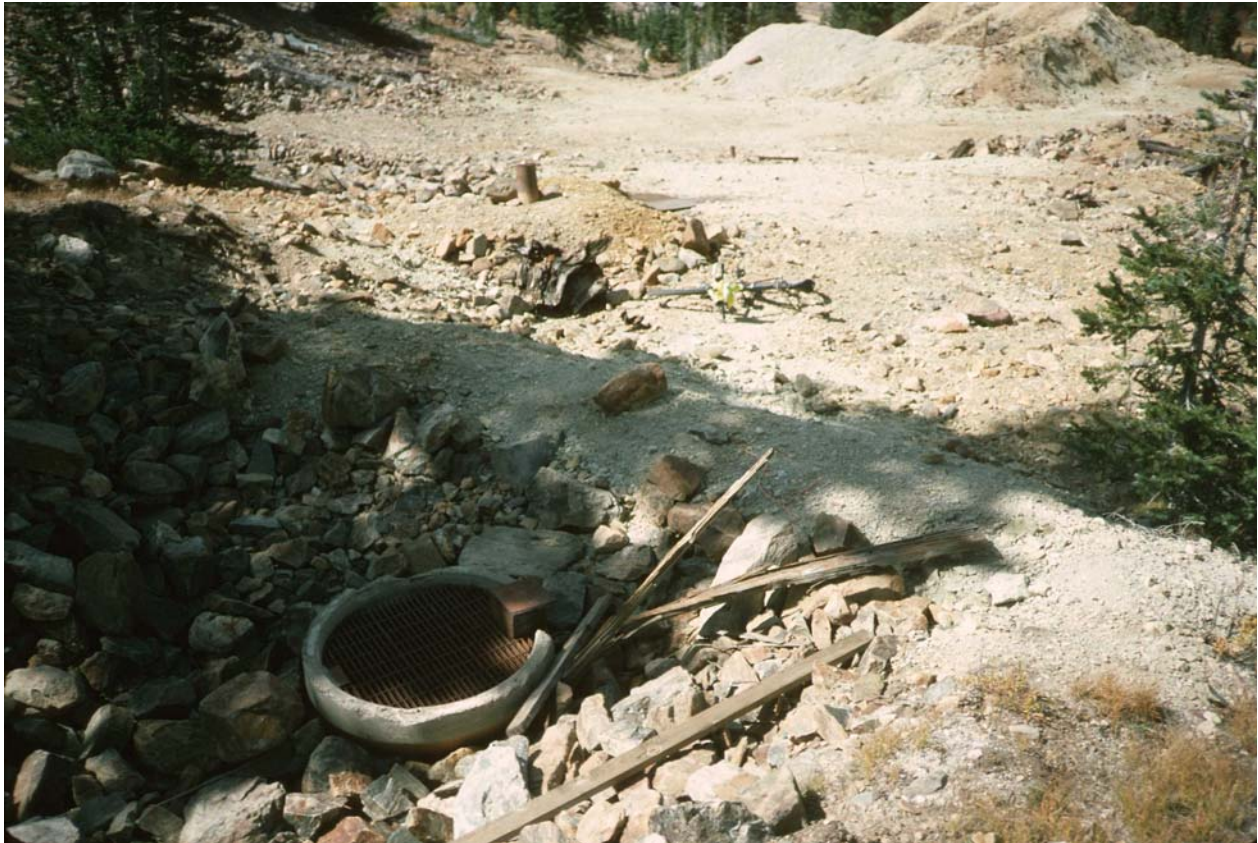
Figure 48. Close-up view of grated effluent inlet, Pennsylvania Mine-level F (#100). Photo taken Sept, 1993.

The Pennsylvania Mine portal was assigned an EDR of 2, indicating significant environmental degradation, due to the effluent discharged to Peru Creek; the physical hazard rating assigned was 5, indicating no hazard.

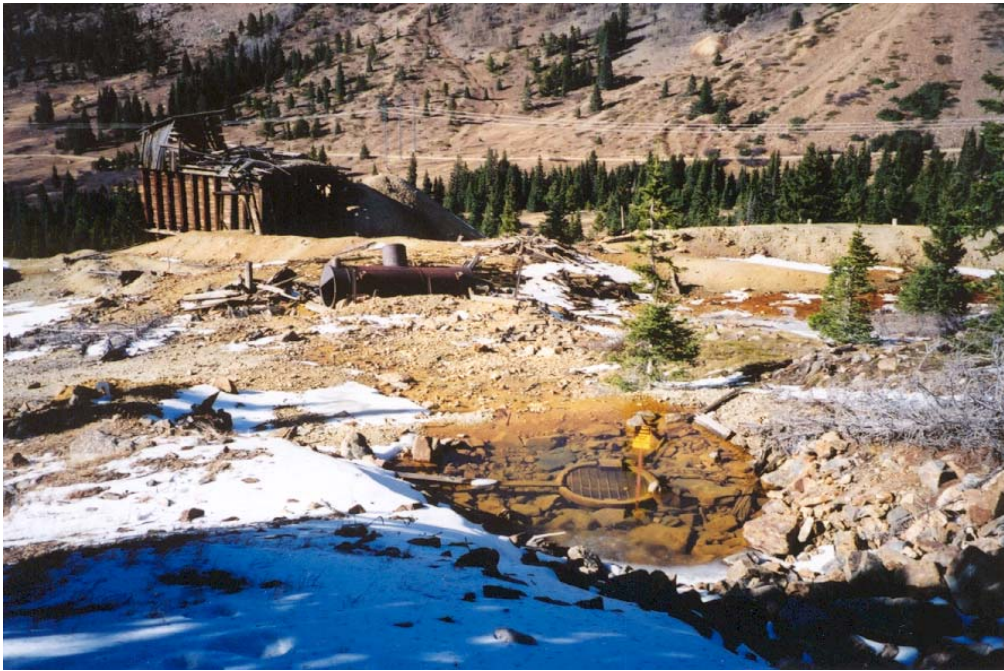
Figure 49. Grated effluent inlet and Pennsylvania Mine-level F adit (feature #100). Photo taken 10/2001.

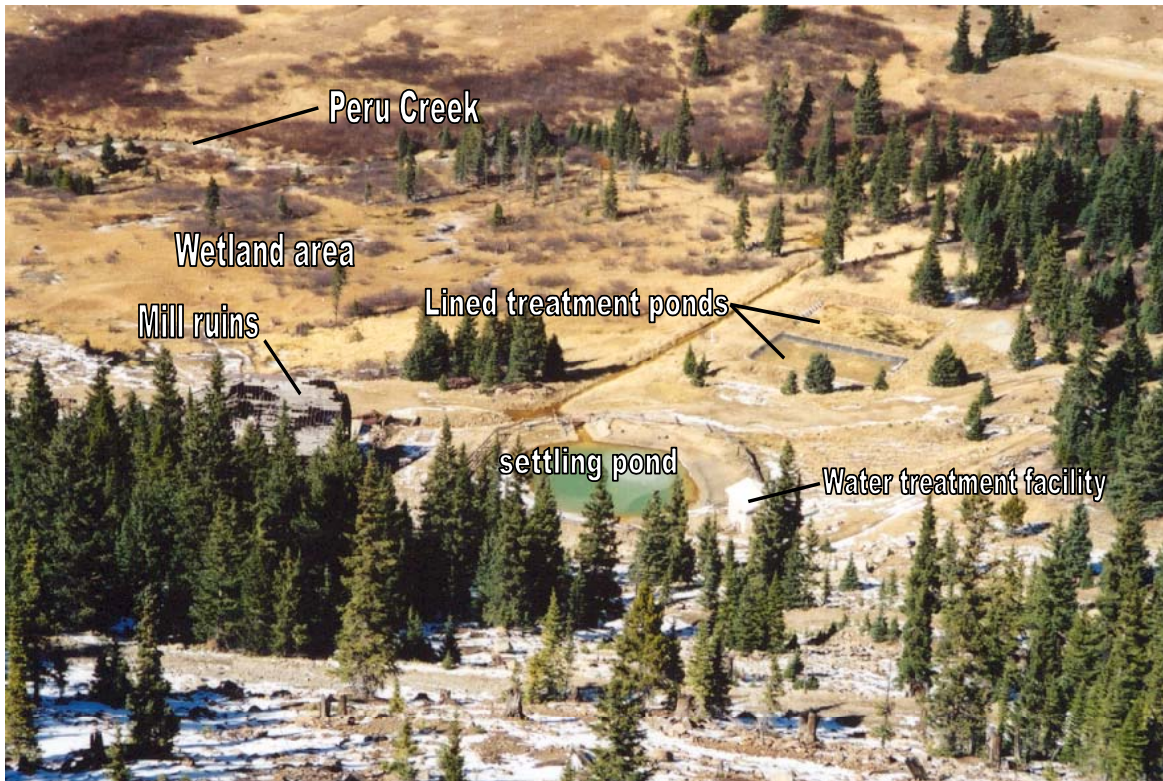
Most of the effluent was piped about 1,000 feet to a cinder-block building and into a settling pond (Figures 50 and 51). The building houses an inactive lime/limestone dosing system designed to add alkalinity to the mine effluent. The effluent was then directed into the settling pond to allow metal oxy-hydroxide floc to settle out of solution. Water from the settling pond flows into a wetland area next to Peru Creek. The grassy wetland area contains mill tailings from the adjacent Pennsylvania Mill (Figure 50). Two lined ponds northeast of the settling pond, not present in 1993, did not appear to be in use (Figure 50). One was dry; the other was filled with water. Iron deposits in the pipeline have apparently constricted the pipe and reduced its capacity to remove all of the effluent collected at the portal. Dump #200 contained an estimated 17,700 cubic yards of material (Figure 52).

Figure 50. Pennsylvania Mill area, with inactive water treatment facility.

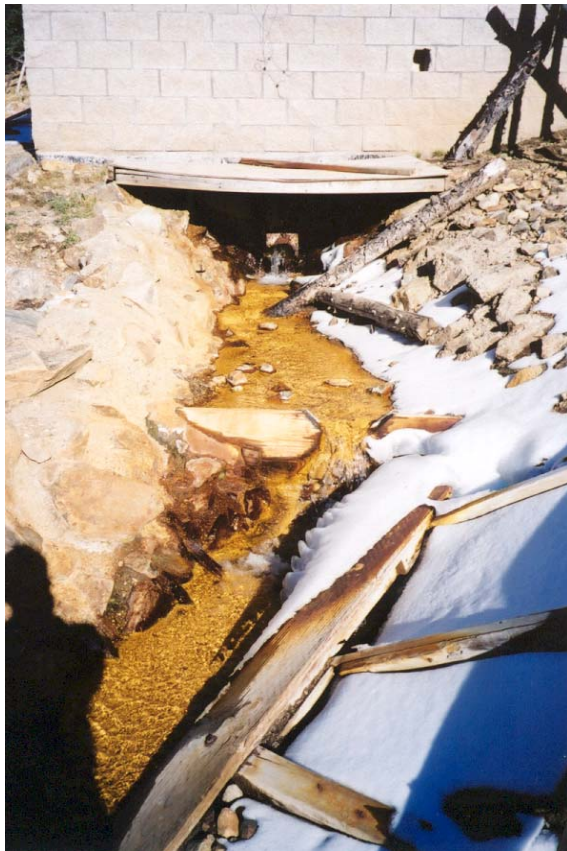
Figure 51. Effluent outlet from the inactive Pennsylvania Mine water treatment facility.

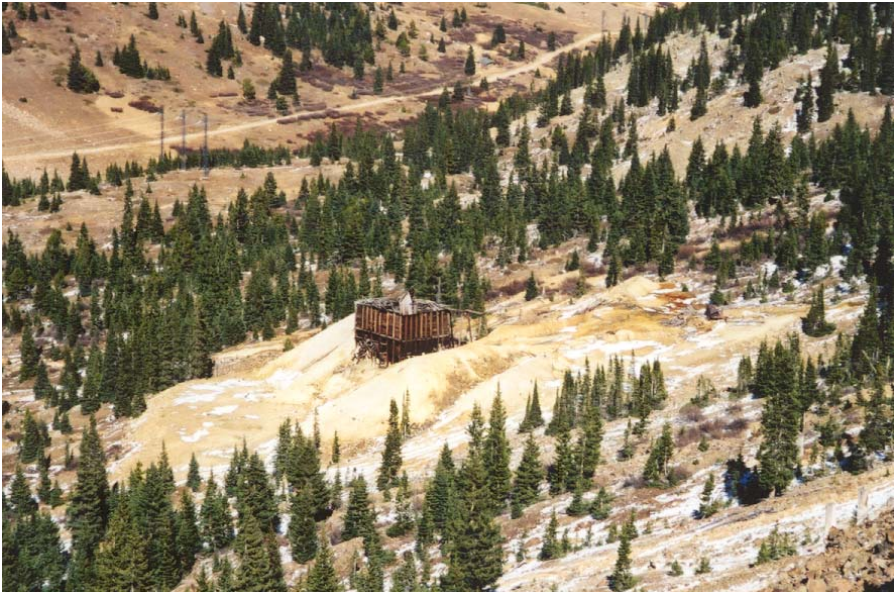
Figure 52. Pennsylvania Mine dump (feature #200).

All six of the waste rock dumps inventoried in the Pennsylvania Mine area received EDR's of 5, indicating no environmental degradation. Tailings feature #206 was assigned an EDR of 3, indicating potentially significant environmental degradation. Spring and mine drainage runs through the tailings and continues down the watershed at a rate of 1.5 gpm. A test of the drainage showed pH of 4.1 and conductivity of 800 $\mu\text{S}/\text{cm}$.

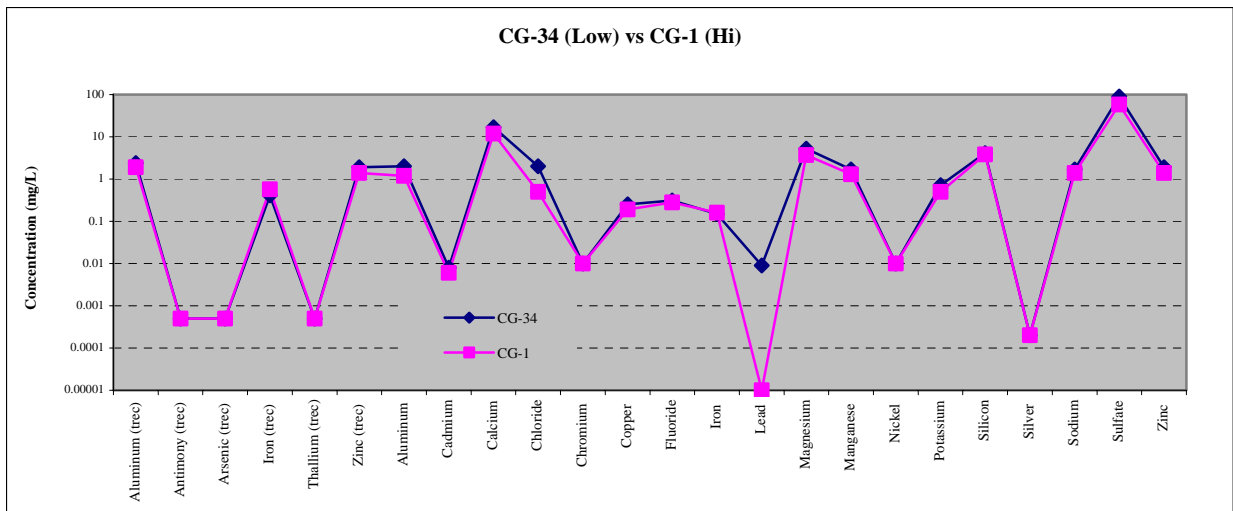
Figure 54. Comparison of chemical concentrations of selected samples in low-flow versus high-flow conditions.

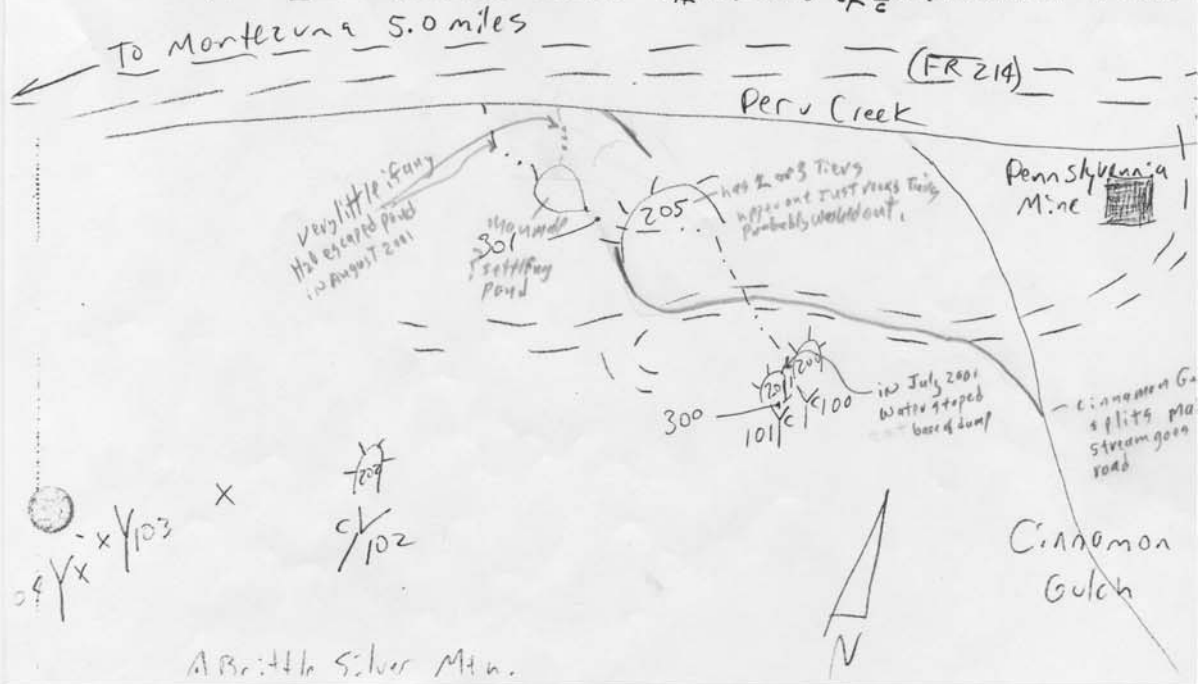
- 100 Collapsed adit no water. No hazard
- 200 Dump is high and dry sulphides observed.
- 101 Collapsed adit with water draining. Slight degradation
- 201 Dump of adit for mine drainage goes through feature forming small gully. Slight degradation sulphides observed.

- 300 Water tested at adit 101. 4.2 p.H., 100mg/L, 2.0 ppm. Some precipitate
- 102 collapsed adit No water. No hazard.
- 202 Dump is high and dry. Dump has been displaced down hill
