# STORM FLOODS ON TROUT CREEK, CHAFFEE COUNTY, COLORADO

*By Keenan Lee*

Colorado Geological Survey  
Open File 19-13

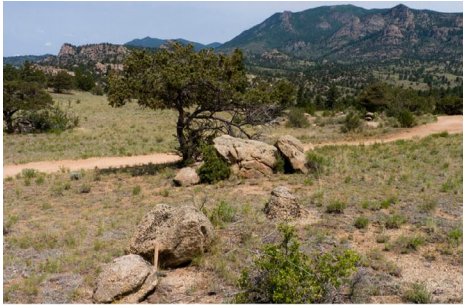
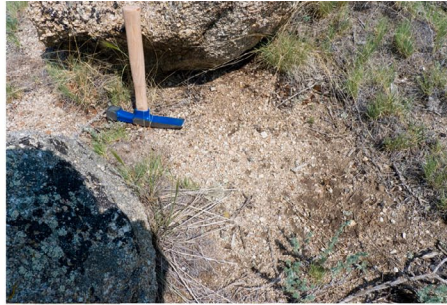
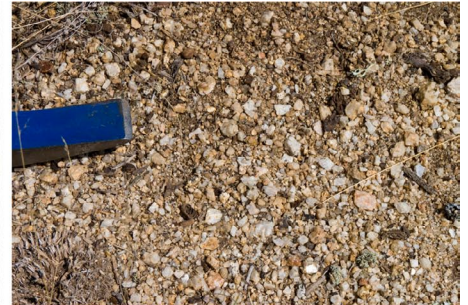
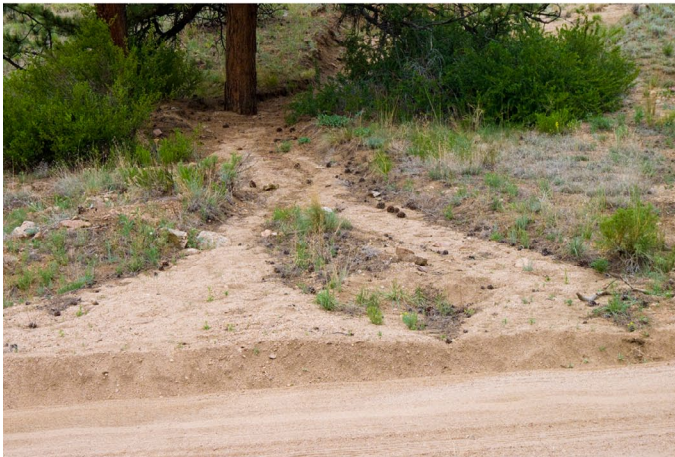
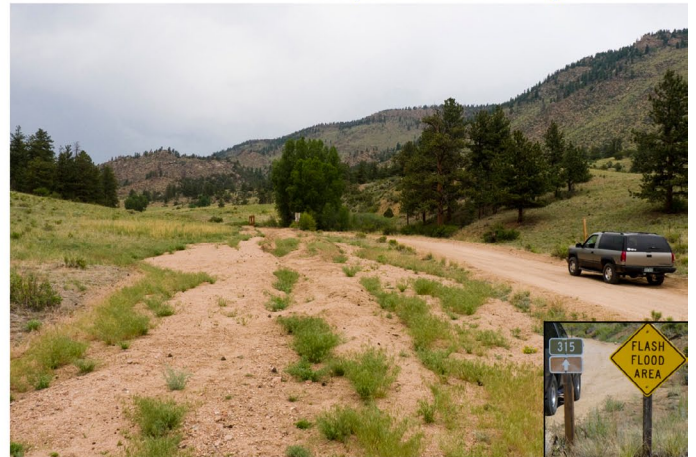
Granite weathering at surface disaggregates

Disaggregated material is termed grus

Grus is individual mineral grains of quartz and feldspar and small rock fragments

All tributary streams, like this small one in Shields Gulch, contribute loads of grus to main streams

Periodic flash floods wash sheets of grus down to Trout Creek, as seen here in Shields Gulch

**Figure 3 – Source of sand and fine gravel in Trout Creek watershed.**

Most of the Trout Creek watershed has a maturely weathered surface of moderate relief developed on granite. In this environment of large temperature ranges and relatively little precipitation, granite tends to disaggregate, rather than decompose, producing thick aprons of loose sand and fine gravel, called grus (Fig. 3).

The flood deposits consist of individual mineral grains of quartz and feldspar and small rock fragments (**Fig. 14**). This material is primarily grus (compare with Fig. 3), with added pebbles of ash-flow tuff from Triad Ridge.

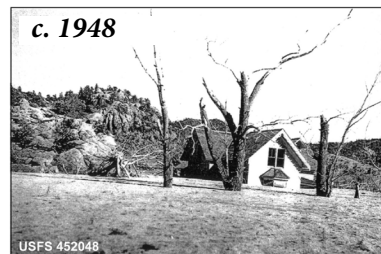
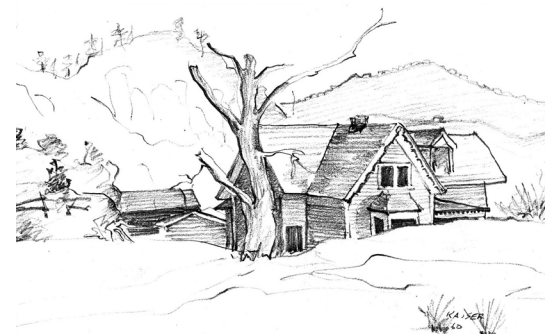
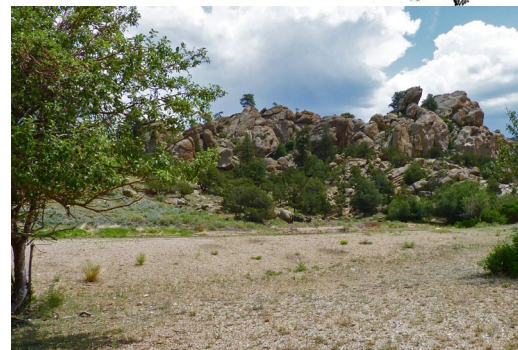
**c. 1890** – Two-story house was built by Benjamin Schwander in 1864. Schwander established an apple orchard and hay meadows. The Friskey family lived in the house when it was buried by flood sand and gravel.

**c. 1960** – Sketch by Dale Kaiser (courtesy Suzy Kelly)

**2016** – A few apple trees survive.

**Figure 6 – History of the Schwander house at the mouth of Box Canyon.**

In 1924 a terrible cloud burst up on Trout Creek Pass came down. It washed out bridges and track of the Denver South Park and Pacific and the huge wall of water carried tons of sand. This water and sand flooded and filled the bottom of the [Schwander] two story house. The orchard was also covered in three feet of sand. Gus Friskey and his mother were living in the house at the time. Gus tells that he and his mother only had time to run upstairs as the water and sand buried the lower level of the house. Everything in the ground floor of the house was covered with sand and debris. (Kelley, 2000, p.106) (see Fig. 6)

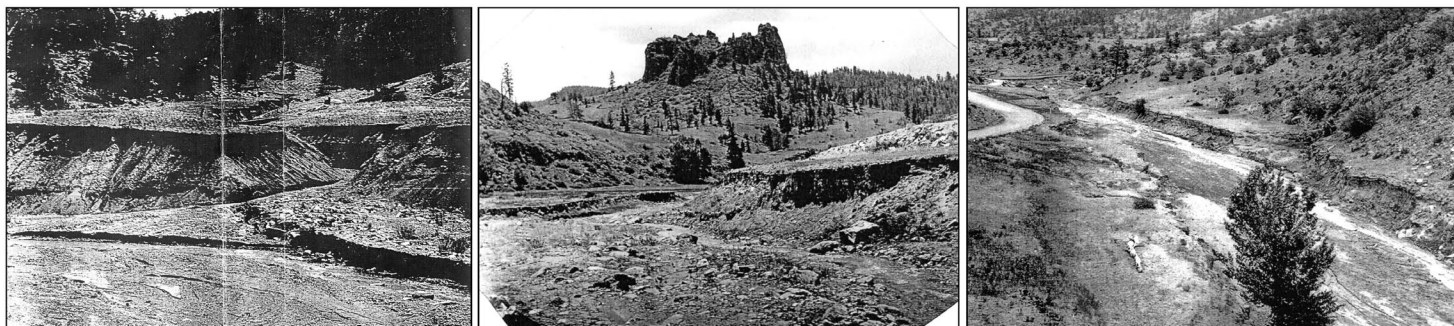
Figure 7 – Flood erosion in 1932 (U.S. Forest Service #279065, #279067, c. 1932).

A series of U.S. Forest Service photographs taken in 1932 and 1933 shows flood erosion in Trout Creek and in Mushroom Gulch from a storm in 1932 (Fig. 7).

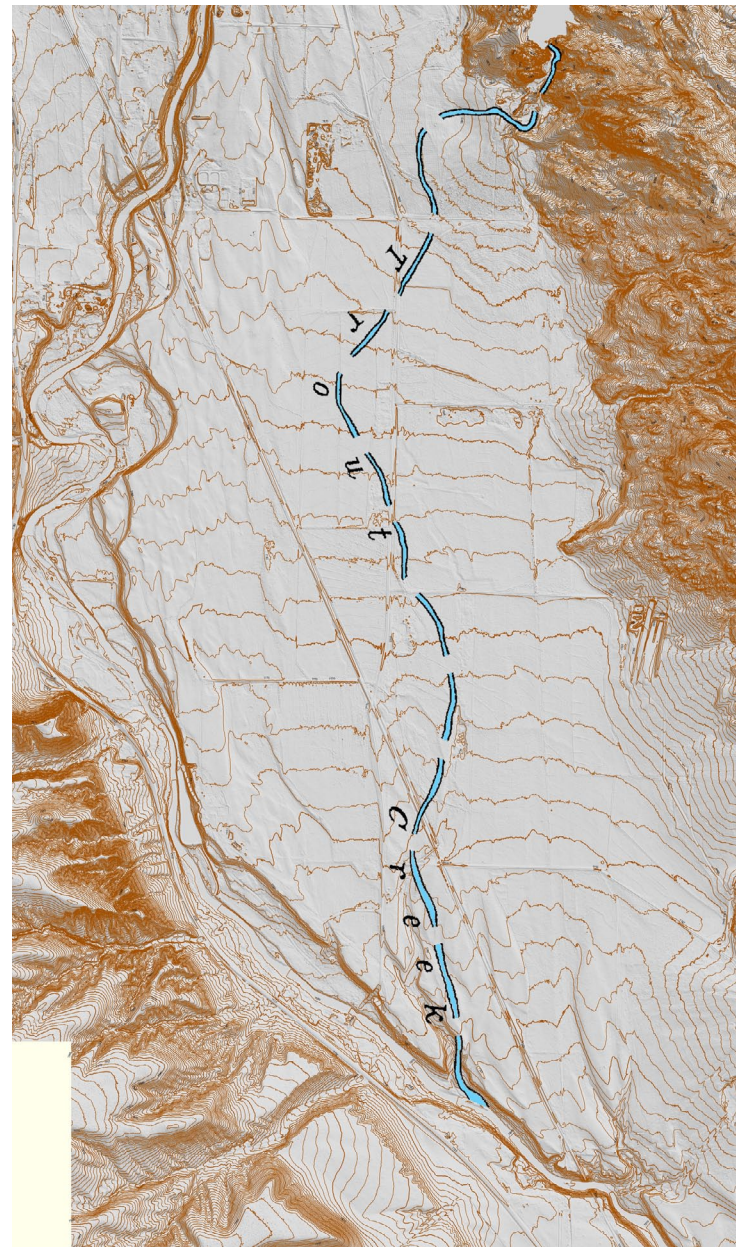
**Figure 10 – Flood deposits from Trout Creek spread out over the Arkansas Valley floor to produce a very flat surface sloping to the south. Contour interval is 5 ft. Ancestral Trout Creek c. 1884 from Poor, 1976, base map by author.**

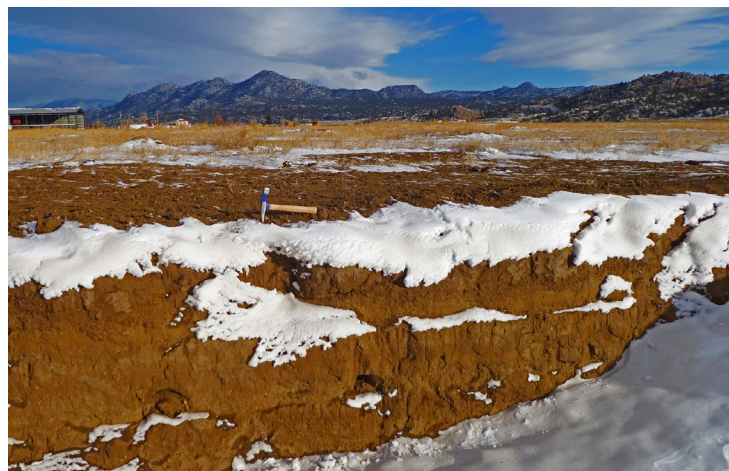
**Figure 12 – Flood deposit in McQuaid Pit is more than 6 ft thick, composed primarily of sand with fine gravel.**

road tracks were excavated at a depth of 13 ft (Paul Moltz, 2016, oral communication), and historical photographs support an estimate that the track bed was about 5 ft above the creek. The deposits that buried the Schwander house (see Fig. 6,) were estimated to be 8–10 ft deep (Woody, 1935), and a mile and a quarter south they are still more than 6 ft thick at the McQuaid Pit (Fig. 12).

This scour surface is quite evident beyond the edges of the flood deposits (see Fig. 9). Relief on this surface is about 3–5 ft, so it would require only 3–5 ft of flood sediments to smooth out the scoured surface. As noted, in about the middle of the Trout Creek flood-deposit area, at the McQuaid Pit, the flood deposits are more than 6 ft thick.

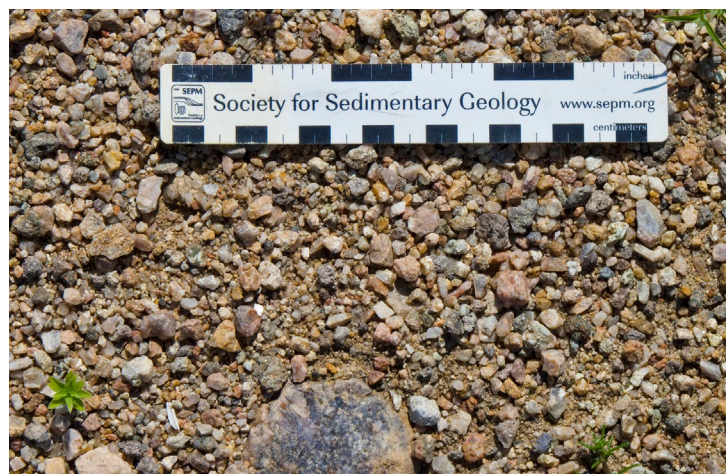
**Figure 14 – Flood deposit at the Schwander house is primarily grus with pebbles of ash-flow tuff from Triad Ridge.**

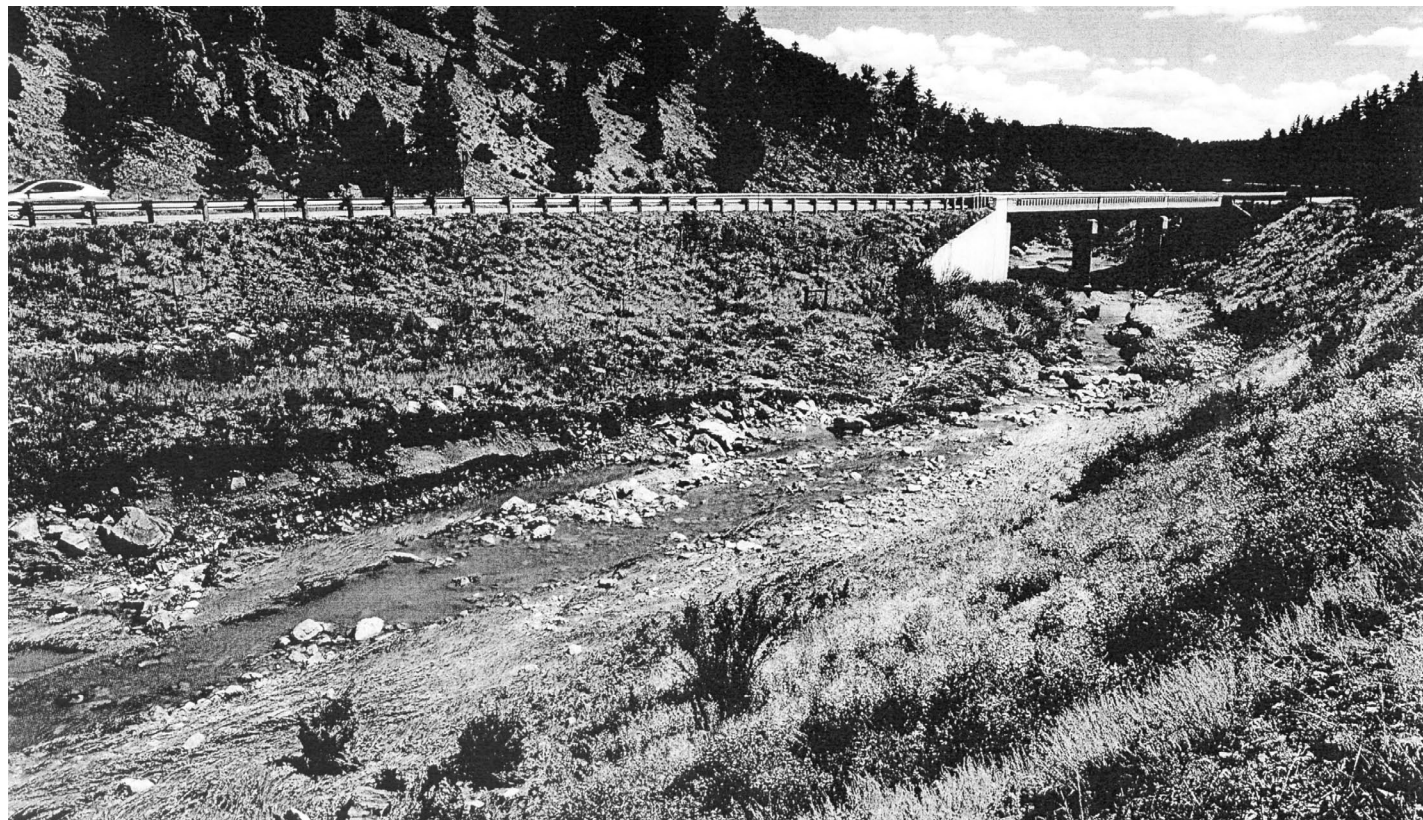
**Figure 17 – Trout Creek at the bottom of Chubb Park shows very little erosion after the flash flood of 1 September 2013 (photo courtesy of Sam Schroeder, U.S. Forest Service).**

Contour ditching, grass seeding, and planting of riparian vegetation and upland conifers successfully restored much of the damaged area. A flash flood occurred in Chubb Park on 1 September 2013; the very limited erosion that resulted demonstrates the success of these efforts (**Fig. 17**).
