**Geology of the 1994 South Canyon Fire Area,
and a Geomorphic Analysis of the September 1, 1994
Debris Flows, South Flank of Storm King Mountain,
Glenwood Springs, Colorado**

By Robert M. Kirkham, Mario Parise, and Susan H. Cannon

Colorado Geological Survey
Department of Natural Resources
Denver, Colorado
2000

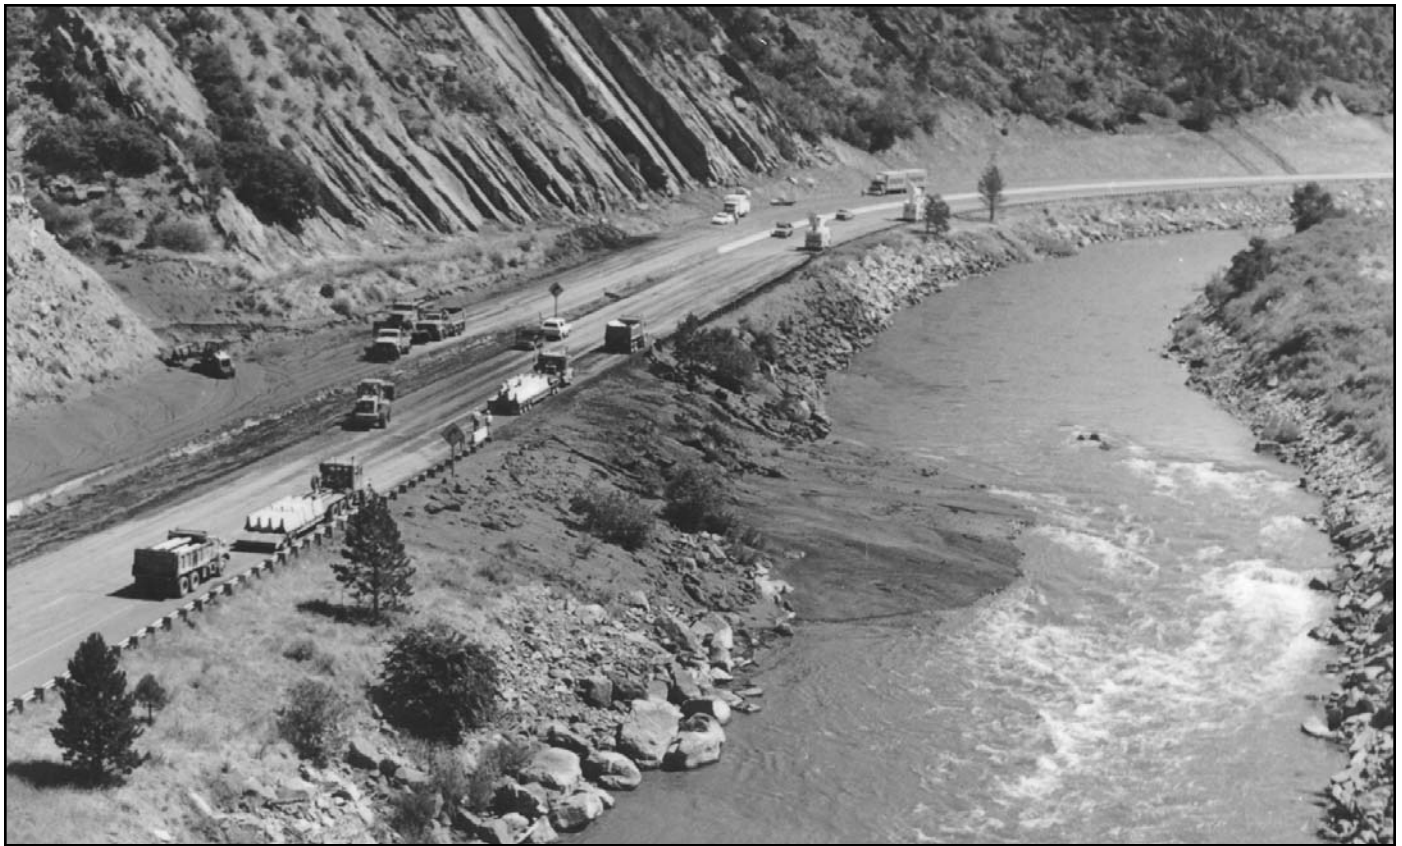
Figure 4. Photograph of debris-flow deposits at the mouth of drainage B. The debris-flow deposits were derived primarily from red soils, yet they are gray, a result of their high ash content. The debris-flow delta created by the 1994 events extended about half way across the river. Most of the fine-grained sediments in the delta have since been eroded away by the river, but large boulders from the deposits remain in the channel, creating a new section of whitewater for river rafters. The debris flows discharged from basin B carried at least two people into the river (see the eyewitness account by Kevin White in Appendix 1). Photograph by Jim Scheidt, BLM.

B is shown in Figure 4. The debris-flow deposits were derived primarily from red soils, yet they are gray, a result of their high ash and charcoal content. The debris-flow fan created by the 1994 events at the mouth of basin B extended about half-way across the river. Most of the fine-grained sediments in the fan have since been eroded away by the river, but large boulders in the fan deposits remain in the channel, creating new rapids for river rafters. The debris flows discharged from basin B carried at least two people into the river, as described in the eyewitness account by Kevin White contained in Appendix 1.

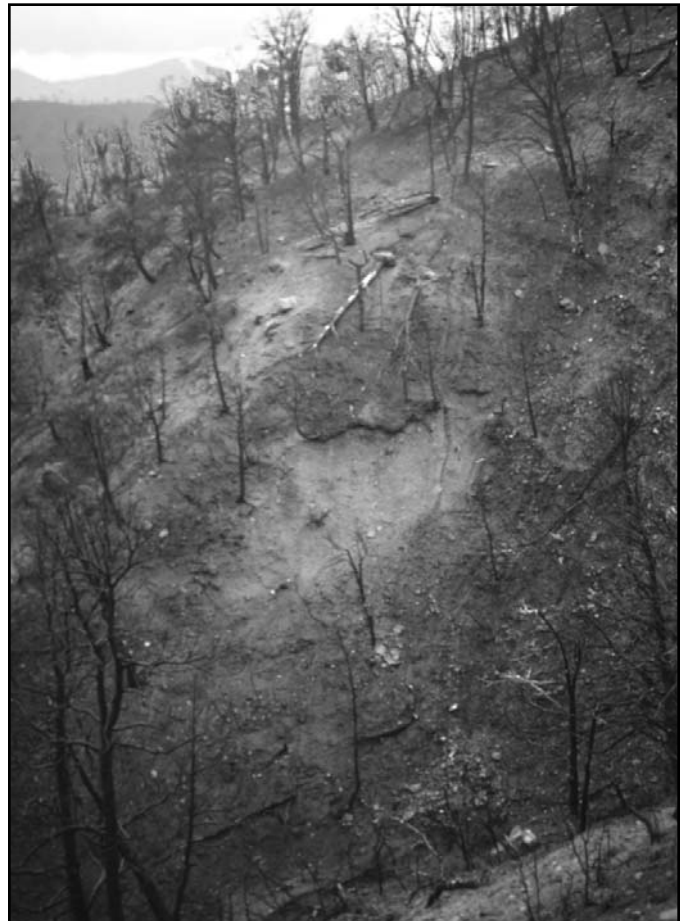
Figure 6. Photograph of a soil-slip scar developed in older landslide deposits in basin F. Note the absence of burned soil in the soil-slip scar, indicating the slip occurred after the wildfire. Note also that the material removed from the scar is not present on the slope below the scar and that the hillslope below the scar was little affected by the downslope transport of the material removed by the soil slip. Photograph by Robert Kirkham.

Scars left by the evacuation of thin, areally small, translational landslides, herein called soil slips, are common on steeper slopes in the area. Figure 6 is a photograph of a typical soil-slip scar developed in older landslide deposits. Material mobilized from the soil slips appears to have been very fluid in that only a few traces of the deposits from soil slips were observed on the hillsides downslope from the scars. This is in contrast with the debris flows in the main channels, which left nearly continuous, up to one-inch thick veneers of mud on the channel banks. Most material from the soil slips apparently traveled over the hillsides and into adjacent channels. No significant deposits from the soil slips were observed in the channels. The soil exposed in the soil-slip scars was not burned, indicating that the soil slips occurred after the fire. When coupled with the observation that most material derived from the soil slips was not preserved

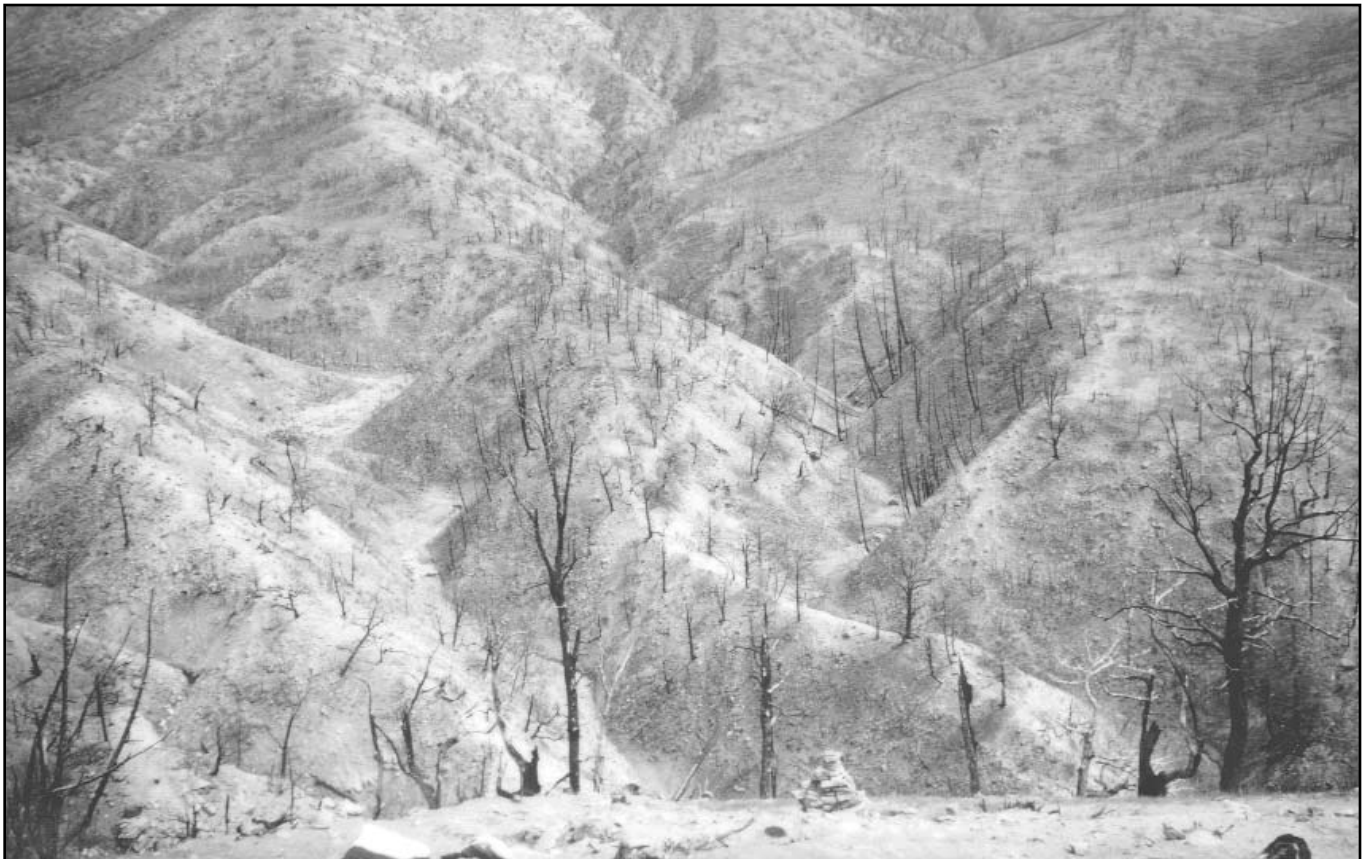
Figure 8. Photograph of older colluvium and sheetwash deposits in basin B taken in May, 1995. Remnants of the original depositional surface of the deposit are preserved on the right (east) side of the photograph. Erosion caused by the 1994 events and deposits left by it can be seen in both of the major tributaries to basin B. Hillslopes where thin veneers of soil were removed during the flood are visible in the lower left and center of the photograph. Trees burned by the South Canyon fire stand as stark reminders of the intensity of the fire. At the time of the photograph stands of grasses and forbs were beginning to be established on the flatter slopes in this basin, but were much less well established on the steep slopes. Photograph by Robert Kirkham.

A photograph taken in May 1995 of deeply dissected older colluvium and sheetwash deposits in basin B (Figure 8) shows remnants of the original depositional surface of the deposit preserved on the right (east). Erosion caused by and deposits left by the 1994 events can be seen in both of the major tributaries to basin B. Hillslopes where thin veneers of soil were removed during the rainstorm are visible in the lower left and center of the photograph. Trees burned by the South Canyon fire stand as stark reminders of the intensity of the fire. At the time of the photograph stands of grasses and forbs were beginning to establish on the

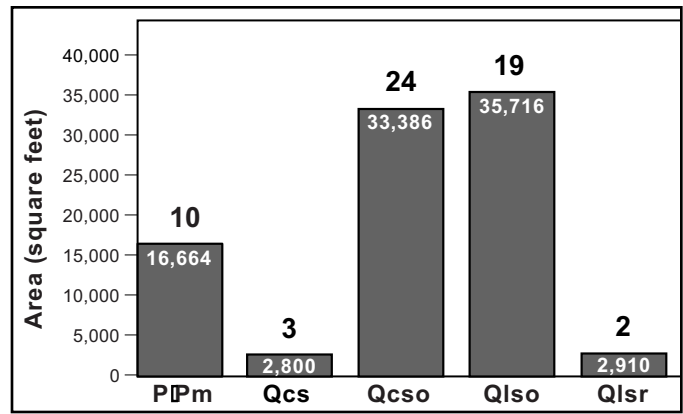
Figure 9. Calculated areas of soil-slip scars and frequency of occurrence by geologic unit and drainage basin.

The spatial frequency and calculated areas of these scars in each drainage, as well as in the host geologic units, are shown in Figure 9. Older colluvium and sheetwash deposits (Qcso) and older landslide deposits (Qlso) were particularly susceptible to failure by soil

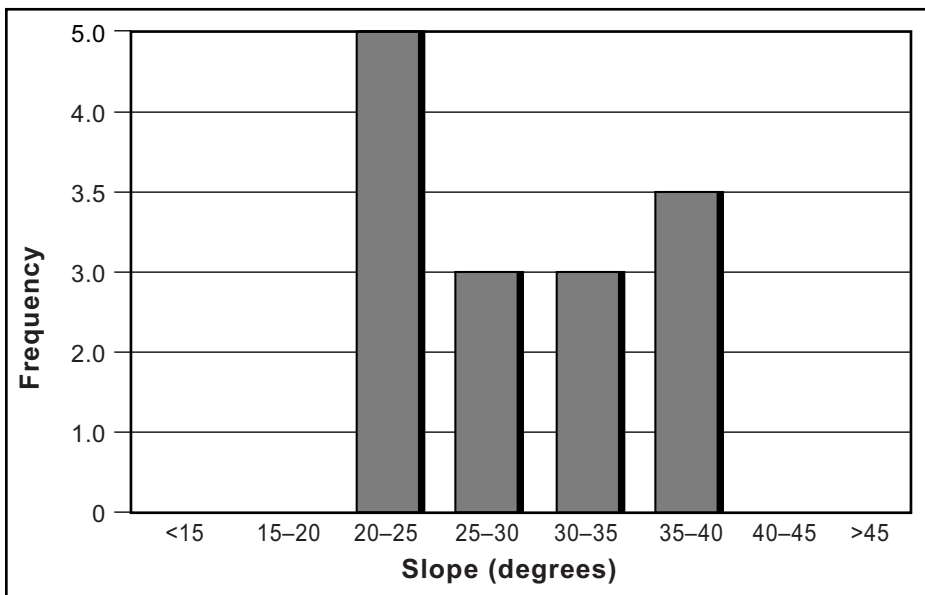
Figure 14. Distribution of debris-flow initiation locations relative to slope for drainages B and F.

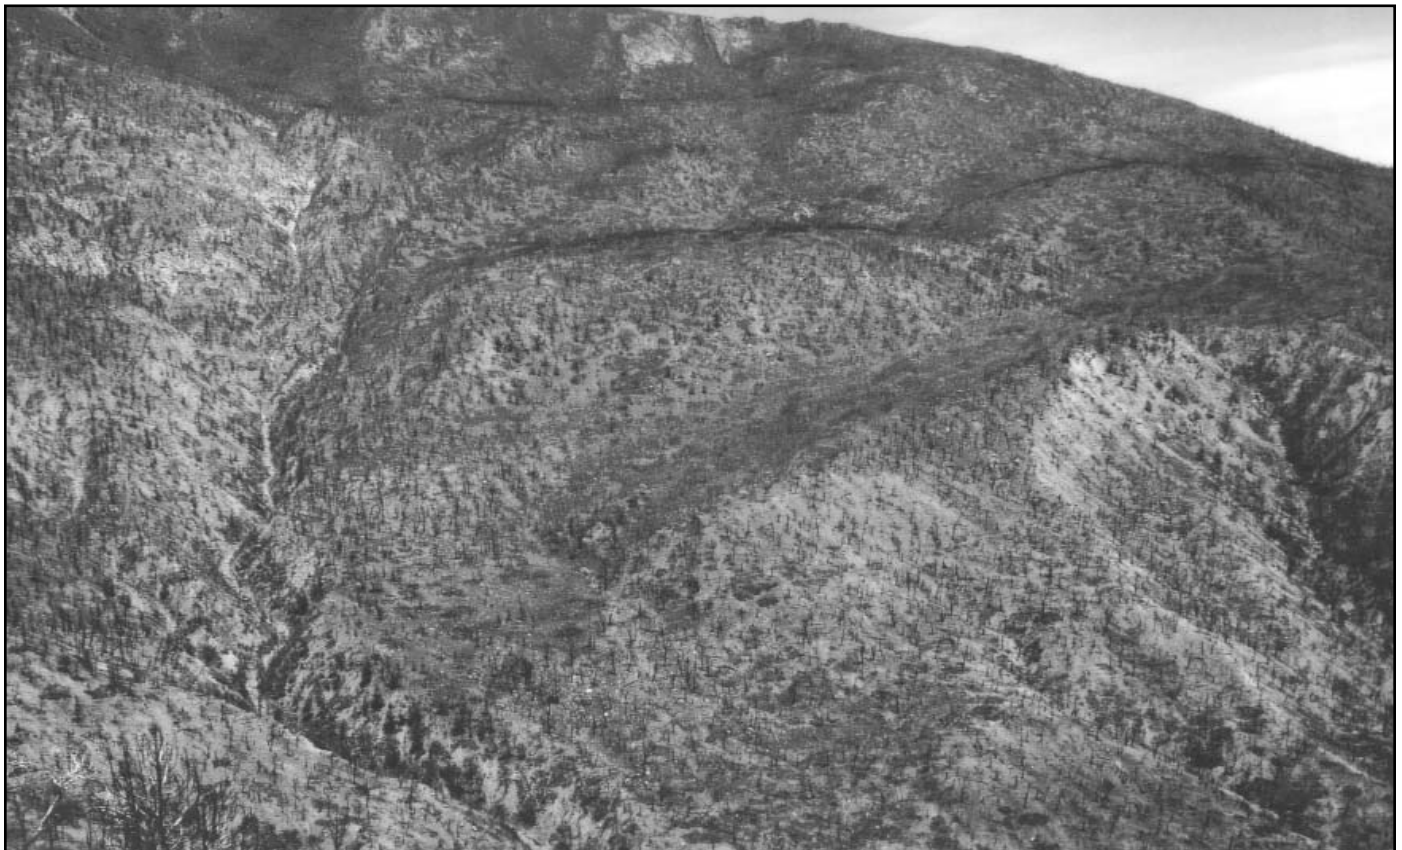
Figure 15. Photograph of older landslide deposits on the south flank of Storm King Mountain taken in May, 1995. Note the prominent, transverse ridges and swales that extend across the landslide. Excellent stands of
