Miscellaneous Publication 8

# Engineering Geologic Factors of the Marble Area, Gunnison County, Colorado

By  
William P. Rogers,  
Engineering Geologist  
and  
John W. Rold,  
Director and State Geologist

Colorado Geological Survey  
Department of Natural Resources  
Denver, Colorado  
1972

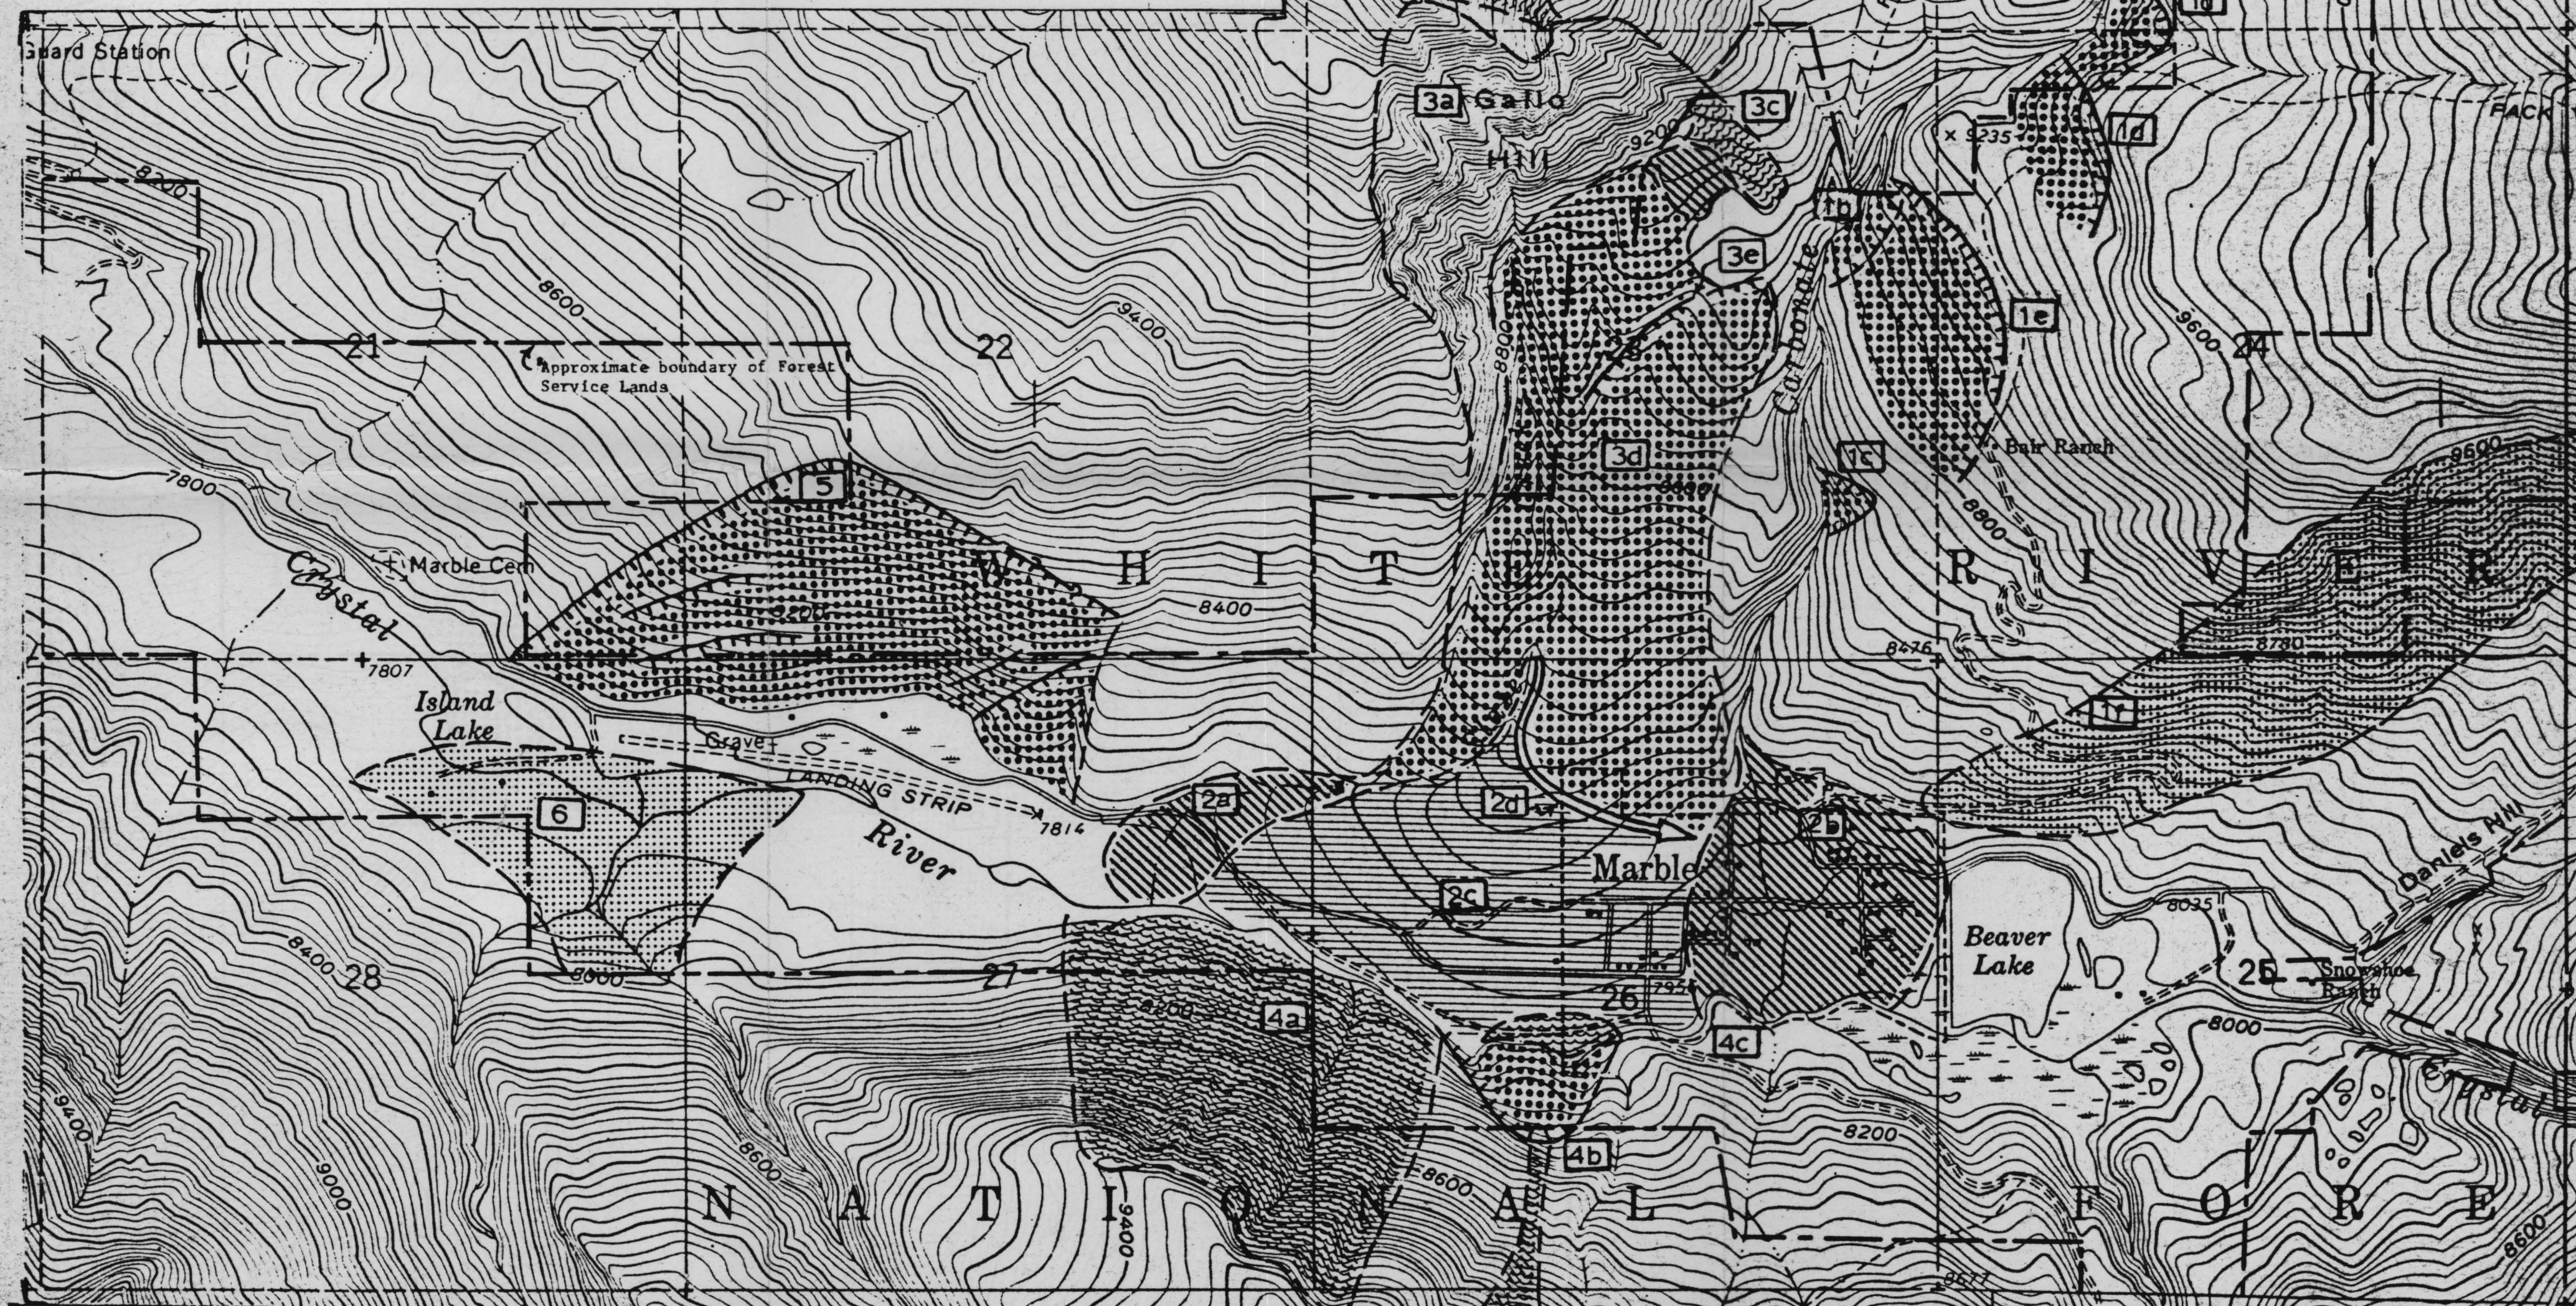
PLATE 1. ENGINEERING GEOLOGIC MAP, MARBLE AREA

The central part of the area south of Crystal River (which is directly opposite the old marble works) is also very steep except for a large and fairly recent landslide mass (4b, plate 1) which has locally deflected the course of the river northward. There are also large accumulation areas and avalanche tracks above the landslide mass. These avalanches do not at the present time appear to be as active as those to the west, but the historic record describes many damaging avalanches which affected the marble works until a protective dike of waste marble was built. We feel that this part of the area also has many serious problems which would have to be resolved before construction of any kind is advisable.
