OPEN-FILE REPORT 00-10

# History, Geology, and Environmental Setting of the Lower Fair Day Mine, Arapaho/Roosevelt National Forest, Boulder County, Colorado

By John Neubert and Robert H. Wood II

Colorado Geological Survey  
Division of Minerals and Geology  
Department of Natural Resources  
Denver, Colorado  
2000

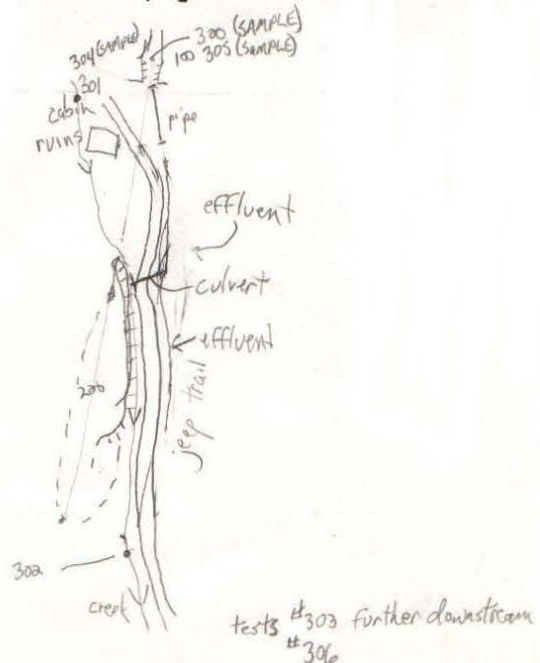
Portal - 0.06 mR/hr  
 170 cps (scinti)  
 South of Cabin - 0.18  
 520 cps  
 North-facing dump face - 0.4  
 1800 cps  
 area on bench, near Southend - 0.4  
 1900 cps  
 Most of dump - 0.25 to 0.35  
 - 1000 to 1500 cps.  
 BACKGROUND = ABOUT 150-250 CPS
