OPEN-FILE REPORT 01-12

History, Geology, and Environmental Setting of the Lienhart Mine, Pike/San Isabel National Forest, Chaffee County, Colorado

Colorado Geological Survey
Department of Natural Resources
Division of Minerals and Geology
Denver, Colorado
2001

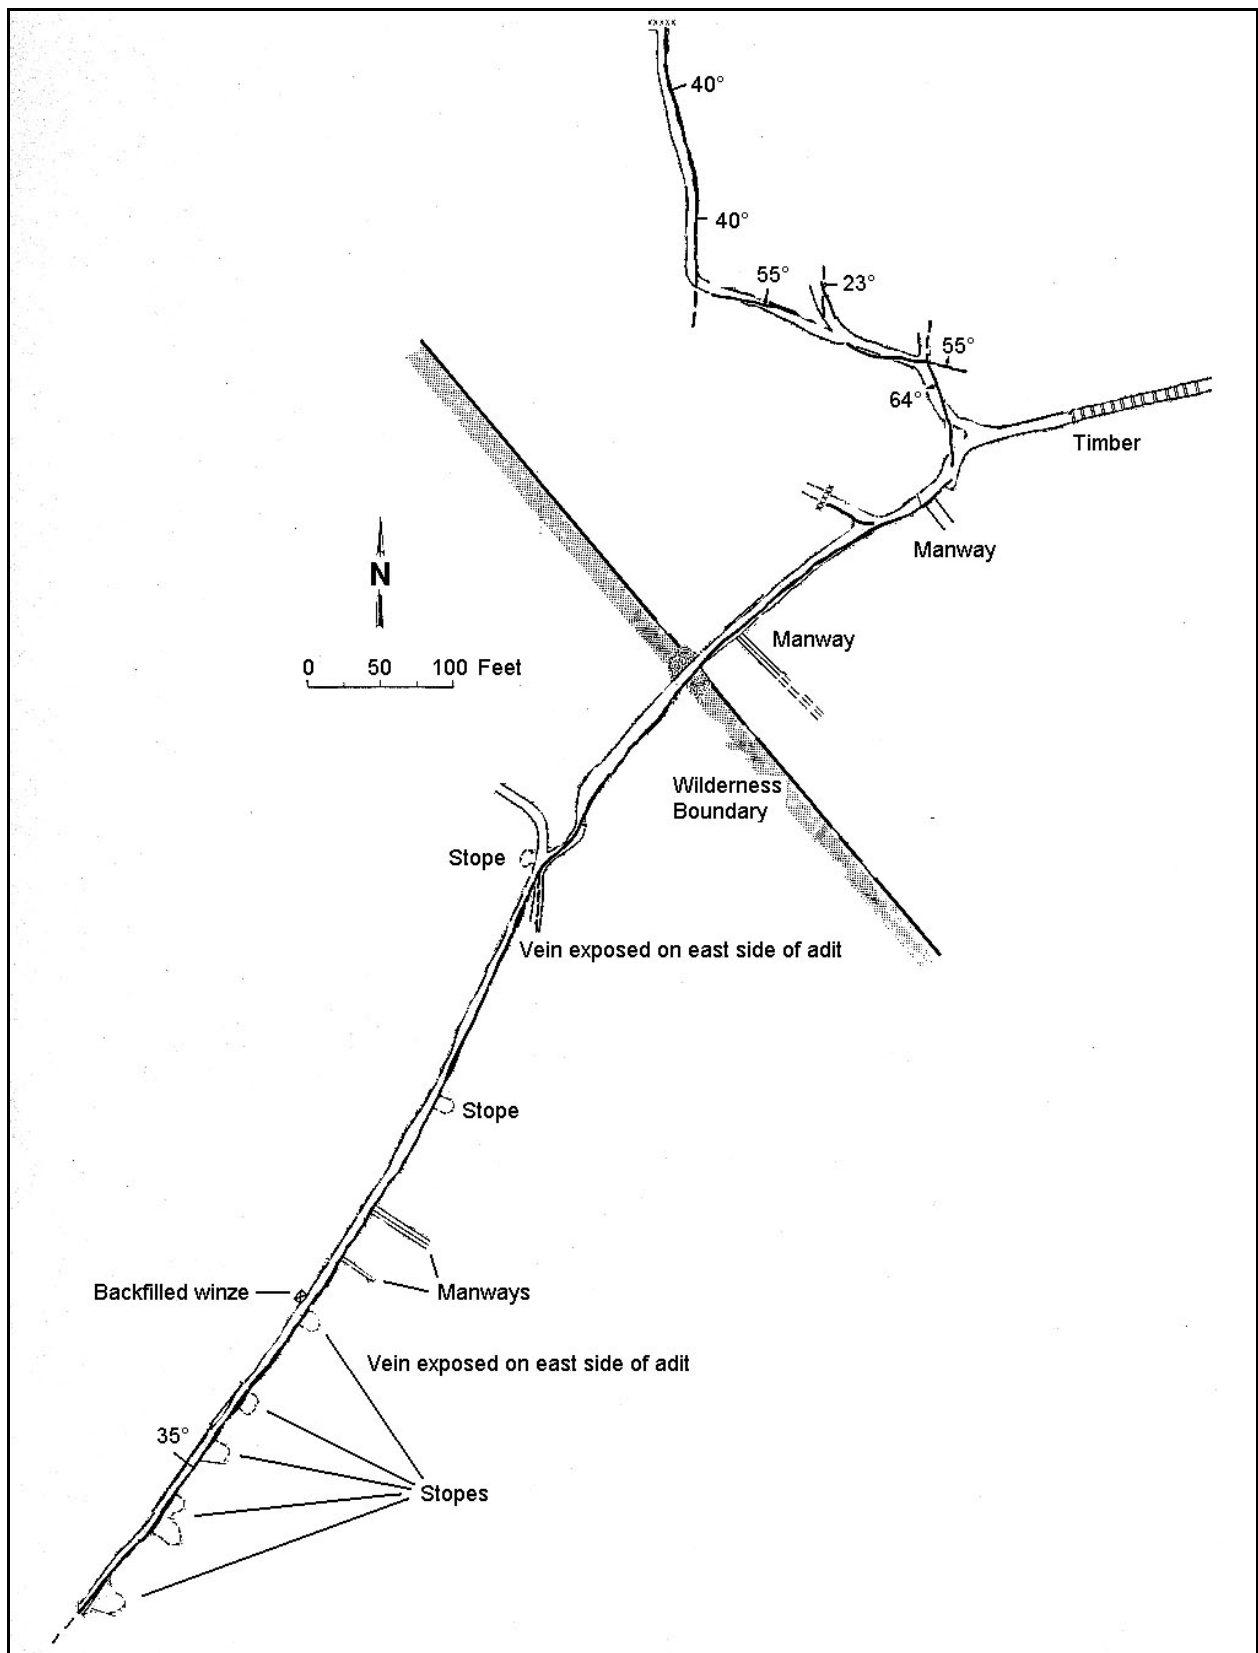
Figure 4. Map of the Lienhart Mine. (Modified from Baskin ,1987, Plate 3.)

The most important vein strikes about 30° to 40° northeast and dips 35° northwest (Figure 4). Pyrite, sphalerite, galena, chalcopyrite, bornite, and limonite were identified in the vein, and gold, silver, lead, copper, and zinc were produced from the mine. More than 37,000 tons of ore reserves containing 0.078 oz/ton gold and 2.36 oz/ton silver remain in the last 400 feet of workings underlying the Collegiate Peaks Wilderness. (See Baskin, 1987, plate 3; p. 15, 34-35.)

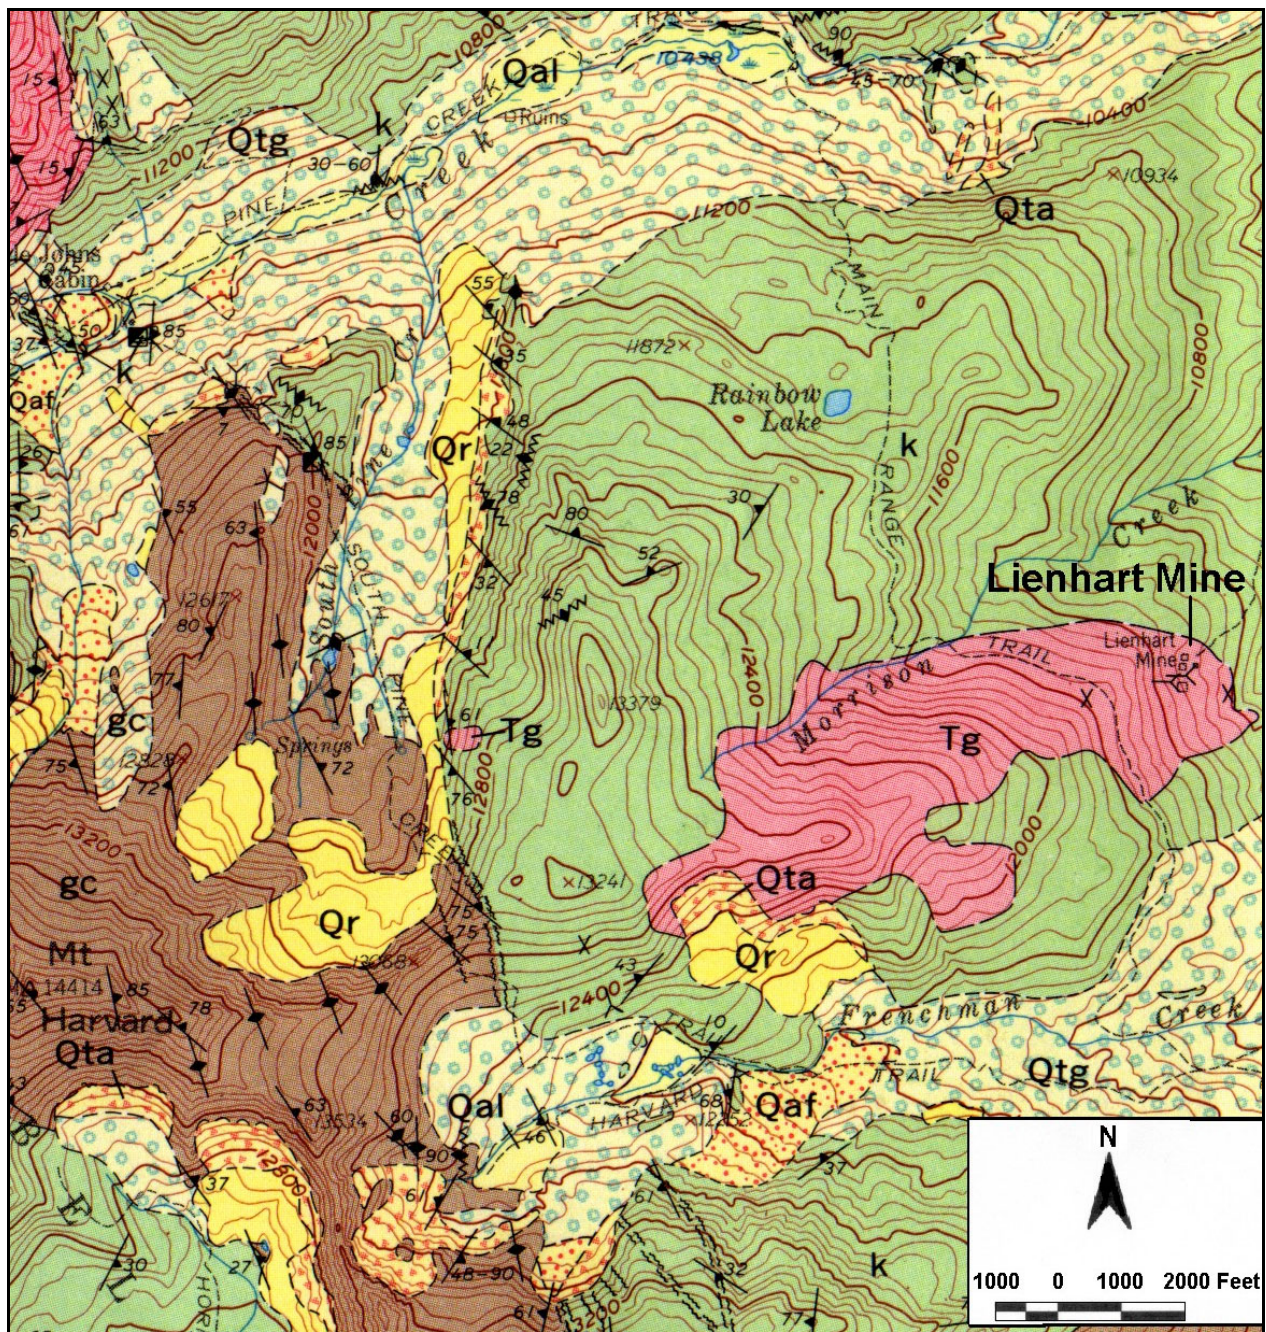
Figure 7. Geologic map of the Lienhart Mine area.
 (From Brock and Barker, 1972; scale is approximate.)

Host rock at the Lienhart Mine is Tertiary granodiorite (Figure 7). This rock unit is gray, medium-grained, and contains abundant biotite and hornblende. Precambrian Kroenke Granodiorite surrounds the Tertiary granodiorite. (See Brock and Barker, 1972.)

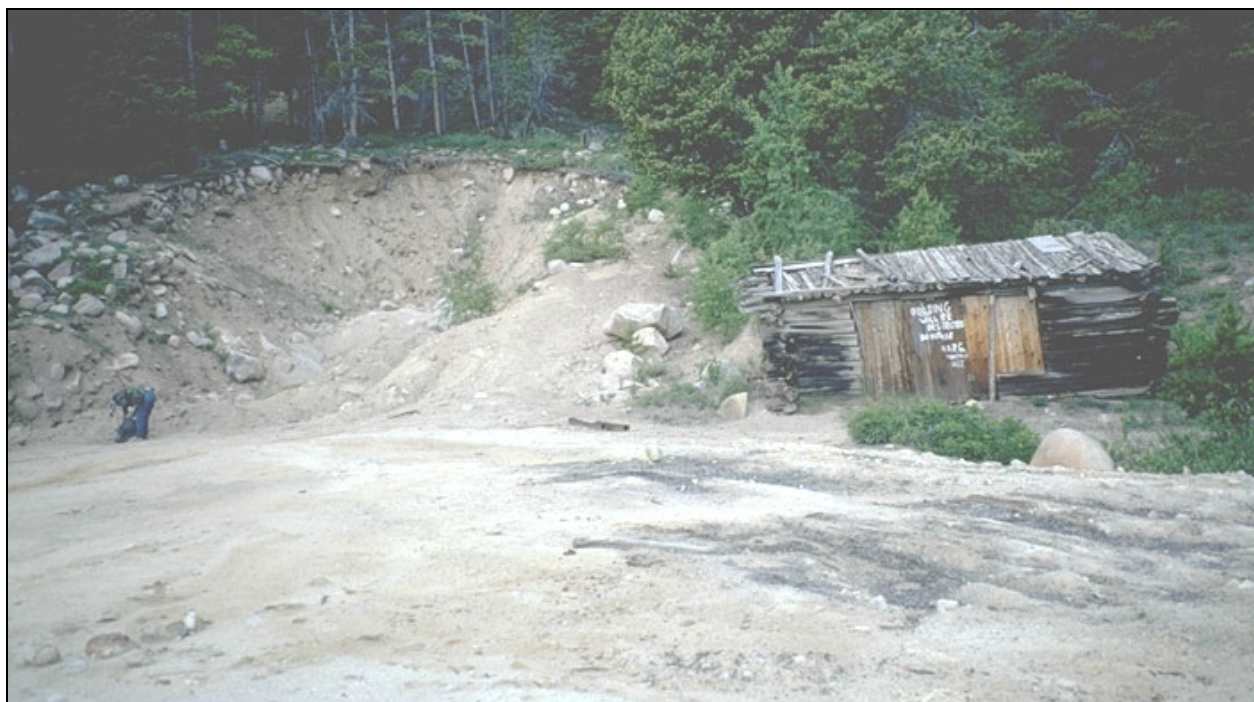
Figure 11. Cabin at the Lienhart Mine.
