OPEN-FILE REPORT 89-01

Field Studies and Modeling Analysis of the Roan Creek Landslide, Garfield County, Colorado

By
David Umstot*

Colorado Geological Survey
Department of Natural Resources
Denver, Colorado
1989

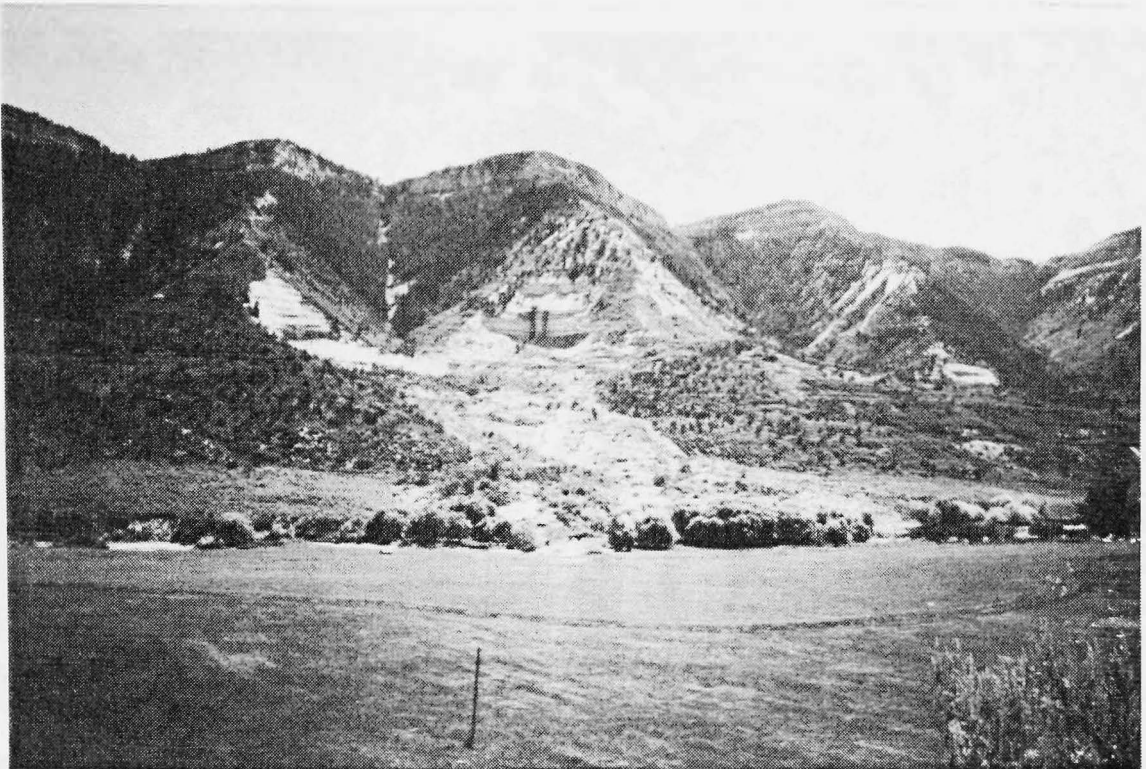
Figure 2. A view of the Roan Creek landslide looking south across Roan Creek valley.

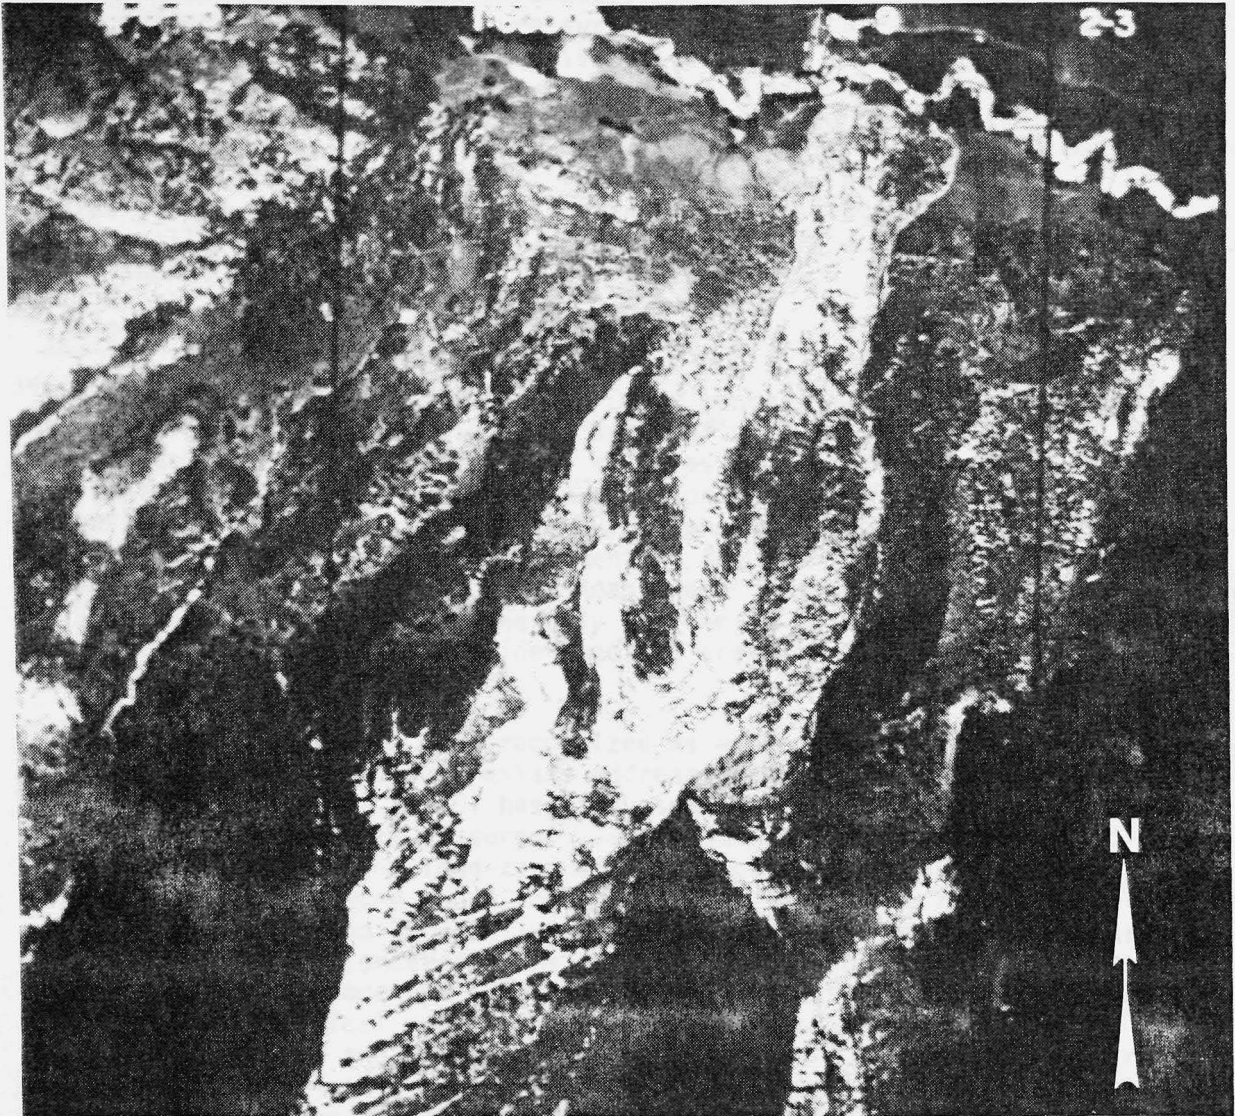
Figure 4. An aerial view of the Roan Creek landslide.

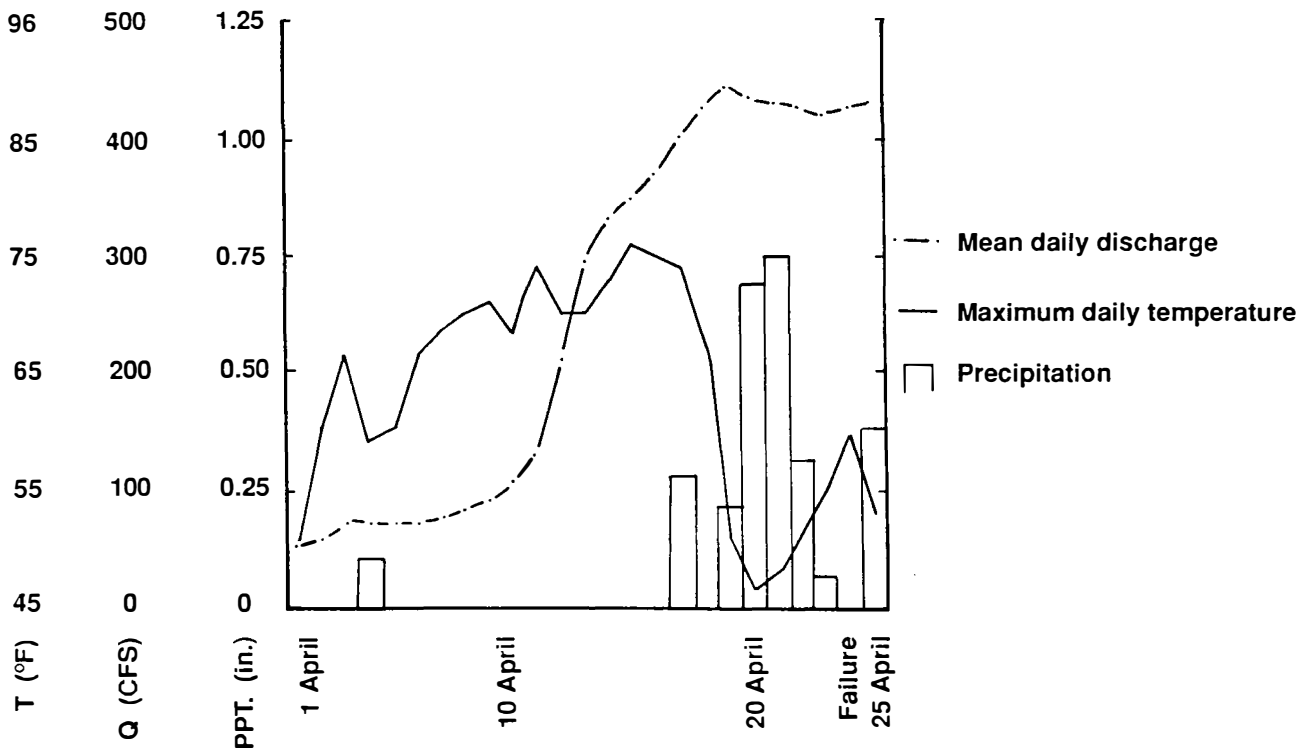
Figure 11 shows the relationships of temperature, Roan Creek discharge and precipitation during the first 25 days of April 1985. As temperature increased through the month, discharge also increased rapidly from 11 April to 19 April when discharge rose from 132 cfs to 443 cfs. The sudden drop in temperature on 17 April was accompanied by an increase in precipitation lasting seven days and a leveling off of discharge to a value of about 425 cfs.

Figure 11. Maximum daily temperature, daily precipitation and mean daily discharge of Roan Creek in the first 25 days of April 1985.

The increase in discharge is significant and implies snowmelt in March and April was considerably above average in 1985. This also strongly suggests that snowmelt on the northern slopes of Kimball Mountain supplied additional water to the slide material as did the previously mentioned precipitation preceding the failure of the landslide. The combined effect of this excess water raised pore water pressure in the slide mass and decreased stability.

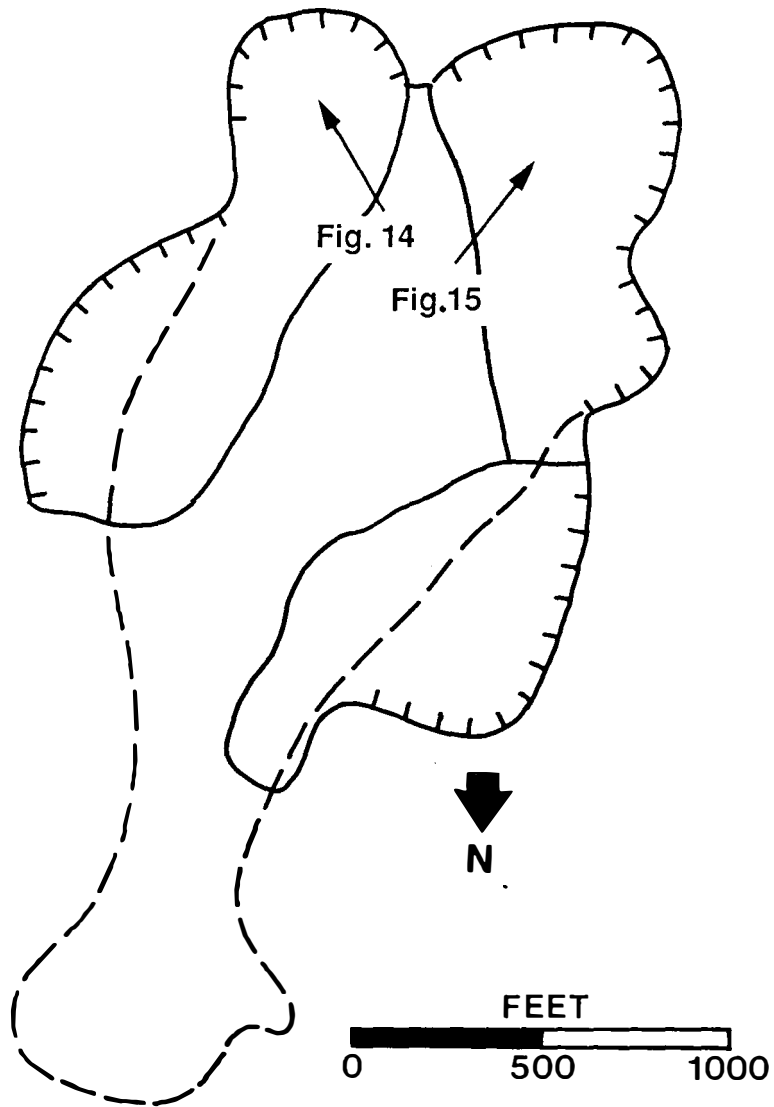
These cliff scarps do appear on aerial photographs flown for the United States Bureau of Land Management (BLM) in 1978. Figure 16 shows head scarp location and associated landslide deposits in 1978 with reference to scarp development and deposits currently observed. Comparing these aerial photographs with 1985 images shows that the cliff faces are larger and more pronounced after the most recent failure of the Roan Creek landslide. Currently the cliff scarps are approximately 150 feet high to the east of the drainage and 200 feet high west of the drainage. The cliff scarps dominate the upper reaches of the slide, but the head scarp is continuous along the upper perimeter of the slide reaching heights of 75 feet along the western margin (Figure 17). All scarps are presented on Figure 18 and Plate 1.

Figure 16. Scarp development and associated landslide deposits in 1978.

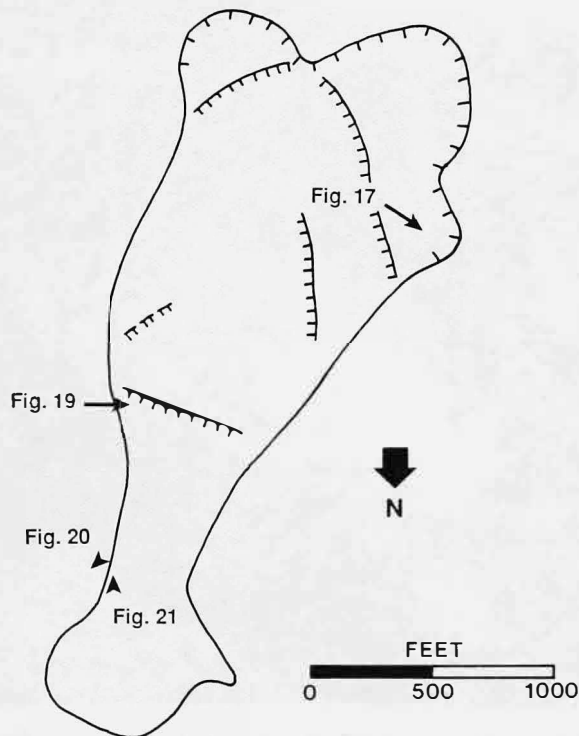
Figure 18. Scarp map of the Roan Creek Landslide.

Another distinct scarp (Figure 19) within the slide mass is located at 6175 feet in elevation and extends across the slide above its narrowest juncture (see Figure 18). It varies in height from 6 to 25 feet, but generally is 20 feet high.

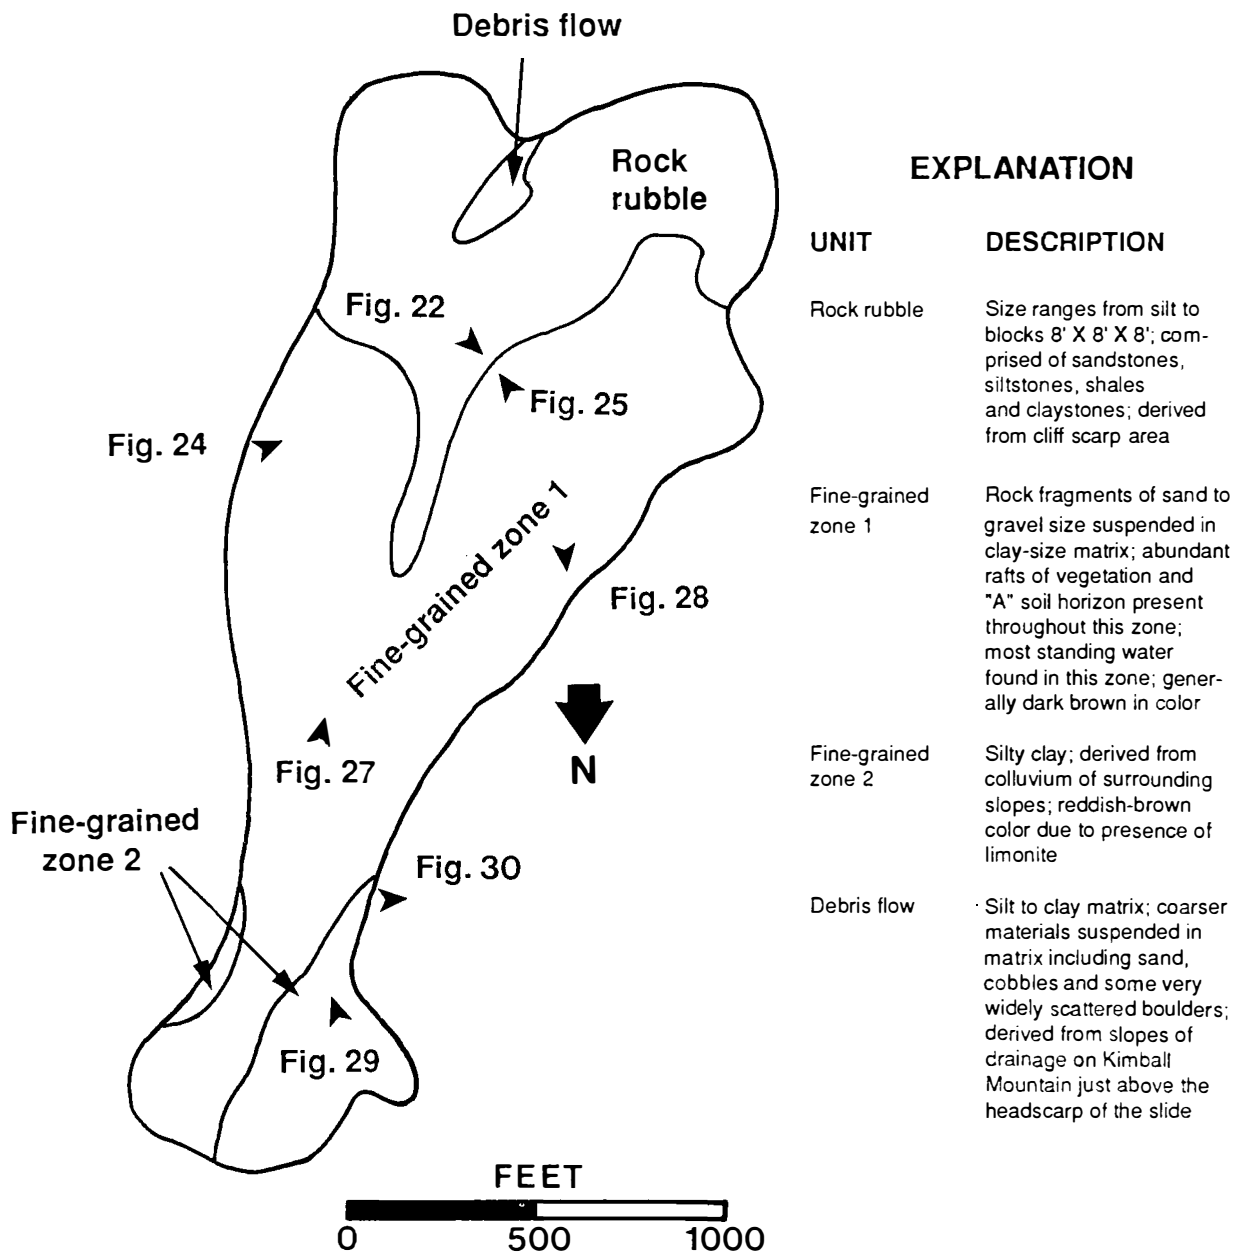
Distinct material zones exist within the slide (Figure 23). In the upper third of the slide, the predominant material present is bedrock rubble (Figures 24 and 25). Due to the heterogeneity of the material and the distance it has traveled, particle size ranges from silt to large blocks. Note the blocks of rock in Figure 25 are generally larger than those observed in Figure 24 due to closer proximity to the source area in the head scarp region. More friable and fissile material has been physically reduced to silt-size particles while stronger rock, such as sandstone, is present in large blocks with dimensions up to 8 feet by 8 feet by 8 feet. The rock rubble was derived from siltstones, fine-grained sandstones, claystones and shale of the Douglas Creek and Garden Gulch Members of the Green River Formation and of the Upper Shire Member of the Wasatch Formation.

The lower two thirds of the slide is predominantly fine-grained with an abundance of smaller rock fragments suspended within the clay-size matrix (Figure 26). In this zone, abundant blocks of vegetation and "A" soil horizon appear to have rafted on top of the slide mass as it moved downhill (Figure 27). The root structures of the vegetation have kept the blocks intact. On the flanks of the toe of the slide, another zone of predominantly fine-grained material is present, denoted as fine-grained zone 2 on Figure 23. It has a different texture and color from the primary fine-grained zone 1 and correlates to the hillslopes adjacent to the slide. The material was most probably incorporated into the slide mass as the slide moved into the drainage bottleneck before spreading onto an alluvial fan. A small debris flow deposit (see Figure 23) is present at the head of the slide below the juncture where the head scarp intersects the drainage from the upper elevations of Kimball Mountain.

Figure 23. Materials zone map of the Roan Creek Landslide.

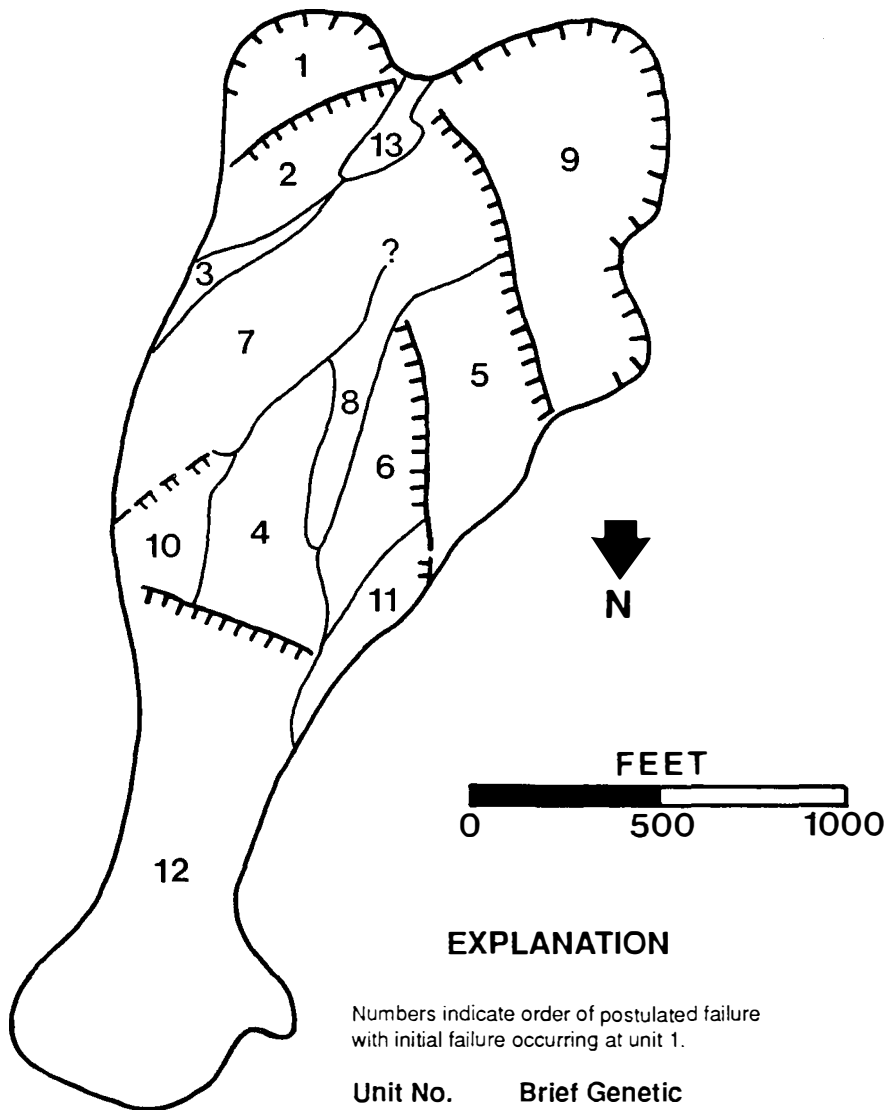
A surficial geology map (Figure 32) is a summary of information presented on Plate 1 and has been compiled from an extensive examination of the 1985 aerial photographs and field notes. Figure 32A is an explanation sheet for the surficial deposits map. All major scarps have been noted, rotation blocks identified and individual flow deposits delineated. The numbers assigned to each unit indicate postulated order of failure with initial failure occurring in unit 1. Units 1, 2 and 9 are rotational blocks below the head cliff scarps while units 5 and 6 are slump blocks below secondary scarps. Units 3, 4, 7, 8, 10, 11 and 12 are flow deposits originating from scarps and failure surfaces uphill. The debris flow deposit post-dating the slide was labeled unit 13. All of these units are also presented on Plate 1.

Initial failure of the 1985 Roan Creek landslide most probably occurred in the upper reaches of the slide at the cliff scarps along preferential, pre-existing failure surfaces. The slump block below the eastern cliff scarp was rotated approximately 45 degrees back into the slope by the 1985 failure as evidenced by tree rotation. The 1978 photos indicate that trees were vertical at that time. In addition, the large scarp downslope from the eastern cliff scarp (upper boundary of unit 2 in Figure 32/Plate 1) developed

Figure 32. Surficial deposits map of the Roan Creek Landslide.

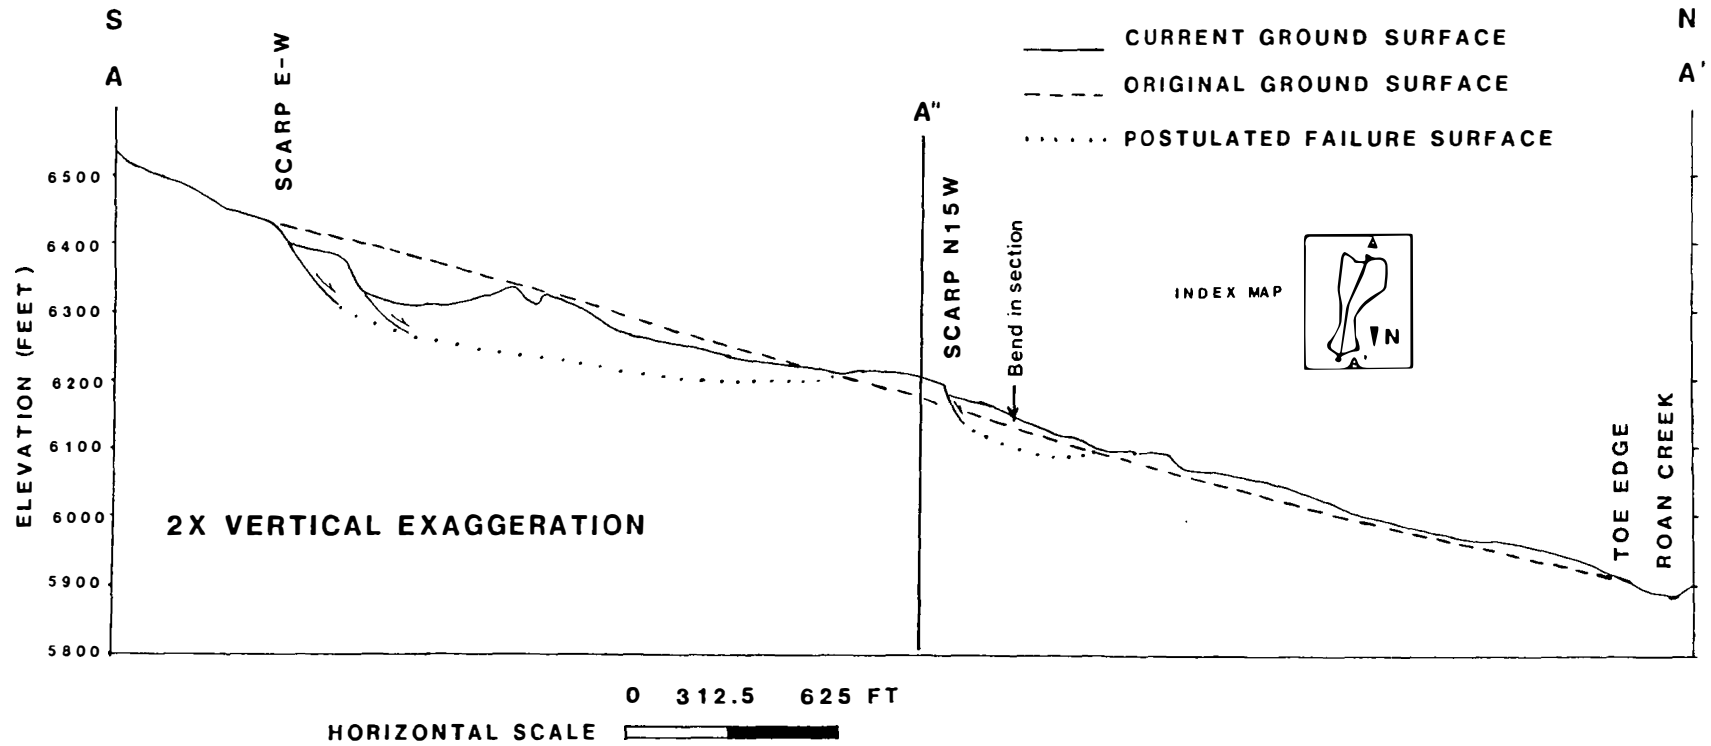
Figure 33. Cross-section along A-A'.

Failure along the scarp oriented N15W (Figures 18 and 33) occurred entirely in the zone of accumulation and is postulated to have occurred after the failure in the upper reaches of the slide. This failure can probably be attributed to high pore water pressures as well as low material shear strength present in the upper region of the zone of accumulation.

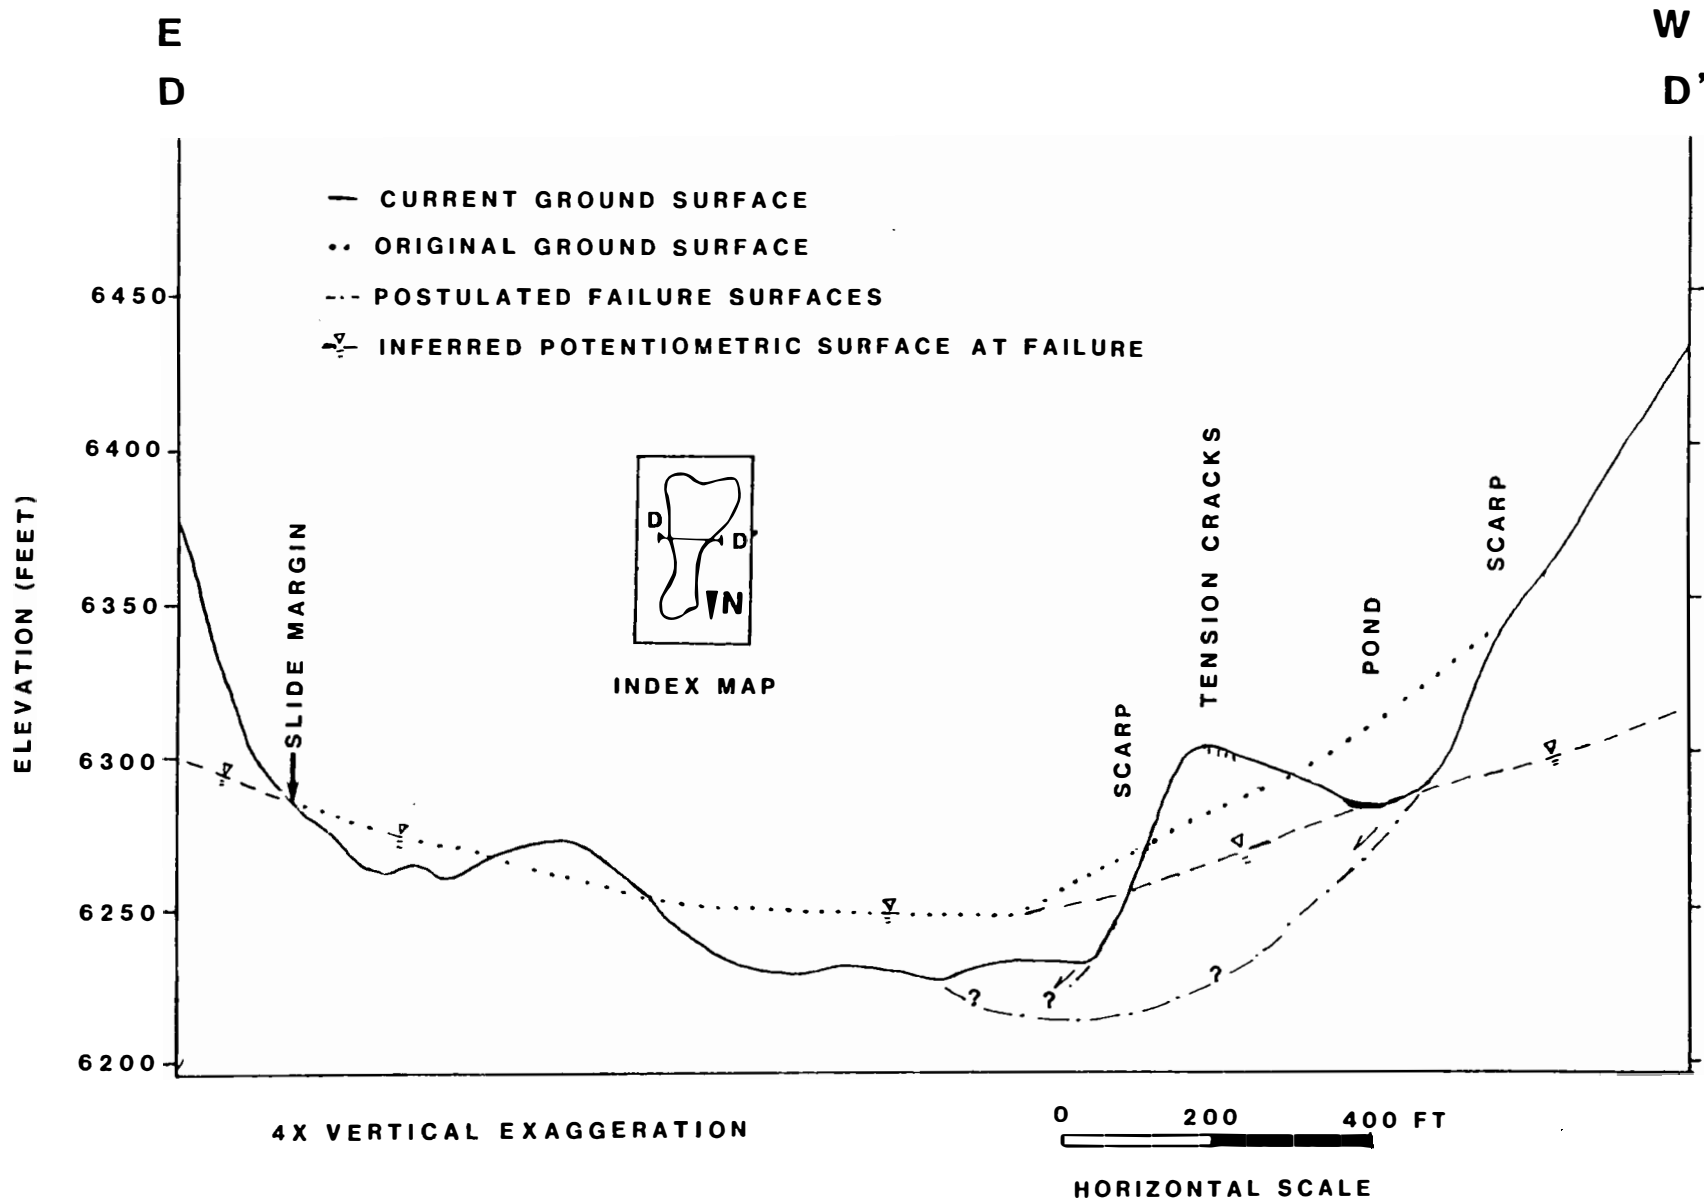
Figure 34. Cross-section along D-D'.

8.2.5 Modeling of failure along profile D-D' The proposed model suggests the third phase of failure occurred along the western margin slopes and in the western cliff scarp region due to reduction of lateral confining pressure after failure along A-A'. According to Figure 32/Plate 1, unit 5 was the first to fail along the western margin. Therefore, PCSTABL4 was utilized to analyze stability along profile D-D' (see Figure 34) prior to and after failure along A-A'. A total stress analysis was conducted with the original topographic conditions outlined on Figure 34 assuming the potentiometric surface to be at the ground surface in the valley bottom and to fall significantly below the ground surface as the slope increased gradient. An undrained cohesion of 1350 psf was specified. This analysis yielded a critical factor of safety of 1.20 for the given conditions suggesting that the slope was stable prior to failure along A-A'. Appendix B-4 contains the input and output for this analysis.

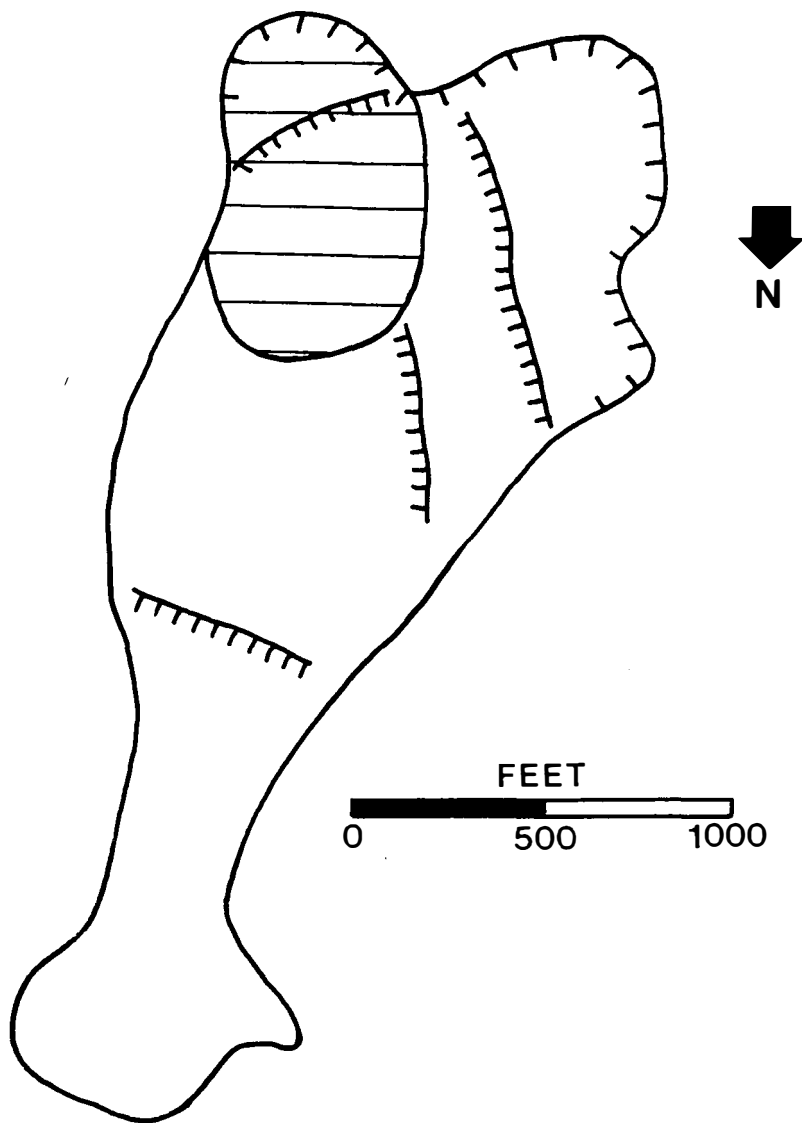
Figure 35. Phase 1 Movement of the Roan Creek landslide.

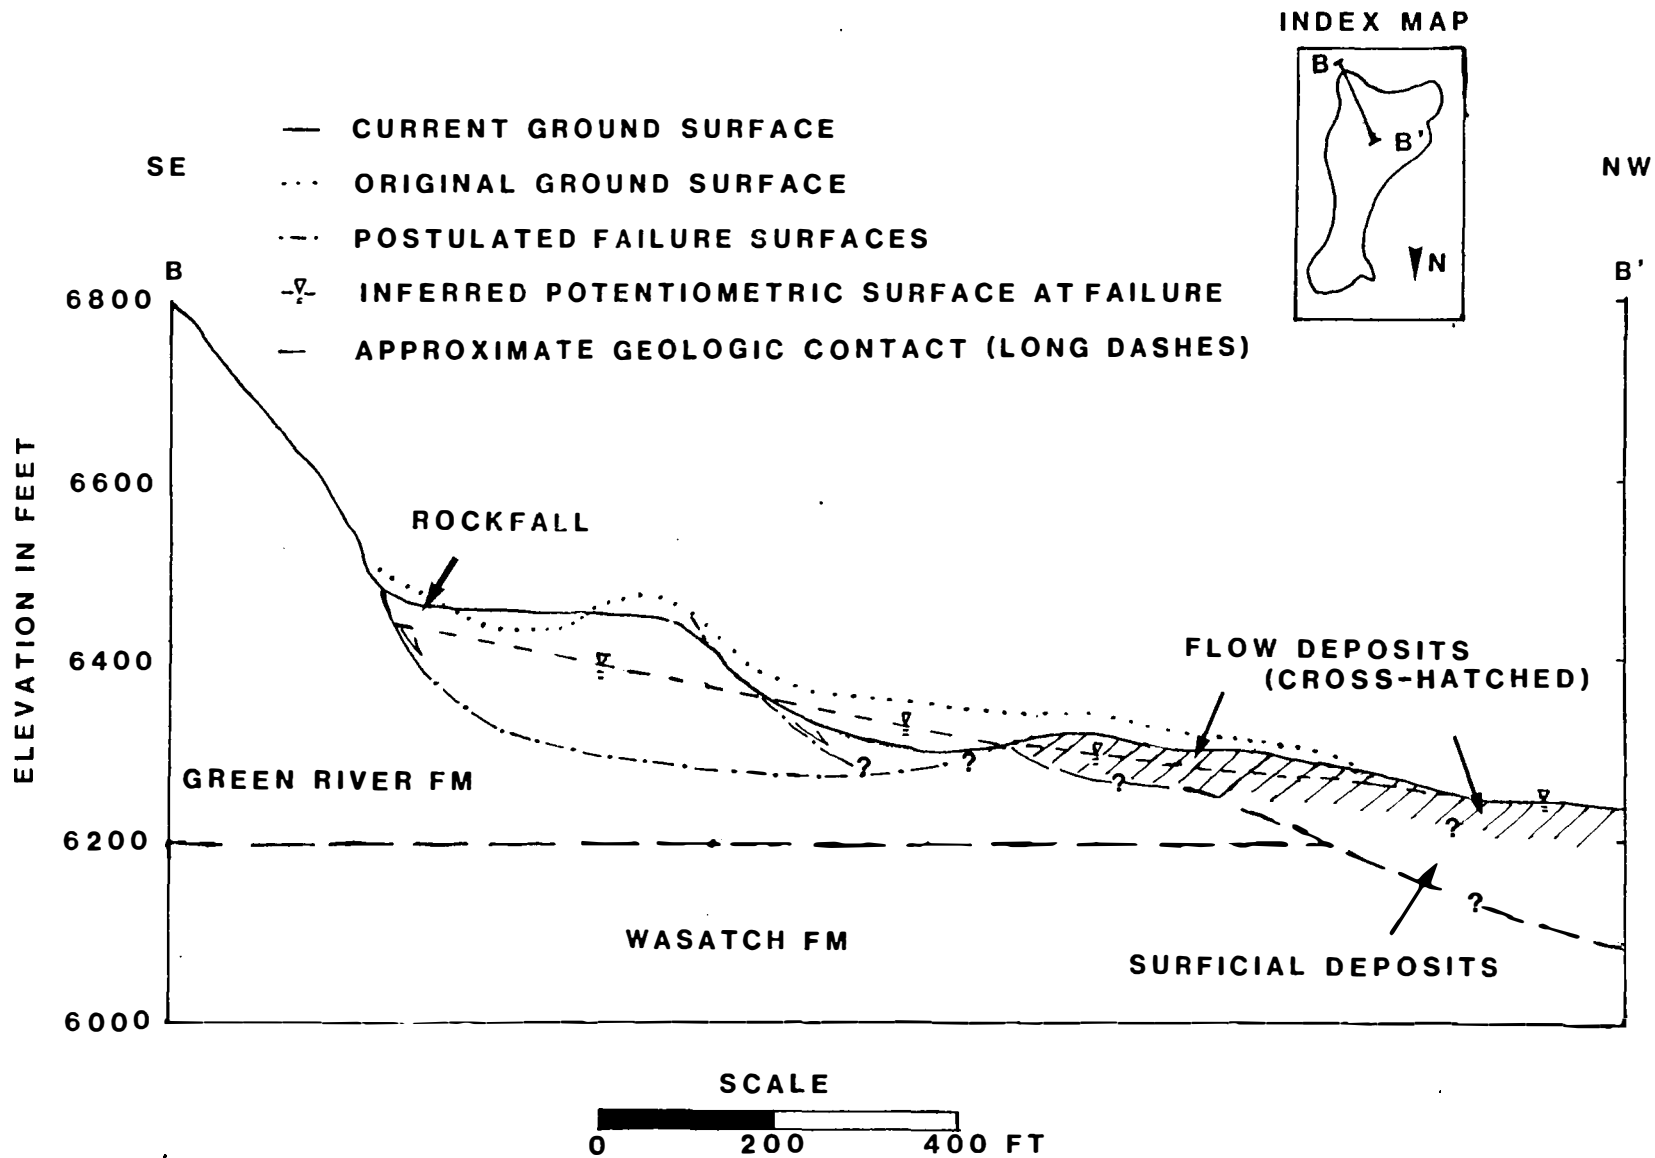
Figure 36. Cross-section along B-B'.

8.2.4 Modeling of failure along profile B-B' According to the failure model proposed in Section 7.4, initial failure of the Roan Creek landslide occurred in the eastern head region along the eastern cliff scarp. A PCSTABL4 analysis along B-B' (see Figure 36) was conducted to define the failure plane configuration and its respective factor of safety. Failure in the head region was well-defined by a cliff scarp (see Figure 14). Failure was assumed to have occurred exclusively in bedrock material as it is the predominant material type present in this section of the slide. Therefore, the bedrock strength parameters presented in Table III were utilized in the analysis. The potentiometric surface along B-B' was assumed to be at the surface near the drainage valley center, but to significantly fall below the previous ground surface towards the eastern cliff scarp (see Figure 36) due to an increase in topographic gradient. Appendix B-2 contains the PCSTABL4 data input file for the analysis along B-B'.

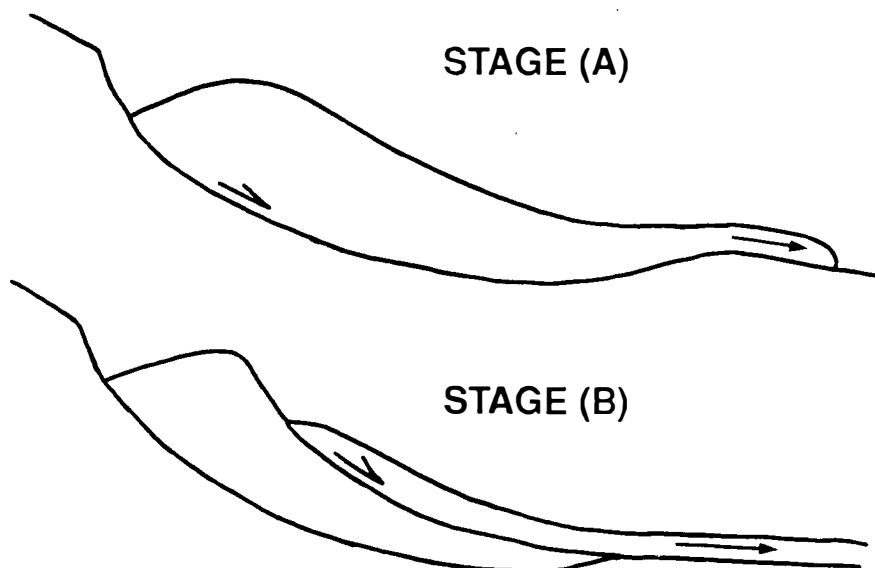
Figure 37 is a two-stage, diagrammatic representation of how failure is believed to have occurred along B-B'. Movement along the pre-existing failure surface daylighting at the eastern cliff scarp initiated failure of the Roan Creek landslide. As the slump block below the cliff scarp rotated back into the slope, secondary failure occurred along a new failure surface on the downslope side of the pre-existing transverse ridge. The postulated failure model then suggests that movement of waste material from this secondary scarp down the drainage generated a surcharge load on the surficial material in the drainage (Figure 38) subsequently reducing the stability of that zone and causing the second phase of failure (Figure 39). Unit 3 on Figure 32/Plate 1 is the last exposed remnant of the surcharge load material.

Figure 37. Diagrammatic representation of proposed failure sequence along cross-section B-B'. (Not to scale.)

plane daylighting at the cliff scarp. The failure along A-A' and subsequent removal of lateral support is represented in stage (b). Failure due to removal of lateral support by failure along A-A' is shown in stage (c). The head scarp of this failure surface is coincident with that representing the upper boundary of unit 5 in Figure 32. Stage (d) shows the vertical displacement at the head scarp in (c) immediately after failure which resulted in reduced lateral support of the failure plane daylighting at the cliff scarp. Failure along the pre-existing failure plane is shown in stage (e).

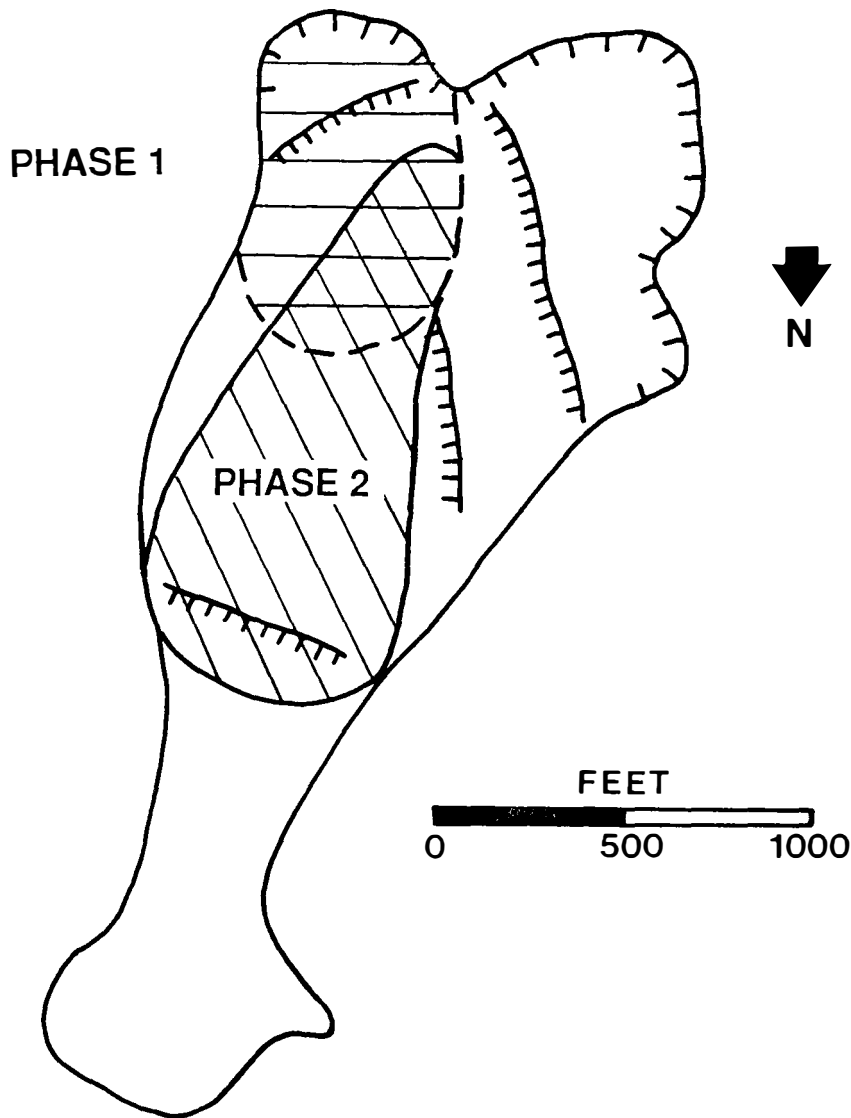
Figure 39. Phase 2 movement of the Roan Creek landslide.

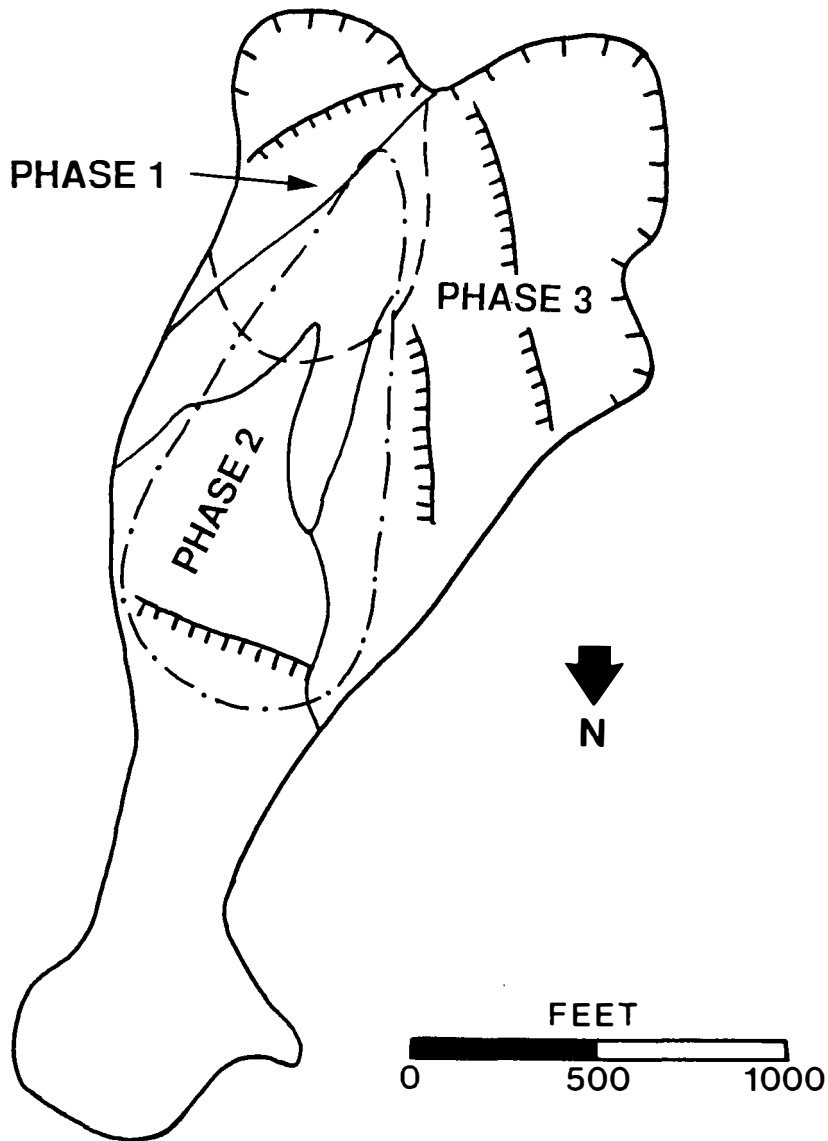
Removal of material in the zone of wasting in the second stage of failure resulted in a significant reduction of lateral confining pressures acting on the rotational block below the western cliff scarp and on the slopes to the west of the drainage. This led to the third phase of failure (Figure 40) which included renewed failure along the western cliff scarp and progressive, downward-migrating, mass wasting of the slopes to the west as evidenced in the field by a series of scarps and tension cracks oriented semi-parallel to the drainage.

Figure 40. Phase 3 movement of the Roan Creek landslide.

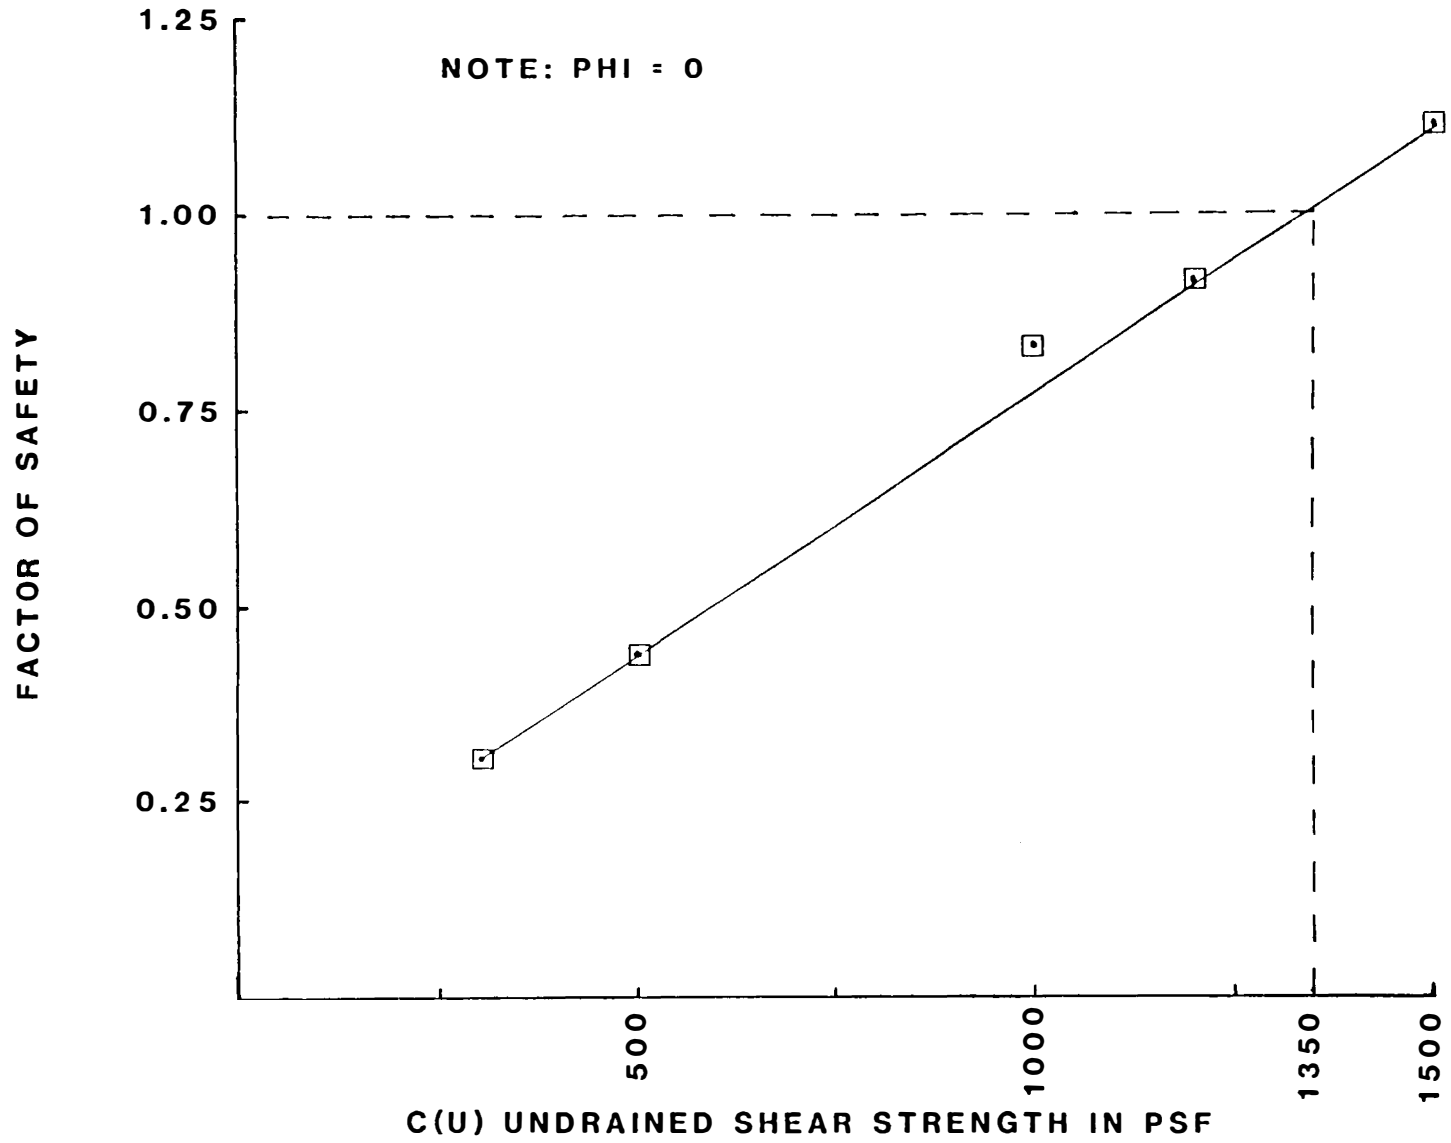
Values of undrained shear strength ranging from 300 to 1500 psf were utilized, in conjunction with the unit weights and groundwater conditions described above for the failure plane defined in Figure 38, to determine what shear strength yielded a factor of safety of 1.0 using the Janbu method of slices. Figure 44 is a plot of factor of safety versus undrained shear strength compiled from PCSTABL4 results.

Figure 44. Determination of undrained shear strength.

Back calculation using a total stress analysis yielded an undrained shear strength of 1350 psf. Analysis along profile A-A' prior to surcharge loading generated a factor of safety of 1.23 suggests that failure was caused due to surcharge loading.

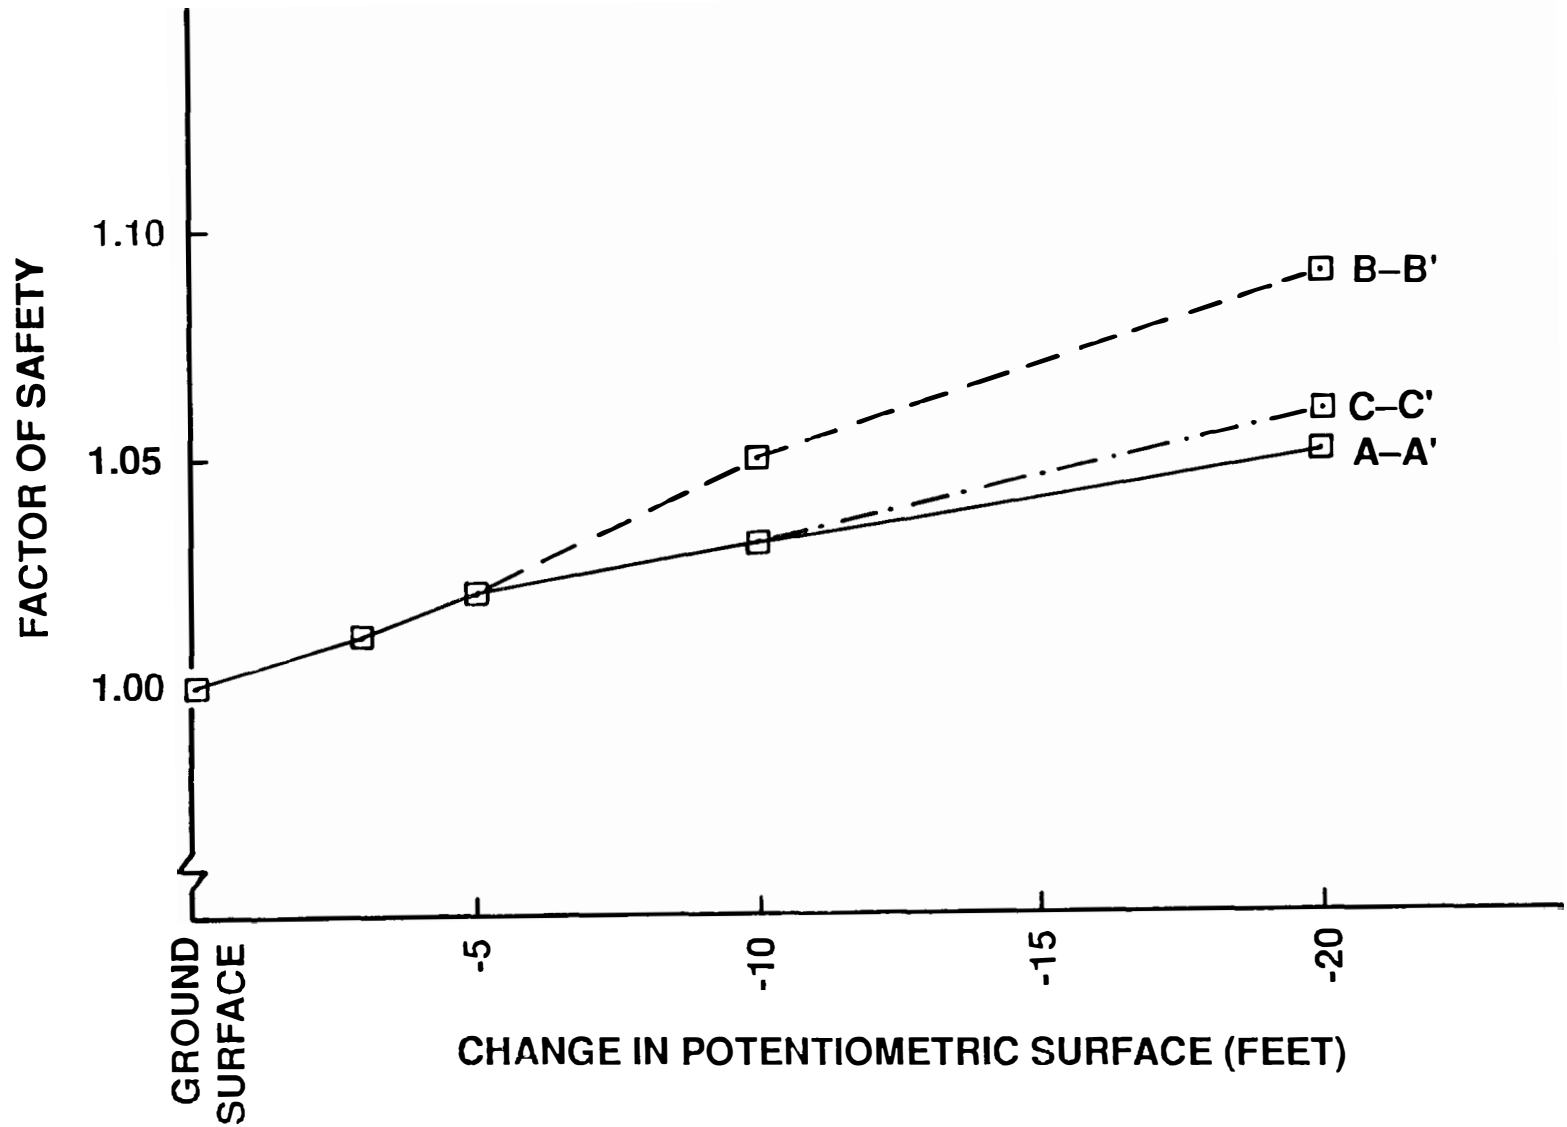
8.2.7 Effect of lowering potentiometric surface on factor of safety After analyses were conducted along the four profiles, the effect of the position of the inferred potentiometric surfaces on factors of safety was addressed. The potentiometric surfaces on factors of safety was addressed. The potentiometric surface was lowered from the position used in the analyses (see previous discussion and Appendix B data input files) by 5, 10 and 20 feet under the most critical failure conditions along profiles A-A', B-B' and C-C'. It should be noted that only the effect on the terminal failure condition along profile C-C' was analyzed. The results are plotted on Figure 45.

Figure 45. Effect of lowering potentiometric surface on factor of safety.
