OPEN-FILE REPORT 89-01

Field Studies and Modeling Analysis of the Roan Creek Landslide, Garfield County, Colorado

By
David Umstot*

Colorado Geological Survey
Department of Natural Resources
Denver, Colorado
1989

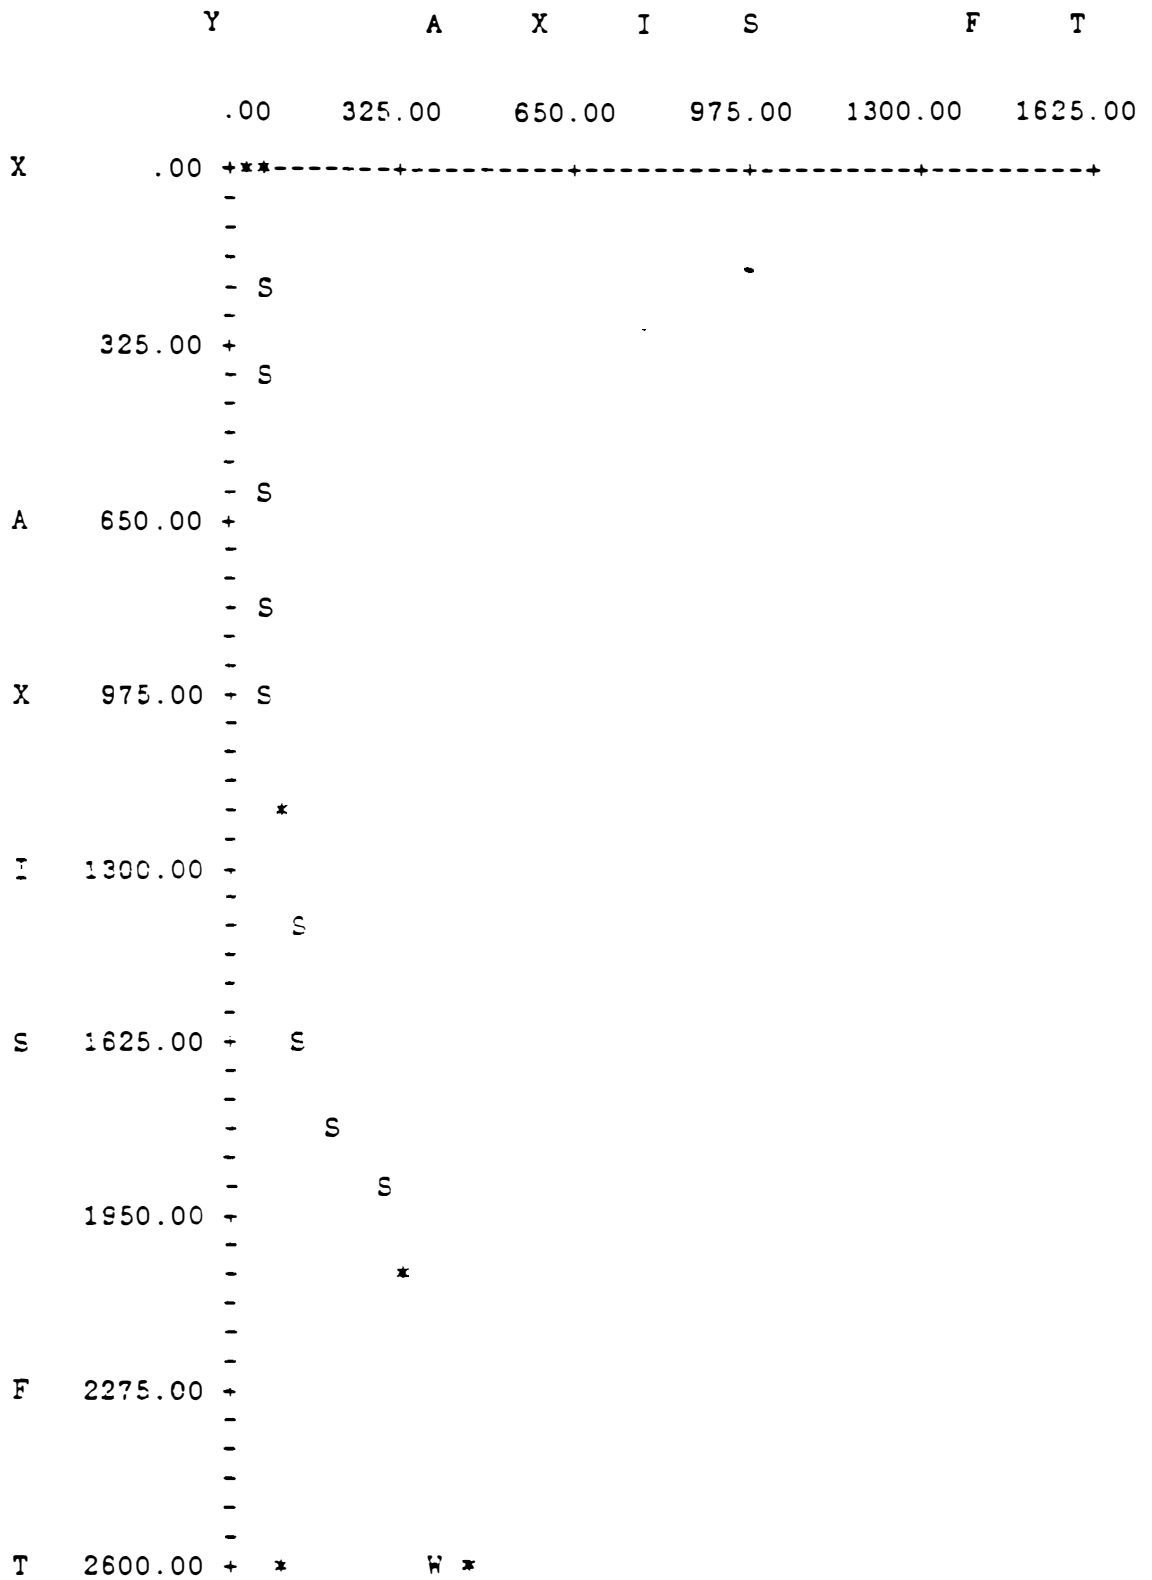
Factor Of Safety For the Preceding Specified Surface = 1.230

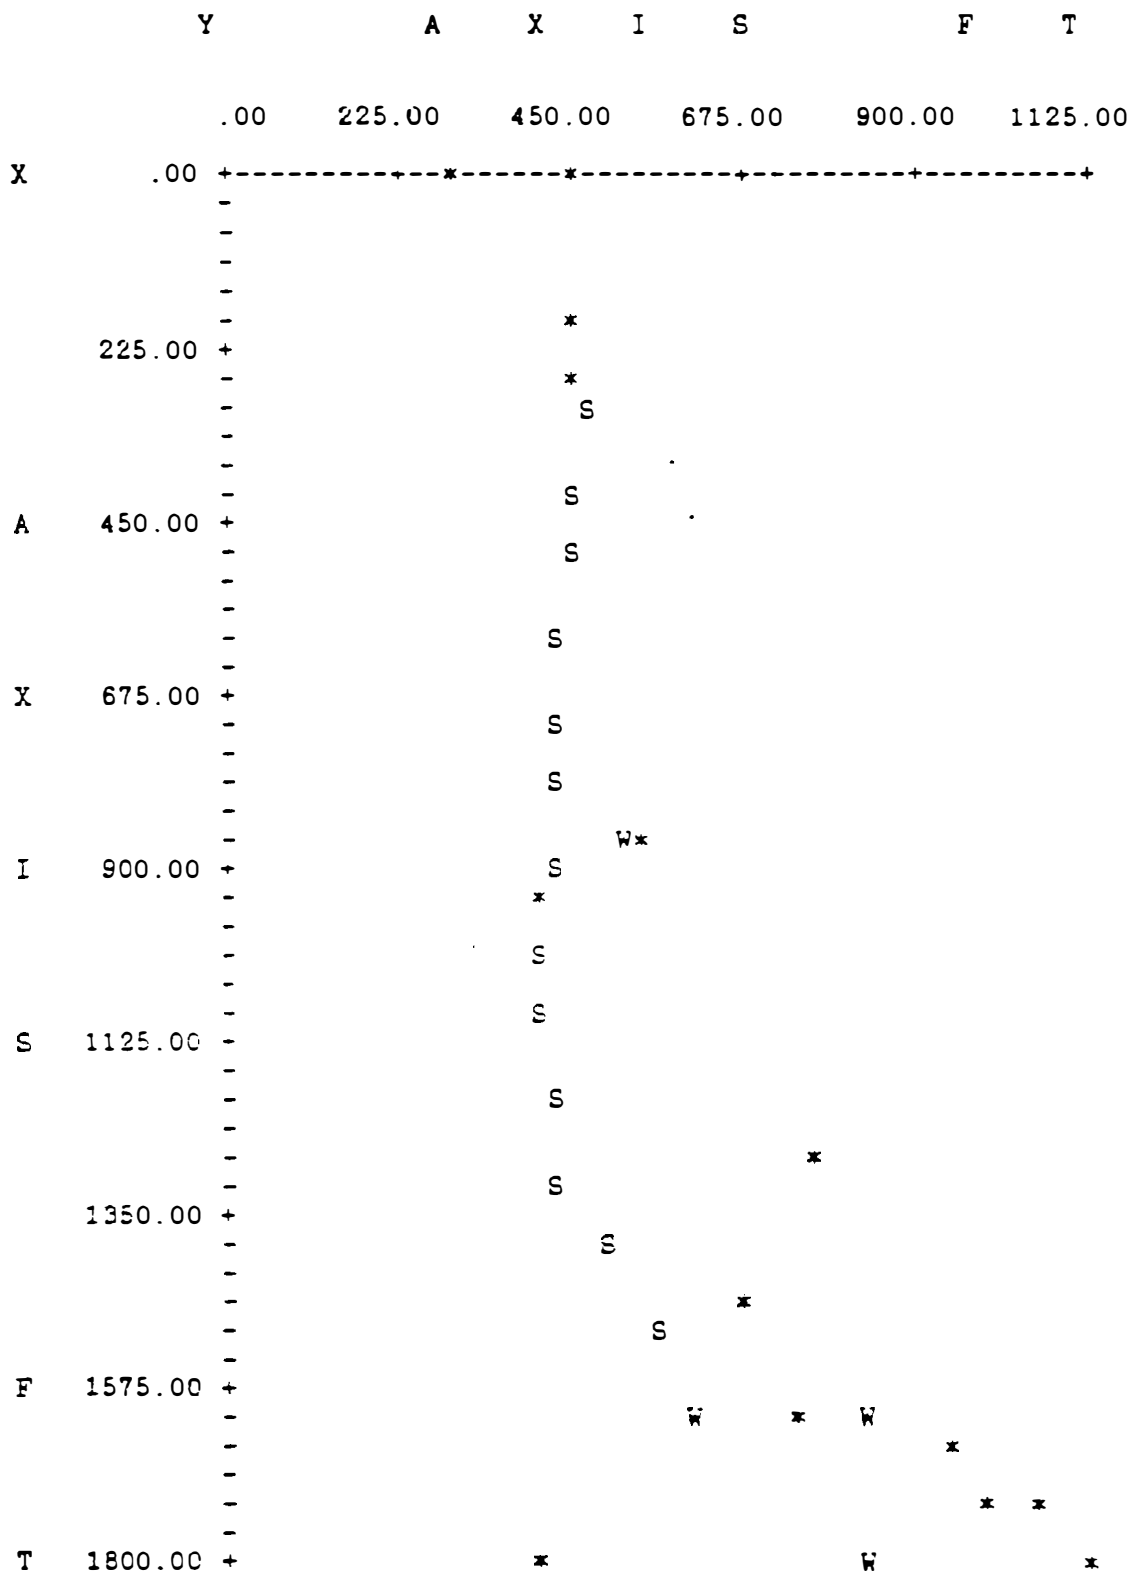
Factor Of Safety For the Preceding Specified Surface = 1.110
