Open File Report 91-01

**Identification and Remediation
of a Mine Flooding Problem in Rico,
Dolores County, Colorado
with a Discussion on the Use of Tracer Dyes**

By Mark W. Davis

Colorado Geological Survey
Division of Minerals and Geology
Department of Natural Resources
Denver, Colorado
1994

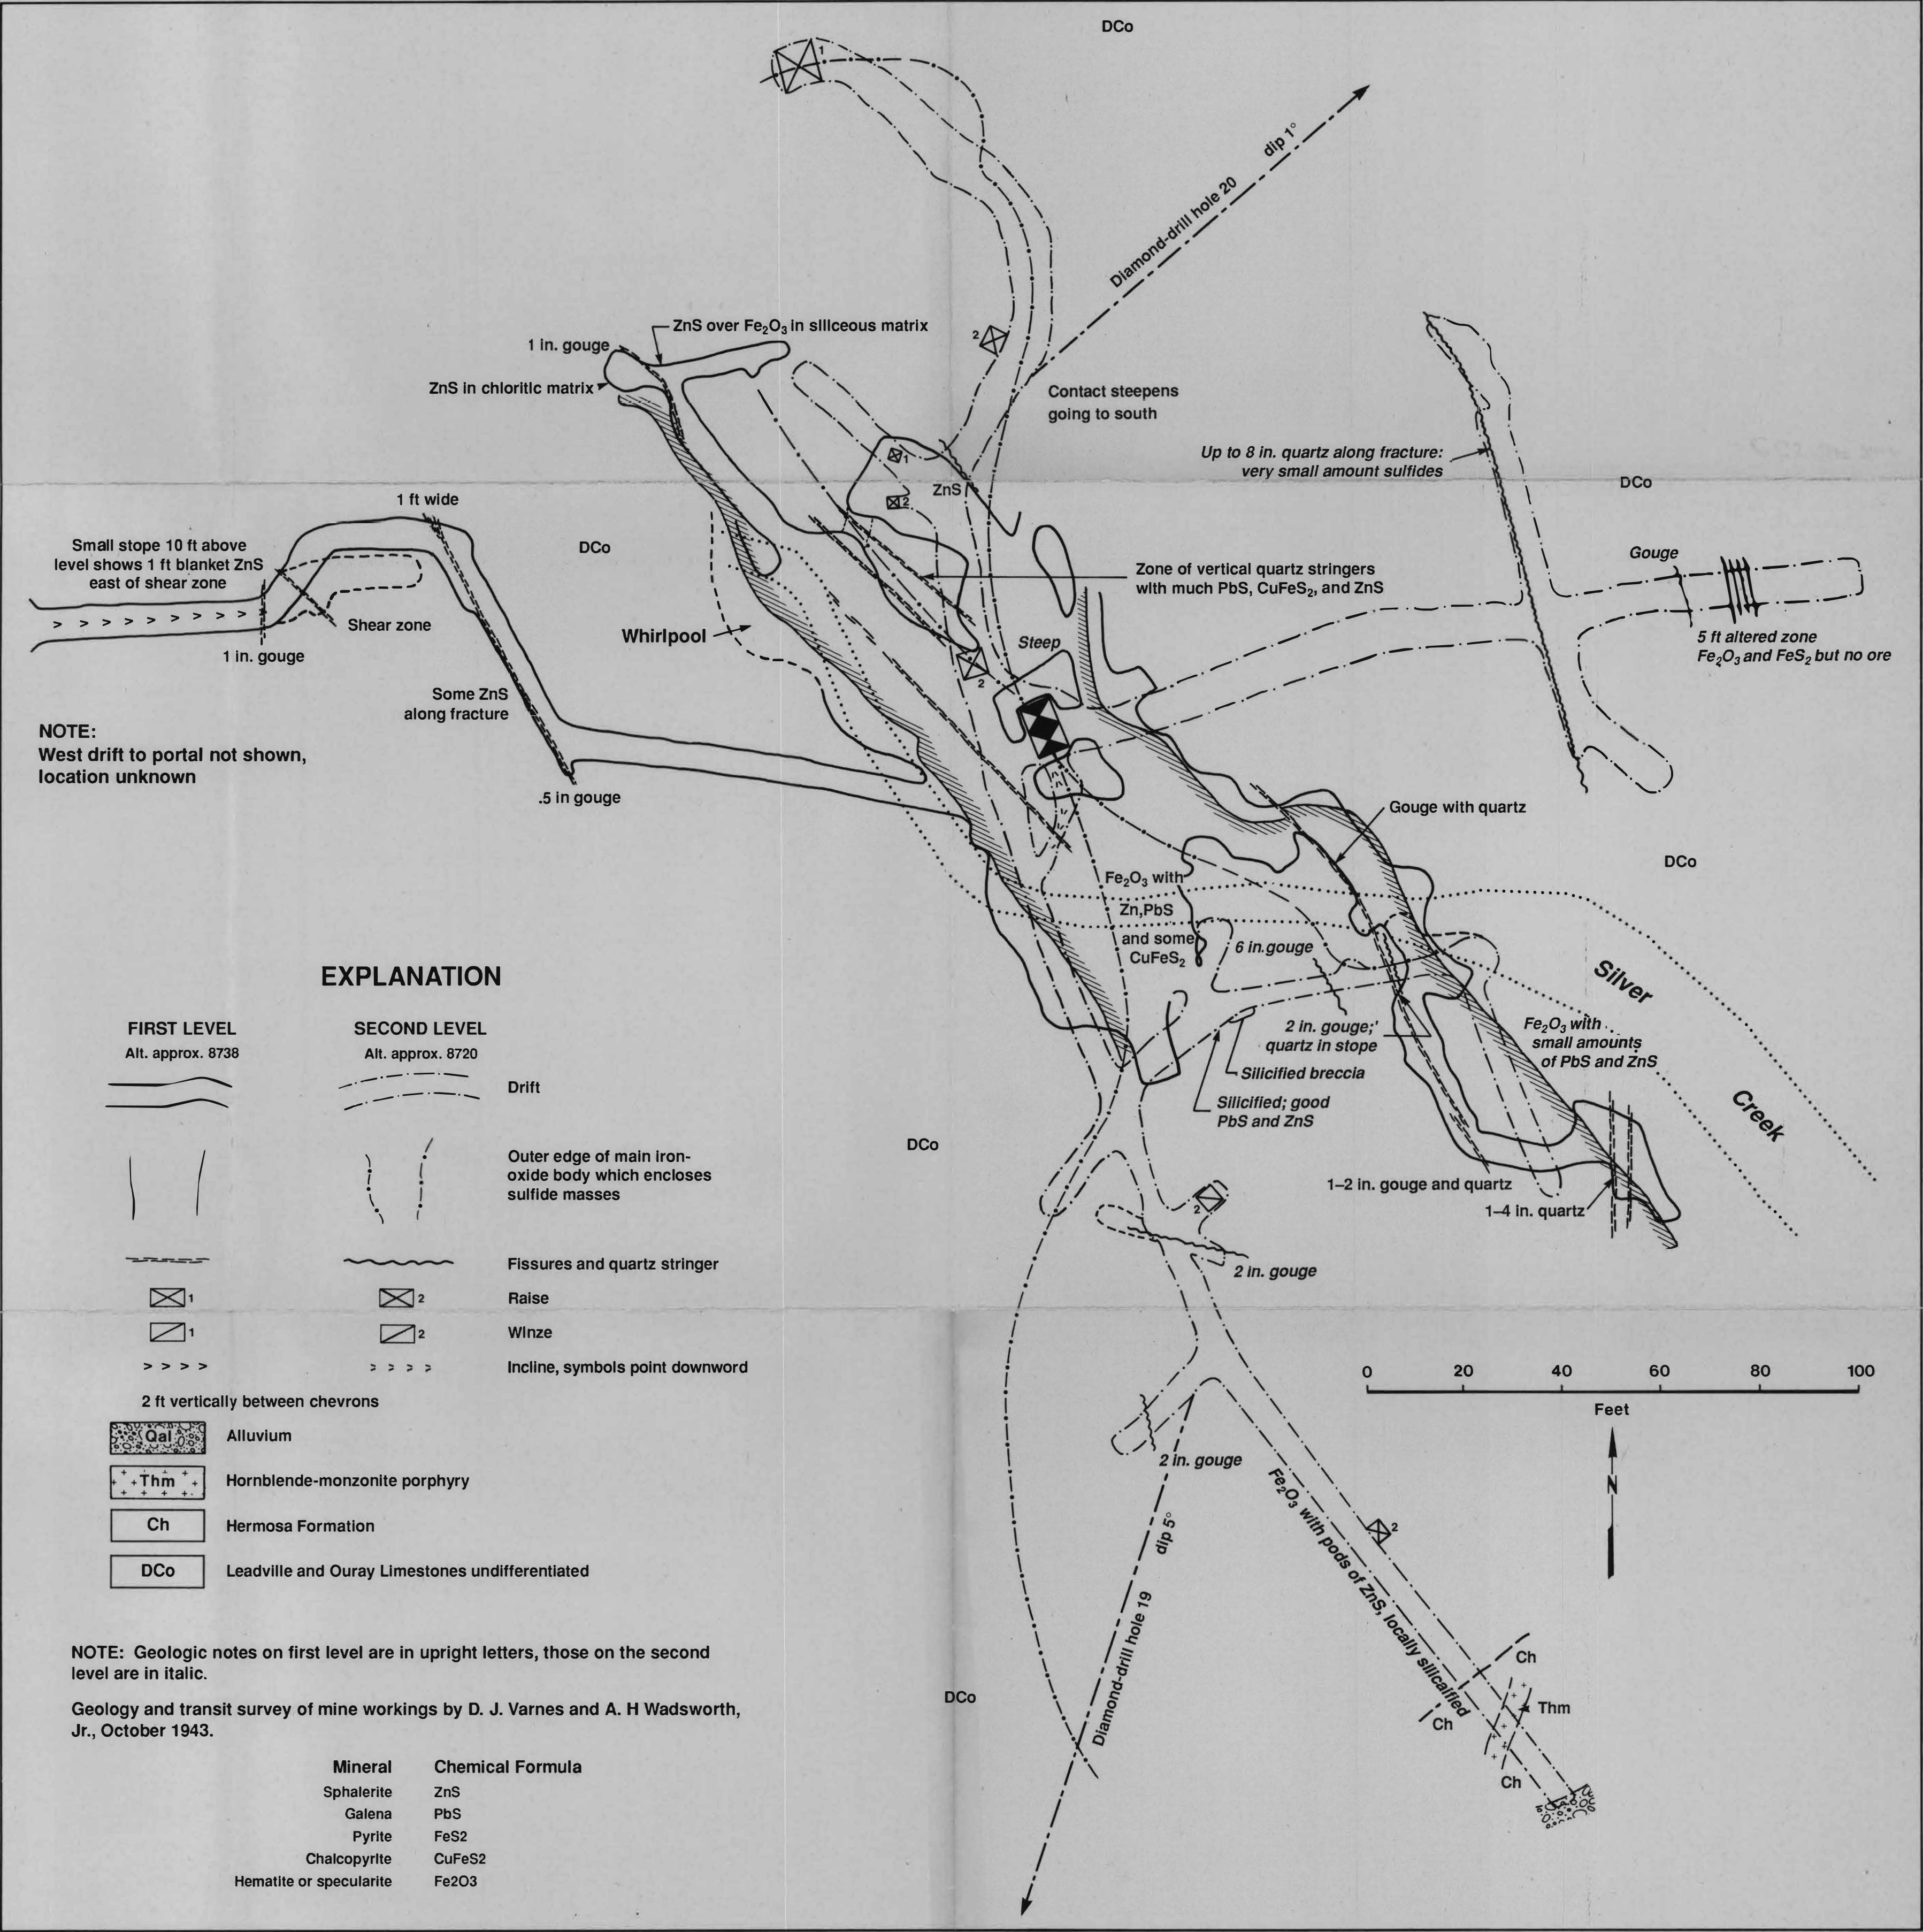
Atlantic Cable Mine, Rico, Colorado Geology and Transit Survey of Mine Workings

The Atlantic Cable Mine was serviced by a two compartment shaft for men and equipment and for hoisting ore. There appear to be three levels at the Atlantic Cable Mine served by the shaft. The main stope was developed for approximately 400 ft in a northwest to southeast direction. Plate 1 depicts a drift driven to the west from the sill of the first level at an elevation of 8,738 ft. This westerly drift extends approximately 200 ft from the shaft to what is shown as an incline to the surface on Plate 1. Another heading was driven westward possibly as an extension of this drift for dewatering and haulage. This 500-ft west drift was utilized to dewater the Atlantic Cable to the first level.

Plate 1 does not extend far enough to the west to indicate the presence or absence of stoping below the residences exhibiting the

4. Stand pipe to water main ditch at the residence located at the confluence of Silver Creek with the Dolores River
5. Silver Creek upstream of highway culvert
6. Pool near cave-in of decline shown on the Plate 1.
