Special Publication 30

# Debris-Flow Hazard in the Immediate Vicinity of Ouray, Colorado

Colorado Geological Survey  
Department of Natural Resources  
Denver, Colorado / 1986

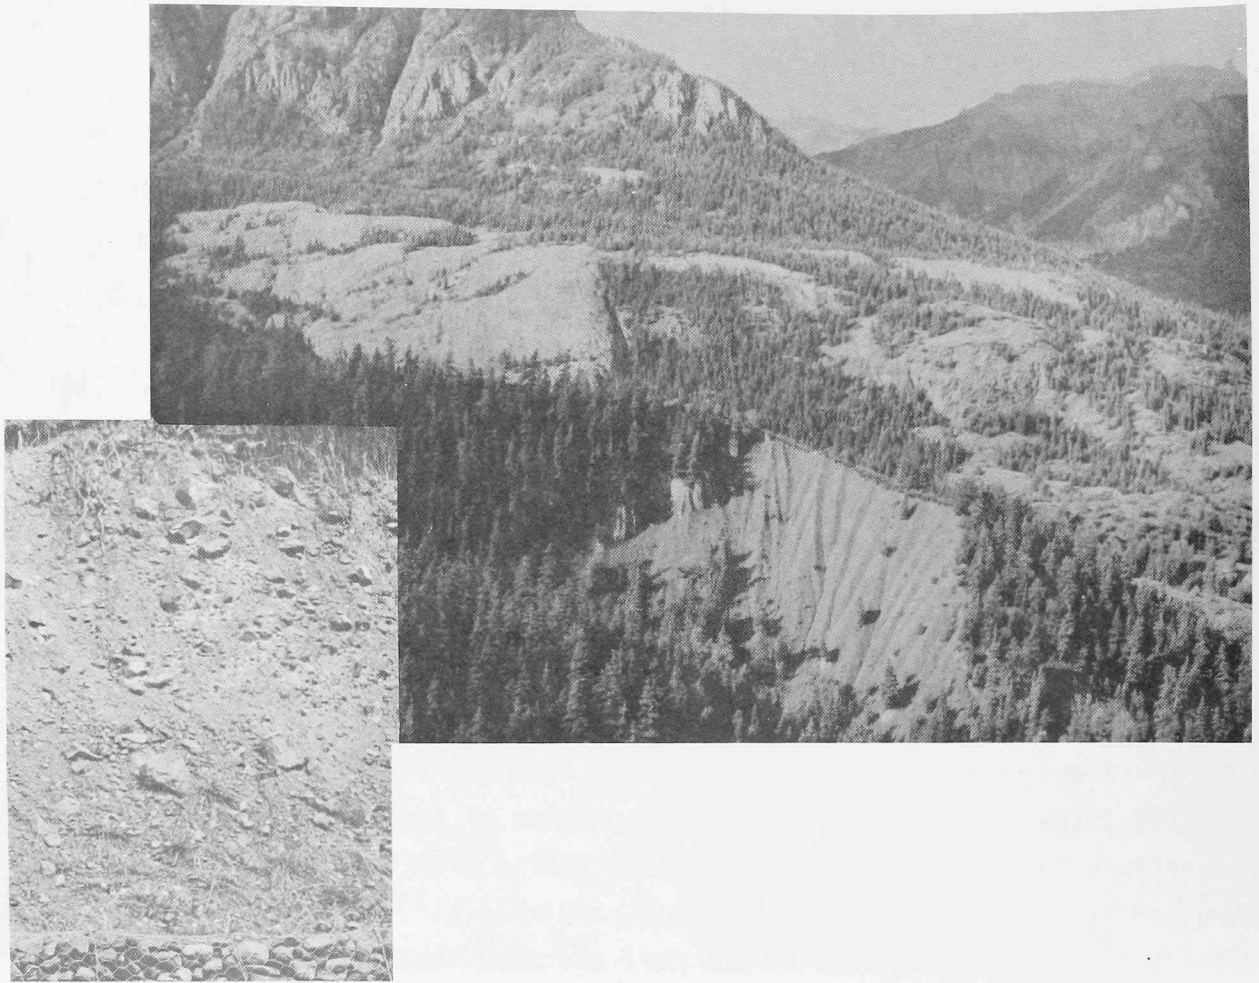
Although some debris is supplied by mass wasting in the highly fractured and faulted volcanic tuff, the major source of debris in this basin is the sheet of glacial drift. Relatively little debris is contributed by the limestone, but the creek has worn a deep, narrow channel through it, and it is through this gorge that the debris flows and floods are funneled before breaking out onto the fan.

Figure 4. Glacial drift deposit in Portland Creek basin. Boulders shown in inset average about one foot in width.

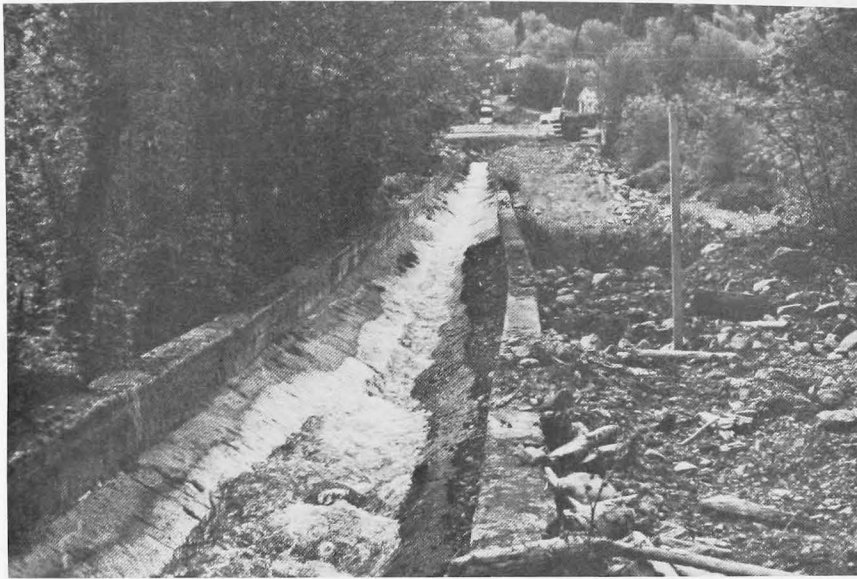
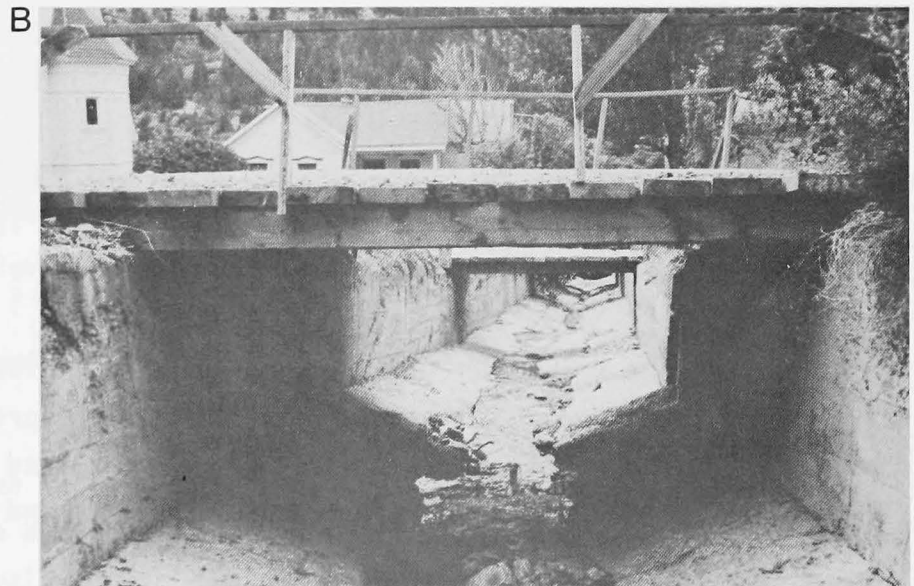
The contract for construction of the flumes was awarded in October of 1909 with a scheduled completion date of December 31, 1909. The Portland Creek flume, as constructed, was reported to be approximately 2,450 feet long, 10 feet wide, 6 feet deep, and had a v-shaped bottom. The Cascade Creek flume was reported to be 2,300 feet long, 8 feet wide, and 5 feet deep. Concrete wedges were added later to give a v-shaped bottom (Fig. 12). Actual dimensions of the flumes varied along their length.

Figure 12. A, Cascade Creek flume. B, Portland Creek flume. (Photo courtesy CWCB)

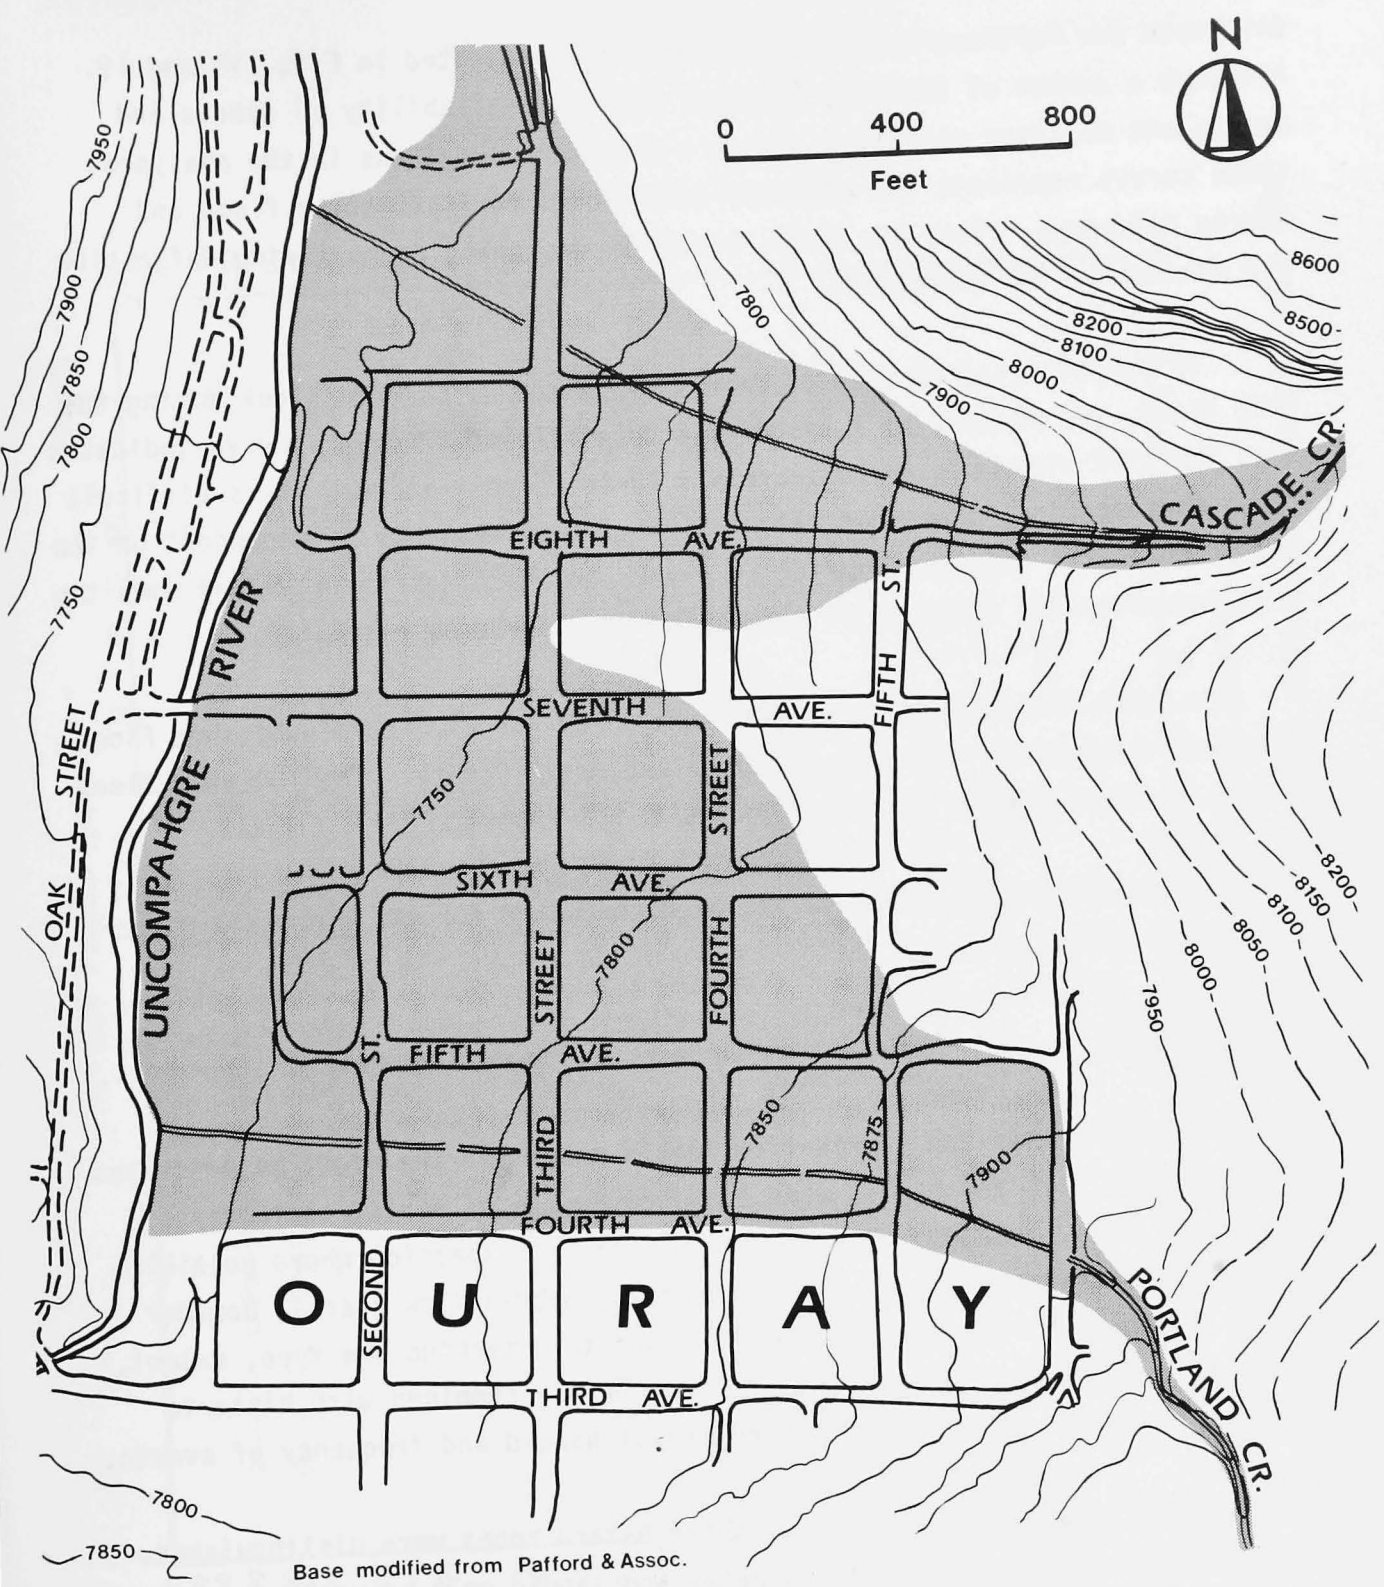
Figure 17. A & S "envelope of hazard due to flooding" for Portland and Cascade Creeks. (A & S Consultants, 1978)

Because of the flumes there is some amount of predictability in the range of the flows. Careful study of past events led A & S Consultants to determine an "envelope of hazard due to flooding". That envelope was developed in 1978. Improvements in the flumes since then should have reduced the hazard within the envelope. However, because of the structures on the fan, the behavior of the flows within the envelope is still unpredictable. An example of the erratic courses of flows within the envelope can be seen in Figs. 20, 21, and 22 where the CWCB has mapped the paths of flows on three successive days of flooding in 1982 (before improvements were made to the flumes).

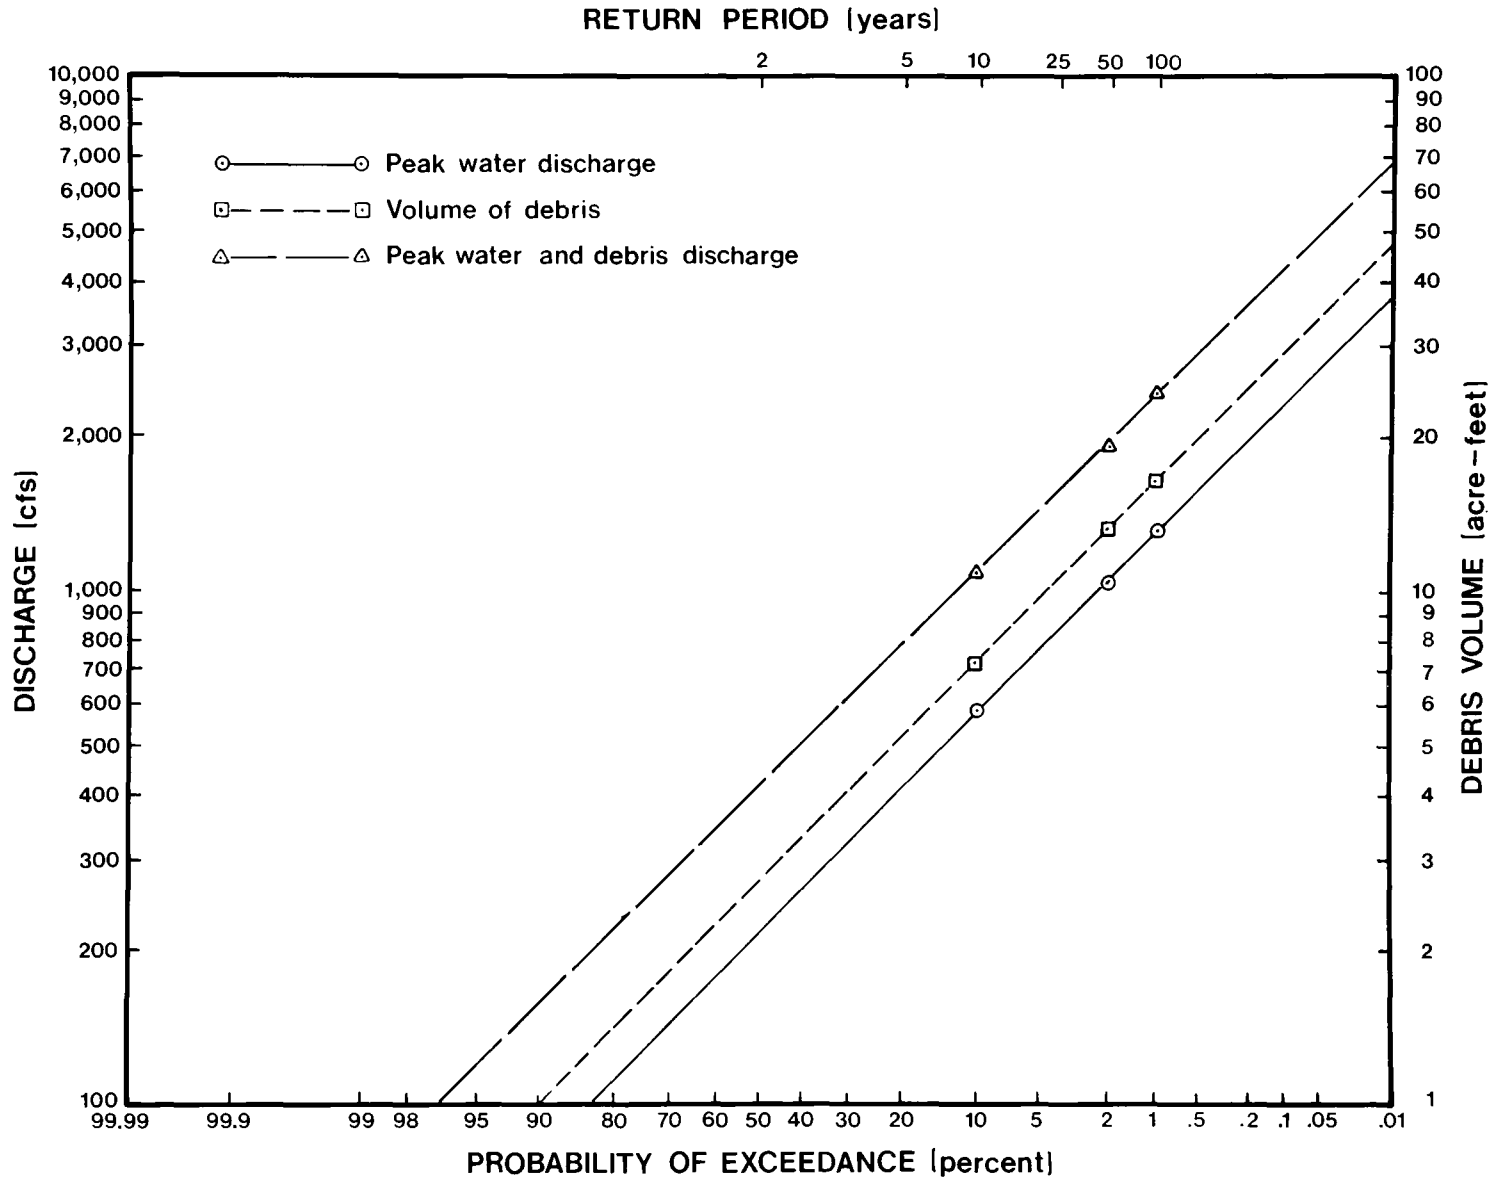
Figure 18. Portland Creek debris/flood frequency curve. (Simons, Li & Assoc., Inc., 1982)

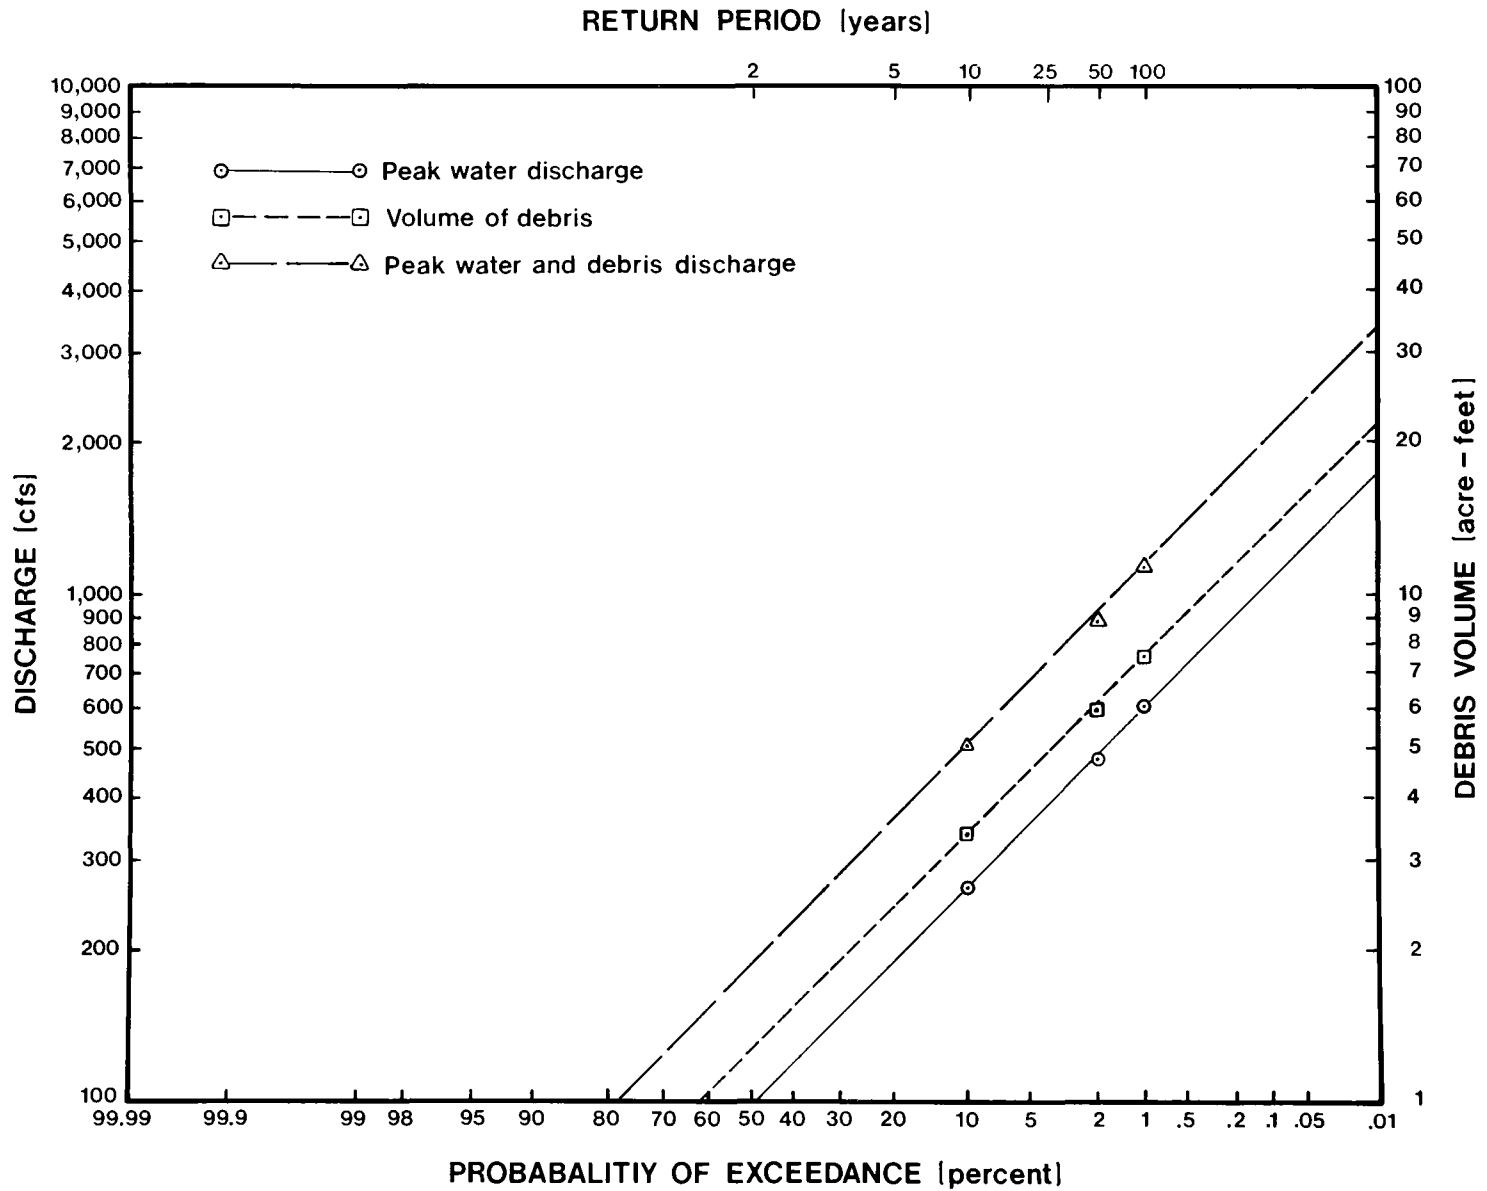
Figure 19. Cascade Creek debris/flood frequency curve. (Simons, Li & Assoc., Inc., 1982)

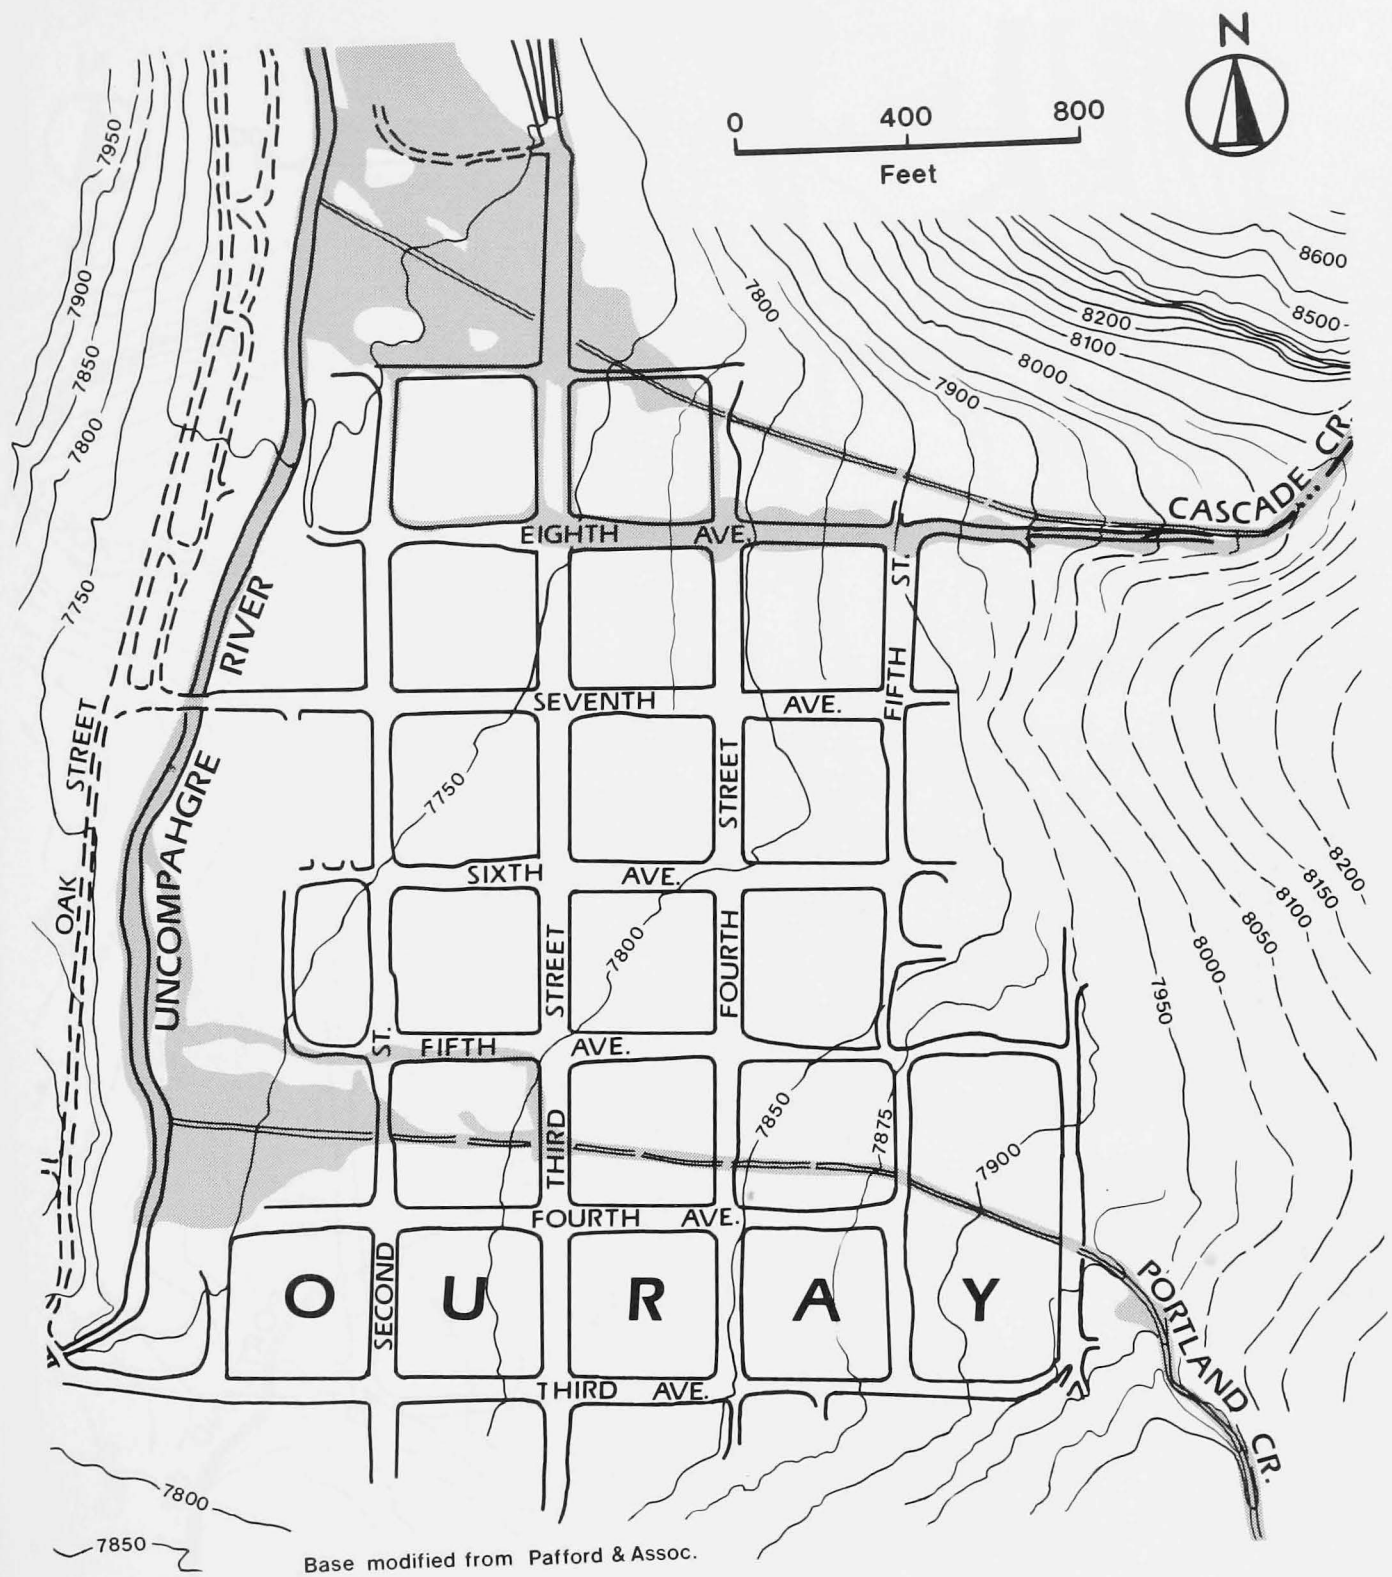
Figure 20. Path of flooding on Portland and Cascade Creeks August 20, 1982 as mapped in the field by William P. Stanton of the CWCB.

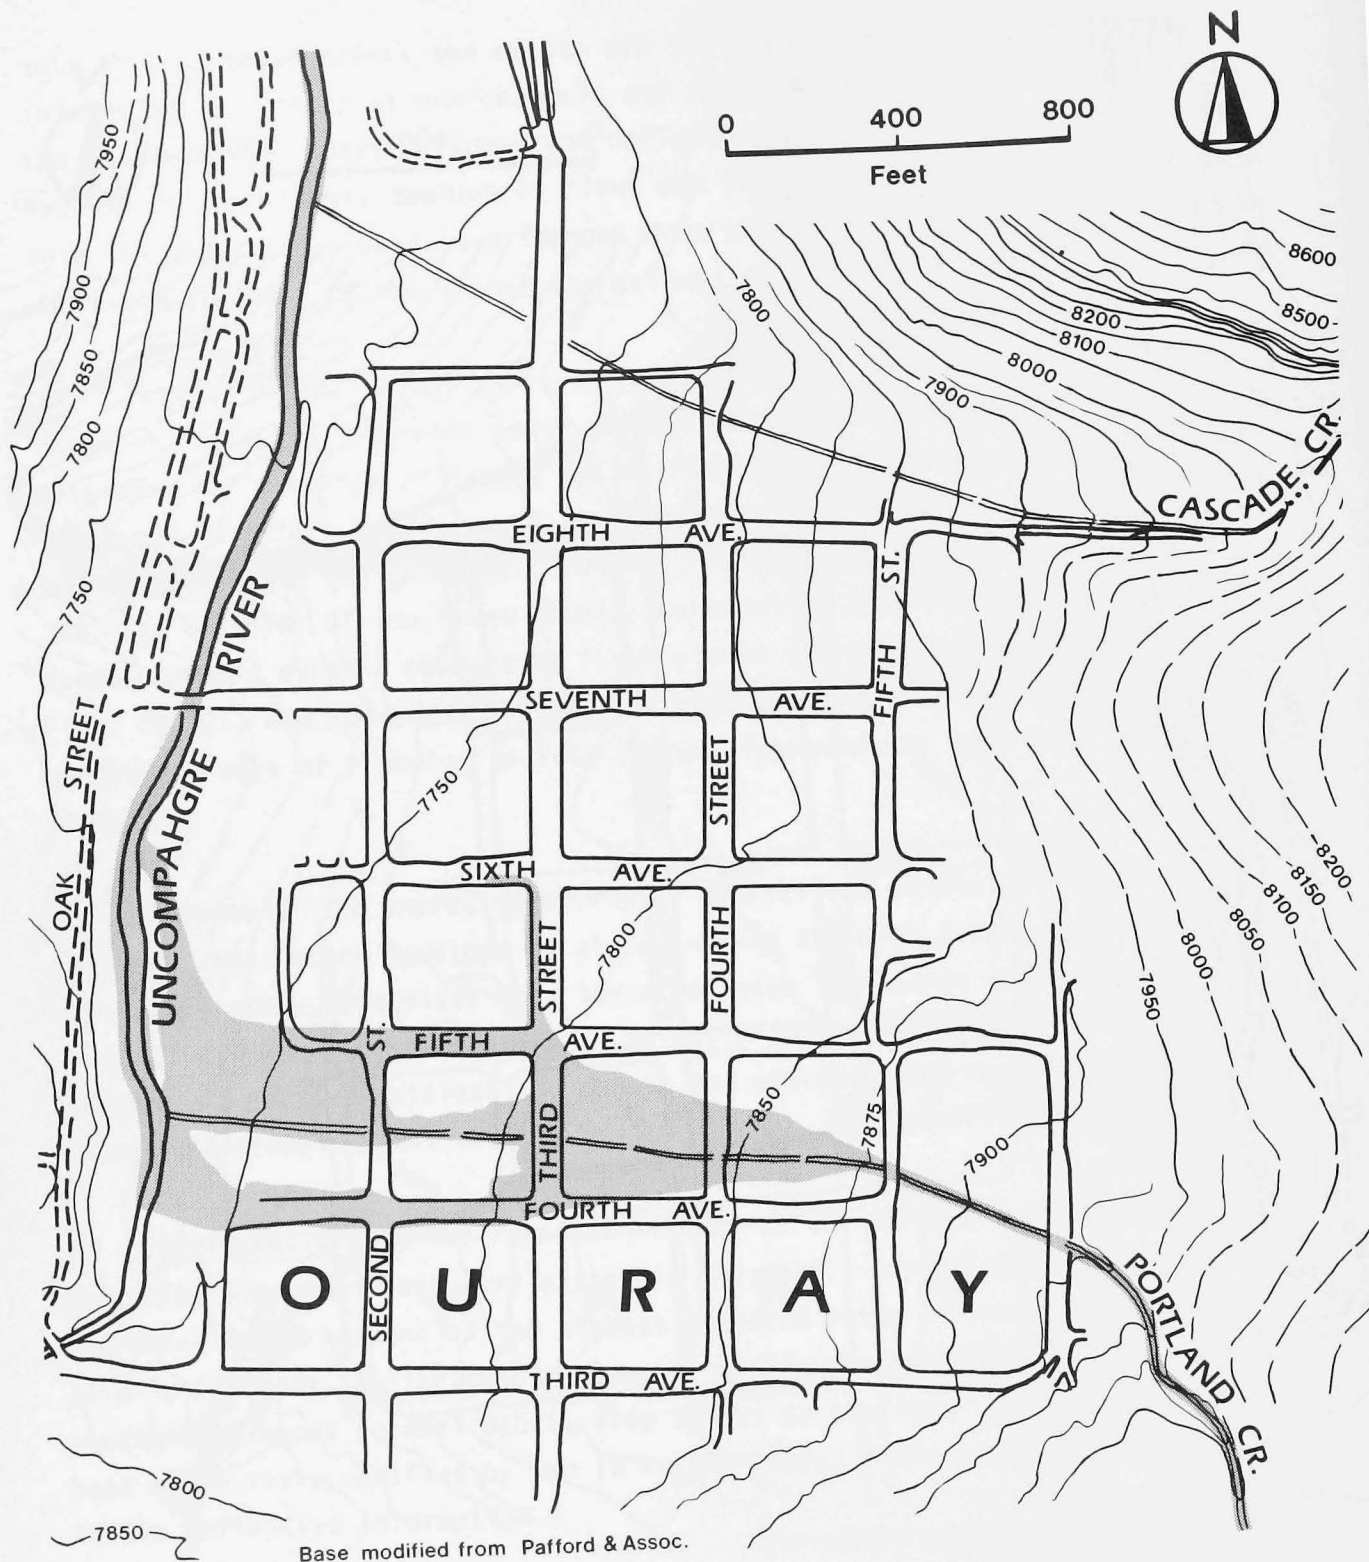
Figure 21. Path of flooding on Portland and Cascade Creeks August 21, 1982 as mapped in the field by William P. Stanton of the CWCB.

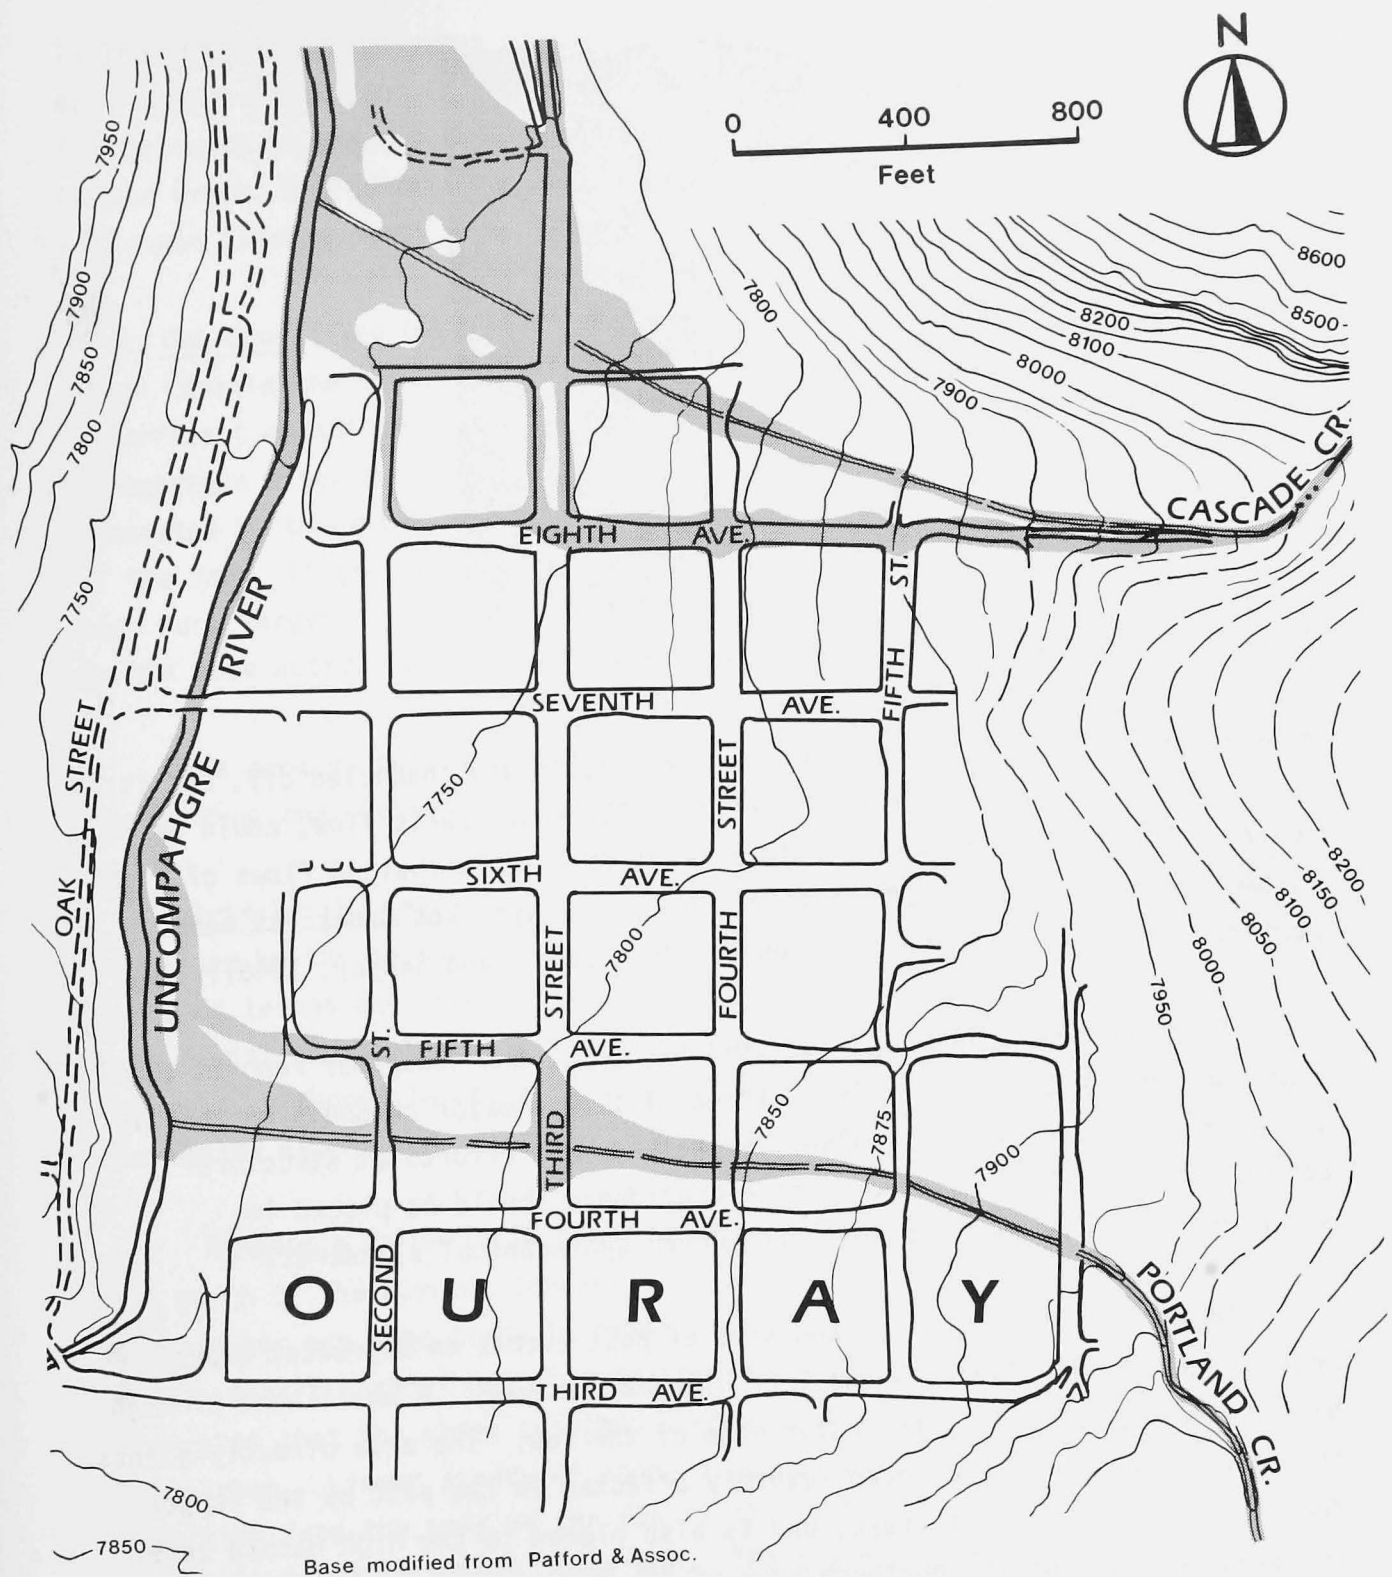
Figure 22. Path of flooding on Portland and Cascade Creeks August 22, 1982 as mapped in the field by William P. Stanton of the CWCB.

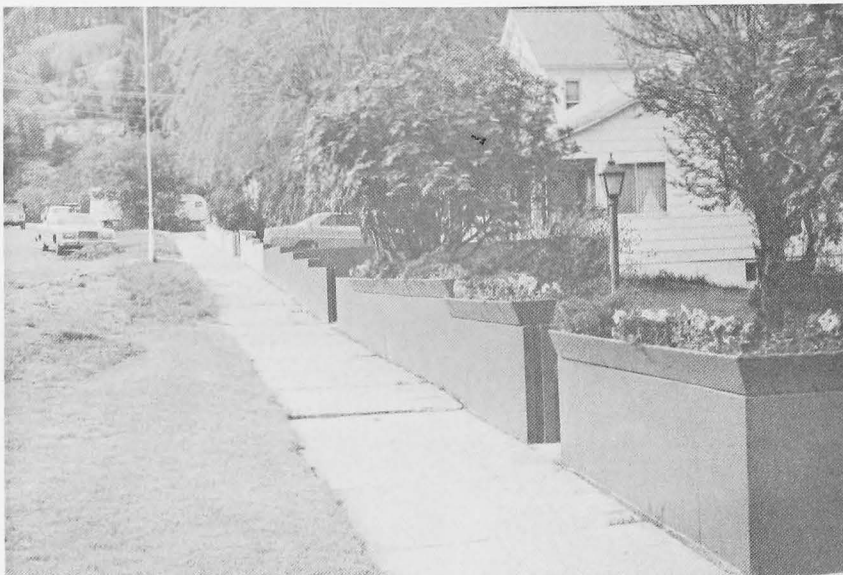
A

been caused by debris, mud, and water getting into buildings and covering yards and streets. This has resulted in unorganized attempts to mitigate the damage of the flows by the construction of deflection walls around individual buildings (Figs. 32 A, B). This can be very effective in areas on the outer edges of a debris flow where it is only a few inches to a couple of feet thick

Figure 32. A, Deflection walls around houses near Portland Creek flume.  
B, Deflection wall around house near Cascade Creek flume.

and may be mostly mud and water. However, unless constructed around all buildings, these walls tend to concentrate the flow and divert it and related damages onto adjacent property.
