EDITORS NOTES

Overview of the Geology of Colorado – Part II: Mineral and Mineral Fuel Resources, Water Resources and Water Quality, and Geologic Hazards - *David C. Noe, Vincent Matthews, III, and Ralf Topper* (This paper is derived from two copyrighted publications from the Colorado Geological Survey – Special Publications 52 and 53 – used with permission; use of this material is subject to the CGS copyrights)

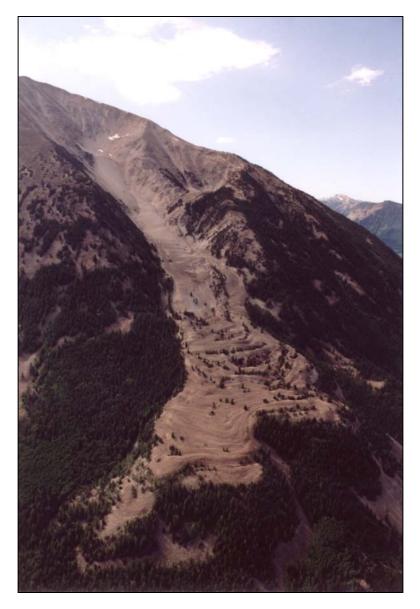
Figure 23. A rock glacier on the side of Mt. Sopris, near Carbondale.

Rock Glaciers – Active and inactive rock glaciers are common in many areas of the high Rocky Mountains. Their overall shape resembles that of ice glaciers. Large boulders and smaller stones typically comprise the surface, which commonly has arcuate ridges and lobes (Figure 23).

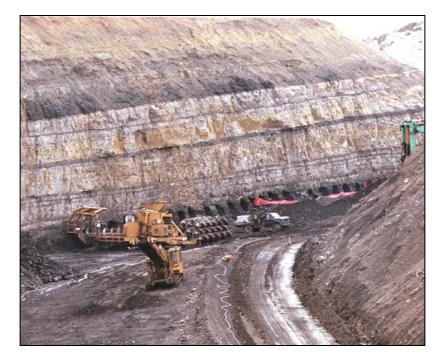
Figure 3. Mining coal with large augers in a surface mine near Hayden. Photo by Christopher Carroll, Colorado Geological Survey.

Coal and Coalbed Methane – Coal is one of Colorado's most widespread mineral and energy resources, underlying 29,600 square miles or 28 percent of land in the state. The majority of coal was formed approximately 80 to 65 million years ago in the swamps of the late Cretaceous and early Tertiary periods. Coal has been commercially mined for at least 140 years in the state. Some of the earliest coal mining began in the 1860s in the Denver Basin, to the north and west of Denver. Early coal mining occurred around the turn of the 20th century in Colorado Springs and in the Raton Basin, west of Trinidad. Today, most of the coal production comes from surface mining in the northwest part of the state (Figure 3).

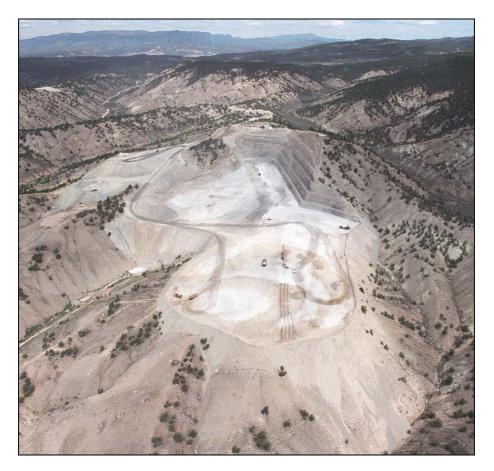
Figure 5. A gypsum quarry in the Pennsylvanian Eagle Valley Evaporite, near Gypsum. Photo by David Noe and Jonathan White, Colorado Geological Survey.

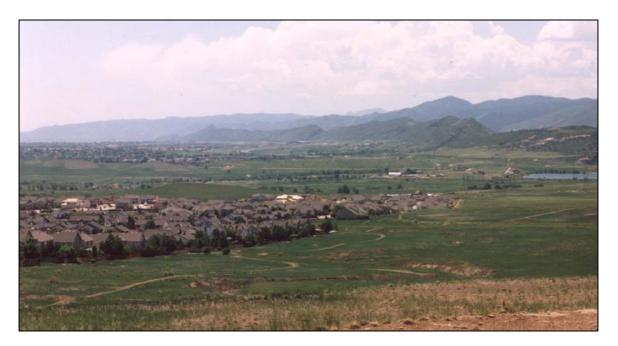
Figure 12. These suburban areas near Denver are encroaching into areas where expansive soil and heaving bedrock are potentially destructive geologic hazards.

Expansive soil and bedrock constitute Colorado's most costly geologic hazard in terms of damage to buildings, roads, and infrastructure. There are widespread surface exposures of these materials across the state. This is due, in part, to the tendency of non-resistant, clay-bearing materials to weather into relatively flat, low topography. Thus, most of Colorado's populated areas are "conveniently" located in areas of expansive soil and bedrock on the eastern plains (Figure 12) and along the valley bottoms in the central mountain and western plateau provinces. The major expansive bedrock units include the Cretaceous Pierre Shale, Mancos Shale, and Laramie Formation, the Cretaceous to Paleocene Denver and Dawson Formations, and the Jurassic Morrison Formation.

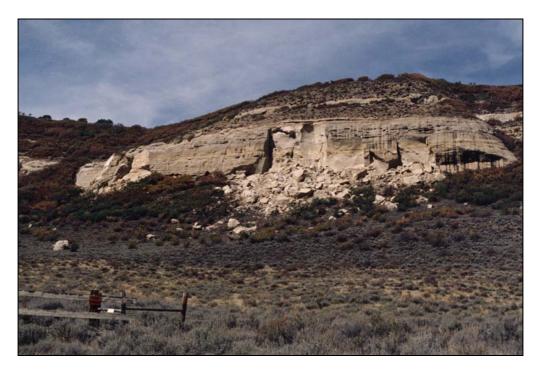
Figure 13. This cliff of Mesaverde sandstone is undergoing subsidence from underground coal mining, resulting in spectacular rockfalls. Photo by Jonathan White, Colorado Geological Survey.

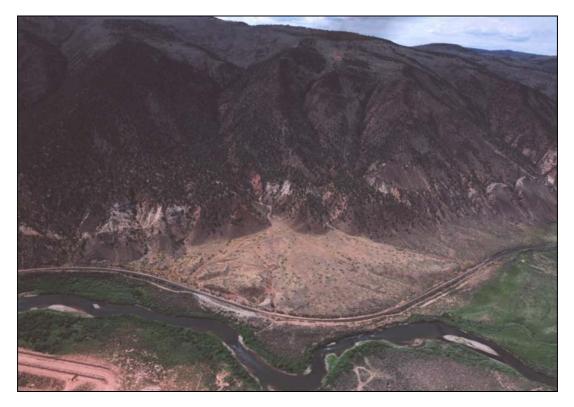
Figure 14. Typical debris flow path in west-central Colorado, near Eagle, showing a well developed initiation zone, a central chute, and runout fan. Photo by David Noe and Jonathan White, Colorado Geological Survey.

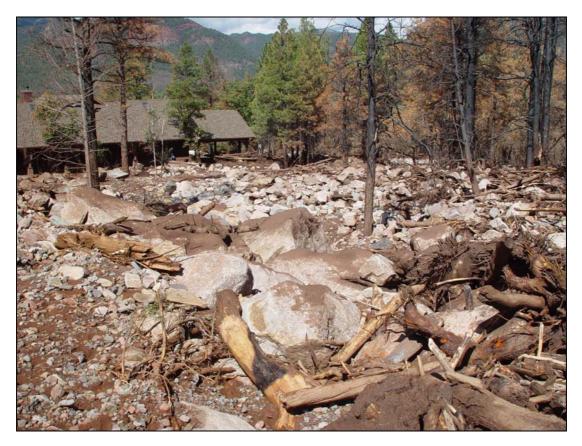
Figure 15. House inundated by debris flows on a fan along the side of the Animas River valley, near Durango, which was reactivated following the 2002 Missionary Ridge wildfire. Photo courtesy of La Plata County Office of Emergency Management.

has revealed a significant connection between wildfire events and subsequent debris-flow and alluvial-fan flooding activity (Coe et al., in press). This relationship has been illustrated dramatically in several areas of the state where numerous significant post-wildfire floods and debris flows have occurred during the 1990s and early 2000s. Recent events of note include those at Buffalo Creek to the west of Denver (Elliott and Parker, 2001), Storm King Mountain near Glenwood Springs (Cannon et al., 2001), and along the Animas River valley near Durango (Cannon et al., 2003, in this volume) (Figure 15).

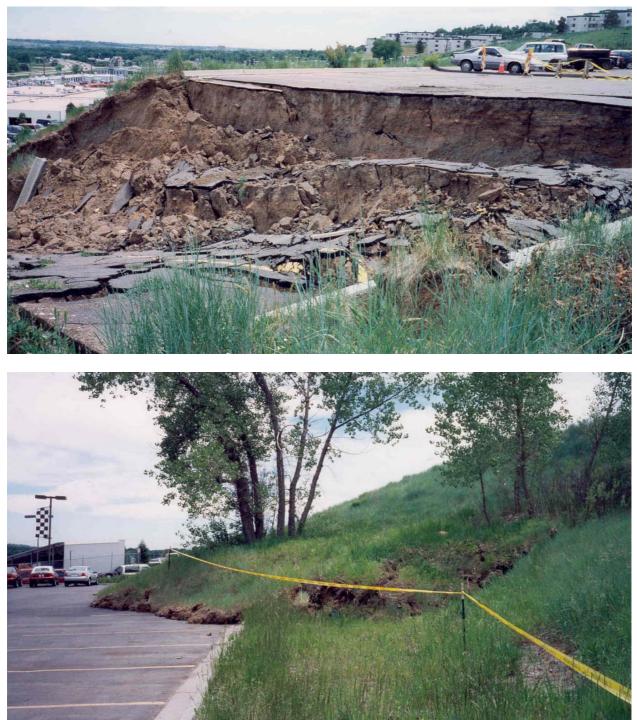
Figure 7 A (above). Former parking lot for auto dealership at the head of landslide. Figure 7 B (below). Toe of the same landslide encroaches onto auto dealership parking lot (Photos by K. Andrew-Hoeser).

Landslides include slides, lateral spreads, and complex landslides as described by Varnes (1978). Potentially unstable slopes are defined as those slopes that in their current configuration are stable, but any modification to the slope through site grading, increase in water content, or erosion may cause the slope to become unstable and may initiate a slope failure. Identification of these slopes and their engineering characterization can be difficult. There are many past examples where development without adequate mitigation has impacted potentially unstable slopes with devastating results, as shown in Figure 7.

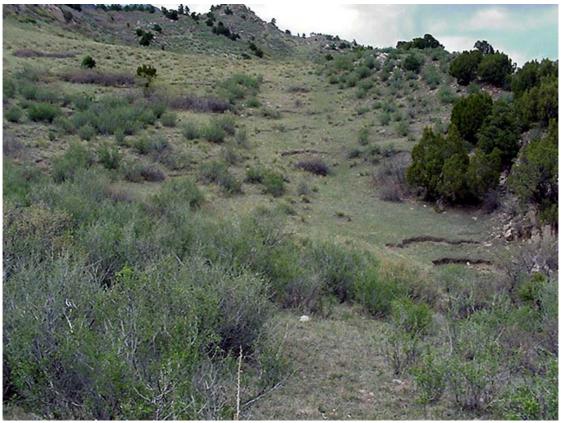
Figure 9. Concentric subsidence features in low-density silty clays at the Base of the Niobrara Fomation (Photo by J. Lovekin).

Collapsible soils generally are fine-grained deposits with a meta-stable structure that have not been fully saturated with water since deposition. The structure of the soil is typically silt grains, bound to one another by clay or other minerals (especially gypsum) in an open, or void structure that has a high dry strength. Collapsible soils are often associated with wind-blown loess, which occur in Fountain, Colorado Center and in the vicinity of Academy Boulevard and Austin Bluffs Parkway. The collapse in these areas has generally been triggered by over irrigation and saturation of the soils. Collapsible soils are also found in the colluvium at the base of the Niobrara Formation. Natural successive subsidence scarps have been observed in these deposits of low-density silty clays (Figure 9).

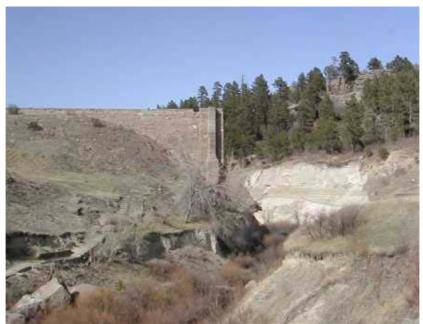
Figure 5. Castlewood Dam Today.

Castlewood Dam: One of the earliest notable dam failures in Colorado was the 1933 failure of Castlewood Dam, located on Cherry Creek south of Denver (Costa, 1978, pp.24-27). Today the remnants of the dam form a focal point for one of Colorado's State parks (Figure 5).

In 1890, Castlewood Dam was built across Cheery Creek about 40 mi south of Denver to provide irrigation to Mennonite cherry orchards south of Denver. The dam was a combined masonry and rockfill structure 600 ft long and with a maximum height of 80 ft. The dam was located in a steep gorge eroded by Cherry Creek into the Castle Rock Conglomerate, Wall Mountain Tuff (Douglas Rhyolite), and the Dawson Formation, a poorly cemented, very friable arkosic sandstone with interbedded claystone. Differential settlement of this poor foundation caused the dam to crack and leak soon after construction. An "impermeable" earthen blanket was placed in the reservoir upstream of the dam to reduce leakage.

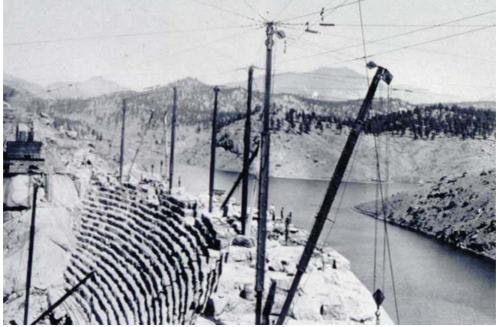
Figure 7. Construction of Cheesman Dam (photo courtesy Denver Water Board).

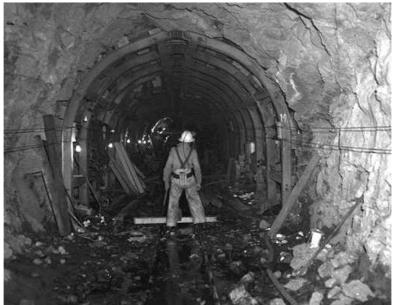
Figure 9. View of Roberts Tunnel under construction (photo courtesy Denver Water Board). and so should have been anticipated. The tunnel was advanced on four headings, from each portal and from two shafts located 5.4 and 8.7 mi from the west portal.

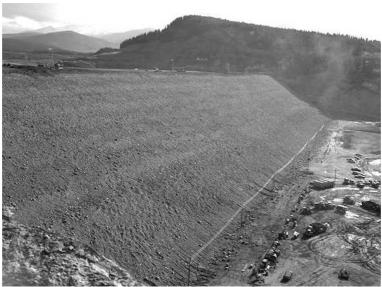
Figure 10. Dillon Dam nearing completion (photo courtesy of Denver Water Board).

Dillon Dam and Reservoir: Dillon Dam is a large earth-fill dam completed in 1963, with a maximum height of 231 ft, and a crest length of 5,888 ft. It has a crest width of 32 ft, and a maximum base width of 1,100 ft. The dam contains more than 12 million cubic yards of fill (Figure 10).

The dam is founded on faulted and extensively jointed Mesozoic sedimentary rocks, and on pervious gravels up to 80 ft deep in the valley below the Blue River. (Wahlstrom, 1966) Geologic features were defined by preliminary exploratory drilling and detailed studies during construction and allowed close control of foundation excavation and grouting. Special problems

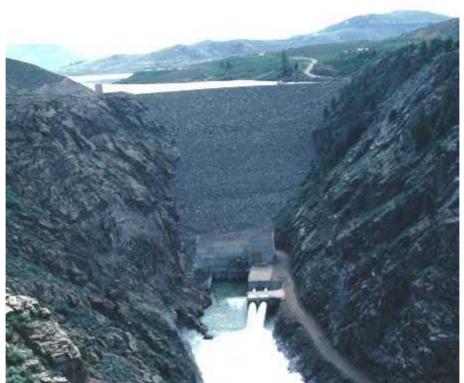
Figure 12. Blue Mesa dam and power plant (U.S. Bureau Reclamation photo).

Constructed between 1962 and 1965, Blue Mesa Dam is on the Gunnison River about 30 mi below Gunnison, and 1.5 mi below Sapinero, Colorado. The zoned earth fill embankment has a structural height of 390 ft, a crest length of 785 ft, and a volume of 3,080,000 cubic yds of materials (Figure 12.).

The spillway consists of a concrete intake structure, a concrete-lined tunnel, concrete flip bucket structure, and stilling basin. Maximum discharge of the spillway is 34,000 cubic ft per sec. Blue Mesa Reservoir has a total capacity of 940,700 acre-ft and an active capacity of 748,430 acre-ft. At maximum water surface elevation, the reservoir occupies 9,180 acres. It is one of the largest

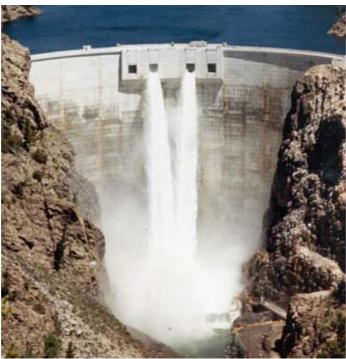
Figure 13. Two spillways operating at Morrow Point Dam (U.S. Bureau Reclamation photo).

Constructed between 1963 and 1968, Morrow Point Dam, 12 mi downstream from Blue Mesa Dam, is the first thin-arch, double-curvature dam designed and constructed by the U. S. Bureau of Reclamation. The dam is 468 ft high, 52 ft thick at the base, and 12 ft thick at the crest, with a crest length of 720 ft, and a volume of 360,000 cubic yds. The spillway consists of four orifice-type openings in the top central part of the dam, providing a free-fall discharge of over 350 ft into the concrete stilling basin at the toe of the dam (Figure 13.). Maximum capacity of the spillway is 41,000 cubic ft per sec. Maximum reservoir capacity behind Morrow Point Dam is 117,190 acre-ft; the active capacity is 42,120 acre-ft. Surface area of Morrow Point Reservoir is only 817 acres, because it lies in the deeply entrenched and narrow Black Canyon of the Gunnison River (now a National Park).

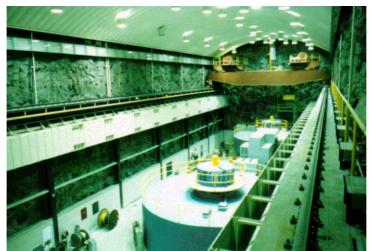
Figure 14. View of Morrow Point underground power plant (U.S. Bureau Reclamation photo).

The Morrow Point power plant is unique within the Bureau of Reclamation. It is an underground chamber tunneled into the canyon wall in the left abutment about 400 ft below the surface. The chamber is 231 ft long and 57 ft wide with a height ranging from 65 to 134 ft. Additional engineering geological studies were required to evaluate a fault encountered at one end of the chamber. The power plant has a generating capacity of 120,000-kilowatts. (Figure 14.)

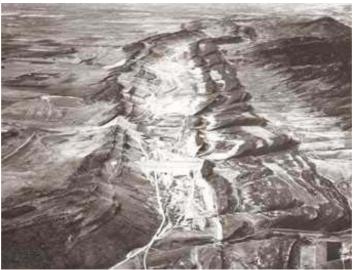
Figure 15. Horsetooth Reservoir under construction circa 1950 (U.S. Bureau Reclamation photo).

Modernization of Horsetooth Reservoir: Horsetooth Reservoir, a component of the C-BT project located immediately west of Fort Collins, constructed in the 1950's, is unusual in that it is placed behind a hogback with four dams closing gaps (Figure 15). Because so many people live downstream from these dams, they must be brought up to standards of the 1984 Safety of Dams Act. All four dams are being modernized. In addition, treatment of seepage under Horsetooth Dam has been included in this work. The estimated cost for the entire project is \$105 million and it will extend from March 2001until September 2003. Work is being conducted in three phases. Phase I, installation of filter and buttress at Horsetooth Dam, was completed during the summer of 2002. Phase II, installation of filters and buttresses at three eastern dams, is planned for completion by the fall of 2003. Phase III, addressing the seepage under Horsetooth Dam, was completed in November 2002 for additional information, see NCWCD WEBSITE references).

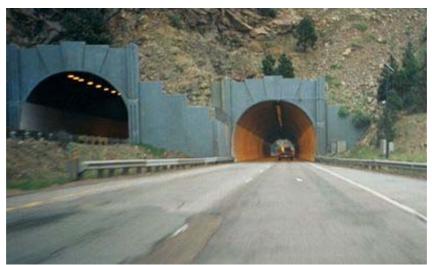
Figure 21. Eastbound view of the "twin tunnels" on Interstate 70 east of Idaho Springs (Photo by M. E. Salek <u>http://www.mesalek.com/colo/index.html</u>).

Idaho Springs Tunnels: Interstate-70 west from Denver avoided the lower section of Clear Creek Canyon, but joined Clear Creek near Idaho Springs where a pair of short, fully-lined, and lighted tunnels were constructed in the late 1960's (Figure 21).

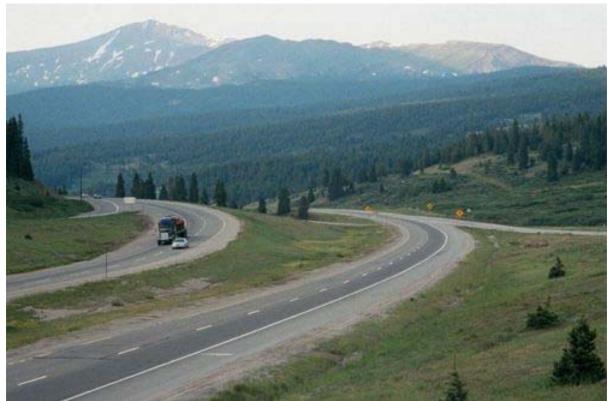
Figure 23. The Summit of Vail Pass showing the environmental integration of the highway with the surrounding landscape (Photo by M. E. Salek <u>http://www.mesalek.com/colo/index.html</u>).

Vail Pass: The decision to abandon the Red Buffalo Pass option and construct Interstate 70 over Vail Pass in close proximity to the existing U.S Highway 6 alignment presented many challenges. The project became a landmark for engineering geology in Colorado because it was the first major project to utilize engineering geology advice throughout – from design to construction (Hynes, 1983a). Its technical success and pleasing aesthetics set the stage for many other projects with engineering geologists being key partners to the design and construction of difficult and challenging engineering works (Figure 23).

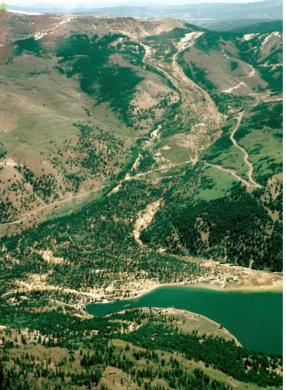
Figure 26. Slumgullion landslide with Lake San Cristobal at lower right (U.S. Geological Survey photo).

Studies of the Slumgullion Landslide: The Slumgullion landslide (Figures 25 and 26) in the San Juan Mountains near Lake City, Colorado is perhaps the most famous Colorado landslide. It is also one of the largest, being about 4.5 mis long and having an estimated volume of 220 million cubic yards (Parise and Guzzi, 1992). Numerous investigators have studied it (Endlich, 1876; Howe, 1909; Atwood and Mather, 1932; Burbank, 1947; Crandell and Varnes, 1960, 1961; Keefer and Johnson, 1983; Fleming, et al., 1996; Varnes and Savage, 1996; Parise and Moscariello, 1997).

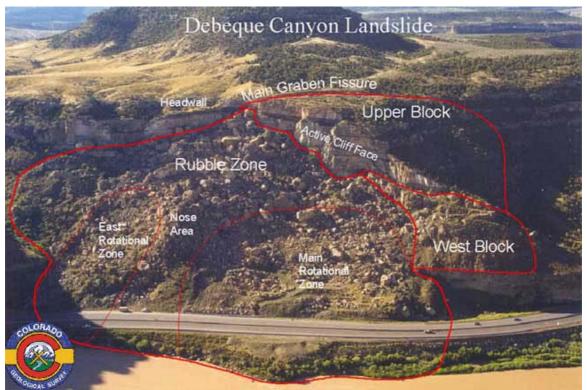
Figure 30. View to the southeast showing delineated morphologic divisions of the DeBeque Canyon Landslide (Photo by J. L. White, Colorado Geological Survey).

In response to the 1998 event, and with concern about possible future catastrophic events, the Federal Highway Administration funded a multi-agency team of geologists and engineers to investigate and monitor the landslide, and to propose mitigation concepts for Interstate 70. The team, administered and managed by the Colorado Department of Transportation Geotechnical Unit, included personnel from the Colorado Geological Survey, Golder Associates, Inc., the Colorado School of Mines, and the United States Geological Survey (Colorado Geological Survey, 2000; White, 2003). The team investigators divided the DeBeque Canyon Landslide into several components or zones (Figure 30).

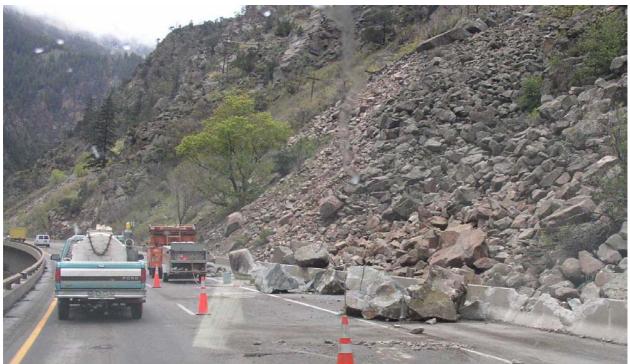
Figure 33. Typical rockfall event in Glenwood Canyon. This occurred on May 8, 2003 (Photo taken May 9, 2003, by Christian Baxter)

impossible to prevent all rockfall events, and rockfalls continue to occur. Fortunately, most do not cause fatalities or major transportation disruptions (Figure 33).

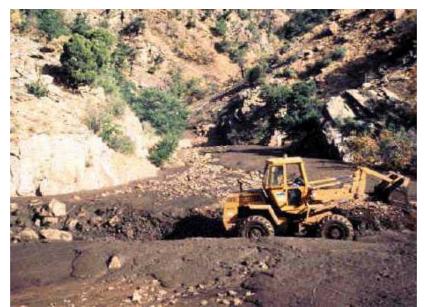
Figure 35. Cleaning debris-flow material from an off-ramp on Interstate-70 near Glenwood Springs, Colorado, September, 1994 (Photo by Lynn Highland, U.S. Geological Survey).

Impacts of Wildfires: In July 1994, a disastrous wildfire occurred on Storm King Mountain adjacent to Glenwood Springs. Subsequently, rains caused debris flows that blocked Interstate 70 (Figure 35). These events caused renewed scientific interest in the relationships between wildfires and debris flows (Cannon, et al., 1995; Kirkham, et al., 1996; Kirkham, et al., 2000; Cannon, et al., 2001). Dry weather conditions in subsequent years resulted in significant additional wildfires near Glenwood Springs, and also at many other locations in Colorado, which added to the urgency of on-going investigations (Colorado Water Conservation Board, 1996; Henz Meteorological Services, 1998; Cannon, 2001; Cannon, et al., 2002)

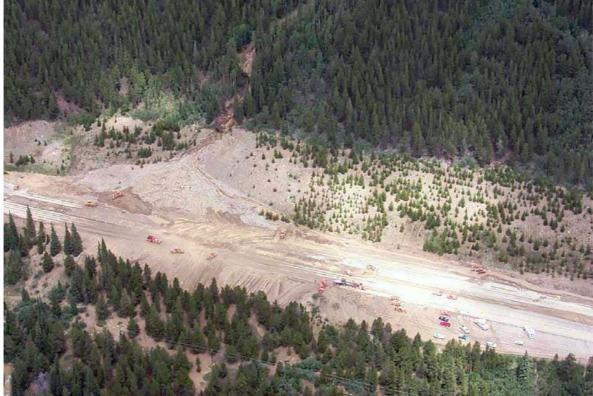
Figure 36. Clean-up in progress on July 29, 1999, of debris flow deposits at Watrous Gulch on Interstate 70 about 2 mi west of Barkerville. Note Vehicles for scale (Photo by Ed Harp, U. S. Geological Survey).

The debris flow hazard was clearly demonstrated on July 28,1999. About 480 debris flows were triggered by an afternoon thunderstorm along the Continental Divide in Clear Creek and Summit counties, with several of these debris flows affecting Interstate 70, U.S. Highway 6,and the Arapahoe Basin ski area. One flow initiated on the south flank of Mount Parnassus, traveled about 1.5 mi down Watrous Gulch and deposited almost 30,000 cubic yards of bouldery debris on Interstate 70 (Figure 36). The Interstate was closed to traffic for about 25 hours. Fortunately

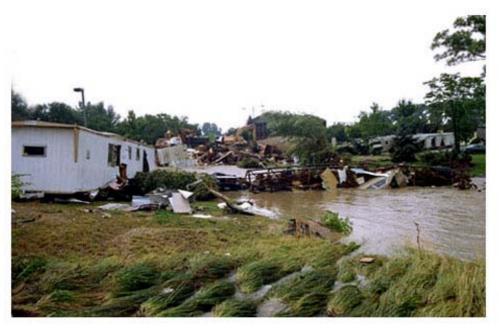
Figure 39. High water and debris along Spring Creek (photo courtesy City of Fort Collins).

projected 100-year and 500-year flows. The City Manager's report showed five people dead, 54 people injured, loss of about 200 homes, and 1500 homes and businesses damaged throughout the City (Figure 39). Damages at Colorado State University were unusually severe, totaling in the range of \$100 million, including building damages, about 425,000 library volumes inundated, and loss of a semester's textbooks in the bookstore

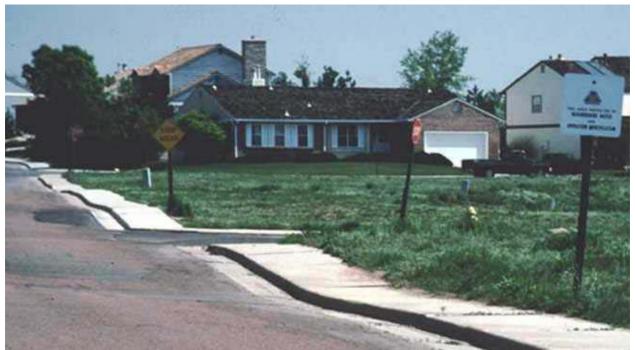
Figure 41. Surface distortions caused by heaving bedrock, Jefferson County (Photo by D. Noe, Colorado Geological Survey).

However, at certain locations along the Front Range, geological conditions conspire to make the problem even more severe and difficult to resolve, because accepted engineering designs for foundations, such as floating slabs or pier-and-grade-beam designs, do not work reliably where steeply-dipping swelling claystone bedrock formations are found. Engineering geologists have investigated these problems since the early 1970's when new residential construction began to expand into susceptible areas (Hart, 1974). In the 1990's large residential developments began in many susceptible areas and the rates of damage increased markedly (Figure 41). Engineering geologists at the Colorado Geological Survey undertook extensive investigations to map and define the extent of the high-risk "heaving bedrock" areas (Himmelreich and Noe, 1999; Noe

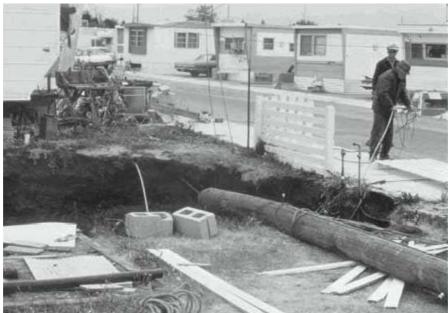
Figure 42. Investigating a coal mine shaft collapse in a trailer park. (Photo by Colorado Geological Survey).

and Ivey, Inc., 1975). In the early 1980's, it was discovered that an entire subdivision in the suburbs southwest of Denver had been constructed over an old coal mine. Investigations for a new shopping center revealed the mine, yet the county planning office had no records showing the mine. Subsequently, developments in Colorado Springs also encountered subsidence from inactive coal mines. In the late 1980's the Colorado Geological Survey undertook additional abandoned mine studies north of Denver in Weld County around the towns of Firestone, Frederick, and Dacono (Hynes, 1987). The Colorado Geological Survey published an annotated bibliography that documents subsidence investigations in five Front Range counties (Hatton and Turney, 1989). The Colorado Geological Survey continues to maintain an up-to-date coal mine subsidence library that provides information on historic coal mine and subsidence risk investigations and assessments (Colorado Geological Survey, 2001). New investigations are conducted as new collapse events occur (Figure 42).

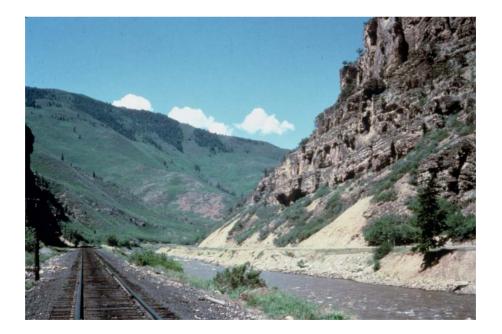
Figure 2. Old Highway 6 alignment. Note the over-steepened riverbank and uphill cuts.

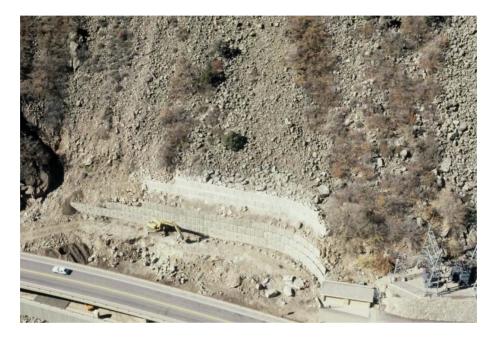
Figure 6. Tie-back wall in talus at Shoshone Power Plant.

contractor, and CDOT agreed to share the extra costs. This provided a valuable lesson for both the owner and the contractor in future installations. It should be noted that, in spite of the contract administration challenges created by the method of payment for the anchors, it was successfully demonstrated that soil anchors could be installed in buried talus/soil conditions, as shown in Figure 6 for example.

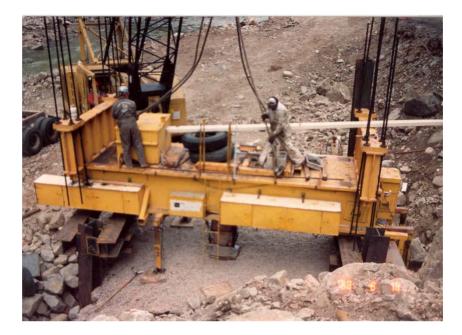
Figure 8. Piling load test.

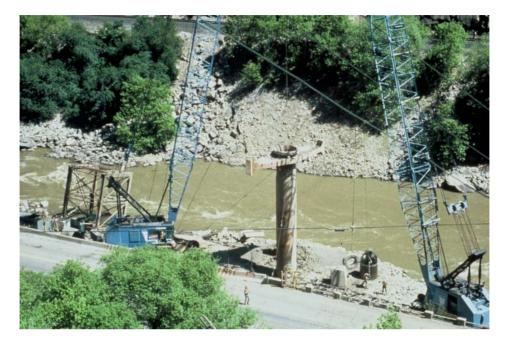
The project was let for bids with an innovative foundation design, using large diameter shafts. The bridge piers were founded on 7-ft (213.36 mm) diameter shafts. The number of shafts depended on the loadings on that particular pier. Pier loads varied as a result of the superstructure design. The contractor elected to use a highly specialized West German construction technique called the Hochstrasser-Weise system. The system consisted of a thick wall (3.14 in) steel casing equipped with a $1\frac{1}{2}$ in hardened steel cutting shoe at the driving end. The barrel had a hydraulically operated swing arm attached to the top (surface) end (see Figure 9). The rotational force of the swing of the arm, combined with the weight of the barrel, penetrated the river deposit. As the barrel advanced, various tools were lowered into the barrel to break up and remove boulders. In some cases, pre-blasting was used. Material was excavated in a saturated condition using a clamshell and/or suction bailers lowered into the barrel. After the planned elevation for the bottom of the shaft was reached, concrete was placed and the positive head pressure was augmented with compressed air applied between the top of the wet concrete and a steel pressure cap. The hydraulic swing arm was actuated to break the adhesion between the casing and soil. With the help of a crawler crane, the barrel was extracted before the concrete had set.

Figure 9. Hochstrasser-Weisse caisson rig.

technique in homogenous soils. With the choice of the Hochstrasser-Weise system and the nonhomogenous environment, these tolerances could not be met. As the steel casing advanced, it became impossible to correct for location and plumbness. A decision was made to evaluate each caisson using group pile analysis. To verify a defect-free installation, Stress Wave Propagation

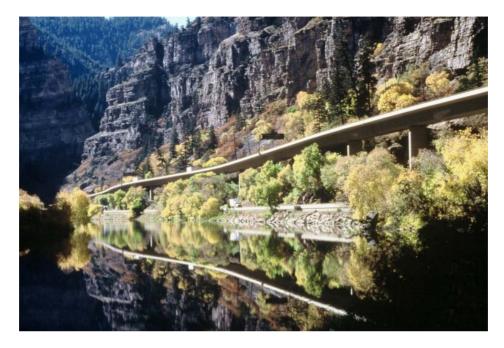
Figure 10. Hanging Lake viaduct.

The main contract was bid in July 1989. Five companies bid the project, with the low bidder coming in \$14 million under the engineer's estimate of \$81.9 million dollars. The successful low bidder was a joint venture led by Frontier Kemper and Traylor Brothers of the United States, joined by Wayss and Freitage (Germany) and Beton and Monierbau (Austria). Excavation of the tunnel began in late 1989 Figure 13). The drill and blast work was completed in late November 1990. The early completion of the tunnel excavation (nearly 4 months ahead of schedule) allowed CDOT to work with bridge contractors at the east (Hanging Lake Viaduct) (Figure 14) and west (Shoshone Dam bridges) to accelerate the overall project completion.

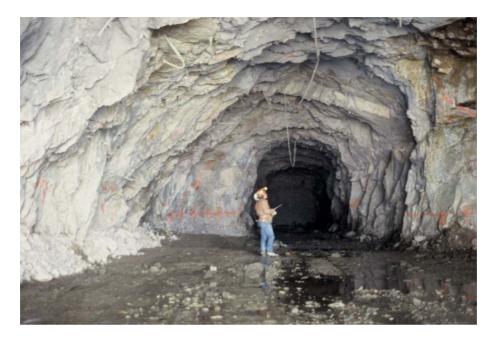
Figure 12. Multiple slash excavation, Hanging Lake Tunnel.

bars installed 30° above horizontal, at 4 ft centers), a 2-in layer of shotcrete and reduced round lengths. Type 3 ground (9% of the tunnel length, mostly through shear zones) required type 2 reinforcement and spiling, reduced round lengths and a second 2-in thick layer of shotcrete. Shotcrete was steel-fiber reinforced. All stabilization types required a multiple slash top heading and bench excavation sequence (Figure 12). No steel ribs or structural concrete were required for tunnel support.

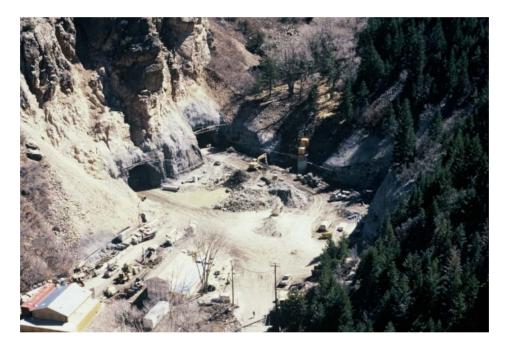
Figure 13. Tunnel construction, Hanging Lake Tunnel.

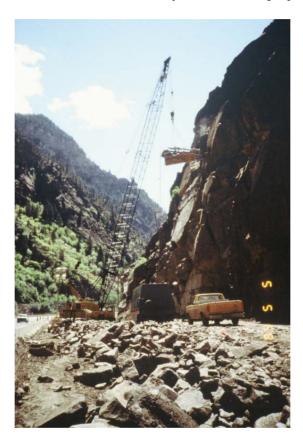
Figure 15. Rock reinforcement installation.

Local stability of rock cuts was a primary concern of the design/construction team. As cuts were taken down, the structural geology of the as-excavated condition was carefully evaluated for stability. Based on these results, and the expert judgment of the engineering geologists, rock reinforcement was often required. Fully encapsulated rock bolts, with epoxy-coated bars and hardware, were used. Much of the bolting was done from a drill rig mounted on a man-basket, lifted by a crane (Figure 15). Safety and stability of the final cut was a primary concern.

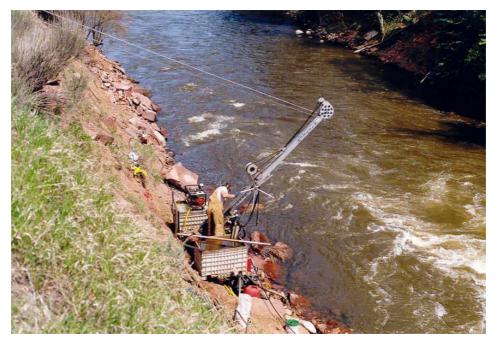
Figure 4. Drilling on the side of Roaring Fork River.

Due to the steep slopes encountered on the project it was necessary to use helicopter transported coring drill rigs to access most of the sites. A total of 289 borings were completed over a two-year period. The most extensive drilling period utilized five drill rigs and one helicopter. Split spoon samples were obtained for subsurface materials above the bedrock. Core samples of the bedrock were obtained to evaluate rock quality. Figure 4 shows one of the drill rigs operating in a steep section near the Roaring Fork River.

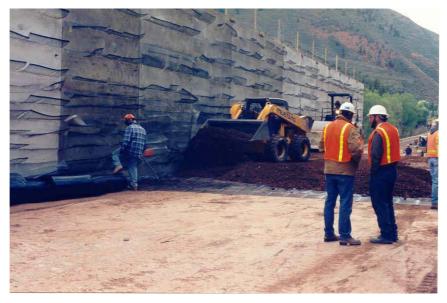
Figure 7. Fill Placement for MSE Wall.

The MSE walls were constructed using pre-cast concrete panels with a geogrid reinforcement system. The panels were shipped to the project site and positioned with temporary support on the front face of the walls. MSE walls on the project ranged from 5 ft to 41 ft (1.5 m to 12.5 m) in height for an approximate total of 315,000 ft² (30,000 m²) of wall face. Figure 6 depicts a generalized profile of the MSE wall system for the project. Figure 7 shows the back of the MSE wall during fill placement.

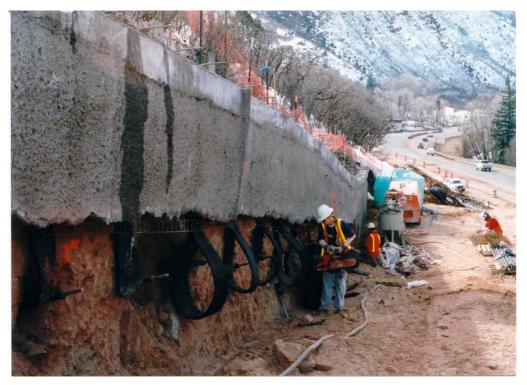
Figure 8. Soil Nail Wall Construction.

Figure 8 shows the installation sequence for the second row of a soil nail wall. Soil nails and shotcrete facing have been completed for the top row. Figure 9 shows the placement of precast panels over the completed permanent soil nail walls.

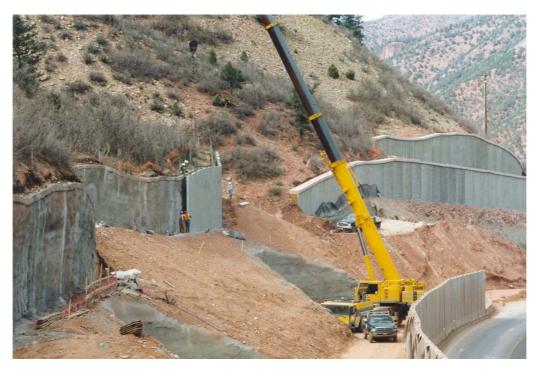
Figure 9. Attaching final pre-cast panel facing over soil nail wall.

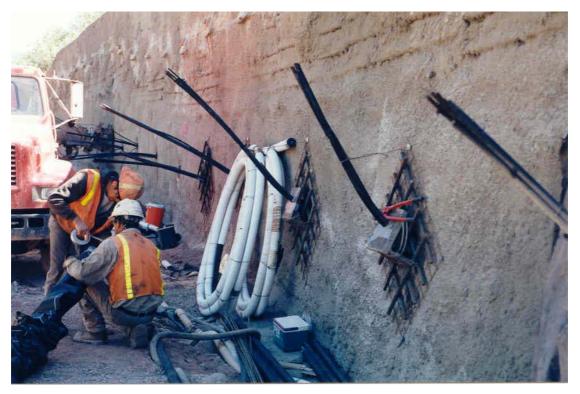
Figure 10. Ground Anchor Installation.

Many areas along the existing slopes were too steep to support effectively with soil nail walls. In these areas, it was necessary to use ground anchor (tieback) support. The ground anchors consisted of multiple strand tendons that ranged in length from 35 ft to 70 ft (10 m to 20 m). Bond lengths of the ground anchors averaged 20 ft (6 m). Due to the overall low bond strength of the colluvial materials it was necessary to place the bond lengths of the anchor systems in bedrock or alluvial materials. The ground anchors were set on an 8 ft horizontal by 8 ft vertical spacing (2.4 m x 2.4 m). One to three rows of permanent tiebacks were used to provide excavation support and to satisfy global stability where necessary. The ground anchor support panels consisted of 8 ft by 8 ft (2.4 m x 2.4 m) rebar reinforced sections that were shotcreted in place. Figure 10 shows installed ground anchors. Workers are putting a grout containment device on an anchor that is to be installed. A coiled ground anchor is visible next to the workers.

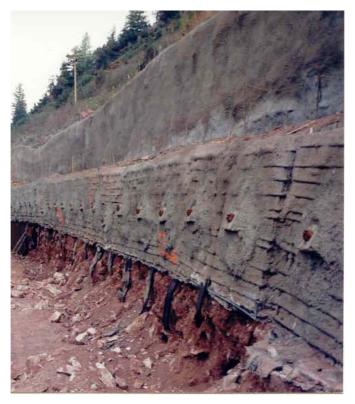
Figure 11. Two rows of a ground anchor wall.

The ground anchor walls were constructed in a top-down manner similar to the soil nail walls. Approximately $35,000 \text{ ft}^2 (3200 \text{ m}^2)$ of permanent ground anchor tiebacks were used on this project. Figure 11 shows two completed rows of a ground anchor / tieback wall.

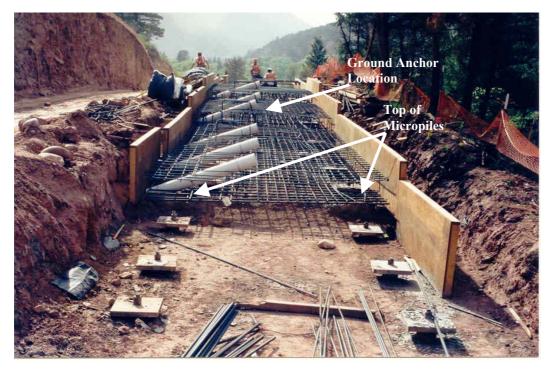
Figure 13. Double tee footing foundation prior to concrete placement.

Figure 12 illustrates the generalized profile of the double tee wall system supported by micropiles and ground anchor tiebacks. Figure 13 shows the footing prior to placement of

concrete. Note the square plates attached to the top of each micropile. The ground anchor tiebacks are placed through the pipes, which are inclined in the left center area of the figure.

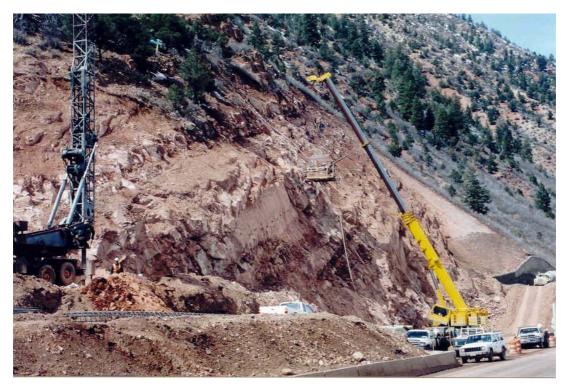
Figure 14. Rock bolting from crane basket.

Most of the slopes above the highway alignment consist of colluvial materials, however certain sections of the alignment are next to steep bedrock cliffs. In these areas, kinematic slope stability analyses and the Colorado Rockfall Simulation Program (CRSP) were used to recommend appropriate mitigative options for rockfall. Typically, rockfall mitigation consisted of spot bolting, pattern bolting, and the use of draped mesh in critical sections. Figure 14 shows the use of a crane basket for bolting a rock cut section that will be located adjacent to a bridge structure. A minimum of 10,000 ft² (929 m²) of exposed rock-cuts will have been meshed by the completion of the project.

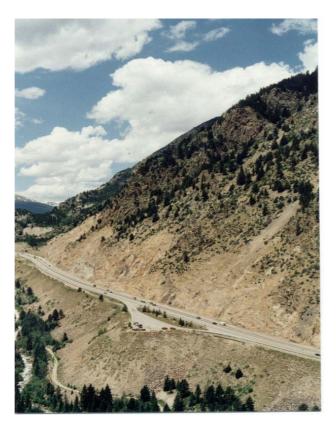
Figure 3. Rockfall Chutes, Georgetown Incline.

Corridor occurs along the Georgetown Incline (Figure 3). The frequency of rocks impacting the existing highway can occur daily.

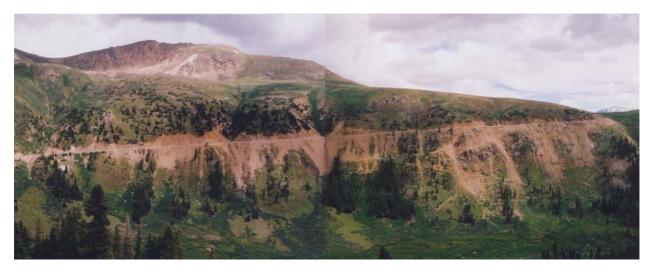
Figure 1. Highway 82 Top Cut area near Independence Pass. A switchback of the historic stagecoach road can be seen on the right, below the existing highway.

In the early design and construction of Highway 82, as in many highways of Colorado, geotechnical and environmental impacts on the long-term erosion and stability of cut slopes was not a policy priority. Once the fragile alpine topsoil was stripped away and the toe of a natural slope is removed, instability results in the oversteepened cut slope. Further erosion of the weathered granitic rock mass occurs and rock and soil debris continually fall from the cut slopes and collect at the base of the slope, many times on the roadway itself. Continued maintenance is then required to dispose of the material. For many years, this material was simply cast over the side of the road embankment, causing additional damage to the native slope below. Figure 1, a photo mosaic taken from across the valley, shows the level of degradation.

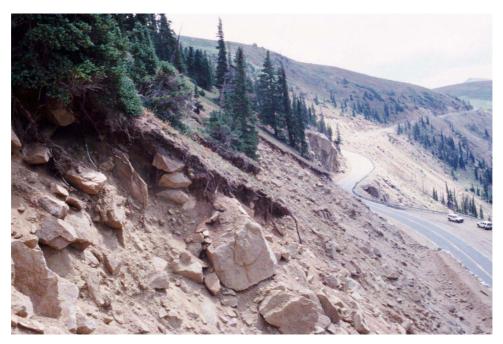
Figure 3. Typical raveling brow at highway cut slope at Independence Pass Top Cut.

The success of the mechanically stabilized rock-buttressed wall for slope reconstruction led IPF to begin a new project for a larger and even more degraded cutslope at the Top Cut. This slope at milepost 59.9 is called the Big Cut. The Big Cut is the longest and highest of the eroding cut slopes along the Highway 82 Top Cut area. The cut length is 600 ft (183 m) and the highest part is 100 vertical feet (30.5 m) above the road surface. The slope cut exposure was mapped as Type 4, Decomposed Rock and Soil. This slope had also been rated in CDOT's statewide rockfall hazard rating system (Andrew, 1994). Slope grades at the site range from the standard angle of repose (34°) of the debris fans, to overhanging at the brow (scarp). The Big Cut slopes are completely barren. The Figure 3 photo was taken of the raveling slope at the Big Cut.

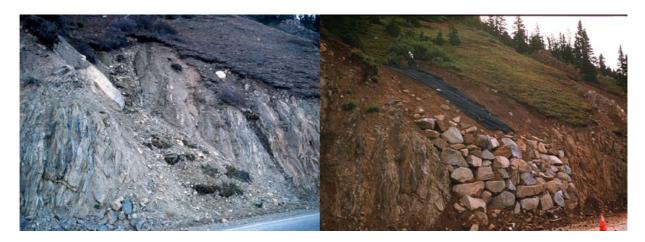
Figure 5. Left gully at Twin Gullies showing before and during slope reconstruction when TRM is being installed. Note clumps of vegetation and top soil in small debris fan at base of slope in left photo

Installation and anchorage of the Enkamat S20 followed. The length of time that it takes for vegetation to establish itself in this location and the stresses of seasonal snow loading made it necessary to take extra care with installation. Matting anchorage was strengthened by the use of 18-in (46 cm), #4 rebar J-hooks. A 1 to 2-in (2.5 to 5 cm) layer of screened (<3-in, <7.6 cm) fines was then placed atop the TRM and worked into the 3D matrix of the matting. A seed mix designed for this altitude was broadcast over the restored slope, plants were installed, and the slope fertilized and hydromulched. The photos in Figure 5 show the before and after look of the reconstruction.

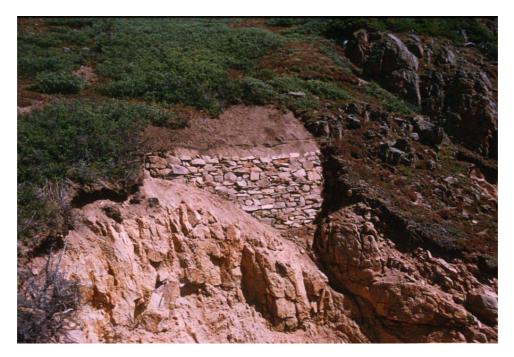
Figure 6. Slope reconstruction is erosional amphitheater. Erosion was cutting into weak rock of a shear zone. During the 2000-2002 project, custom-colored anchored shotcrete was applied to the base of this slope below the rock wall.

In addition to the twin gullies reconstruction, other prototype work was completed. Figure 6 shows a rock-faced, geotextile reinforced slope constructed in a small erosional amphitheater in very weak decomposed rock near a large shear zone. As with the Twin Gullies reconstruction, TRM was also installed. This work was high on the slope and required a crane for mobilization of the rock and fill by bucket. The dangerous high slopes required technical rock climbing so contract labor at high-scaling rates was required. Total costs were \$75 per square face foot for the wall, and \$30 per square foot for slope reconstruction including TRM installation. Figure 7 is a close up photo of that reconstructed slope and shows the anchored TRM prior to being covered by topsoil.

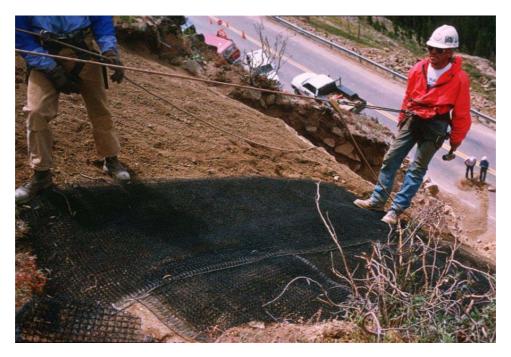
Figure 7. Close-up of TRM installation at erosional amphitheater. Note geo-grid backing in the matting panels.

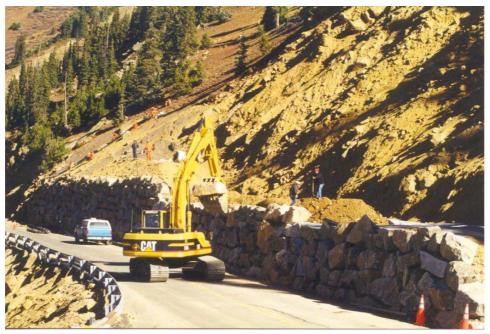
Figure 9. Construction of the geotextile reinforced-soil wall at the Big Cut.

The functionality of this design was very favorable for the location. The rock facing is natural rock, and while obviously a man-made wall, it is compatible with the high alpine environment. The boulders also can accommodate minor settlement with no visible or structural effects. Another design advantage is that the wall, by virtue of the gaps between the boulders and excellent granular fill, is free draining. Figure 9 is a picture of the construction of the Big Cut wall.

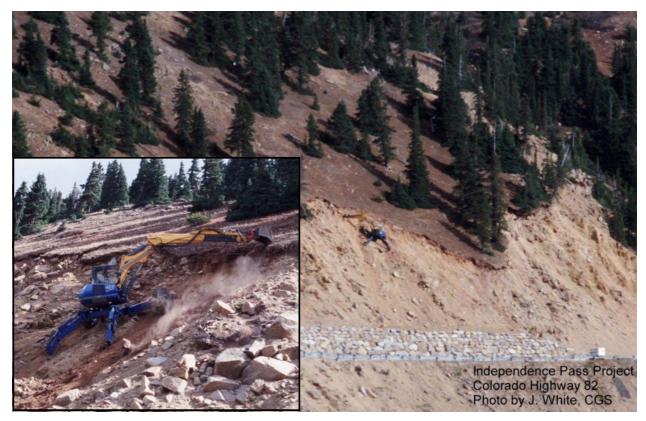
Figure 11. Spyderhoe scaling 1:1 slope at Big Cut.

Figure 4, significant shaping and scaling of the brow was needed. This was accomplished mostly by using what the contractor called a *spyderhoe*, an excavator with legs that can "walk" up 1:1 or 100% grades. Figure 11 is a picture of the spyderhoe in action at the Big Cut.

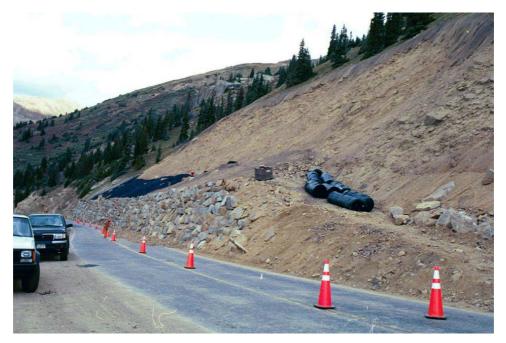
Figure 12. Nearly completed Big Cut Project. Wiremesh is in place on cut slope above and TRM (black material) is being staked to the reconstructed slope

The project was completed in Spring 2002. By using the innovative spyderhoe and through certain value-engineering proposals accepted by CDOT, significant cost savings were realized. Savings were such that additional rockbolt locations and increased wire mesh and cable netting installations could be added to the project scope while staying under the original project budget. After the completion of the combined CDOT and IPF project in the Spring of 2002, IPF proceeded to complete the 1½:1 reconstruction of the slope above the rock wall. Rocky fill derived from scaling operations was used for the slope. The slope was smoothed and a nominal 2-3 inches (2.5 5 cm) of topsoil was placed. TCM was installed and topsoil was dumped on the slope by crane basket. Department of Corrections inmates raked the fill into the 3D matrix and covered the TRM with another 2 inches (5 cm) of topsoil. Trees were planted, the slope was seeded and fertilized, and hydromulch and tackifier were applied. Figure 12 shows slope reconstruction in progress.

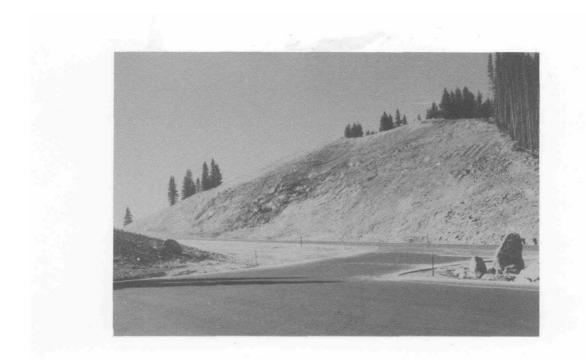
Figure 3. Exposure of Minturn-Maroon Formations in west side of road cut on south side of Clinton Dam.

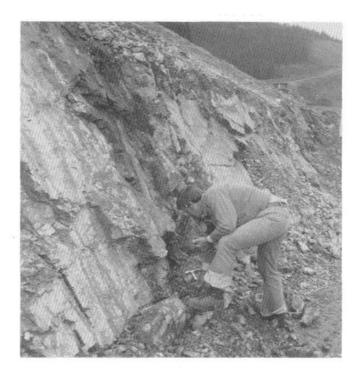
Figure 4. Exposure of Tertiary intrusive rock in trench dug on south side of Mayflower Gulch.

Igneous and Metamorphic Rocks – The igneous intrusives of Tertiary age in the study area are quartz monzonite porphyries that are relatively sound and stable in their unaltered state (Figure 4). If these rocks are encountered in a weathered and (or) fractured condition at grade along the alignment they could cause stability problems.

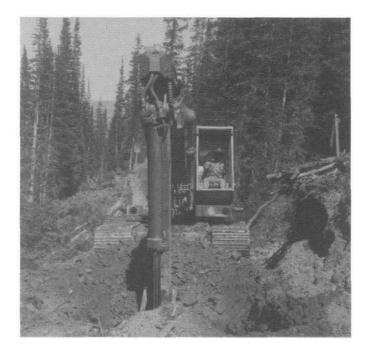
Figure 5. Backhoe in operation on pioneer road in "tenderloin" area.

Exposures of intrusive rocks in outcrops or test pits along the alignment were dug easily with a backhoe because they were weathered and well jointed (Figures 5 and 6). It was determined that these rocks should prove to be rippable close to the surface where frost action and weathering have weakened them.

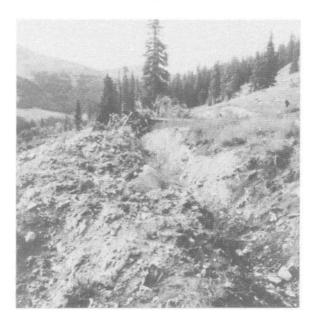
Figure 7. Glacial till exposed above Borrow Area B. Material on left (west) has slumped; note light-colored scar marking uphill limit of slump.

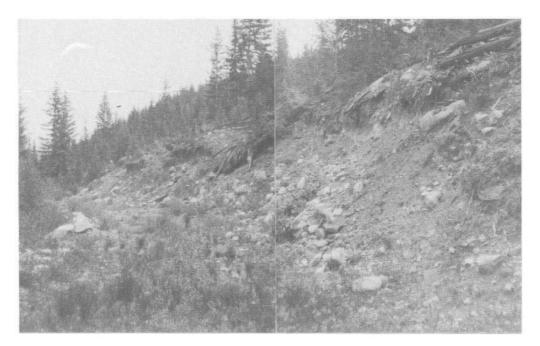
Figure 8. Glacial till exposed in old drill site road at about Sta. 164+50.

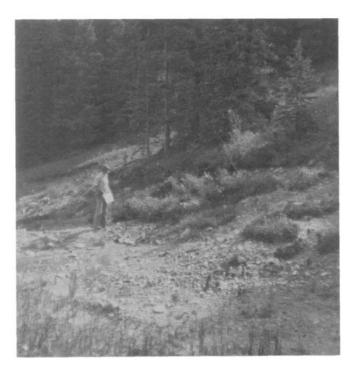
Figure 10. Small landslide or slump that occurred between August 6 and 8,1976, in morainal material at about Sta. 110 on the north side of Mayflower Creek.

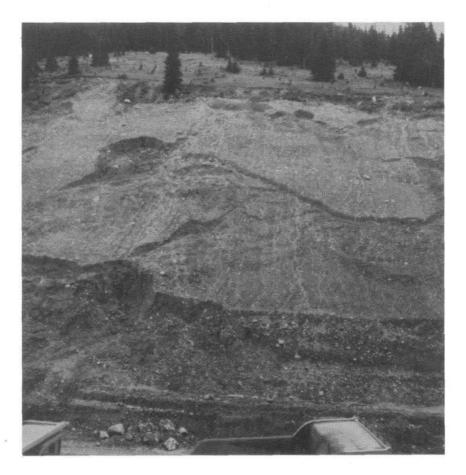
Figure 12. Right cut slope at about Sta. 39+00 in Borrow Area B, September 1976. Note failures indicated by multiple scarps. This picture is typical of conditions in the cut slope between Stas. 36+50 and 41+00.

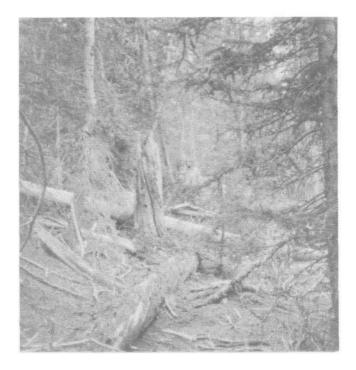
Figure 14. Dense vegetation in the "tenderloin" area.

Tenderloin Area - An area of extremely unstable surface conditions had been known for several years (Klauber, 1975) and had been studied along the alignment from approximately Sta. 115+00 to Sta. 157+00 (Figure 11). Figures 14, 15, and 16 illustrate density of vegetation cover and unstable morainal materials in this area, which has been nicknamed the "tenderloin." Numerous scarps and related evidences of failure, as well as dozens of seeps, springs and small boggy areas filled with lush, water-loving vegetation indicated the general instability of this reach of the alignment. The surficial deposits in this area appeared to be a relatively thin, highly irregular mantle of till and colluvium.

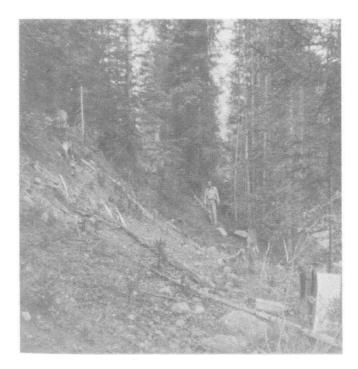
Figure 15. Unstable slope in morainal deposits, "temderloin" area.

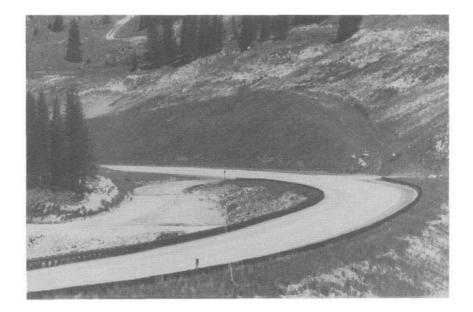
Figure 18. Borrow Area A. Berm (dark arcuate area) in lower part of cut has been an effective barrier to major failure.

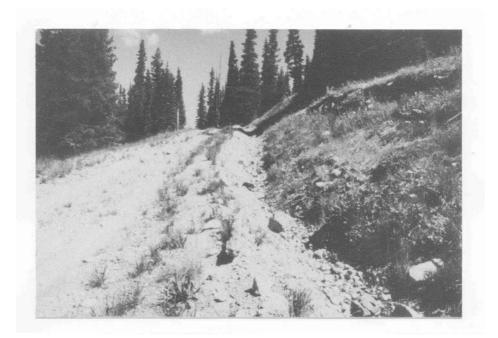
Figure 19. Crest drain on right above Borrow Area B cut. Drain is effectively transmitting water through porous blanket although some sloughing has occurred.

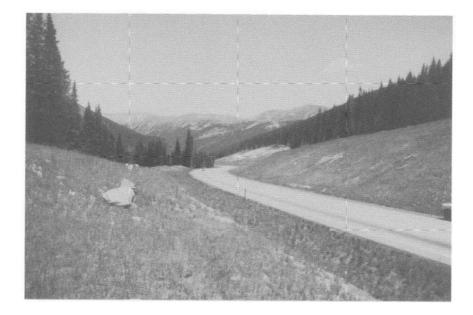
Figure 22. Panoramic view of "tenderloin" area. Note the well-established stand of grass in the foreground. Rocks such as the large boulder to the left were place at random along some of the slopes as a matter of aesthetics.

The system of subdrains placed in the "tenderloin" area was of particular interest. Figure 22 is a panoramic view of the "tenderloin" in which it can be seen that no major failures have occurred. Minor slump features such as the one shown in Figure 23 are uncommon through this reach of the alignment.
