EDITORS NOTES

Overview of the Geology of Colorado – Part II: Mineral and Mineral Fuel Resources, Water Resources and Water Quality, and Geologic Hazards - *David C. Noe, Vincent Matthews, III, and Ralf Topper* (This paper is derived from two copyrighted publications from the Colorado Geological Survey – Special Publications 52 and 53 – used with permission; use of this material is subject to the CGS copyrights)

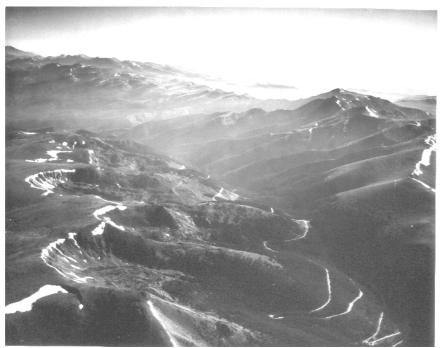
Figure 3. Aerial oblique of Berthoud Pass and the continental divide looking north. Summit can be seen just below the center right of the photo. In the midst of such steep and rugged terrain, the two prominent glacier circues in the foreground provided a tempting opportunity to switch back the road (T.S. Lovering, USGS Geologist ca 1933).

Figure 3 is a 1933 oblique air photo of Berthoud Pass looking north. Today the road alignment follows essentially the same route as seen in this photo. Portions of the US Highway 40 roadway that were widened during the recent project are partially shown in the foreground and include all

of the sharp switchbacks shown in the photo. As this early photo clearly shows, the terrain is dominated by glacial landforms. The slopes adjacent to the roadway steepen to nearly 40 degrees at the lower elevations of the project. Notice that the road switches back in the glacial cirques where the slopes are flatter. The two glacial cirques in the foreground mark the origins of Pinedale Age Glaciers that were active in the project area over 12,000 years B.P. The two prominent glaciated valleys below the Berthoud Pass Summit are seen trending parallel to one another and are oriented in a southeasterly direction. The soils encountered in the project site consist primarily of immature glacial drift mostly ice-laid with minor amounts of sediment deposited by melt water. The remnants of what was likely a hanging valley in the darkened shadow of the photo, referred to as Floral Park, provided a highly prized and protected alpine wetland habitat. Along the highway in Floral Park the steep wall of the glacial valley with a northwestern exposure is a protalus rampart. These thick (approximately 10 m) deposits of scree formed nearly parallel ridges that are almost fully concealed by a dense, evergreen forest supported by a thin layer of topsoil. Figure 4 is a photo of the 1905 wagon road that traversed the area and shows unstratified well-graded sediments ranging from boulders to fine silts and clays.

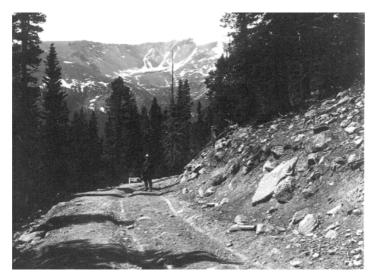
Figure 4. Wagon Road towards Berthoud Pass. Note the unstratified glacial drift in road cut (Campbell, circa 1905).

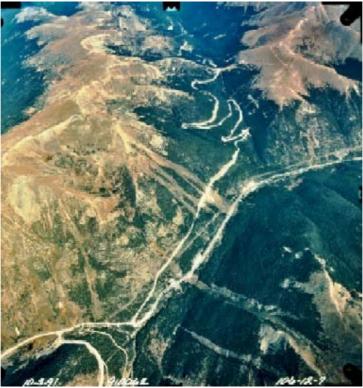
Figure 6. Aerial photo showing Berthoud Pass switchbacks. Fault lineation aligned with Hoop Creek is prominent as are numerous snow avalanche paths on either side of glacial valley. Poorly developed hanging valley is located near switchback 1 (see Figure 5). [USDA, ca 1991].

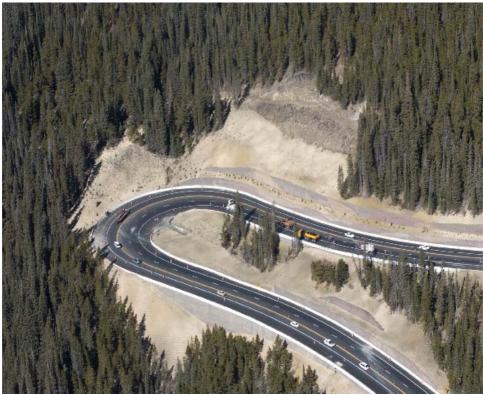
Figure 8. Completed roadway showing landslide area. Seven rows of permanent tiebacks are buried in the slope. The tiered hybrid MSE wall transitions smoothly into another hybrid MSE wall façade [CDOT, ca 2002].

two tiered hybrid mechanically stabilized earth (MSE) wall installed near the roadway to flatten and buttress the regraded slope (Figure 8). Prior to and throughout construction a steady flow of water sprung from the slope midway up the slide and ran along it's left flank (Figure 7). The flow occurs at the trace of the slip plane on the ground surface. Groundwater encountering the slip plane likely follows the zone of disturbed dilated soil until reaching the ground surface. The author observed this same stream of water flowing down the slope prior to 1996 while traveling over the pass. It appeared as a spring on the hillside. From a field inspection of the slope shortly after the 1996 slide event, it became apparent that this "spring" flowed along the left flank of the landslide. The right flank traces through the heavy forest and did not contain a stream of water.

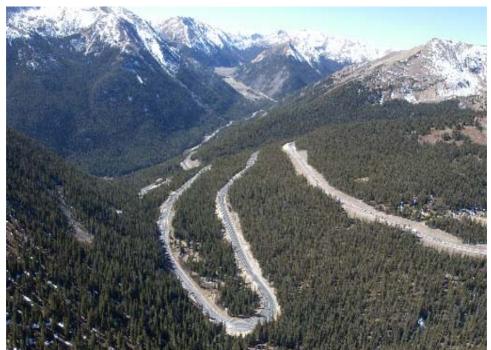
Figure 9. View of switchback 3 looking into Floral Park. Wetland habitat is located inside the hairpin turn. The scree is deposited against the mountain slope on the viewer's left. A small portion of the scree is visible high up on the mountain [CDOT, ca 2002].

Near switchback 3 a significant deposit of scree complicated construction in two ways. Groundwater flowing from the scree would surge soon after rainfall events flooding the traffic detour and adjacent work areas and grout containment for ground nails within the scree was difficult. Extensive underdrains were installed adjacent to the scree deposits to intercept the surging groundwater and channel it into the Floral Park wetland habitat (Figure 9). Hoop Creek crosses the highway and enters Floral Park at switchback 3.

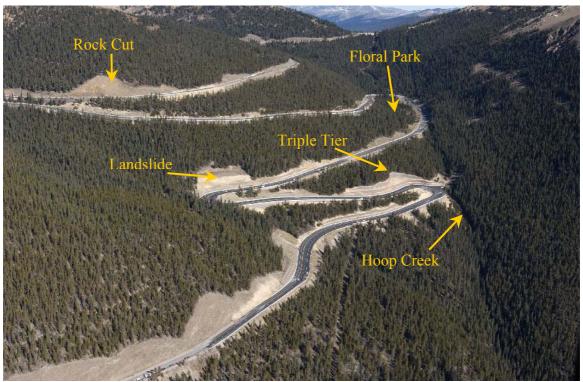
Figure 10. The completed project with a few labeled landmarks. [CDOT, ca 2002]

investigations, design changes, and multiple, alternate designs were completed during construction. In general, the earthen materials were quite strong; however, large seepage forces, particularly in the roadway switchbacks were initially underestimated. The 1920 roadway realignment project constructed three switchbacks in glacial troughs. The recent widening project encountered significant flows of continuous groundwater within these troughs, prompting design adjustments during construction. An on-going evaluation and field verification of the ground conditions and their impact on the design and construction activities evolved as the work progressed. Although working in such an environment produces a sense of immediacy not normally associated with highway design it can be successfully managed as the US Highway 40 project attests (Figure 10).

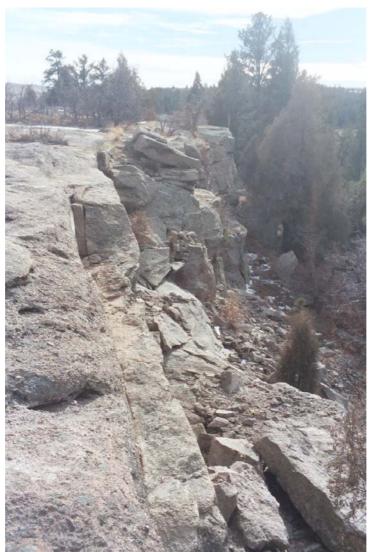
Figure 3. Right abutment quarry displaying primary joint set in conglomerate. Note irregular rock breakage in center of photo.

Discontinuities – One, well-developed, primary joint set is evident in the conglomerate on the right abutment, bearing approximately N10W (Figure 3). Joint spacing varies from 2 to 8 ft (.6 to 2.5 m). This well developed joint set is nearly vertical and was used in the quarries to obtain uniform blocks for dam construction. A second, less well-developed joint set is evident at right angles to the primary set, also with a vertical dip. On the upper left abutment, joint orientation is approximately the same as on the right abutment. Evidence of bedding planes or horizontal joints exists in the quarry on the right abutment. Some curvilinear joints are also present in the quarry on the right abutment.

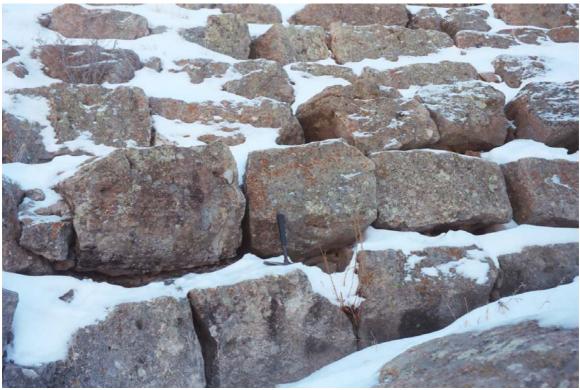
Figure 4. Conglomerate block, stair-stepped downstream face. Note irregularities of rock surfaces and deterioration of interstitial mortar.

Engineering Properties – The Castle Rock Conglomerate is well cemented, durable, and is of high compressive strength; which made it suitable for obtaining rock-blocks for the construction of Castlewood Dam (Figure 4). However interbeds of less well cemented sandstones and mudstones degrade the quality of the rock in areas. The well-defined joint sets allow the quarrying of somewhat uniform sized blocks suitable for this type of construction. However, adverse curvilinear joints, weak bedding planes and other minor adverse joint orientations result in a high number of irregular blocks, making fitting, placing and mortaring of the blocks very difficult. Much evidence of the poorly shaped blocks can be seen in the dam, resulting in less than ideal structural and water retention integrity of the upstream wall and downstream stair-stepped shell. In addition, the conglomerate is not uniformly cemented or bedded which results in much fragmentation. This high degree of fragmentation is evident in the rubble fill and resulted in most of the irregular rock being used in the rubble fill. The Castlewood Conglomerate is rarely used as a building stone in the local area. On the other hand, the Castle Rock Rhyolite in the area near the dam is much better suited for shaping.

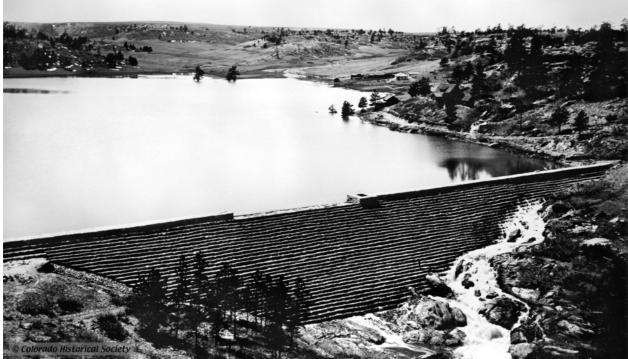
Figure 6. Completed dam prior to reconstruction with extensive seepage through dam on left abutment. Note riprap placed along the downstream, right abutment groin (Colorado Historical Society).

During and following construction, the residents downstream continually questioned the safety of the structure. In the mid 1890s, the dam was inspected by the original designer and it was determined that construction was faulty (Figure 6). However, the designer felt that the dam could be made safe by the addition upstream of an extensive earthen berm, constructed to the top of the spillway and riprapped. A partial berm had already been installed during construction; but was not completed as intended by the design/construction engineer. This recommendation to complete the upstream berm was not carried out until the dam partially failed on August 3, 1897 as a result of heavy rains in the area (USGS, 1899).

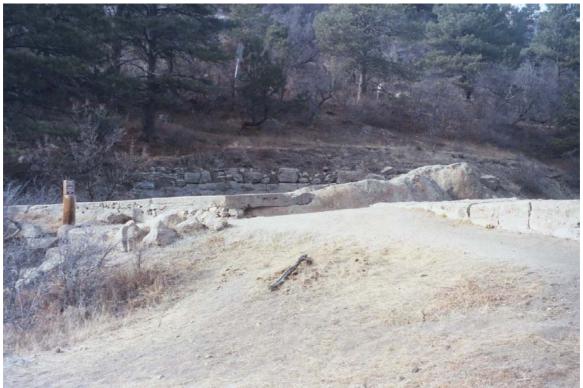
Figure 9. Left spillway following reconstruction. Dam crest is at right of photo. The reconstructed spillway sill is at left of photo. Note large conglomerate boulder in center of photo that forms left end of dam. Also note left spillway retaining wall at far left side of spillway, erected during reconstruction.

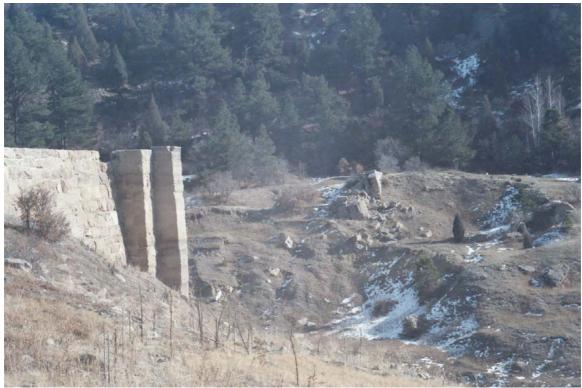
Figure 10. View across valley at remaining right side of dam, center right of photo. Note upstream control-tower extension and upstream berm.

The intake tower and outlet works are nearly intact (Figure 10). Some of the outlet pipe is missing downstream. However, the outlet pipe still exists in the approximate footprint of the original dam. Two possible reasons it remains are: (1) a large conglomerate block exists at this location and it is clear that the dam and outlet were constructed around this large rock-block; and (2) the outlet works was encased in concrete giving it added strength within the dam footprint. The outlet-works tower, with a triangular cross section, is the only portion of the dam constructed with large amounts of concrete and consequently is stiffer and better able to resist erosion. The concrete intake tower upstream of the dam, part of the reconstruction, was formed for its entire height except for that portion which was below original ground (approximately 6 ft [2 m]). Below ground level, the concrete surfaces were placed directly against the Dawson Arkose and when that rock was washed away; an irregular textured surface to the exposed concrete was left. This intake tower construction was probably doweled into the masonry upstream wall of the dam, as evidenced by the lack of separation

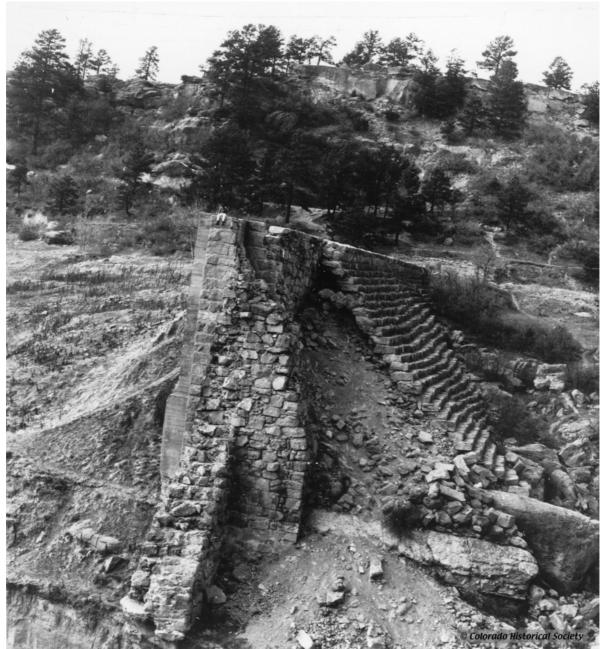
Figure 11. Remaining portion of dam from control-tower to left abutment. Note condition of rubble fill and downstream stair-stepped masonry shell, 1971 (Colorado Historical Society).

The upstream masonry wall of quarried conglomerate is intact at the intake- and outlet- works area and a large triangular, well-mortared series of blocks remains in the dam core area downstream of the upstream masonry wall and directly above the outlet works (Figure 11 and 12).

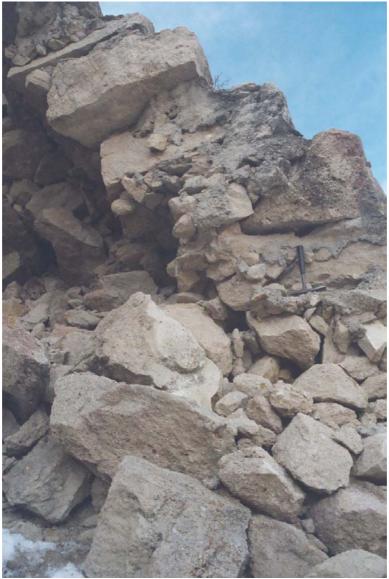
Figure 12. Close-up of remaining rubble fill and stair-stepped downstream, rock-block shell. Note poor condition and chinking of mortar between conglomerate blocks.

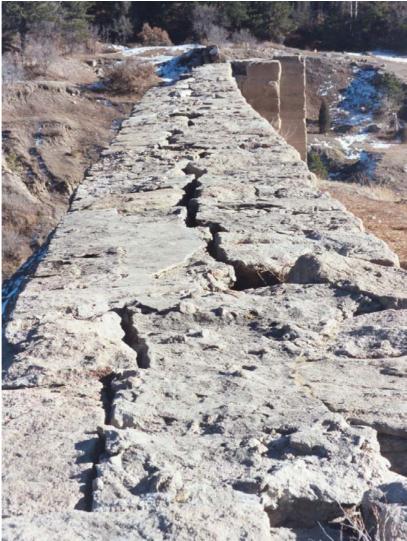
Figure 14. Left crest of dam. Note minor longitudinal crack.

Viewed from the crest of the dam, there appears to be a separation between the two rows of quarried-blocks, indicating possible downstream movement of the downstream row (Figure 14). This is probably the first required repair to the dam mentioned in the construction section. Also, it is obvious that this original repair did not last; since further downstream separation has occurred over time. Also, when looking at the crest of the dam, much mortar at the surface is missing between the two main rock-block rows, possibly exaggerating the amount of observed separation.

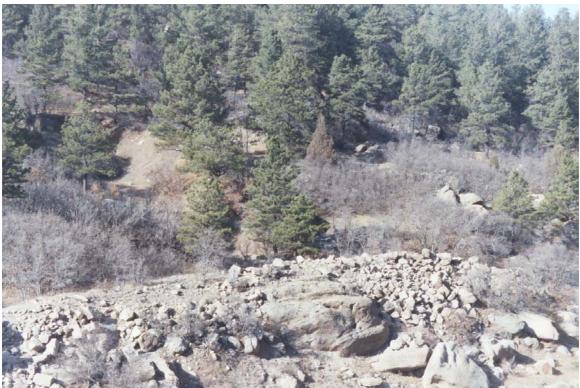
Figure 15. View of spillway discharge-channel on left abutment. Downstream toe of dam is just to left of the photo. Note large pile of dam debris at downstream toe of discharge-channel, along lower portion of photo.

At the extreme left abutment, the dam is tied into a large, house-sized, conglomerate boulder left in place. The original auxiliary spillway was constructed as a trench to the left of this large inplace boulder, which also formed the left end of the dam. It appears that the original spillway in this location was not lined and was not protected by either a sill structure or retaining walls. The current sill structure, constructed as part of the 1898 reconstruction, is constructed of a one-layer thick, mortared conglomerate-block wall. The conglomerate blocks average about 1-ft (0.3 m) thick and are considerably smaller than the blocks used in the main portion of the dam. The sill structure was clearly constructed in one operation, with no obvious break or change in color as would be expected if raised at a subsequent time. The upstream sill continues to the left forming the left retaining wall of the spillway, which in turn is abutted to natural material of the Dawson Arkose (Figure 9). The Castle Rock Conglomerate contact is much further up the hill, above the dam on the left abutment. The floor of the spillway is unlined. The spillway discharge-channel follows an apparent natural draw down the side of the valley and exits into the main channel approximately 100 ft (30 m) downstream of the downstream toe of the dam and approximately 20 to 30 ft (6 to 9 m) above the current streambed (Figure 15). It appears that when the spillway was first used, a great deal of erosion occurred in the discharge-channel, which subsequently endangered the downstream toe of the dam. The extensive damage caused by the early flows appears to have been subdued over time. Currently, the eroded walls are somewhat rounded and only minor secondary erosion is evident with occasional large, exposed conglomerate boulders. With construction of the present spillway sill about 1 ft (0.3 m) above the crest of the dam, it was clearly intended that this spillway would only be used in emergencies, after the dam had already overtopped.

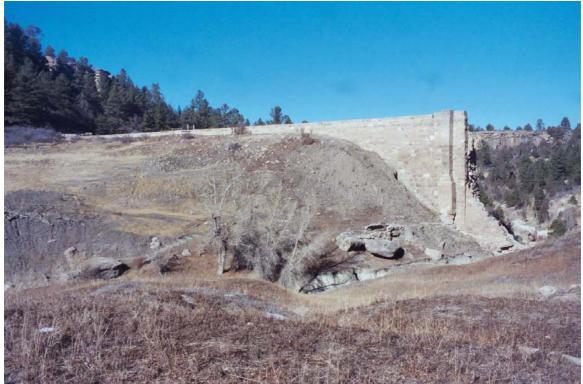
Figure 16. Remaining upstream berm on left abutment. Note remains of intake pipe at center of photo.

The upstream earthen berm, which was placed against the upstream face of the dam in an attempt to reduce seepage through the dam, is still in place to the left of the outlet-works (Figure 16). The exact method of placement of the berm is not known and the exact source of the material used in this berm is unknown. Evidence of the puddled-clay portion could not be observed due to a graveled walkway constructed in this area. The upstream slope of the berm is steeper than 3:1 and it contains much dark-brown topsoil within the fill. It was reported that the berm was

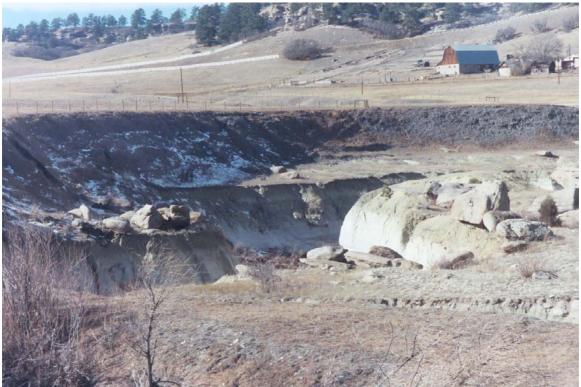
Figure 17. Terraces in valley upstream of dam. The lowest terrace, center of photo, may also pre-date dam failure. Note excessive erosion following dam failure

The same apparent stability is evident on the right abutment where the main dam failure occurred. These eroded slopes have been rounded and appear today as having been only slightly eroded during the dam failure. This illusion is made more complete by the appearance of two apparent stream terraces high up on the right abutment. When first observed, these two apparent terraces appear to predate the dam and one appears to line up very well with the oldest terrace upstream, which possibly predates the dam (Figure 17). However due to the method of dam construction, these two terraces should not have predated the dam. Appearances can be deceiving and this may have been one of the items that encouraged the designers to build Castlewood Dam at the chosen location.

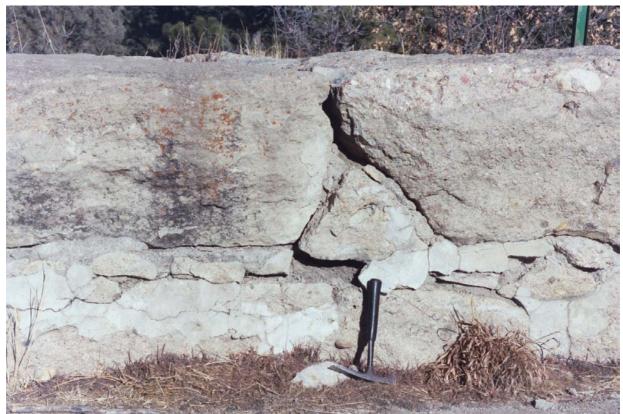
Figure 18. Upstream face at crest of dam. Note irregularity of conglomerate rock-blocks and very poor condition of mortar with multiple patching.

The use of the local Castle Rock Conglomerate for facing stones was not the best of choices (Figure 18). Upon first observation of the conglomerate, the primary and secondary joint systems seem favorable for producing rectangular rock-blocks with uniform surfaces. However,

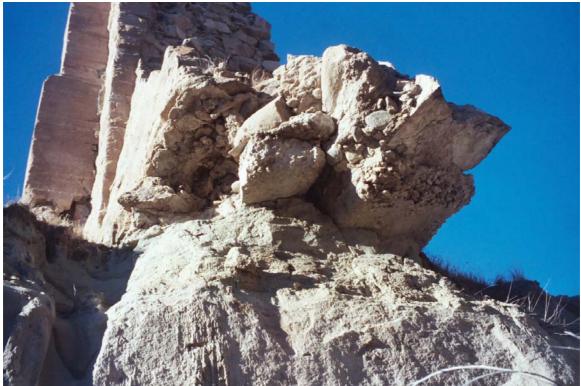
Figure 20. Leveling pad at center base of dam. Note mudstone left in place immediately below leveling pad.

The designer/construction engineer states emphatically that a 6 ft (1.8 m) cutoff trench was incorporated into the design and construction (Horan, 1997) and other sources indicate that the upstream wall rests on a concrete footing 5 to 22 ft (1.5 to 6.7 m) below ground level (USGS, 1899). No evidence of this cutoff trench could be found in the portions of the dam that can be observed. At the base of the dam, in the lowest part of the structure, only traces of a leveling-pad can be seen under the upstream masonry wall (Figure 20). Because of the smooth sides of this leveling-pad, it appears that this leveling-pad was not excavated into rock and the smooth bottom surface indicates that the foundation was shaped to lessen the amount of leveling-pad required. The only area of the remaining dam where excavation into rock is apparent and the structure tied into the rock side cut are in the areas of the reconstructed intake tower and intake pipe, the gate chamber, and the outlet-works. In these areas, the rough texture of the outside face of the concrete indicates that the concrete was placed directly against natural materials. It is also curious that the failure of the dam was arrested in this same area. Apparently, the stiffness of this triangular-shaped control structure and the cohesive mass of this thoroughly mortared rockblock structure were sufficient to prevent erosion further into the left side of the dam. However, some of the outlet-works, portions of the downstream masonry stair stepped face and portions of the rubble fill were removed just to the left of the outlet works during and after the failure flood, probably by eddying currents. Another reason for this area withstanding the failure forces was the very large block of rock left in place just to the left of the outlet-works.

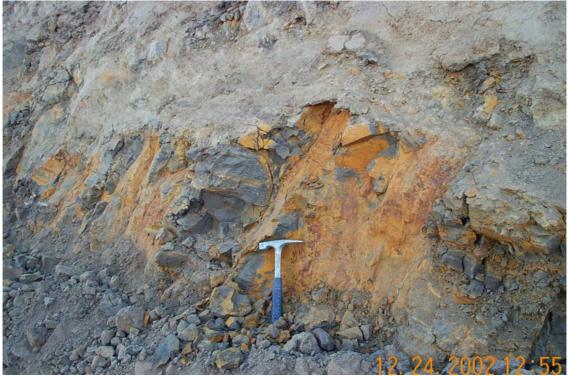
Figure 4. Weathered Slickensided Claystone at the Outlet Tunnel Portal Area.

The weathering profile is gradational from the surface of the bedrock where the rock is intensely weathered grading to slightly or less weathered bedrock with depth. At shallow depths, the bedrock has an iron stained fissured soil-like structure, which grades to a very blocky and jointed iron stained structure. Figure 4 shows slickensides and the iron stained joints in the weathered claystone near the outlet tunnel portal. The rock becomes progressively less jointed and less iron stained with increasing depth. An upper weathered zone in the bedrock and a lower lessweathered zone are shown on the geologic profile. The rock in the upper weathered zone ranges from intensely weathered to soil-like to blocky structure, to moderately weathered with describes the less jointed bedrock but with pervasive iron staining, to slightly weathered which described bedrock with occasional iron stained joint surfaced. The rock in the less weathered zone ranges from massive to moderately jointed bedrock with little or no iron staining on the joint surfaces, and little in the way of other visible indications of weathering. The term "less weathered" is utilized rather an "unweathered" because some intact loss of rock strength has occurred over the truly unweathered claystones encountered at greater depths. Another indication of the weathering is the rock in the upper zones tends, in particular the claystones, tend to have higher moisture contents and lower dry densities than the bedrock in the less weathered zones. In the weathered zone, the clavstones generally have moisture contents ranging from 14% to 16%, and dry densities in the range of 110 to 120 pounds per cubic foot (pcf) (1.76 to 1.92 g/cm³). In the less weathered zone, the claystones generally have lower moisture contents and higher densities.

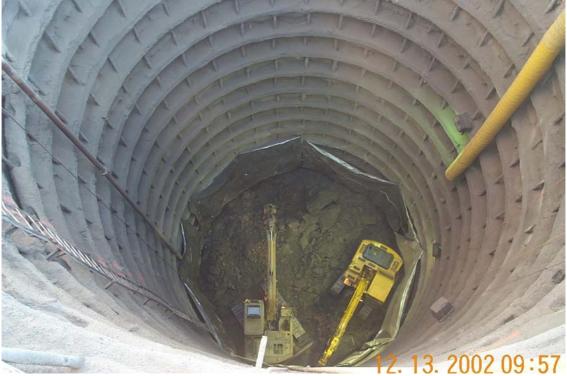
Figure 5. Excavators in Shaft During Construction

The primary support was installed as the excavation proceeded in 4-ft vertical increments. The initial shotcrete layer was applied to the claystone shortly after final trimming of the 4-ft intervals. The radial rock dowels were then drilled and installed, and completed with bearing plates. The steel ribs were then placed using tie rods and collar bracing, and blocked as required. Following the next excavation interval, the full 3 in. (7.62 cm) of shotcrete was applied and the rib was encased. Figure 5 shows the shaft during excavation.

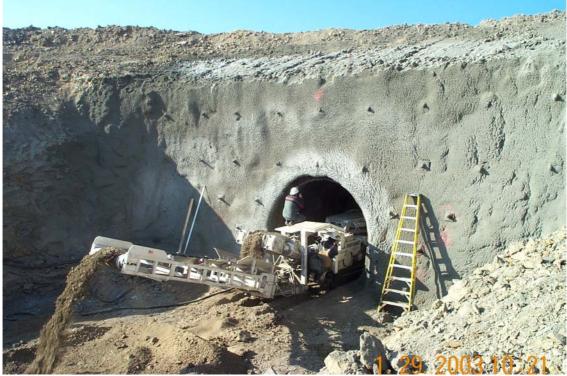
Figure 6. Outlet Tunnel Portal and Roadheader Excavating Tunnel.

The construction of the outlet tunnel started the week of January 27, 2003. The contractor chose to excavate the tunnel using a roadheader type machine for the excavation and shotcrete and lattice girders for his primary support. The downstream portal for the outlet tunnel was prepared during the weeks prior to January 27th. The machine turned under on January 29th. By January 30th, the tunnel had advanced approximately 26 ft (7.9 m) from the portal. Figure 6 shows the tunnel portal and the road header starting the excavation.

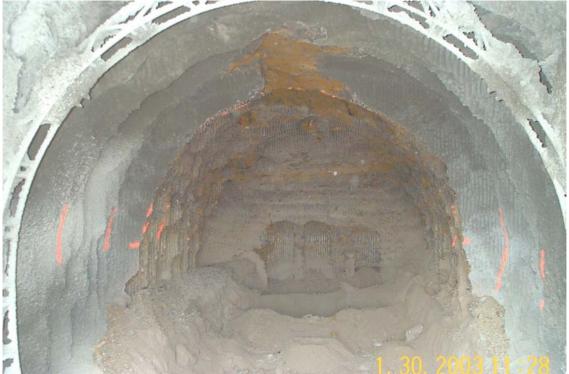
Figure 7. Minor Crown Fallout on Slickensided Joint.

The claystone near the portal behaved as firm to slow raveling ground. Shotcrete was applied soon after the rock was exposed to reduce slaking and raveling. The lattice girders were installed on 4-ft (1.21 m) centers and encased in shotcrete as the heading advanced. Figure 7 shows an area where minor fallout occurred from the tunnel crown on a slickensided joint after the initial shotcrete was applied. The roadheader has had no difficulty excavating the claystone. No significant harder concretions or nodules have been encountered thus far.

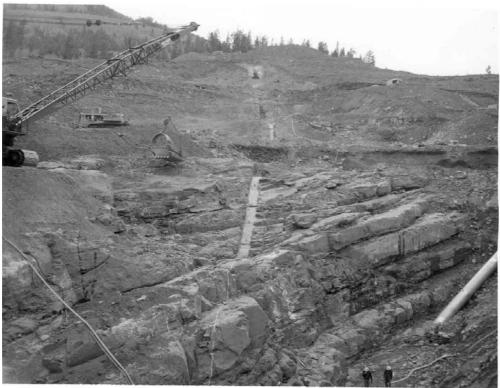
Figure 1. Lemon Dam - Photograph shows inner gorge and grout cap.

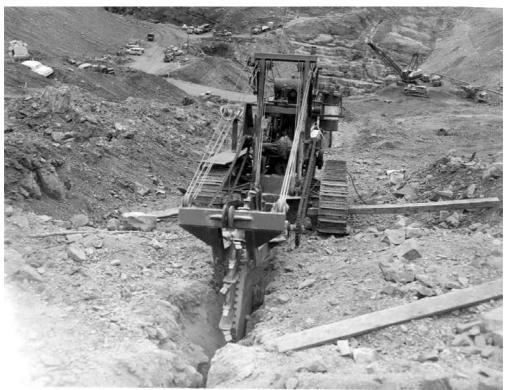
Figure 3. Lemon Dam - A rock saw excavating the grout cap and cutoff trench.

abutments, and a cutoff trench within the limits of the Zone 1 core and extending 5 ft (1.5 m) into bedrock or a minimum base depth of 30 ft (9 m) (Figure 3). The trench was excavated to a 10-ft (3 m) width in siltstone below the old river channel. Photographs of the construction area can be used to gather missing geologic data. Photographs such as Figures 1 and 2 can be used to gather general information on rock units, jointing, rock hardness, bedding, and other attributes. However none of this data was documented during construction.

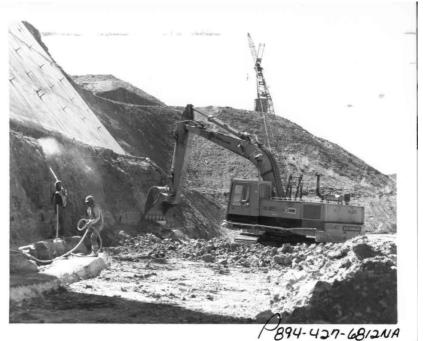
Figure 4. Ridgway Dam - Foundation clean-up on the left abutment.

of the embankment material and concrete work (Figures 4 and 5). Initial filling of the reservoir began in 1987 and was completed in 1990.

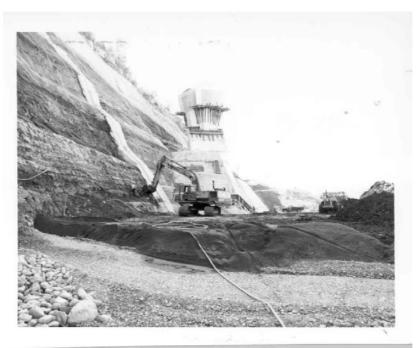
Figure 5. Ridgway Dam - Foundation excavation and final cleanup on the right abutment, near dam centerline.

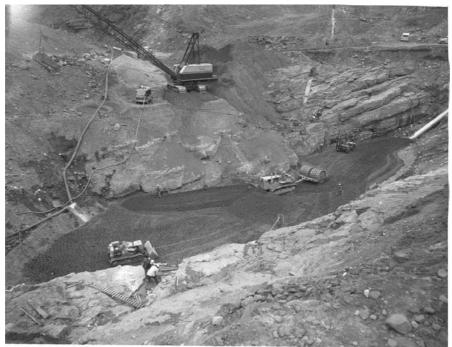
Figure 6. Lemon Dam - Zone 1 placement in the inner gorge area.

Some information could be deduced from old photographs taken of the site and during construction. Photographs taken during construction show general bedding and jointing conditions, seep locations and quantities, and construction practices. In Figure 6, zone 1 material is being placed in the inner gorge area of Lemon Dam. From the photograph, small seeps can be seen in the bedrock on the right side, a sump can be seen in the left center of the photograph. Water entering the excavation appears to be a relatively small quantity. In the bedrock on the right side, several joints can be seen trending sub parallel to the dam axis. Bedding thickness can be estimated based on equipment heights and the cutoff trench width.

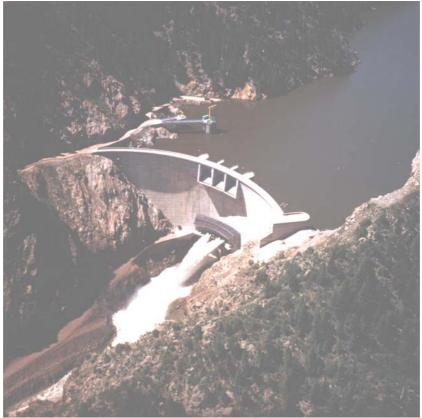
Figure 5. View of Strontia Springs Dam.

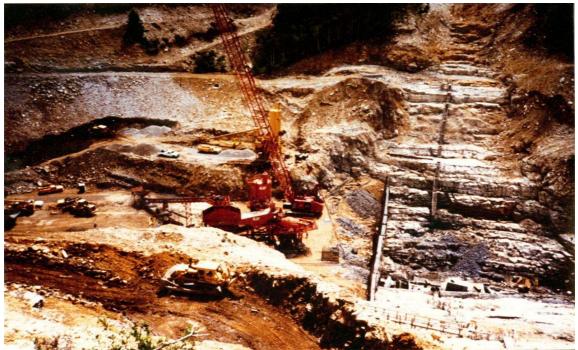
Figure 3. Core trench excavation for the original dam from the right abutment. Note temporary construction tie-back retaining wall and work area on the left.

The contractor constructed a temporary sheet-pile tieback wall that retained a temporary fill parallel to, and about 20-ft (6 m) upstream of, the upstream face of the dam. The wall consisted of 50-ft (23 m) (maximum) high sheets, held in place by "I" beam walers and rebar tiebacks anchored into the fill by concrete "dead-men", as shown on Figure 3. The valley upstream of the wall was backfilled with required excavation material to elevation 7430 (2,266 m), or about mid-height of the dam. This temporary platform served as a working area throughout construction of the dam and formed the foundation for the RCC batch plant, conveyor system, and platform from which a large crane operated. Figure 4 shows the construction site layout in plan view.

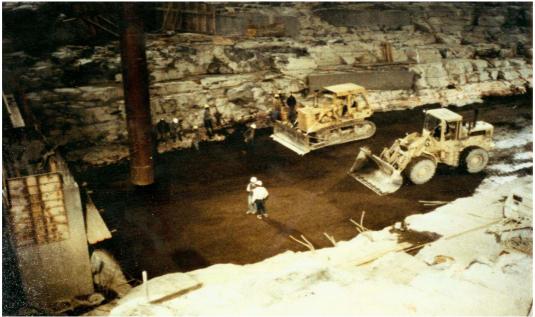
Figure 6. Night-time RCC placement operation at lower elevation of the dam as viewed from upstream on the right abutment.

Production of RCC averaged four lifts per day with only a few delays. Work on the RCC dam was halted at elevation 7457.5 (2,260 m) from August 26 to September 4 to allow for drilling of the internal drain holes through the dam and for completing excavation and cleanup of the abutments from elevation 7460 (2,260 m) to 7496 (2,272 m). Construction joints in the RCC 10 hours or more old were treated by cleaning up the surface and covering with a thin layer (one- in [25 mm]) of bedding concrete. Construction of the RCC dam was completed in the early morning of September 15, 1984. Figures 6, 7, and 8 show typical placement conditions at the base, mid-height, and near the crest of the dam respectively.

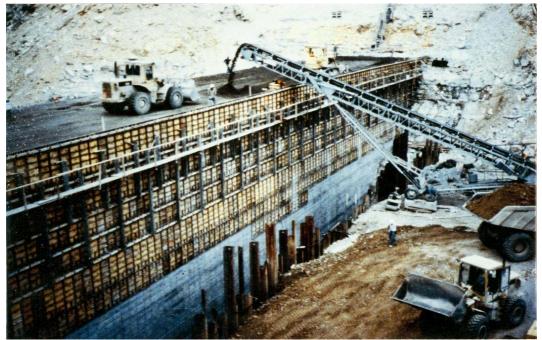
Figure 7. RCC dam at about two-thirds height with conveyor delivering RCC directly onto the lift surface.

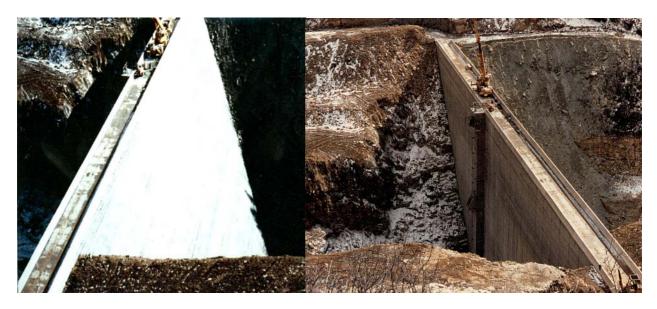
Figure 9. Completed dam as viewed from downstream and upstream on the right abutment. The reservoir control structure can be seen rising up the face of the dam. Note the vertical crack-control grooves and horizontal rustication grooves in the upstream face, and the steps on the downstream face.

proper dropped to about 50 percent as the dam healed. The foundation flows remained nearly constant. Approximately 25 percent of the seepage came from the internal drainage curtain. Calcium carbonate precipitated at the point of emergence of the seepage within the gallery. The drains required periodic cleaning. Seepage volume from the dam was judged acceptable by the owner, considering the functional requirements of the structure. The dam has continued to perform satisfactorily since. Figure 9 shows the completed dam from downstream and upstream on the right abutment.

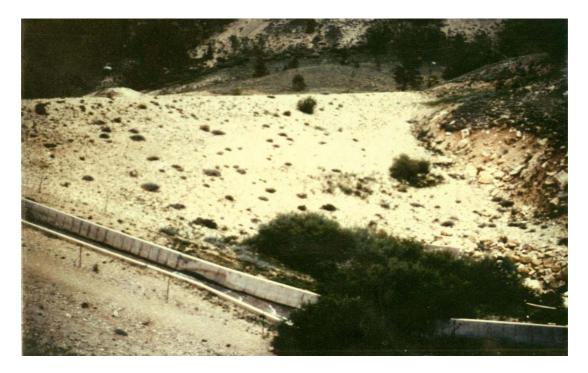
Figure 1. View of Spring Creek Dam and service spillway prior to modification. Photograph taken from the right abutment looking upstream.

Spring Creek Dam is one of these dams (Figure 1). It is an earth embankment dam approximately 50-ft (15 m) high with a crest length of about 575-ft (174 m). The dam crest is situated at elevation 10,022-ft (3,037 m) above mean sea level (msl) and is located approximately 25-mi (40 km) northwest of the town of Gunnison. A service spillway is located on the right abutment, and is a broad crested concrete weir, with a concrete lined chute terminating in a stilling basin at the toe of the dam. The outlet works consists of a 18-in-diameter concrete pipe, controlled at the upstream end by an inclined slide gate. The dam was constructed in 1961-62 by the Colorado Division of Wildlife (CDOW) and the reservoir is maintained for recreational purposes.

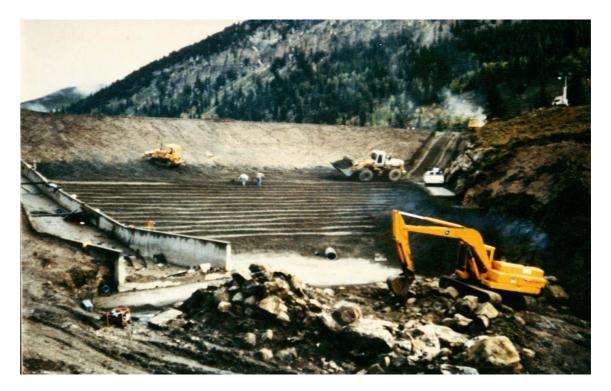
Figure 3. View from downstream, looking upstream, with RCC placement about fifty percent complete. All the placement, spreading, and compacting equipment used on the project can be seen. Note the steps in the RCC liner and the left containment wall on the right side of the photograph.

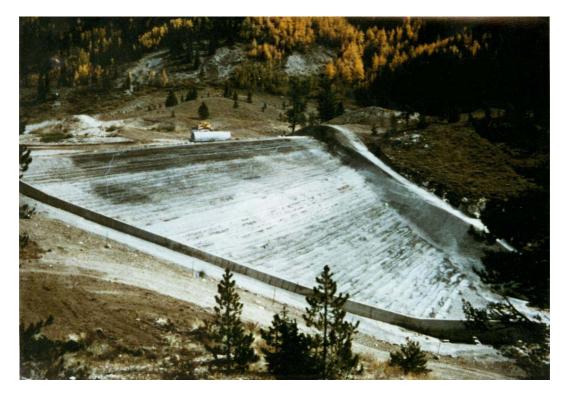
Figure 4. Completed dam viewed from downstream on the right abutment.

The project is located in the Gunnison National Forest, adjacent to a campground, and the reservoir is maintained solely for recreational purposes. Therefore, preservation of natural vegetation in the area was of paramount importance. By balancing the excavation and fill volumes, and obtaining the RCC aggregate from a previously disturbed borrow area, minimal disturbance to the environment occurred. The finished project is an aesthetically pleasing structure that blends in well with the pristine surroundings (Figure 4 and 5).

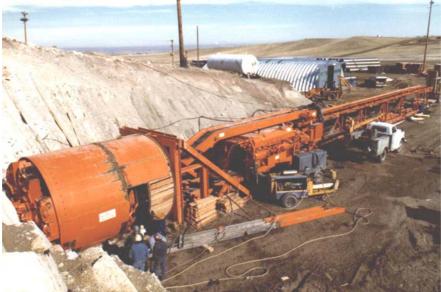
Figure 2. TBM and Trailing Gear at Portal.

The fully shielded Calweld TBM excavated a 13.33 ft. diameter tunnel and was equipped to push off the ring beam and lagging support system using 10 ft. - 6 inches diameter x 60 inch stroke hydraulic cylinders operating at pressures up to 8,000 psi (Figure 2).

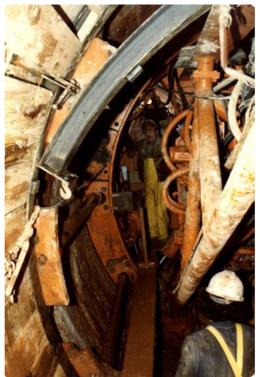
Figure 3. TBM Operator.

Sedimentary rocks in the project included sandstones having compressive strengths up to 12,000 psi, and a variety of shales and siltstones having much lower strength. TBM penetration rates varied from 1 inch to 6 inches per minute, with the most common rates being 3-4 inches per minute. Average production was approximately 80 ft. per day, fully supported with ring beams and lagging, working 2 x 8 hour shifts. The graveyard shift was used to maintain the TBM and to advance utilities (Figure 3).

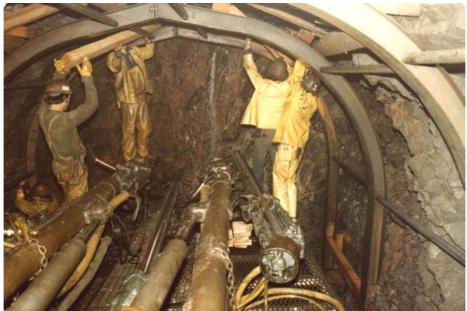
Figure 4. Placement of Steel Sets and Wood Lagging.

The remaining 13,200 ft. of tunnel was driven both ways from a canyon, Stevens Gulch, which intersected the tunnel line, approximately 1,700 ft. downstream from the intake in Strontia Springs Reservoir. The 1,700 ft. west leg was driven first, then the 11,500 ft. east leg was driven to hole through with the already completed TBM section. The drilled and blasted tunnel was excavated as a 14 x 14 ft. horseshoe (Figure 4).

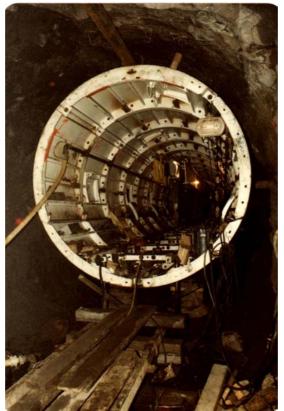
Figure 5. Telescoping Concrete Tunnel Form.

The final lining of the tunnel included 3,700 ft. of steel lining, concrete backfilled, and 14,100 ft. of concrete lining, both having a diameter of 10.67 ft (Figure 5 and 6).

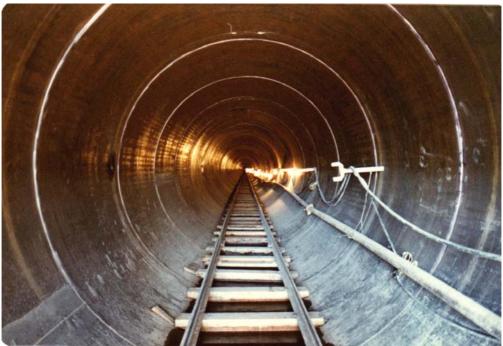
Figure 6. Steel Tunnel Liner.

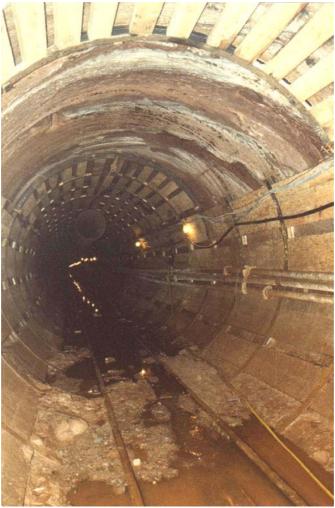
Figure 7. Surge Chamber.

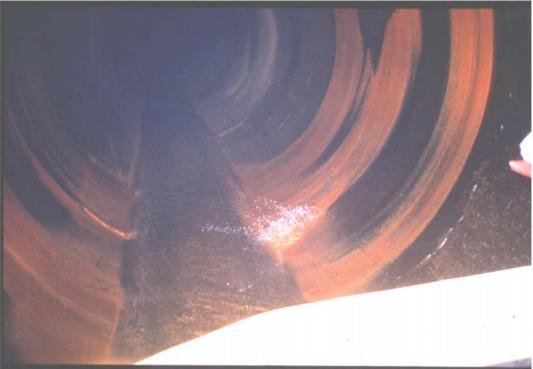
Figure 8. Water Inflow from Check Valve.

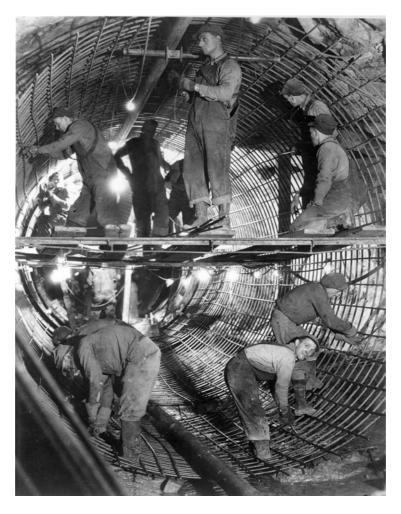
Figure 11. Placing Steel Reinforcement for Tunnel Lining.

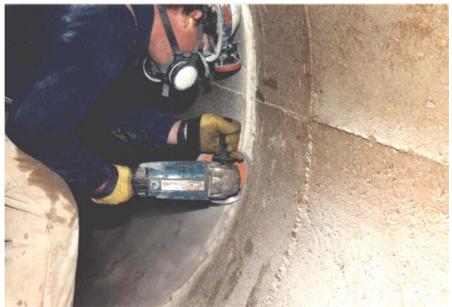
Figure 13. Saw Cutting Concrete at Crack Location.

- a. Cracks in the Concrete Tunnel Lining.
 Each crack was cut to form a notch with the dimensions between 1 inch and ¹/₂ inch in depth and between ¹/₄ inch and ¹/₂ inch in width. This cut in the concrete was accomplished by means of a <u>dry</u> mechanical router and concrete saw (Figure 14).

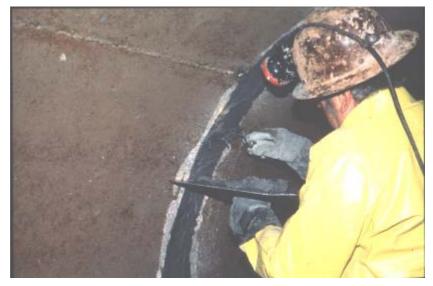
Figure 14. Application of SIKA TOP 123.

- C. SIKADUR 35-HI-MOD LV was painted over the concrete "notch" containing SIKADUR-51-NS and SIKA SET PLUG in a thin coat that was approximately 2-3 inches wide over the surrounding <u>clean</u> concrete.
- D. SIKA TOP 123 was applied on top of concrete "notch" containing IKADUR-51-NS, SIKA SET PLUG and SIKADUR-35-HI MOD LV in areas that a depression had been created in the concrete tunnel lining as a result of removal (chipping) of old mortar patches. The completed sealed and patched areas of concrete tunnel lining formed a smooth level surface consistent with the original diameter of the concrete tunnel lining.

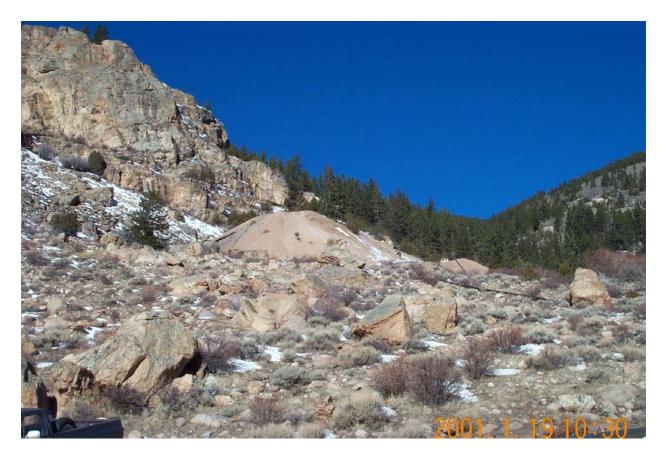
Figure 2. Portal and muck pile on the east side.

On the east side, the tunnel was driven with a rough rectangular cross section 10ft (3m) wide and 8ft (2.4m) tall. Leyner No. 7 water drills were initially used, but the hard ground required the development of a more robust drill, which later became the Leyner No. 8 (Brunton 1911). For explosives, a blasting gelatin having 60 percent of the strength of pure nitroglycerine was used for most of the drive. To aid in mucking, steel plates were placed on the invert in front of the face. These provided a smooth surface from which to shovel. Mules were then used to haul the muck cars. While the tunnel portal is hidden, the muck pile is visible from Highway 14 and is shown in Figure 2.

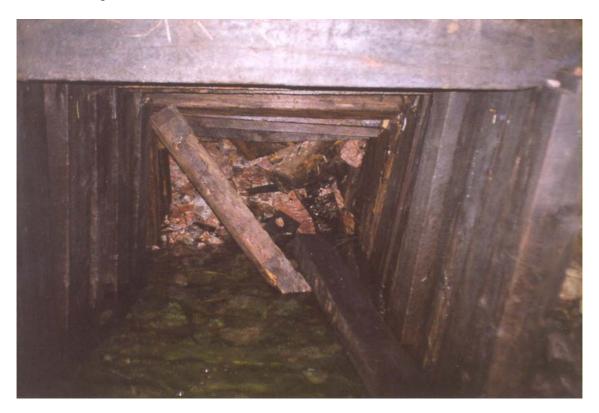
Figure 4. Photograph of west (upstream side) of cave in.

Rocky Mountain Consultants Inc. (now Tetra tech RMC) was contacted by the Tunnel Water Company in the summer of 2000 to investigate the collapse, recommend a solution, develop plans and specifications, and provide construction oversight. Engineers and geologists examined the surface above the tunnel and both sides of the tunnel from the portals to the caved area. Near the center of the tunnel, on the west side, a timbered section gave way to a nearly vertical face of collapsed rock (Figure 4). On the east side, debris from the collapse was visible several hundred meters downstream. As one approached the caved area, the debris built up like a ramp until the tunnel became impassable.

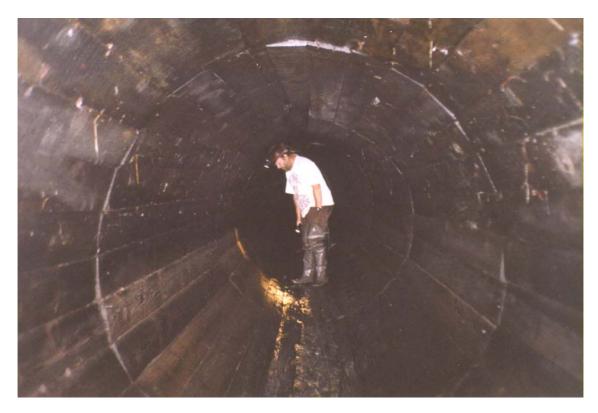
Figure 6. Photograph of west side timber barrel section.

The most unusual support was a timber "barrel." This timber barrel consisted of 10ft (3m) long timbers that were laid end-to-end, parallel to the flow, and arranged in a circle like the staves of a barrel. Behind the timber barrel was cast in place concrete. The ends of the barrel sections had attractive transition areas made of stones cast within the concrete. Figure 6 shows a typical section.

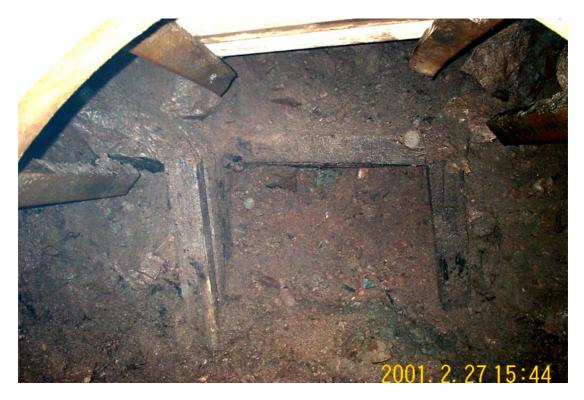
Figure 7. Photograph of face during mining. Note the crown bars and make up of the muck.

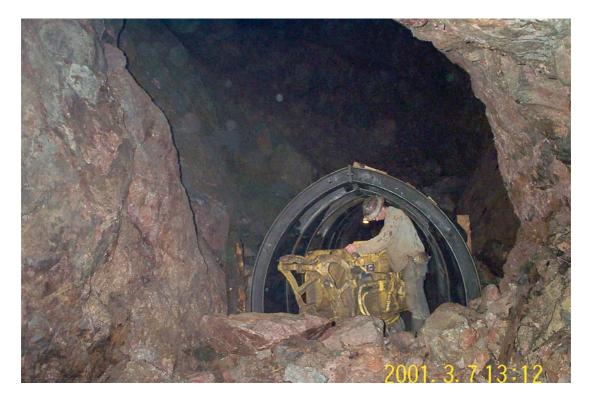
Figure 8. Photograph of final mucking and cave, taken from the west side.

When the crews broke through on March 6, 2001, they looked back on a 1200cy (920m³) cave, 60ft (20m) long. Above the tunnel, the cave reached up 40ft (12m), but to the north the cave reached at least 80ft (24m) before pinching out in the darkness. A picture taken from the west side shortly after breakthrough appears in Figure 8.

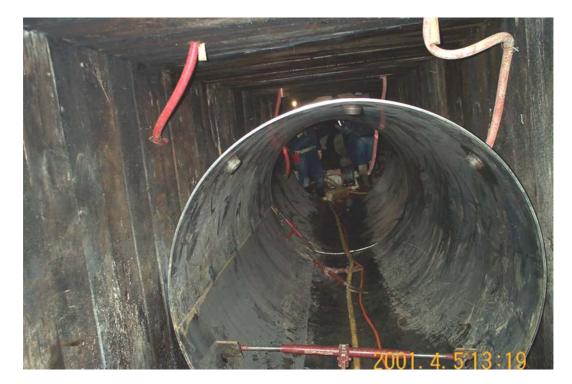
Figure 9. Photograph of expandable steel pipe with grout hoses in place.

The longer timbered sections had to be repaired in place with an expandable steel pipe, placed inside the sets and grouted into place. The pipe was made of 3/8in (1cm) thick steel that was split longitudinally rolled together so that the ends overlapped. This compressed pipe was able to navigate tight spots within the tunnel while being moved into place with the locomotive. It allowed the pipe to fit through tunnel constrictions instead of having to locally remove support and re-mine. Once the pipe was in place, the overlapping joints were expanded to 5.3ft (1.6m), filling the inside of the timbers. After all the joints were welded, the ends were sealed with shotcrete bulkheads. Next, cellular concrete grout was pumped though grout ports in the upper haunches of the pipe. The grout filled both the annular space between the pipe and timber as well as the voids in the crown. 414ft (126m) of tunnel were repaired in this manner. Figures 9 and 10 show the repair in progress and the completed repair respectively.

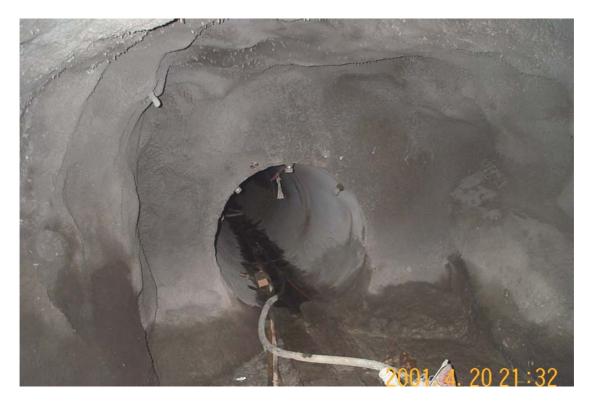
Figure 10. Completed repair of a timbered section.

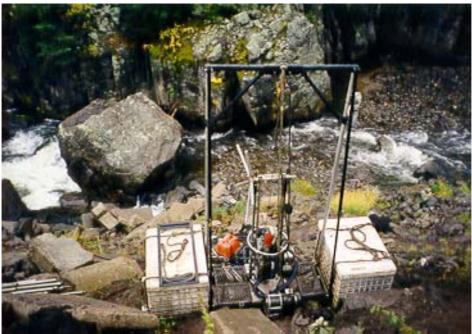
Figure 3. Winkie Drill Rig Above River.

Borings were located on the existing road and the canyon slopes above and below the road. Truck mounted drill rigs were used for borings along the existing road with some holes aligned horizontal or angled. Access to borings outside the road was challenging due to the steep canyon topography, coarse talus, and rock outcrops. Additionally, visual standards and environmental impacts prevented constructing temporary roads to access drill sites. Many of the borings were drilled with portable lightweight Winkie drill rigs mobilized with a helicopter, as shown in Figure 3. These drill rigs disassemble into three major parts and can be easily set up on virtually any slope using a small platform constructed by hand.

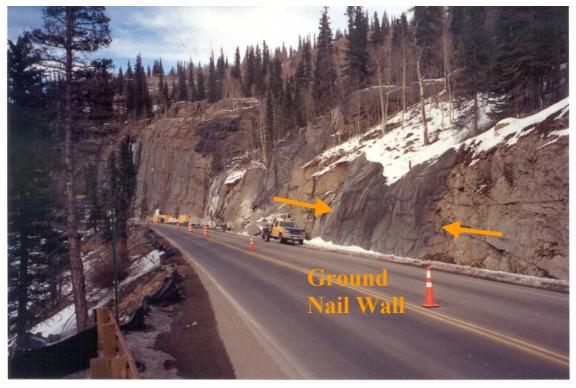
Figure 4. Ground Nail Wall and Rock Cuts.

The visual appearance of the GNWs was of great interest to the design team, CDOT, and the United States Forest Service. GNWs are normally faced with shotcrete, which is commonly considered to have an unattractive, artificial look. Other recent projects in Colorado have utilized mechanical stabilized earth (MSE) walls with a block facing in front of the GNW to provide a more appealing finish. This adds substantially to the cost of the wall, however, and requires the GNW to be positioned farther into the hill than otherwise would be necessary. Additionally, the block facing of MSE walls has an artificial appearance that is not desirable for a natural setting, although it is generally considered to be more attractive than shotcrete. For an economical solution, the GNWs in the Upper Narrows Project used sculpted and colored shotcrete. This outer shotcrete facing is applied after construction of the structural portion of the wall is complete. Sculpting consists of mimicking rock joints and features with an artistic trowel finish and potentially staining for accent. Additionally, the shotcrete is colored to match other nearby rock exposures, and stain is applied after application for additional effect. The concept is to mimic the natural rock cliffs in color and character so that the walls blend into the natural surroundings. Figure 4 shows a completed wall between two rock cuts south of the west portal.

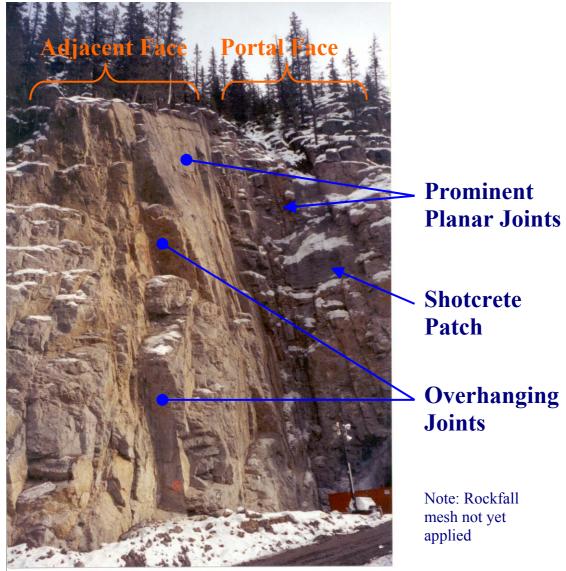
Figure 5. East Portal Rock Cut.

As constructed, the cuts follow these two joint sets in a saw-tooth configuration when looked at in plan view. The cut follows a smooth joint surface sub-parallel (20 degrees off) with the road, then cross back on the complementary joints in a jagged fashion until another sub-parallel joint is picked up. Similarly, the cut face for the east portal of the tunnel follows the second joint and is angled 20 degrees off of perpendicular to the road. There are at least three such "teeth" in the cut face. Figure 5 shows the jointing at the East Portal. The shotcrete patch is visible, but the rockfall mesh had not been applied when this photo was taken.

This situation has both advantages and disadvantages. The saw-tooth profile resulted in a rock cut with a more natural appearance than a smooth planar cut breaking to a line of drill holes. The smooth planar joint surfaces are often free of loose blocks resulting in a low probability for

rockfall. In some areas the rockfall mesh was eliminated. On the negative side, the joints resulted in significant overbreak, which was 25 to 30 percent of the theoretical minimum cut volume. Additionally, a major joint close to the blast trim line led to a large slab failure immediately after a blast.
