EDITORS NOTES

Overview of the Geology of Colorado – Part II: Mineral and Mineral Fuel Resources, Water Resources and Water Quality, and Geologic Hazards - *David C. Noe, Vincent Matthews, III, and Ralf Topper* (This paper is derived from two copyrighted publications from the Colorado Geological Survey – Special Publications 52 and 53 – used with permission; use of this material is subject to the CGS copyrights)

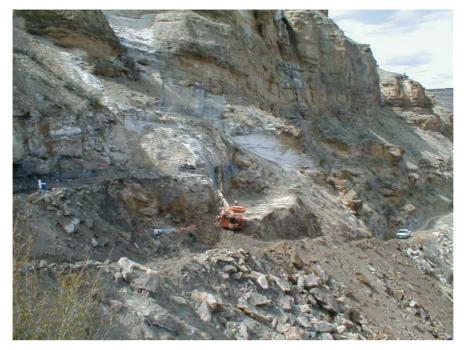
Figure 5. Construction of the East Portal of the Lower Mesa Tunnel. Note rock excavation partially complete for portal and rockfall fence above rock cut

Construction started in November 1999 and was substantially complete in March 2001 for the tunnel and September 2002 for the entire project. Site preparatory work included providing access to the portal locations and excavation of each of the four portals. Access and portal construction were more difficult at the Lower Mesa Tunnel portals as compared to the Lower Canyon Tunnel portals. Significant rock excavation was required at the east portal of the Lower Mesa Tunnel in order to provide an adequate working area for the tunnel construction. In addition, a Geobrugg rockfall fence was installed above this portal in order to provide protection of the area from rockfalls, as shown in Figure 5.

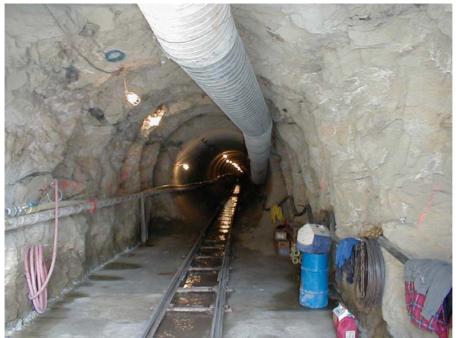
Figure 6. Drill and Blast Starter Tunnel in Foreground and TBM Tunnel in Background

After excavation and support of the portals, starter tunnels were constructed at the east portal of the Lower Mesa Tunnel and west portal of the Lower Canyon Tunnel where the TBM was launched. The starter tunnels were constructed by conventional drill and blast methods. Each tunnel was constructed to a 14-ft (4.2 m) horseshoe shape for a distance of approximately 40 ft (12 m) (Figure 6). After the initial 8-ft (2.4 m) round, the heading was advance using a jackleg drill to drill each round of 6-ft (1.8 m) blast holes. Approximately 44 holes were drilled for each round with perimeter holes (not loaded) drilled on approximately 8-in (20 cm) centers for smooth wall blasting. The holes were loaded with Magnum, paper-packaged, detonator sensitive emulsion explosives, and stemmed with 12-in (30 cm) clay dummies. Each hole was loaded with 4.15 lbs (9.13 kg) of explosives. Each round was initiated using an Exel LP long delay, non-electric detonation system and Cordtex 18 detonating cord. Figure 8 shows the configuration of the starter tunnel for the Lower Mesa Tunnel in the background.

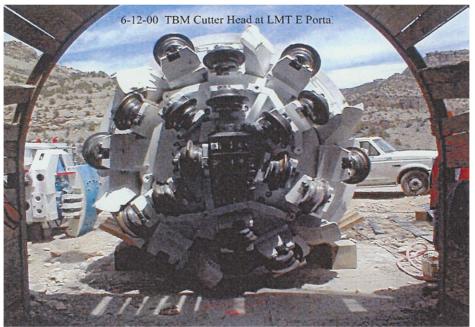
Figure 7. TBM Cutter Head Prior to Initial Launching.

After the starter tunnels were excavated and supported, the TBM was mobilized to the tunnel heading to excavate a 10-ft (3 m) diameter tunnel for the remainder of the alignment (Figure 7). The TBM was a 10-ft (3 m) diameter, main beam type Robbins Model #91-155. Prior to arriving on site, the machine was refurbished and upgraded. The cutterhead was rebuilt with 17-in (43 cm) diameter, wedge lock disc cutters. The four original 125 horsepower electric motors were upgraded to 200 horsepower, water-cooled, 480 volt electric motors. The TBM weighed 75 tons and was 155 ft (47 m) long, including trailing gear.

The TBM cutterhead contained 22 cutting discs and 6 muck buckets. The recommended cutter load, per cutter, was 26 tons maximum and 22 tons operating. The cutterhead speed was 11.4 RPM at 800 horsepower. The thrust capacity was 597 tons at 4,500 psi (315 kg/cm²). After each 46-in (117cm) stroke, the TBM was reset by retracting the grippers, moving the gripper carriage forward, and regripping. The machine was then positioned for the next push.

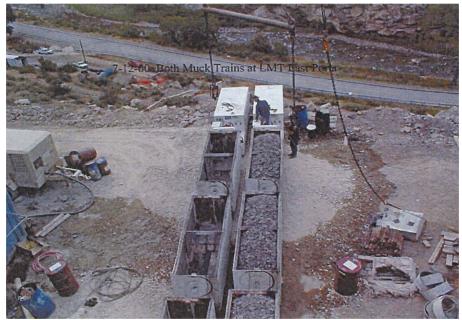
Figure 8. Muck Disposal at East Portal of Lower Mesa Tunnel.

Muck buckets on the cutterhead picked up the spoil from the bottom of the tunnel and deposited the material on the 18-in (46 cm) wide machine conveyor. The conveyor transported the muck to the trailing conveyor and then to muck cars at the end of the TBM. The spoil was transported out of the tunnel using three trains riding on 24-gauge, 60-lb (132 kg) rail. A moveable California switch was used to allow the trains to pass one another in the tunnel. Three diesel locomotives were used to pull muck trains. The muck cars were 4 cubic yd, lift-off type cars. The muck cars were unloaded at the portals using a crane (Figure 8).

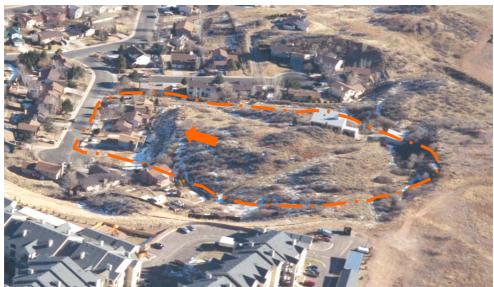
Figure 5. Landslide geomorphic features of the Hofstead landslide on the northeast flank of "The Mesa" in Colorado Springs in 1999. Note the "step-and-bench" topography below the head scarp and the cut slope into the old landslide toe. The dashed line indicates the extents of the slide reactivation in 1999. Arrow shows slide direction. Also note the back-tilting of the closest home in the toe. That home, and others, were demolished subsequent to this photo. Photo by M. Squire, OEM.

drainage channels often indicate areas that have been affected by landslides. An example of classic geomorphic landslide terrain in Colorado Springs is shown in Figure 5. The DEM and air photos were examined for evidence of landslide deposits. Follow-up fieldwork and stereo aerial photographic analyses either confirmed or eliminated the area as a landslide or landslide susceptible area. Areas that were determined to be landslides were digitized and included in the known landslide-inventory coverage. Areas that were not actual landslides, but appeared to have favorable geologic and topographic characteristics for landslide susceptibility were evaluated for inclusion in the landslide-susceptibility coverage.

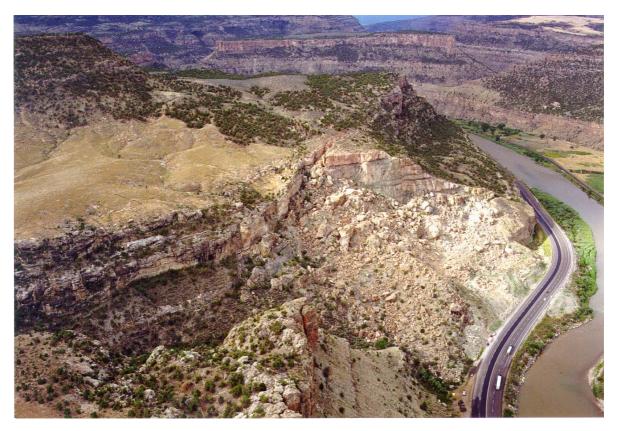
Figure 1. Oblique aerial view of DeBeque Canyon landslide. View is to the west. Photo by J. White taken in 1999.

The DeBeque Canyon landslide, also referred to historically as the "Tunnel Landslide," is a major landslide complex that has historically impacted a major highway, a major railway line, and the Colorado River (Figure 1). The last major re-activation in April 1998 caused Interstate

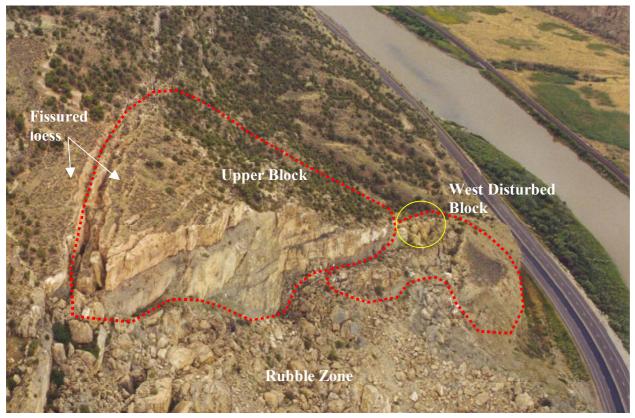
Figure 6. Oblique aerial photo of the Upper Block and West Disturbed Block. Note main graben and the fissures in loess that mantle top of Upper Block. Note also the proximity to Interstate 70, the Colorado River, and the railroad tracks below. Yellow circle is location of mid-Pleistocene (Bull Lake) gravel terrace remnant. Photo taken in 1999 by J. White. View is to the west.

The West Disturbed Block is located west of the Rubble Zone and directly below (north of) the Upper Block. The West Disturbed Block is a transitional feature in the landslide that has differentially sheared and separated from the Upper Block in a scissors-like fashion. Even though slumping, shearing, tilting, and fissuring have disturbed the rock strata, it has not been completely reduced to rubble and can be easily identified. This feature is identified as the West Block on Figures 5 and 8, and is shown on the right side of Figure 6.

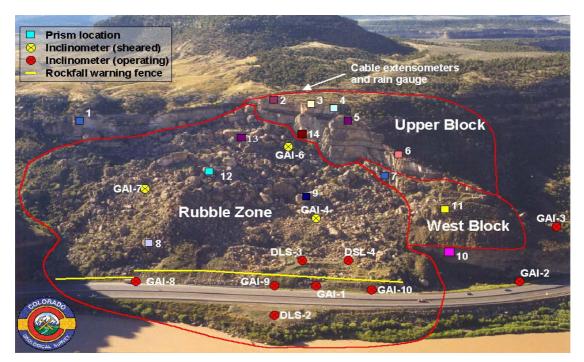
Figure 8. Oblique aerial photo of landslide showing location of various monitoring tools. Photo taken in 1999 by J. White.

Since 1998, the DeBeque landslide has been instrumented with inclinometers, peizometers, vibrating-wire extensioneters, tiltmeters, precipitation gages, rockfall warning fences, prism survey stations, and GPS survey stations. Figures 8 and 9 show the locations of the various

instruments and stations on the landslide. Prism station locations are also shown on the geologic map plate. Many of these monitoring instruments are automated, and two data logger stations have been constructed at the site that allow cellular phone communication. Project monitoring for the last four years has shown continued movements of the Upper Block, the upper reaches of the Rubble Zone, and the West Disturbed Block. Inclinometers have now sheared, except for those near the roadway. Figures 10 and 11 present vector graphs of the prism and GPS surveys that have been completed since 1999. They show conclusively that the Upper Block is moving to the north, towards the highway and Colorado River. The data collected also indicate that movement rates accelerate during the late fall and winter, then slow during the spring and summer. These movement variations are likely related to moisture surplus and shadow effects of the north-facing slopes when days are shorter and the sun angle is lower.

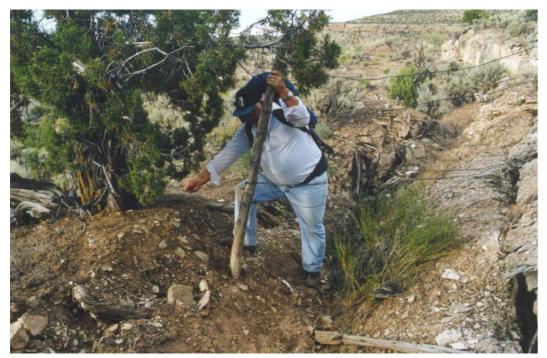
Figure 20. Photo of barbed-wire gate showing offset. Subjects right hand is holding wire loop that fence post originally was placed into to close the gate. Note fissures below the wire-fence gate. Photo taken in 1999 by J. White.

- 6. Carbon-14 dating by the USGS of wood fragments taken from the bottoms of fissures near the west side of the Upper Block, between the cross section B traverse and the offset fence gate, date to 460 BP (+/- 50 BP) (Ellis and Coe, unpubl.). These wood fragments were lying on an unknown thickness of soil in-fill in the fissures, so actual fissure age may be on the order of several hundred years older.

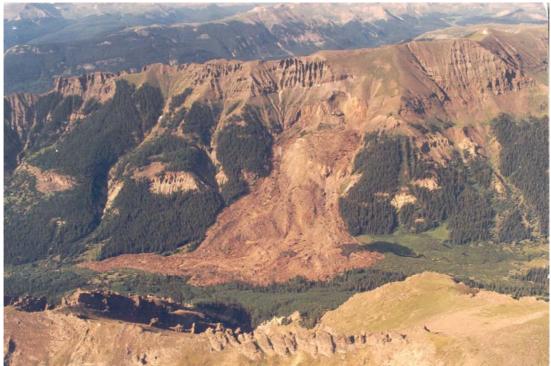
Figure 2. Aerial oblique view of the July 30, 1991 West Lost Trail Creek landslide (photo courtesy of Dave Noe)

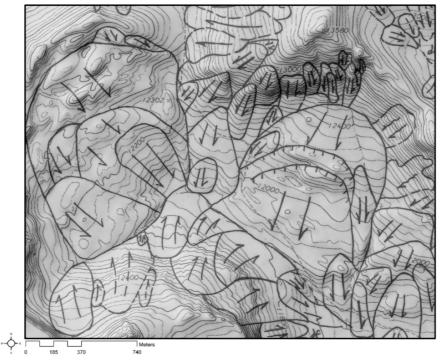
Figure 4. Landslide inventory map of the same area shown in Figure 3. This map overlays a shaded DEM, topography from a DRG, and mapped landslide contacts.

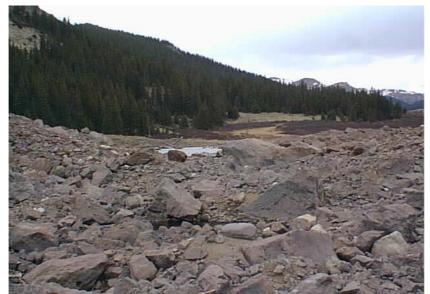
Figure 12. The variability in size of the landslide debris can be appreciated in this view of the debris field, looking upstream (westerly) towards the impounded lake shown in Figure 6. Many of the boulders are as large as small buildings (25 x 50 ft or more).

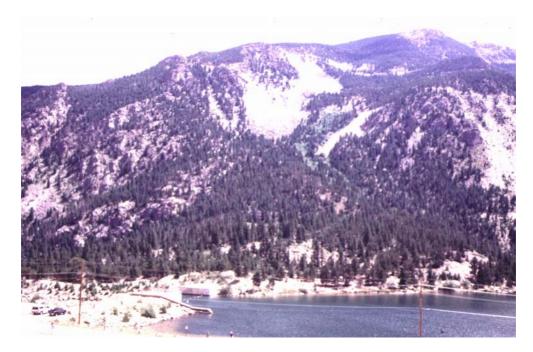
Figure 4. Georgetown Lake (Harry Locke) Dam (lower left in photo) and large rock avalanche that forms its right abutment (center of photo). View is from left valley wall above Interstate 70, 2 mi (3.2 km) north (i.e., toward Denver) of downtown Georgetown. (2000 photo)

Georgetown Lake (Harry Locke) Dam is located on Clear Creek, 4.5 mi (7.2 km) downstream (i.e., north) from Clear Lake Dam. This 30-ft (9-m) high earthfill dam, built for recreation and hydroelectric power, is too small to be included in the Table 1 compilation of "large" dams. However, it is worthy of mention because it is an outstanding example of a dam that has been built in contact with the toe of a large rock avalanche, and because it is easily viewed from Interstate 70 at a point 2 mi (3.2 km) north (i.e., toward Denver) from downtown Georgetown (Figure 4). The original dam at this site was built in 1906; this structure failed in June 1956 due to overtopping during flood stage (Woodward-Clyde & Associates, 1970). There is a strong possibility that the inherent weakness of the landslide material that comprised the right abutment of the dam contributed to the failure. The current dam, constructed in 1960, is performing satisfactorily.

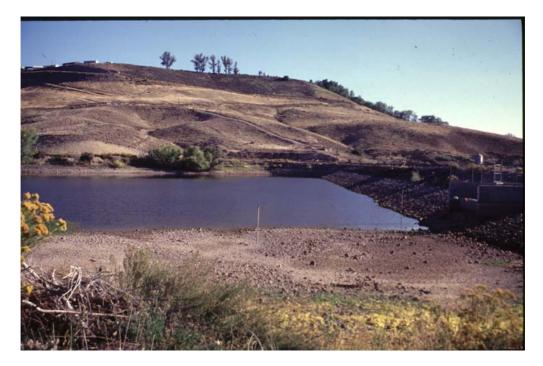
Figure 7. Fruitgrowers Dam, a federal irrigation dam in southwestern Colorado, showing landslide topography in Mancos Shale on slope at the left abutment. (1999 photograph)

Fruitgrowers Dam – The present 55-ft (17-m) high Fruitgrowers Dam (Figure 7) on Alfalfa Run, a tributary of the Gunnison River south of the Grand Mesa, was built in 1939 on the site of a 19th-century dam that had failed in 1937 due to faulty design and materials. The left abutment and part of the left foundation of this federal earthfill irrigation dam is an ancient block-glide landslide in Mancos Shale, which has reactivated since the dam was put into service. Slow reactivation along the gently dipping failure surface of this block glide presumably tilted the original spillway, which, as a result, was relocated to the right end of the dam in 1987. As determined by inclinometers, the rate of movement of the left-abutment landslide toward the dam from 1981 to 1999 ranged from 1/3 to one inch (0.8 to 2.5 cm) per year; this movement continues to be monitored.

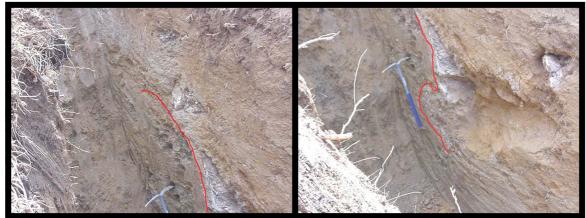
Figure 7. Top and bottom photos from test pit-location "b" shown in Figure 6. Note the contact of disturbed claystone and sand and gravel deposits (red lines). (Approximate scale 1:30)

gravel at the surface. The sand and gravel varies in thickness from about 20 ft (6 m) to about 105 ft (32 m) and generally thins to the east (CTL/Thompson, Inc., 2002 a, b, c, unpublished). The sand and gravel is generally underlain by weathered claystone and claystone that varies in thickness from less than 1 ft (0.3 m) to 60 ft (18 m). Some of the thicker weathered claystone areas have occasional to frequent layers of sand and gravel that indicate the material is likely earth flow. Below the step and bench feature the sand-and-gravel deposits appear to be thin, based on shallow borings that penetrated through the upper sand and gravel layers to underlying weathered claystone deposits. Trenching and borings also indicate disturbed claystone at and near the ground surface.

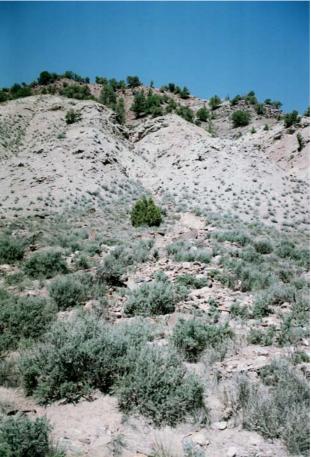
Figure 2. Photograph of drainage basin and debris fan F5 (Table 1, Figure 1). The debris fan can be distinguished from hillslopes by the presence of vegetation. Fresh debris is visible on the fan surface in the foreground. Photograph taken 4/12/00.

The Evaporite underlies a proportionally larger area of the smaller basins (Figure 1), and variability in the particle size and rate of colluvium produced from the Evaporite may influence the gradients of the fans. Additionally, several of the smallest basins are essentially large gullies (Figure 2) that drain a flat lying ridge or bench (Figure 1) mantled with a silty regolith. Figure 7 is a photograph of a rill network that has developed at the head of drainage basin/fan F5. The approximate drainage divide is just behind the person in the photograph. The material delivered from these drainage heads to the debris fans may account for some of the scatter in the fan

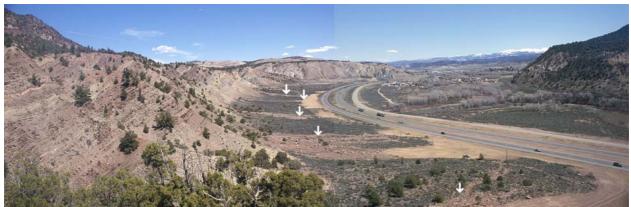
Figure 3. Photograph of the study area showing fresh debris-flow deposits indicated by small arrows. Interstate 70 roughly parallels the axis of the Eagle River anticline (Figure 1) and is shown in the steeply dipping beds of the Eagle Valley formation in the foreground on the left (Lidke et al, 2002). The Eagle Valley Evaporite underlies the Eagle Valley formation at the base of the hillslopes (Figure 1). Photograph was taken on 4/17/00 from the right flank of basin F3 looking east.

created by the diapiric flow of evaporite (Widmann, 1997, Lidke et al., 2002) and is expressed in the dipping beds of the overlying formations (Figure 3). In contrast to the broadly deformed overlying sedimentary rocks, the Eagle Valley Evaporite is complexly folded and subject to a variety of phenomena including hydrocompaction, subsidence, landslides, debris flows and rockfalls (Widmann, 1997, Mock, 2002). Hillslopes in the study area are mantled with a thin (generally less than 3.3 yds (3 m) thick) colluvium composed of angular clasts of gravel to boulder size supported in a sandy silt or low plasticity sandy clay matrix (Mock, 2002).

to the North American Monsoon (Adams & Comrie, 1997, Soule, 1999, Coe et al., 2002, Coe et al., 2003, Godt & Coe, 2003). Along the 3.7 mi (6 km) stretch of I-70 between Dotsero and Gypsum about 20 recent debris-flow deposits were identified in April of 2000 (Figure 3).

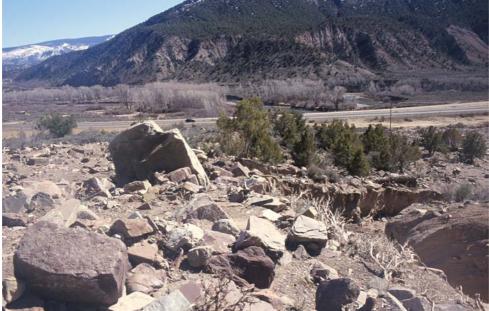
Figure 4. Photograph of the surface of fan F1 showing damaged vegetation, large boulder (~1.5 m in diameter), and newly incised gully (~3 m deep). Photograph taken on 4/12/00.

The presence and condition of vegetation evidenced the recency of deposition on fan surfaces. Fresh deposits were identified by the absence of small vegetation such as grasses and damage to larger plants, such as the stripping of leaves, indicated the recent passage of coarse debris (Figure 4). However, new deposition did not cover the entire fan surface often leaving some of the vegetation intact.

Recent debris-flow deposits were composed of angular, fresh, unstratified, poorly-sorted sediments (Figure 4) ranging in size from silt to boulders as large as 8.2 ft (2.5 m) in long dimension. No obvious landslide scars were observed on hillslopes in the basins in the study area indicating that the debris flows were likely generated by the mobilization of material from hillslopes and stream channels by overland flow of water (Johnson & Rodine, 1984, Coe et al., 2002, Godt & Coe, 2003). The transport of loose colluvium by overland flow concentrated into rills and gullies on hillslopes and in channels has been identified as a process that may generate debris flows in basins that are sparsely vegetated or have been recently burned by wildfire (e.g. Johnson & Rodine, 1984, Cannon et al., 2001, Coe et al., 2002).

Global Positioning System (GPS) techniques were used to survey 15 fans on which fresh material was deposited. Fan apices were identified in the field based on the abrupt change from the erosional surface of the drainage basins, to the depositional surface of the fans. The fan apex is spatially coincident with the drainage basin mouth (Figure 5). The location of drainage basin mouth/fan apex for a given basin may cover an area of a few square meters in the field. Additionally, many of the larger fans were incised up to 9.8 ft (3.0 m) near the apex of the fan (Figure 4). The fan apex point was surveyed on the fan surface, not in the newly incised channel.

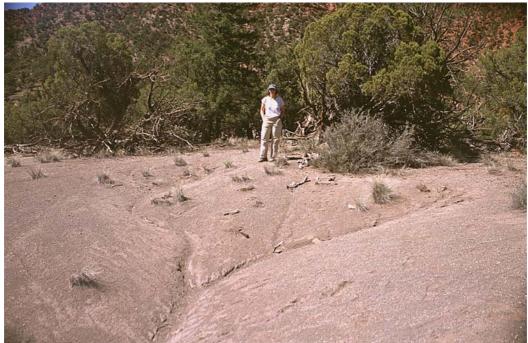
Figure 7. Rill network near the top of drainage basin F5 (Figure 1). Rill networks have developed on the moderate slopes near the drainage divides of several of the smaller basins.

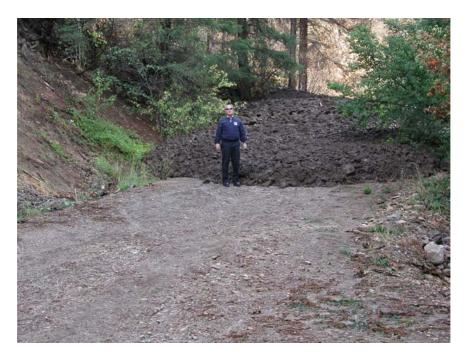
Figure 4. Debris-flow deposit produced during August 5, 2002, storm from Basin H, Coal Seam Fire.

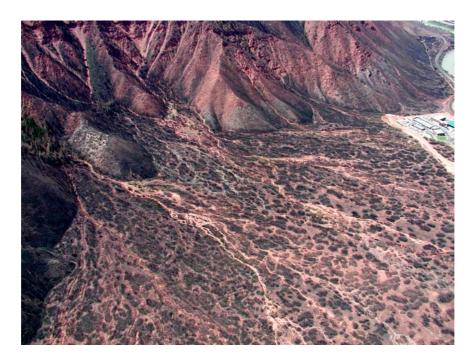
Figure 5. Debris-flow paths (lighter colored material) from the August 5, 2002, storm on the Red Mountain Fan. Buildings in upper right for scale.

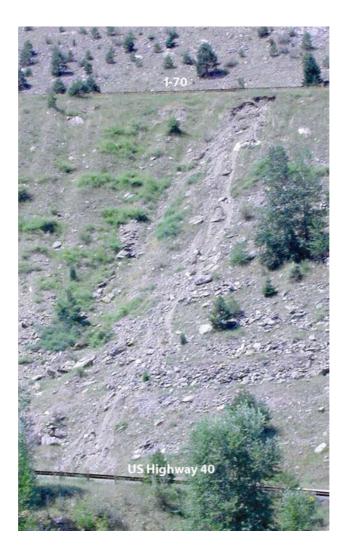
Figure 3. Debris flow along the north flank of I-70 at Floyd Hill. View is to the south. Photo taken August 4, 2000. See guard rails along I-70 and US Highway 40 for scale.

The historical debris-flow event located farthest east in Clear Creek County is on the north flank of Floyd Hill near mile marker 245 (Figures 1 and 3, Event 1 in Table 1). To our knowledge, this was the only debris flow triggered by a rainstorm in late July 2000. This debris flow initiated as a shallow landslide (also referred to as a soil slip, Campbell, 1975; also see Reid et al., 1988 and Iverson et al., 1997) in fill material beneath I-70 (Figure 3). Another debris flow occurred at Floyd Hill on July 8, 2001 (Event 2, Table 1). This debris flow deposited debris on the eastbound lane(s) of the highway.

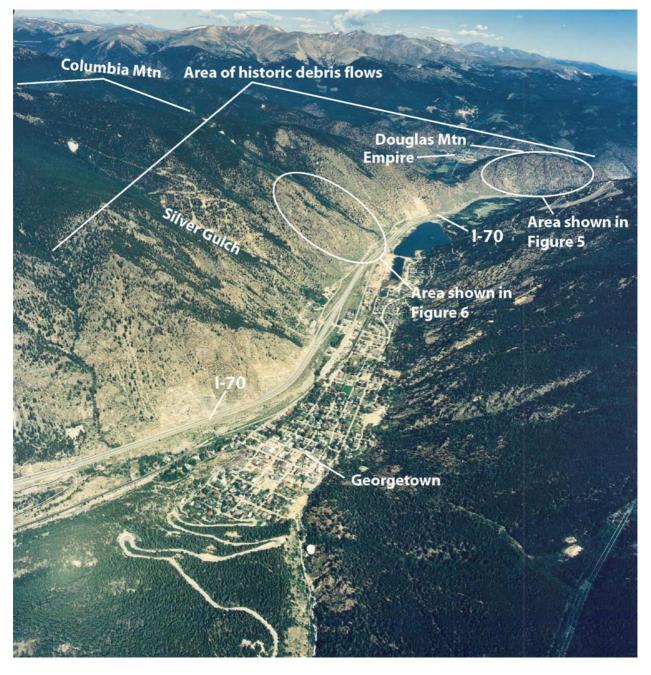
Figure 4. Oblique aerial photo showing historical debris-flow areas near Georgetown. U.S. Geological Survey photograph taken on August 18, 1999 by Intrasearch, Inc. View is to the north.

The most active debris-flow area along I-70 is on the north side of the highway between the US Highway 40/I-70 junction and Georgetown along the southern and eastern flanks of Douglas, Columbia, and Democrat Mountains (Figures 1, 4-6, Events 5-11 in Table 1). The valley in this area has been glaciated and is U-shaped with small and steep tributary basins (Figure 4). Tributary basins in this area tend to have Melton's Numbers greater than 1, are sparsely vegetated, and are dominated by bedrock slopes in their upper portions and fan aprons in their lower portions. The mean recurrence interval between recent debris-flow events in this area is about 7 yrs or less (Coe et al., in press).

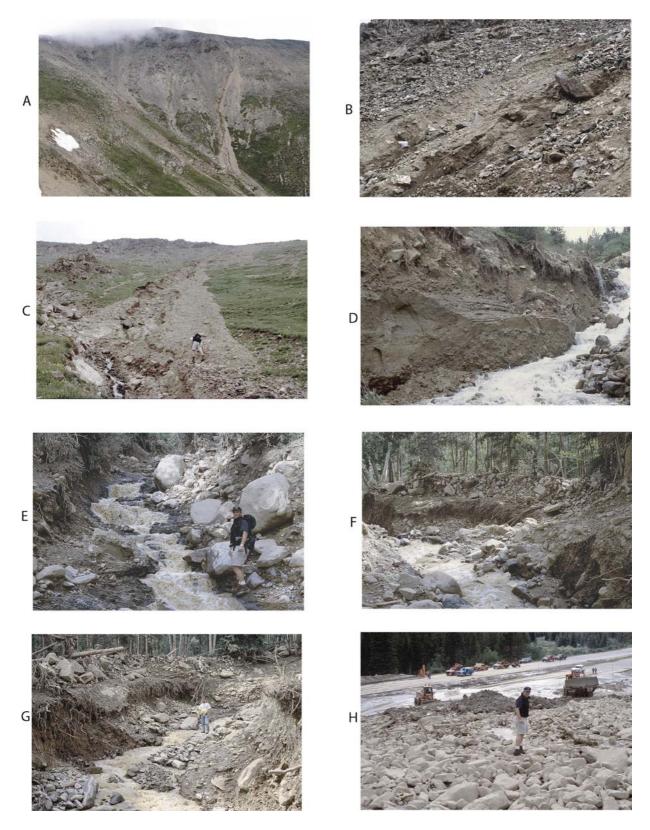
Figure 10. Photographs of Watrous Gulch taken after the July 28, 1999, debris-flow event. A) Rills in the source area. View to the east. Relief visible is about 610 m (2,000 ft).

Figure 10 – continued. B) Head of the largest rill in the source area (see quart-sized sample bag at lower left for scale). View to the north. C) View upstream along the largest rill. Note geologist for scale. D) Deposits exposed by the July 1999 debris-flow event located about half way between the head of the largest rill and the fan. Channel is about 3 m deep. Matrix-supported boulder-rich deposit on top, sorted, stratified, silt-rich deposit at base. View to the northwest. E) Bedrock-lined channel exposed by the July 1999 debris flow. F) Matrix-supported levee deposits along a bend in the channel above the fan. View downstream to south. Channel depth (thalweg to top of levee) is about 4 m. G) Matrix-supported levee deposits along a bend in the channel above the fan. H) Fan on I-70. Photos A through D taken on August 4, 1999. Photos E through H taken July 29, 1999.

Figure 9. July 28, 1999 debris flows on the south flank of Mount Parnassus. A) Oblique aerial photo of Mount Parnassus. U.S.Geological Survey photograph taken on August 18, 1999 by Intrasearch, Inc. B) Debris-flow deposit on I-70 at the mouth of Watrous Gulch. See vehicles on I-70 for scale. Photo taken on July 29, 1999, by Ed Harp, U.S. Geological Survey. The flows on the south flank of Mount Parnassus that fed into Watrous Gulch initiated as large rills on steep, non-vegetated slopes above timberline (Figures 10a, b, and c). The matrix of

colluvium at the head of the largest rill included 84 percent sand-sized material, 8 percent siltsized material, and 8 percent clay-sized material (U.S. Geological Survey, 1999, unpublished data). Clasts made up about 50 percent of the colluvium. As the Watrous Gulch debris flow(s) progressed downslope, it eroded material from the channel. Parts of the channel were incised several meters by the flow (Figures 10d, e, f, g). Material eroded from the channel included deposits of layered sandy-silt (Figure 10d), as well as matrix-supported deposits containing subangular to sub-rounded boulders (Figure 10d). The matrix of the flow became finer-grained as it progressed downslope. The matrix of the deposit on I-70 (Figure 10h) included 69 percent sandsized material, 24 percent silt-sized material, and 7 percent clay-sized material. Clasts made up about 70 percent of the deposit on I-70 and were larger and more rounded than those in the colluvium at the source area (compare Figure 10b with Figure 10h).

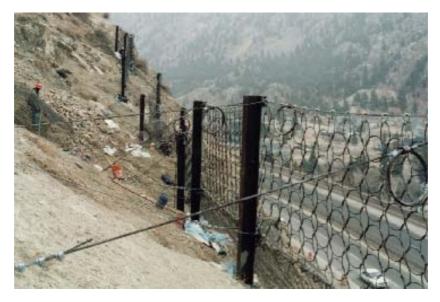
Figure 8. Rockfall fence located on the basis of CRSP analysis.

Following the evaluation, three fence systems were located near the areas of high rates of rockfall accidents. The systems installed were fences constructed with either cable net or ring nets (Figure 8). A 3-foot-high (1-m) gap was designed at the bottom of the fence to aid in clean out of the system. Draped cable net was attached above the gap to contain the fallen material and direct it to the roadside ditches. Although these systems will not completely eliminate the risk of rockfall at the selected locations, they will help minimize the potential of rocks reaching the highway.

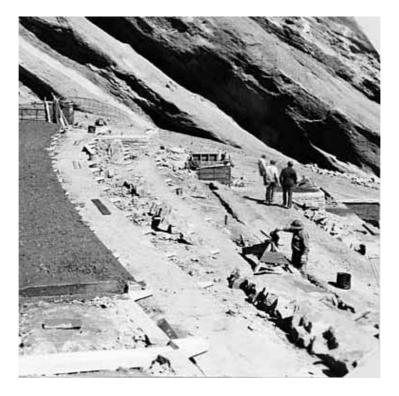
Figure 6. Concrete pour in the amphitheatre seating area (Image courtesy of DPL Western History Photo Gallery).

From Figure 5, it is evident that end-dumping was practiced at the top of the amphitheater where the new visitor center is located. Approximately 50,000 cubic ft of material was moved. Figure 6 depicts a concrete pour in the amphitheater seating area. The drainage gradient from north to south along the seating slabs is still functioning well today. However, the material underneath these slabs may be eroding.

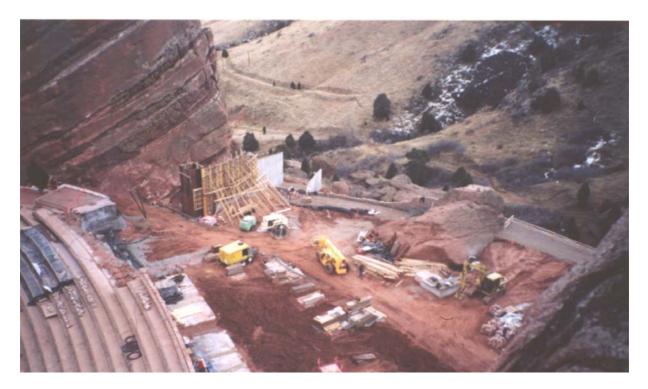
Figure 12. Soil nails were used to support the seating at the top of the amphitheatre during construction (Image courtesy of David Mashburn).

Permanent shoring was provided in the form of soil nails along the north and east side of the new visitor center (Figures 11 and 12). The maximum height and length of the soil nail wall was 33 ft and 450 ft, respectively. Along the north side of the excavation, soil nails from the concourse area were continued down slope. Number 8 bars were used in 4-in diameter holes in silty sand materials on a 5-ft horizontal by 5-ft vertical spacing. When weak rock instead of soil was encountered, the drill hole diameter was reduced to 3 inches and the bar size reduced to a #7 with 6-ft horizontal to 6-ft vertical spacing. Soil nails were eliminated when competent bedrock was encountered. The soil nail wall was directly connected to the structural wall of the Visitor Center, so no facing needed to be designed. Adjacent to the seating area, loose silty sand was encountered, requiring longer soil nail lengths to maintain the desired factor of safety. Additionally, the nails in this area were inclined 30 degrees downward in order to avoid intersecting the historic amphitheater seats.

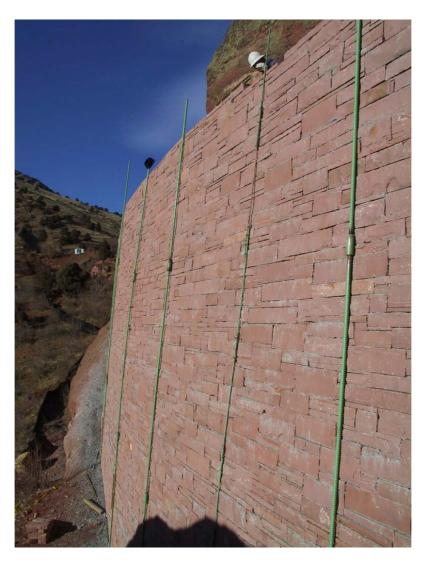
Figure 14. Construction of the MSE wall with Lyons sandstone facing that matches the pattern and blocks used in other areas of the historical amphitheatre (Image courtesy of David Mashburn).

The subsurface material below the MSE wall consisted of fill, colluvium, boulders, and sandstone bedrock. The boulders ranged from 12-in to greater than 30-ft in diameter. Several large boulders were trimmed along the south side of the MSE wall by blasting. Before construction, there was no available geotechnical information regarding the soil parameters of

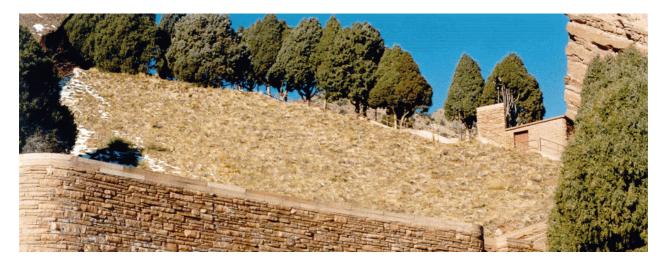
Figure 15. The south stairs of the amphitheatre and the slope that appeared to be moving before renovations.

The south part of the seating area was undergoing movement, which raised questions about the slope being a landslide (Figure 15). It appears that damage was being caused by settlement and movement of the fill, which was probably end-dumped into place as uncompacted material over 60 years ago during the original construction of the amphitheatre. Poor storm drainage had contributed to the problem, and large void areas had formed beneath the seats due to erosion and transport of the granular fill material (CGS, 1999).

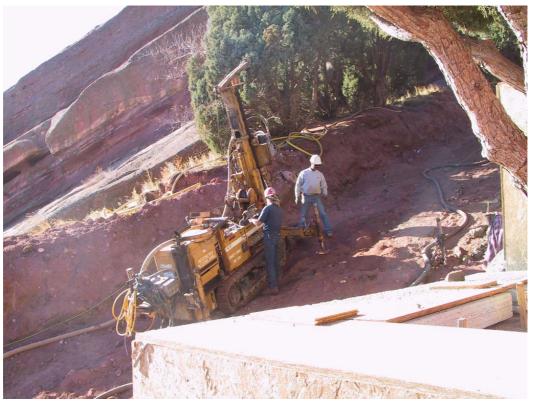
Figure 16. Compaction grouting was used to densify fill materials that may have been settling.

Compaction grouting was used to densify the loose fill (Figure 16). Borings were extended to bedrock ranging in depth from five to twenty ft, on a staggered 5-ft pattern in three rows following the imprint of the new stairs. Grout was pumped into the borings until either the grout pressure exceeded 400psi or more than 5 ft³ of grout was injected per 3-ft interval at a pressure of 100 psi or greater.

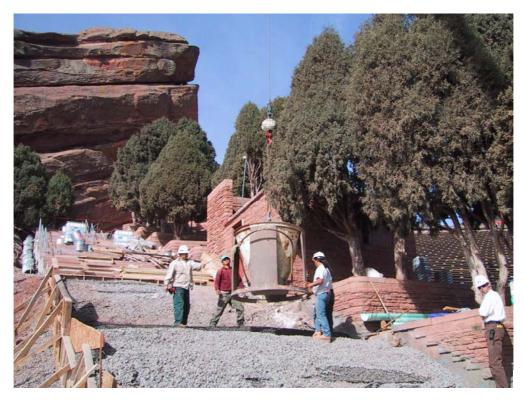
Figure 17. A reinforced soil slope was built as a platform for the new stairs and to assist in the potential instability of the slope below.

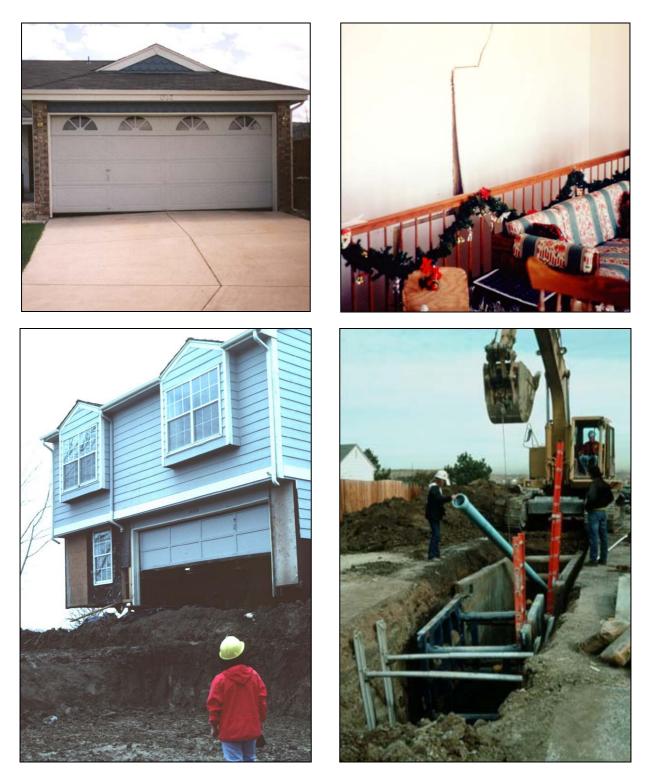
Figure 1. Examples of damage caused by expansive soil and bedrock. Top photos from Noe and others (1997).

Although many areas in the United States have expansive soil and bedrock, Colorado's semiarid climate and geology combine to make it one of the most severely affected. The volumetric heaving and settling caused by post-construction, swelling and shrinking of clay-bearing soil and bedrock constitutes Colorado's most costly geologic hazard. Expansive soil has caused varied levels of damage to pavements, driveways and sidewalks; building walls, floors, and foundations; and water and sewer lines in many parts of the state (Figure 1).

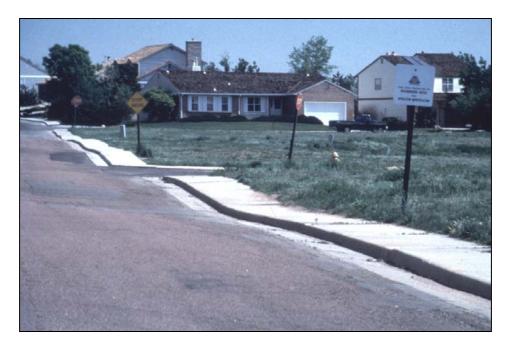
Figure 9. This "roller-coaster road" in Jefferson County, near Denver, is the result of uneven swelling and heaving of steeply dipping bedrock layers in the Pierre Shale. From Noe (1997).

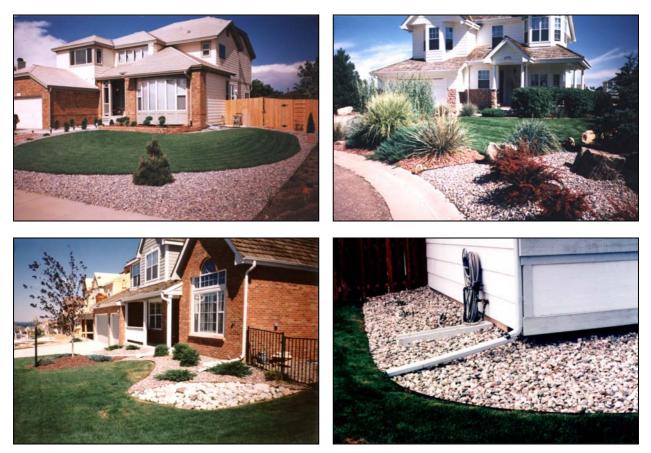
Figure 24. Examples of landscaping using mulch ground cover, where the central lawn area is accented by gravel edging. From Noe and others (1997).

Mulch ground covers are an important component of Xeriscaping, especially for areas of expansive soil. A mulch landscape consists of two parts, a geotextile fabric base and an overlying mulch cover. A good-quality geotextile fabric will control weeds and retard infiltration, but will still permit evaporation. The use of impermeable plastic sheeting is discouraged because it prevents normal evaporation from occurring. Mulches can be organic (bark, wood chips, etc.) or inorganic (boulders, cobbles, gravel, or crushed rock). An attractive, relatively low-maintenance landscape can be created by using gravel edgings, rock gardens, low-water ground cover, and a limited central area of lawn (Figure 24).

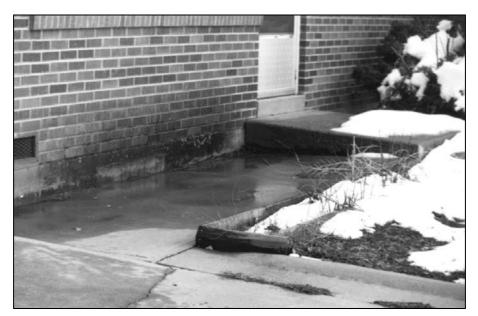
Figure 25. Settling of the backfill material has caused this sidewalk slab to settle and crack, resulting in reversed drainage and ponding next to the foundation. From Noe and others (1997); from Jochim (1987).

A critical aspect of surface drainage is maintaining a positive slope over the backfill area next to the building foundation. This material may settle enough to reverse or flatten the slope. Reverse or negative drainage will cause ponding and infiltration of water during precipitation or heavy irrigation. Regular maintenance involves maintaining the slope angle, re-compacting the surface soil, and sealing or replacing damaged concrete slabs (Figure 25).

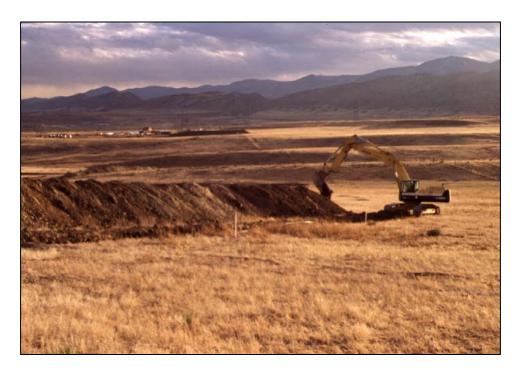
Figure 5. Trenching operation using a trackhoe.

Large trackhoe rigs are recommended for this type of trenching (Figure 5). Trackhoes have the advantage over smaller backhoes in that they can dig faster and deeper, and produce a wider trench. During the trenching operation, the project geologist and engineer should be present to determine the depth and cross-sectional shape of the trench (Figure 6). Trench sidewalls should be sloped or stepped according to OSHA safety regulations for trenches. Slot-type trenches with shoring supports have not been used, to the author's knowledge; however, it is possible this method could be used, provided that both safety and sidewall exposure and access are attained.

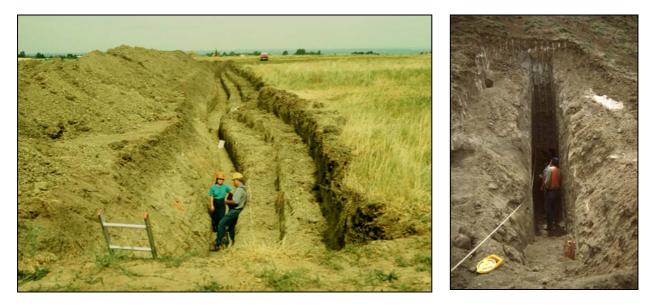
Figure 6. Examples of trenches in steeply dipping bedrock. The stepped trench (left) was dug with a backhoe and is safe for entry by geologists. The unsupported single-slot trench (right), dug by a backhoe, is unsafe for entry or sampling until it is properly shored.

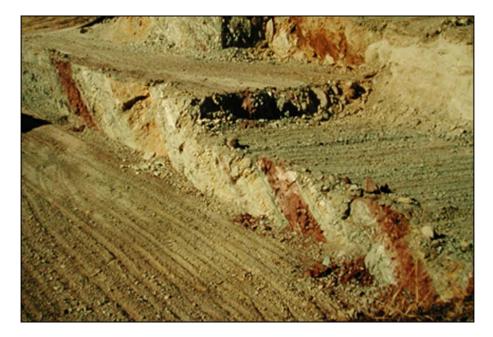
Figure 8. Steeply dipping beds of the Morrison Formation exposed in a basement excavation. Each of the bedding zones has a different composition and swell potential. From Noe and Dodson (1999).

Bedrock layers or zones – The bedding contacts of major bedrock layers or zones should be shown on the log, especially if there appear to be changes in lithology and swell properties (Figure 8). The continuity of bedding along the trench walls is shown graphically by drawing the beds on the log sheet. Each zone should be annotated with information about rock type, color, grain size, sedimentary structures and, if possible, an interpretation of the unit's mineral composition, material properties, and Unified Soil Classification. In particular, all bentonite beds should be logged as distinct units, even if they are less than 12 inches or 30.5 cm thick (Figure 9); such layers may cause dramatic ground heaving because of their very high swell potentials.

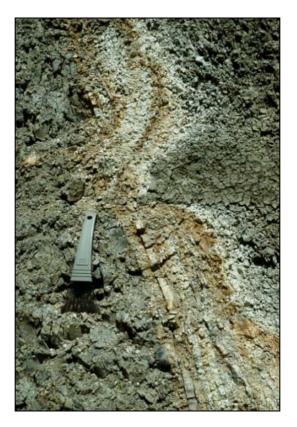
Figure 9. Steeply dipping bentonite bed of the Pierre Shale. This 12-inch (30.5-m) thick bed has caused over a foot of vertical heaving in a nearby road (see Gill et al., 1996). From Noe and Dodson (1999).

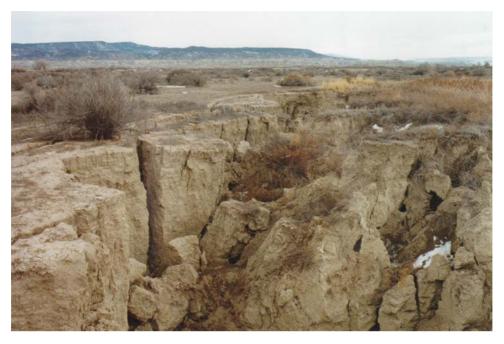
Figure 10. Soil dispersion and dissolution has created a pseudo-karst morphology near Loutsenhizer Arroyo near Montrose. Photo from White and Greenman, (in prep.) used by permission.

In the western Colorado plateau region, large broad valleys form where the thick Mancos Shale formation is the surficial bedrock unit. Prominent lowlands occur at Mancos Valley and Montezuma Valley near Cortez; the Grand and Uncompahgre Valleys that extend from the Utah border through Grand Junction and on to Montrose; and the broad White River Valley near Rangely. The surficial soils are formed from large broad mudflow alluvial fans, mud flats, and aggraded fine-grained alluvium eroded from shale badlands, now commonly gullied by tributary streams and arroyos. They can have high percentages of gypsum and alkali salts. Such very fine-grained soils in generally arid climates are prone to hydrocompaction and hydroconsolidation, dispersion, piping, and creation of voids and surface subsidence features that are collectively called pseudo-karst morphology (Figures 2 and 10).

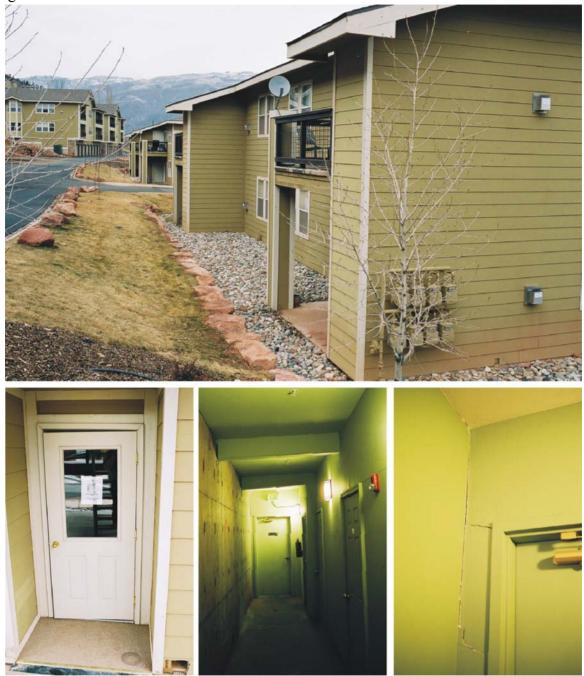
Figure 11. Distress of recently constructed townhomes (2001-2002) in Glenwood Springs. Note lack of roof rain gutters and nearly flat and poorly drained, rocked-in area below. Bottom left photo shows deflection of doorframe. Middle photo shows deflected beams above hallway as concrete retaining wall on left is settling. Photo on lower right is of doorway shown in middle photo with wall cracks forming as wall is being pulled down in relation to doorframe. Photos from White and Greenman (in prep.) used by permission.

Even today, with the knowledge of collapsible soils and the settlement damage that they can cause, inadequate foundation type and poor drainage design can result in significant damage. For example, a large complex of townhomes in Glenwood Springs that was just completed last summer (2002) is currently experiencing significant settlement damage (Figure 11). Even though the underlying soils were well known to be potentially hydrocompactive, these townhomes were built on standard spread footings (R. Grance, Glenwood Springs Building official, pers. comm.) with very poor positive drainage on the backside of the units and, astoundingly, no rain gutters and downspouts for the portion of the roofs that slope that way. As rain collects and flows to the roof edge, it falls as curtains of water, pooling and saturating the soils along the back of the units. Significant ground settlement and structural distress has now begun (and will continue without immediate landscaping and drainage improvements) that will require remedial foundation design and repair.

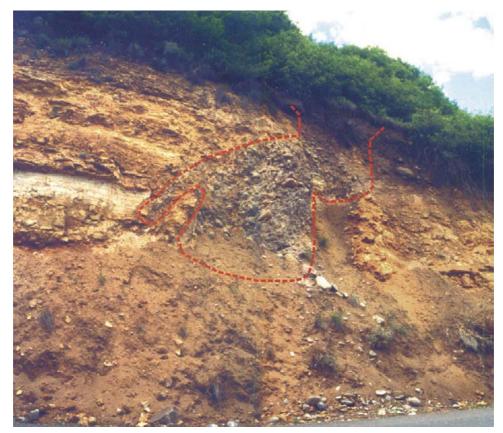
Figure 2. Roadway cutslope in mid-Pleistocene river terrace and evaporite rock has exposed dissolution slots and voids filled with gravel near Buford.

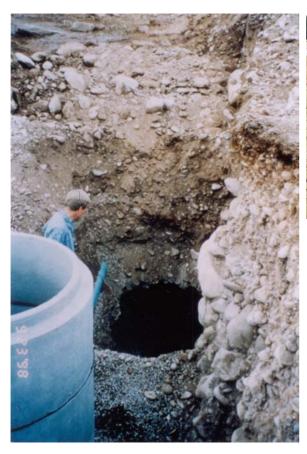
Figure 6. Photo on left is a void opened in river terrace gravels from utility excavation in the Roaring Fork Valley. Photo courtesy of Ralph Mock, Hepworth-Pawlak Geotechnical, used by permission. Photo on right is a sinkhole that opened in loess on a soccer field at Colorado Mountain College in February 2003. Maintenance staff has begun backfilling the crater.

sinkholes have been typically avoided during the planning process. Not all subsurface voids have visible evidence of subsidence at the ground surface, however. Rare spontaneous sinkholes occur and, occasionally, during utility trenching or overlot grading, subsurface holes are encountered that were unforeseen (Figure 6). Swarms of sinkholes lie in development areas and as residential density increases the probability of damage to a structure will rise. Figure 7 photos show the density at which sinkholes can occur in the Roaring Fork River valley and the proximity of sinkholes to existing developments. For more information about evaporite-related geologic hazards in this area, see the paper in this volume by Lovekin and Higgins (2003).

Where evaporite is exposed at the surface or underlies unconsolidated surficial deposits, karst features occur and there is potential risk that other features, currently hidden, could manifest themselves in the future. Dissolution of evaporite rock creates subsurface voids, chimney rubble and dissolution breccia zones, and fissures. Caverns, open fissures, ground depressions, and sinkholes occur at the surface, all of which can be of concern for development in the area. The hazard is probably greater in areas with higher sinkhole densities; however, future sinkholes may not be restricted to these areas. While spontaneous collapse and openings of subsurface voids can be dangerous and life threatening, such occurrences are relatively rare. They do occur, though. Figure 6 shows two such occurrences. One is a void that was encountered during utility

excavation in the Roaring Fork Valley. The other is a spontaneous sinkhole, 25 ft (7.6 m) wide and 20 ft (6.1 m) deep that recently opened at the Colorado Mountain College Soccer field where thick colluvial soils overlie evaporite rocks. More commonly, differential settlement subsidence and removal of fine-grained soils by piping into subsurface voids or fissures, with the resulting differential stress and strain to rigid structures, cause damage to facilities that are unknowingly constructed over or near sinkholes, subsidence troughs, or near-surface underground voids.

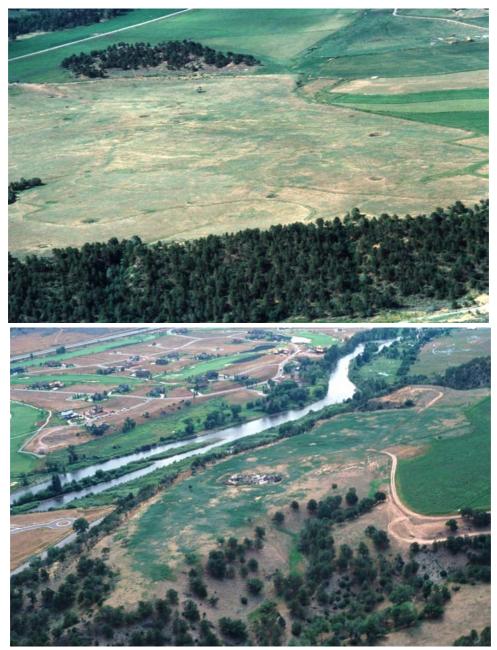
Figure 7. Swarm of sinkholes in upper photo on mid-Pleistocene terrace. Large sinkhole (full of trash) and smaller sinkholes in the lower photo are on the same terrace about one mile down valley. Note proximity of development on both sides of Roaring Fork River.

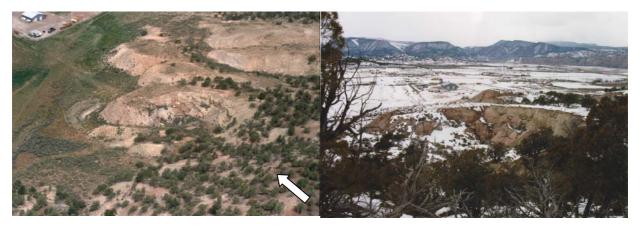
Figure 8. Large sinkhole near Town of Gypsum. Arrow shows view of photo on right. Eagle Country airport can be seen in right middle background of photo on right.

and Edwards have become bedroom communities and resort/second home destinations in their own right. Some of the largest sinkholes in Colorado occur in the Eagle River Basin (Figure 8).

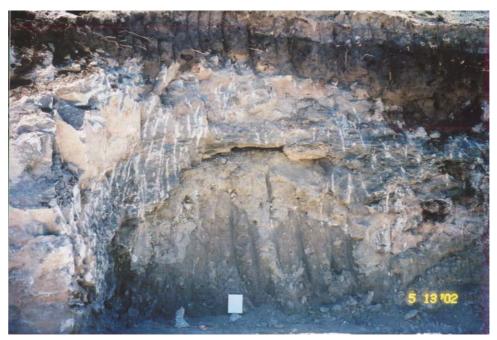
Figure 9. Home excavation revealing a clay in-filled cavern in massive gypsum. Note small void at top of in-fill, overlain by about 3 ft of gypsum roof below topsoil horizons. Photo courtesy of Steve Pawlak, Hepworth-Pawlak Geotechnical, used by permission.

Figure 9 is a photo of such a location where an in-filled cavern in massive gypsum was found during home excavation.

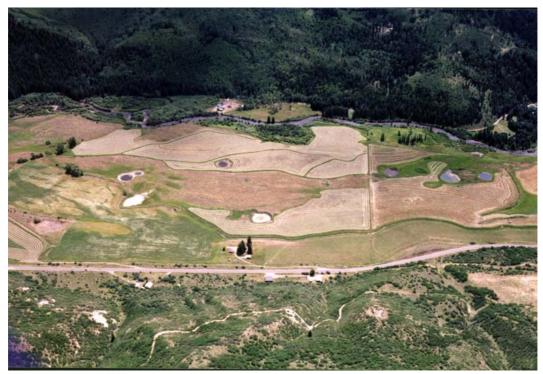
Figure 10. Sinkholes of Pot Hole Valley along the North Fork of the White River, east of Buford.

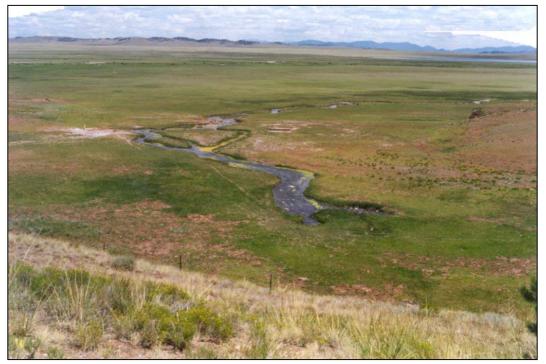
Figure 12. Salt Spring is a brackish subterranean flow that re-emerges as a meandering stream in South Park. Antero Reservoir can be seen in right middle background.

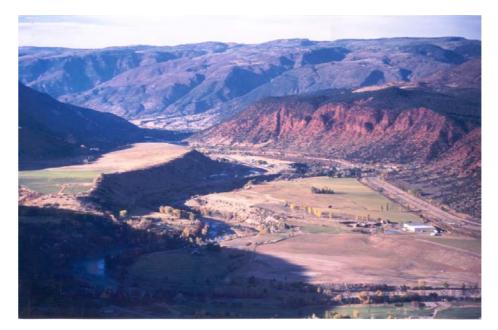
Figure 14. Deformed and tilted mid-Pleistocene terrace in the Roaring Fork Valley. Note tilt away from center of river valley. The top of this terrace is currently under residential development. White River Uplift is in background. Down valley is Glenwood Springs and confluence with Colorado River in middle background. Photo by R. Kirkham, CGS.

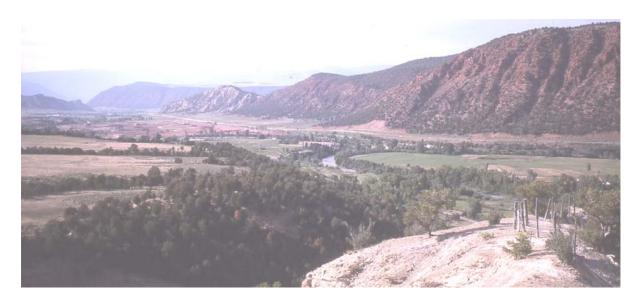
Figure 2. Typical topographic and geomorphic features of the study area. The Crystal River is in the foreground, its confluence with the Roaring Fork River is just right of center.

The study area location is shown on Figure 1. It includes a portion of the Roaring Fork and Crystal River valleys, including their confluence, and is within the Cattle Creek and Carbondale Quadrangles. It lies within the complex geologic transition between the Rocky Mountains and the Colorado Plateau. The surface geology reflects bedrock structure from salt and evaporite intrusions and dissolution (Kirkham and Widmann, 1997). Also, processes of erosion and deposition have formed steep bedrock slopes bounding the river valley and various gravity and alluvial surficial deposits. Topographically the area includes river valleys, tributary drainageways, river and outwash terrace landforms, and steep valley slopes with associated debris fans and rock rubble at the base of these slopes as shown on Figure 2.

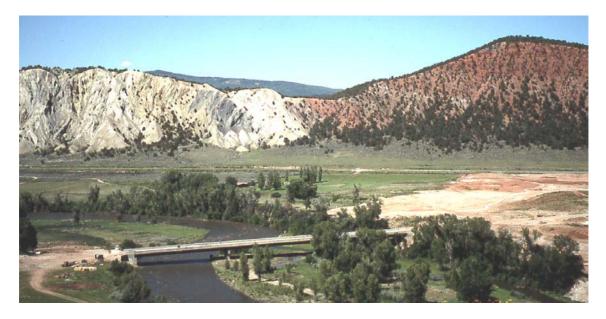
Figure 3. Contacts between Eagle Valley Evaporite, Eagle Valley Formation, and Maroon Formations (left to right). The Eagle Valley Evaporite is the white material on the left side of the picture. The Maroon Formation forms the red outcrop at the skyline on the right side of the picture and the Eagle Valley Formation is the material in between.

The Eagle Valley Evaporite, Eagle Valley Formation, and Maroon Formation underlie the valley alluvium and are exposed on steep slopes on either side of the valley as shown on Figure 3.

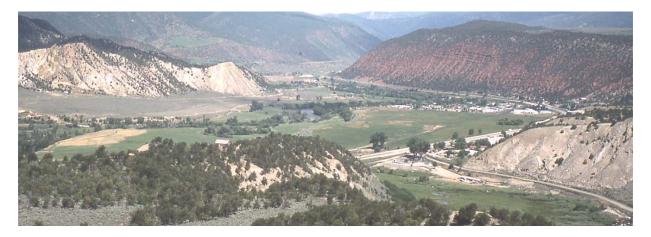
Figure 6. The Cattle Creek Anticline is located in the middle of the Roaring Fork River valley (middle background) where Cattle Creek enters the valley (right foreground).

The Roaring Fork River follows the easily erodible Eagle Valley Evaporite, which in the Cattle Creek Quadrangle is also the crest of the Cattle Creek anticline. A salt diapir exists beneath the valley at the junction of the Roaring Fork River and Cattle Creek as shown on Figure 6.

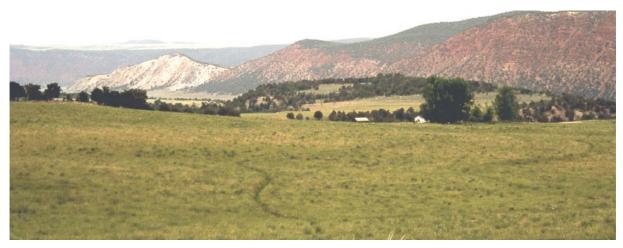
Figure 7. The surface of these alluvial terrace deposits reflect variations in dip of the deposits. In general, the dip is away from the center of the valley due to intrusion of evaporites, but undulations are likely due to dissolution.

Dissolution of Bedrock- Within the study area, subsidence thought to result from dissolution of evaporite bedrock can be observed regionally as well as locally. On a regional scale, subtle variations in dip of alluvial terraces overlying evaporite deposits can be observed. An example of this can be seen in the varying dip of the terrace deposits as reflected in the surface topography on Figure 7. This has been explained as the result of the intrusion of the underlying evaporites, and/or the dissolution of the evaporites. (Kirkam, et al, in press).
