EDITORS NOTES

Overview of the Geology of Colorado – Part II: Mineral and Mineral Fuel Resources, Water Resources and Water Quality, and Geologic Hazards - *David C. Noe, Vincent Matthews, III, and Ralf Topper* (This paper is derived from two copyrighted publications from the Colorado Geological Survey – Special Publications 52 and 53 – used with permission; use of this material is subject to the CGS copyrights)

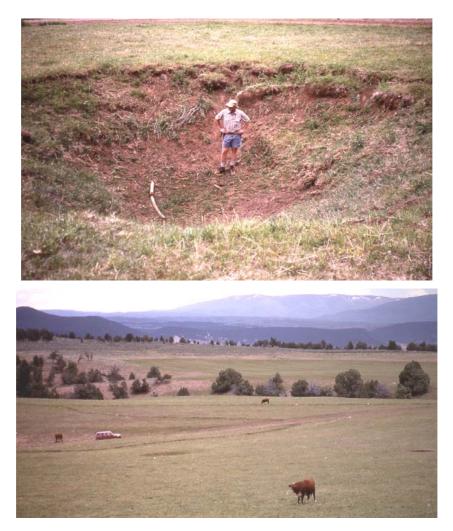
Figure 10. Collapsed sinkholes, seen as depressions in an alluvial terrace, have formed as a result of irrigation-induced dissolution of the underlying Eagle Valley Evaporite.

and the potato fields were abandoned to pasture. The heavy irrigation apparently percolated through the permeable terrace gravels and dissolved the underlying evaporite bedrock within a few to tens of years. The gravels subsequently collapsed into the voids left from dissolution and formed the various sizes of sinkholes illustrated on Figures 10 and 11.

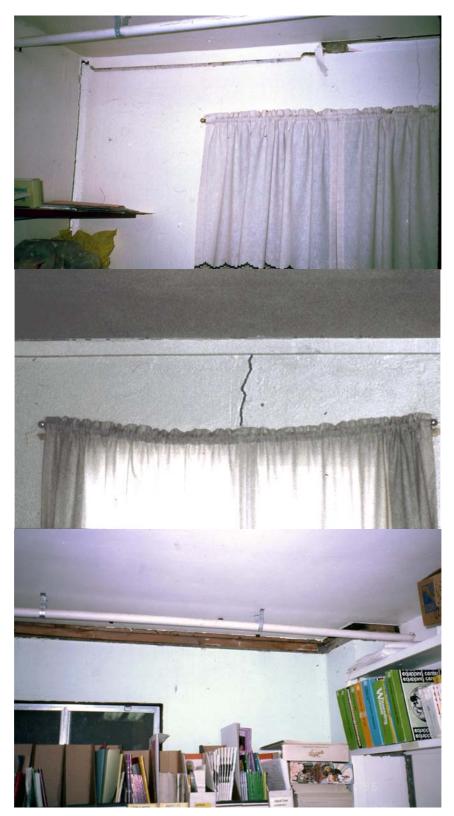
Figure 15. Structural damage showing both lateral and vertical movement within the church building.

The Mid Valley Baptist Church exemplifies problems that can be expected when structures are located on sediments derived from the Eagle Valley Evaporite. The church building is located on a small alluvial fan composed of gypsiferous and silty materials as shown on Figure 14. The fan is formed at the mouth of a small drainage that dissects the steep slope of the Eagle Valley Evaporite. The mouth of the drainage and apex of the fan is within about 25 ft (7.6 m) of the rear of the building. The building foundation was placed partially in this fan and partially on fill material that was derived from the same bedrock. Slowly, the building differentially settled resulting in severe structural damage that became obvious to even the casual observer. Figure 15 illustrates some of the damage.

When the authors first visited the property they were informed of the damage to the building (Pastor Roland Behnke, personal communication). The structure had settled a total of 20 3/8 in (51.8 cm) from north to south with the south portion of the building settling in relation to the north. Initially, the roof of the building was not guttered and all roof runoff affected the soil adjacent to the building. At one point the pastor took a shovel and was able to push the handle all the way into the honeycombed ground without resistance. Within the structure there was a 4 in (10.2 cm) vertical drift out of plumb over a distance of 10 ft (3.1 m). The floor was pulling away from the walls. The water line had completely rusted out.

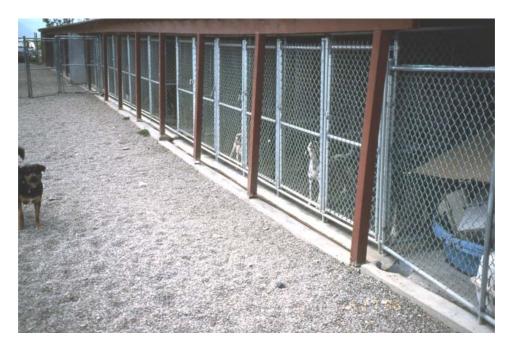
Figure 17. Differential settlement along expansion joints at the Mid Valley Kennels where daily hosing of kennels occurs. Flatwork is 1 year old in this photograph.

The Mid-Valley Kennels are located east of the church and cabin. Standard operating procedures are to hose down the kennels on a daily basis. The slab foundation, which was a year old at the time of our site visit, shows the effects of differential settlement along its expansion joints as shown on Figure 17. Below the kennels, in an area where much of the surface runoff collects, a small sinkhole continually opens up. This is in-filled with gravel on a regular basis. The area of the sinkhole is covered with gravel as shown on Figure 18. Also on Figure 18 is a house, located to the south of the kennel that experiences broken windows on a regular basis from settlement along one side.

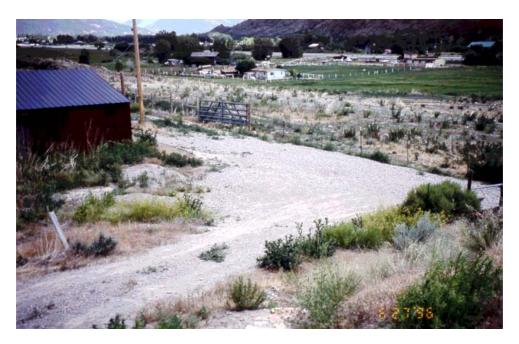
Figure 18. Re-occurring sinkhole in-filled with gravel below the kennels. The house in the middle distance experiences repeatedly broken windows from differential settlement.

Known weathering by-products of gypsiferous soils and bedrock include sulfuric acid and sulfates (Bell, 1981). These by-products are corrosive to Portland cement, concrete, and metals. When these materials are in contact with the soil, bedrock, and/or ground water, their service expectancy is typically shortened significantly. Individual homeowners describe extensive corrosion to their water-well systems that requires premature replacement after only some years of use. This includes the owners of the house shown on Figure 18 as well as the Mid Valley Baptist Church.

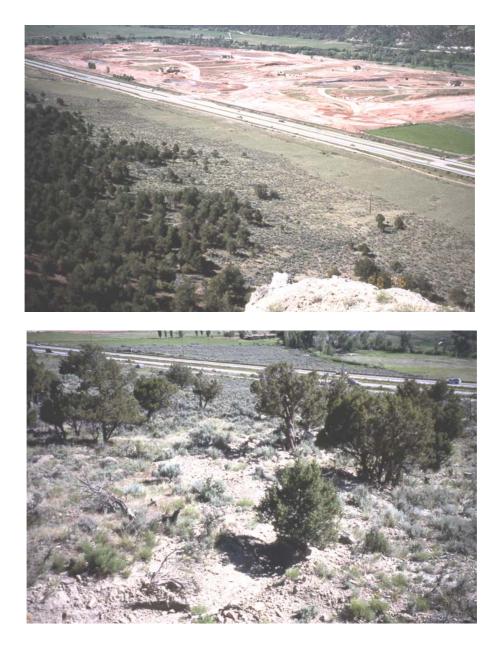
Figure 20. (A) Coalescing debris fans along the base of steep slopes. Note the vegetation change along the distal edge of fans. (B) Recent debris flow deposits on a fan.

Variation in material texture on the debris fans is illustrated on Figure 20A. The predominately coarse-grained fraction of the deposit extends from the channel mouth to the margin of evergreen foliage, and a dominately silty, well drained material extends to the edge of the sagebrush. Typical of debris flow deposits, the coarse-grained clasts are supported by a silty matrix. Running water carries additional silt farther down the fan. The rapid deposition and drainage of these deposits leaves a high void ratio, low-density structure in which clasts are supported by a dry silt and clay binder. This type of structure may be in a meta-stable condition in a semi-arid

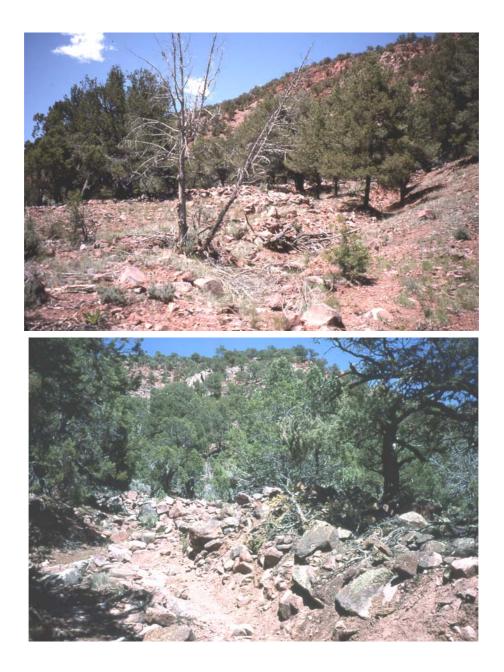
Figure 21. Recent debris flow deposits on upstream portion of a fan. (B) Debris flow natural levee near mouth of drainage and apex of fan.

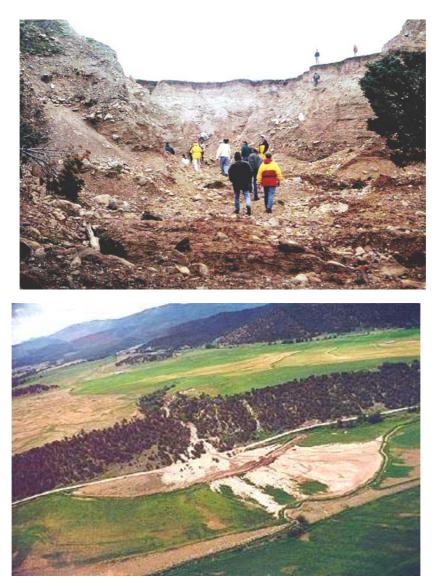
Figure 22(A) Landslide scarp in the steep slopes of an alluvial terrace (B) the resulting debris flow deposit. Figure 22(B) is by Jon White (CGS) and Robert Florez (CDOT Aerial Reconnaissance Group) and was used by permission.

irrigates it to maintain sufficient grass to support livestock in dry months. Individuals near the ranch reported that irrigation remained running much longer than normal on the area above the slope where the debris flow initiated. Examination of the scarp in the terrace slope face, shown on Figure 22(A), suggests that the debris flow initiated by a sudden slope failure of the gravels along the contact with bedrock. The resulting debris fan is shown on Figure 22(B). It is likely that the heavy irrigation, in combination with higher than normal precipitation, built up a high ground-water head in the gravels and initiated the sudden slope failure. Following the slope failure, the gravels rapidly dewatered and moved down the existing drainage as a debris flow. White (1998) described the incident in some detail and suggested a possible failure scenario. He estimated approximately 65,000 yd³ (49,696 m³) of material was involved in the slope failure and debris flow.

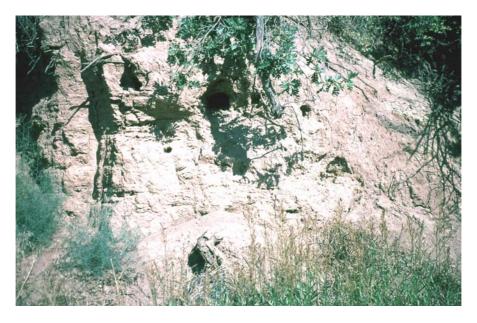
Figure 24. Piping derived voids in silty, surficial deposits.

Silt-rich deposits within the study area are known to erode by piping, as shown on Figure 24. Piping has been observed in colluvium, eolian (loess), and alluvial deposits in the area. It may be initiated by heavy irrigation or by ponding of water. Much of the piping damage observed was associated with human activity. Flow from heavily irrigated fields may percolate laterally in the subsurface and daylight in a road cut or hill slope at the edge of the field. Piping may also start in root holes or animal burrows. Several examples were observed of greatly enlarged pipes forming or multiple pipes coalescing and collapsing as shown on Figure 25. Typically this results in minor to moderate erosion damage. In a populated area, the opportunity exists for piping to occur under structures and to result in a potential collapse of the pipe and damage to the structure. Piping may be severe along leaking or ruptured water lines. In such settings, pipes can form and expand rapidly and result in very large voids that can undermine foundations.

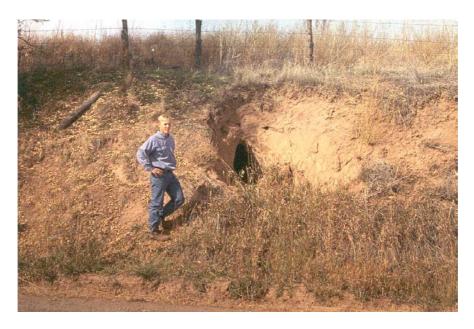
Figure 25. Piping erosion in slope below irrigated field.

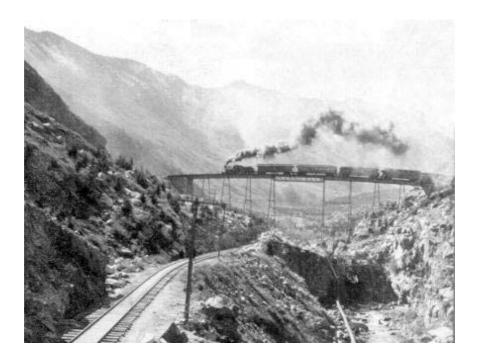
Figure 4. The Devil's Gate Viaduct above Georgetown was built 180 degrees backwards and did not fit the abutments properly. It was rebuilt in six weeks being completed January 23, 1884.

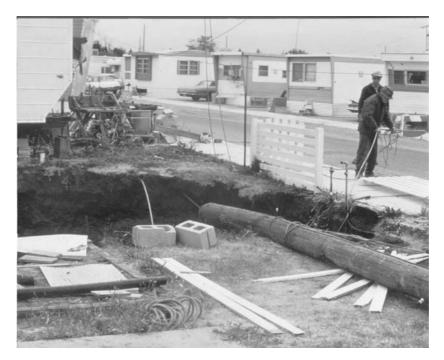
In dipping coal beds that have been mined, such as those along the foothills of the Front Range and in the Piceance Basin and near Newcastle, voids can migrate vertically and diagonally upward (updip) along the bedding surface, a process called stoping (Turney, 1985). Mine shafts present special problems. The shaft might represent open or discontinuously open space from the surface to the mined horizon. Shafts, including hoist shafts and ventilation shafts, are typically indicated on mine maps, but not always. Shafts might have been inexpertly closed by filling the void with debris, which can shift at some time in the future. Although small in area compared to an overall mine plan, shafts that have not been structurally sealed represent the greatest subsidence hazard (Figure 5).

Figure 5. Subsidence related to shaft opening in a trailer park.

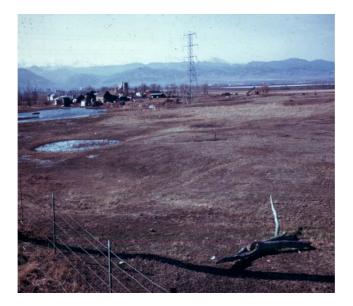
Figure 7. Sinkholes in the Marshall area.

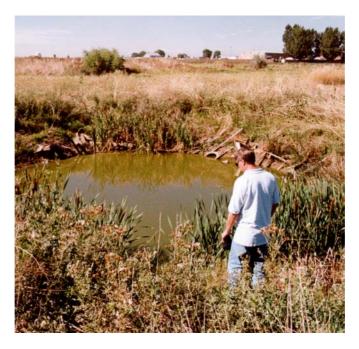
Figure 9. Sinkhole associated with the Shamrock mine, west of Frederick, Weld County.

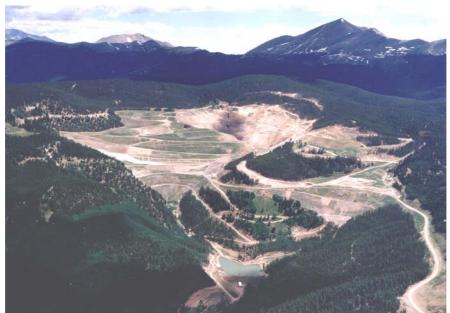
Figure 1. Photograph of North Pit looking north.

The North Pit currently extends from a maximum elevation of about 10,900 ft (3323 m) above mean sea level (amsl) at the east wall, to the level of the North Pit Lake at about 10,320 ft (3146 m) amsl. The North Pit has a maximum length of about 1200 ft (366 m) and a maximum width of about 1000 ft (305 m). It is comprised of the east wall, north wall, south wall, west wall, and the northeast corner. A shallow pit lake (North Pit Lake) currently occupies the bottom of the North Pit. Figure 1 is a photograph of the North Pit.

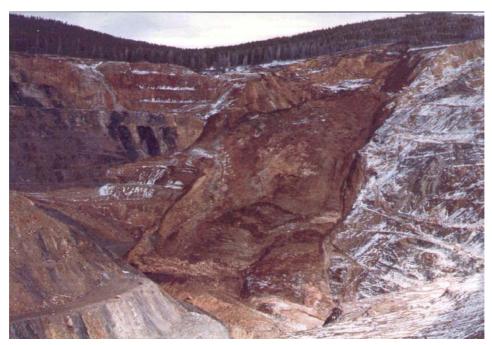
Figure 5. Northeast corner slope failure — October 1983.

Homestake began mining operations at the Pitch Mine in 1977. By 1979, excavation of the North Pit was underway. Raveling and minor slope failures began to occur in the shallow pit walls during the first year of excavation. The first slope failure on the east wall occurred in March 1980. This was a bench-scale failure. In March 1983, a large-scale, rapid slope failure occurred in the northeast corner of the east wall. Figure 4 is an historic photograph of the March 1983 slope failure. In October 1983, a second large-scale, rapid slope failure occurred in the northeast corner of the east wall. The October 1983 failure involved about twice the volume of the March 1983 event. Figure 5 is an historic photograph of the October 1983 slope failure.

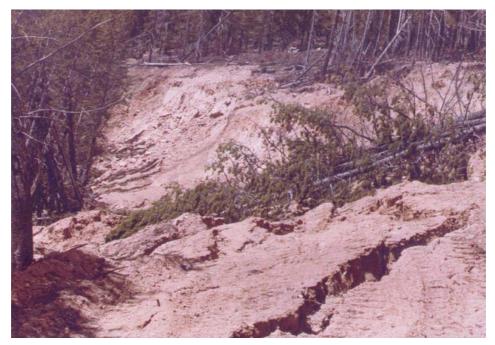
Figure 6. East wall headscarp following the March 1983 northeast corner slope failure.

Figure 6 is a Homestake photograph of the headscarp taken after the March 1983 event. Figure 7 is a photograph from a similar perspective that was taken after the October 1983 event. Comparison of these photographs reveals the magnitude of displacement at the headscarp initiated by the two 1983 slope failures.

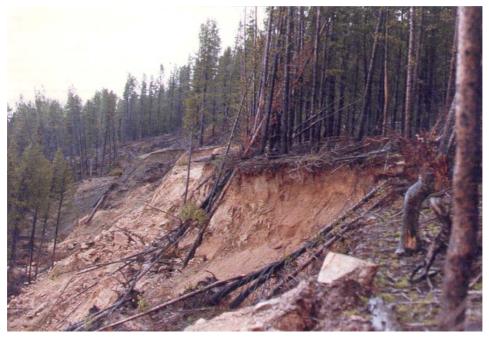
Figure 7. East wall headscarp following the October 1983 northeast corner slope failure.

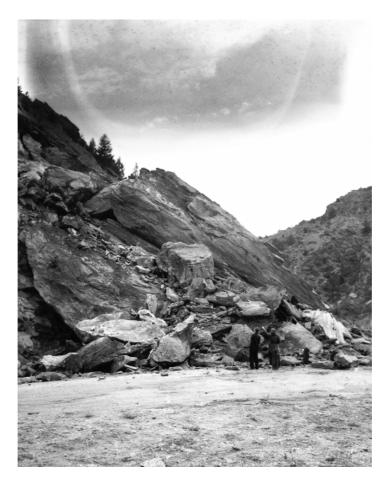
Figure 2. View of Floyd Hill Landslide.

Figure 2 shows the Floyd Hill Landslide in May 1947 when approximately 35,000 cubic yards of material closed US Highway 6.
