Guide to the Geology of the Glenwood Springs Area, Garfield County, Colorado

**Earth Science Week Field Trip
October 13, 2000**

**COLORADO GEOLOGICAL SURVEY
DIVISION OF MINERALS AND GEOLOGY
DEPARTMENT OF NATURAL RESOURCES
DENVER, COLORADO / 2000**

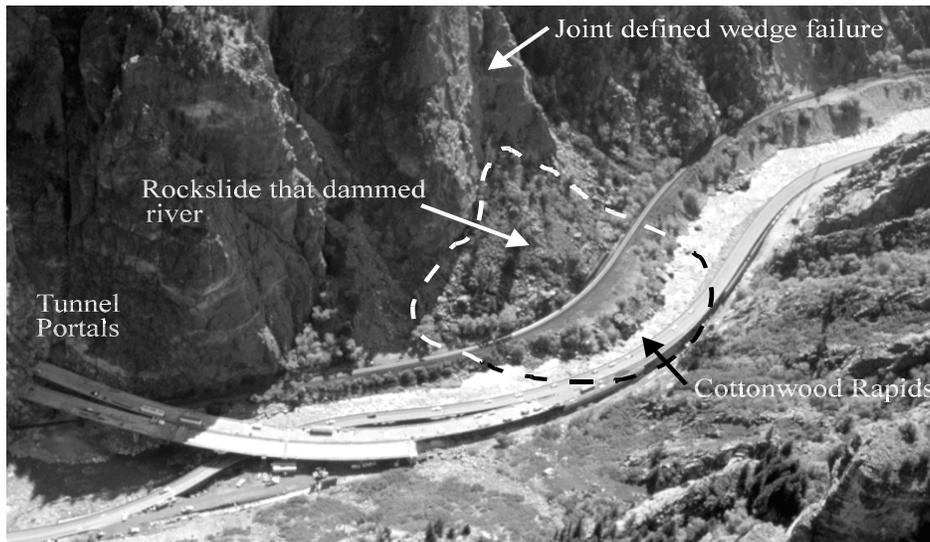
Figure 1: Cottonwood Falls. Location of Late Pleistocene rockslide that dammed the Colorado River in Glenwood Canyon (photo by J.L. White).

A major contribution to the aggradation of the canyon floor was a rock slide that occurred near the Hanging Lake Rest Area in a narrow portion of the canyon (Figure 1). Investigative borings indicated that many areas within the canyon have Holocene sediments over 200 feet thick. Borings also revealed that a massive rockslide completely dammed the river, formed a lake, thereby creating lacustrine deposits of soft compressible silts and clays 60 feet in thickness, referred to earlier as the Gray Layer. On the canyon walls mass wasting of the steep cliffs created thick aprons of talus (rockfall deposits) that interfingered with earlier and later rising alluvial deposits.

Figure 1 shows the location of the huge rockslide that filled the canyon floor, dammed the river, and created the Cottonwood Falls seen today.

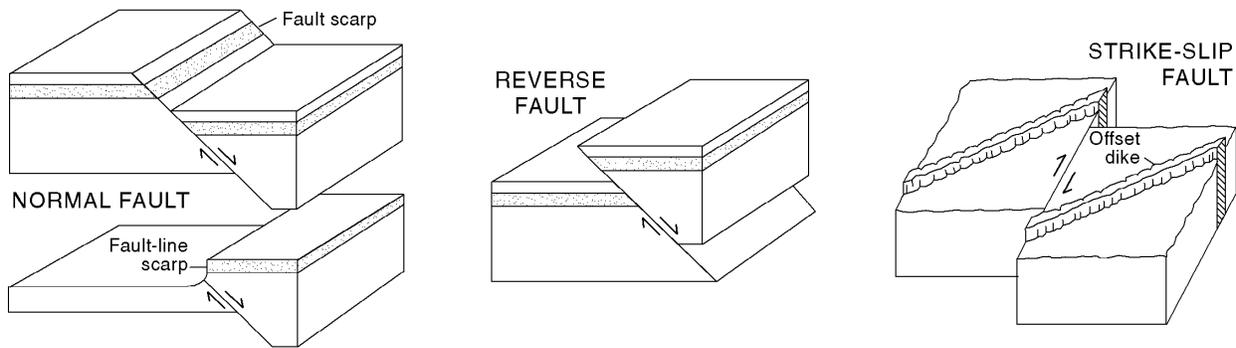
Figure 2: Types of faults (from Cvancara, 1995).

The No Name Fault is a normal fault. A normal fault is one in which the block above the fault has moved down relative to the block beneath it. The term “relative to” is used because the upper block may have moved down, the lower block may have moved up, or both may have moved in opposite directions. Normal faults are caused by pulling apart or tensional stresses (Cvancara, 1995). Other types of faults are shown in Figure 2.

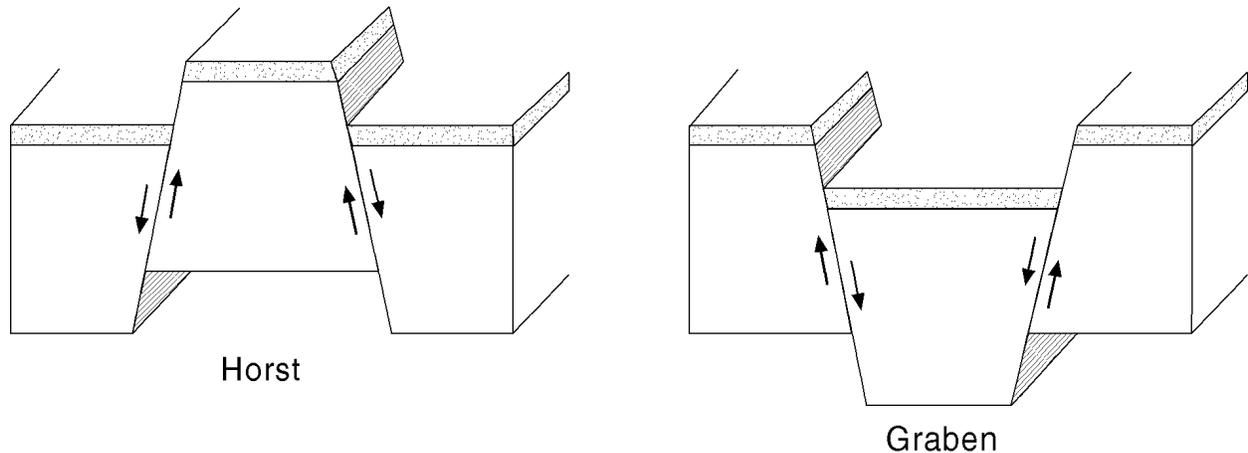
Figure 3: Horst and graben (from Frankie and others, 1998).

The No Name Fault forms the southwest limb of the No Name Graben. Two normal faults that dip toward one another produce a down-dropped block or graben. Normal faults often occur in groups and form a series of grabens with intervening high, linear plateaus or mountains, called horsts (Figure 3).

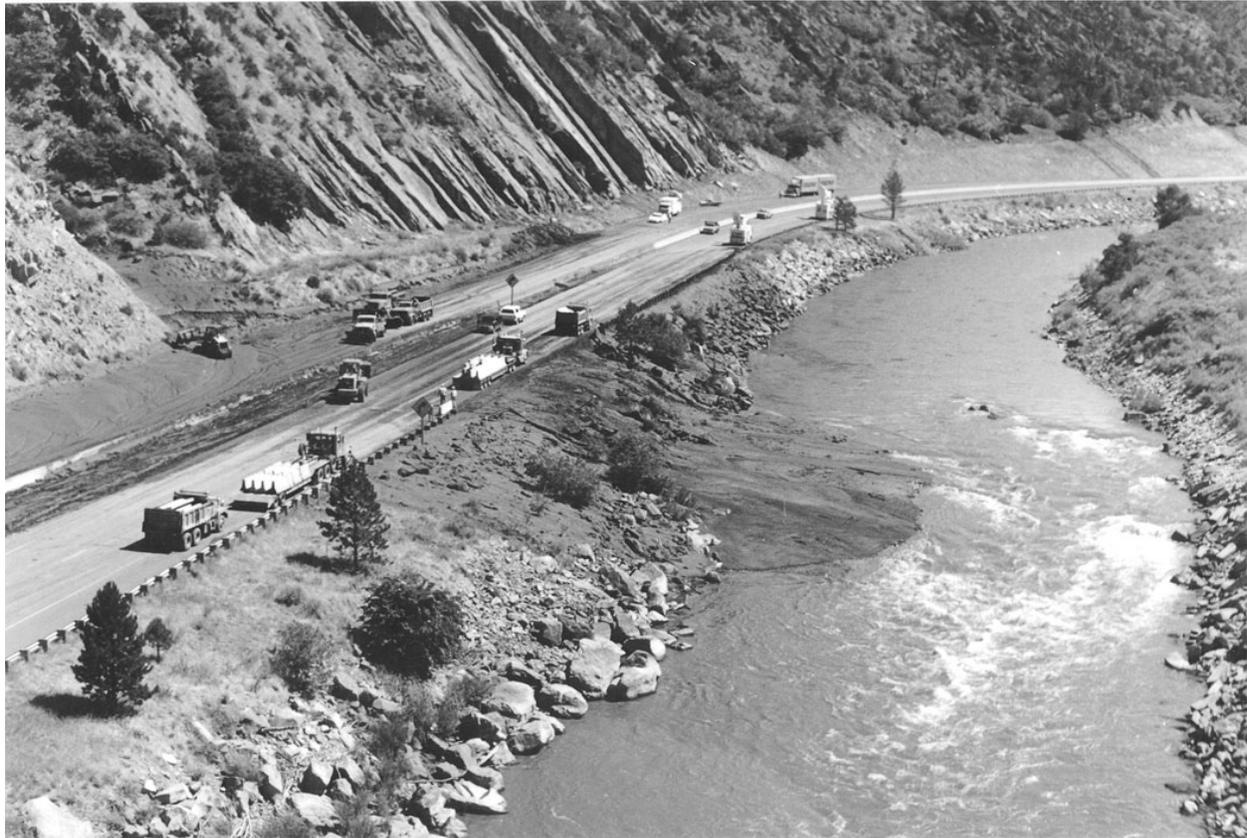
Figure 4: Debris flow on Storm King Mountain (photo by J. Scheidt, Bureau of Land Management).

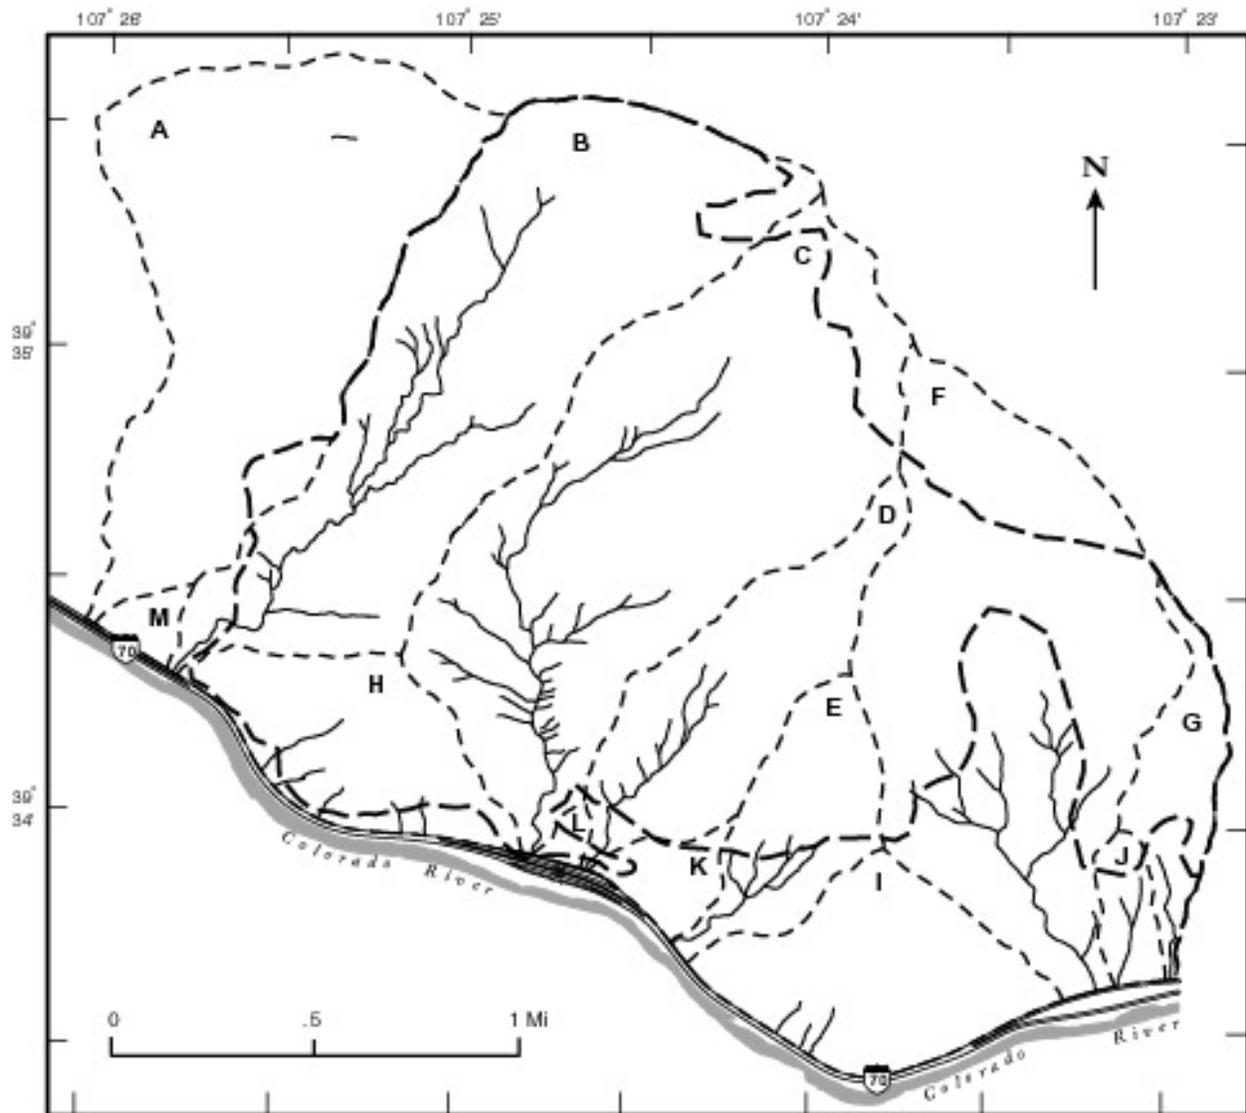
Figure 5: Drainage basins, extent of burned area and debris-flow paths on the south flank of Storm King Mountain. Drainage basins are labeled A through M and delineated by thin dashed lines. The heavy dashed lines mark the extent of the South Canyon fire of July 1994. Paths of the debris flows that occurred on September 1, 1994 are shown by solid lines.

Although the burn area was aerielly seeded in November 1994, additional debris flows poured out of Basin F during 1995 (Figure 5). The revegetation effort was very successful on gentle slopes where the original soil profiles were preserved, but steep slopes are revegetating poorly due to absence of productive soil horizons and removal of seed by sheetwash during rainstorms prior to sprouting. On a positive note, burned oakbrush is rapidly developing new shoots which “sucker up” from roots. Abundant unconsolidated materials remain within these basins and will be susceptible to mobilization during future storm events. A few small landslides have moved

An interesting way in which to mitigate the flood hazards was clearly demonstrated during the flooding. Sediment-laden waters ran out of Basins C and D (Figure 5), spilling out onto the entrance and exit ramps at the South Canyon exit on I-70. Debris then flowed down the ramps towards the underpass beneath I-70. The underpass provided a pathway for the debris to flow on to the Colorado River without interfering with traffic on the highway, effectively mitigating the hazard to the highway.

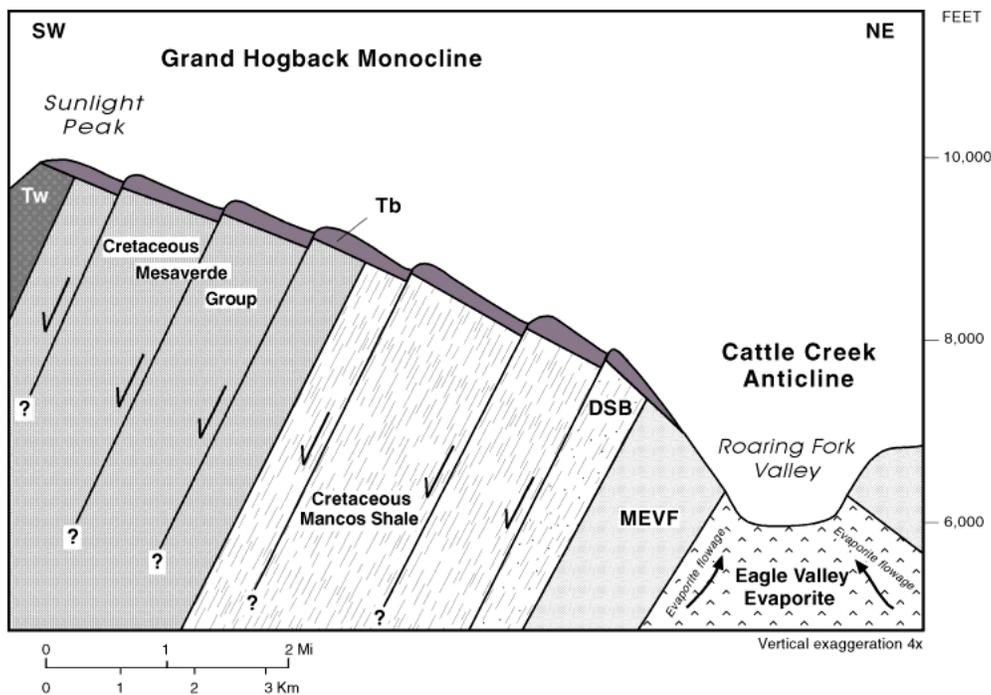
Figure 6: Grand Hogback Monocline.

The Grand Hogback Monocline separates the Piceance Basin from the White River Uplift. There is over 20,000 feet of structural relief across the monocline, most if not all of which occurred very late during the Laramide orogeny, probably in Middle to Late Eocene time. The lower Roaring Fork Valley coincides with the axis of the Cattle Creek Anticline from Glenwood Springs to about Carbondale. The Cattle Creek Anticline appears to be a Laramide structure that has been modified by salt diapirism during the Tertiary. (See Stop 8 description for explanation of diapirism.) The Cattle Creek Anticline forms the upper limb of the Grand Hogback Monocline in the lower Roaring Fork Valley.

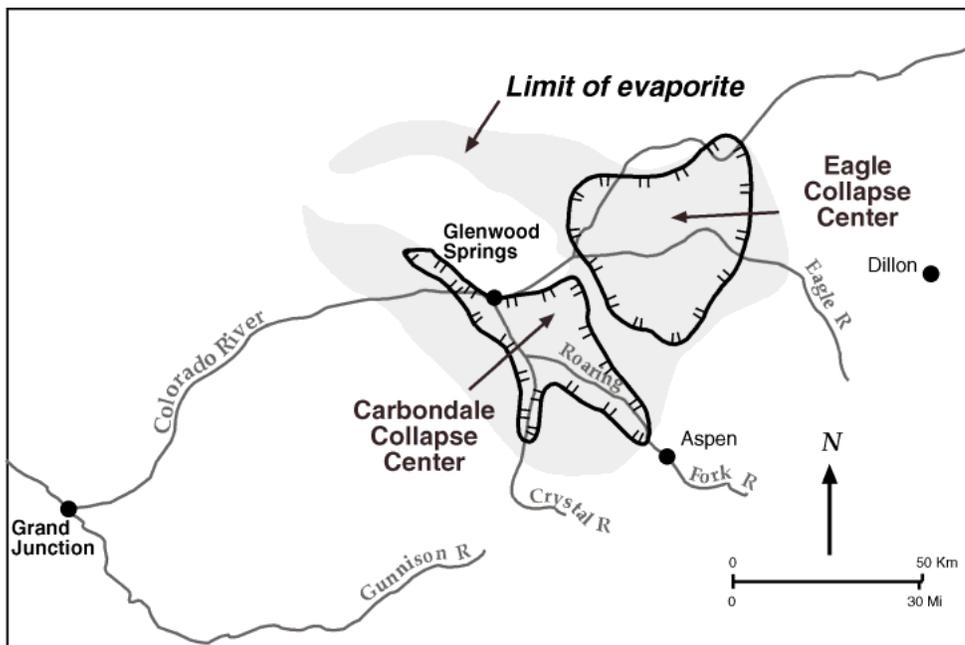
Figure 7: Carbondale and Eagle Valley collapse centers.

These unusual evaporite-related structures occur within a prominent regional topographic depression that lies within an area where evaporitic rocks are at or near the ground surface. The topographic depression is as much as 4,000 feet lower in elevation than surrounding terrain, and late Tertiary basalts are downdropped 3,000 to 4,000 feet within the collapse block. We interpret the topographic depression as a large collapse block that has resulted from dissolution and flowage of evaporitic rocks from beneath the area and have named this regional collapse feature the Carbondale collapse center (Figure 7). Based on preliminary geologic mapping in the Gypsum-Eagle area, another regional collapse feature, the Eagle collapse center, may exist in that area (Figure 7).

Geologists at the Colorado Geological Survey and the U.S. Geological Survey have developed a model called the salt-dissolution collapse theory to explain the regional collapse found here in Spring Valley and throughout the Glenwood Springs-Carbondale area (Figure 7). Evaporite flowage plays a major role in the model, but the ultimate way in which the evaporite is removed from the collapse area is by dissolution. The dissolved salts are then carried down the Colorado River. The process initiated as the Roaring Fork River downcut into rocks that overlie the evaporitic rocks, creating differential overburden loadings on the evaporite and causing it to flow from beneath the adjacent uplands towards the river valley. As the evaporite thickness diminished when it flowed out from beneath the uplands, deposits overlying the evaporite slowly dropped downward. When the low-density evaporitic rocks reached the valleys they rose upward, piercing into and/or doming overlying rocks and surficial deposits. (See Stop 8 description for explanation of diapirism and piercing.) Wherever fresh ground water encountered the evaporite it was dissolved, creating caverns into which younger, overlying materials subsided.

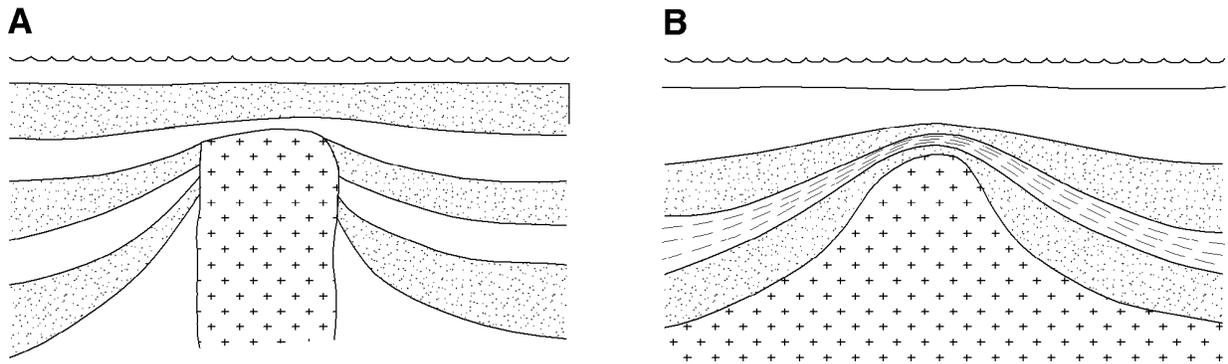
Figure 8: (A) piercement and (B) nonpiercement diapirs (from Davis, 1984).

Salt intrusions are normally described as diapirs, domelike, pipelike, or pluglike intrusions that ascend hundreds to thousands of feet from their source bed(s) into and/or through the overlying sedimentary cover. “Diapir” means “to pierce,” and indeed many salt piercement diapirs literally intrude overlying sediments, as if the diapir had risen through a cylindrical hole. Diapirs that dome but do not actually puncture the overburden are called nonpiercement diapirs (Davis, 1984).

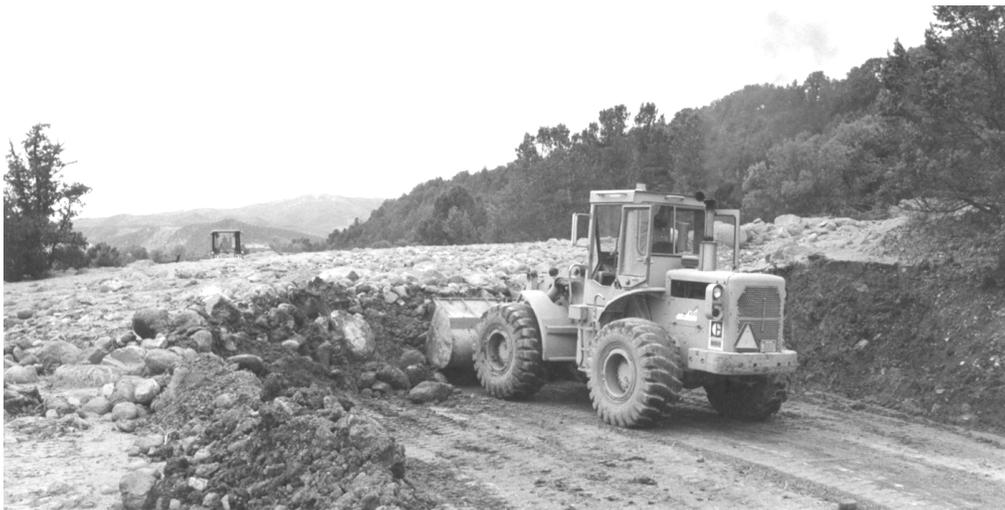
Figure 9: Clean-up of CR 109 after debris flow (photo by J.L. White).

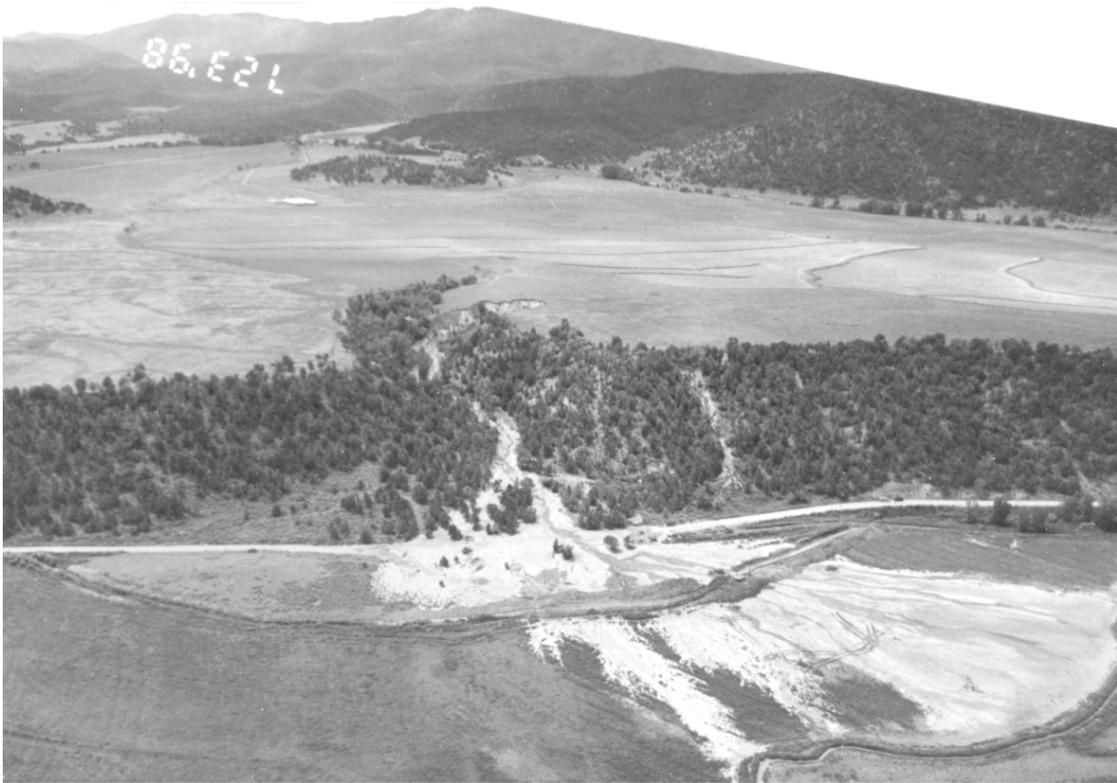
Figure 10: Oblique aerial photo of CR 109 debris flow (photo by CDOT Geology Unit).

It is likely that high perched ground water in the terrace above caused the failure within the existing basin. The same mechanism probably caused the small slip that exists about 300 feet to the northwest on the terrace scarp (Figures 10 and 11). This failure was likely a sloughing of saturated colluvial soils near the contact with the underlying Eagle Valley Evaporite on the terrace bank. Ground-water levels in the terrace gravels, by a combination of field irrigation exacerbated by higher than normal precipitation and infiltration, probably created perched ground-water conditions that may have rose to very near the ground surface of the above terrace. Likely the bank colluvial soils, being less permeable, were acting as an aquitard. Seepage occurred and as the bank soils became increasingly saturated, failed, and the more permeable gravels of the terrace were exposed. The high ground water perched within the terrace gravels mobilized and began to flow through the gravels, along the contact with the bedrock, towards the breach. Basically, the approximately 25 feet or more hydraulic head blew out the terrace bank at the contact with the underlying bedrock.

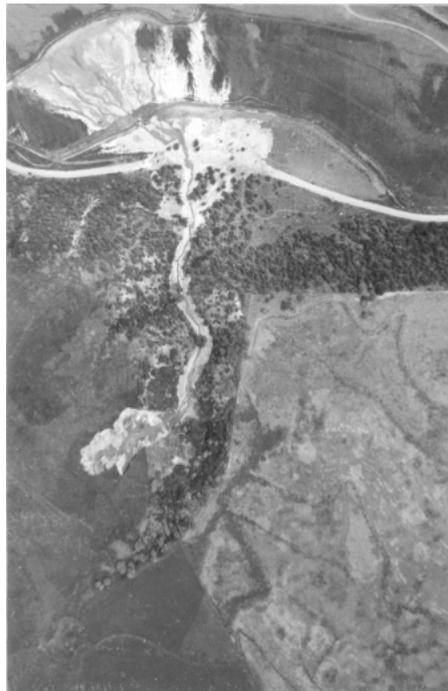
Figure 11: Aerial view of CR 109 debris flow (photo by CDOT Geology Unit).
