The San Juan Mountains of Southwest Colorado: Geology, Water Quality, Mine Remediation, and Avalanche Hazards

FIELD TRIP GUIDEBOOK OCTOBER 17, 2001

J. Andrew Gleason, Matthew A. Sares Rob Blair

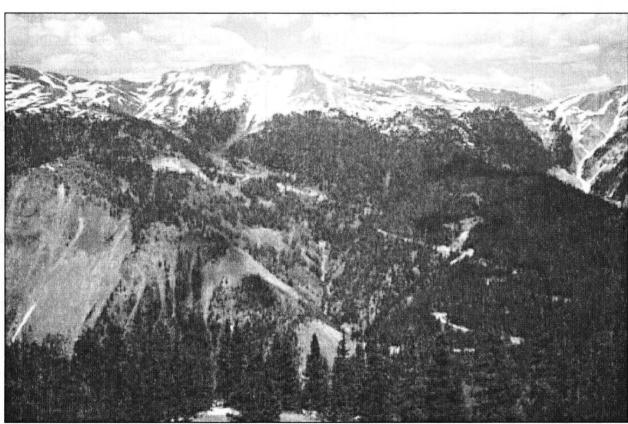
Browns Gulch area, Mineral Creek basin. View of west-central part of the Silverton Caldera.

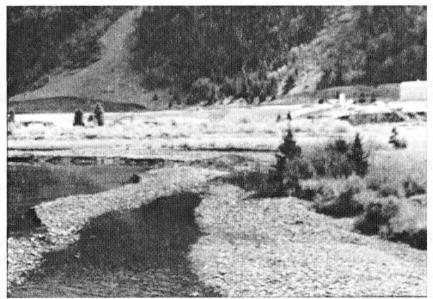
Tailings of the Pride of the West Mill (in distance) along the Animas River northwest of Silverton. Mill buildings are to left. (photo by William Simon)

The Silver Wing Company is working in conjunction with the Animas River Stakeholders Group to reopen the Pride of the West Mill. Old tailings piles and dumps from around the area will be reworked to extract metals. This will not only provide metals; it will aid in the cleanup of mineral-rich tailings piles in the region.

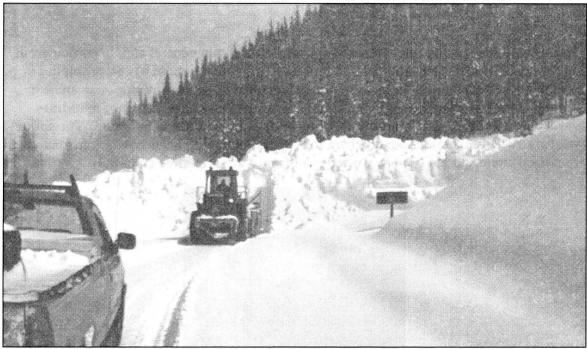
A 1998 avalanche deposits 18 feet of snow on State Highway 550 at Ophir Road.

- 68.0 **Roll By Battleship Slide** avalanche path is to the west. When it runs, it must flow uphill over 250 feet from South Mineral Creek to hit the highway.
- 68.8 **Roll By** The **Ophir Pass Road Avalanche Path** extends east of State Highway 550, at the intersection with the Ophir Pass road (County Road 8). In the spring of 1998, this avalanche put 18 ft of snow on the highway. Historically, snow had just barely reached the road. That spring brought at least a hundred-year slide to this avalanche path. Ten acres of trees were flattened by the slide as it ran down the track. Most of the trees dated to about 130 years old. The crown height of the avalanche was 20 ft in the upper part of the starting zone.

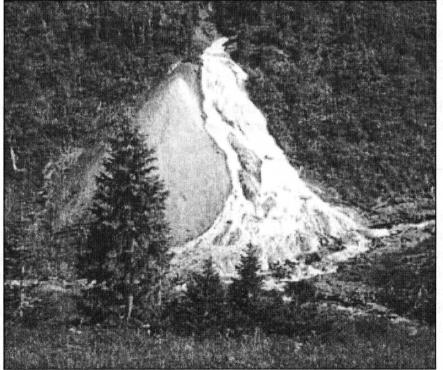
The Paradise Mine. Mine effluent precipitates aluminum hydroxide on the dump and in Middle Fork Mineral Creek (it's not snow!).

This stop provides one of the most spectacular views of acid mine drainage in Colorado. The mine effluent flows at 340 gpm, has a "milky" color, and leaves a white precipitate on the dump that is visible from the Ophir Pass road (County Road 8). In August 1995, the mine effluent had pH = 5.43 and had a very high conductivity = 1815 μ S/cm. Effluent from the portal area was sampled and lab analyses for dissolved constituents indicate that aluminum (7,200 μ g/L), iron (61,000 μ g/L), and manganese (4,600 μ g/L) exceed state standards for the adjacent downstream segment of Mineral Creek. The white precipitate is aluminum hydroxide that has dropped out of solution (dissolved phase). This sample was also high in calcium, magnesium, and sodium, which account for some of the high conductivity. The pH in Middle Fork drops from 7.34 above the Paradise Portal to 6.00 below the mine site. The mine appears to have been fairly small, so perhaps a natural subsurface watercourse was intercepted by the workings to obtain such a large effluent flow. If so, then the metal-laden water could be partially natural in occurrence.

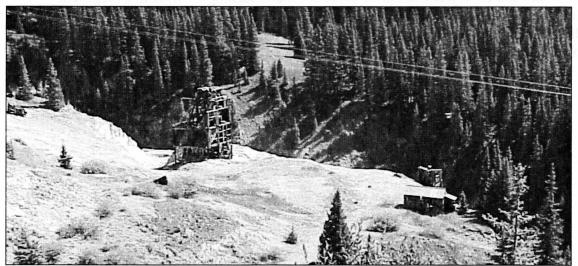
Silver Ledge Mine shaft house adjacent to Mineral Creek near Chattanooga.

- 77.5 **Roll By Silver Crown Mine** and avalanche path on west side of the "Chattanooga curve" in Mill Creek drainage.
- 77.8 **Roll By Silver Ledge Mine.** On your right you will see the shaft house of the Silver Ledge Mine.
