Open File Report 99-13

Active Surficial-Geologic Processes and Related Geologic Hazards in Georgetown, Clear Creek County, Colorado

By James M. Soule

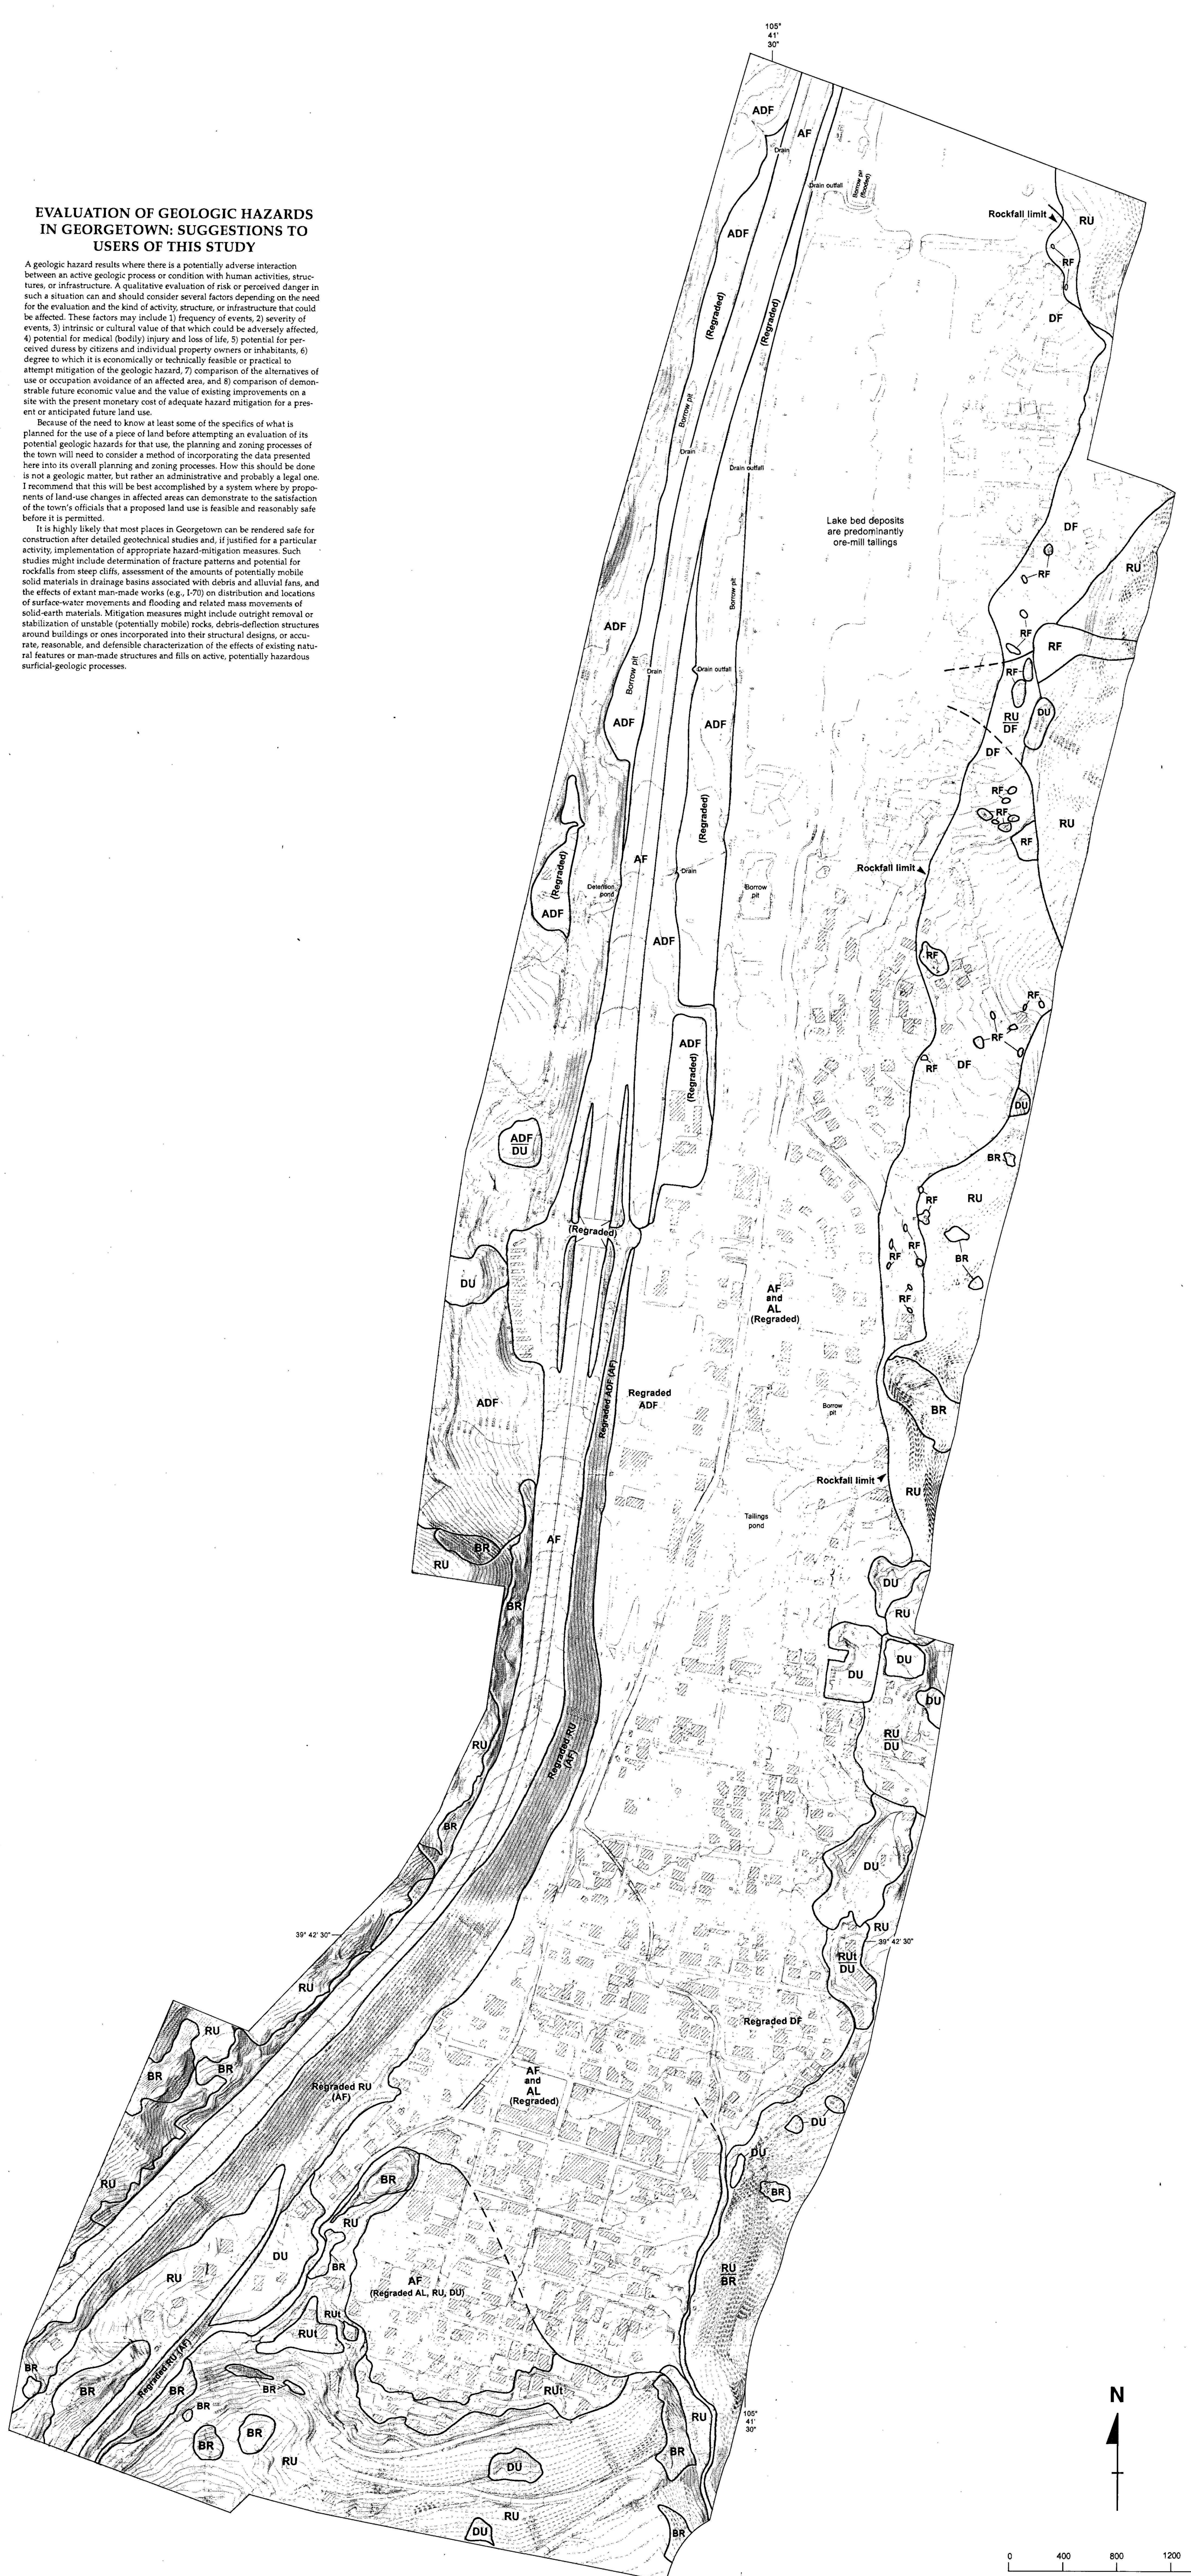
- BR** In Place Bedrock—Localities where bedrock is exposed or is within a foot or so of the surface. Most of the bedrock in the Georgetown area is composed of several high grade metamorphic-rock types with some smaller bodies of intrusive igneous rocks contained within them, most commonly pegmatites. As it would serve little purpose in identifying areas susceptible to active surficial geologic processes, no attempt was made in this study to differentiate bedrock by lithologic type. The most important relevant characteristic of the bedrock is that it is highly fractured by several sets of joints (fractures) on which there has been essentially no displacement. This condition can make steep exposures very unstable (i.e., prone to rockfalls) and greatly affects and accelerates rates of cliff disintegration and rubble accumulation on slopes. Most bedrock exposures grade at the surface to rubble deposits indicated below.

- RU** Rubble—Localities where rock fragments derived from underlying rock outcrop or nearby exposures predominate at the surface. These are steep areas where typically the bedrock is so fractured that it is virtually impossible to differentiate in-place materials from those which may in the Holocene (within the last 10,000 years-post glacial time) have moved a relatively short distance downslope from their source(s). Sizes and angularity of clasts in these areas can be highly variable and the sloping areas can be the source, particularly where vegetation is sparse, of the debris deposited on the debris and alluvial fans indicated below. On lesser slopes and especially in places where the modern vegetation cover is relatively dense, these areas, as discussed in the booklet, are apparently not particularly susceptible to slope movements, even in places where cuts have been made in them. This may be due, in part, to modern reforestation as old photographs suggest that slope movements in these areas were common and most likely frequent early in the history of the town.

- DF** Debris Fan—Localities on the east side of Clear Creek Valley that are subject to rapid mass movements (debris flows) of boundary debris derived ultimately from cliff disintegration and rockfalls from the steep, fractured cliffs above them. This debris is deposited in steep, rock-rubble-strewn chutes in drainages above the debris fans(s). The debris-flow events are thought to occur during short duration, very intense rainfall events, although, as opposed to the west side of Clear Creek valley, no such event in the history of the town has been documented. Larger rock blocks, some as large as automobiles, occur on these debris fans. Some of these larger rocks are the result of rockfalls (see below) onto the debris-fan deposits whereas others were incorporated into the debris-fan deposits during the debris-flow events that produced them. Where naturally in place, those transported by debris flows can be distinguished from fallen rocks by their surficial weathering patterns, positions with respect to pedogenic soils that surround them, their lithology and its position, and, where seen in the matrix that contains them, their sedimentologic relationships with smaller clasts near their source.

- AF** Artificial Fill—Human placed deposits. These occur in virtually all of the developed parts of the town. The composition and distribution of these materials is complex and cannot be determined with sufficient accuracy for conventional geologic mapping without detailed drilling and trenching which was not done as part of this study. Only the larger and easily recognized deposits are mapped or noted on the map. Most of these include the fills placed for the construction of 1970 and some other larger roads. The 1970 fills consist largely of materials organized in alluvial-debris fan/apron and rock rubble deposits indicated above and many of the other fills consist of rock rubble, waste rock from mine dumps, and moved and regraded debris-fan deposits and stream alluvium, especially from the alluvial-fan complexes at the south end of the town.

- Unit boundary—Dashed where uncertain

As the discussion in the booklet indicates, most of Georgetown's geologic hazards are related to mass earth movements and deposits of solid earth materials resulting from these movements. Virtually all of the resulting deposits have been subsequently man-modified during the past and current development of the town. This situation makes conventional geologic mapping of these deposits very difficult to impossible and conceptual as the natural boundaries of the affected areas have been mostly greatly modified or obliterated altogether. This is most problematical in all of the older parts of the town and in many places undergoing residential development at the present time. Also, the effects of existing major infrastructure (e.g., 1970 and other roads), regrades, and fill placements are virtually impossible to quantify and incorporate into mapping units that can be
