Rockfall in Colorado

Rockfall incidents will happen in Colorado, but in some cases rockfall can be avoided or mitigated. This issue of *RockTalk* covers the wide-ranging issues related to this geologic hazard.

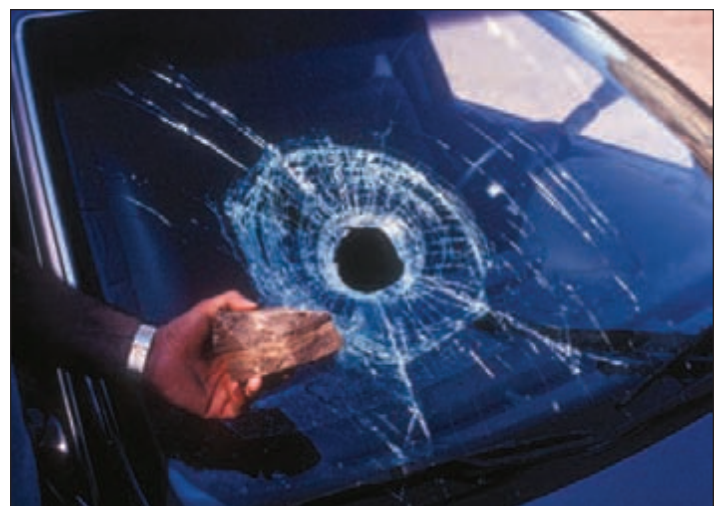
Figure 1: Rockfall accident in Glenwood Canyon. This hand-sized rock free fell 300 feet before striking the vehicle. The driver was unhurt and, luckily, there was no front seat passenger. (Photo by Jon White.)

By their very nature, rocks are heavy—and when traveling at 60 feet per second or more, their energy upon impact is frightful to consider. Rockfall events can instantly demolish structures and kill people unfortunate enough to be in their way. Even a single baseball-sized falling rock has the potential for deadly consequences (Figure 1).

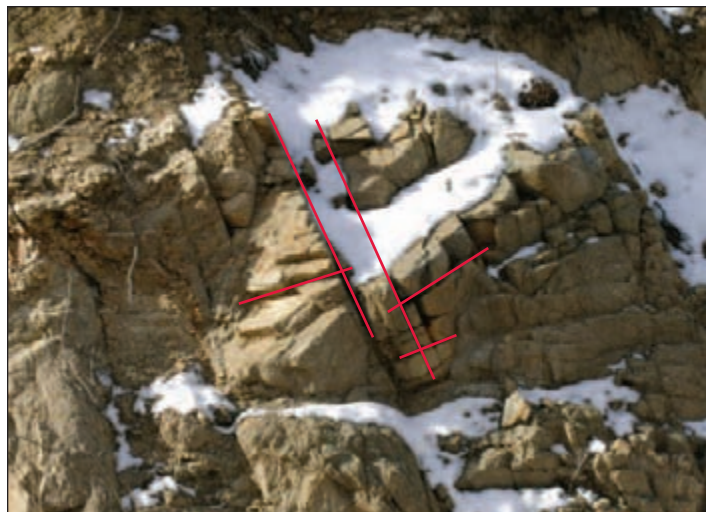
Figure 3: Discontinuities (cracks and fractures, some shown with red lines) in a Precambrian gneiss outcrop near Evergreen, CO. Weathering processes continually work to break apart the rock mass. The fractures are obvious zones of weakness. The orientation of the fractures is important in assessing rockfall hazard. (Photo by TC Wait)

faults, and bedding planes, are exposed to weathering processes that weaken the rockmass (Figure 3). The vast majority of rock units have discontinuities, or cracks. The orientation, length (persistence), spacing, and general condition of these cracks make a big difference as to the overall stability of the rockmass.

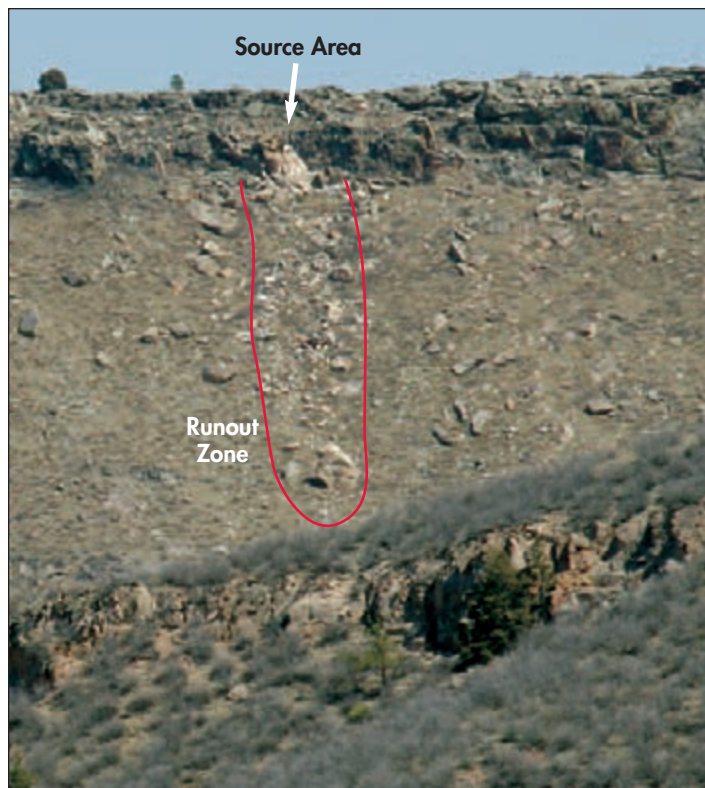
Figure 4: Rockfall source area and runout zone from a rockfall that was triggered by a lightning strike. The whiter rocks indicate the fresh rockfaces of the most recent rockfall event; however the slope is littered with large rocks from older events also. (Photo by Vince Matthews.)

Rockfall initiates from high outcrops of more resistant rock that becomes unstable for a variety of reasons. The size of the falling rock depends on the source area geology (bedding thickness, bedding dip and dip direction, hardness, joint/fracture orientation), weathering, position, and steepness of the slope (Figure 4).

The areas where fallen, rolling, or bouncing rocks accumulate are called **runout zones**. The size and shape of the runout zone depends greatly on the steepness of the slope, the size and quantity of the falling rock, and other factors like vegetation cover. A large quantity of loose fractured rock debris on a slope is sometimes called **talus** or **scree**. Talus on steep slopes is often the result of numerous small rockfall events. If the base of a slope or valley is littered with angular or block-shaped boulders and there is a high cliff up on the valley wall of the same rock type, then it is a rockfall runout zone (Figure 4).

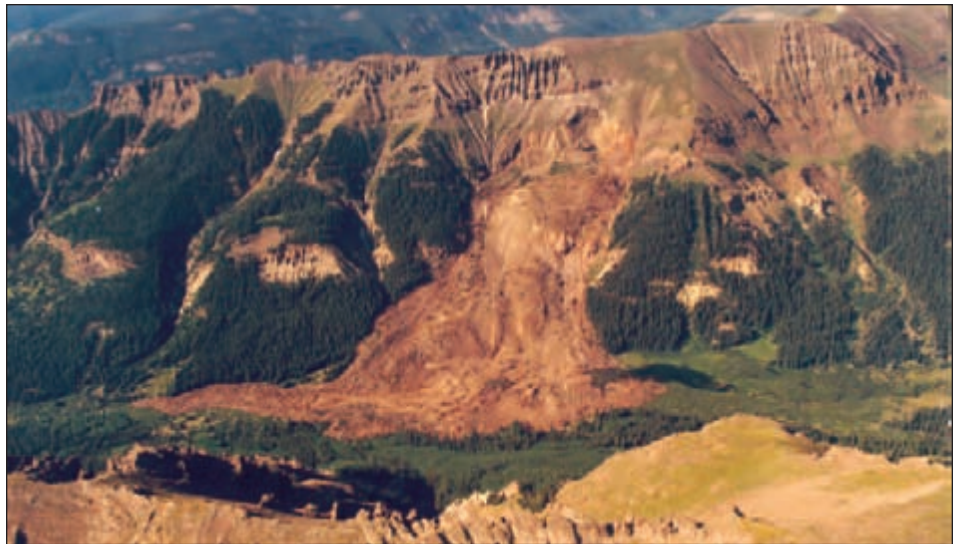
Figure 5: The July 1991 West Lost Trail Creek rockslide in Hinsdale County, Colorado. This estimated 10 million cubic-yard rock and debris avalanche began as a massive rockslide. (Photo from CGS archives.)

Rockfall in the extreme form is a **rock avalanche** that completely buries the existing ground. When a rockslide occurs with enough mass and long steep slopes, such as a flank of an entire mountain, it quickly becomes a catastrophic landslide. Figure 5 shows the 1991 West Lost Trail Creek landslide in the San Juan Mountains. This gigantic landslide began as a rock avalanche on the flank of Pole Creek Mountain and quickly grew into a large avalanche as it accelerated down the steep slopes to “flow” onto the valley floor.

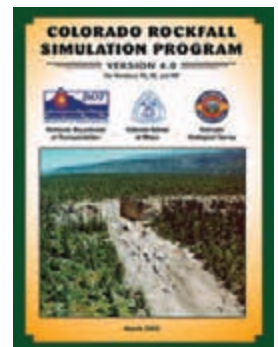
Figure 6: Documentation and user's manual for the Colorado Rockfall Simulation Program, version 4.0, available from the CGS.

CRSP has been revised and re-calibrated in later versions. Today, CRSP Version 4.0 is the current version available. CGS sells the program and a user's manual for \$25 through the CGS online bookstore (<http://dnr.state.co.us/geostore/Search.aspx?Keyword=CRSP>) (Figure 6). Stay tuned, though. The CDOT Rockfall Program is financing the development of a wholly revised CRSP that should be available within a couple of years.

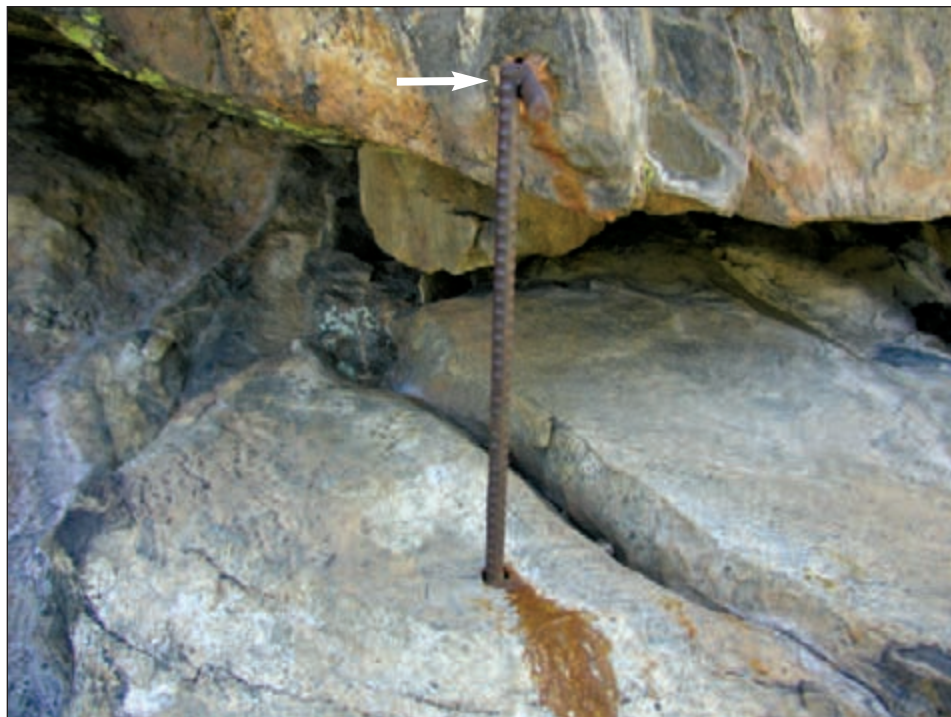
Figure 7: Close up view of tell-tale gauge. Two steel rebar segments (shown with arrow) have been cemented into small drill holes above and below the large crack in the rock. Any movement could be measured by the offset of the two bars that were touching when cemented. This rock has not moved since the gauge was installed in 2003. (Photo by Ty Ortiz, CDOT.)

Some of the methods can be very simple but still effective. Crack gauges and other "tell-tales" are simple devices that are generally affixed to a rock face spanning a fracture or other discontinuity in the rockmass (Figure 7). As the rock moves, a gap begins to show between the two indicators that can be measured. A drawback of these old-fashioned types of devices is that they need to be visited to be read, not a pleasant thought if the crack gauge is anchored up on a 600-foot cliff and it's winter time.

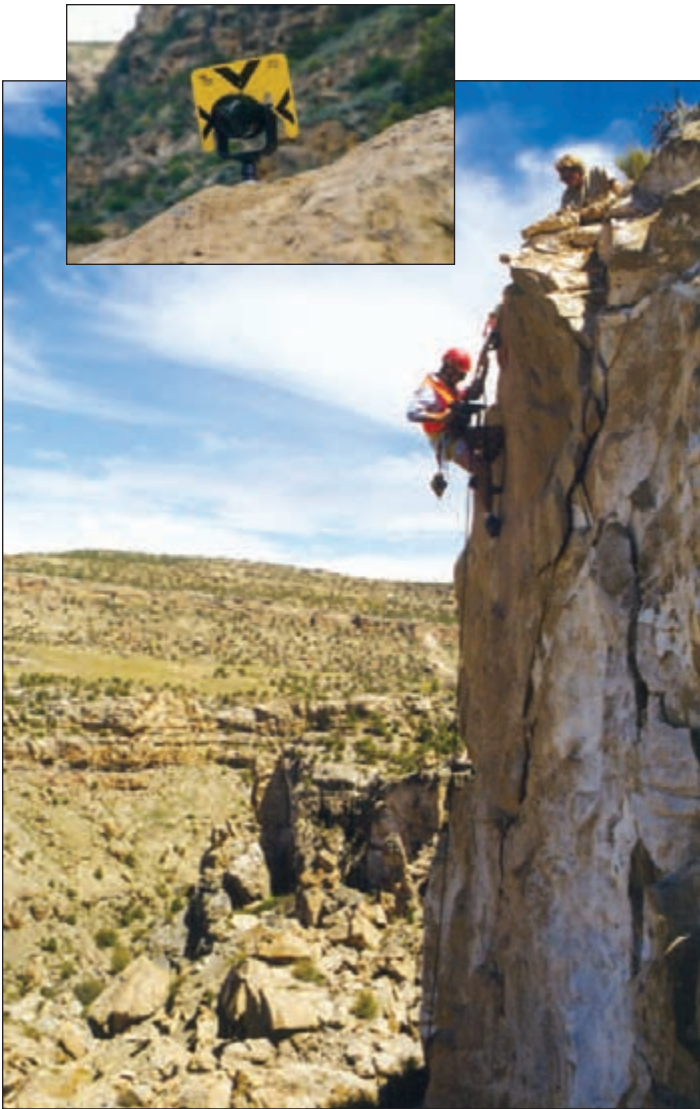
Figure 9: Installation of target prism anchored to a cliff to measure rock movement. Prism is screwed into a wedge anchor bolt that is installed into a drill hole. (Photos by Jon White.)

Survey equipment is also commonly used to monitor rocks and rockmasses. Target prisms or other reflectors can be affixed to a rock face (Figure 9) and periodically measured with a laser surveying instrument. More advanced survey equipment, called laser scans or 3D scans, has entered the market in recent years. These laser-distance tools “sweep” a rockface and the return laser beam scatter is measured and deciphered as 3D points in space. Thousands of these points create a three-dimensional “point cloud” that depict an accurate image of the rockface (Figure 10). Each sweep of the tool generates new 3D points at the same location. Each successive reading is compared to previous readings, and software can measure incremental movements of the rock face.

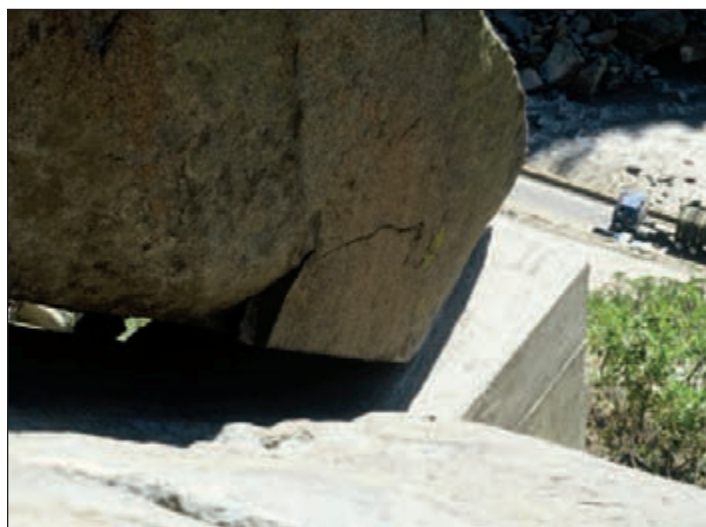
Figure 14: Smaller, upslope concrete buttresses are anchored to the rock face with rockbolts. Then, concrete rebar and wood forms are wired to the anchors in Glenwood Canyon. The concrete is carried in mud buckets by helicopter. The three photos show the progression of the installation. (Photos by Jon White.)

Surface retention of an unstable rockmass includes anchored concrete buttresses (Figure 14), and wire mesh (similar to chain-link fencing) or cable netting, either anchored to the rock face or draped down on a rock slope (which serves to redirect a falling rock into a ditch). Occasionally, large rocks can be stabilized by cable lashing, which also serves to hold the rock in place. Cable lashing is often employed to protect existing structures and roads from precariously balanced rocks that are too dangerous to remove or too unstable to drill into (Figure I, page 17). Another form of surface retention of rock is shotcrete, which is the pneumatic spraying of concrete onto a rock face or cut slope. Shotcrete can be very effective when applied on cut slopes in rocky soils (Figure 15) and in poor rock conditions such as slaking shale slopes that are undermining more resistant rock above.

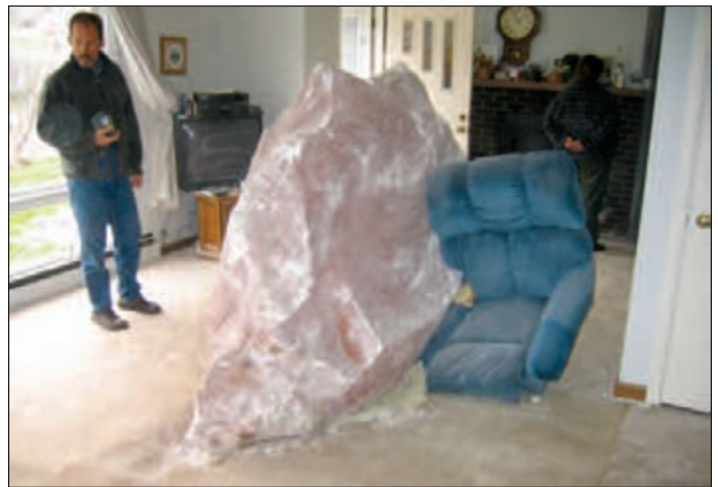
Figure B: In April 2004, this rock from the source area shown above smashed through the wall of a home and came to rest against an easy chair. The homeowner built a rockfall protection fence afterwards. (Photo taken in 2004 by Steve Vanderleest, City of Glenwood Springs.)

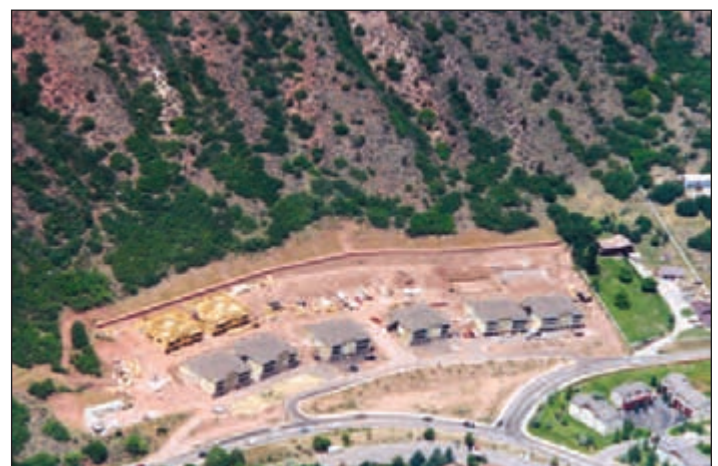
Figure C: This newer development in west Glenwood Springs constructed a rockfall impact wall above their townhomes to protect against both rockfall and mudslides (debris flows). (Photo by Jon White.)

The town of Glenwood Springs in west-central Colorado lies at the confluence of the Roaring Fork and Colorado Rivers. The town is tightly constrained by the steep river valleys so land-development pressure is causing more residential growth to advance into rockfall hazard areas. In West Glenwood, on the west side of the Roaring Fork River, the valley is rimmed with sandstone outcrops (Figure A). The sandstone layers are being undercut by the erosion of underlying softer siltstone and shale so that large sandstone blocks are being actively undermined and destabilized. In this area, there have been several large rockfall events from the valley rim; some that have severely damaged homes on the valley floor, 1,100 vertical feet below (Figure B). Fortunately, there have been no injuries or fatalities. Rapids in the river are evidence of continuous rockfall over many centuries. While there has been rockfall mitigation in some locations (Figure C), the threat remains in other areas.

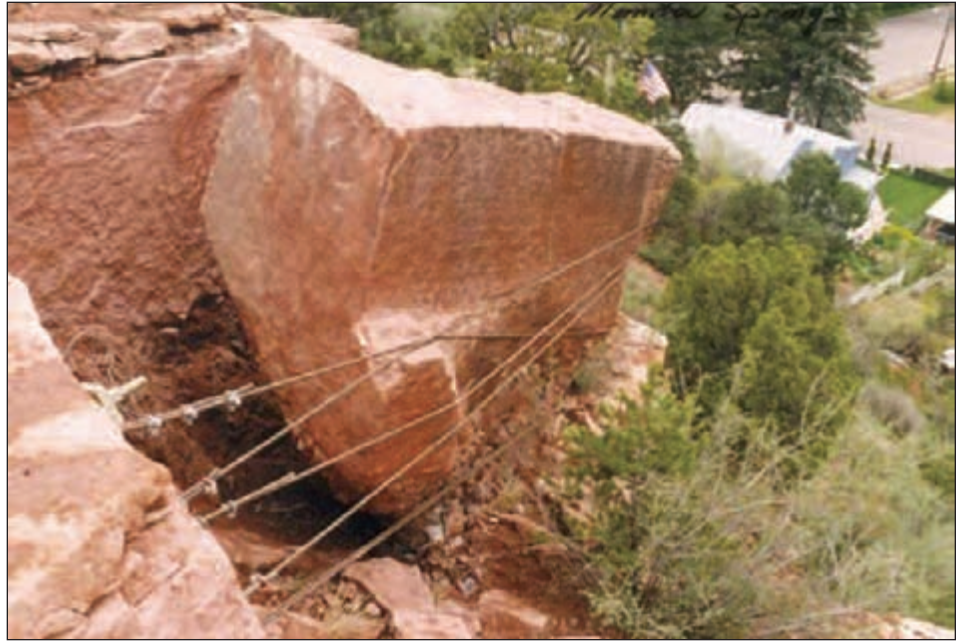
Figure H: A precarious rock above Manitou Springs started to move in 1995 after a period of wet weather. As an emergency measure, high-strength steel cables were wrapped around the rock and anchored to the surrounding ledge to arrest the movement. (Photo by Jon White.)

imity of homes directly below, so high-strength steel cables were wrapped around the rock and anchored to the surrounding ledge (Figure H). Once the block was safely restrained, additional cables were

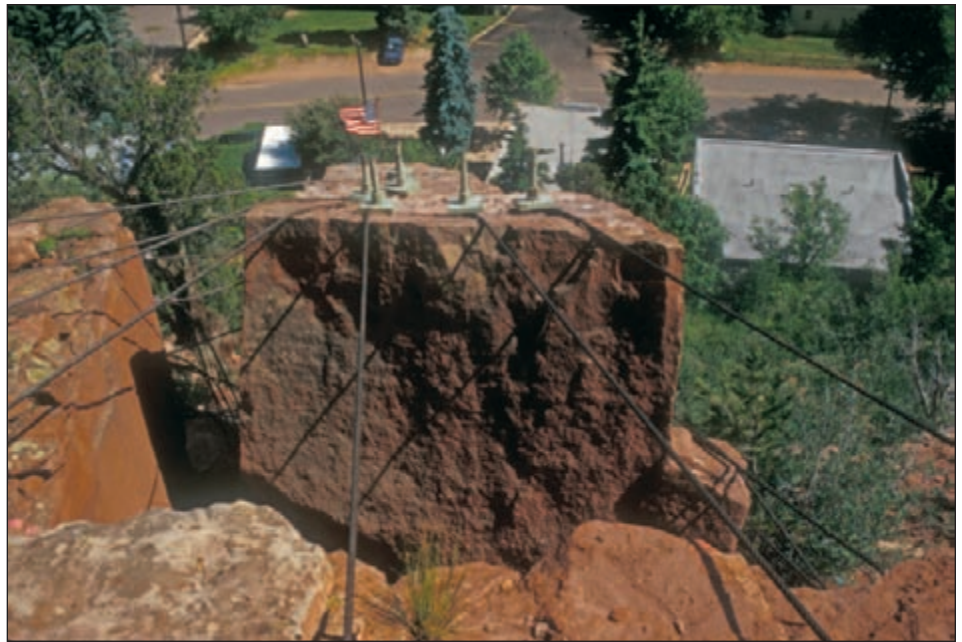
Figure I: After the rock was stabilized, additional cables were physically attached to the top of the rock block and secured to surrounding stable rock. (Photo by Jon White.)

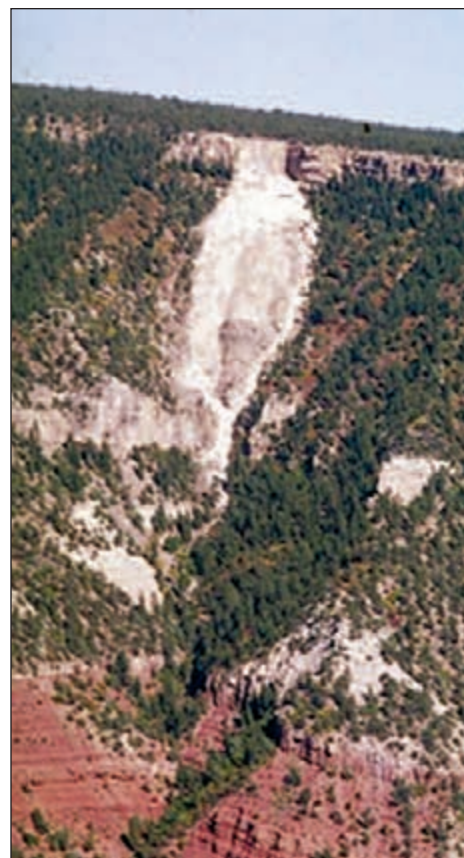
Figure A: Aerial view of the Durango rockslide in 1998. White cliff at the top is the Dakota Sandstone and Burro Canyon Formation. Slope with the rockslide scar is the Morrison Formation. Lower red cliffs near the valley floor are the Entrada Sandstone and Dolores Formation. See geologic terrain model in Figure B. (Photo courtesy of the CDOT Aerial Reconnaissance Unit.)

The rockfall scar is quite visible from Durango (Figure A). Fortunately the falling rock did not reach the valley floor where homes are located so no injuries or fatalities occurred. When it fell and crashed down the valley side, a plume of dust was created that completely filled the valley. At the time of the rockfall, CGS geologists were mapping the area and immediately responded by assisting La Plata County's assessment of the rockfall event.

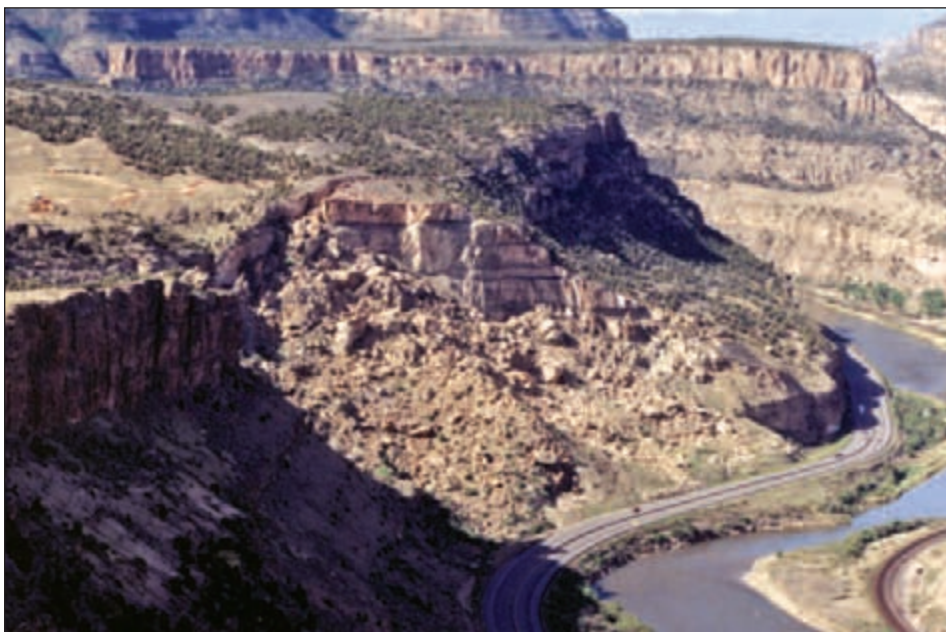
Figure C: Oblique view of the DeBeque Canyon rockslide. Note the large blocks in the rubble and how the river course has been diverted and narrowed. The ground fissure can be seen at the headwall of the landslide, left of center. Interstate 70 crosses the toe of the landslide. (Photo by Jon White.)

The active landslide (Figure C) at milepost 51 of Interstate 70, 36 miles east of Grand Junction, began its life as a massive rockslide. A large, 900-foot long, 300-foot high, and possibly 400-foot wide chunk of the sandstone cliff that had fissured from the southern canyon wall in the recent geologic past, finally fell into the Colorado River. The date of this rockslide is uncertain but the event occurred prior to 1910. It is documented that the rockslide, with rock blocks the size of small homes, partially dammed the river and pushed the river course north towards the opposite bank. The historic records mention that part of the railroad was washed out, as well as a peach orchard and structures at Tunnel, a work camp that was located across the river from the rockslide. Fortunately, there was no road on this side of the canyon at the time of the rockslide. The entire fissured sandstone cliff did not fall, however. A remnant of the upper block in front of the fissure still remains and continues to creep towards the river and Interstate 70. This continued movement is monitored by the Colorado Geological Survey for the Colorado Department of Transportation.

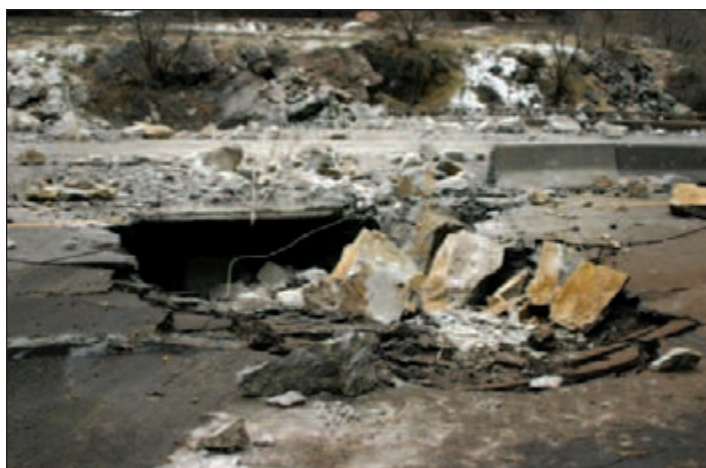
Figure F: Westbound deck of I-70 with extensive damage.

When the dust cleared, the highway was littered with boulders of all sizes (See Figure E). Upon closer inspection, the true nature of the damage became apparent as large holes were punched through the concrete deck and the westbound retaining wall, demolishing a section of the bicycle path below, as well as damage to the bridge girder of the adjacent eastbound bridge (Figure F). Fortunately, no one was caught in this major rockfall event.

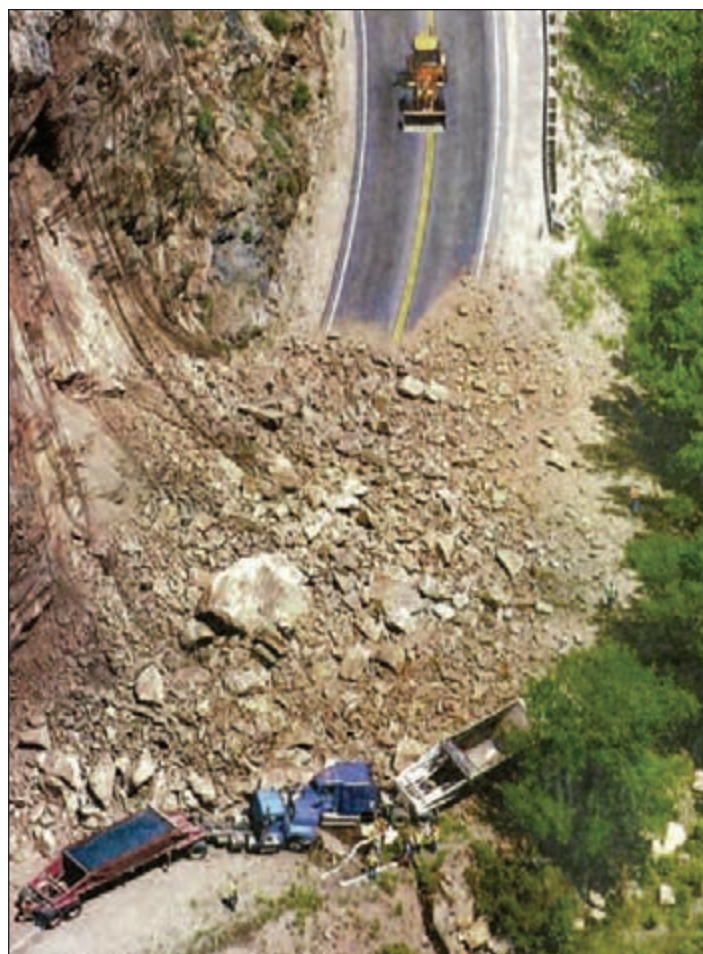
Figure G: Aerial view of the Clear Creek Canyon rockslide. Note how fallen rock pushed the blue and white haul truck across the roadway to hit, head on, with another haul truck (blue and red). Luckily the blue and white truck was not buried and crushed in the debris. Draped wire mesh shown hanging from the outcrop (upper left of photo) was not designed for such a massive rockslide. (Photo courtesy of the Denver Post.)

A high-profile rockslide event occurred on June 21, 2005 along U.S. Highway 6 in Clear Creek Canyon, approximately 10 miles west of Golden, CO. Around 11 AM, 2,000 cubic yards of rock slid from a pre-existing road cut on the north side of the road and completely covered the road (Figure G). Two tractor-trailers were caught in the rockslide and were pushed off the road by the debris. The tractor-trailers were totaled, but only minor injuries were sustained by the drivers.

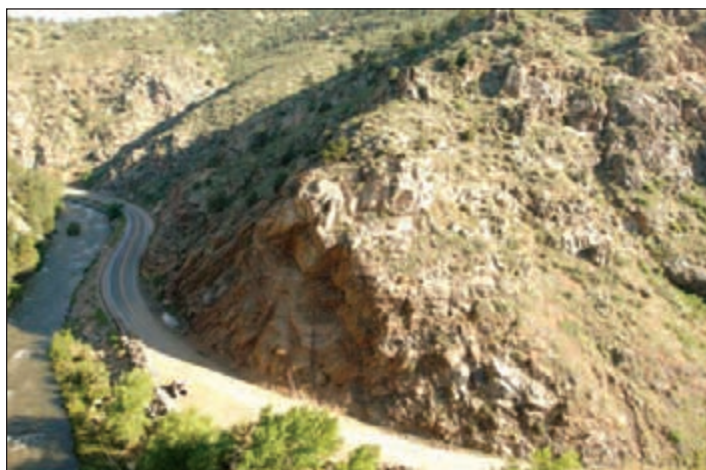
Figure H: Oblique aerial photo of rockslide area after clean-up, before stabilization project. Note the overhanging, unstable rock. (Photo by CDOT.)

of clay-rich material. The clayey zone was structurally weak, providing a plane for the rocks above to detach from the underlying rocks and produce this large rock slide (Figure H).

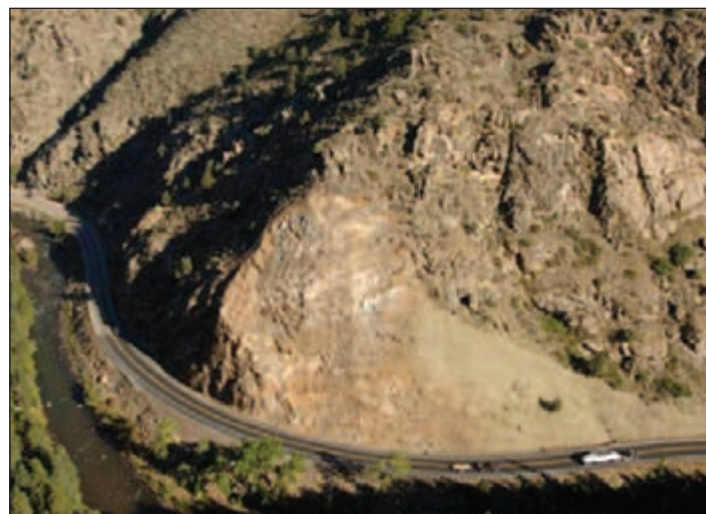
Figure I: Oblique aerial photo of rockslide area after rock excavation project. (Photo by CDOT.)

To mitigate the unstable rock slope left after the slide, approximately 35,000 cubic yards of rock had to be excavated by blasting. The slope was laid back to an angle of 45 degrees, and rock reinforcement anchors were installed into the slope to enhance stability (Figure I). Wire mesh was then draped over the slope to help control any small rocks that will inevitably get loose. By the end of August 2005, after the longest full road closure in Colorado's history, the road was reopened to traffic.

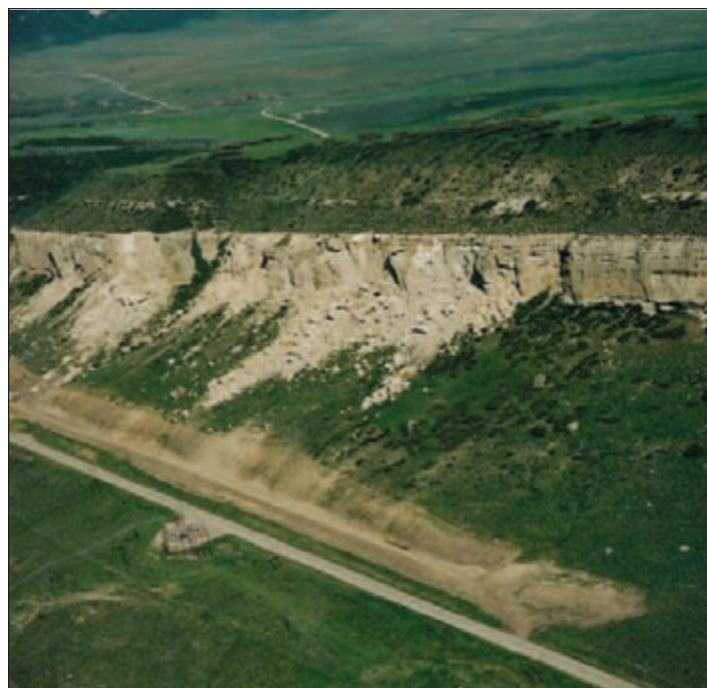
Figure J: Subsidence of the Foidel Creek Mine resulted in rockfall in the Twentymile Sandstone cliff face. Note rockfall ditch and berm above roadway. (Photo courtesy of Colorado Division of Reclamation, Mining, and Safety.)

A mile long stretch of rockfall-prone land in Colorado is entirely due to human activity! In the coal mining areas of Routt County in north-central Colorado, a technique called “long-wall mining” is often the most economical and preferred method for underground extraction of coal. Depending on thicknesses of the overburden (the rock and soil overlying the coal), long-wall mining and resulting collapse of the mined-out cavern can result in several feet of subsidence at the ground surface. At the Foidel Creek Mine in the mid to late 1990s, long-wall mining was extended below the surface exposure of the Twentymile Sandstone, a 100-foot thick, massively bedded, sandstone cliff that is exposed on the slope above Routt County Road 27. The strain from the ground subsidence fractured and broke almost 1½ miles of the exposed sandstone cliff, which resulted in several large rockfall events with some rock blocks the size of small homes (Figure J). The potential of rockfall was anticipated by the mine operator, the Colorado Division of Reclamation Mining and Safety, and the Colorado Geological Survey. A mile-long span of ditches and berms were constructed on the slope above Routt County Road 27 to mitigate the anticipated rockfall. Individual rock blocks in these rockfalls that rolled to the ditch have been completely contained by this mitigative design.

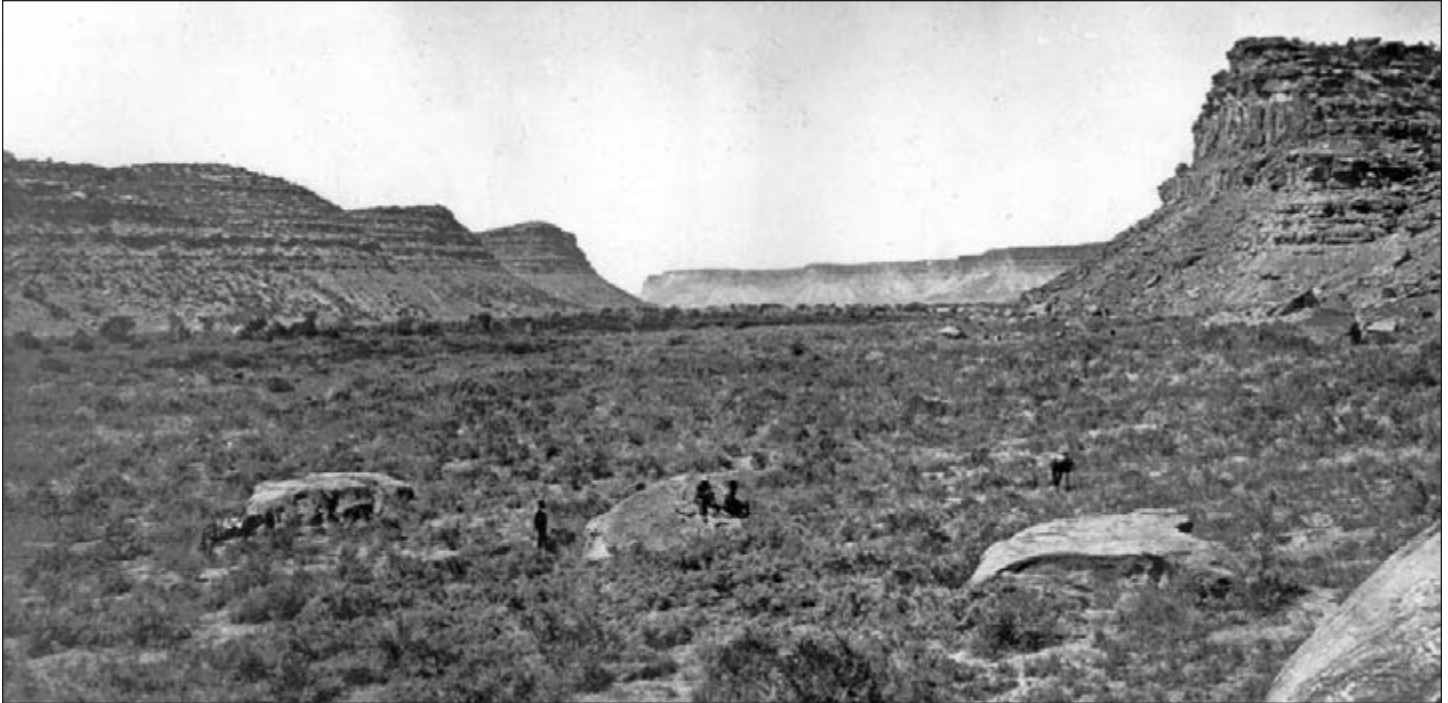
The Mancos Valley of Southwest Colorado. Top photo by William Jackson circa 1870s; bottom photo by John Fielder© 1999. Note the new rockfall block (right foreground) in the more recent picture.

1870 and Fielder's recent color images. In one pair from Mancos Valley in Southwest Colorado, Fielder, with keen observation, comments on a new addition to a group of very large boulders. These images illustrate that in locations where very large blocks of rock litter a valley beneath steep slopes, they will in time be joined by others through continuing erosion and rockfall.

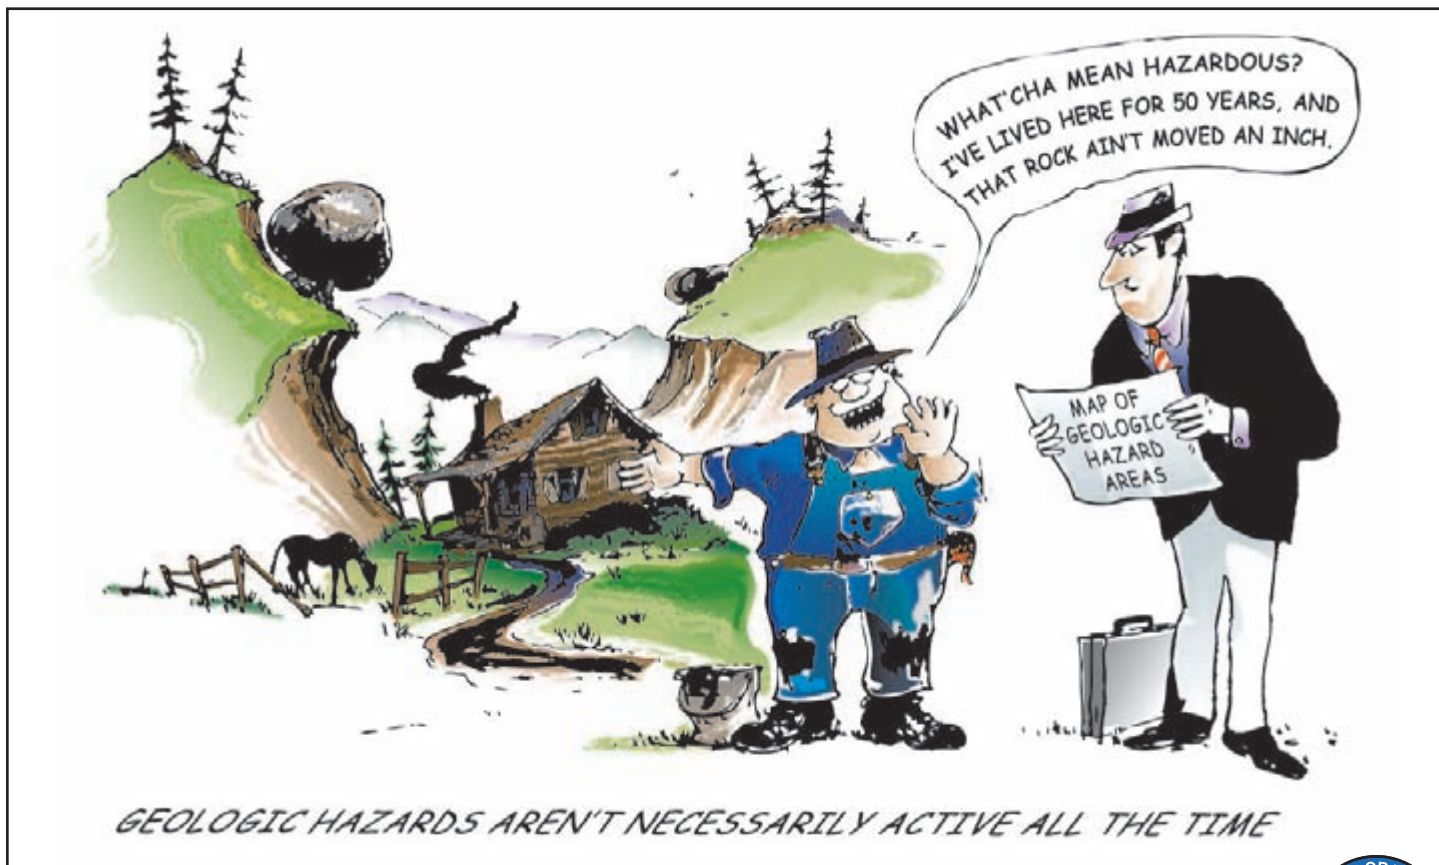
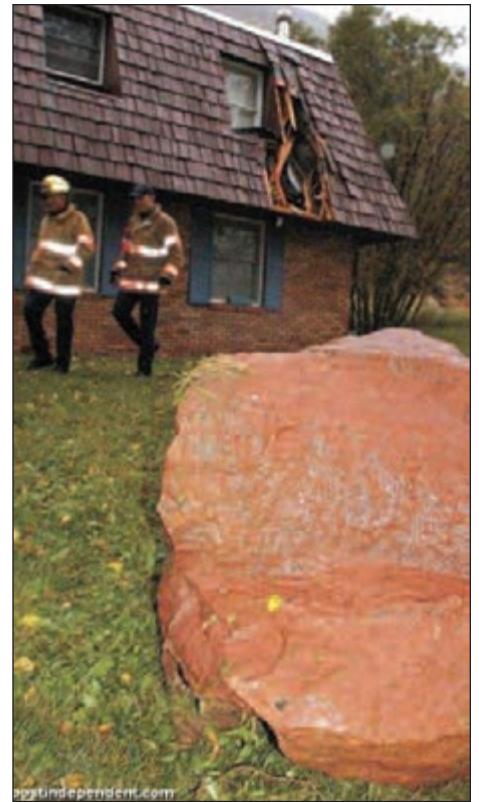
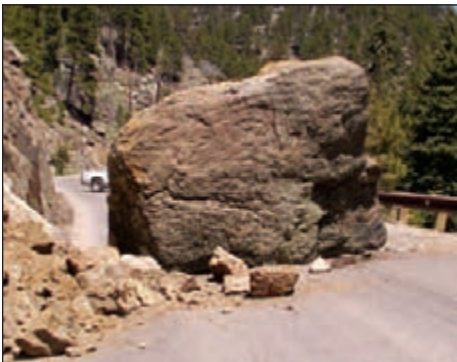
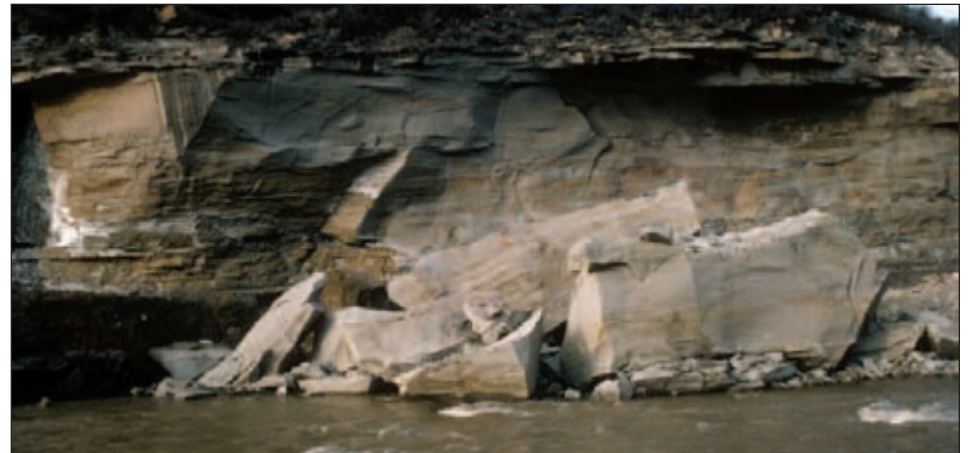
Clockwise, from upper left: Rockfall debris on Highway 133 near Paonia that occurred in the spring of 2007 (Photo by Jon White); Large boulder that fell through an apartment in Glenwood Springs in the fall of 2005 (Photo courtesy of the Glenwood Springs Post Independent); Rivers can undercut banks and create rockfall hazards; Large rockslide on Missionary Ridge near Durango that occurred in 1998 (Photo by CDOT); Boulder that fell on a county road in Jefferson County in the spring of 2007 (Photo by Inter-Canyon Fire Department).
