(Special Publication 42)

Heaving-Bedrock Hazards Associated with Expansive, Steeply Dipping Bedrock in Douglas County, Colorado

By David C. Noe and
Marilyn D. Dodson

Colorado Geological Survey
Department of Natural Resources
Denver, Colorado/1999

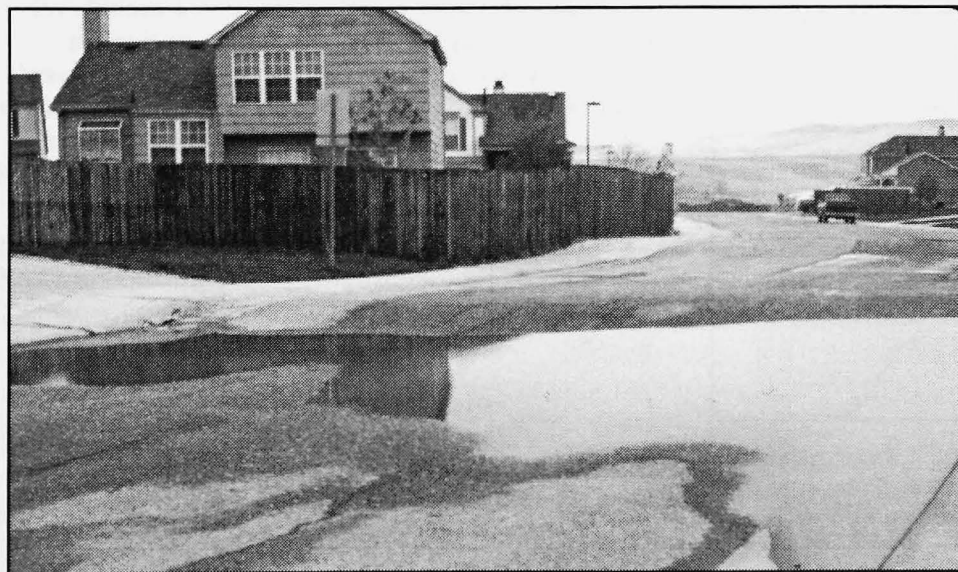
Figure 1. Linear heave feature associated with heaving bedrock in Douglas County. This heave feature has literally formed a dam that blocks storm drainage, resulting in surface-water ponding. Heaving bedrock has caused extensive damage in this neighborhood.

A high incidence of damage to roads, utilities, and lightly loaded residential and commercial structures has occurred where steeply dipping beds of expansive (swelling) claystone bedrock are encountered at shallow depth along Colorado's Front Range piedmont¹. Uneven ground deformations can occur in such areas, resulting in the growth of elongate heave features. The geological hazard responsible for this type of deformation is "heaving bedrock". Individual heave features may attain sizes as large as two feet high, several tens of feet wide, and several hundreds of feet long (Fig. 1).

(7A) Cross-sectional view of a near-vertical bentonite layer containing lenticular veins of fibrous calcite fracture-fill, flanked on either side by less-expansive claystone (note window scraper for scale). This one-foot thick bentonite layer forms the core of the large, linear heave feature shown in Figure 1.

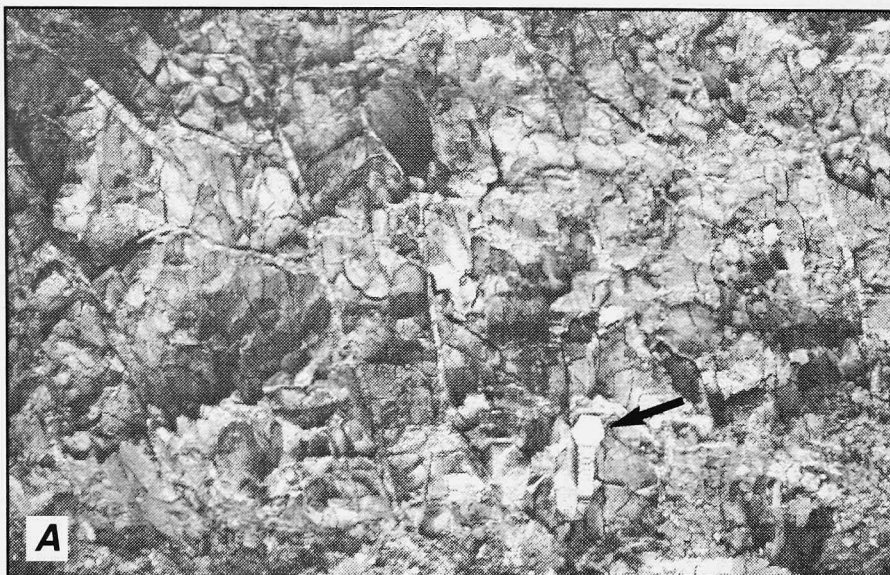
Figure 6. Fractured bedrock and characteristic heave features.

(6A) Highly fractured bedrock in an area where heaving bedrock damage has occurred. Most of these fractures are filled with veins of gypsum crystals. Note wristwatch for scale (arrow).

The CGS has found that the most heave-prone claystone intervals tend to be highly fractured (Figs. 6A and 6B). Fractures are often conduits for ground water. They allow for relatively rapid and deep wetting of the bedrock. Conversely, some fracture surfaces and bentonite layers may act as subsurface barriers and allow ground water to build up along one side. Uneven ground heave, in the form of asymmetrical heave features (Figs. 3C and 6C), may result from this heterogeneous distribution of ground water.

Gypsum is a chemical by-product of the leaching and weathering of claystone. Its presence as a fracture fill (see Fig. 6A) suggests that water has penetrated and chemically altered the claystone in the past, and could do so again. Fibrous calcite, another weathering product, is almost exclusively associated with beds of bentonite. Published investigations from South Dakota (summarized in Grimm and Guven, 1978) show that the bentonites having the highest potential for expansion will almost always contain some secondary calcite, a relationship that appears to be substantiated by CGS observations in Colorado (e.g., Fig. 7A).

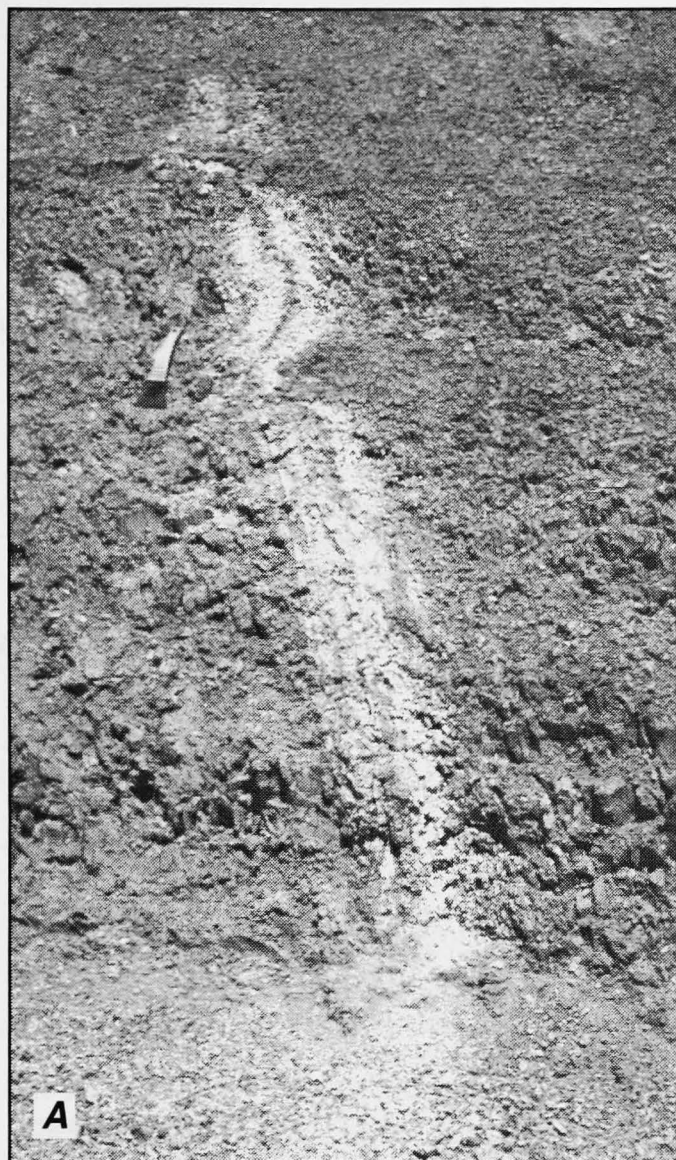
Figure 7. Bentonite beds and characteristic heave features.

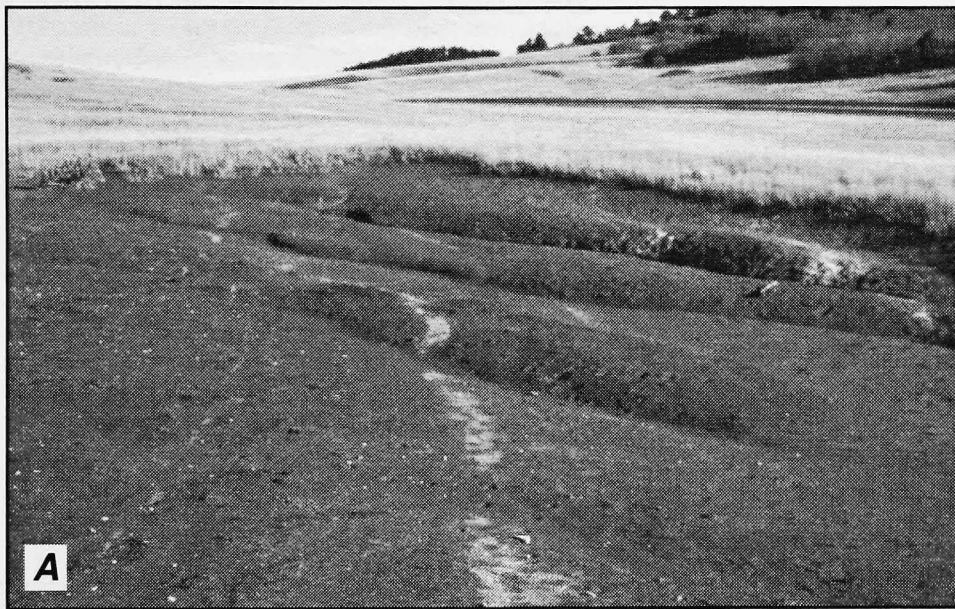
Figure 12. Graneros Shale outcrop in south-central Douglas County

(12A) Outcrop during dry weather. The dark areas are composed of silty claystone, and the white stripes are bentonite beds.

These formations are sometimes considered as a single bedrock unit called the Benton Formation. The unit contains interbedded zones of high- and low-swell-ing bedrock, with numerous discrete beds of bentonite throughout (Fig. 12). Although some of the claystone-bearing zones are relatively pure, others are known to be calcareous, silty, or sandy. Bedding is highly continuous. Damage was not

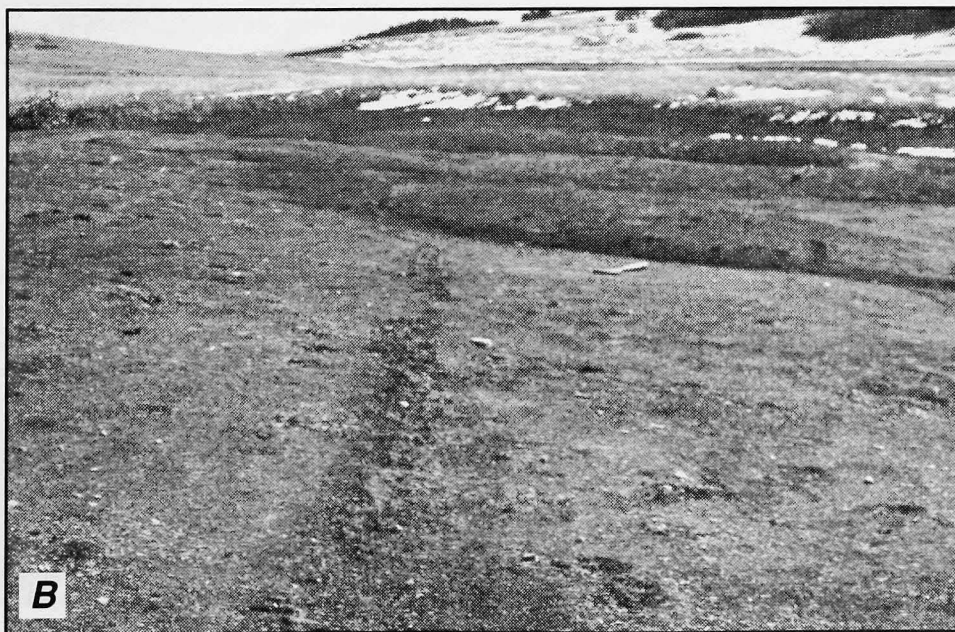
(12B) The same outcrop after a spring snowstorm. The bentonite beds have absorbed the moisture from the melted snow, turned darker in color, heaved out of the ground, and are beginning to desiccate in the sun. The desiccated chips will later blow away, and the scene will quickly revert into one resembling that shown in (A).

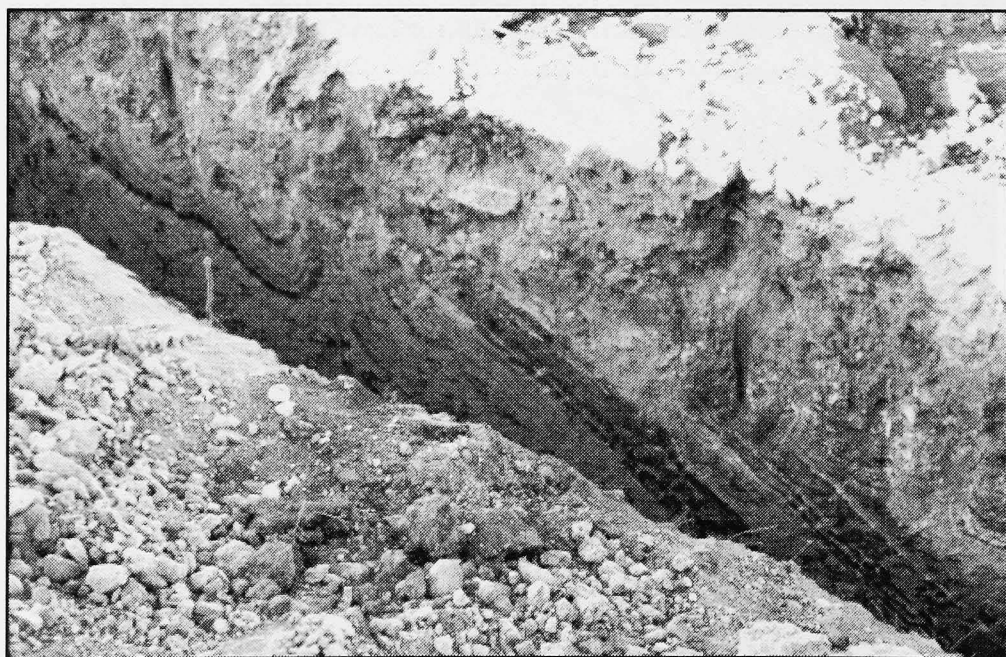
Figure 13. Smoky Hill Shale exposed in a trench in Jefferson County. Bentonite beds are seen in the trench as dark bands that are contorted on the left and steeply dipping on the right.

The Smoky Hill Shale consists primarily of low- to moderate-swelling claystone, but there are some bedding zones that contain high-swelling claystone. Bentonite beds are common in many of the higher swelling zones (Fig. 13). The low-swelling claystone can be silty, sandy, or calcareous and chalky. Bedding zones are continuous within the unit. No damage was observed due to lack of development. Liquid limit values for seven samples ranged from 45 to 55 percent and plasticity indices values ranged from 20 to 32 percent. Most of the material is low-swelling clay (CL) with some high swelling clay (CH). Due to the variability of the swelling characteristics of different zones within this unit, there is a moderate potential for heaving bedrock.

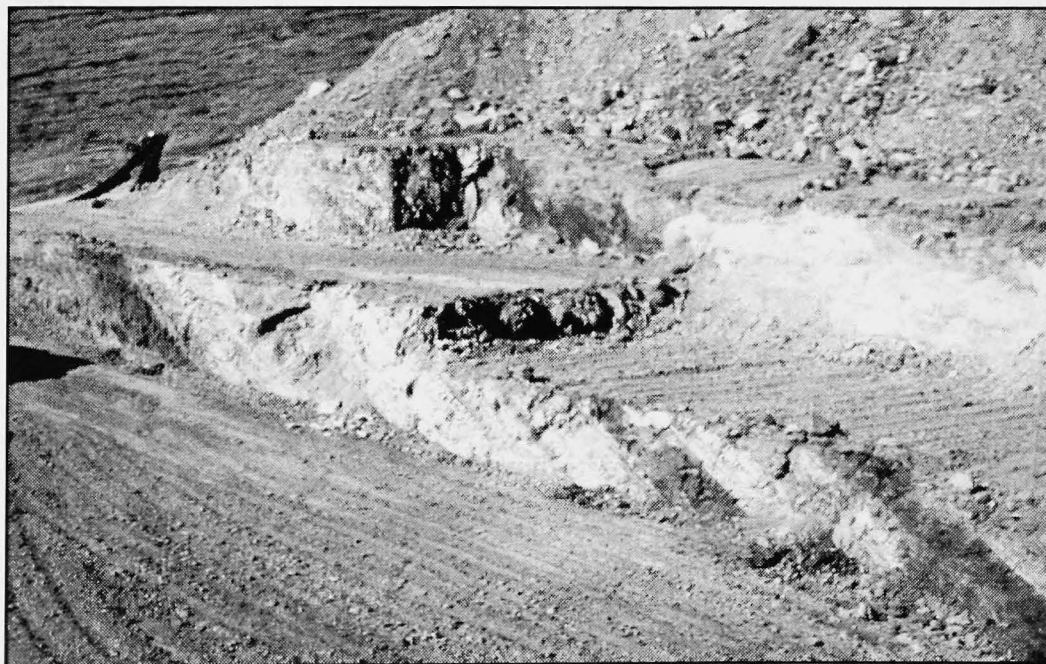
Figure 14. Middle part of Morrison Formation exposed in a basement excavation in northwestern Douglas County. The bedrock consists of steeply dipping layers of dark-red claystone, light-gray claystone, and medium-brown sandstone. The claystone beds tend to be moderate- to high-swelling, while the sandstone beds are typically non-swelling.

This unit is composed of interbedded claystone, siltstone, sandstone, and limestone. The middle part of the formation is primarily composed of high-swelling, smectite-bearing claystone with occasional, thin interbeds of very high-swelling bentonite and non-swelling sandstone and limestone (Fig. 14). The upper and lower parts of the formation contain more sandstone beds, and the claystones consist of kaolinite and illite. Because of these geologic characteristics, the middle part of the formation is the most heave-prone. Bedding continuity is transitional in the middle part, and discontinuous and lenticular in the upper and lower parts. Damage was not observed because the outcrop area is largely undeveloped, and because the developed areas have only recently been constructed. Liquid limit values from 20 samples ranged from 41 to 145 percent and plasticity index values ranged from 19 to 114 percent. Most of the material in the middle part is a high swelling clay (CH), with some low swelling clay (CL) and poorly sorted silty sand (SP-SM). Because of the large variation in bedrock compositions, swell potentials, and bedding continuity, the Morrison Formation has a high potential for bedrock heave.

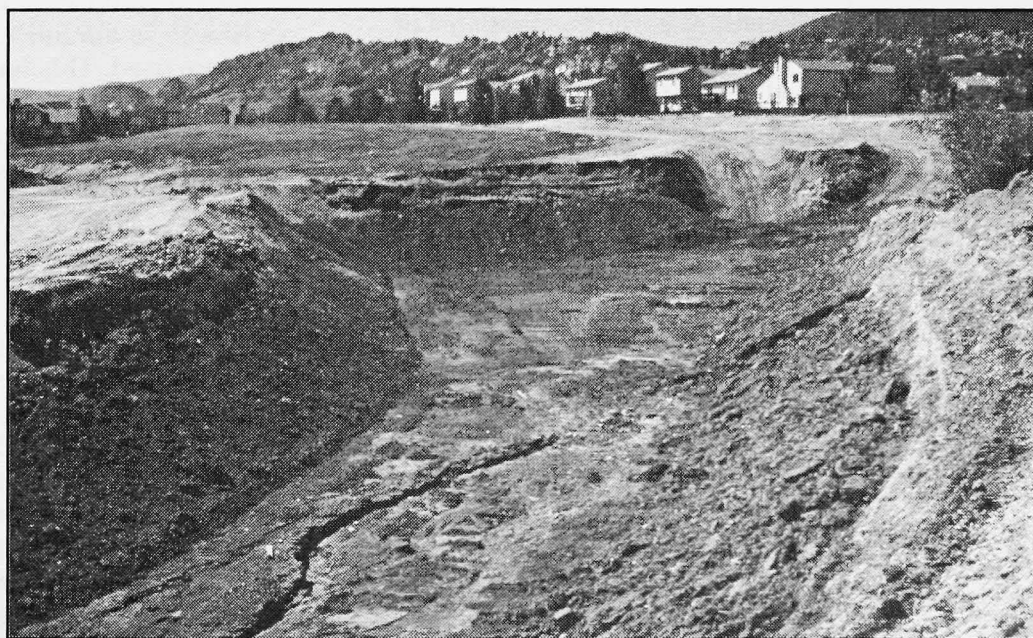
Figure 17. Overexcavation operation in progress at a subdivision in northwest Douglas County. The overexcavation area consists of a 16–20 foot deep cut that has been partially refilled with claystone as a sealant. The upper part of the cut was later filled with non-expansive material, and houses were built on the fill. beds are typically non-swelling.

long-term ground water flow into the bedrock from Little Willow Creek, which flows down a valley located preferentially within the shale. It is notable that two areas of shallow bedrock in Parcels C and F are being constructed using overexcavation with engineered fill replacement (Fig. 17). This mitigation design was chosen because the bedrock was found to contain numerous bentonite layers.
