MINERALOGICAL ALTERATIONS OF SOIL IRRIGATED WITH ACIDIC MINE WATER IN THE ALAMOSA RIVER BASIN

Colorado State University,
Department of Soil and Crop Sciences
Fort Collins, Colorado 80523

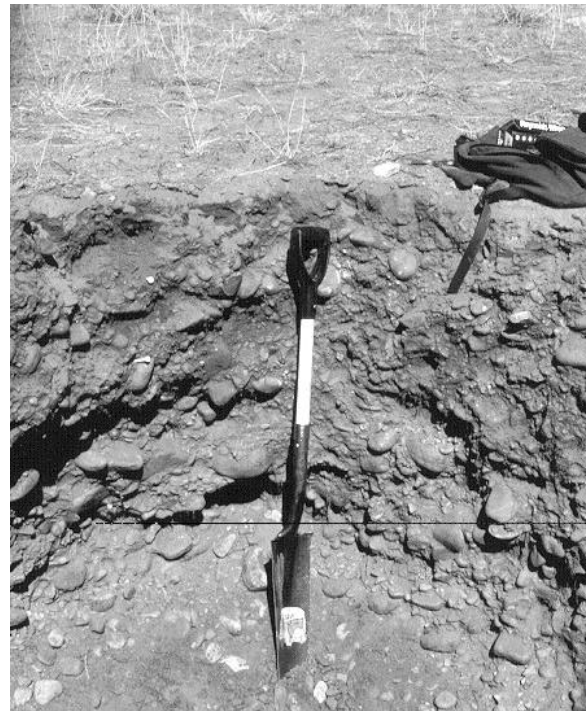
Ap-- 0 to 23 cm; very gravelly sandy clay loam; brown (7.5YR 4/3) moist; weak fine granular structure; soft, very friable, slightly sticky and non plastic; common fine roots throughout; no effervescence; 30% gravels; 5% cobbles; clear wavy boundary.

Bt--23 to 42 cm; very gravelly sandy clay loam; brown (7.5YR 4/4) moist; weak subangular blocky structure; soft, very friable, slightly sticky and non plastic; common fine and few very fine roots throughout; no effervescence; 50% gravels, 5% cobbles; clear wavy boundary.

2BCK1--42 to 81 cm; extremely gravelly sand; brown (7.5YR 5/4) moist; single grained; loose; non sticky and non plastic; common fine roots throughout; carbonates - none in matrix, pendant coatings on clasts; slight effervescence; 60% gravels, 25% cobbles; clear wavy boundary.

2BCK2--81+ cm; extremely gravelly sand; brown (7.5YR 4/2) moist; single grained; loose non sticky and non plastic; few very fine roots throughout; carbonates - none in matrix, pendant coatings on clasts (slightly greater concentration than 2BCK1); slight effervescence; 70% pebbles, 10% cobbles; gradual wavy boundary.

Figure 2. Site 2 - pre-1984 soil profile.

The degree of weathering in the Graypoint series differs according to which of the six different management schemes the soil is under. Under virgin conditions (site 1), soil formation and weathering are assumed to occur at natural rates typical of arid environments. These weathering processes have slowly developed an argillic horizon from illuviation of clay from the surface. Carbonates have accumulated on the undersides of rock clasts at and below 34 cm with increasing concentration down the soil profile. There are no carbonate concretions in the matrix. The rocks identified from this site show comparatively moderate weathering rinds and are still intact. Site 2 (irrigated and cultivated prior to but not after 1984) also has an argillic horizon and the remnants of a plowed surface horizon which has been subjected to severe disturbance and possible erosion. Carbonates are absent in the upper portion of the profile but can be found on the undersides of rock clasts at and below 42 cm as in site 1. The rocks identified from this site show larger weathering rinds than in site 1 and have some oxide staining but still are intact.

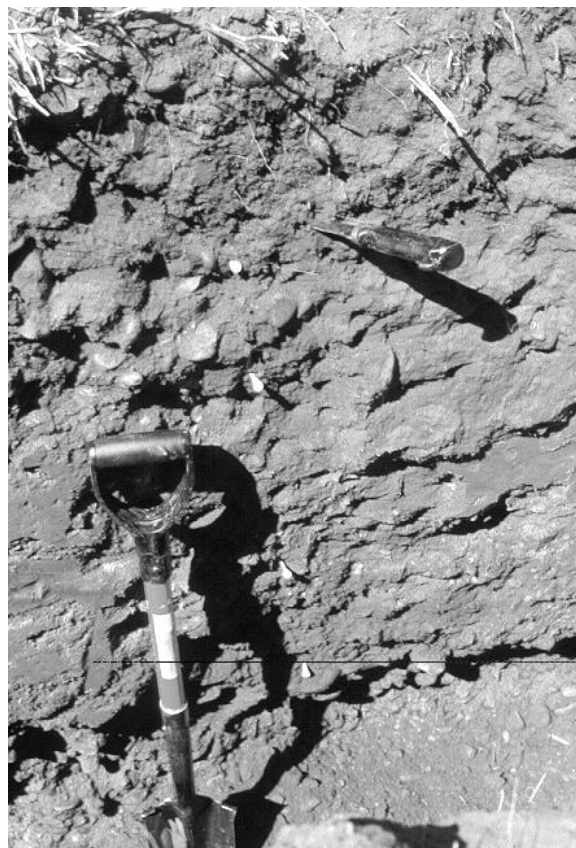
Ap--0 to 28 cm; gravelly sandy clay loam; reddish brown (5YR 4/3) moist; weak fine granular structure; slightly hard, friable, slightly sticky and slightly plastic; common very fine roots throughout; no effervescence; 25% gravels, 5% cobbles; abrupt smooth boundary.

Bw1--28 to 57 cm; extremely gravelly sandy loam; reddish brown (5YR 4/3) moist; single grained; loose; non sticky and non plastic; few very fine roots throughout; no effervescence; 70% gravels, 3% cobbles; clear smooth boundary.

Bw2--57 to 79 cm; extremely gravelly loam; yellowish red (5YR 5/6) upper half of the horizon and reddish brown (5YR 4/3) moist; single grained; soft, very friable, slightly sticky and non plastic; common medium and very fine roots throughout; no effervescence; 65 % gravels, 3% cobbles, 5% stones; clear wavy boundary.

2Bw3--79 to 108 cm; extremely gravelly sand; dark reddish brown (5YR 3/3) moist; single grained; loose; non sticky and non plastic; few fine roots throughout; iron and manganese staining on coarse fragments; no effervescence; 80% pebbles, 5% cobbles; gradual wavy boundary.

2Bw4--108+ cm; extremely gravelly sand; dark brown (7.5YR 3/2) moist; single grained; loose; non sticky and non plastic; few very fine roots throughout; very thin carbonate coatings on coarse fragments (unreactive) no effervescence; 70% pebbles, 20% cobbles.

Figure 5. Site 5 - Alamosa flood irrigated soil profile.
