# THE SLUMGULLION LANDSLIDE, HINSDALE COUNTY, COLORADO

by Robert W. Fleming, Rex L. Baum, and William Z. Savage  
U.S. Geological Survey  
Box 25046, M.S. 966  
Denver, CO 80225-0046

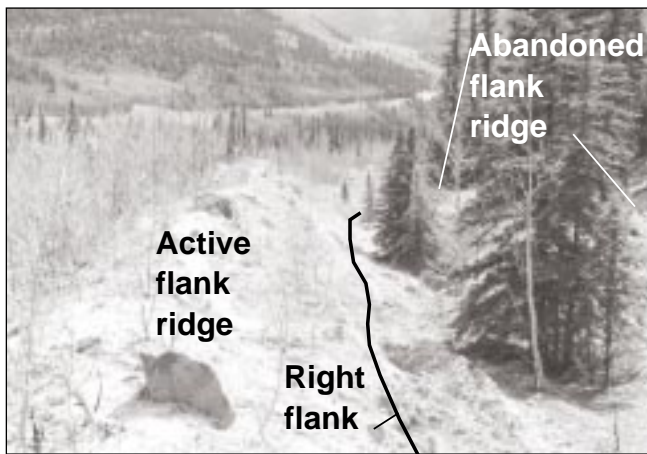
**Figure 2.** View of flank ridge at downslope end of pull-apart basin on right flank, looking southwest.

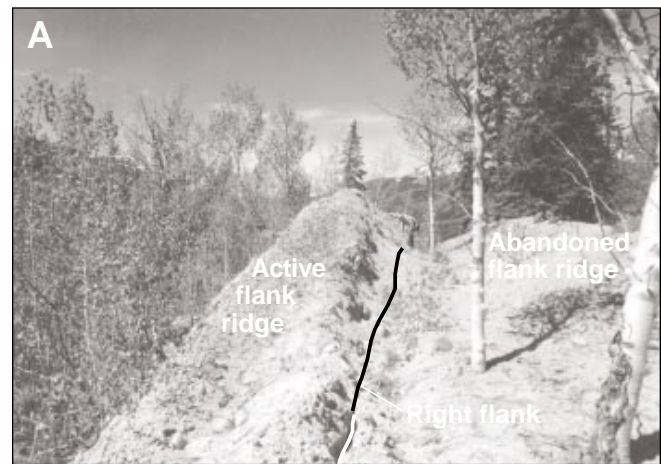
**Figure 3.** Views of an active flank ridge. **A.** Uphill end, looking southwest along right flank. Trees to left of ridge have deformed trunks. **B.** Downhill end looking east (Baum and Fleming, 1996). Exposed shear surface and clay dike inside right flank. A scarp at the outboard side of ridge (light area at center) exposes an emergent part of the lateral shear surface. This shear surface is between the crest and the trace of the right-lateral shear zone (shown by a dashed line). The scarp tapers from a height of about 2 m in foreground to 0 m in the background (about 20 m upslope, beyond left edge of photograph). The taper is consistent with screw-like movement along this part of the flank; the ridge growth is about 0.1 meter per meter of downslope of displacement. Annual movement here is about 3.5 m. The scarp is convex and is covered with sheared, highly plastic, blue-gray clay (liquid limit = 105, plasticity index = 77) that differs in color and texture from the stony, light-brown landslide material in the ridge. Movement at the shear zone has brought a tabular dike of blue-gray clay to the surface and injected the clay into the landslide materials.

We found tabular dikes of highly plastic clay (liquid limit = 110, plasticity index = 75) intruded into the landslide debris at several locations in the active landslide, notably along the strike-slip faults at the flanks (Fig. 3B) (Baum and Fleming, 1996). Similar intruded dikes were reported in the Twin Lake landslide in Utah by Fleming and Johnson (1989). Evidently the clay intrudes the faults during landslide movement. This clay is apparently much weaker than the rocky landslide debris on either side of the fault and intrusions of clay dikes along fault zones could facilitate continued movement by creating a weak, slippery (low angle of internal friction) layer between the active landslide and underlying materials. Creation of such a weak layer could permit the landslide to move in response to smaller loads or pore pressures than existed at the time of its initiation or reactivation.

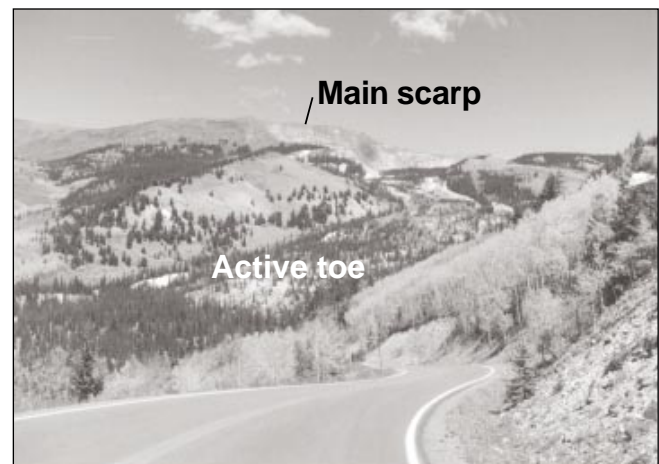
**Figure 6. Active part of the Slumgullion landslide, view to northwest from Stop 1 (photograph by Jack Odum, U.S. Geological Survey).**

At this stop we will view Lake San Cristobal (Fig. 4B), and most of the Slumgullion landslide (Fig. 6). Lake San Cristobal, Colorado's second largest natural lake, formed about 800-900 years ago when the Slumgullion landslide dammed the Lake Fork of the Gunnison River. Originally the lake was 4.3 km long, and had a surface area of 1.8 km<sup>2</sup>, but sediment deposited in deltas of Slumgullion Creek and the Lake Fork have reduced the lake's length to 3.3 km and its area to 1.34 km<sup>2</sup>. The lake is 27 m deep and has a volume of approximately 14 million m<sup>3</sup> (Schuster, 1996). The landslide buried the original channel of the Lake Fork and the river eventually cut a new channel around the perimeter of the landslide toe 200 m west of and 28 m higher than the old channel. The new channel, which originally formed because the low point in the landslide-dam crest was against the west wall of the valley, has cut down about 10 m into resistant bedrock forming a stable, erosion-resistant channel. Headward erosion of the downstream channel has created 25-m-high Argenta Falls at a resistant bedrock ledge (Schuster, 1996).

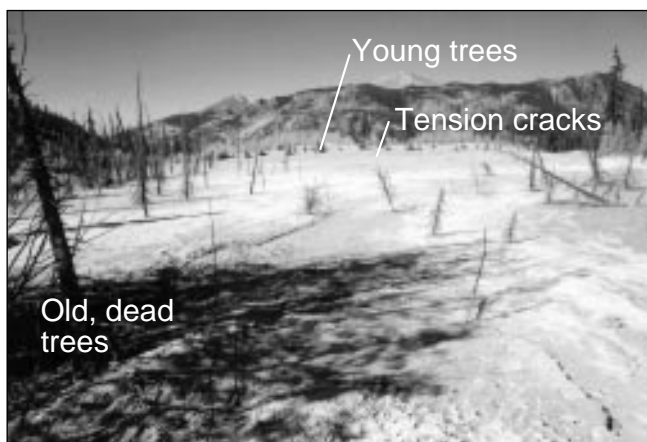
**Figure 18.** Pond sediments of Zone 5, viewed from inlet, looking west-southwest.

an extensive area (80 m by 80 m) of pond deposits (Fig. 7B and 17). These deposits begin near line **P-P'**, directly downslope from hummocky, thrust-faulted topography (Fig. 17). The area no longer contains a pond; the surface has been tilted northward to the point that a small stream that formerly fed the pond now flows across the north side of the pond deposits and continues downhill (Fig. 18). A few remnant spruce trees stick partly out of the sediment and small aspen and spruce trees are growing in the sediments near the downhill edge of the former pond (Fig. 18). The downhill edge is at a broad break in slope that separates surfaces that are tilted uphill and downhill. The position of the break in slope has apparently remained fixed about 100 m downhill from the thrust faults.

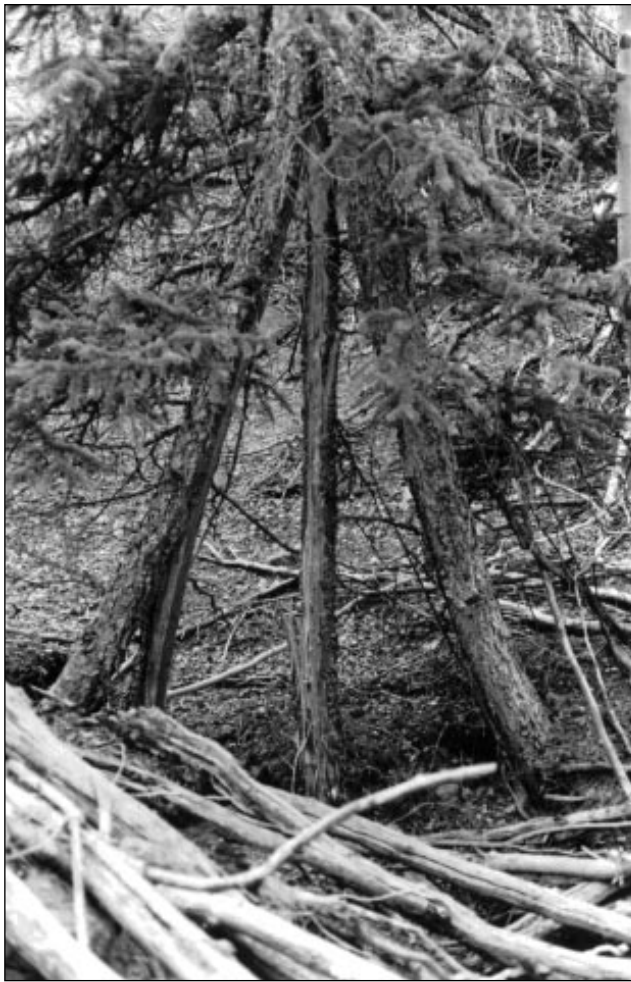
**Figure 20.** View of split tree in Zone 6, looking uphill. The tree is broken in four parts by right-lateral and spreading movement. Fault that causes rupture of the tree does not create a fracture at the ground surface, but does form a linear trough about 1 m deep.

The deformation structures on the north side of the landslide consist of strike-slip and oblique-slip (right-lateral slip and opening or spreading) faults. Pure strike-slip faults are difficult to identify in this part of the landslide because the crumbly landslide debris does not preserve fractures well. In a few places along the trend of a strike-slip fault, a scarp is produced, and the fault position can be accurately located. Where a pure strike-slip fault changes orientation, a scarp is produced and stretched roots or split trees (Fig. 20) reveal that the fault accommodates oblique slip indicative of spreading of the toe.

The entire north side of the landslide toe is composed of oblique-slip structures. Deformation across these structures consist of right-lateral slip and opening/spreading. This is well illustrated at a spruce tree that was caught in one of these oblique-slip zones (Fig. 20). The fault zone occupies a small furrow that crosses under the tree. There are no open cracks or fractures; the position of the fault is given only by the furrow and the split tree. The right-hand side of the tree is about 1 m farther downslope than the left-hand side, and the opening normal to the strike-slip direction is about 0.8 m. The split tree is definitive evidence of right-lateral slip together with spreading. There are numerous troughs and furrows in this part of the landslide, and only in a few places, like shown in Figure 20, can they be shown to be locations of active movement.

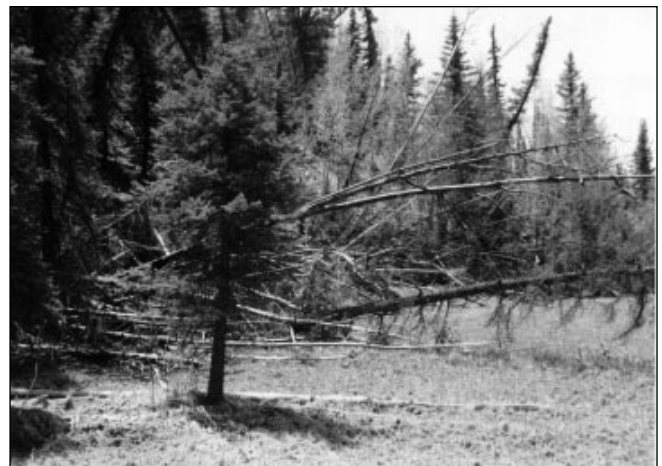
**Figure 21.** View of north side of active toe (Zone 7) where trees are being overridden by bulldozer-like movement of the landslide. Moving ground on left pushes trees over and buries them.

The active toe bounds the downhill terminus of the active landslide beginning about 25 m from **O** toward **P** and continuing all the way around the perimeter, **O-P-Q-R'-Q'**. Everywhere along the perimeter, the toe is advancing across the surface of the old, inactive landslide. In the process of overriding the landscape, it pushes trees over and engulfs them into the base of the landslide (Fig. 21).
