Map of Areas Susceptible to Differential Heave in Expansive, Steeply Dipping Bedrock, City of Colorado Springs, Colorado

By John W. Himmelreich, Jr. and David C. Noe

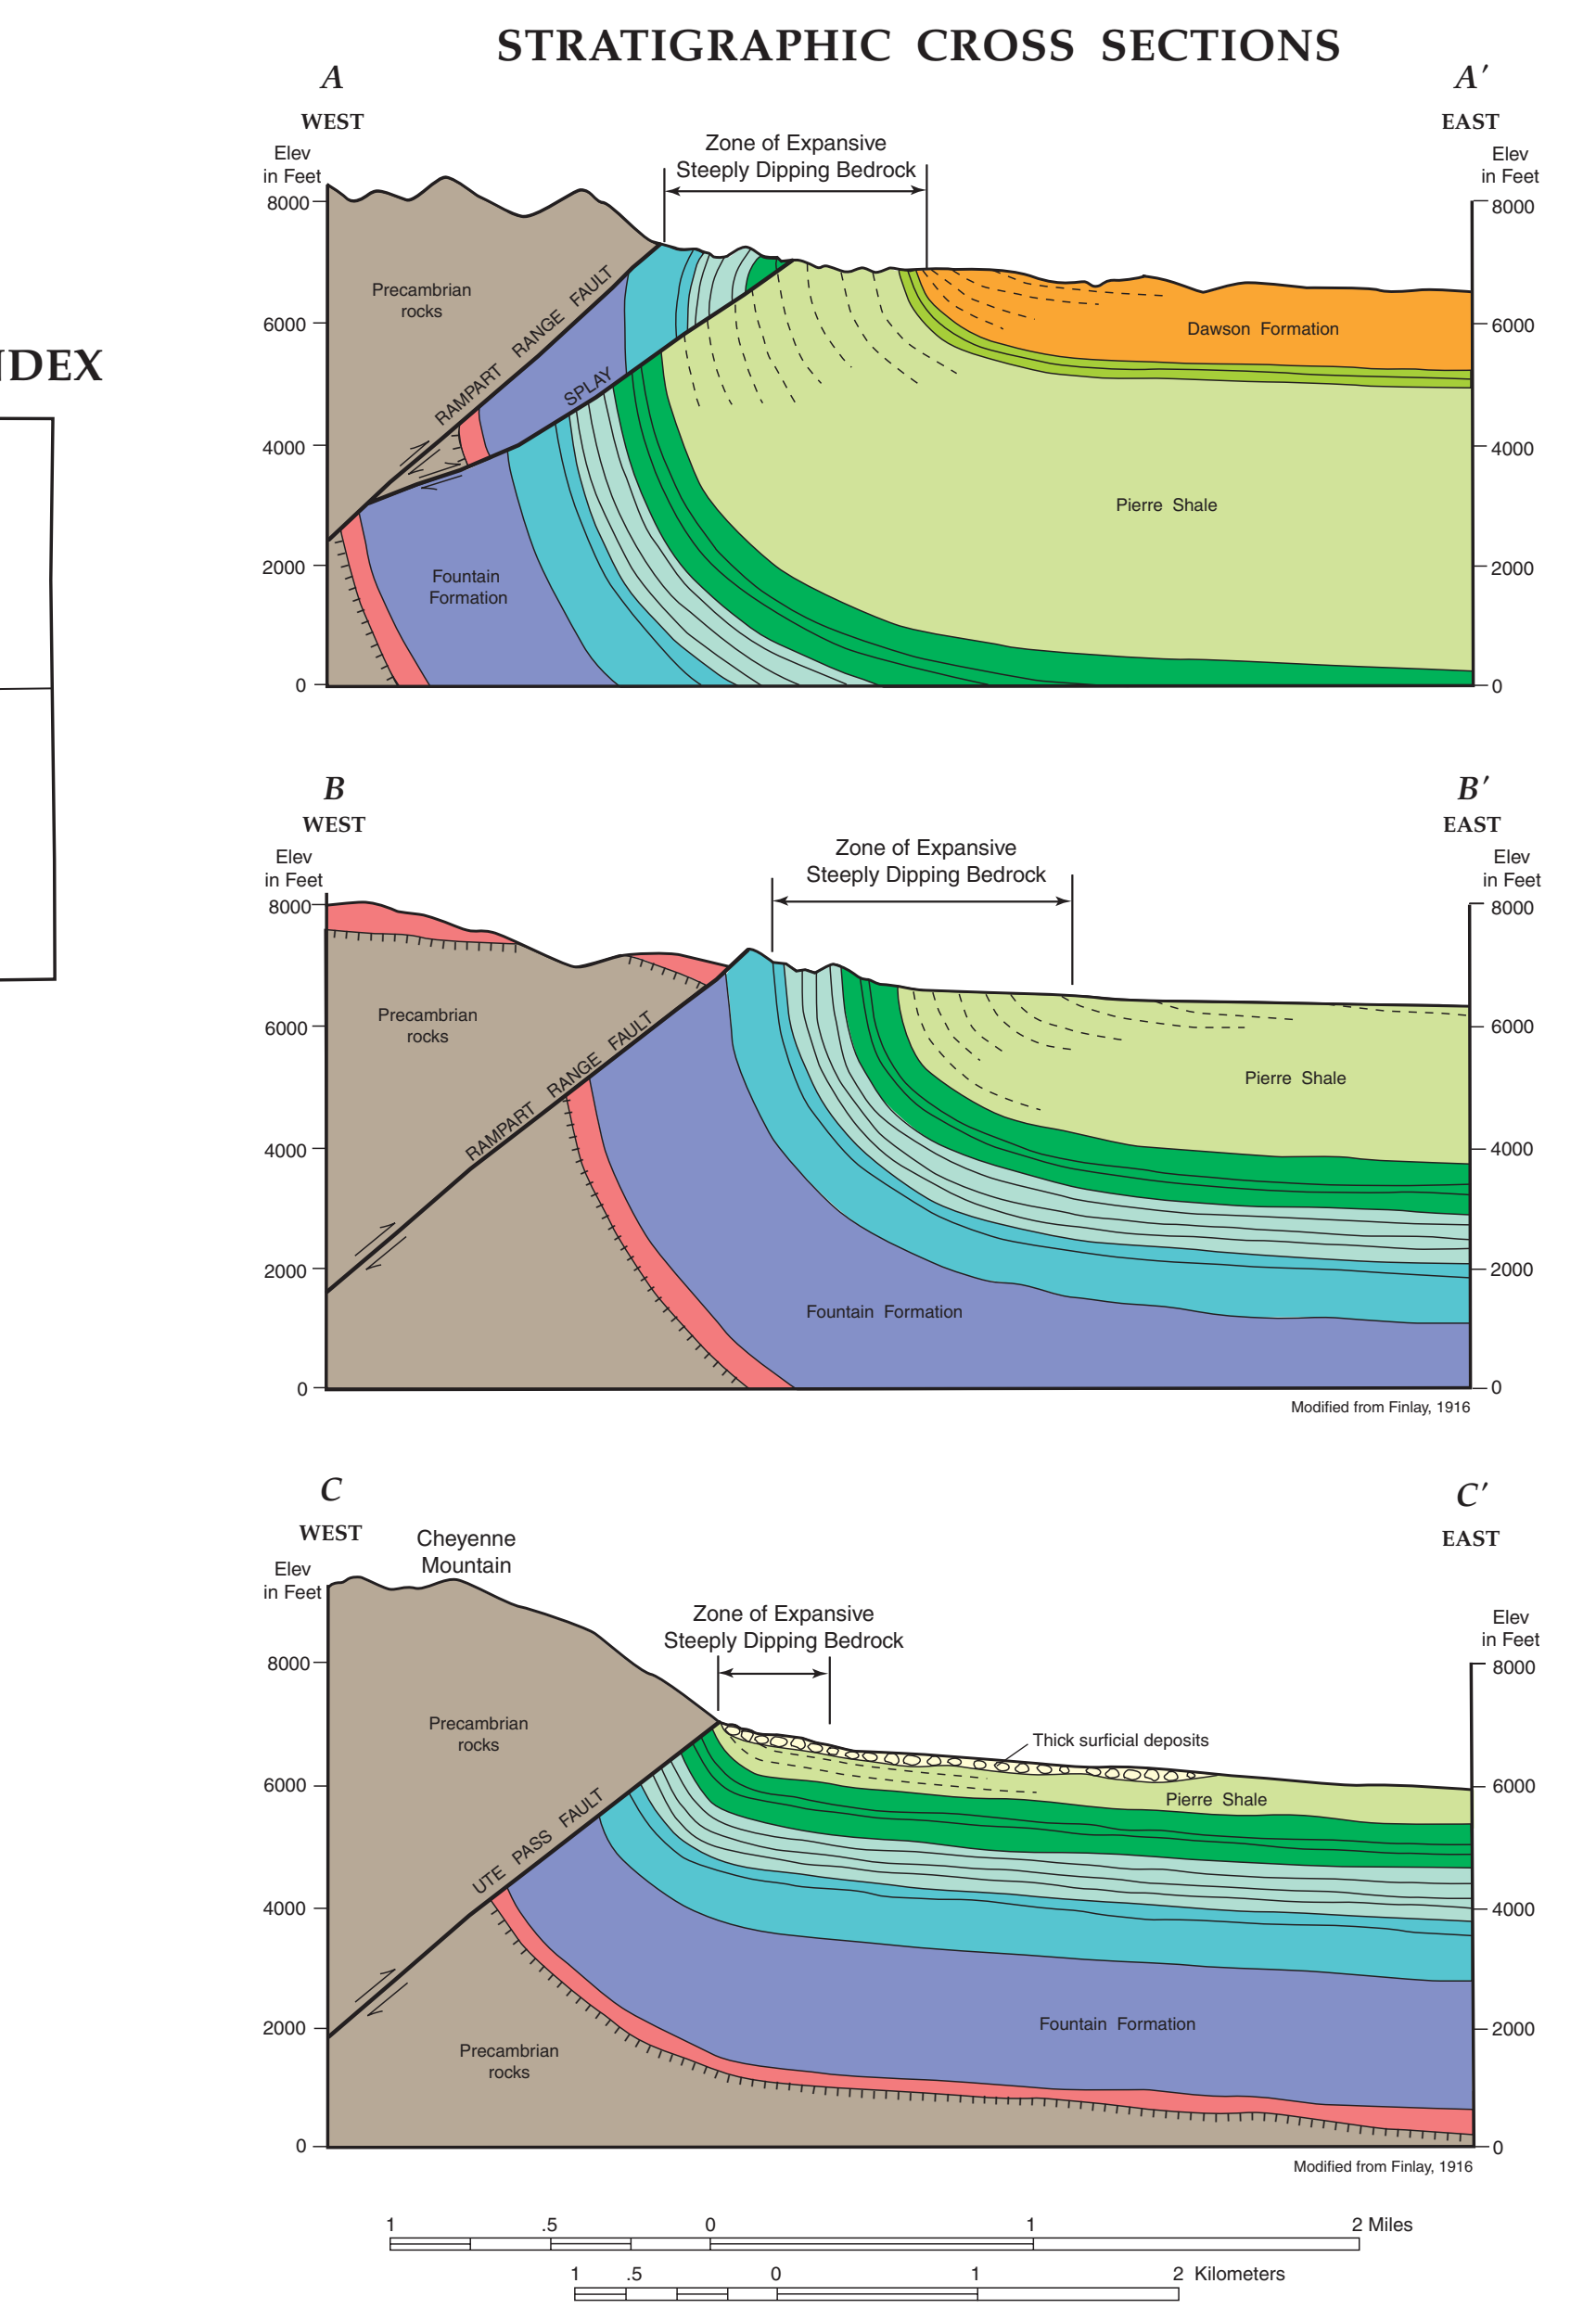
STRATIGRAPHIC COLUMN

Stratigraphic Column	Age	Formation	Member or Informal Unit	Lithology (listed from most to least common)	Thickness (feet)
CENOZOIC Tertiary	CENOZOIC Tertiary	Dawson Formation	Upper part of formation	Sandstone, siltstone, claystone	1,800
			Lower part of formation	Sandstone, siltstone, claystone	200
		Laramie Formation		Sandstone, claystone, siltstone, coal	250
MESOZOIC (Jurassic, Cretaceous)	MESOZOIC (Jurassic, Cretaceous)	Fox Hills Sandstone	Upper transition zone	Siltstone, sandstone, claystone	590
		Pierre Shale	Main part of formation	Claystone, siltstone, sandstone, limestone	3,150-4,800
		Niobrara Formation	Smoky Hill Shale	Siltstone, claystone, limestone, chalk	530
			Fort Hays Limestone	Limestone	30-40
		Carlile Shale		Claystone, siltstone, limestone, sandstone	300
		Greenhorn Limestone		Sandstone, siltstone, claystone	400
		Granger Shale		Claystone, siltstone, sandstone, limestone	225
		Dakota Sandstone		Sandstone, siltstone, gypsum, limestone	20

Purgatoire Formation		Siltstone, sandstone, claystone, limestone, gypsum	180
		Morrison Formation		Sandstone, conglomerate	700-800
PALEOZOIC (Pennsylvanian, Permian, Triassic)	PALEOZOIC (Pennsylvanian, Permian, Triassic)	Lyons Sandstone		Conglomerate, sandstone, siltstone, claystone	4,300
		Fountain Formation		Glen Eyrie Shale	100
PALEOZOIC (Permian, Triassic)	PALEOZOIC (Permian, Triassic)			Older Paleozoic rocks	445
				Precambrian rocks	—

Geology and Boundaries
The dipping bedrock hazard area within the City of Colorado Springs is underlain by sedimentary formations of Pennsylvanian through Cretaceous age (see Stratigraphic Column, below). The western boundary of the hazard area is mapped at the base of the western-most, steeply dipping zone of expansive bedrock. This includes the base of the Lyons Formation and the Glen Eyrie Shale Member at the base of the Fountain Formation. The traces of the Ute Pass and Rampart Range Faults (or, in some locations, splays associated with these faults) are used as the western boundary where these basal contacts are missing due to faulting. The eastern boundary of the hazard area corresponds to the trace of the axis of a monoclinial fold, which separates the moderately to steeply dipping bedrock to the west from the more gently dipping bedrock to the east. This decrease in dip occurs over a relatively short distance, about 50 to 300 feet, due to folding of the bedrock layers (see Stratigraphic Cross-Sections A-A', B-B', and C-C', below). This fold can be observed at an outcrop at the base of Popes Bluff (Location 1 on Map A), at a road cut on Uintah Street near 27th Street (Location 2 on Map A), and in an outcrop along Little Fountain Creek (Location 3 on Map B). Because this eastern boundary is based on limited exposures and evidence, it should be considered approximate.
